9 September 2020

RE: INTERIM AUDIT ADVICE LETTER NO. 1 - REVIEW OF REMEDIAL ACTION PLAN, PROPOSED GREEN SQUARE SCHOOL, 3 JOYNTON AVENUE, ZETLAND, NSW

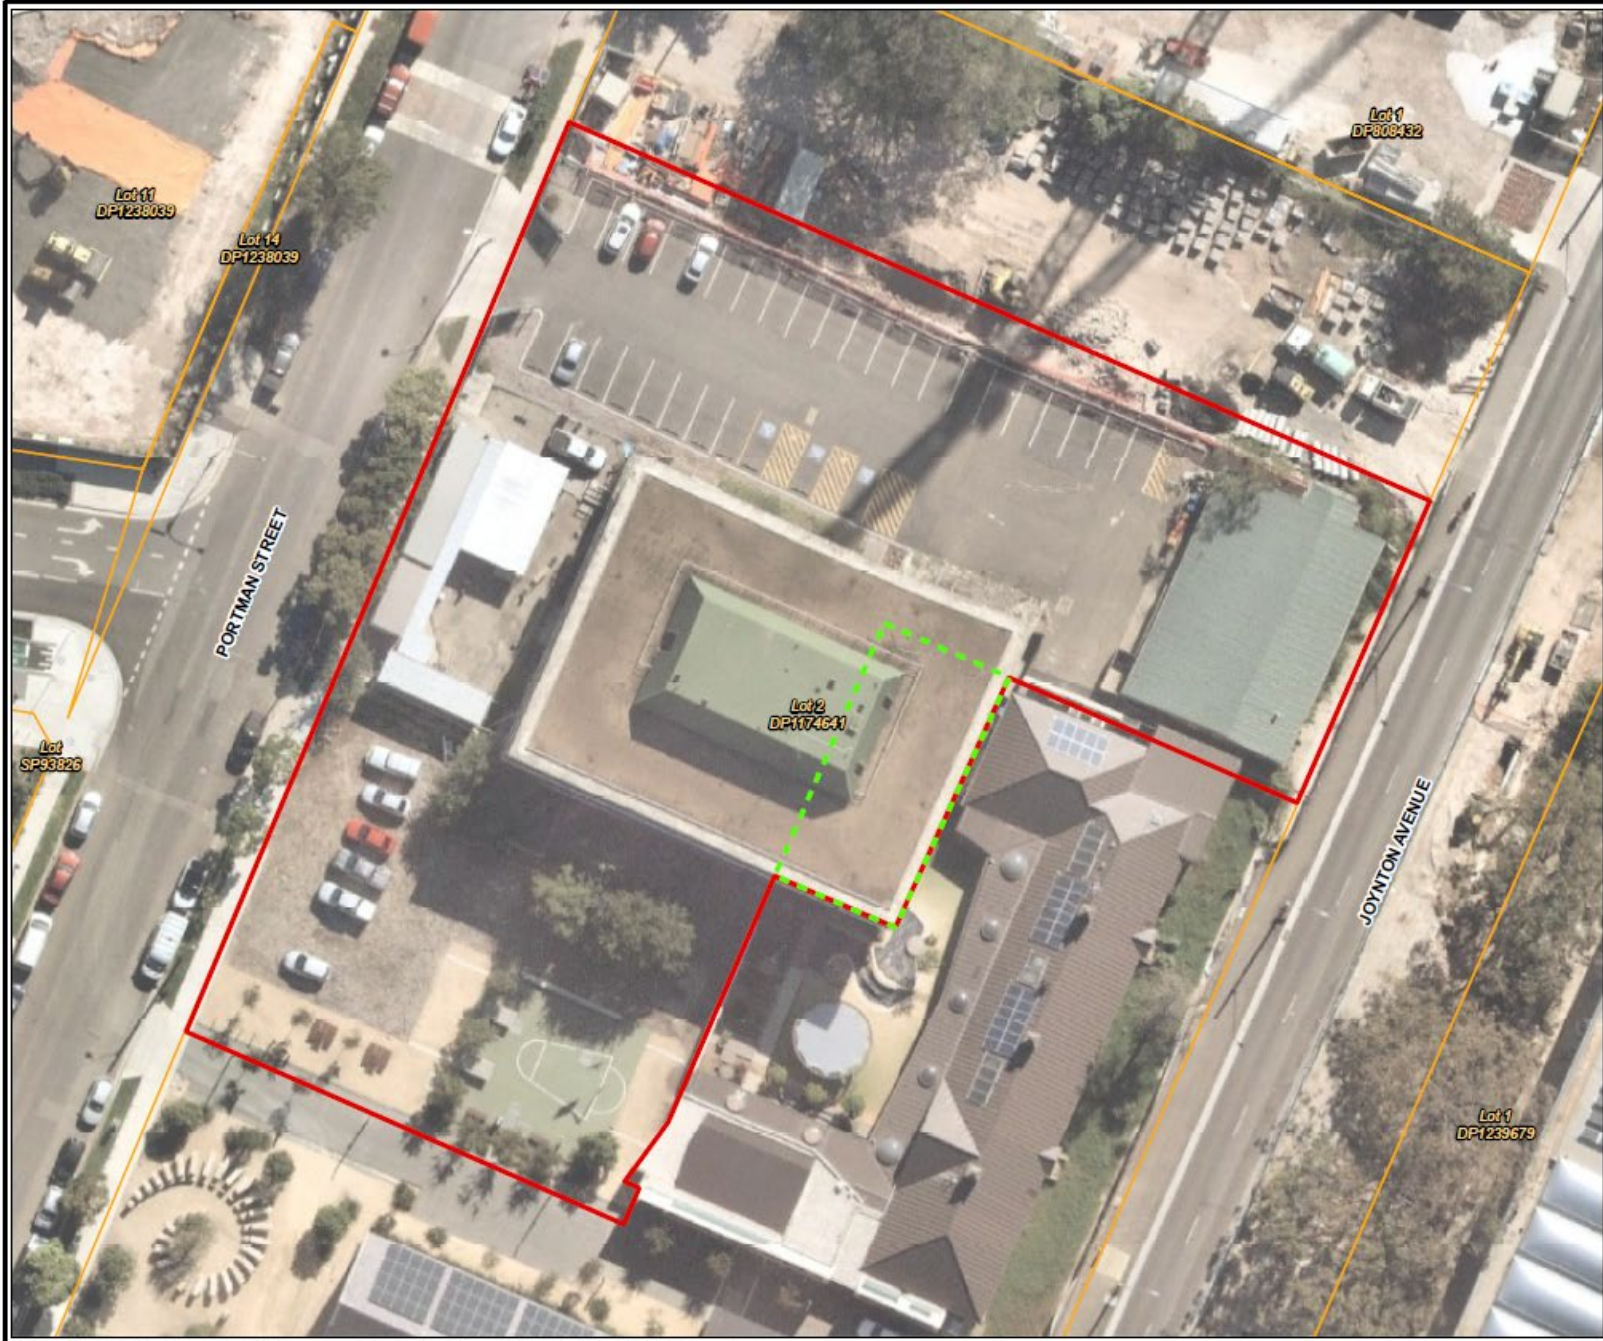
FIGURE 2

The current site audit relates to the proposed development of a school (Green Square Public School) (Attachment 2). The current site layout, including the location of the proposed playground to be dedicated to the adjacent childcare, is shown in Attachment 3.

- Legend:**
- ▭ Approximate Site Boundary
 - ▭ Proposed Childcare Centre
 - ▭ Playground Boundary
 - ▭ Cadastre (NSW LPI, 2020)

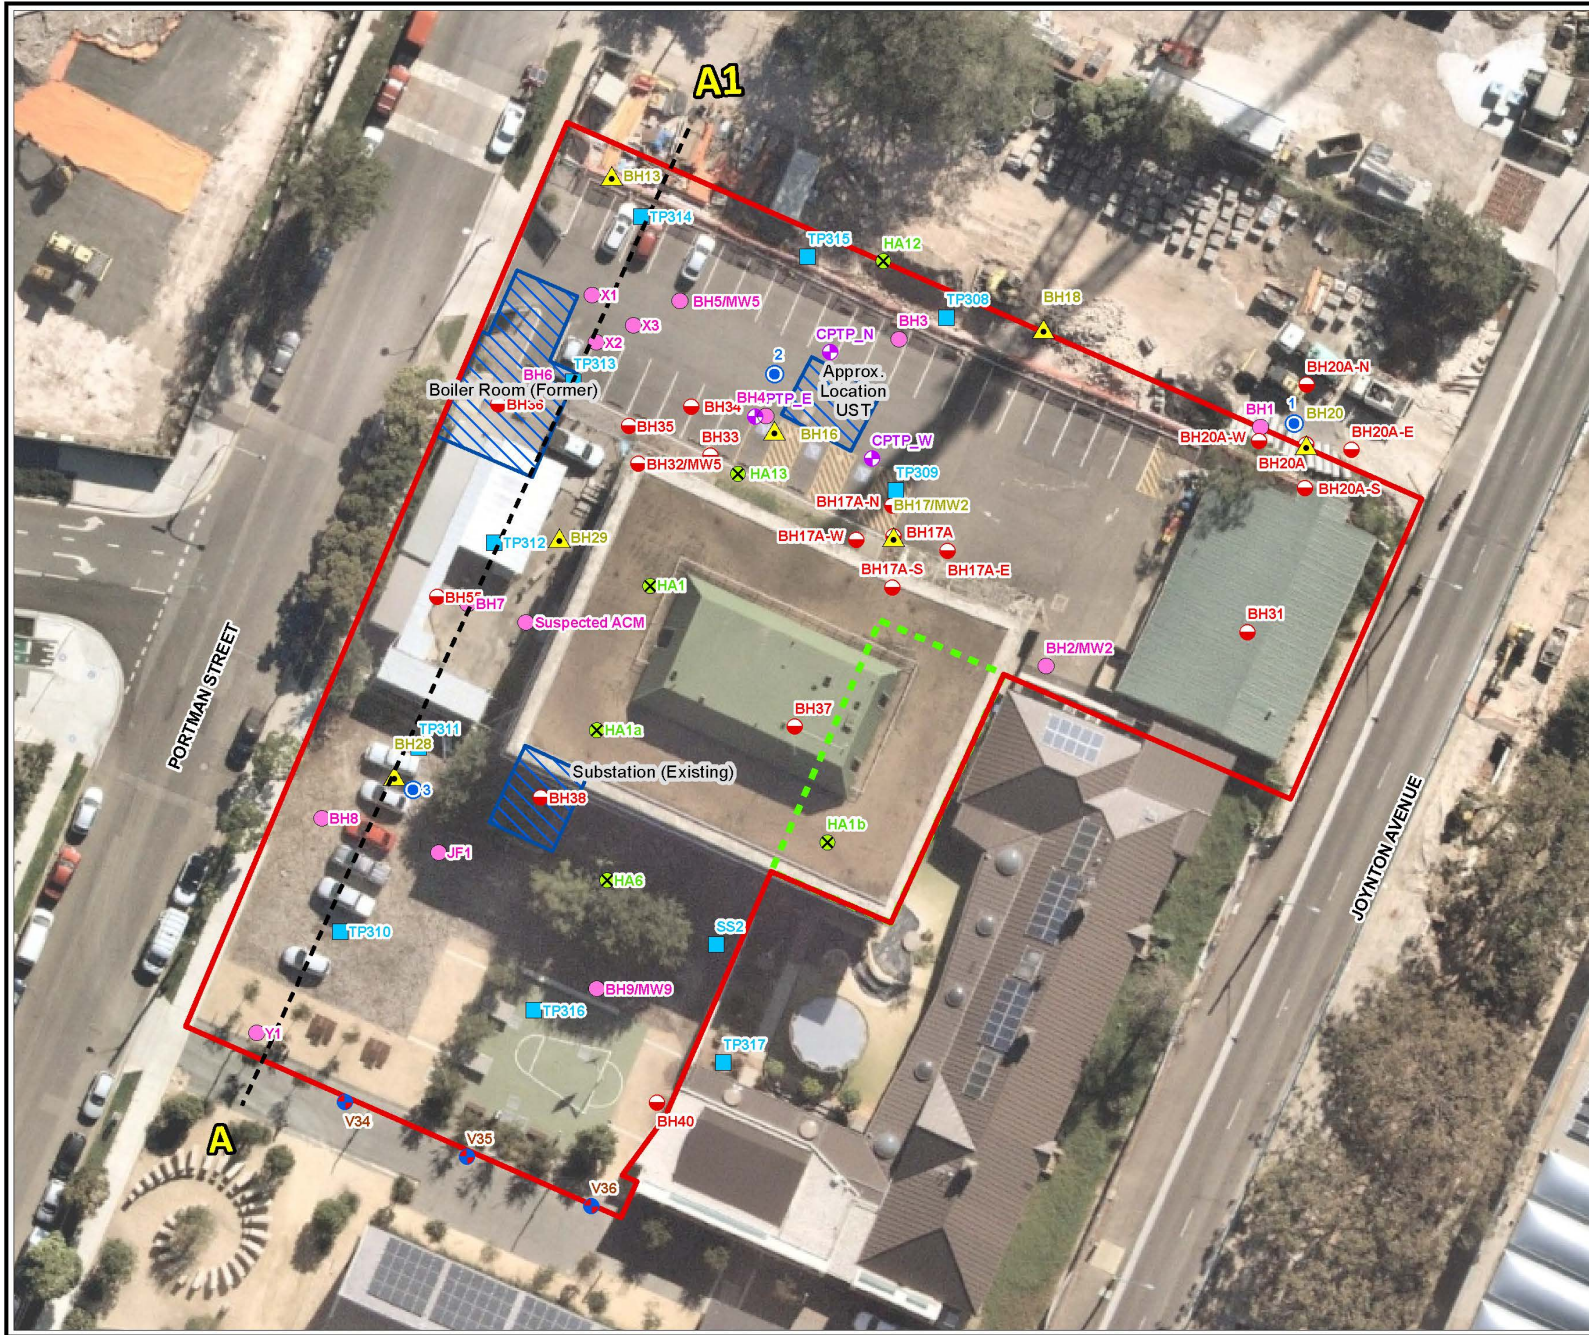
Attachment 4: Historical Sample Locations

Over 50 boreholes have been undertaken at the site during investigations between 1998 and 2018 (Attachment 4). The sub-surface profile encountered is summarised by the Auditor in Table 5.1.

- Legend:**
- Approximate Site Boundary
 - Approximate Childcare Centre Playground Boundary
 - Site Features
 - Cadastre (NSW LPI, 2020)
- Historical Sample Locations**
- DP 1998
 - ✕ GA 2000
 - ▲ DP 2007
 - JBS 2012
 - EIS 2014
 - AECOM 2018
 - EIS 2018
 - JBS&G 2018
- Cross Section (A-A1) (See Fig 6)
