School Infrastructure NSW
Green Square Public School
Remedial Action Plan

3 Joynton Avenue
Zetland NSW

3 September 2020
58719/129939 (Rev 1)
JBS&G Australia Pty Ltd

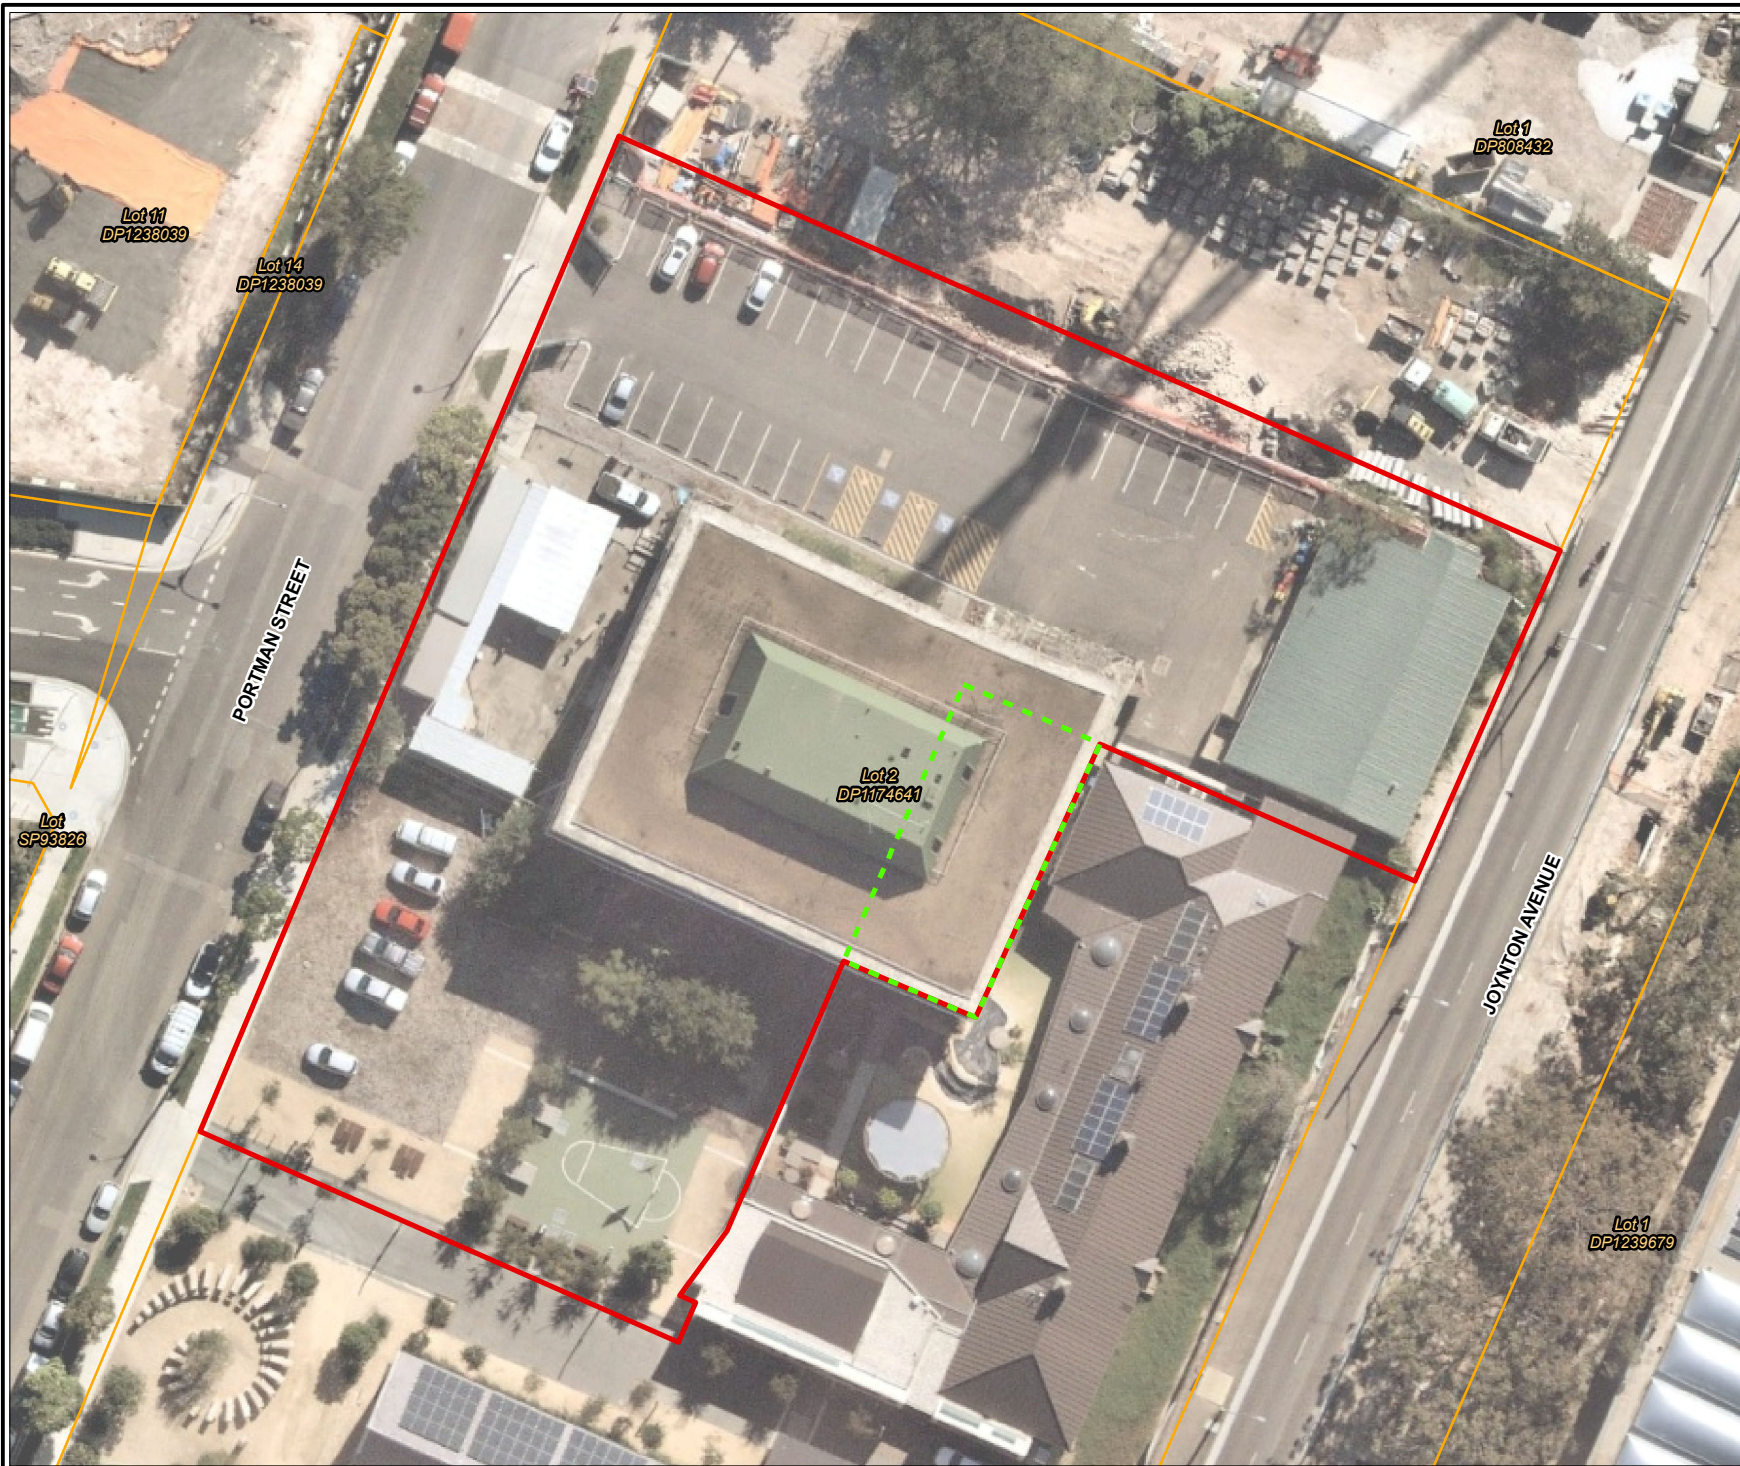
FIGURE 2

CURRENT SITE LAYOUT

DP (2007) further reported that three large reinforced concrete gatic covers were observed in the northern section of the former RSSH site in front of the former orthotics building in the centre of the lawn area identified as possible petrol USTs. It is understood that these features have been removed with the construction of the temporary car park circa 2018 (refer to **Figure 2**).

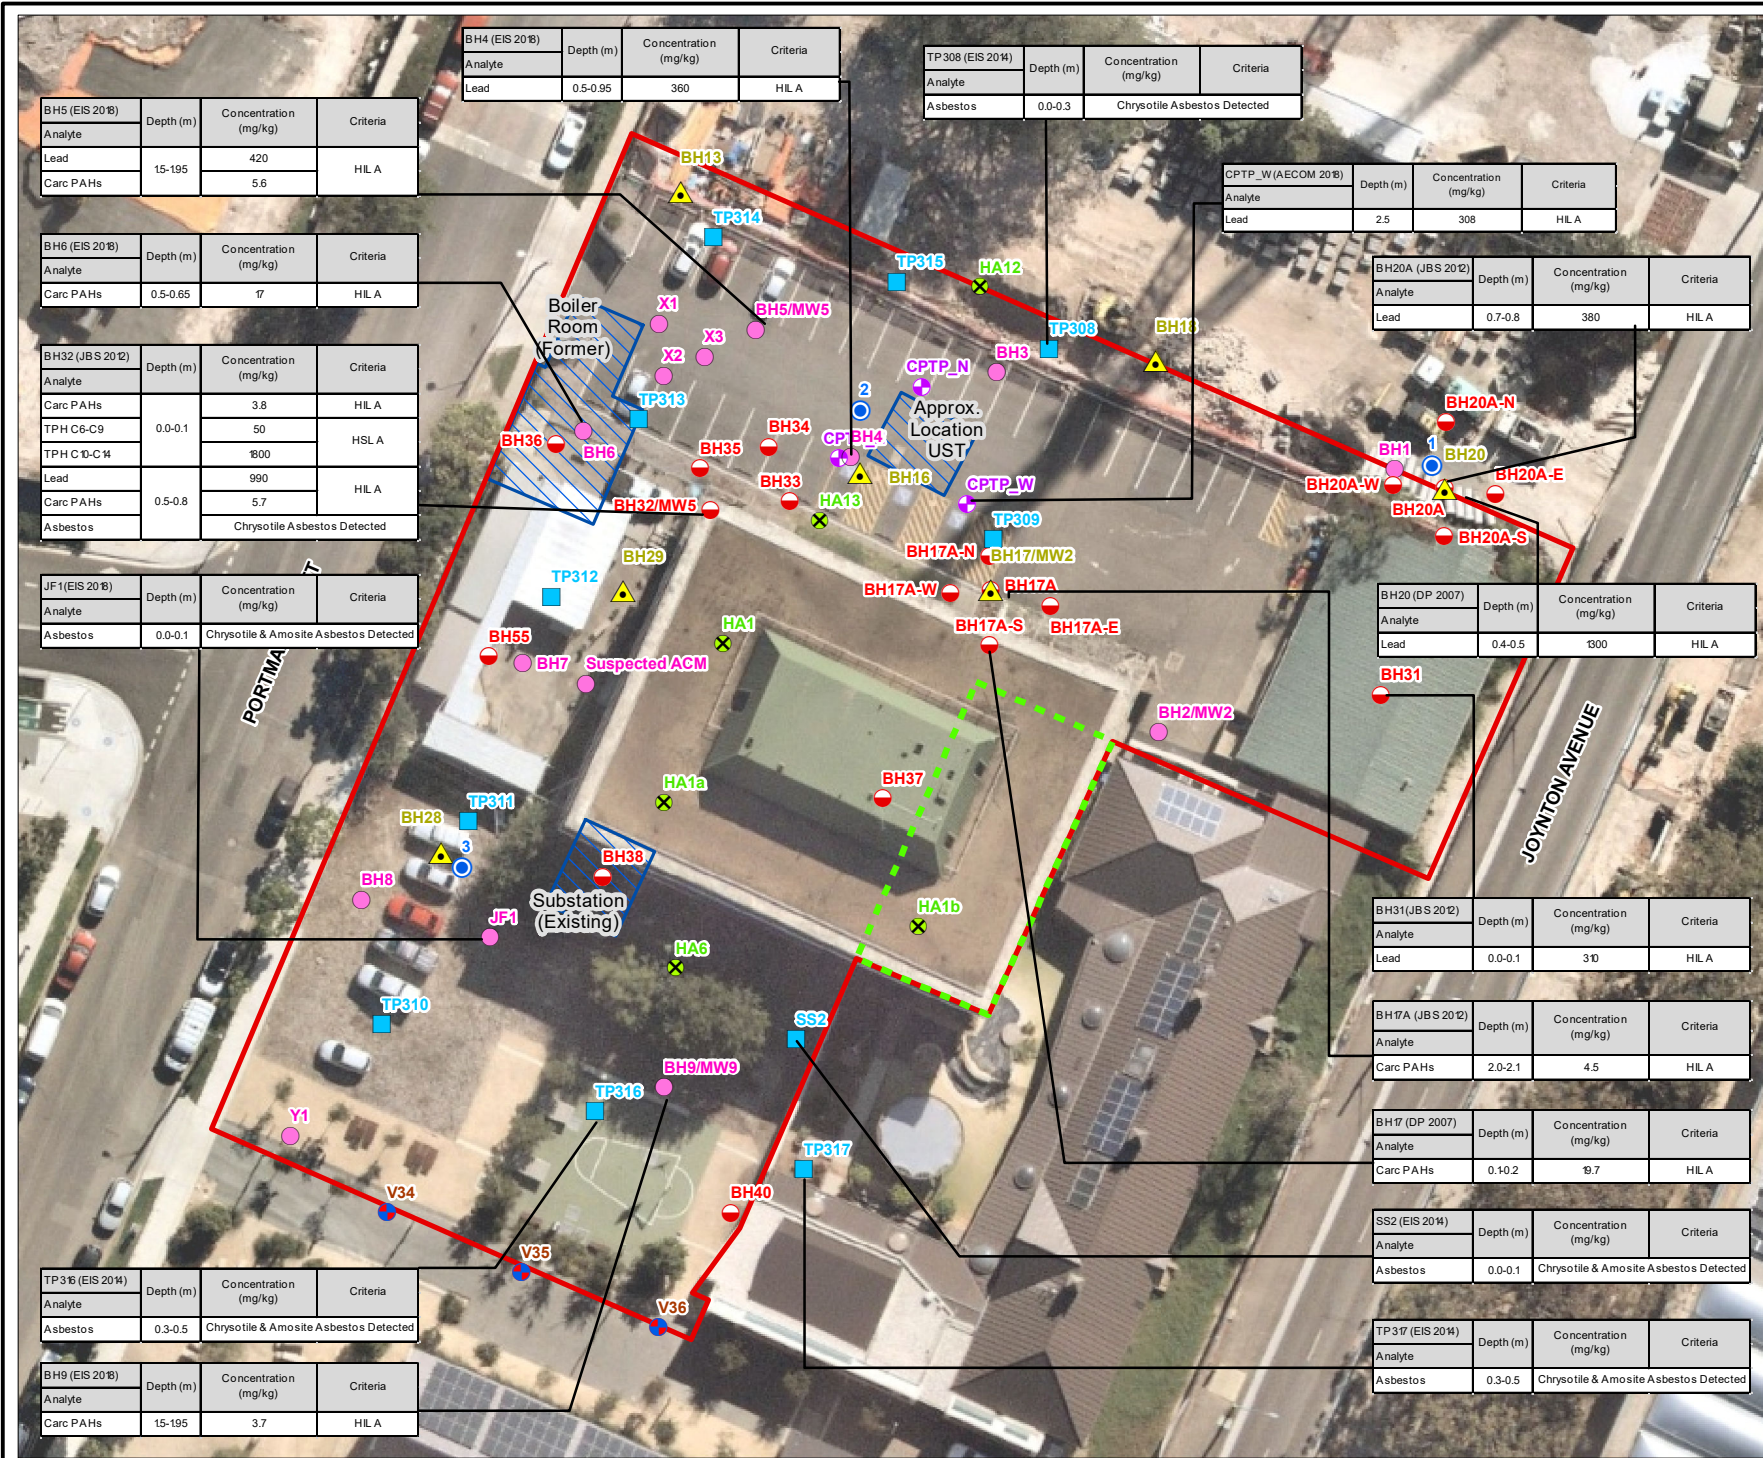
FIGURE 3

**PROPOSED DEVELOPMENT
PLAN**

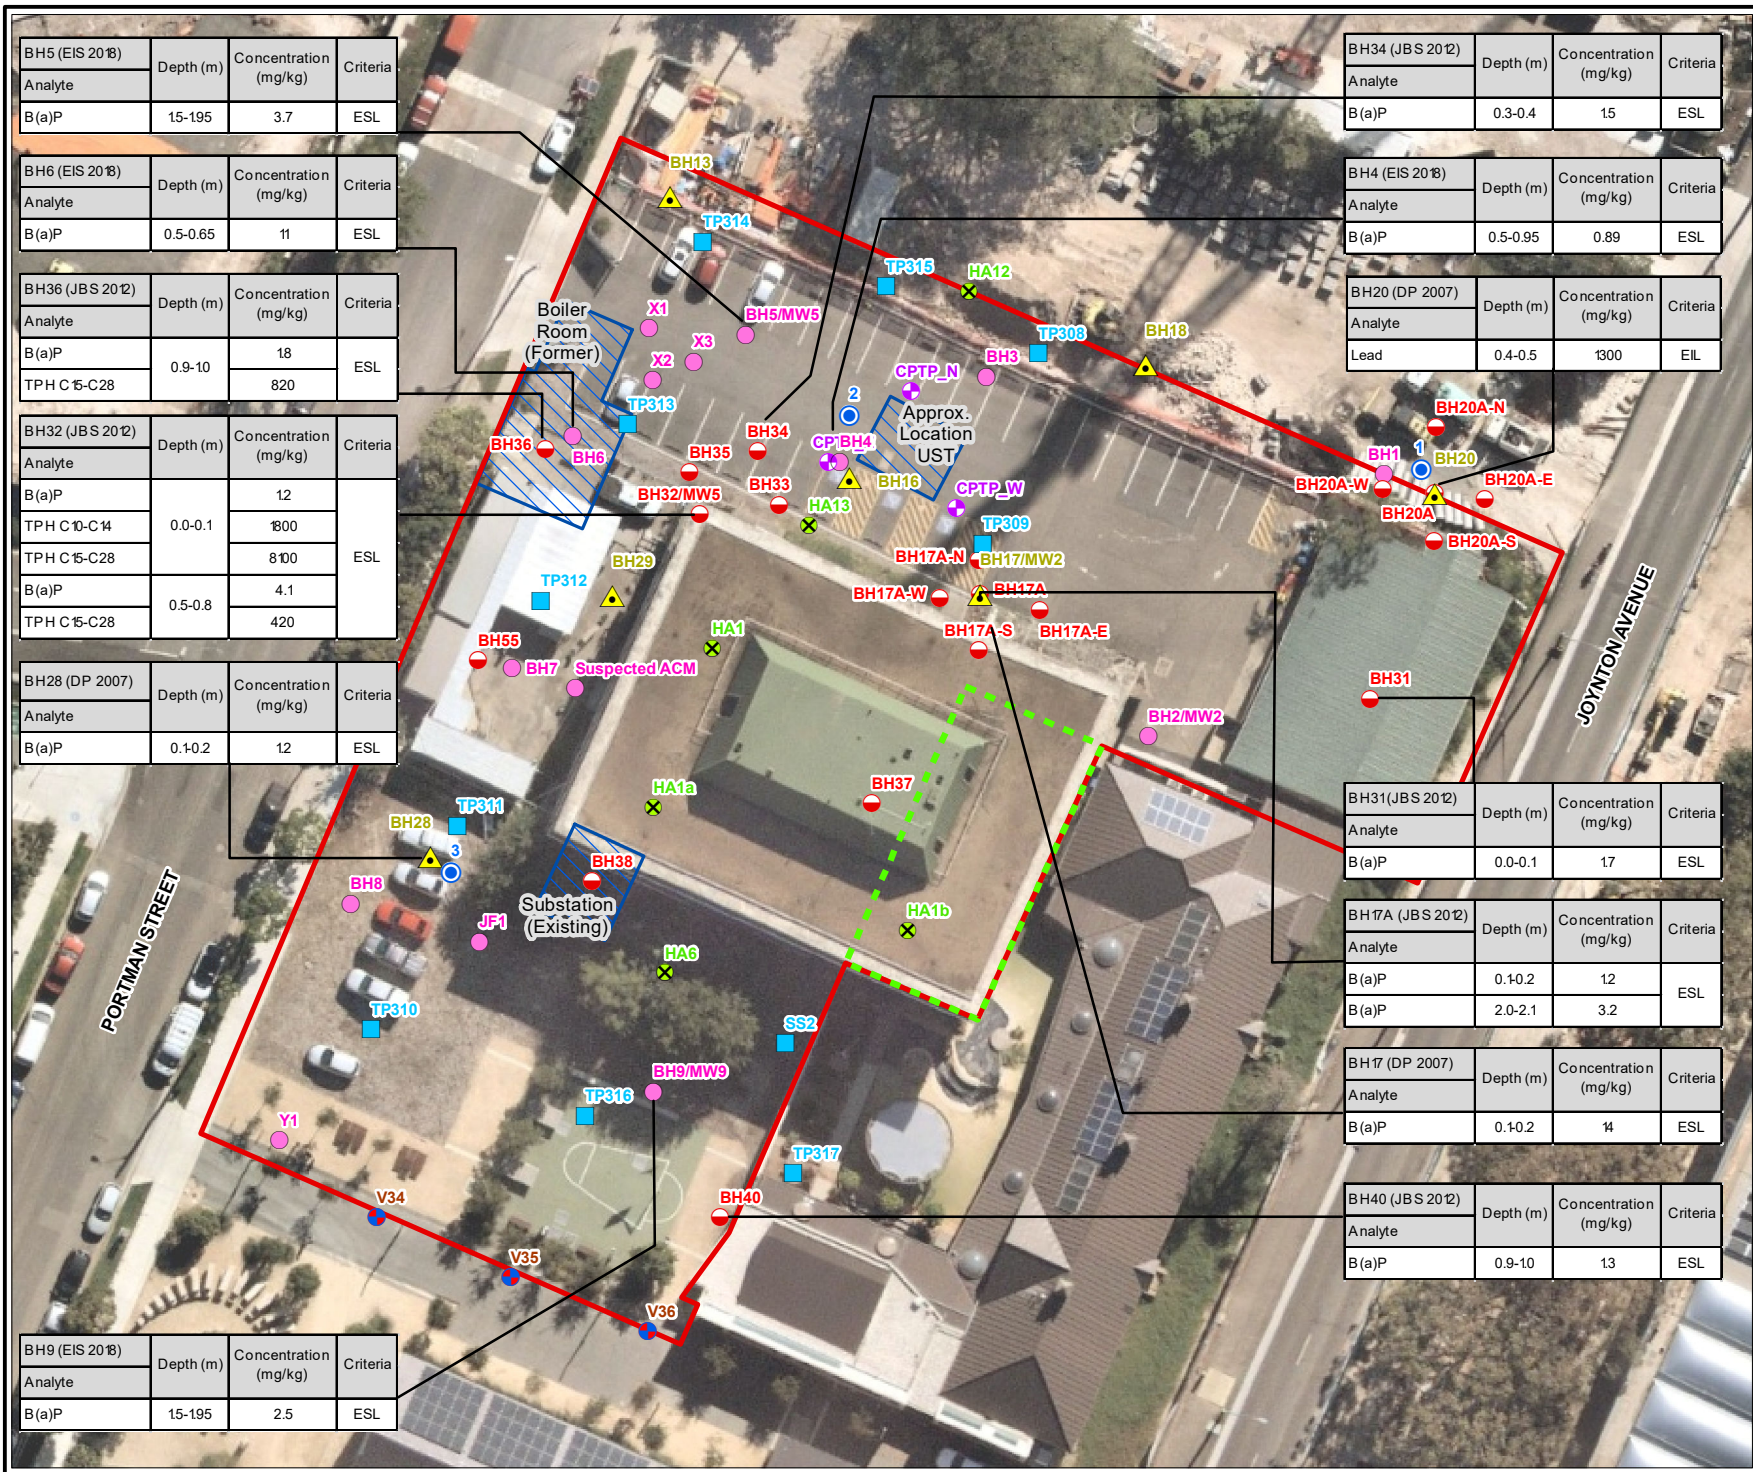
FIGURE 5A

SOIL CRITERIA EXCEEDANCES (HUMAN HEALTH)

Exceedances of validation criteria presented in **Section 7.5** with respect to future land uses are also discussed herein, shown in accompanying summary results tables (**Appendix A**) and on **Figure 5A** and **5B**. Relevant borehole logs are included in **Appendix D**.

Evaluation of the historical data with regard to the current land use scenario and adopted criteria as presented in **Section 7.5**, indicates data present for the following soil data locations exceeded the final adopted assessment criteria, as presented in **Figures 5A** and **5B**:

With reference to the adopted criteria in **Section 7.5**, the following samples exceeded the final adopted land use criteria (refer to **Figure 5A** and **5B**):

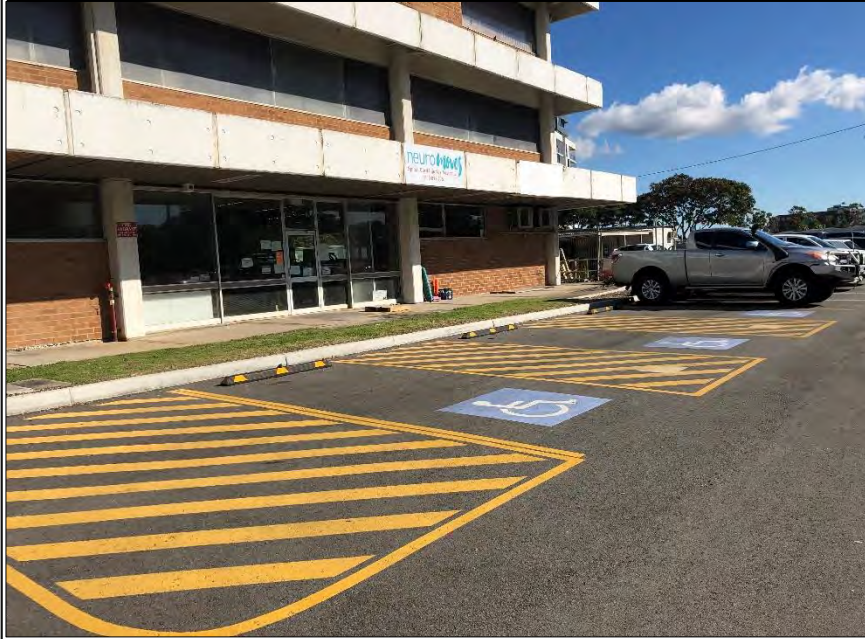
PHOTOGRAPH 5: NORTHERN CARPARK POTENTIAL UST AREA

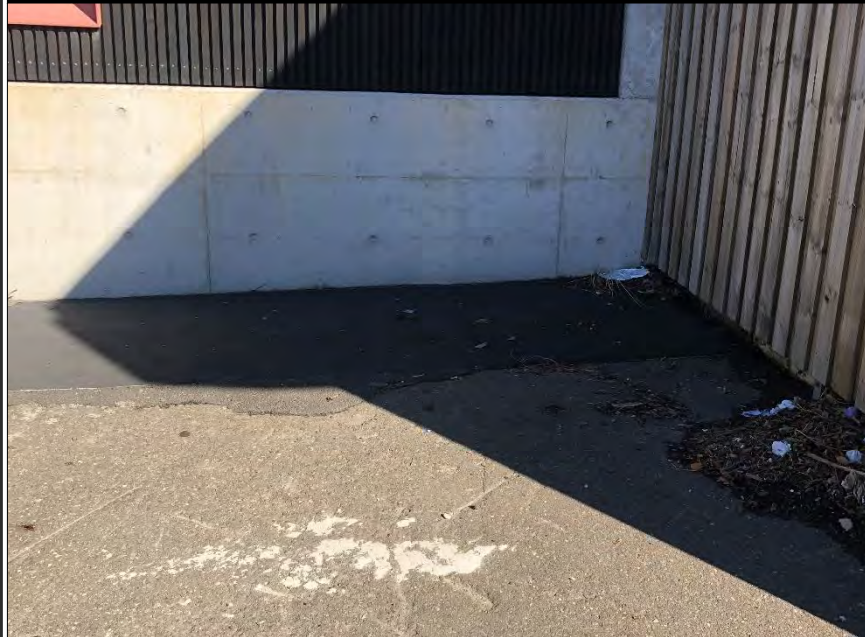
PHOTOGRAPH 7: LOCATION OF GROUNDWATER MONITORING WELL MW2 (EIS 2018) IN SOUTH EASTERN EXTENT OF CARPARK

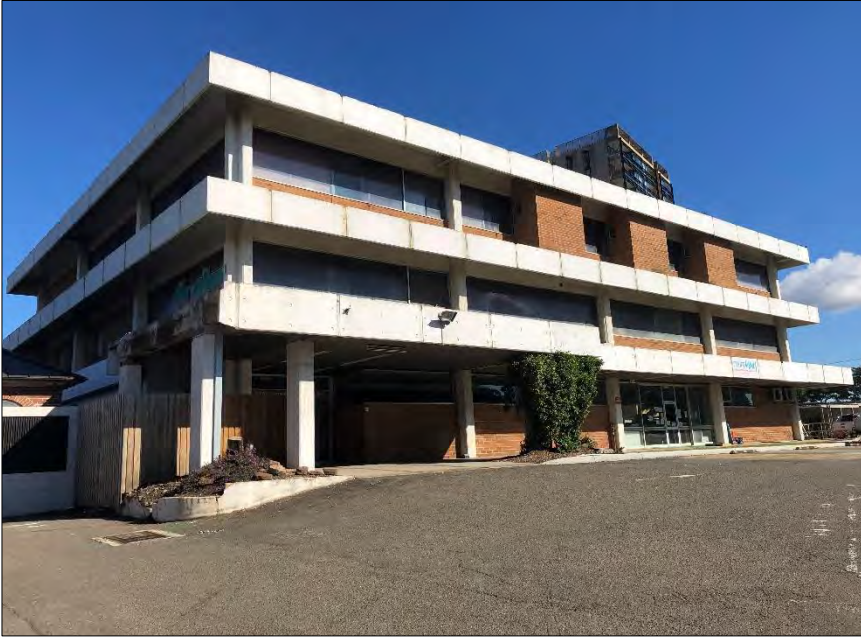
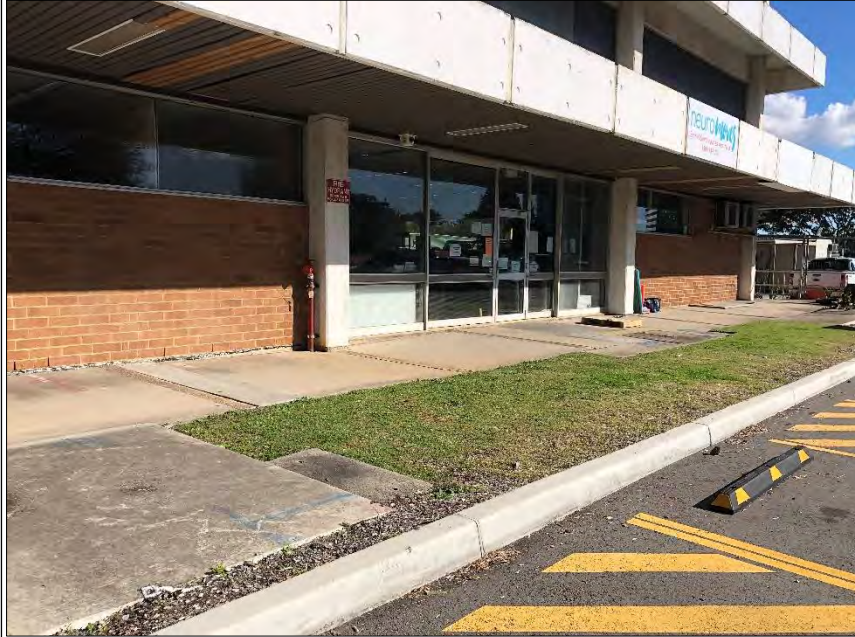
**PHOTOGRAPH 9: NAOMI WING REHABILITATION BUILDING
VIEW FROM NORTHERN CARPARK FACING SOUTHEAST**

PHOTOGRAPH 10: NAOMI WING REHABILITATION BUILDING

The central section of the site was occupied by a three-storey building of brick and concrete construction identified as the Naomi Wing Rehabilitation Building (**Photographs 9 and 10, Appendix E**). The ground floor of Naomi Wing Rehabilitation Building contained a hydrotherapy pool and associated treatment/office/storage rooms and the partial basement level contained a plant room (**Photographs 11 and 12, Appendix E**). Level one was observed to be utilised as an office space by construction contractors undertaking adjacent road/infrastructure construction activities whilst level two was observed to be vacant.

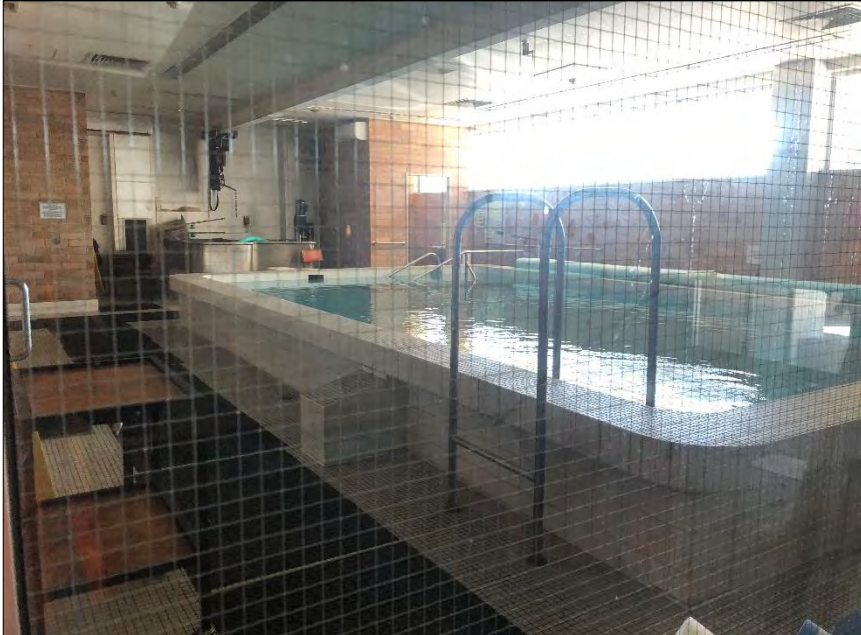
**PHOTOGRAPH 11: NAOMI WING REHABILITATION BUILDING
HYDROTHERAPY POOL LOCATED ON GROUND FLOOR**

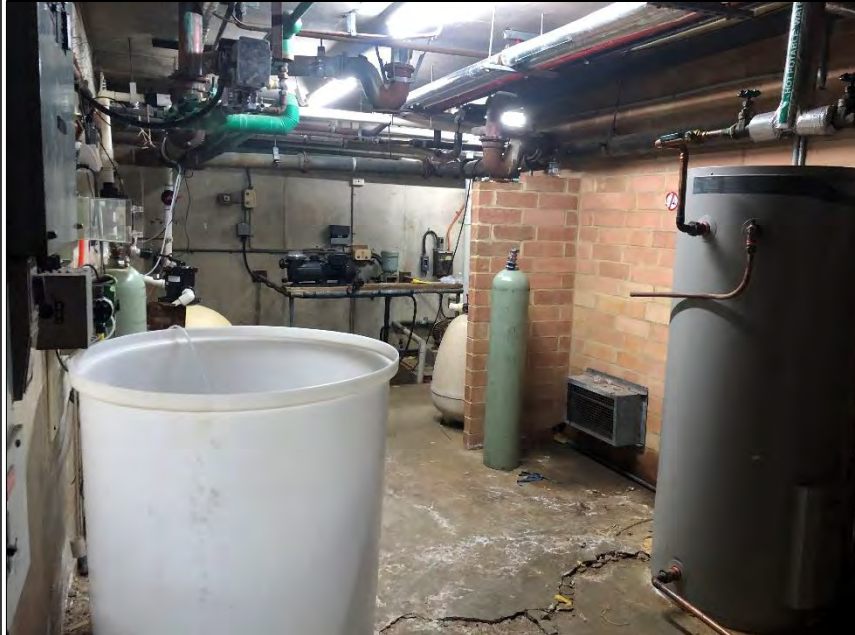
**PHOTOGRAPH 12: NAOMI WING REHABILITATION BUILDING
BASEMENT PLANT ROOM**

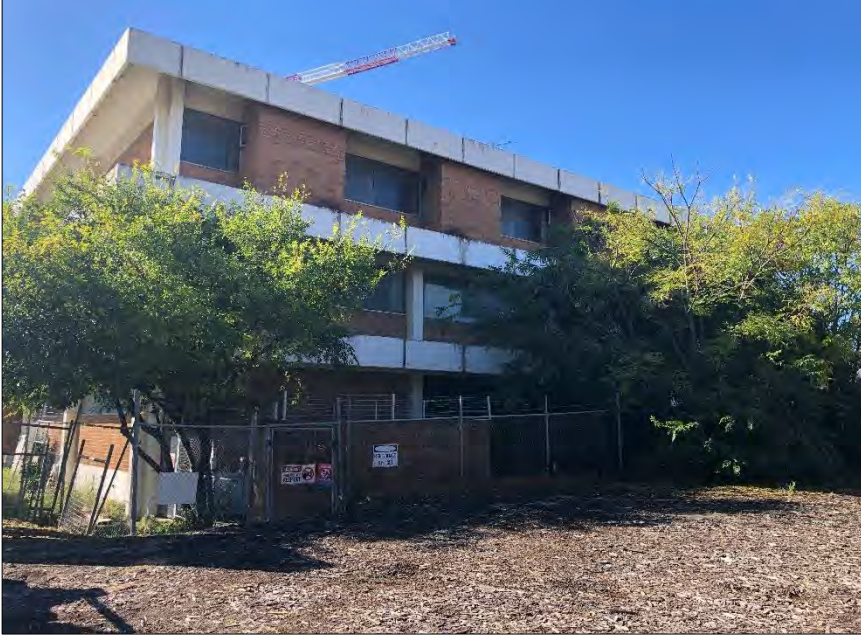
PHOTOGRAPH 13: NAOMI WING REHABILITATION BUILDING VIEW FROM TEMPORARY CARPARK FACING NORTHEAST

A substation was located immediately to the south of the south west corner of the Naomi Wing Building and this area, including the adjacent derelict yard space area was fenced off (**Photographs 13, 14 and 16, Appendix E**). A brick retaining wall and concrete slab associated with former RSSH infrastructure was observed to the south of the substation covered in mulch (**Photograph 15, Appendix E**). The area to the south was retained at a higher level to the ground slab of Naomi Wing Rehabilitation Building and substation indicating filling had occurred in this area.

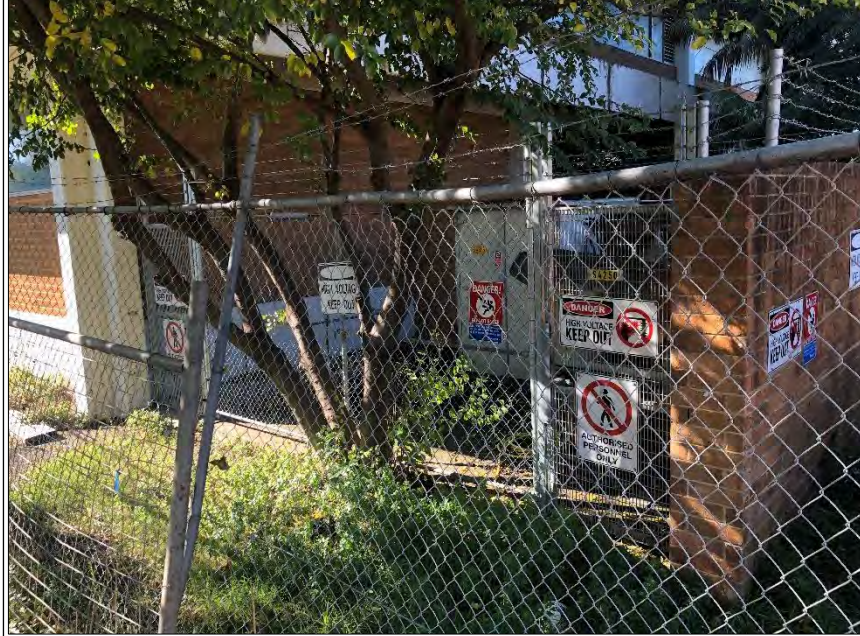
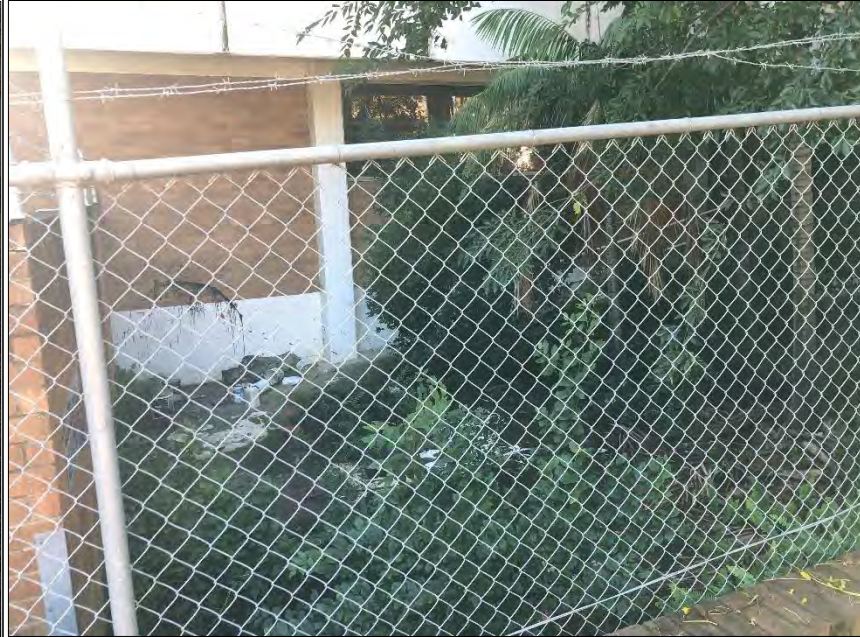
PHOTOGRAPH 14: SUBSTATION ADJACENT TO NAOMI WING REHABILITATION BUILDING

PHOTOGRAPH 16: FENCED AREA TO THE SOUTH OF NAOMI WING REHABILITATION BUILDING INCLUDING SUBSTATION

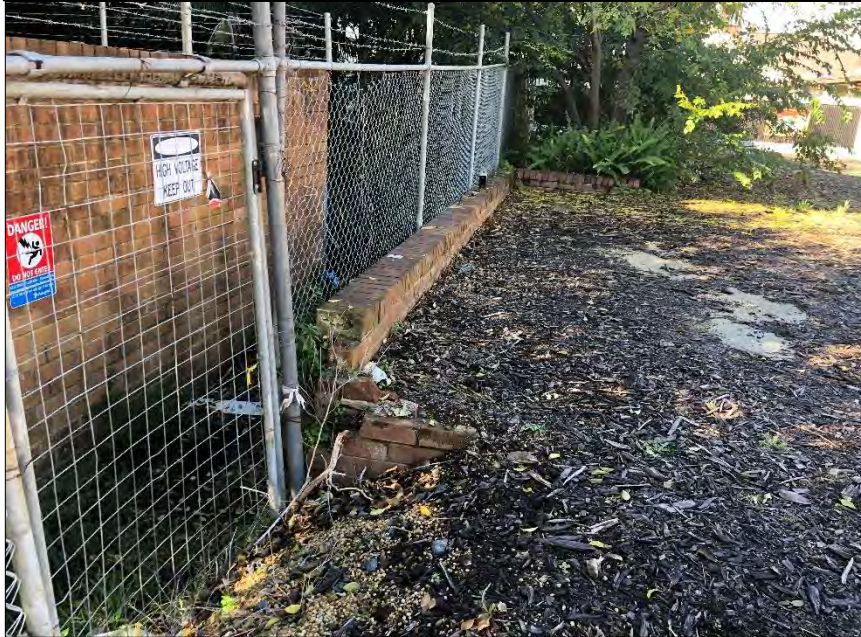
PHOTOGRAPH 15: BRICK RETAINING WALL TO THE SOUTH OF SUBSTATION

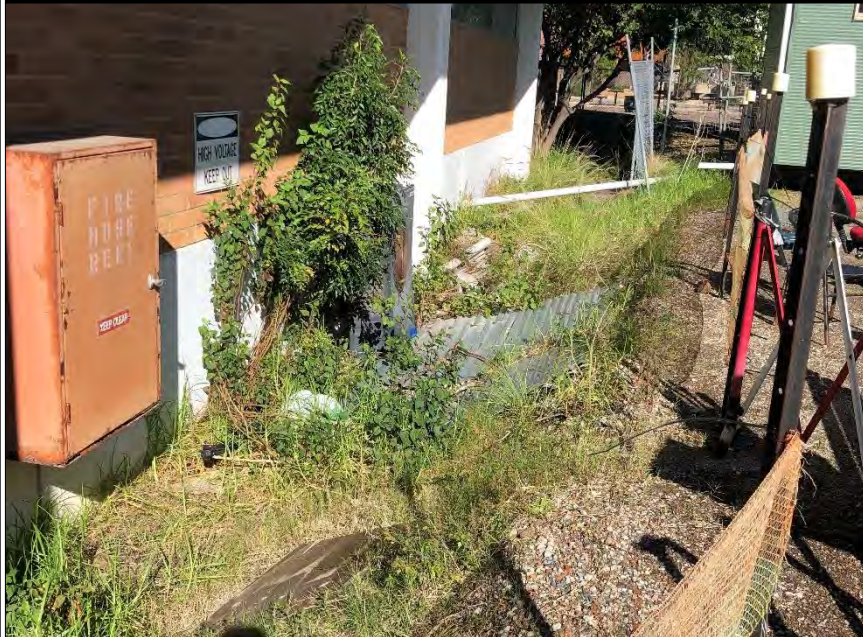
PHOTOGRAPH 19: TEMPORARY SITE OFFICES TO THE WEST OF THE NAOMI WING REHABILITATION BUILDING

Demountable site sheds utilised by construction contractors were observed located adjacent to Portman Street to the west of the Naomi Wing Rehabilitation Building (**Photographs 17 and 18, Appendix E**). The site compound area was generally level with the northern carpark and was retained at a higher level to the ground slab of Naomi Wing Rehabilitation Building indicating filling had occurred in this area (**Photograph 19, Appendix E**).

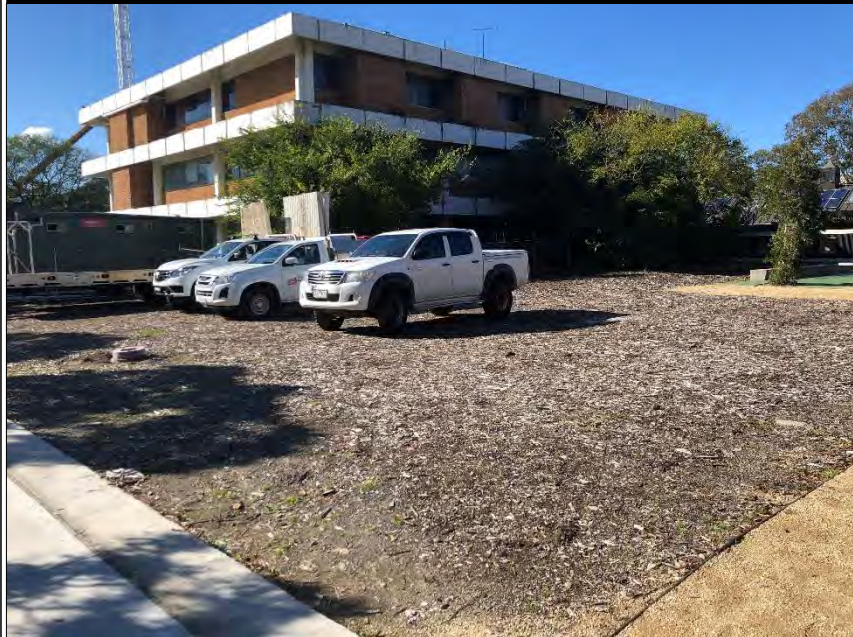
PHOTOGRAPH 20: VACANT AREA SURFACED WITH MULCH USED AS TEMPORARY CARPARK TO THE SOUTHWEST OF THE NAOMI WING REHABILITATION BUILDING

The area to the south west of the Naomi Wing Rehabilitation Building comprised a vacant area surfaced with eucalyptus mulch and was observed to be used for carparking (**Photograph 20, Appendix E**) at the time of the inspection. The area to the south of the substation comprised a community playground understood to have been constructed as part of the adjacent Green Square Community and Cultural Precinct redevelopment works within the southern portion of the RSSH site. This includes a hardstand pavement area with a small basketball court and table tennis tables, surrounded by minor landscaping beds with ground covers and medium to large shrubs (**Photographs 22 and 24, Appendix E**).
