Report on  
Detailed Site (Contamination) Investigation

Student Housing Development  
90-102 Regent Street, Redfern

Project 86852.01  
October 2020

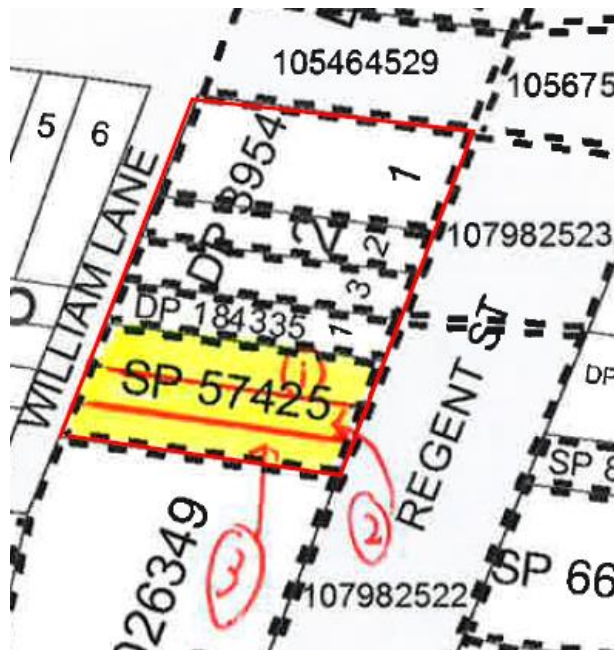
Figure 1: Cadastral Map Extracted from Title Deeds Search

Title deeds dating back to 1904, 1909 and 1924 were obtained for Lot 1 to Lot 3, Section 2, Deposited Plan 3954; Lot 1, Deposited Plan 184335; and SP57425, respectively. Review of the title deeds indicates that SP57425 was previously divided into three parts as shown on Figure 1 below.

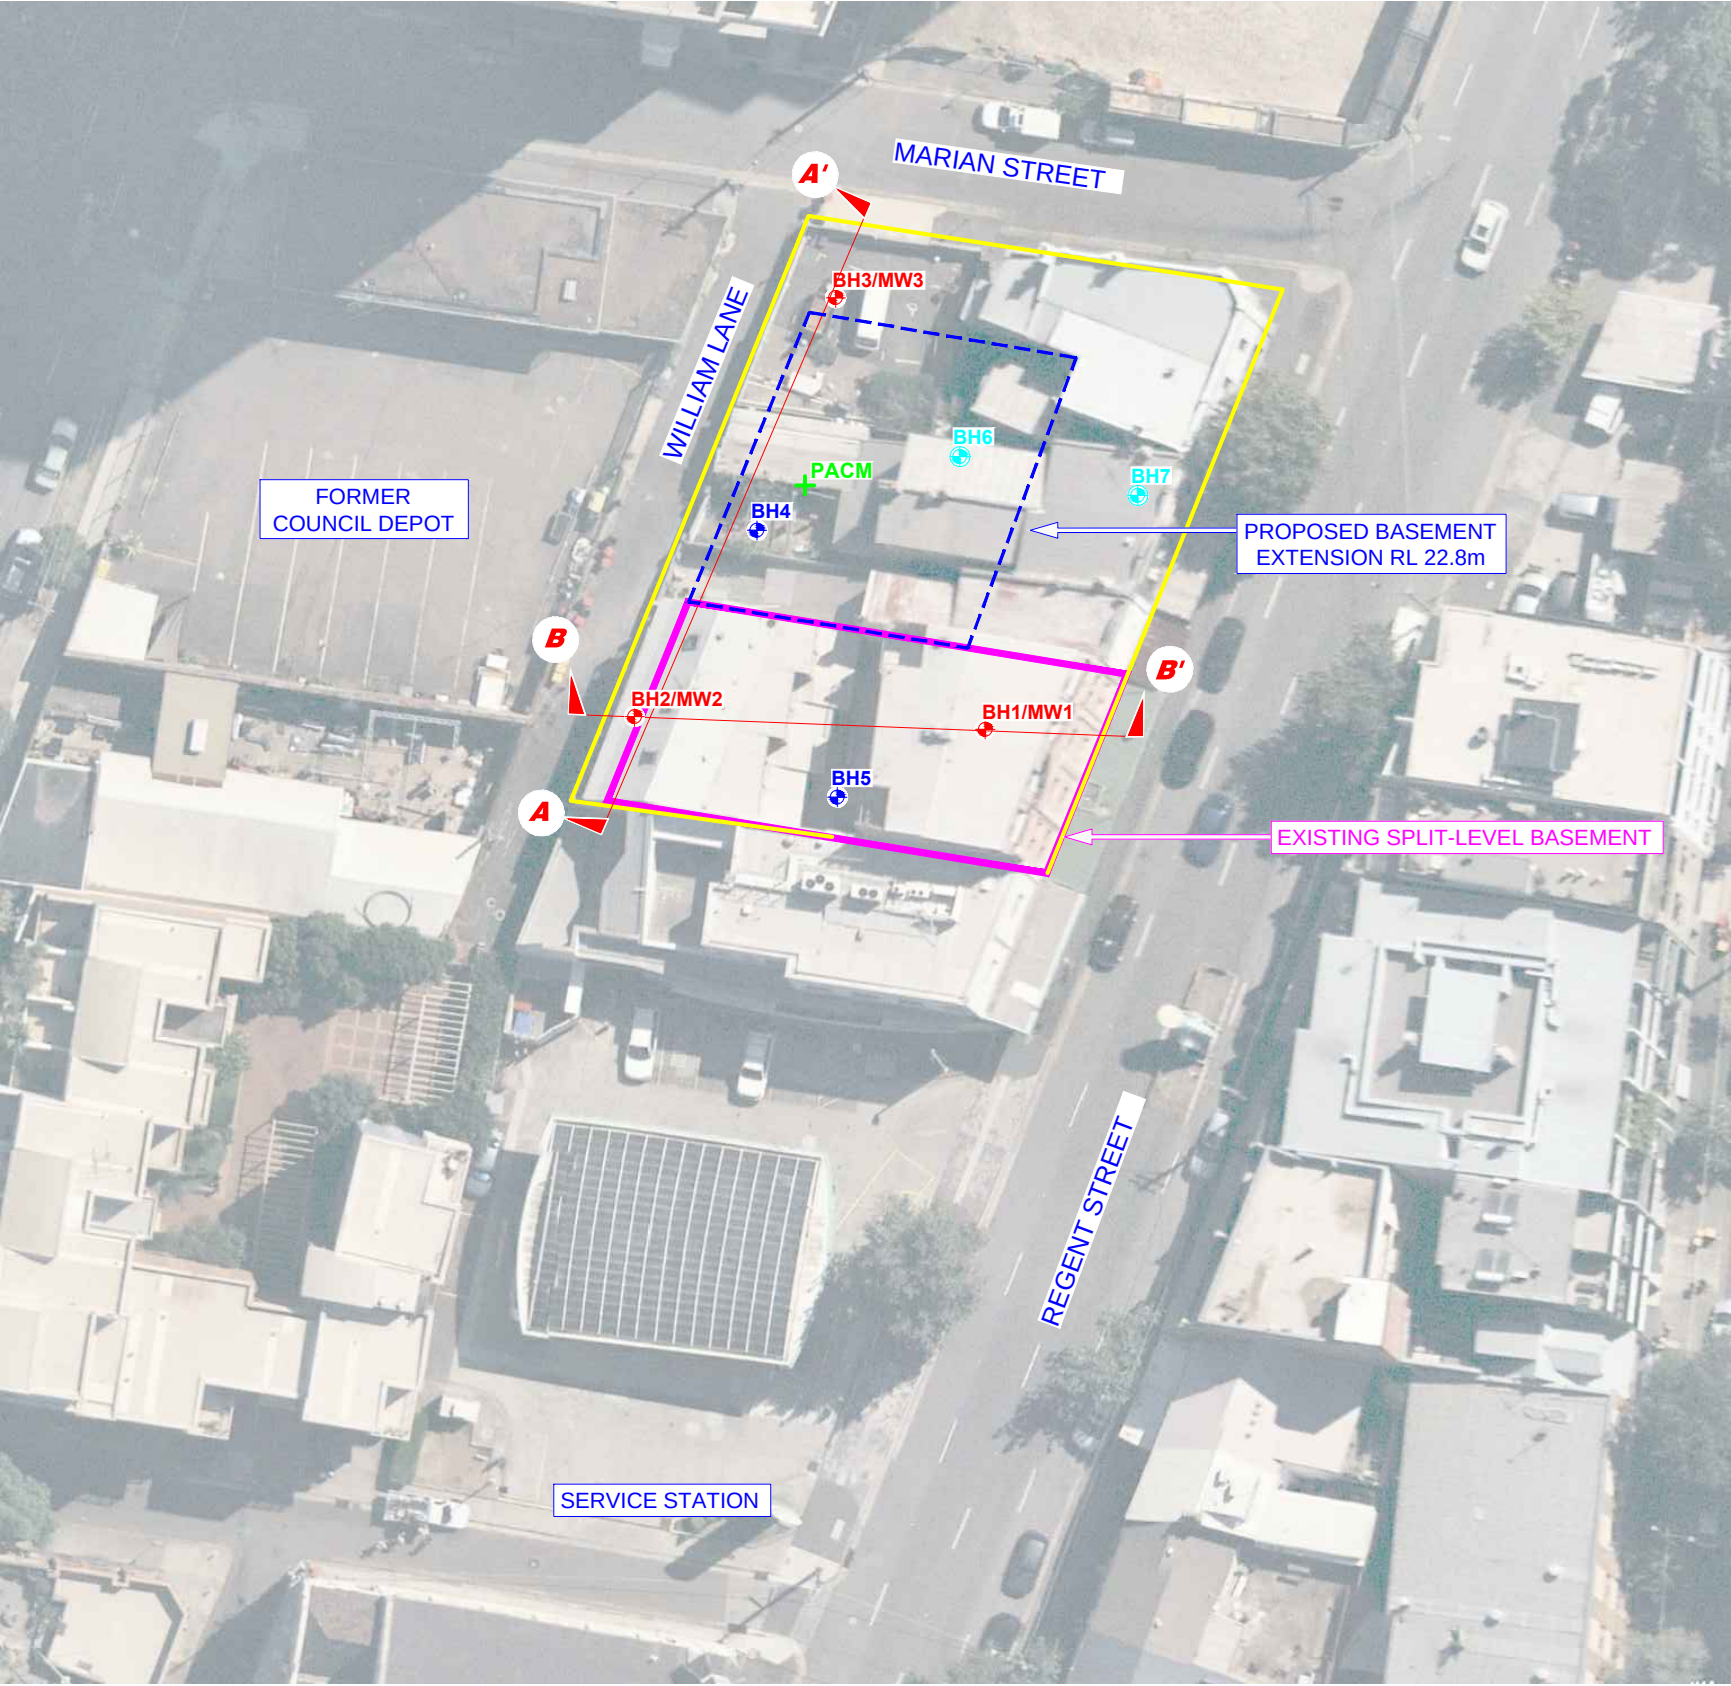
The field work comprised the drilling of seven boreholes, which is consistent with the sampling frequency recommended in the NSW EPA *Sampling Design Guidelines* (1995) for a 2,000 m<sup>2</sup> site. The borehole locations were positioned on the basis of the geotechnical requirements (DP, 2020), but are considered to be appropriately positioned for general site coverage. The borehole locations are shown on Drawing 1, Appendix A.

- The fragment of fibre-cement material observed on the ground surface during the site walkover (PACM, refer to Drawing 1, Appendix A) was confirmed to contain chrysotile and crocidolite asbestos.

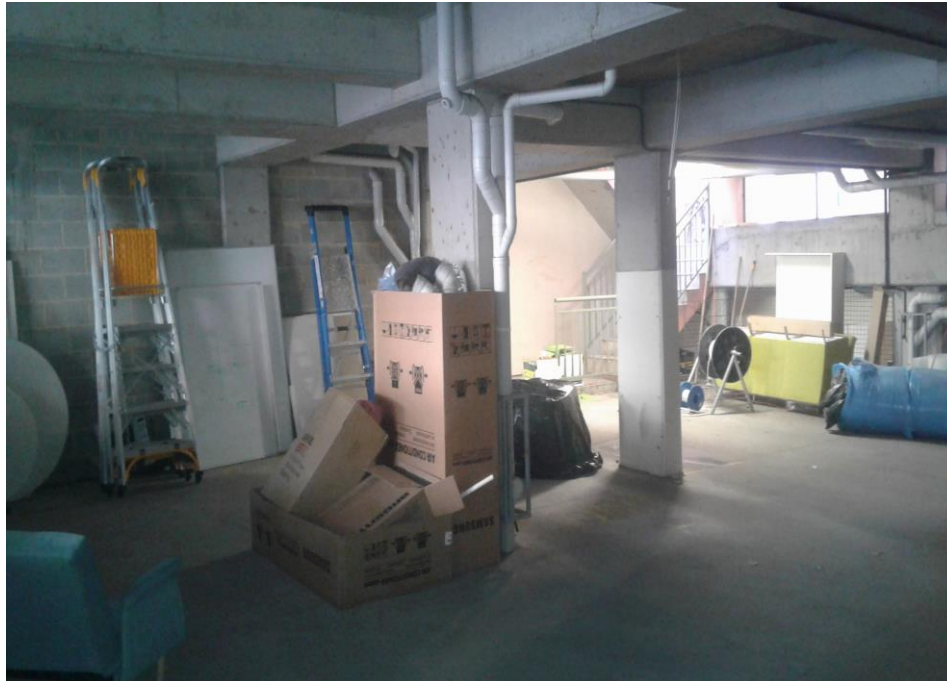
Photograph 1: Basement carpark used as a storage area

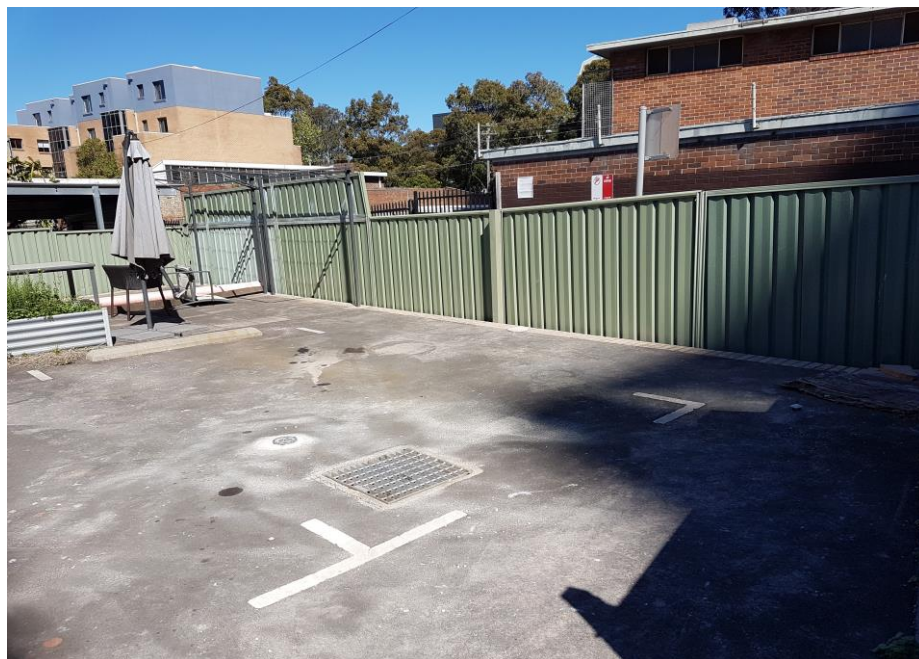
Photograph 2: Rear of No. 90 Regent Street

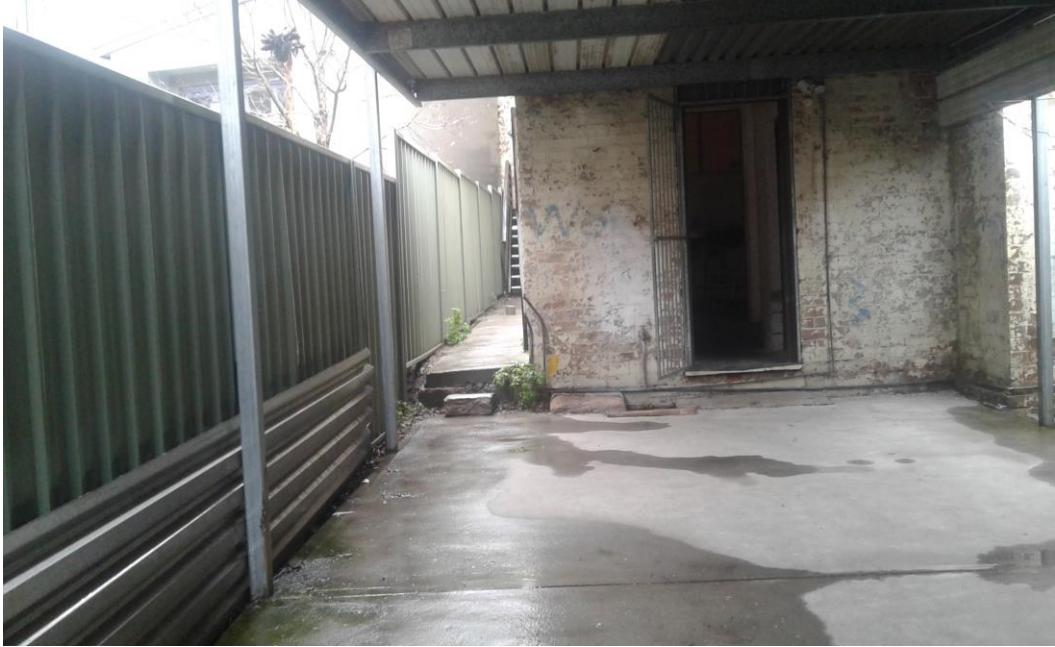
Photograph 3: Rear of No. 92 Regent Street

The remaining properties were un-occupied at the time of the investigation. There was a carport at the rear of No. 92 Regent Street (Photograph 3) with the ground surface covered in concrete hardstand. The exterior wall and some of the interior brick walls were observed to have paint flaking off (Photograph 4). The interior of the building was mostly empty with a bathroom, sink facilities and some cabinets (Photograph 5).

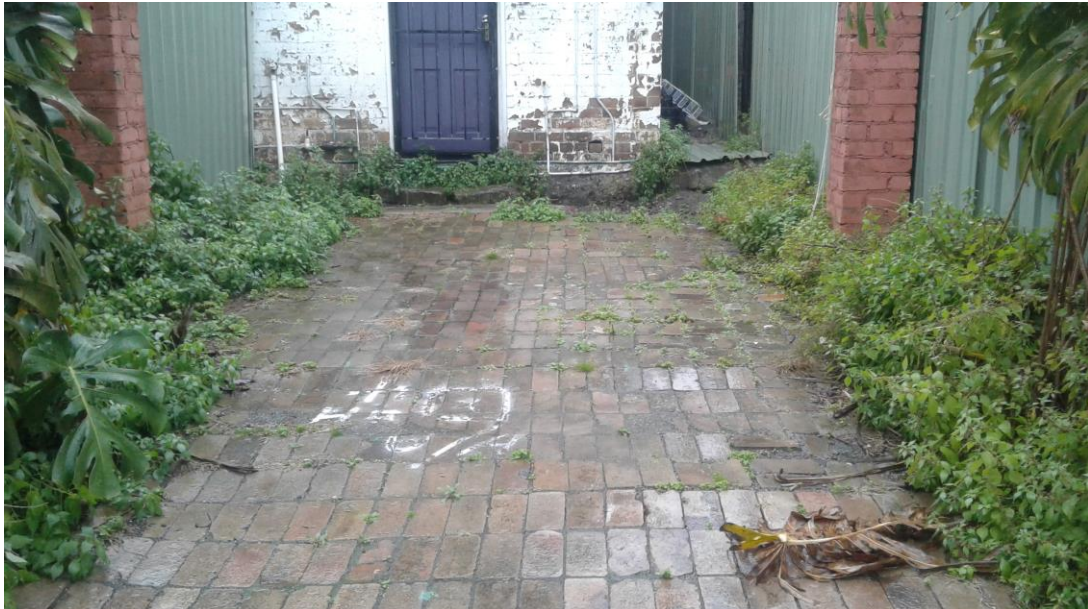
Photograph 6: Rear of No. 94 Regent Street

The rear of Property No. 94 Regent Street had a brick paved area with a garden bed along the perimeter (Photograph 6). A fragment of potential asbestos containing material (PACM) was observed on the ground surface, in the garden bed (refer to Drawing 1, Appendix A for approximate location). The exterior brick work was observed to have paint flaking off (Photograph 6). The interior was observed to consist of tiled surfaces and polished wooden floors (Photograph 7) and the building was vacant.

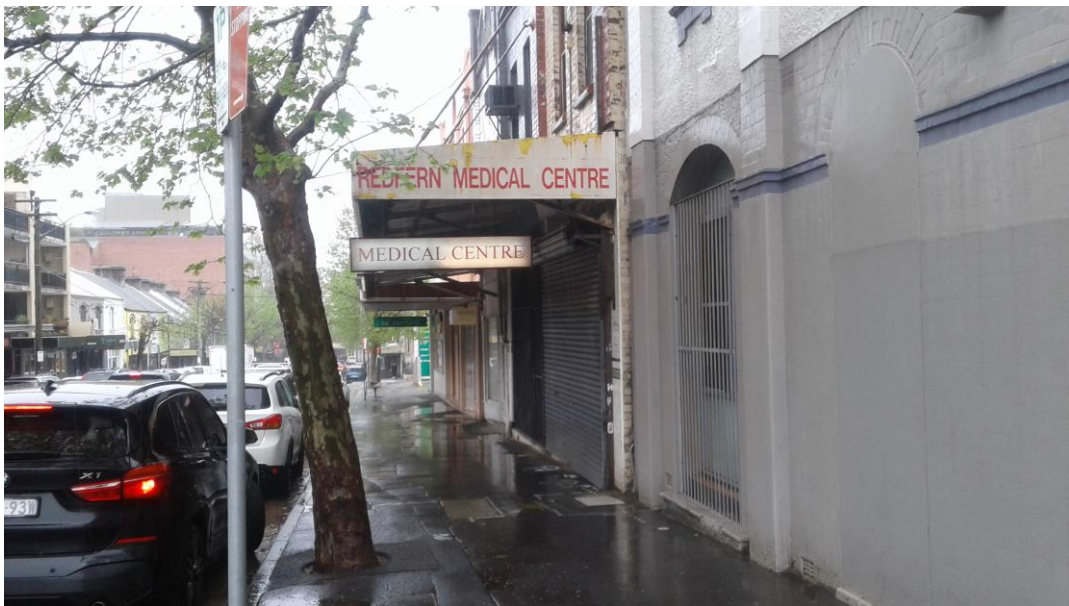
Photograph 8: Regent Street, Street View

Based on the street frontage along Regent Street, the shop signage indicated that Property No. 92 was formerly a medical centre (Photograph 8). Based on street view on Google Maps, it appears that Property No. 94 was formerly a printing shop.

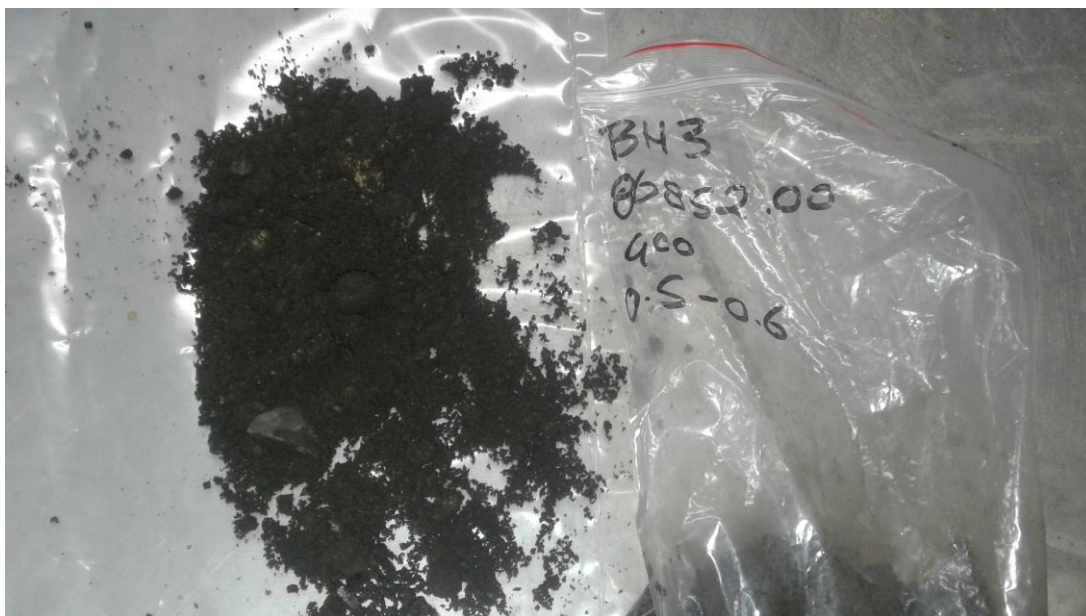
Photograph 9: Ash-containing material in BH3

Anthropogenic inclusions were encountered in the fill at the majority of borehole locations including trace concrete gravel (BH1), trace brick fragments (BH2), trace glass fragments (BH4), and trace tile and PVC fragments (BH6). Timber fragments, concrete gravels, terracotta, trace charcoal and brick fragments were observed in BH7, located below the floor void. Ash and / or charcoal were observed in BH3 at depths of 0.05 to 1.2 m (see Photograph 9, Appendix B).

Given that the concentrations of TRH F2, naphthalene, BaP TEQ and total PAH were 2.5 times over the SAC, this location was considered a contamination hotspot. The high concentrations of PAH are likely attributable to the ash-containing material found in this sample;

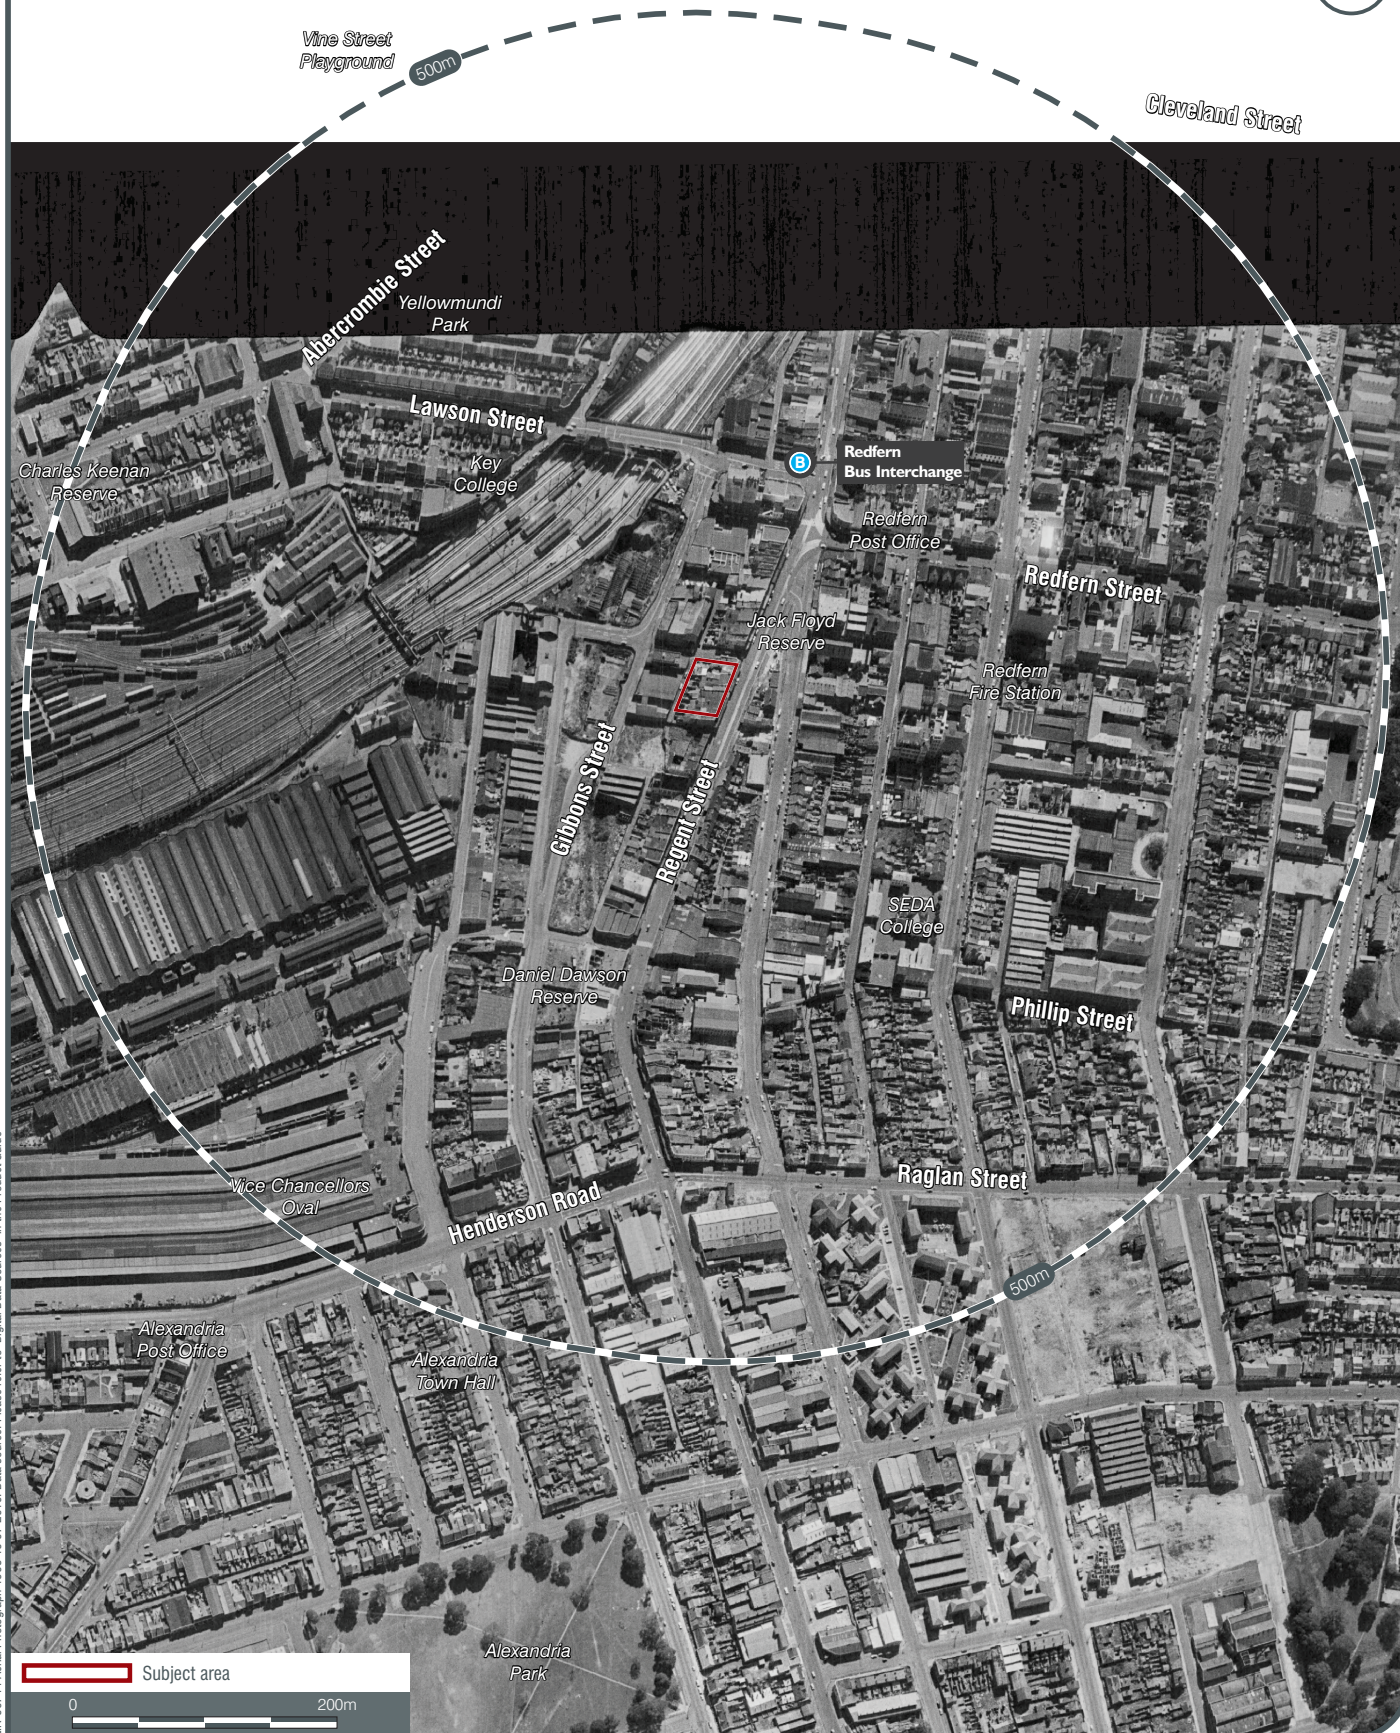
## HISTORIC AERIAL PHOTOGRAPH - 1965

**1965** - The majority of the structures south / south west of the site, in the adjacent block of land have been demolished. It appears that new buildings have been constructed on the property west of the site, and the buildings observed in the 1951 aerial have been demolished.
