Catholic Education Diocese of Parramatta C/- WINIM  
Developments Pty Ltd

# Preliminary Geotechnical and Hydrogeological Assessment: WCC Stage 1 - 2 Darcy Road, Westmead NSW

P1907547JR02V02  
February 2020

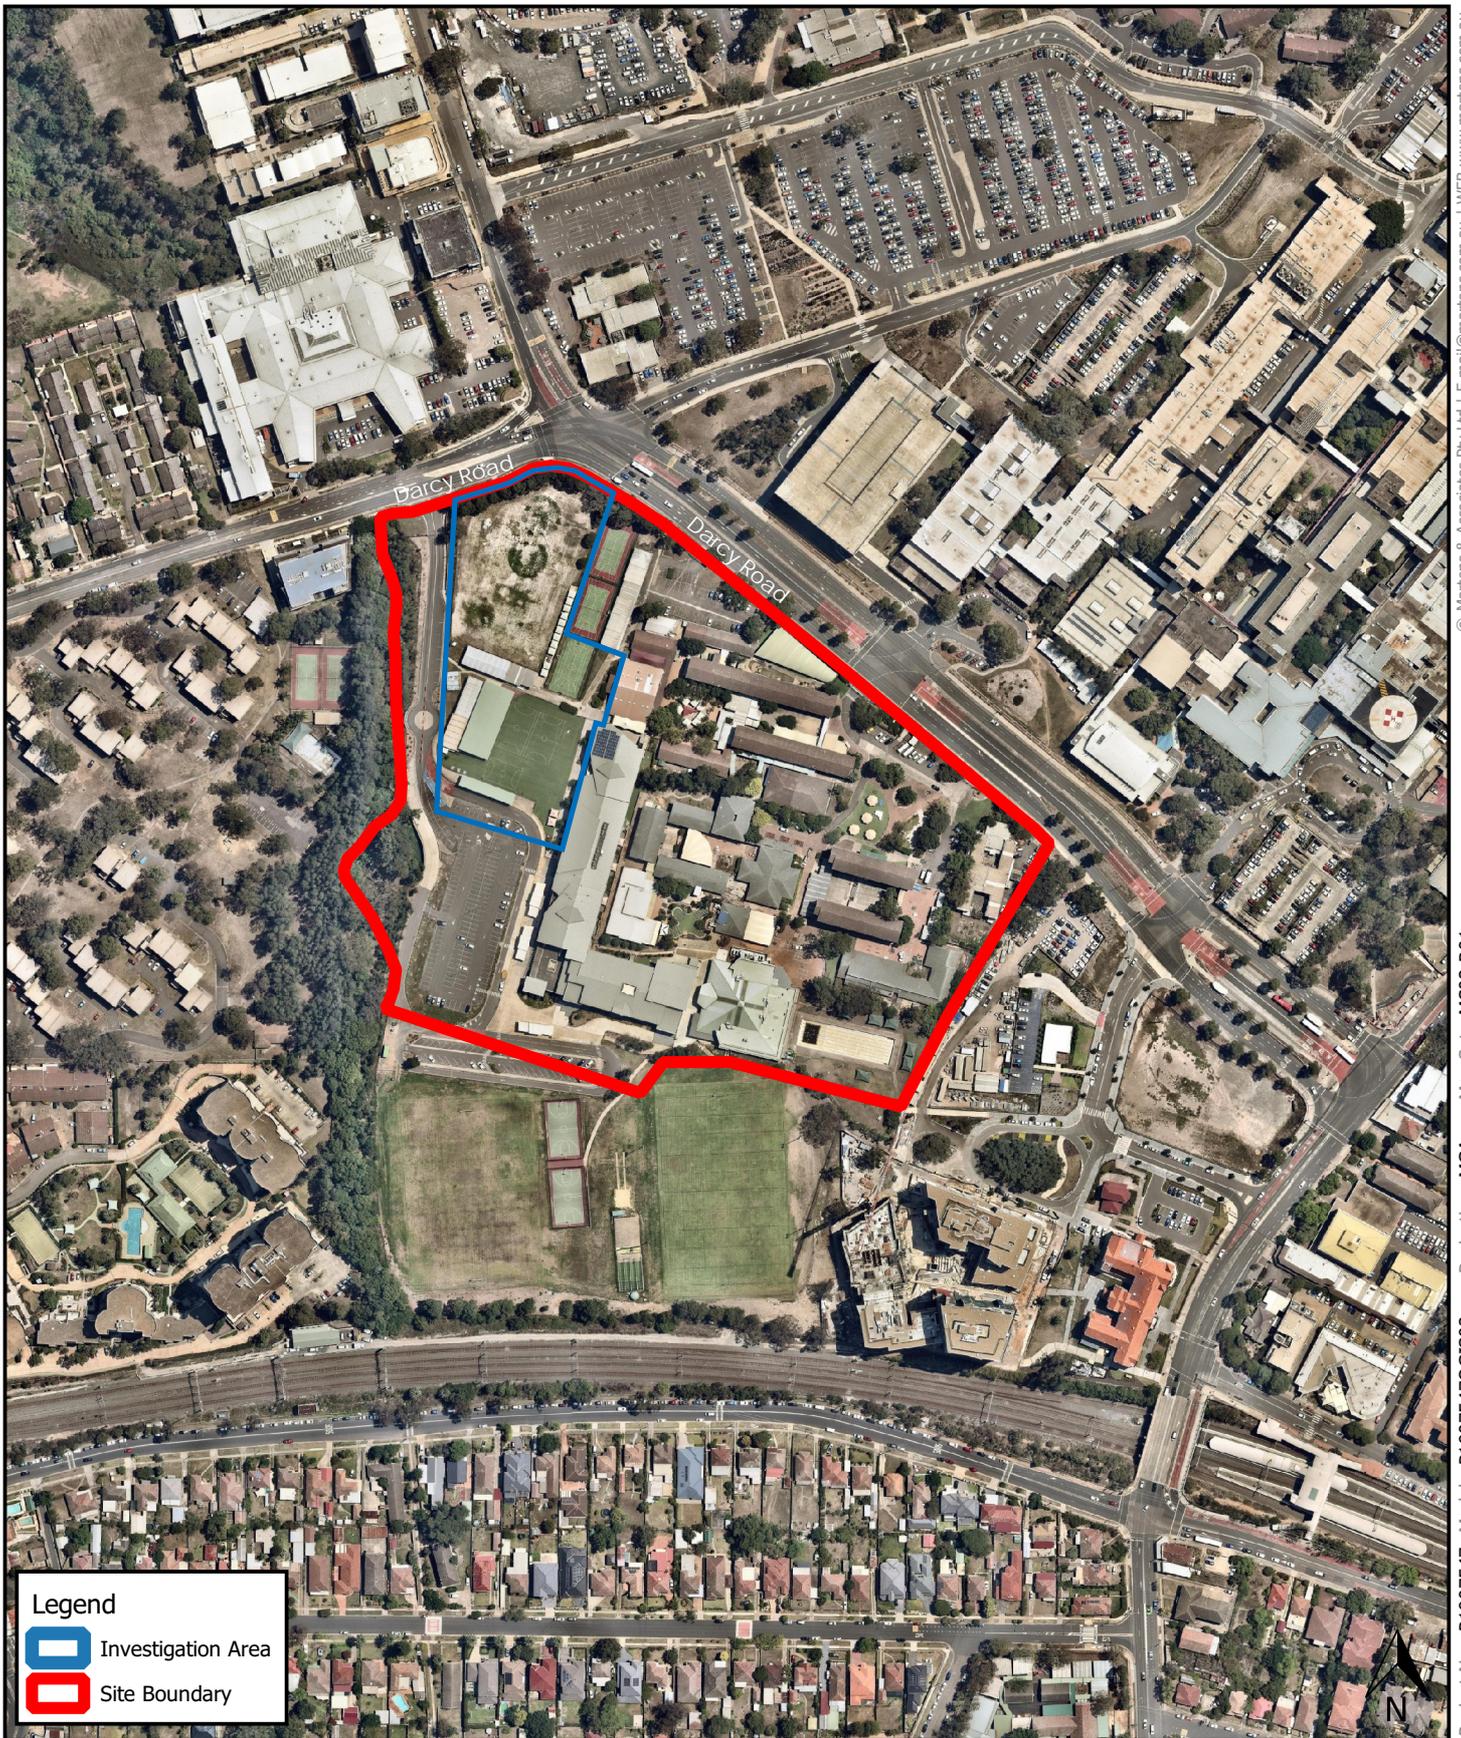
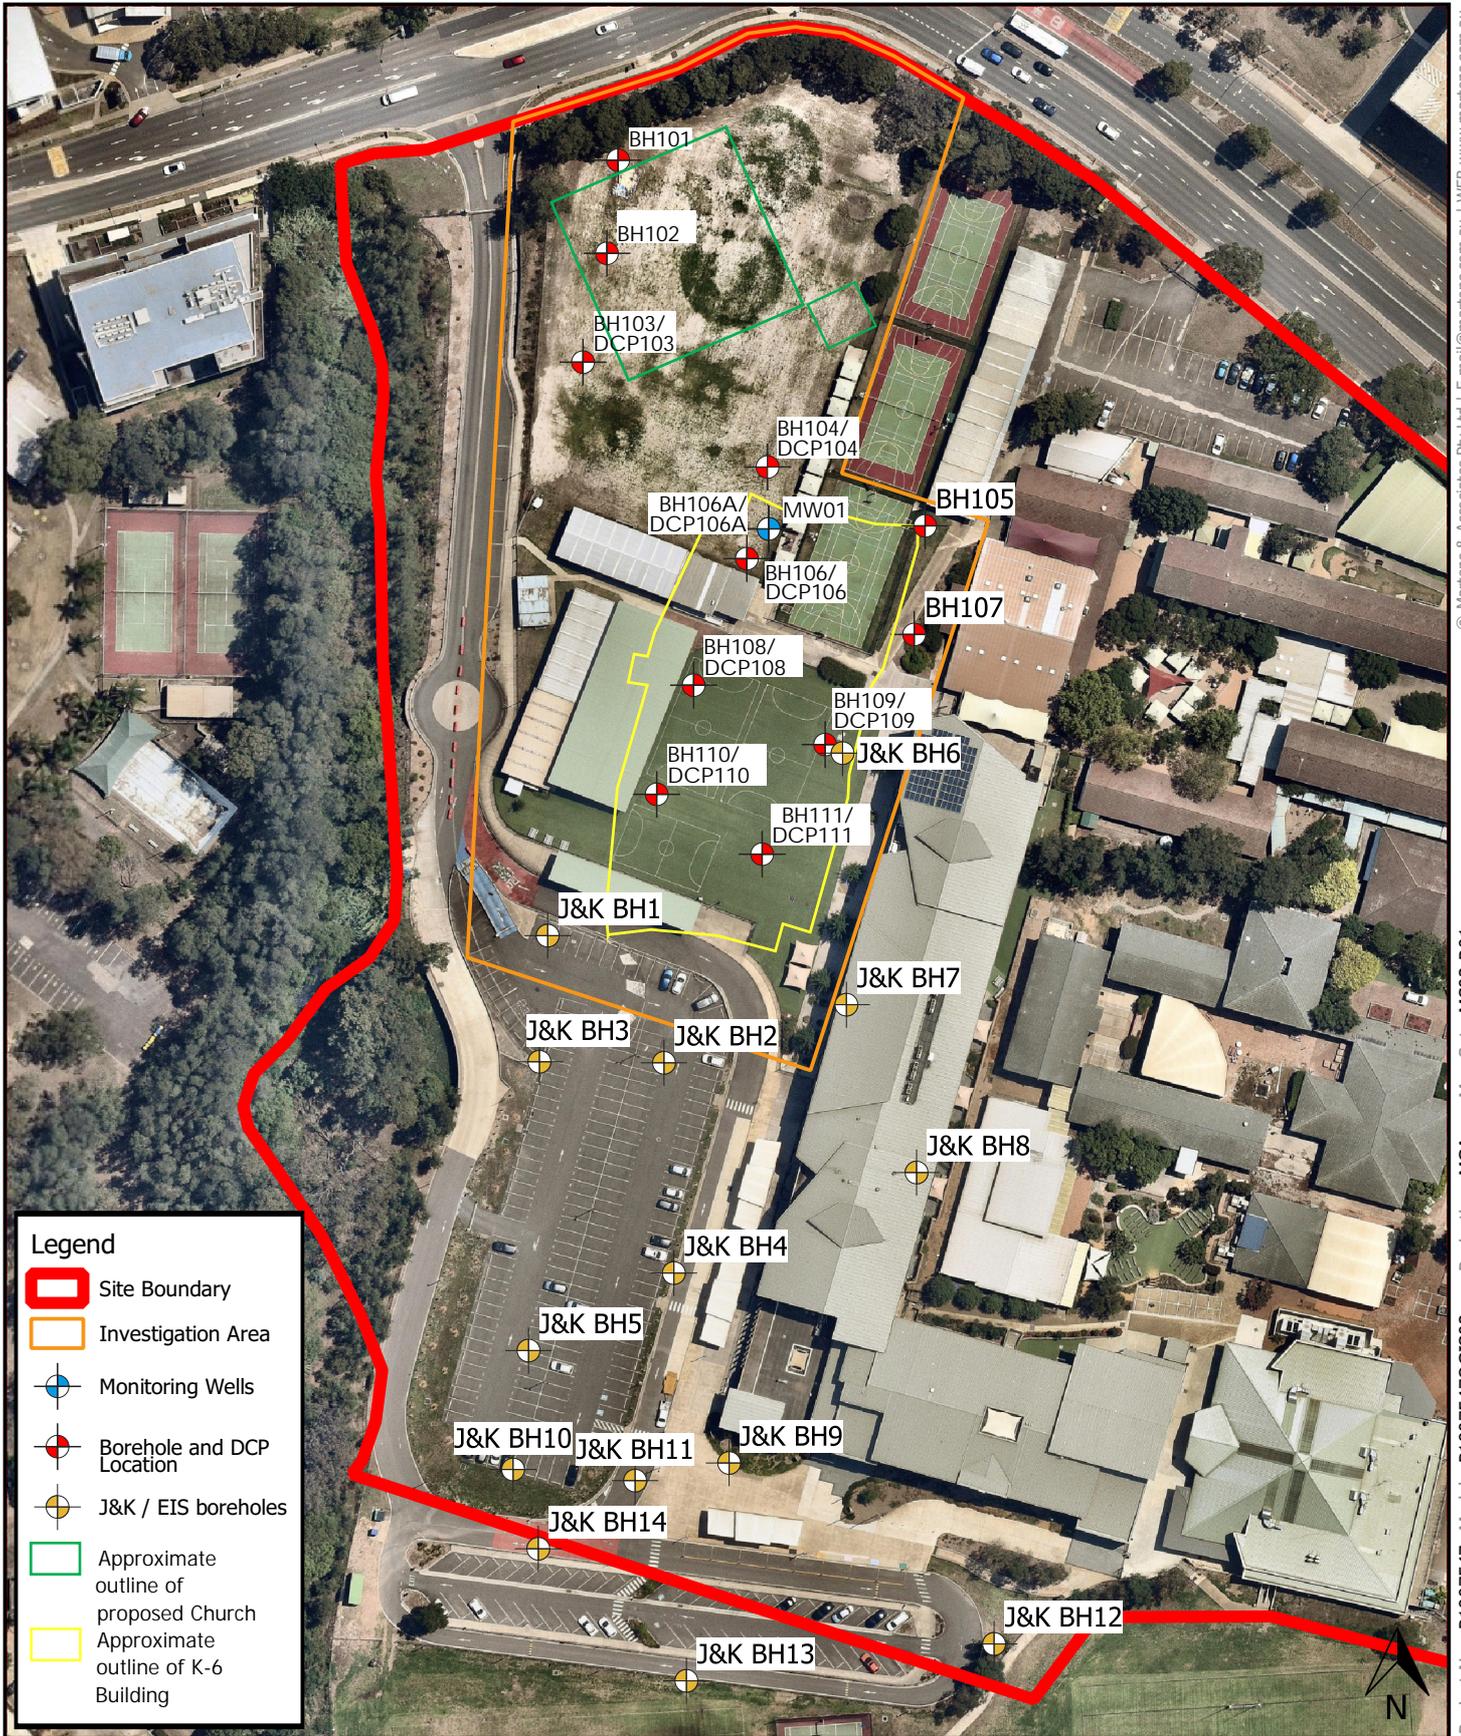
# Site Plan

- Site Boundary
- Investigation Area
- + Monitoring Wells
- + Borehole and DCP Location
- + J&K / EIS boreholes
- Approximate outline of proposed Church
- Approximate outline of K-6 Building
