SIRIUS DEVELOPMENTS PTY LTD

Geotechnical Investigation

2-60 Cumberland Street, The Rocks

E24614.G03_Rev2
6 July 2020

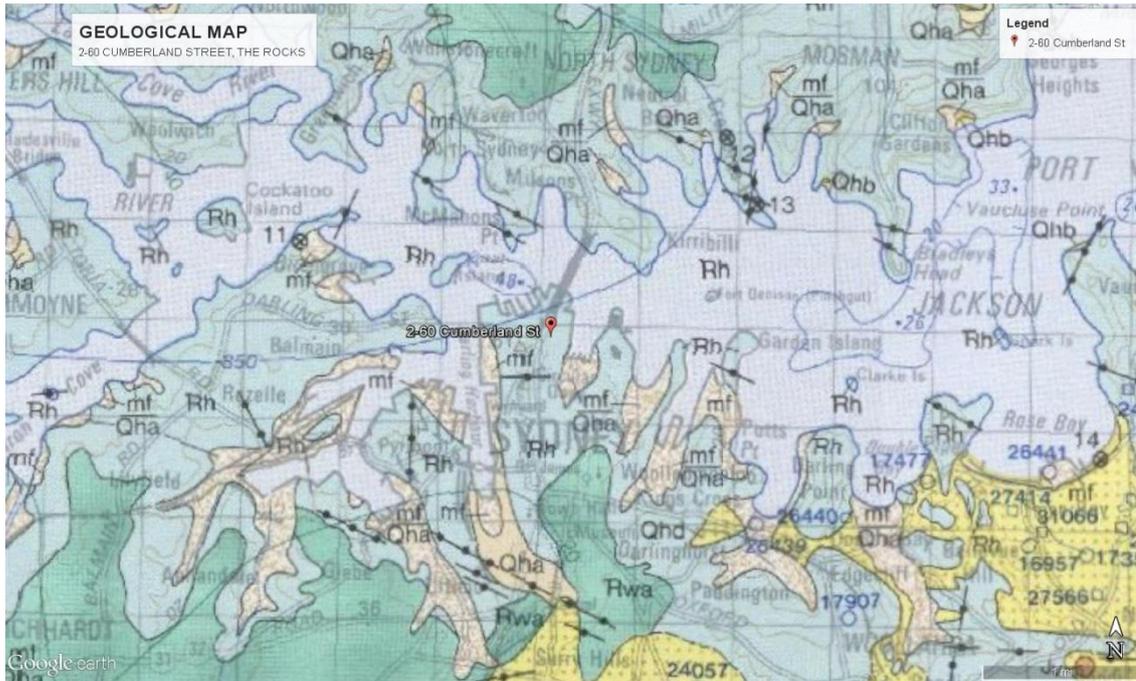
Plate 2: Excerpt of geological map showing location of site.

Attribute	Description
Topography	The site is located on the eastern side of Cumberland Street within moderately (10° to 18°) east dipping topography.
Regional Geology	Information on regional sub-surface conditions, referenced from the Department of Mineral Resources Geological Map Sydney 1:100,000 Geological Series Sheet 9130 (DMR 1983) indicates the site to be underlain by Hawkesbury Sandstone, which consists of medium to coarse-grained quartz sandstone with very minor shale and laminite lenses.

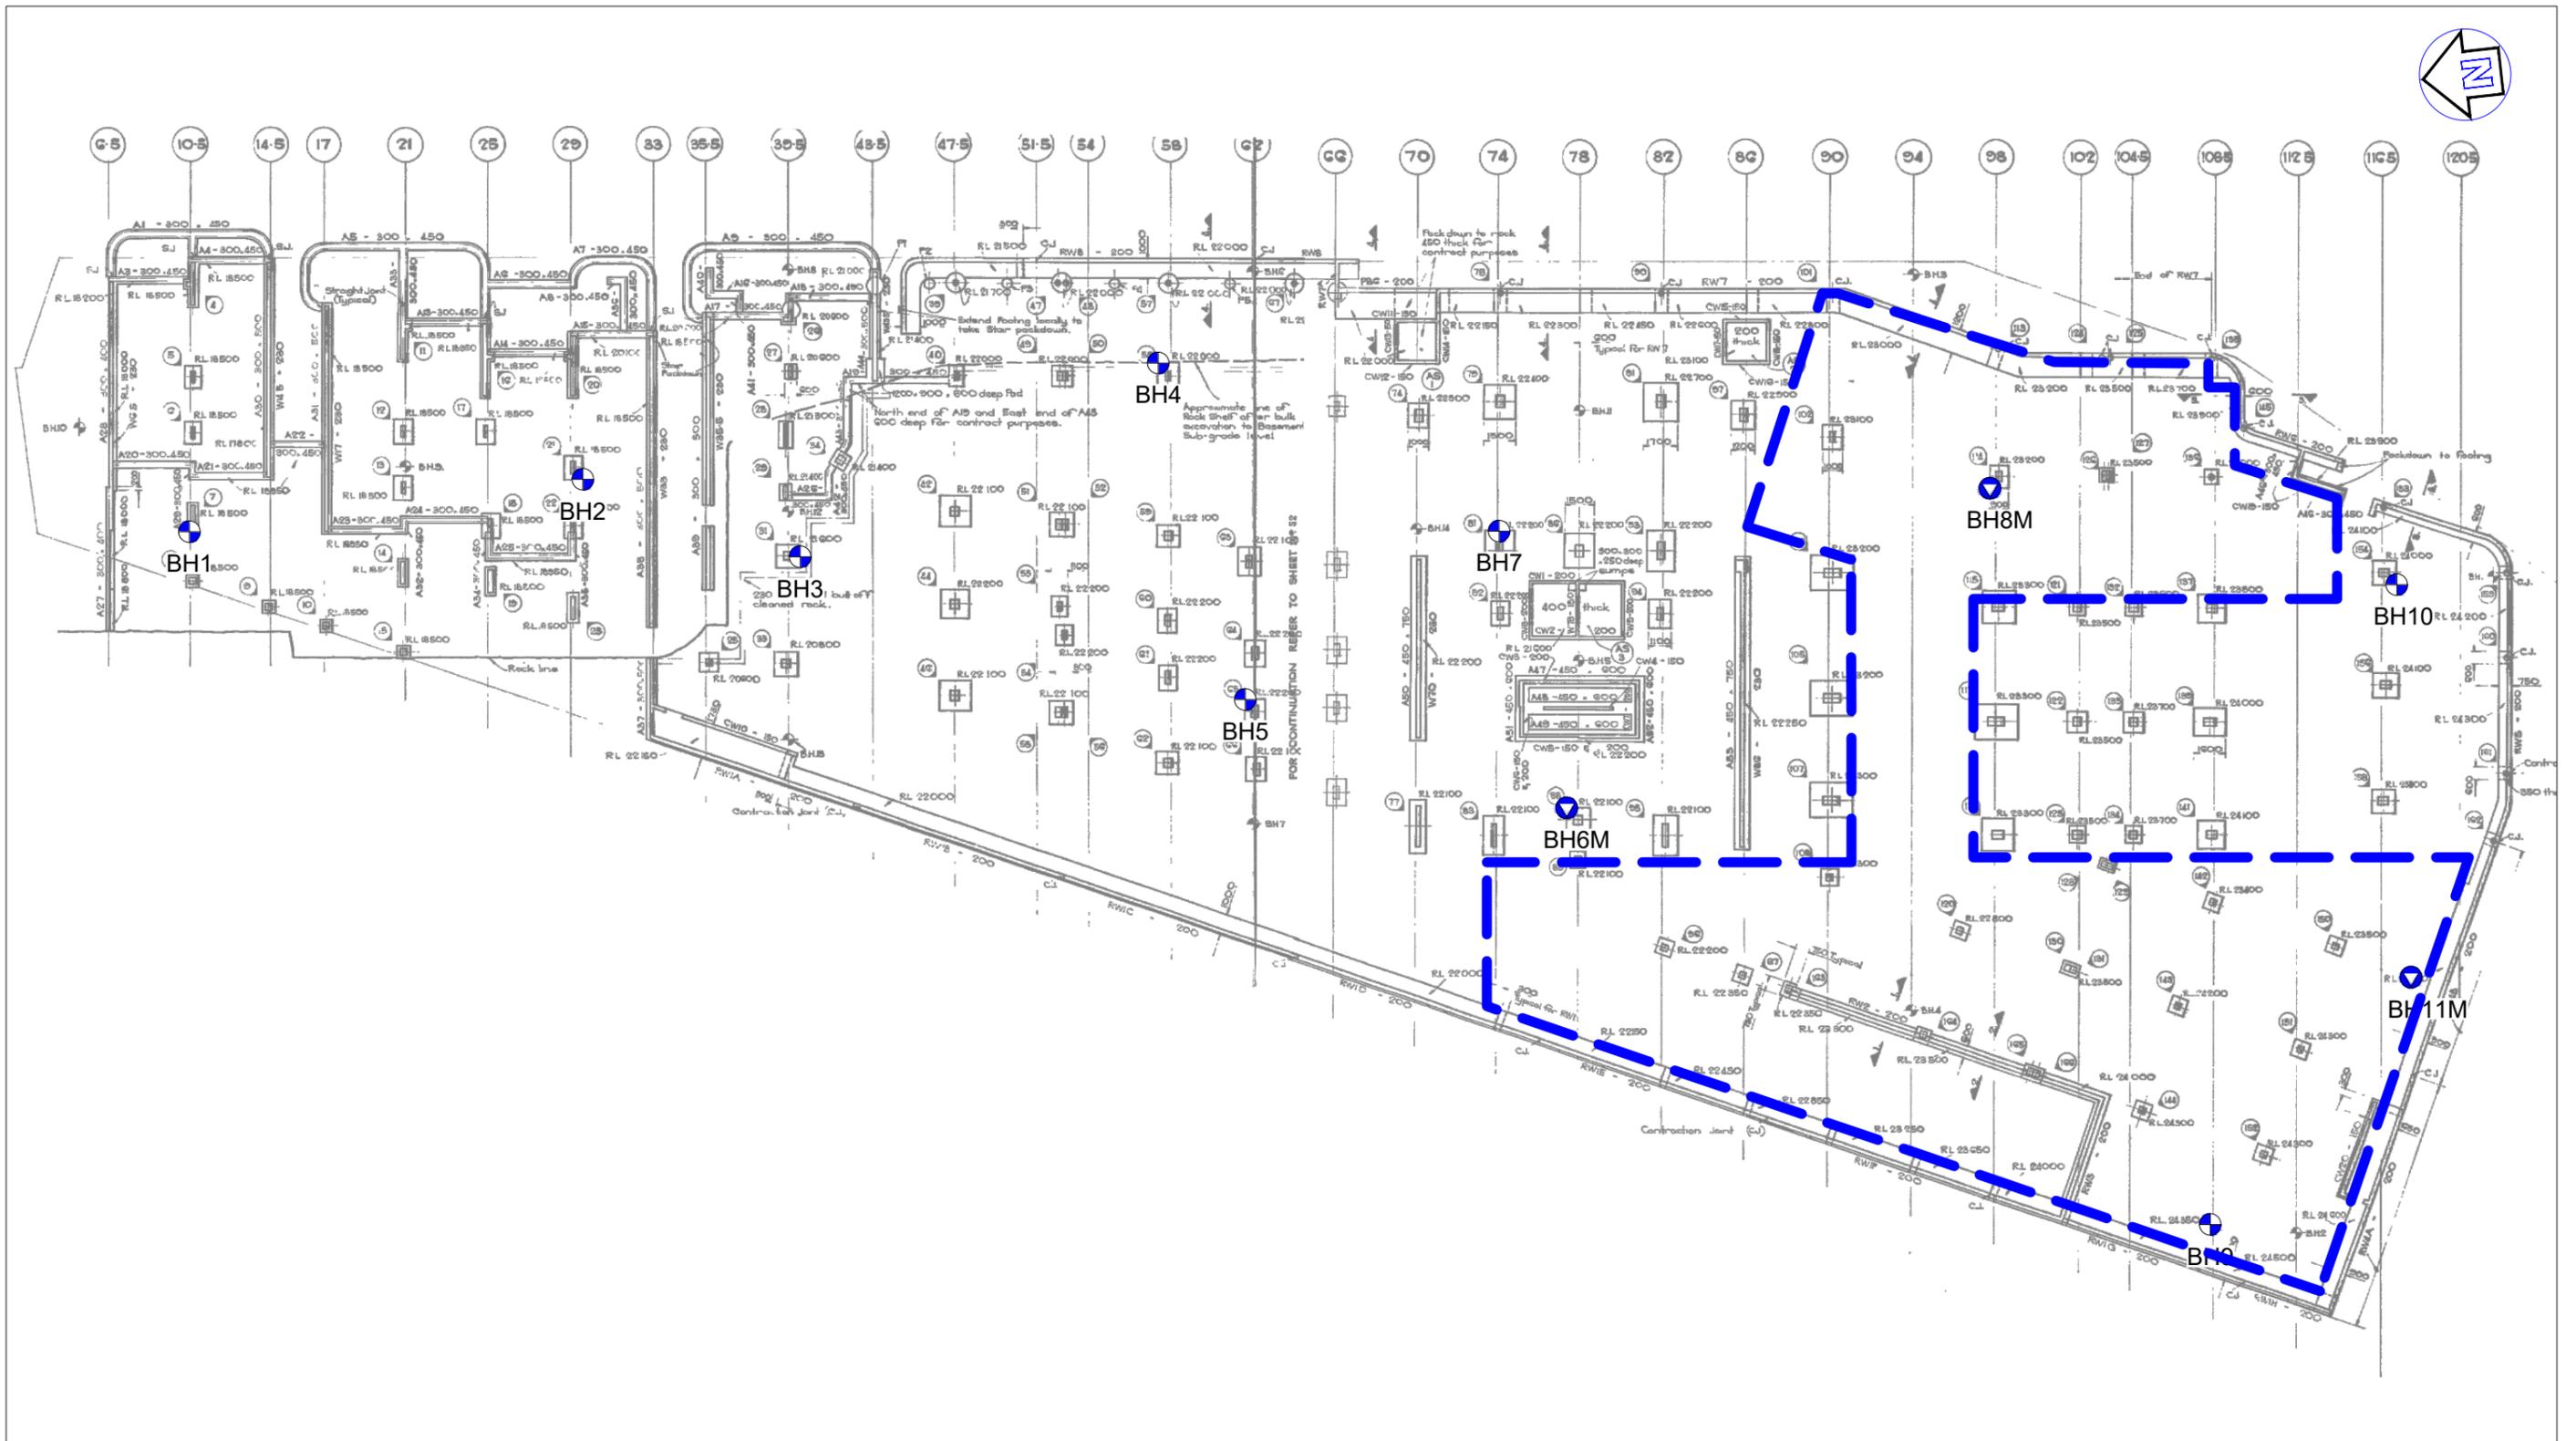
Figure:
2
 Project: E24614.G03_Rev1

- LEGEND**
- Proposed basement boundary
 - Approximate borehole location
 - Approximate borehole/monitoring well location

Sirius Developments Pty Ltd
 Additional Geotechnical Investigation
 2-60 Cumberland Street, The Rocks NSW
 Borehole Location Plan

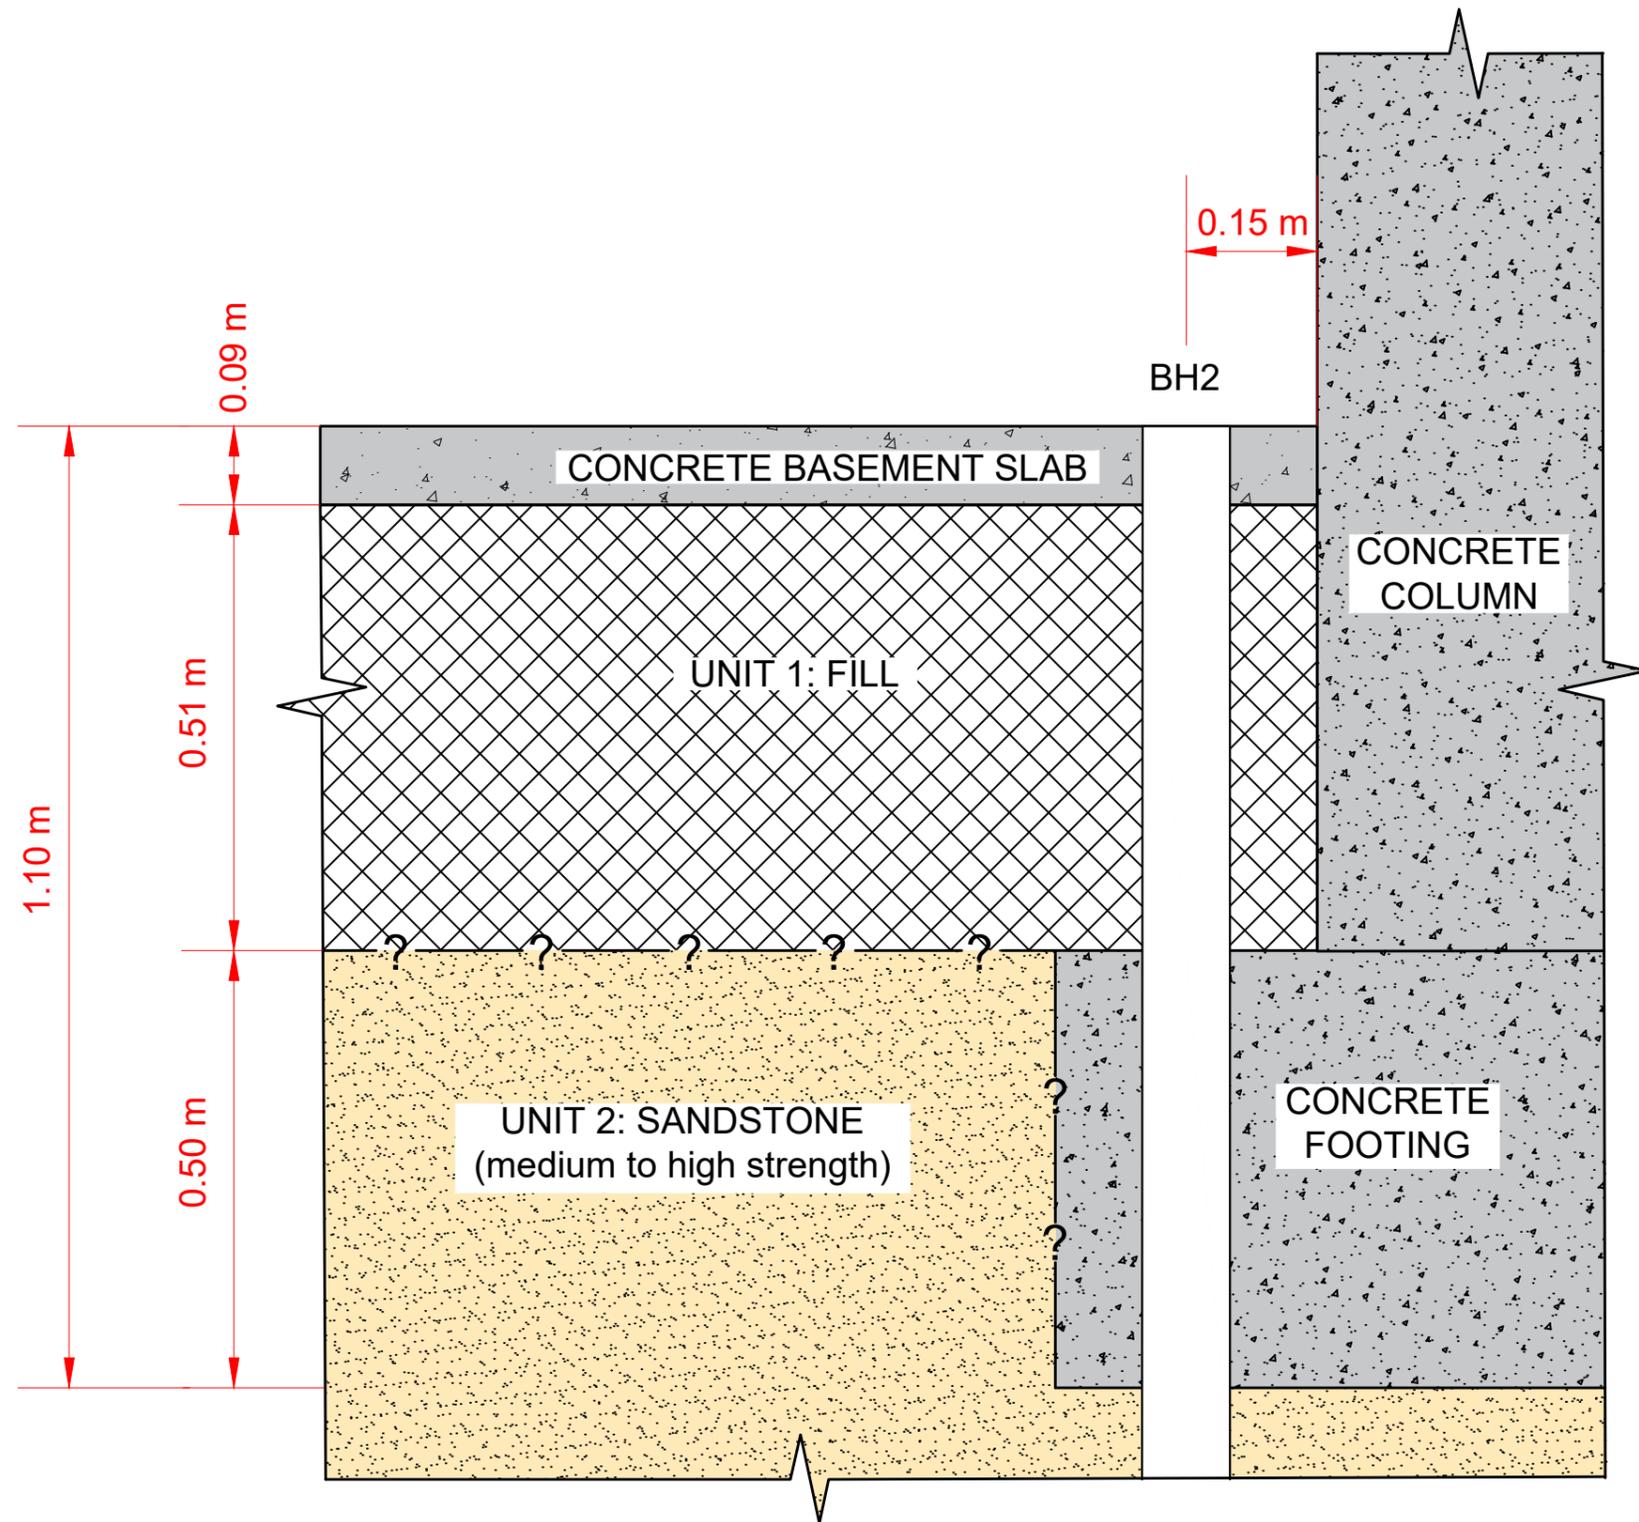
| Figure 3 | Footing Cross Section at Column 24 (BH2) |

Based on the findings of our investigation, the footings for Column 7 (BH1), Column 24 (BH2), Column 31 (BH3), Column 65 (BH5), Column 88 (BH6M), Column 81 (BH7), Column 114 (BH8) and Column 154 (BH10) are founded upon sandstone bedrock of medium to high strength (Unit 2) and can be redesigned for an allowable bearing capacity of 3500kPa subject to serviceability. **Figure 3** provides an indicative cross section for the above column footings based on the encountered conditions at Column 24 (BH2).

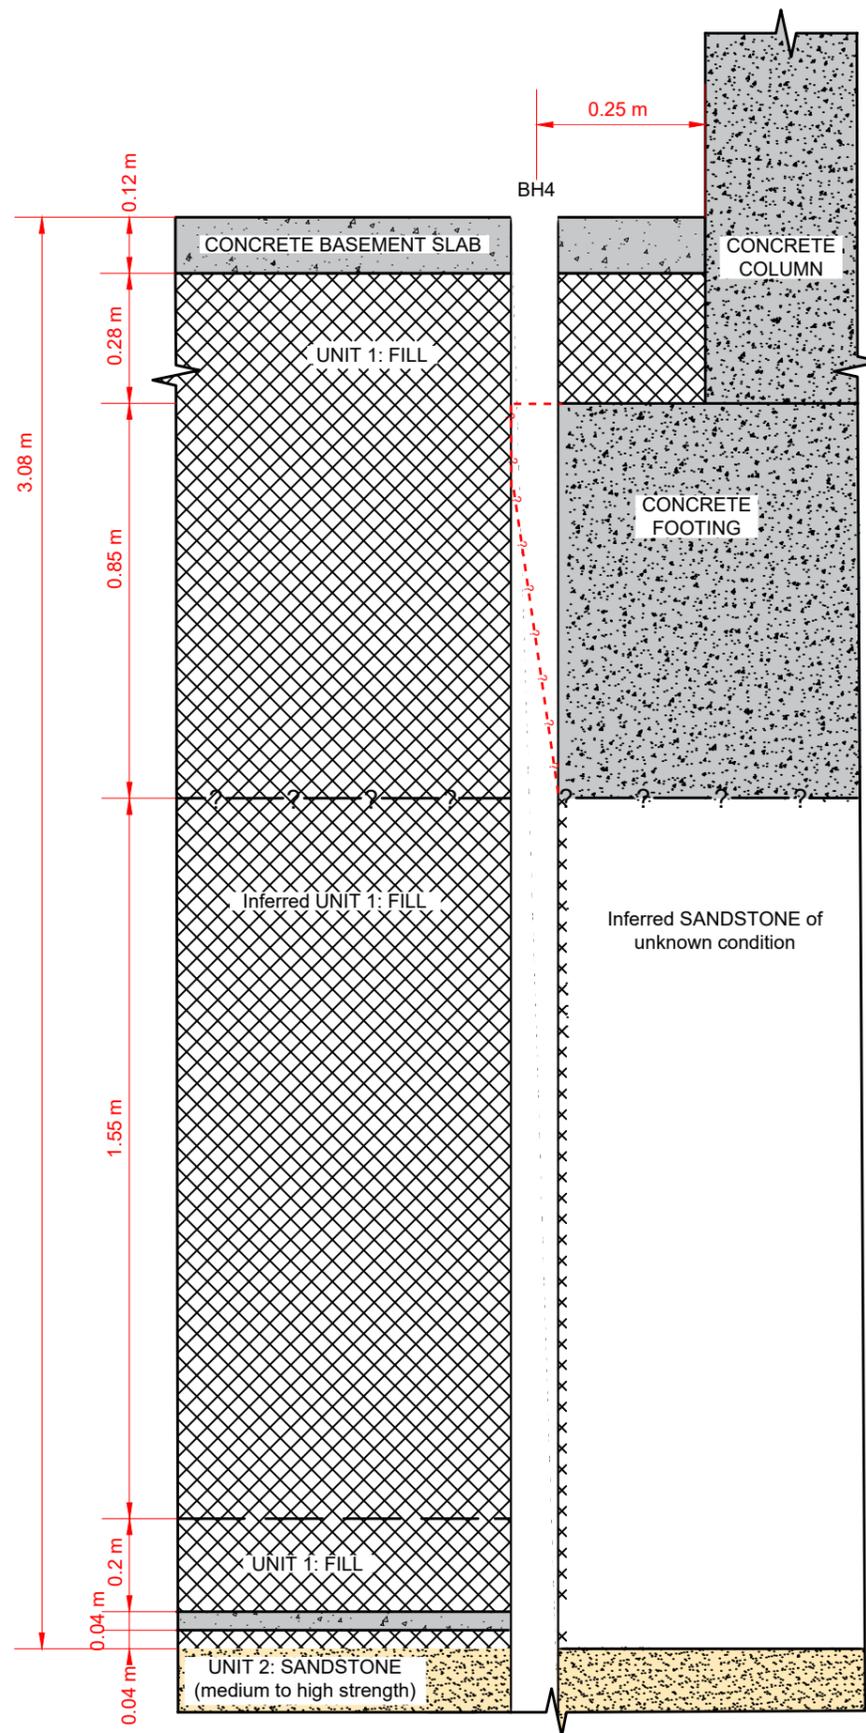
| Figure 4 | Footing Cross Section at Column 58 (BH4) |

The findings of our investigation were inconclusive as to the founding conditions beneath the footings for Column 58 (BH4) and Column 154 (BH10).

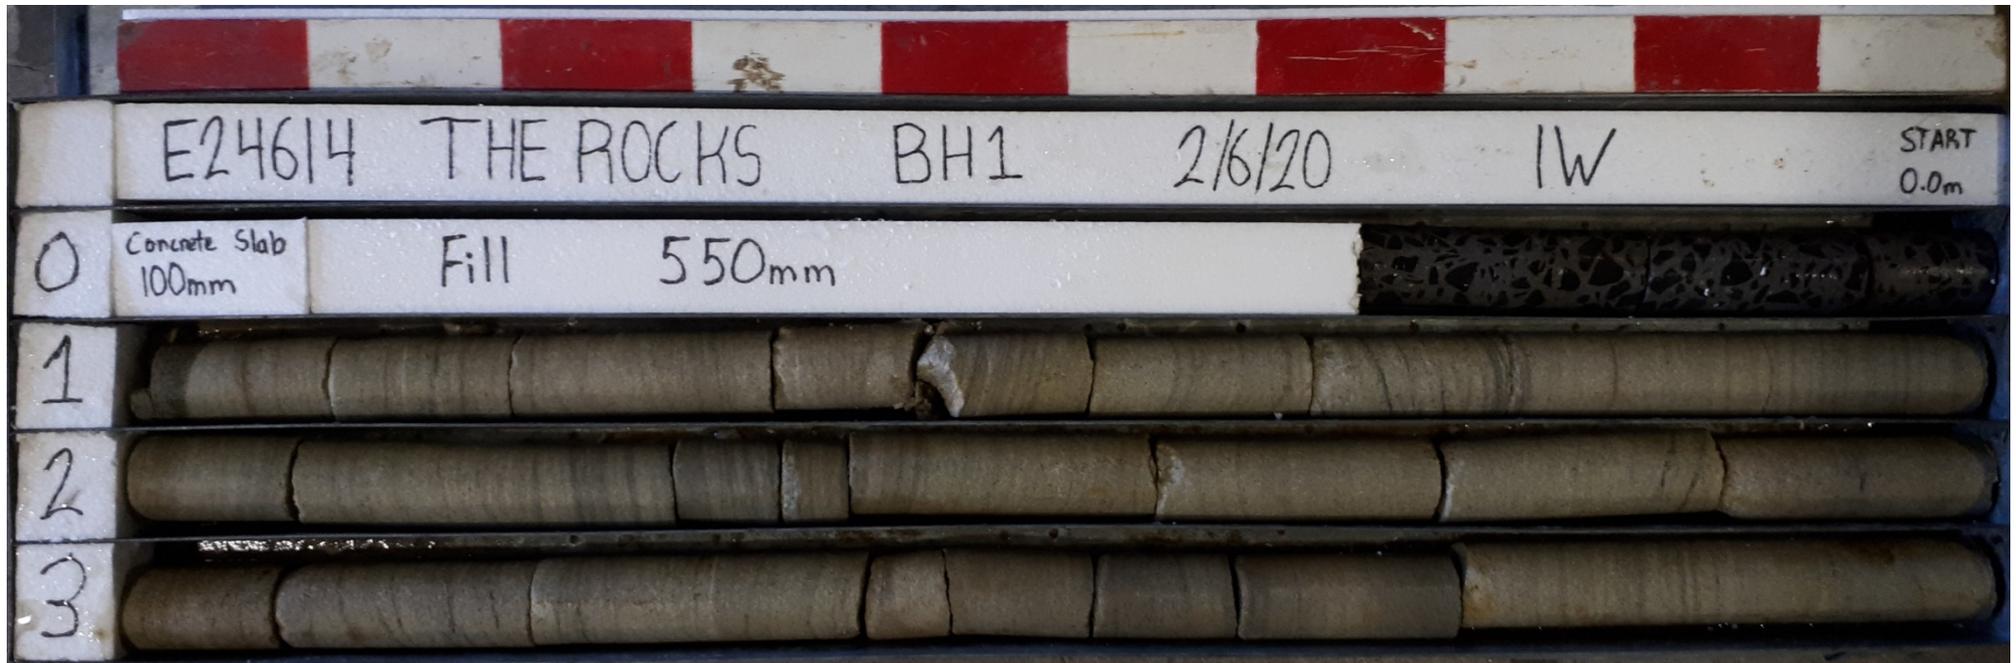
Project	Proposed Residential Development	Depth Range	0.0m to 4.0m BEGL	
Location	2-60 Cumberland Street, The Rocks NSW	Contractor	TJ Core Drilling	
Position	See Figure 2	Drill Rig	Hand portable	
Job No.	E24614.G04	Logged	IW	Date 02 / 06 / 2020
Client	Sirius Developments Pty Ltd	Box	1 of 1	Checked SK Date 15 / 06 / 2020
		Surface RL	≈ 19.1m	
		Inclination	-90°

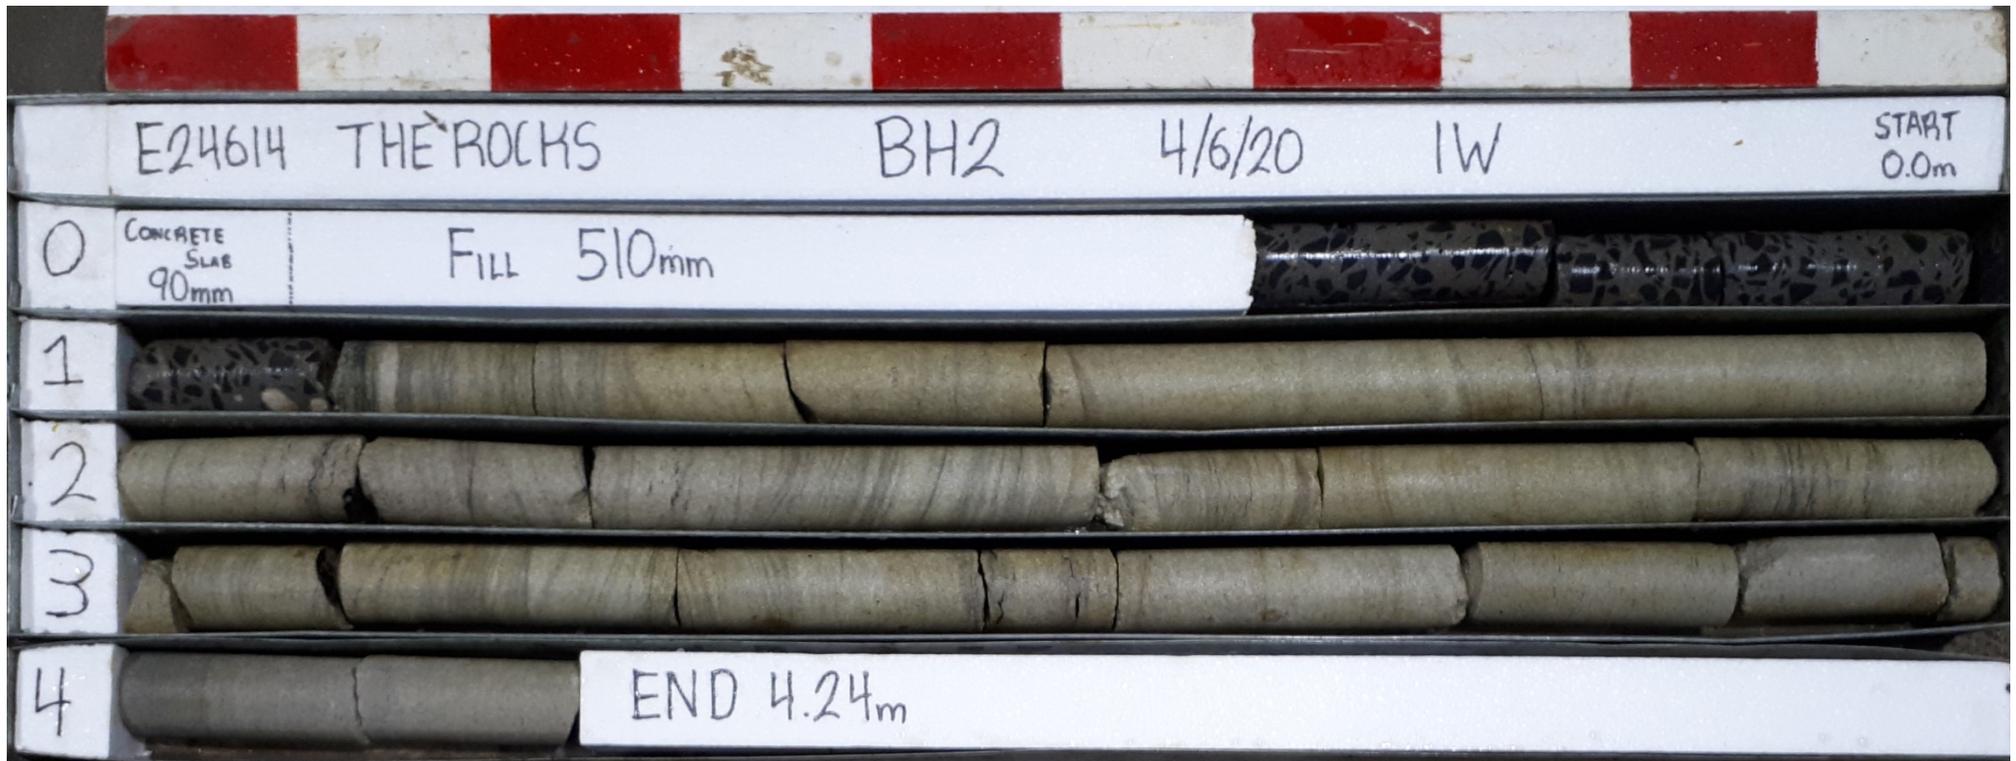
Project	Proposed Residential Development	Depth Range	0.0m to 4.24m BEGL	
Location	2-60 Cumberland Street, The Rocks NSW	Contractor	TJ Core Drilling	
Position	See Figure 2	Drill Rig	Hand portable	
Job No.	E24614.G04	Logged	IW	Date 04 / 06 / 2020
Client	Sirius Developments Pty Ltd	Box	1-2 of 2	Checked SK Date 15 / 06 / 2020
		Surface RL	≈ 19.1m	
		Inclination	-90°

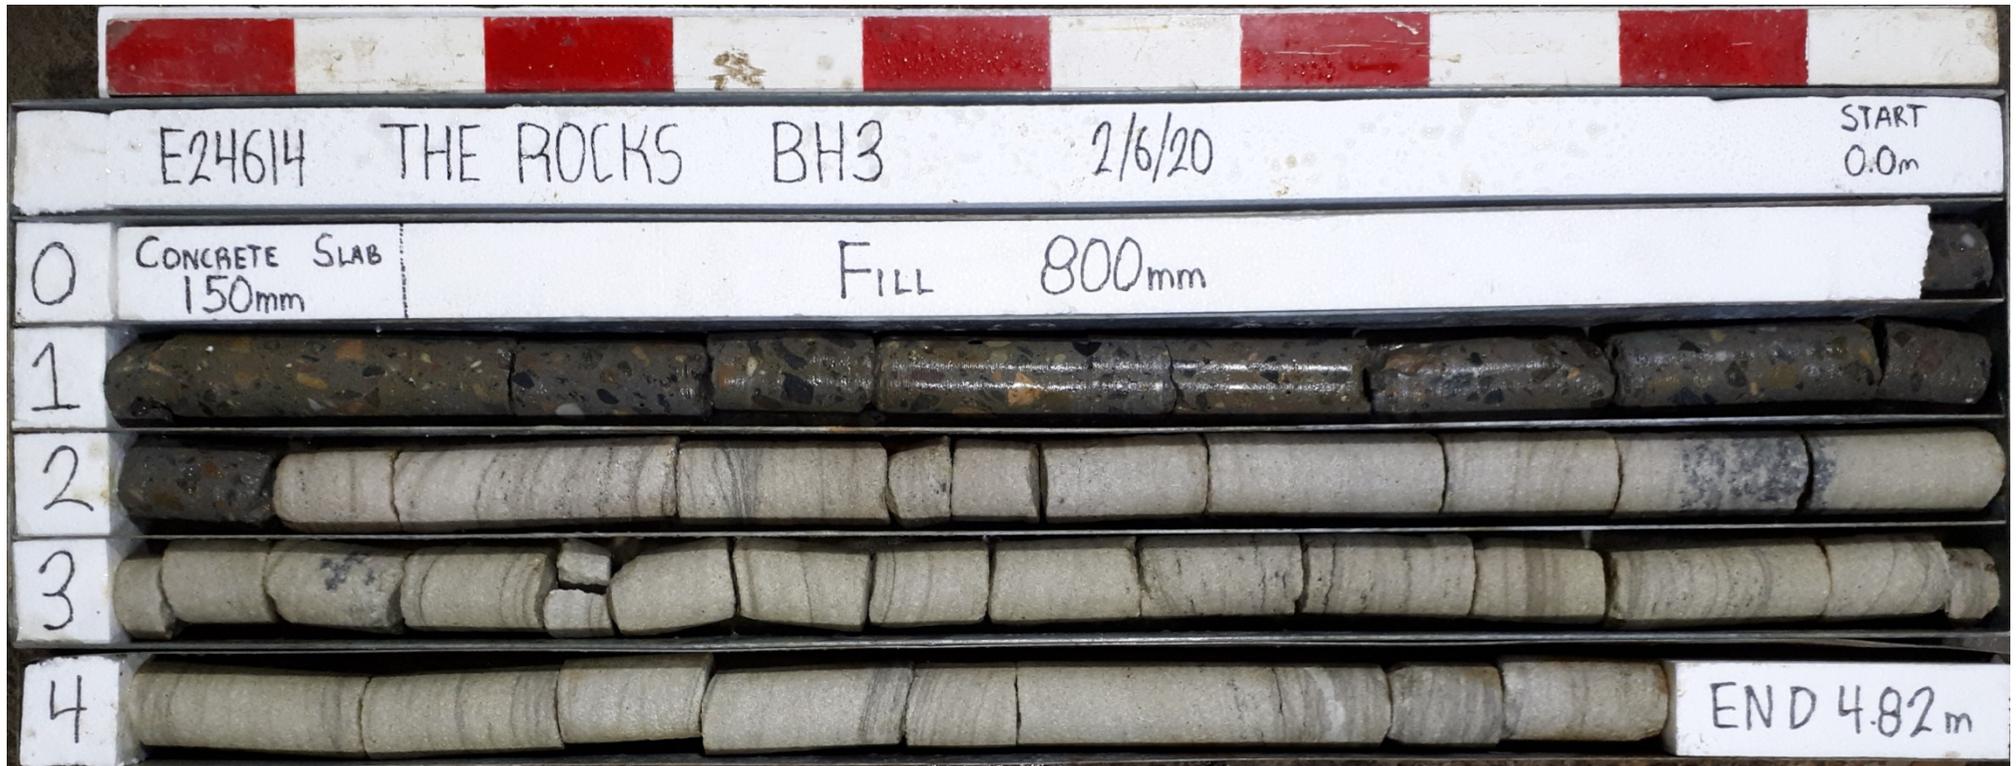
Project	Proposed Residential Development	Depth Range	0.0m to 4.82m BEGL	
Location	2-60 Cumberland Street, The Rocks NSW	Contractor	TJ Core Drilling	
Position	See Figure 2	Drill Rig	Hand portable	
Job No.	E24614.G04	Surface RL	≈ 22.6m	Logged
Client	Sirius Developments Pty Ltd	Inclination	-90°	Date
		Box	1-2 of 2	Date
				04 / 06 / 2020
				15 / 06 / 2020

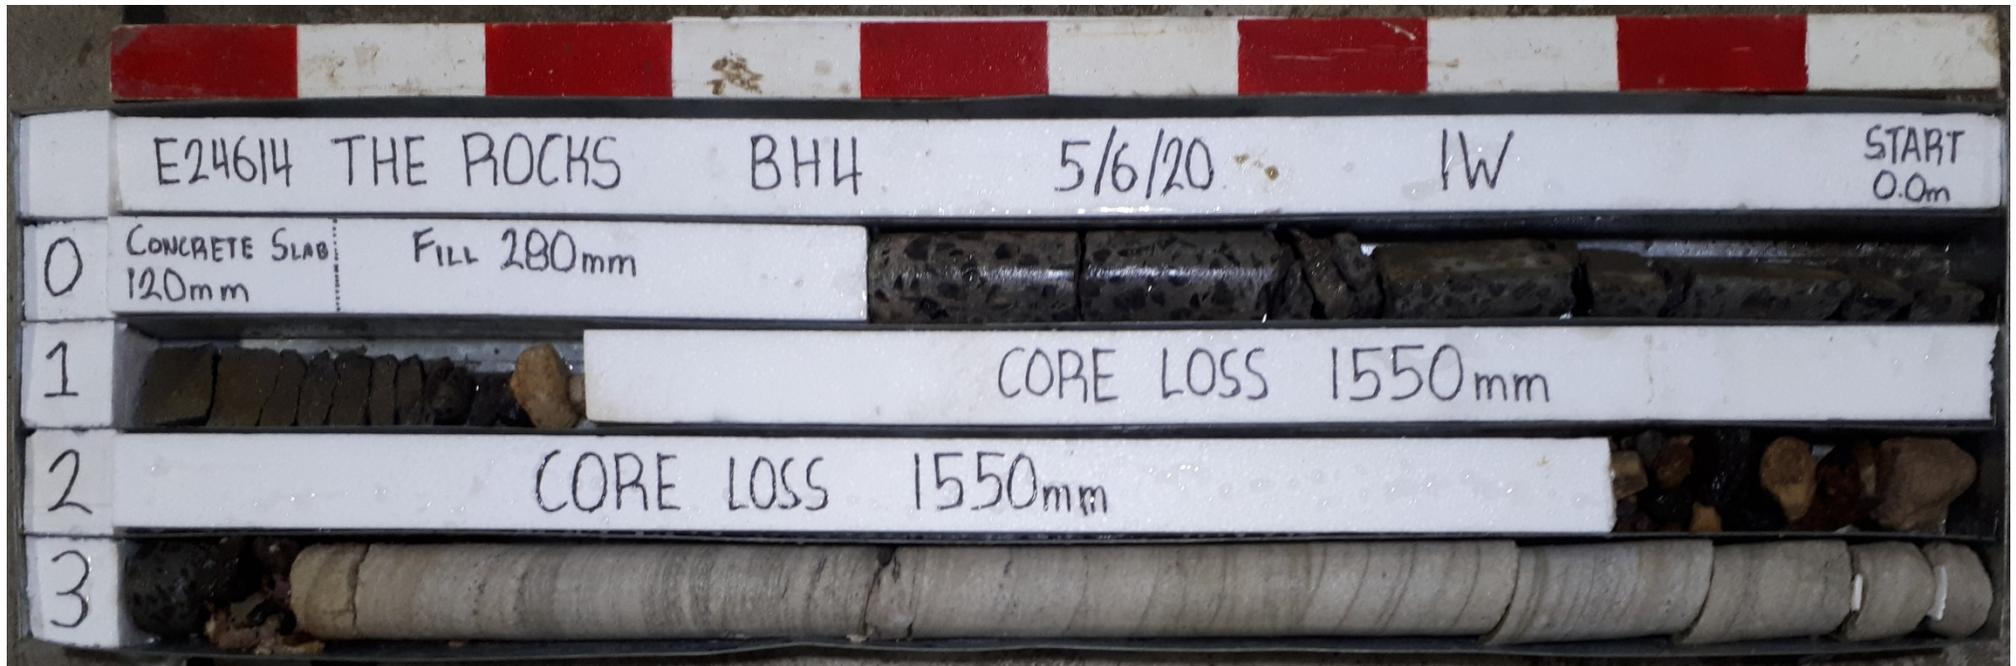
Project	Proposed Residential Development	Depth Range	0.0m to 4.0m BEGL	
Location	2-60 Cumberland Street, The Rocks NSW	Contractor	TJ Core Drilling	
Position	See Figure 2	Drill Rig	Hand portable	
Job No.	E24614.G04	Logged	IW	Date 05 / 06 / 2020
Client	Sirius Developments Pty Ltd	Box	1 of 1	Checked SK Date 15 / 06 / 2020
		Surface RL	≈ 22.4m	
		Inclination	-90°

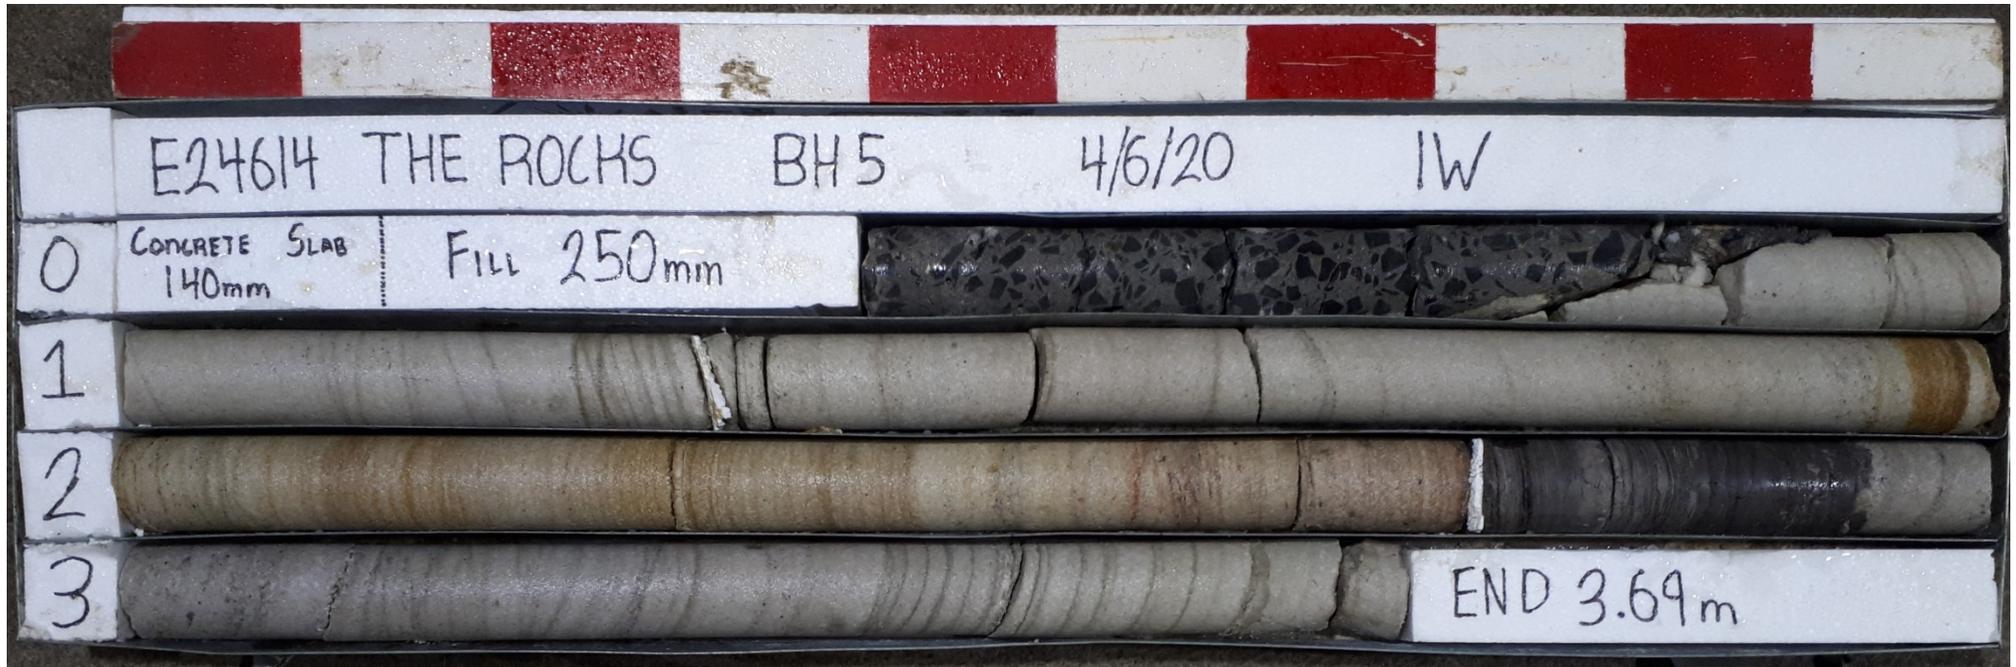
Project	Proposed Residential Development	Depth Range	0.0m to 3.69m BEGL	
Location	2-60 Cumberland Street, The Rocks NSW	Contractor	Geosense Drilling	
Position	See Figure 2	Drill Rig	Tight Access	
Job No.	E24614.G04	Surface RL	≈ 22.6m	Logged
Client	Sirius Developments Pty Ltd	Inclination	-90°	Date
		Box	1 of 1	Date
				04 / 06 / 2020
				15 / 06 / 2020

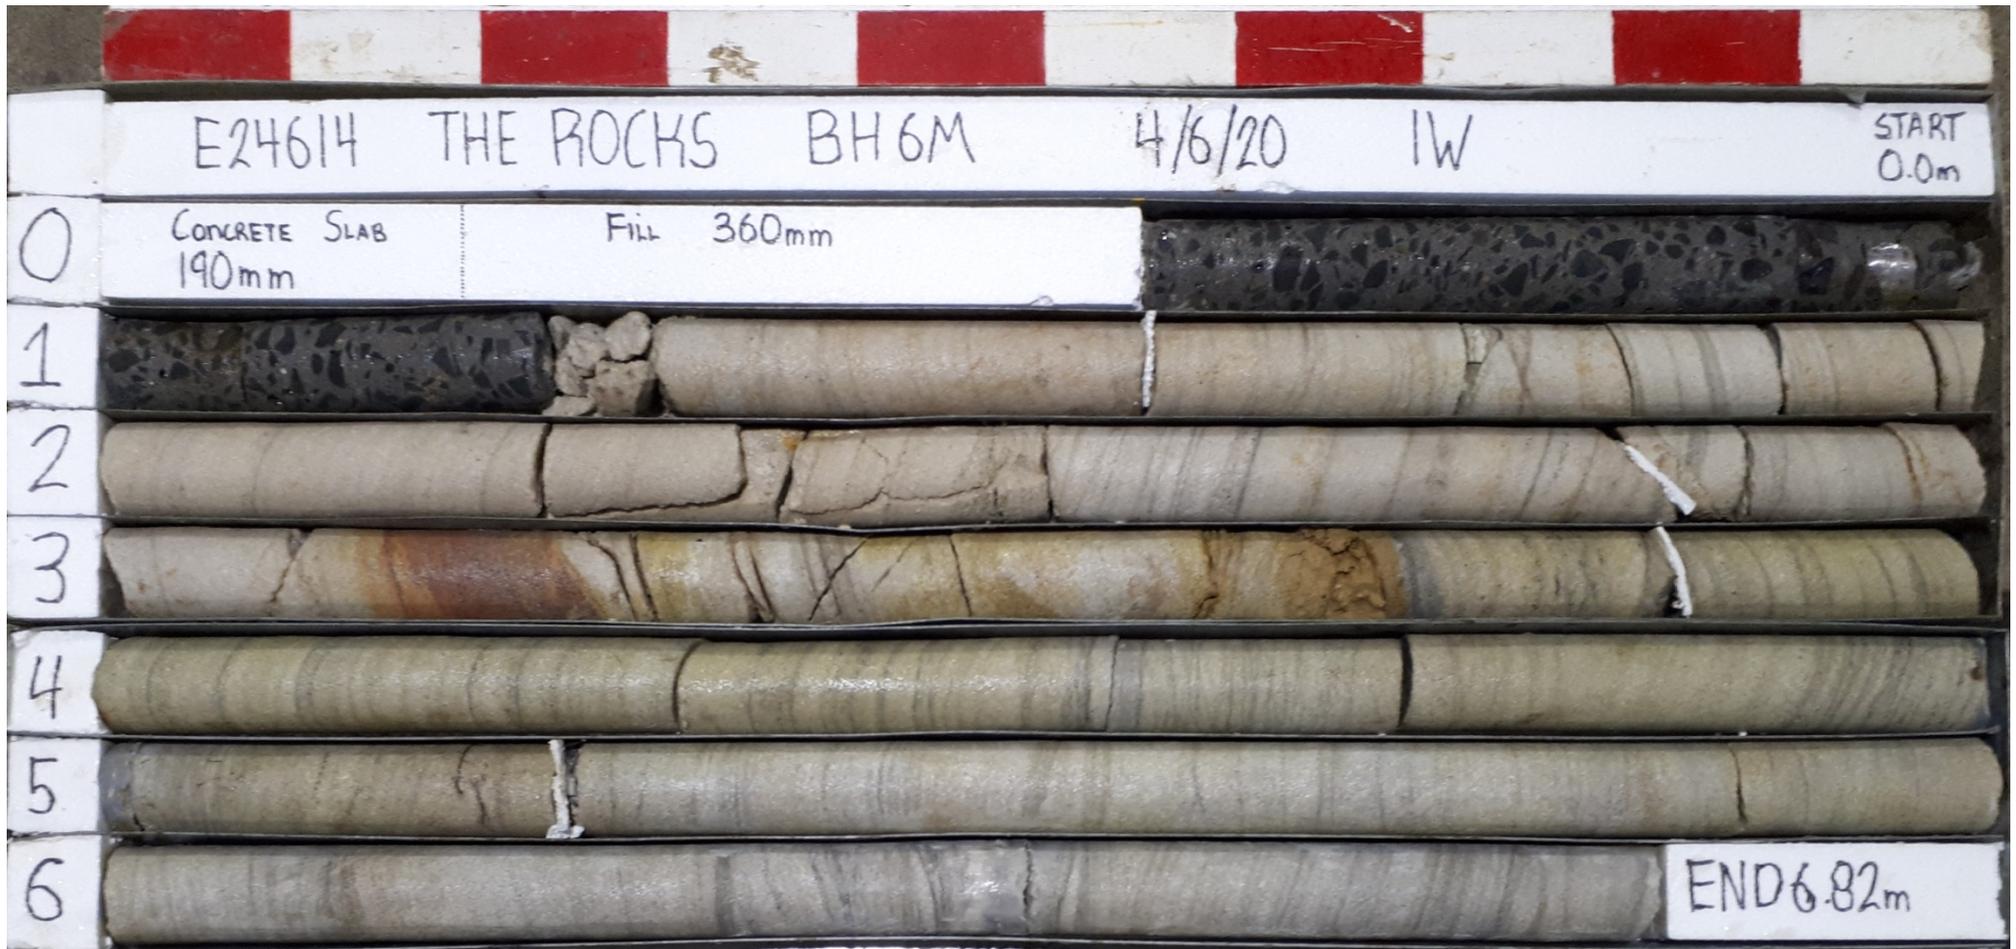
Project	Proposed Residential Development	Depth Range	0.0m to 6.82m BEGL	
Location	2-60 Cumberland Street, The Rocks NSW	Contractor	Geosense Drilling	
Position	See Figure 2	Drill Rig	Tight Access	
Job No.	E24614.G04	Surface RL	≈ 22.70m	Logged IW Date 04 / 06 / 2020
Client	Sirius Developments Pty Ltd	Inclination	-90°	Checked SK Date 15 / 06 / 2020
		Box	1-2 of 2

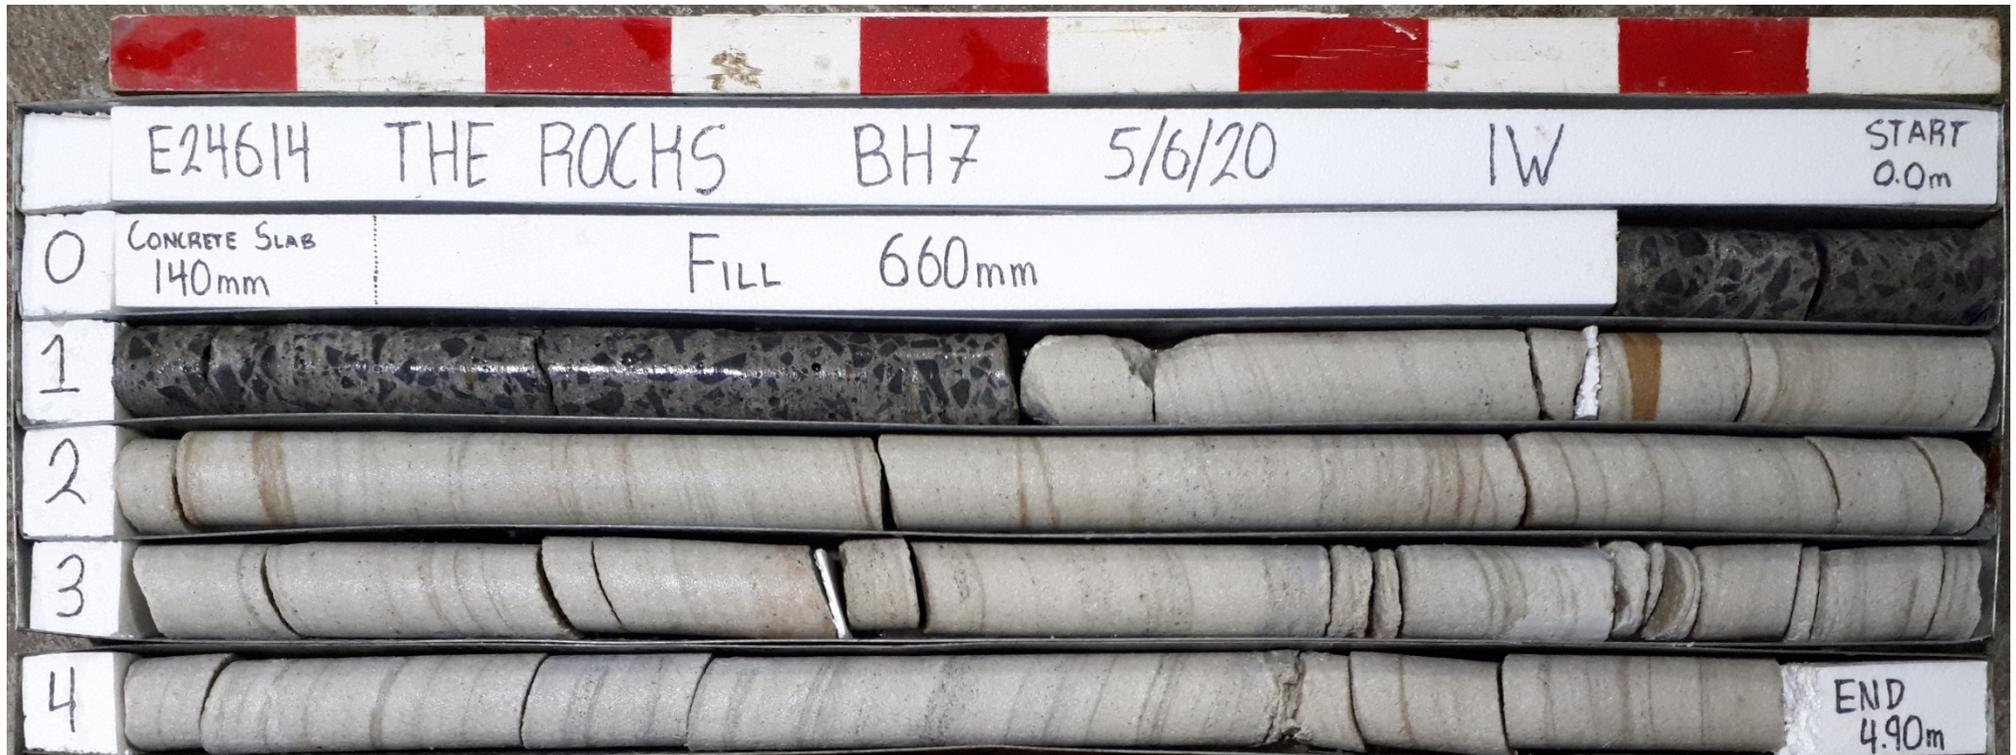
Project	Proposed Residential Development	Depth Range	0.0m to 4.9m BEGL	
Location	2-60 Cumberland Street, The Rocks NSW	Contractor	Geosense Drilling	
Position	See Figure 2	Drill Rig	Tight Access	
Job No.	E24614.G04	Surface RL	≈ 22.8m	Logged
Client	Sirius Developments Pty Ltd	Inclination	-90°	Date
		Box	1-2 of 2	Date
				05 / 06 / 2020
				15 / 06 / 2020

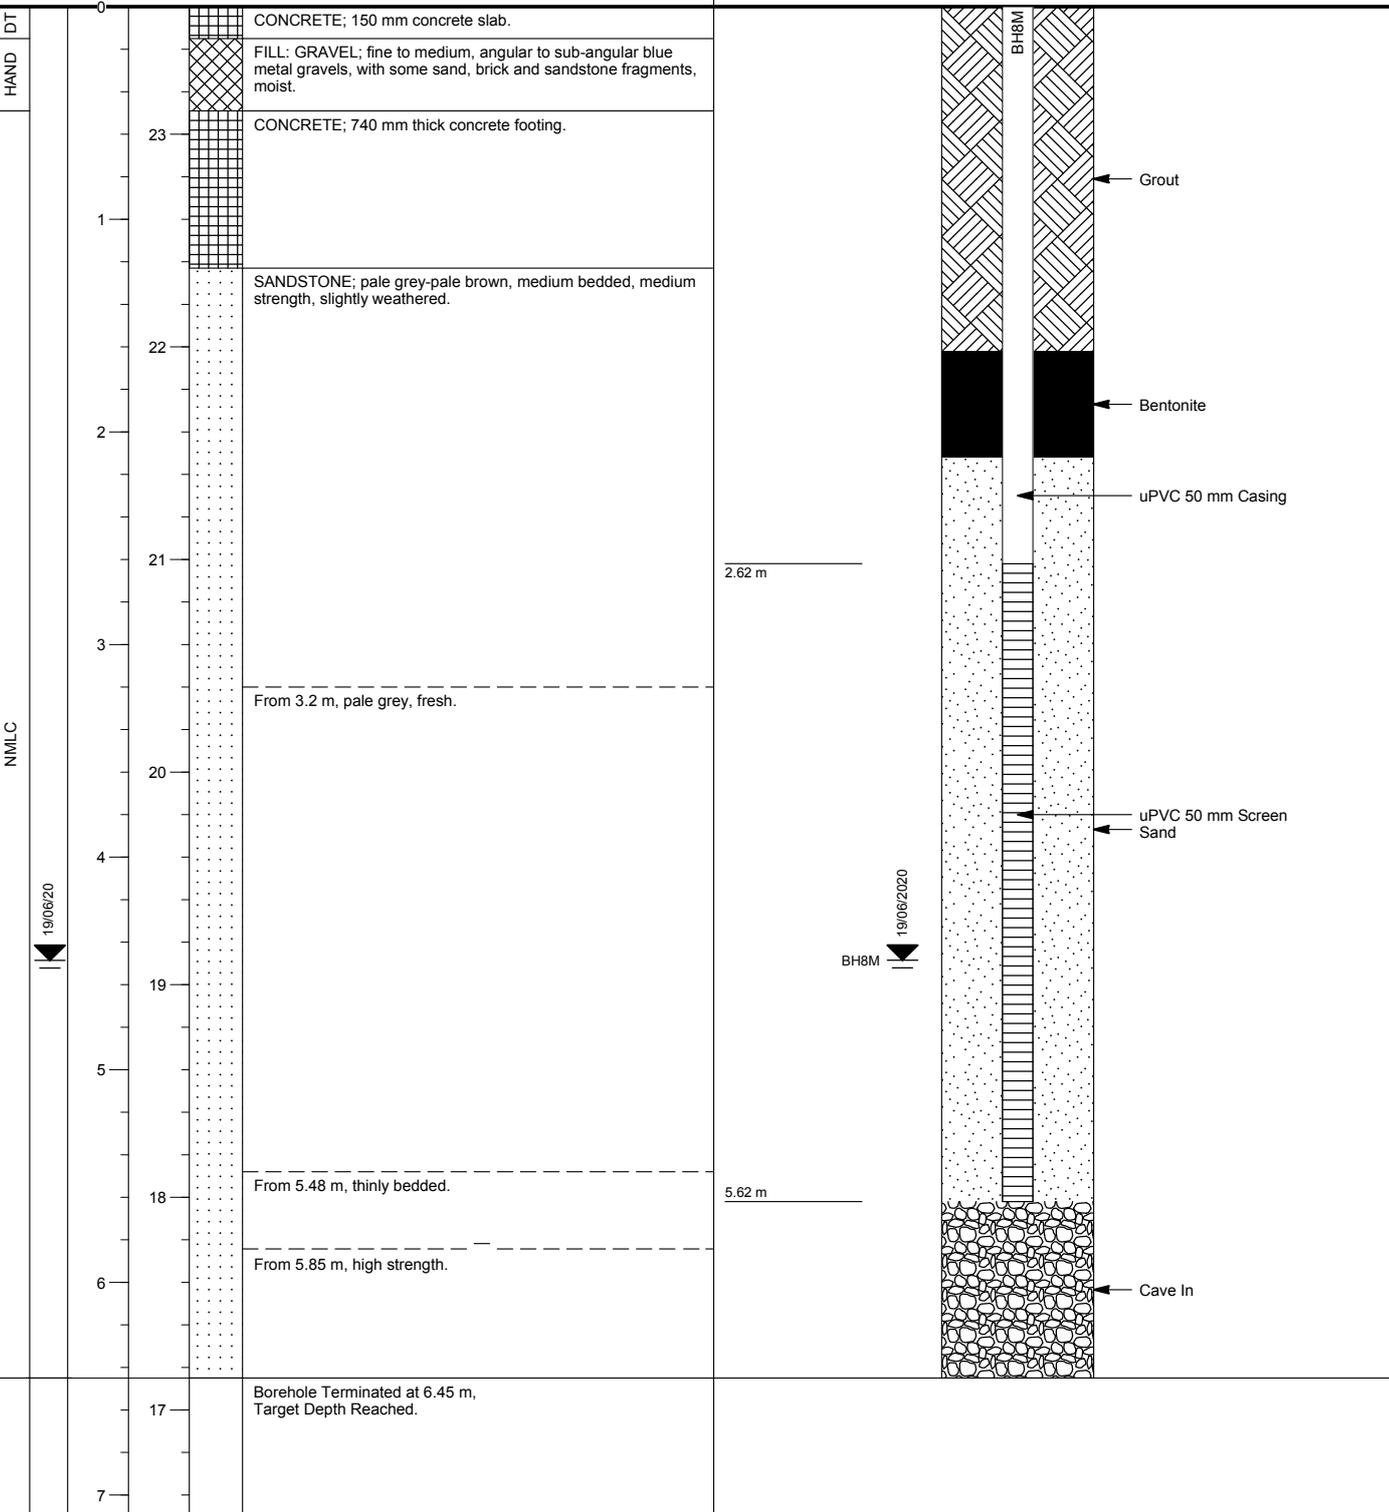
METHOD	WATER	DEPTH (m)	RL (m AHD)	GRAPHIC LOG	SOIL/ROCK MATERIAL DESCRIPTION	PIEZOMETER CONSTRUCTION DETAILS					
						ID	Type	Stick Up & RL	Tip Depth & RL	Installation Date	Static Water Level
						BH8M	Standpipe	0.08 m 23.52 m	5.62 m 17.98 m

Groundwater was observed in all monitoring wells as detailed in **Table 3-3**, all of which are above the assumed bulk excavation levels of RL 17.80m and RL 18.50m.
