SIRIUS DEVELOPMENTS PTY LTD

Geotechnical Investigation

2-60 Cumberland Street, The Rocks

E24614.G03_Rev2
6 July 2020

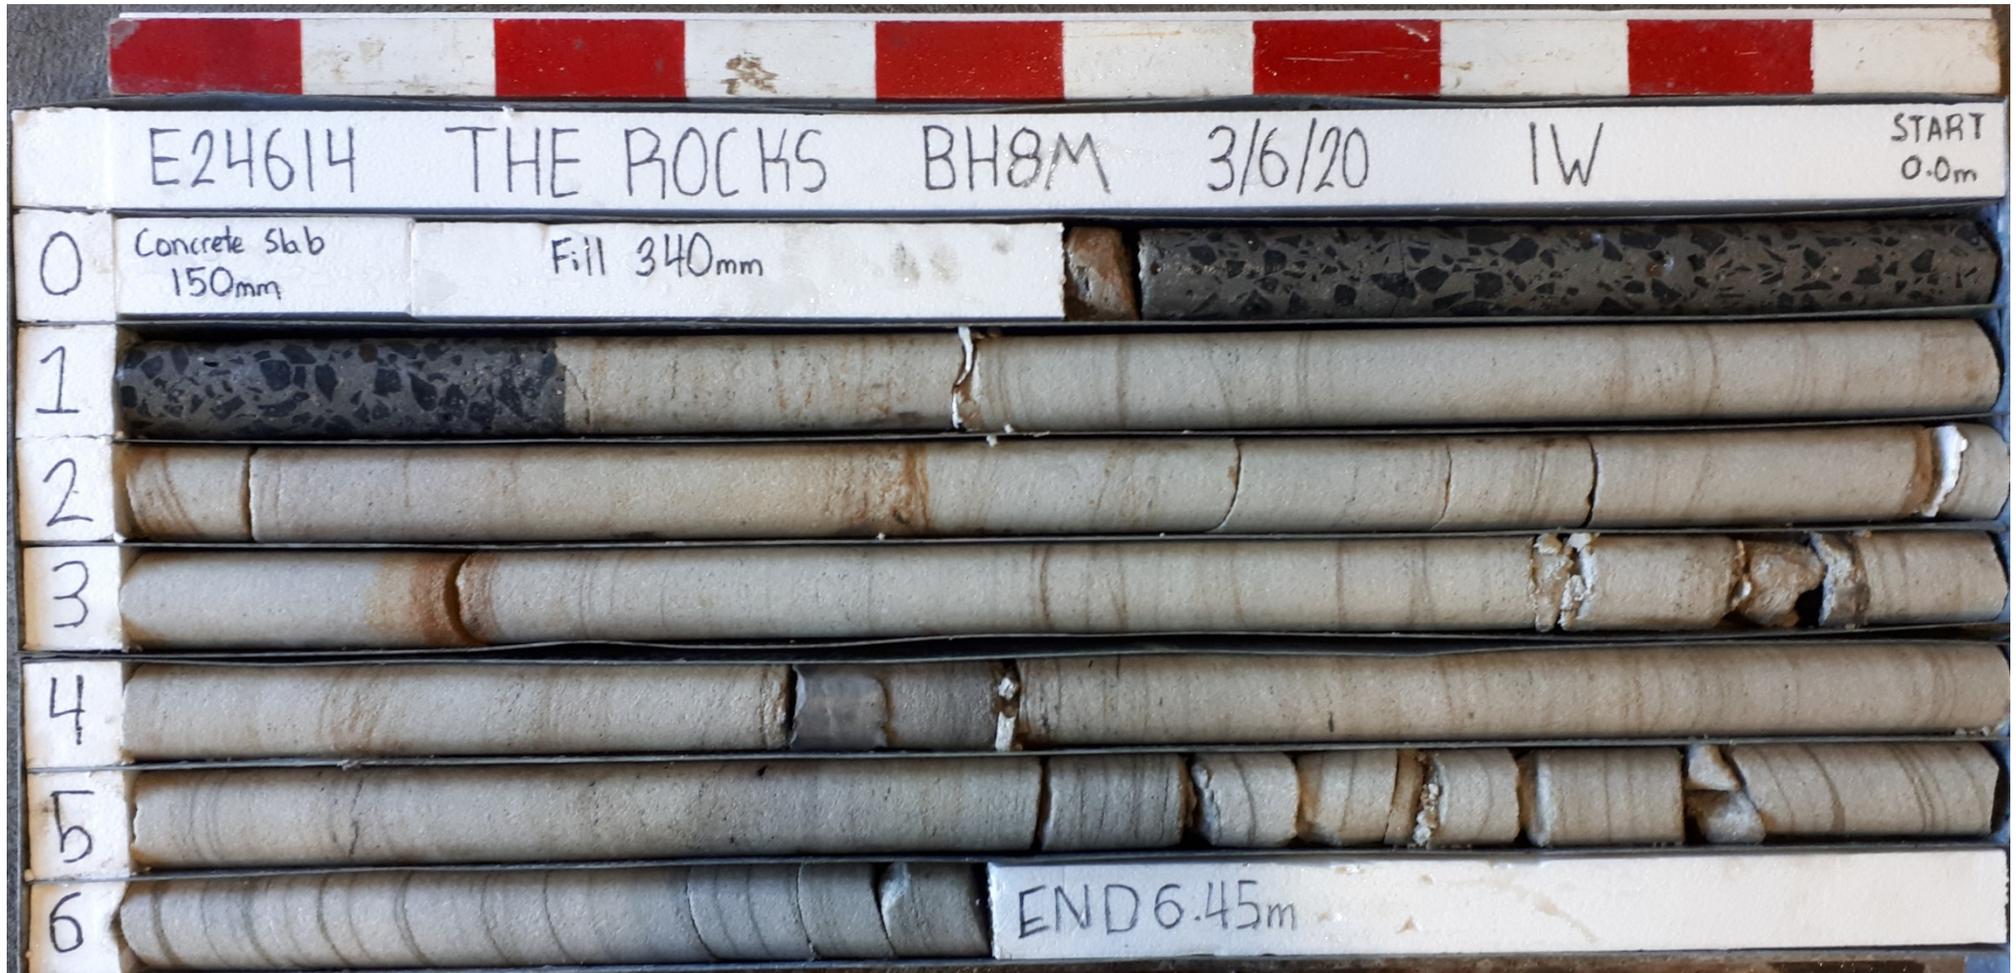
Project	Proposed Residential Development	Depth Range	0.0m to 6.45m BEGL	
Location	2-60 Cumberland Street, The Rocks NSW	Contractor	Geosense Drilling	
Position	See Figure 2	Drill Rig	Tight Access	
Job No.	E24614.G04	Surface RL	≈ 23.6m	Logged IW Date 03 / 06 / 2020
Client	Sirius Developments Pty Ltd	Inclination	-90°	Checked SK Date 15 / 06 / 2020
		Box	1-2 of 2

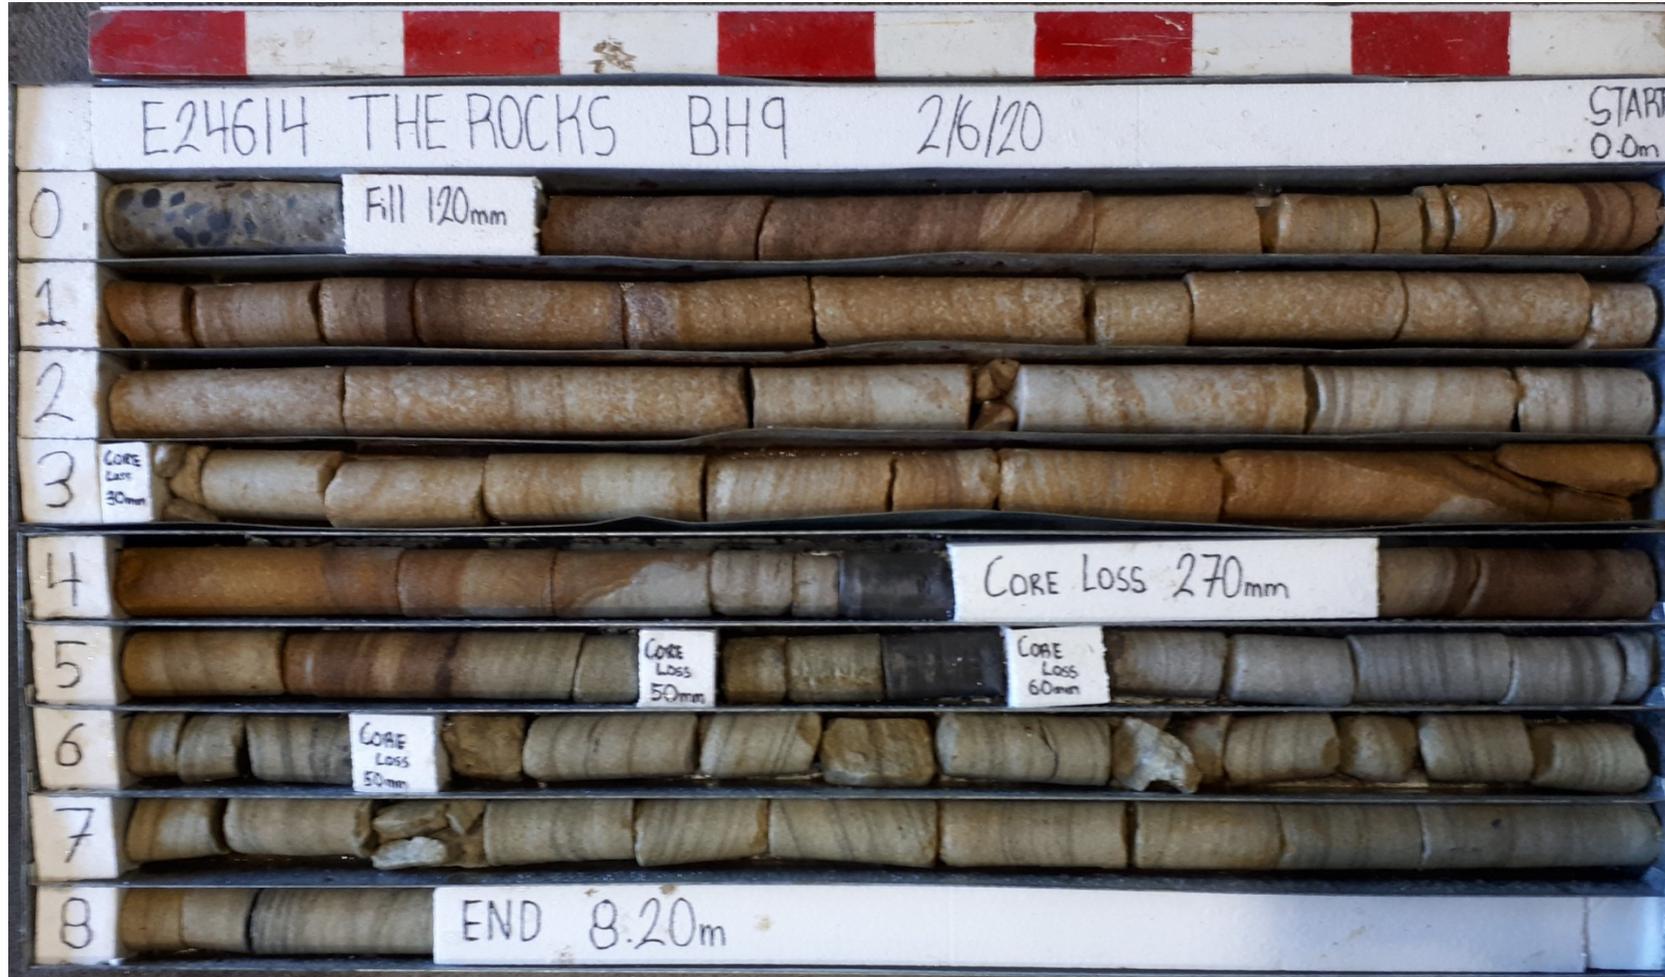
Project	Proposed Residential Development	Depth Range	0.0m to 8.2m BEGL	
Location	2-60 Cumberland Street, The Rocks NSW	Contractor	Geosense Drilling	
Position	See Figure 2	Drill Rig	Tight Access	
Job No.	E24614.G04	Surface RL	≈ 24.8m	Logged IW Date 02 / 06 / 2020
Client	Sirius Developments Pty Ltd	Inclination	-90°	Checked SK Date 15 / 06 / 2020
		Box	1-2 of 2

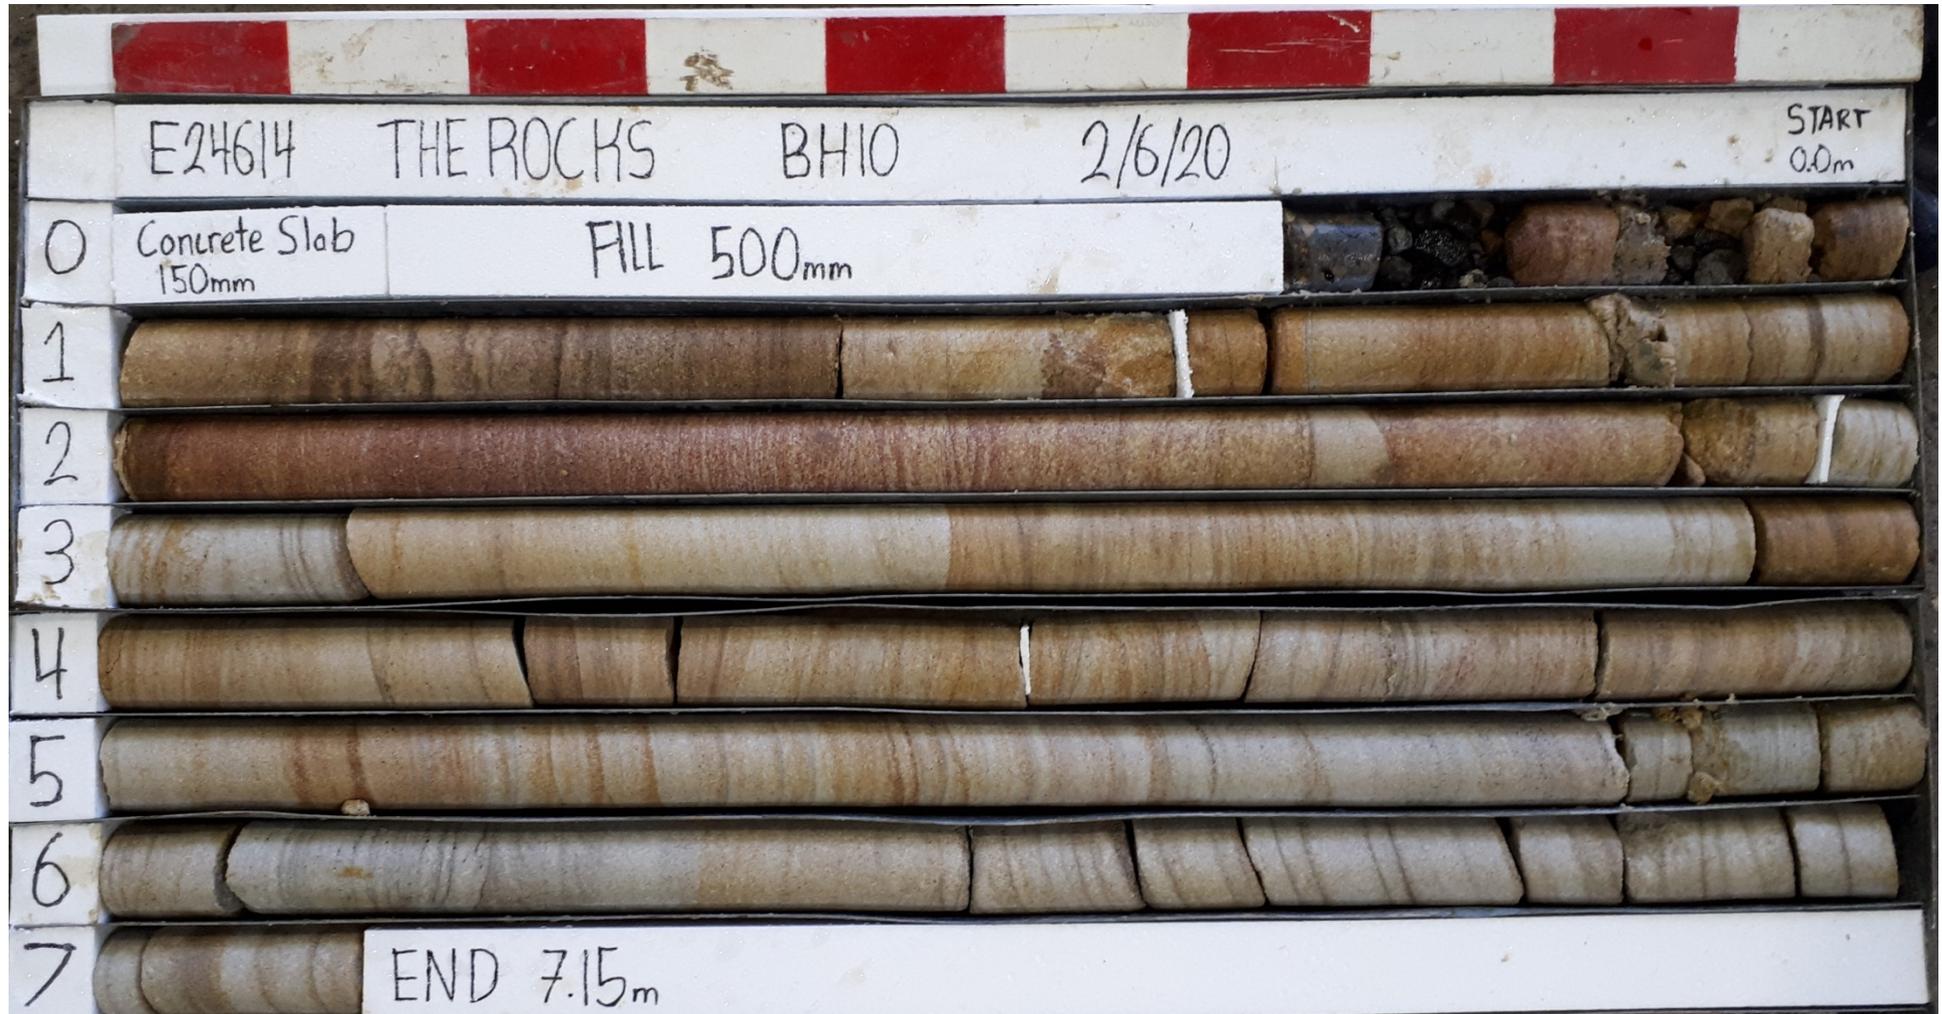
Project	Proposed Residential Development	Depth Range	0.0m to 7.15m BEGL	
Location	2-60 Cumberland Street, The Rocks NSW	Contractor	Geosense Drilling	
Position	See Figure 2	Drill Rig	Tight Access	
Job No.	E24614.G04	Surface RL	≈ 24.9m	Logged IW Date 02 / 06 / 2020
Client	Sirius Developments Pty Ltd	Inclination	-90°	Checked SK Date 15 / 06 / 2020
		Box	1-2 of 2

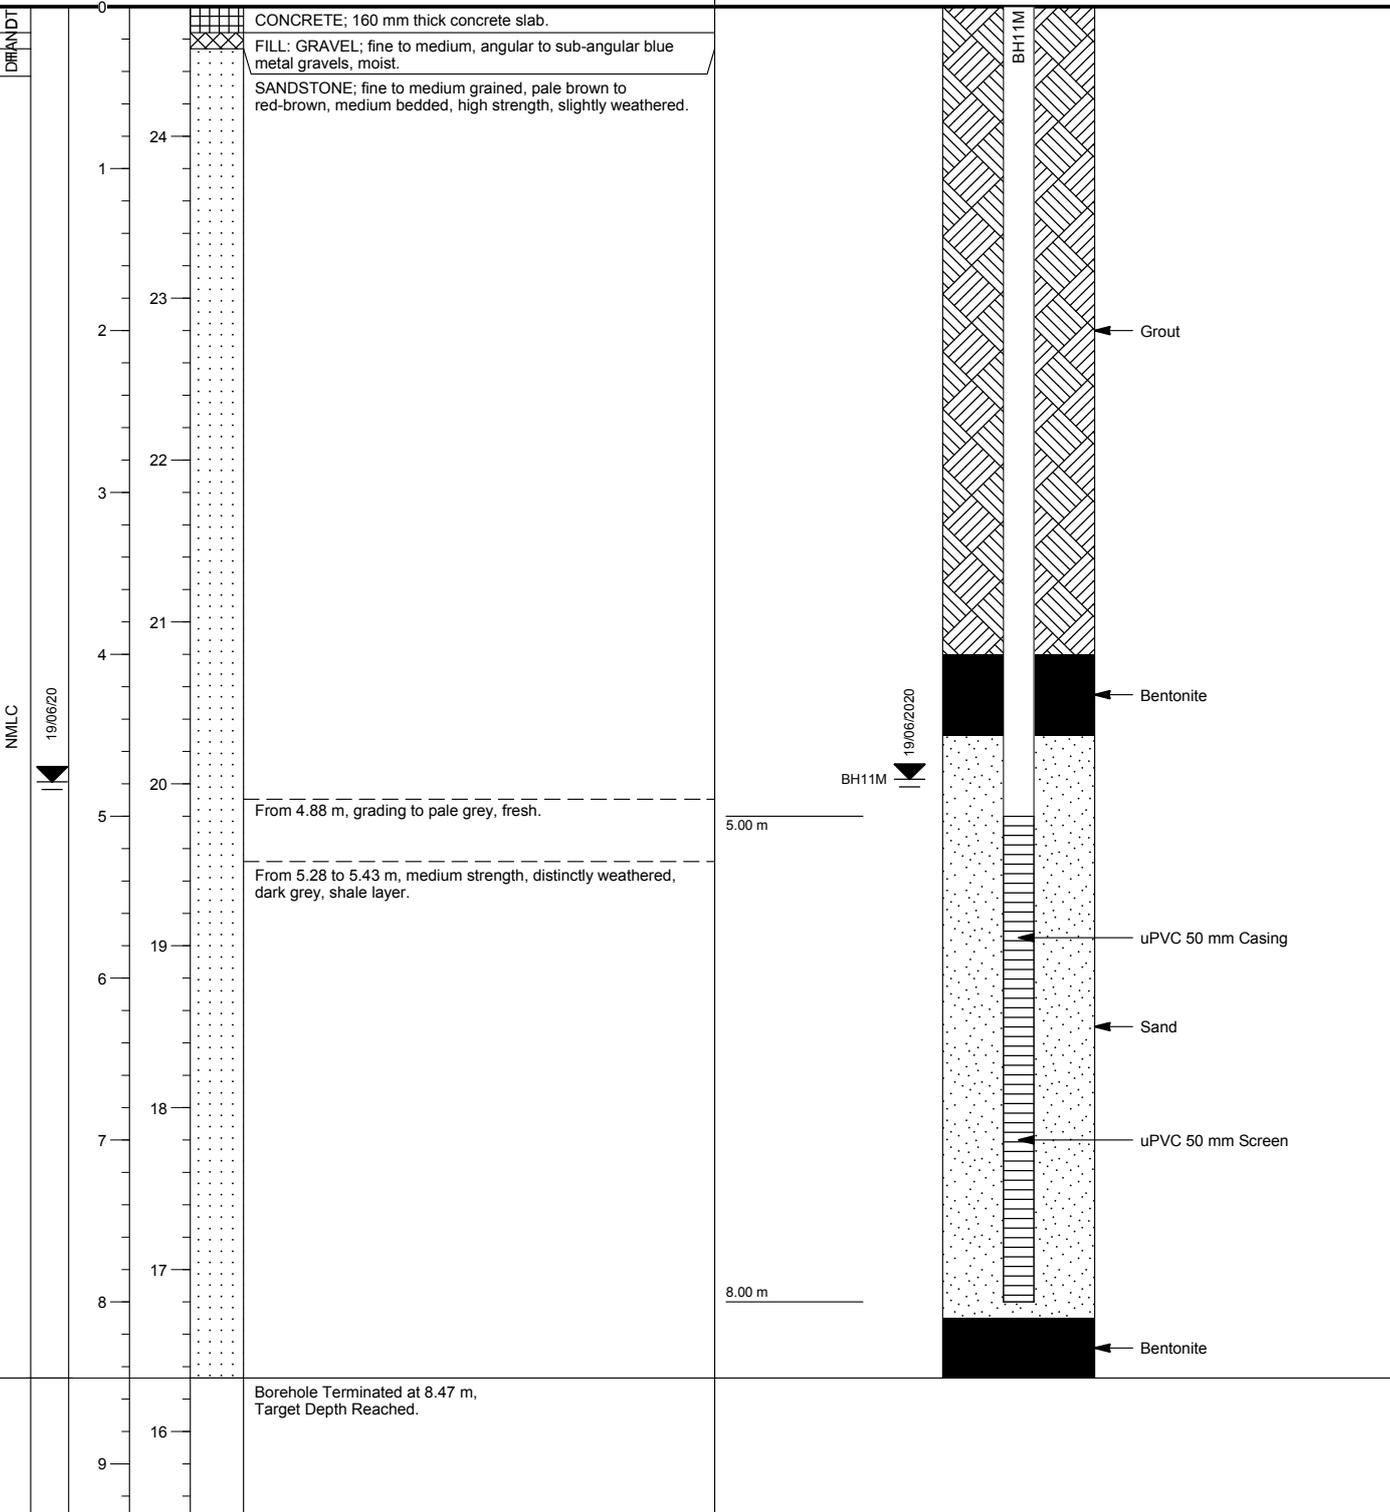
METHOD	WATER	DEPTH (m)	RL (m AHD)	GRAPHIC LOG	SOIL/ROCK MATERIAL DESCRIPTION	PIEZOMETER CONSTRUCTION DETAILS					
						ID	Type	Stick Up & RL	Tip Depth & RL	Installation Date	Static Water Level
						BH11M	Standpipe	0.10 m 24.70 m	8.00 m 16.80 m

Groundwater was observed in all monitoring wells as detailed in **Table 3-3**, all of which are above the assumed bulk excavation levels of RL 17.80m and RL 18.50m.

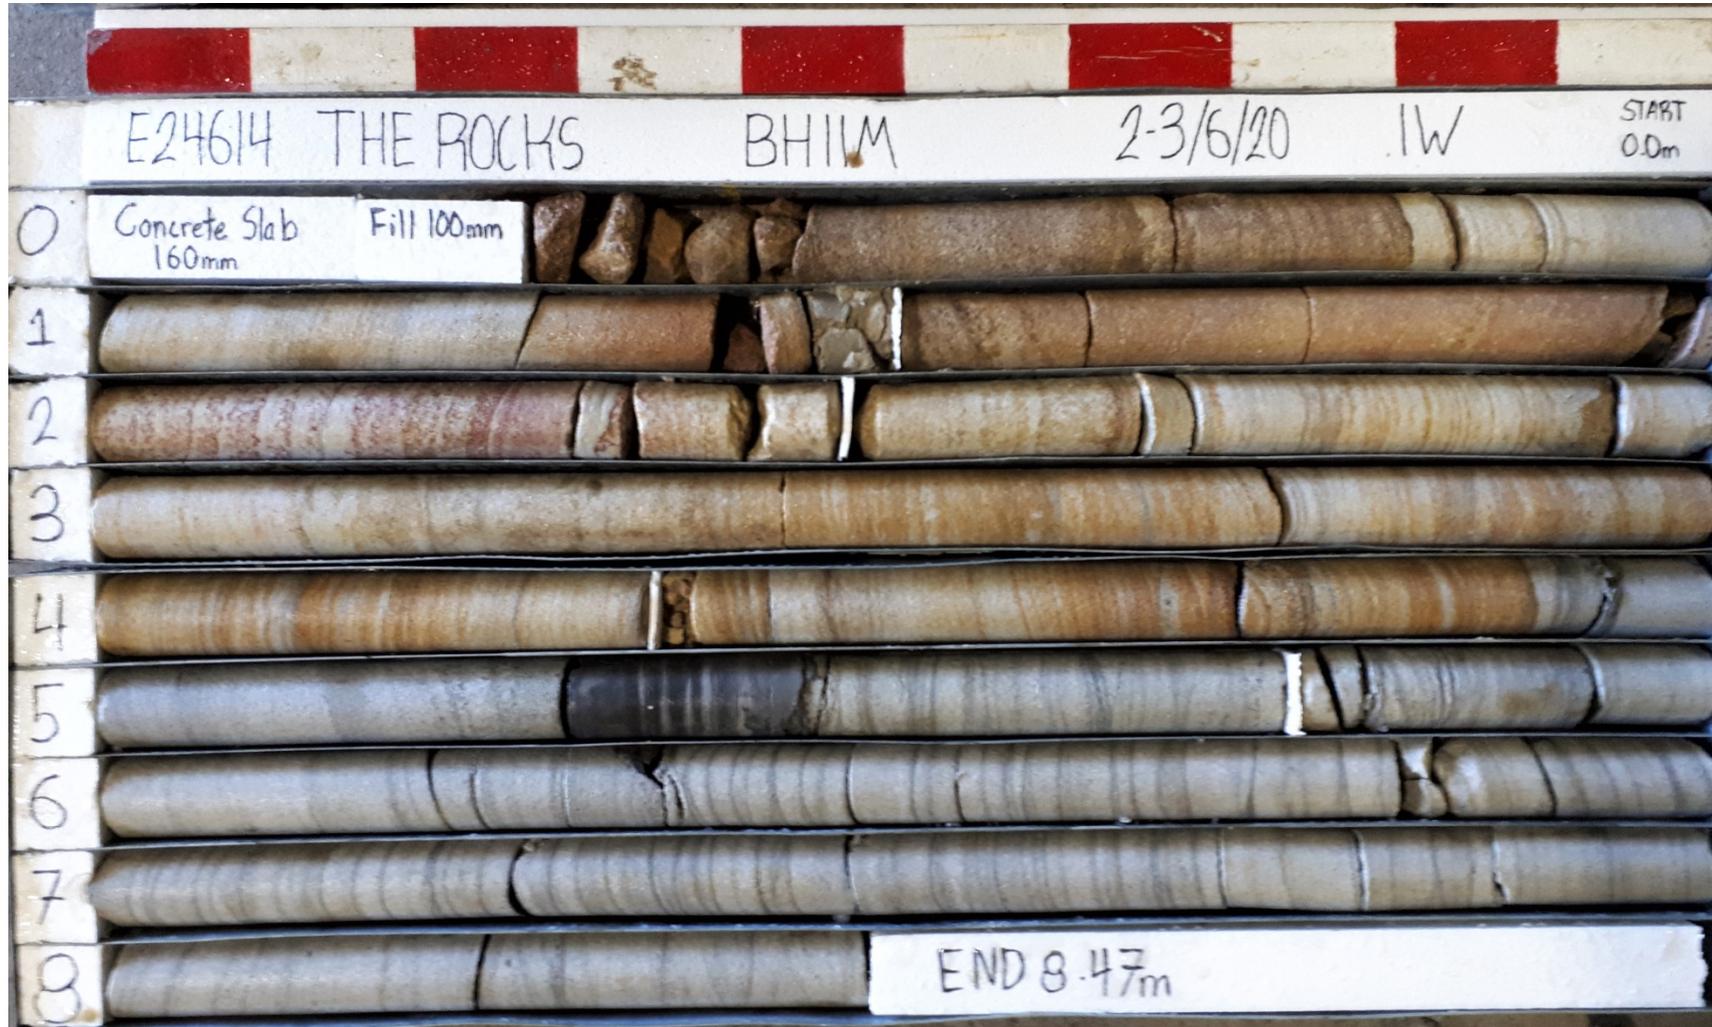
Project	Proposed Residential Development	Depth Range	0.0m to 8.47m BEGL	
Location	2-60 Cumberland Street, The Rocks NSW	Contractor	Geosense Drilling	
Position	See Figure 2	Drill Rig	Tight Access	
Job No.	E24614.G04	Surface RL	≈ 24.8m	Logged IW Date 02 / 06 / 2020
Client	Sirius Developments Pty Ltd	Inclination	-90°	Checked SK Date 15 / 06 / 2020
		Box	1-2 of 2
