# ARBORICULTURAL IMPACT ASSESSMENT

KAMBALA GIRLS HIGH SCHOOL, ROSE BAY

28/4/2020

CLIENT: CARMICHAEL TOMKINS PROPERTY GROUP

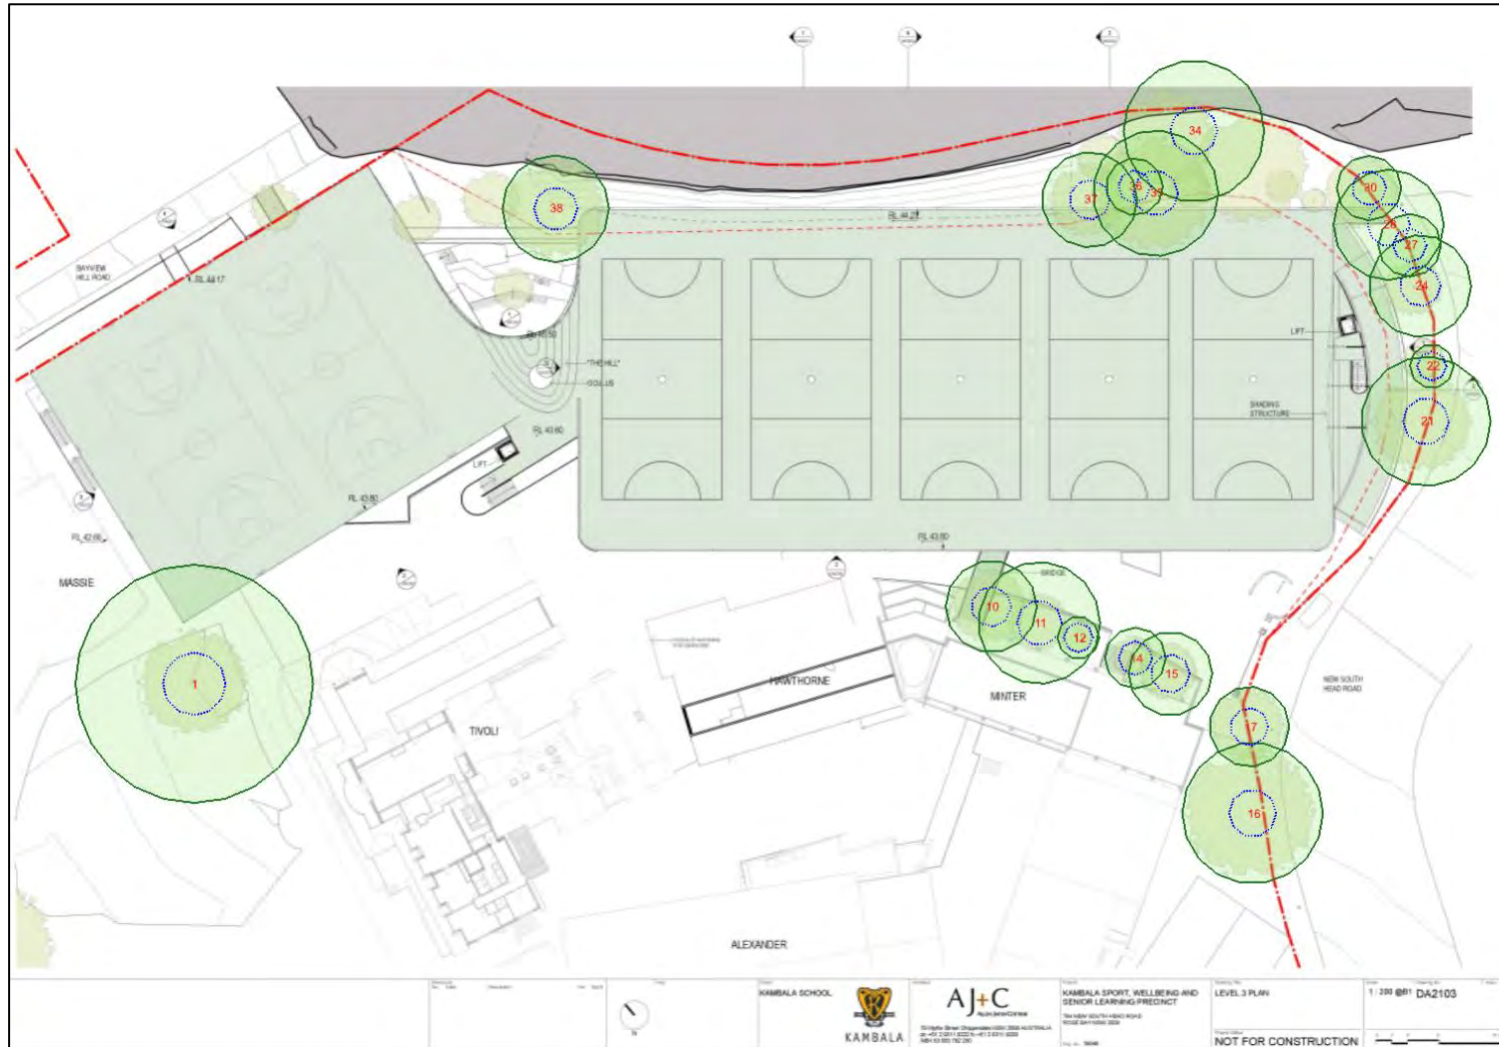
## 11.5 PROPOSED DEVELOPMENT PLAN AND TREES TO BE RETAINED SHOWING TPZs / SRZs

PLAN OF SITE SHOWING TREES TO BE PROTECTED (TPZ OUTER GREEN CIRCLE, SRZ DASHED INNER CIRCLE) - TPZ FENCING INSTRUCTIONS IN SECTION 11.1.

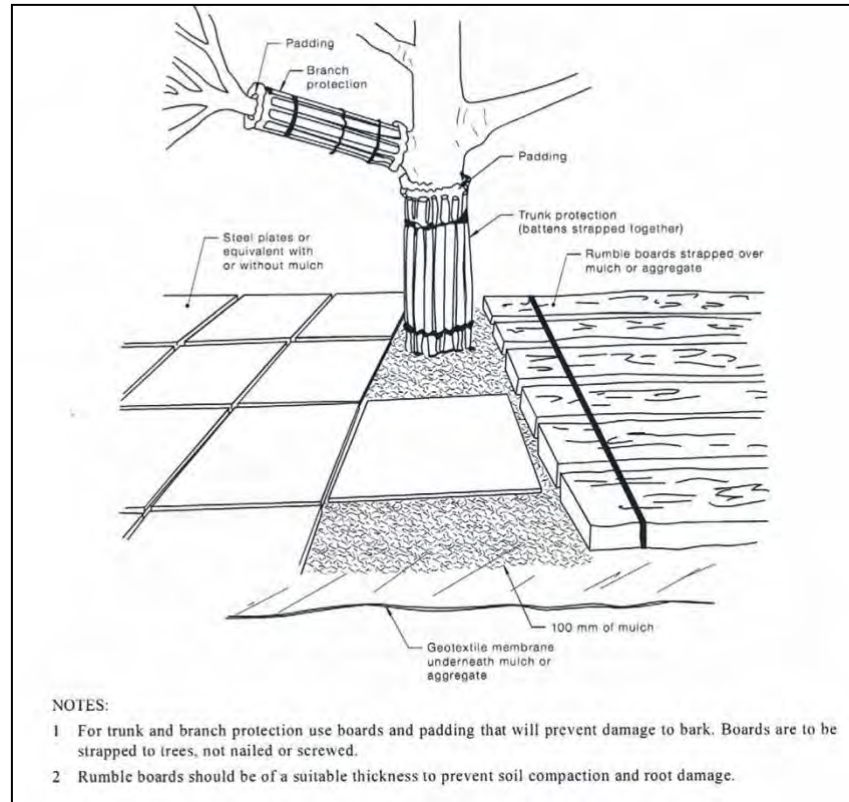
- Trunk and Branch Protection  
If access into the TPZ area is required for any scaffolding, or machinery, within 2m of the trees, then trunk and branch protection will need to be installed on limbs up to those above the height of tallest vehicle/scaffold. This should be installed by wrapping 2 layers of hessian (or similar material) around the branches and then securing hardwood battens (75x50x2000mm) at 100mm centers as shown in figure 9 below.
