CONSERVATION MANAGEMENT PLAN

Kambala School - Tivoli

Prepared for
KAMBALA SCHOOL
23 July 2020

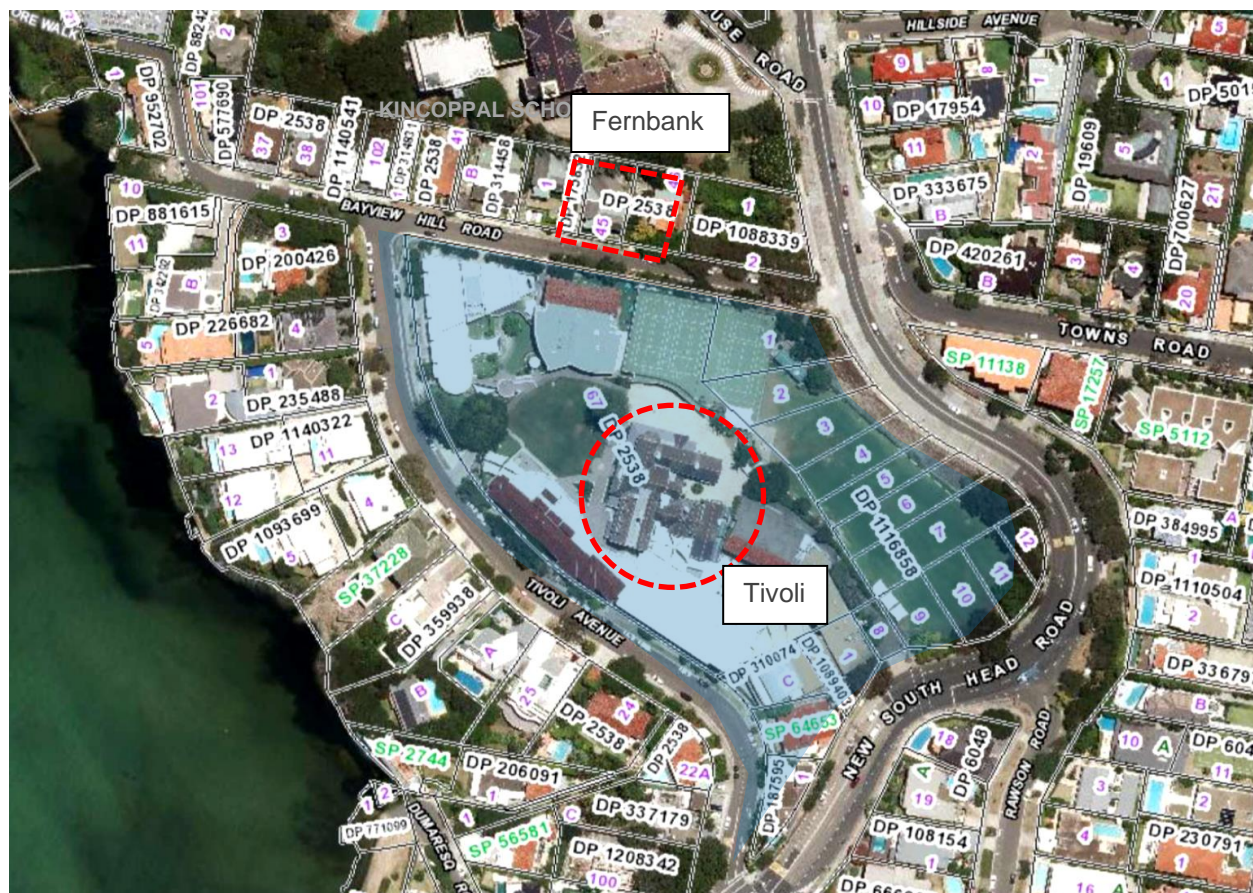
Figure 2 - The land forming the main Kambala School campus (shaded in blue). 'Tivoli' and 'Fernbank' are outlined in red.

The main Kambala School Campus is located at 794 New South Head Road, Rose Bay as shown in Figure 1. 'Tivoli' is centrally located within the campus. (Figure 2). It is a large irregular site with the following allotments:

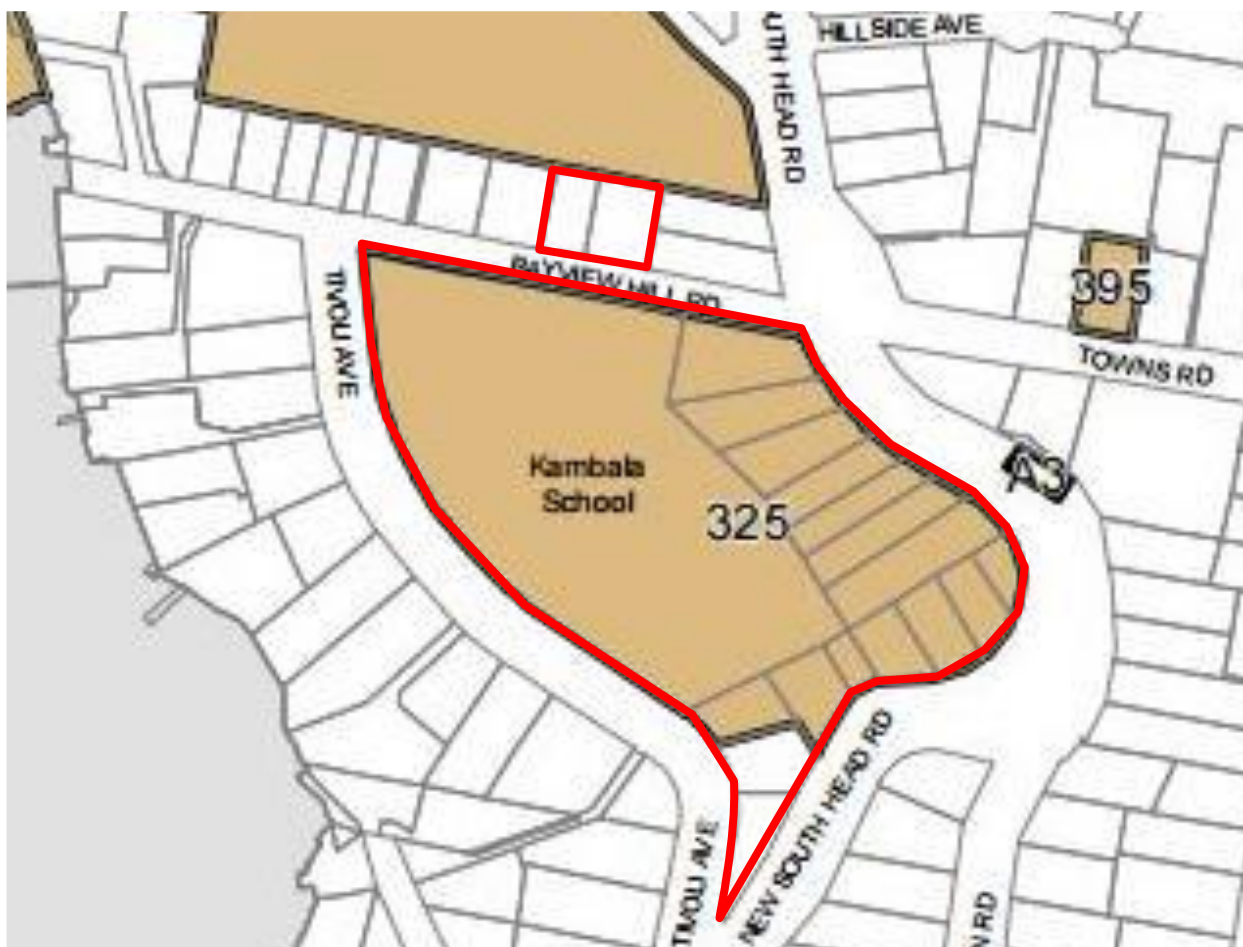
Figure 3 – Detail from Woollahra LEP 2014 Heritage Map showing the boundary of the school site.

Kambala is currently a local heritage listed item under the Woollahra Local Environmental Plan (LEP) 2014, being 'Kambala School—building formerly Tivoli and interiors, gateposts, gates and flanking walls with railing facing Tivoli Avenue, 2 Norfolk Island Pines' (Item No. 325), as shown in Figure 3 below.

Kambala is a local heritage listed item under the Woollahra Local Environmental Plan (LEP) 2014, being '*Kambala School—building formerly Tivoli and interiors, gateposts, gates and flanking walls with railing facing Tivoli Avenue, 2 Norfolk Island Pines*' (Item No. 325), as shown in Figure 3.

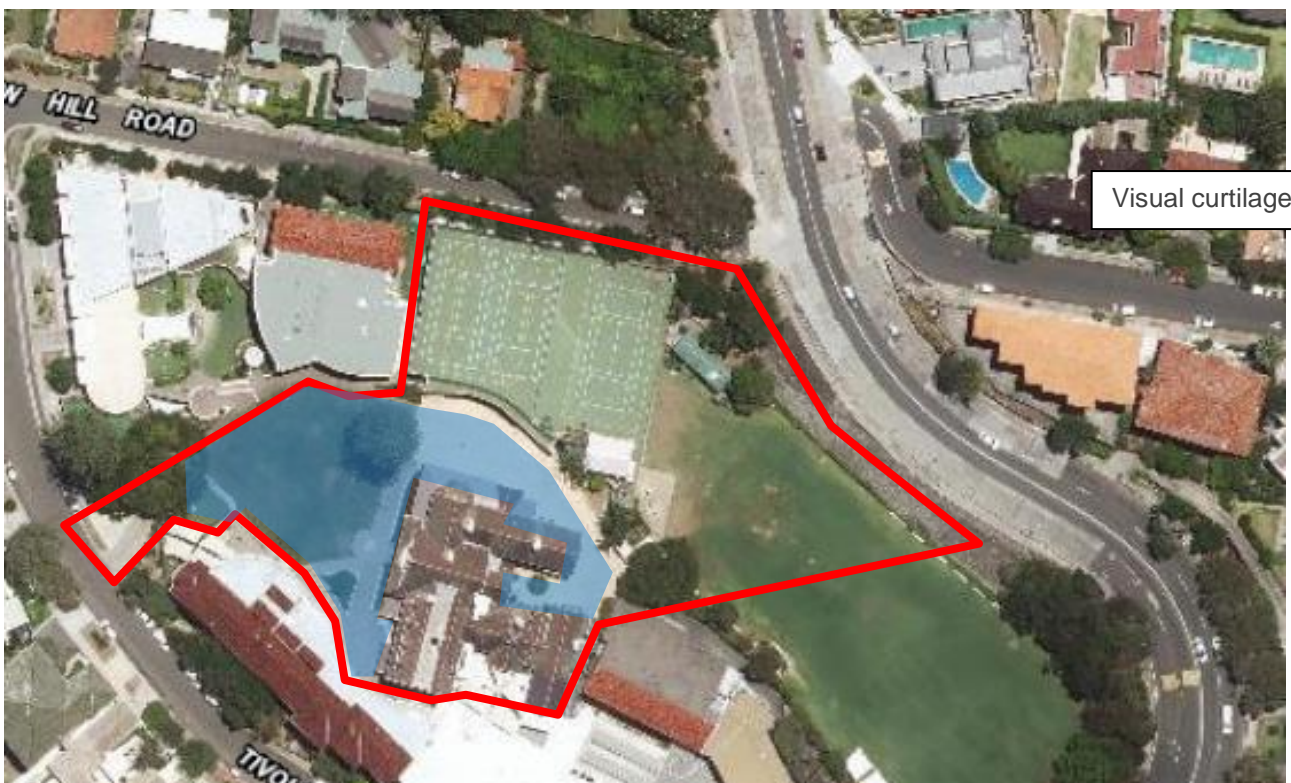
Figure 7 – Visual Curtilage. The red indicates areas of distant high visibility and significance. The blue overlay indicates areas of high visibility and significance in the immediate setting.

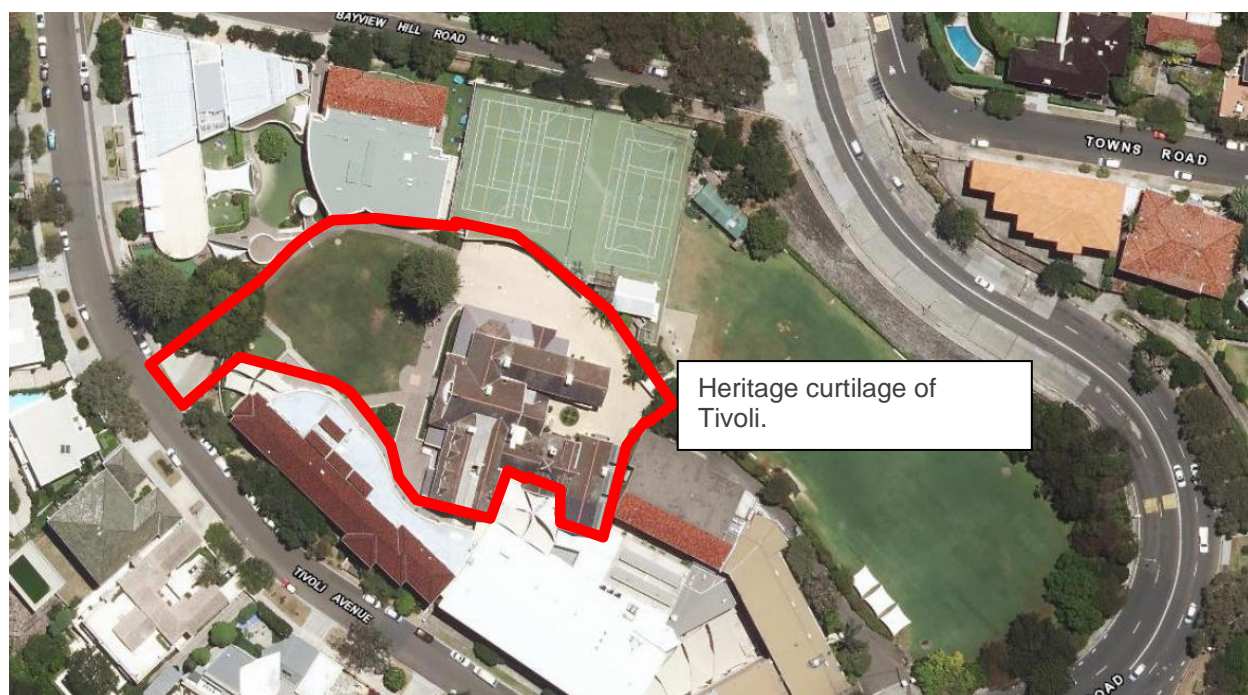
Figure 8 – The heritage curtilage of Tivoli

The original gardens and outbuildings associated with Tivoli have been replaced with further development. The only surviving elements of the former estate existing on the site are the caved sandstone gate piers and gates and the remnant palisade fence located at the entrance to Tivoli from Tivoli Avenue. Two araucaria Norfolk Island pines are the only surviving remnants of the nineteenth century garden.

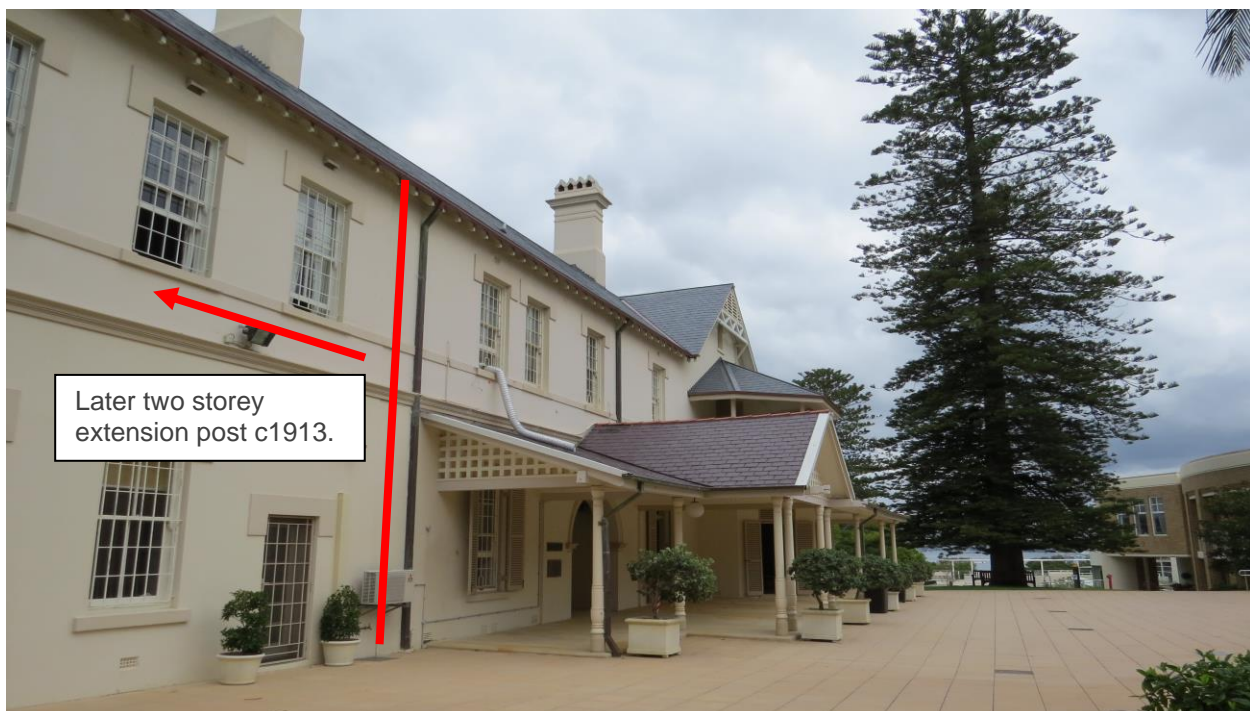
Figure 10 – Northern elevation showing verandah and gabled entrance.

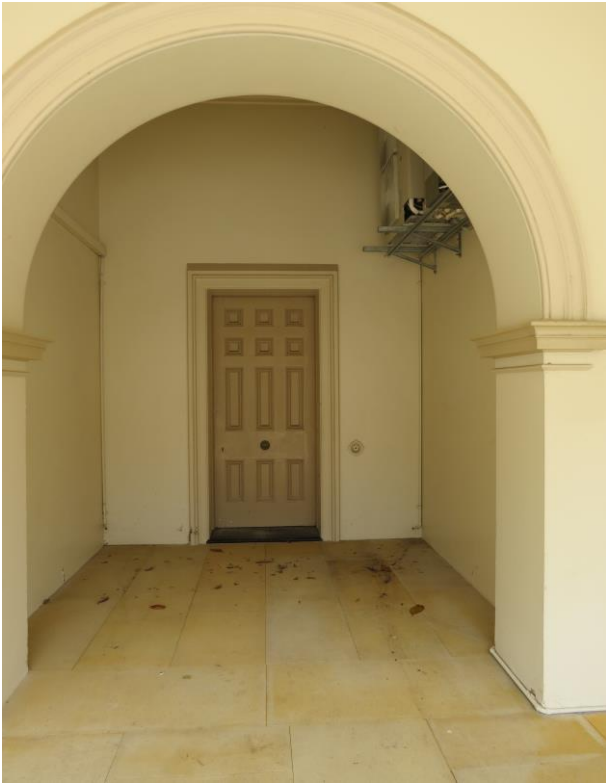
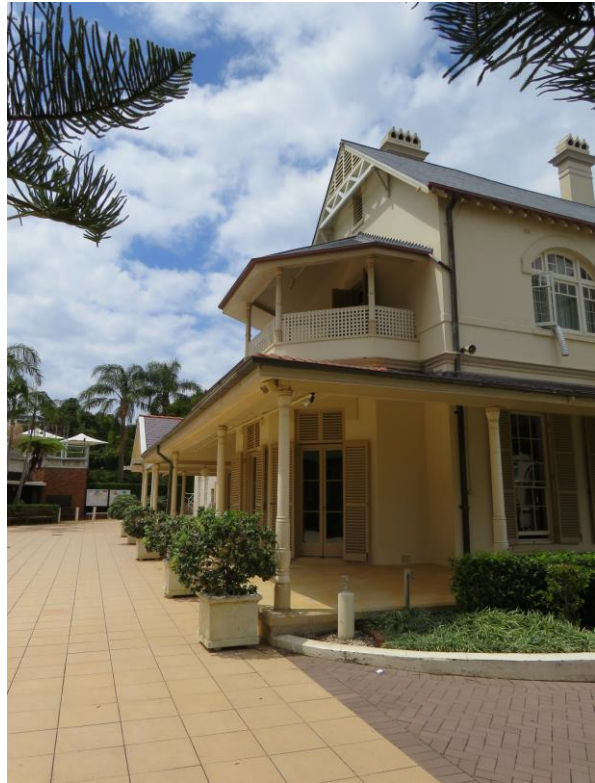
Figure 11 – Northern elevation showing front entrance door recessed and bay window on north-western corner.

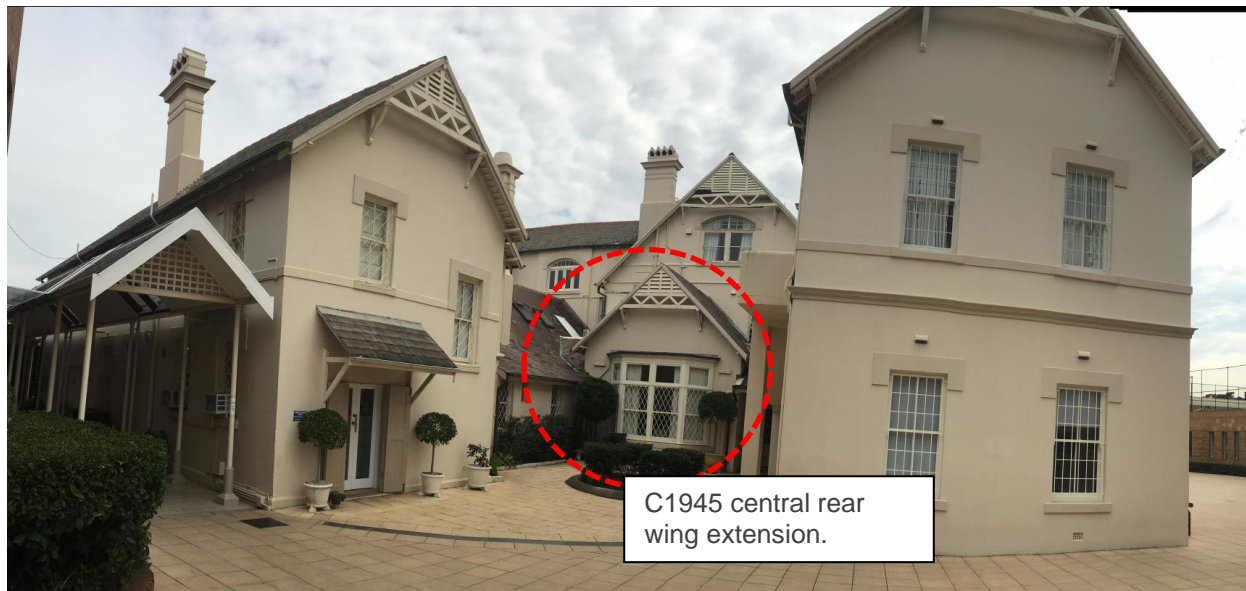
Figure 13 – Eastern elevation

The eastern elevation (rear courtyard) contains a secondary entrance and features a series of service wings centred around a courtyard. The service wing of the original house runs off the eastern end of the main dining room on the ground floor, forming the southern side of the courtyard. It links to a second service wing at the eastern end that forms a partial enclosure of the courtyard. A single storey gabled addition to the central rear gable was constructed c1945.

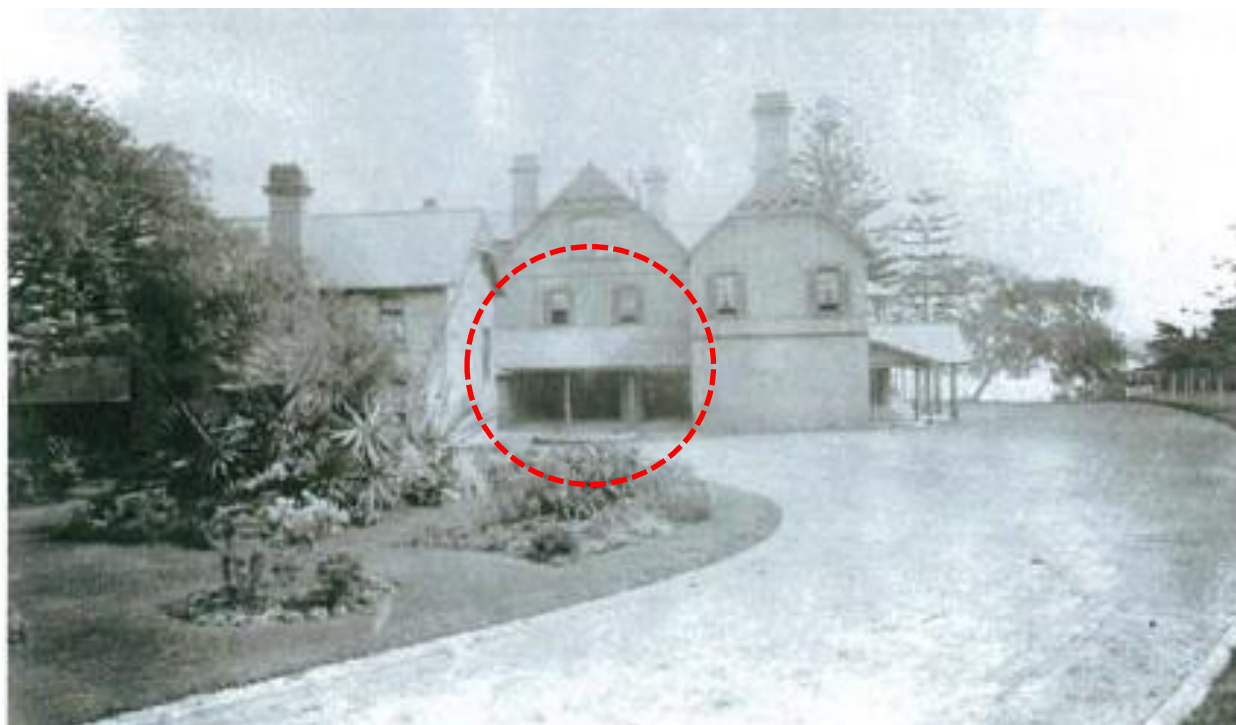
Figure 14 – Rear of Tivoli, c1911, prior to central rear extension.

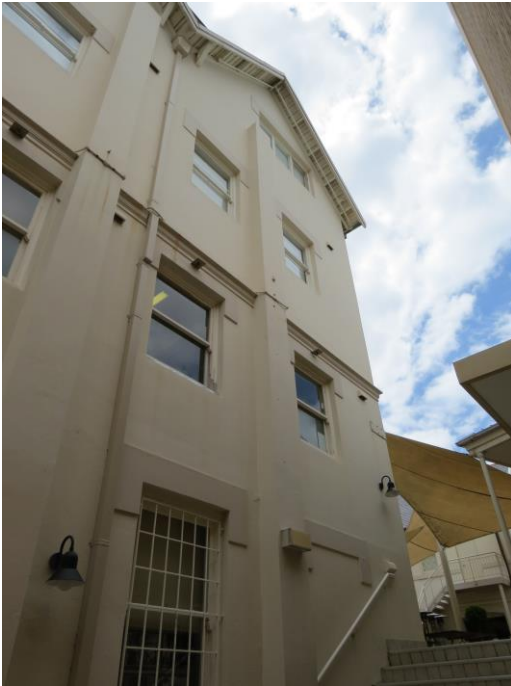
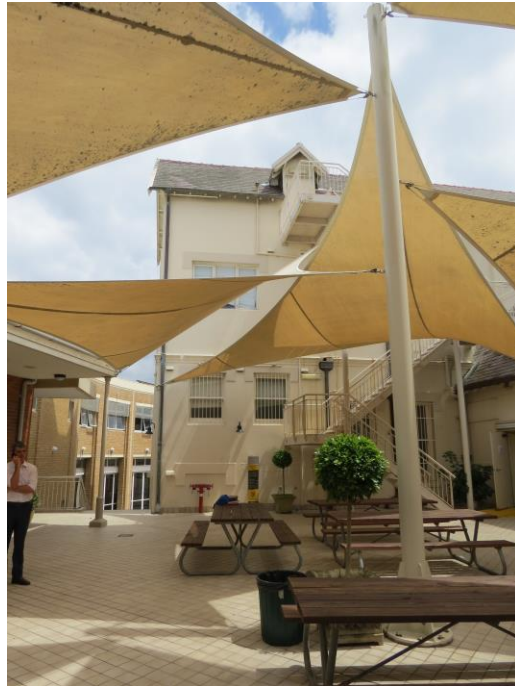
Figure 15 – Southern elevation and courtyard.

The southern elevation comprises the southern side of the rear service wings and a recent paved courtyard with canteen (a later addition).

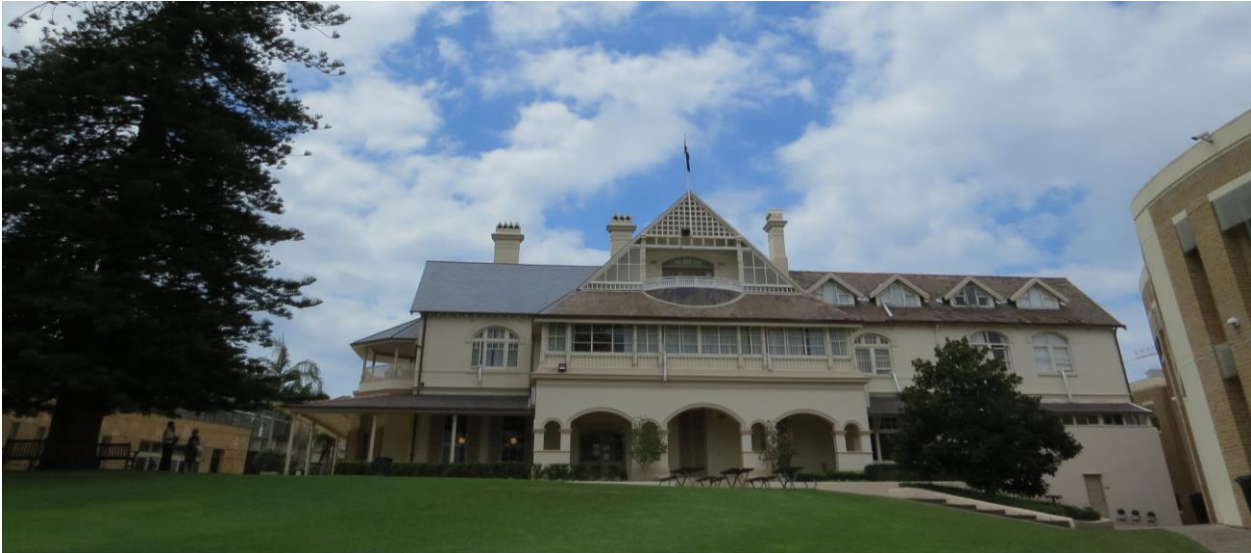
Figure 17 – Western elevation showing prominent gable with lattice detailing, colonnaded verandah and Norfolk Island Pine.

The western elevation is the principal elevation to the building and features a high prominent gable and a large ground floor colonnaded verandah. The gable features a large lattice screen and a first floor and attic balcony with timber posts, shingles and detailing and beam end grotesques. It is noted that the first floor verandah has been entirely enclosed with windows.

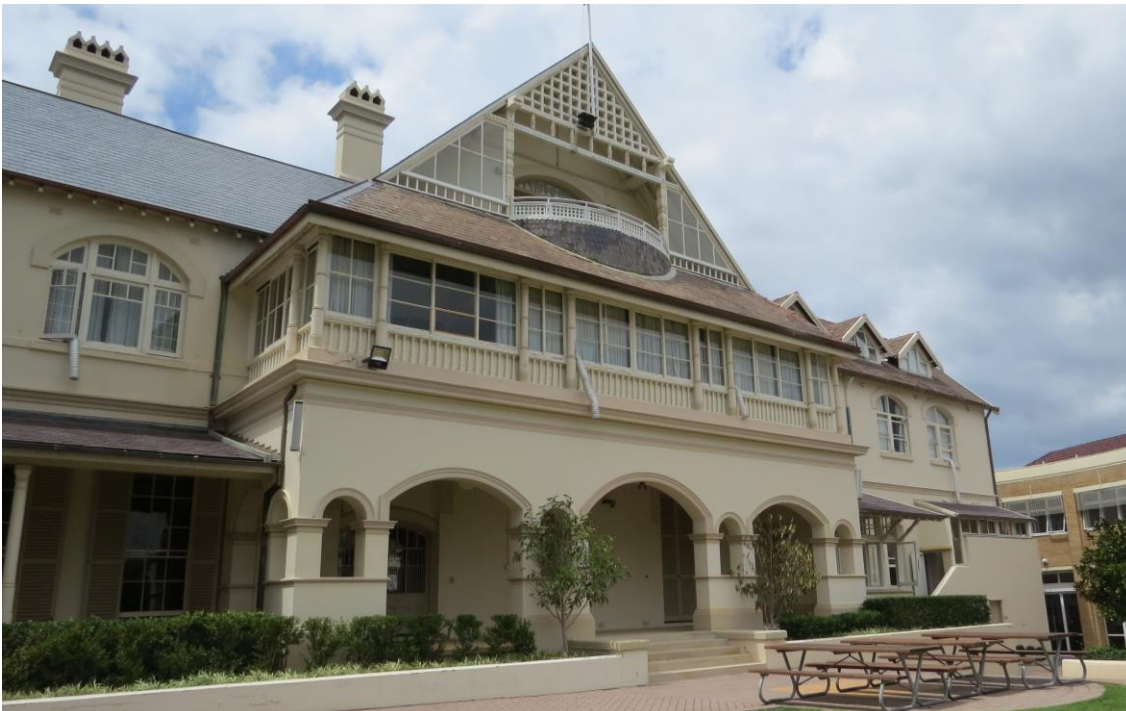
Figure 18 – Detail of western gable.

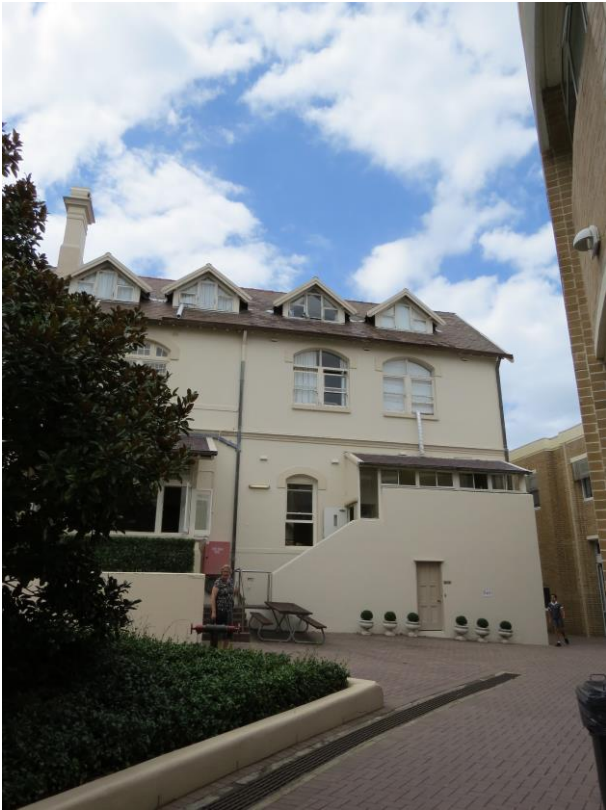
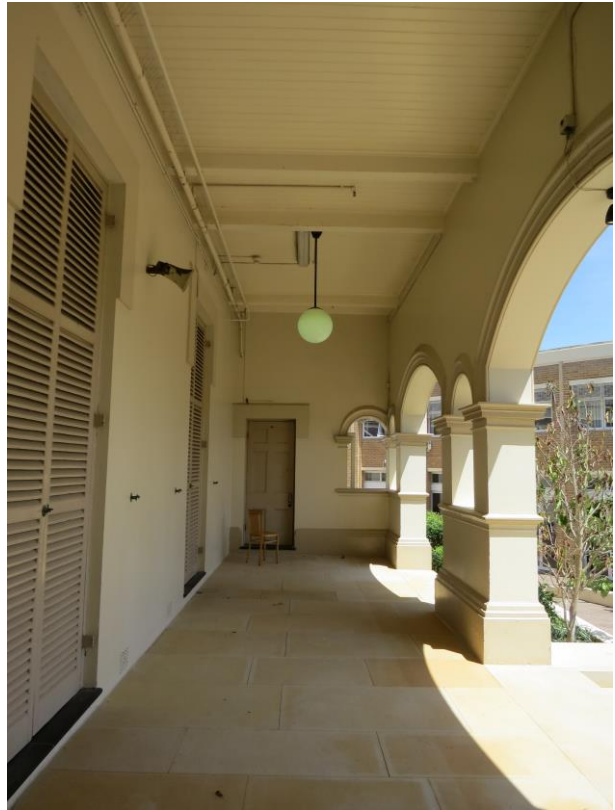
Figure 19 – Detail of later extension to southern end of western elevation and colonnaded verandah.

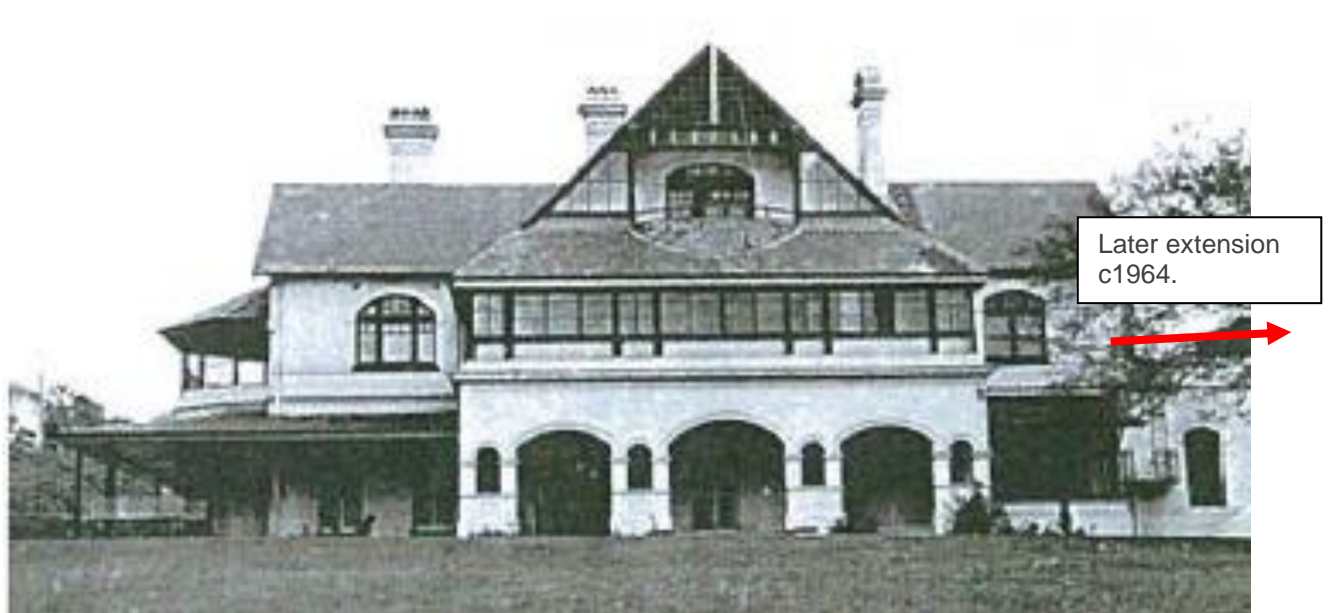
Figure 20 – Tivoli prior to extension of southern end of western elevation 1964.

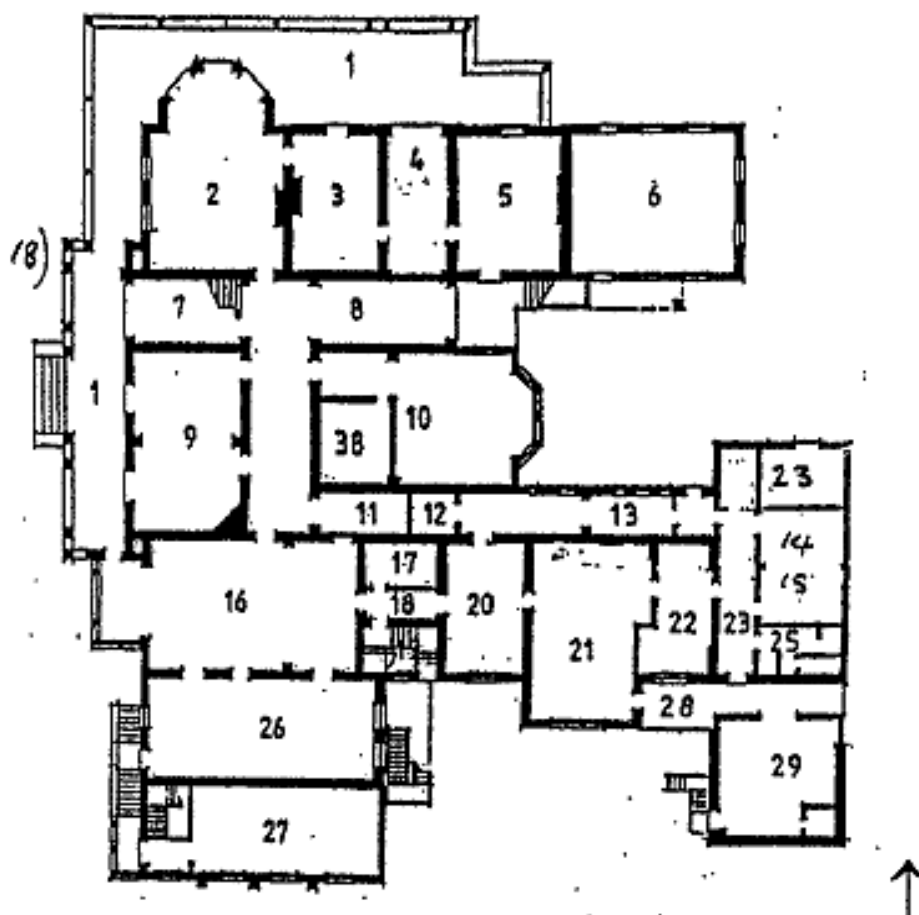
Figure 22 – Ground Floor

TIVOLI - KAMBALA
Ground Floor Plan Current Uses 2003

1	Verandah	16	Main Dining Room
2	Drawing Room	17	Staff Room
3	Enrolments	18	Service hall
4	Entry Hall	19	Service Stair
5	Foundation Office	20	Wash-up area
6	Archives Office	21	Kitchen
7	Main Stair	22	Dry Stores
8	Main Hall	23	Service Passage
9	Music Rooms	24	Property Manager
10	Year 10 Common Room	25	Staff Wash Room
11	Toilet	26	Dining Annex
12	Store	27	Games Room
13	Service Passage	28	Service Passage
14	Laundry	29	School Canteen
15	Laundry

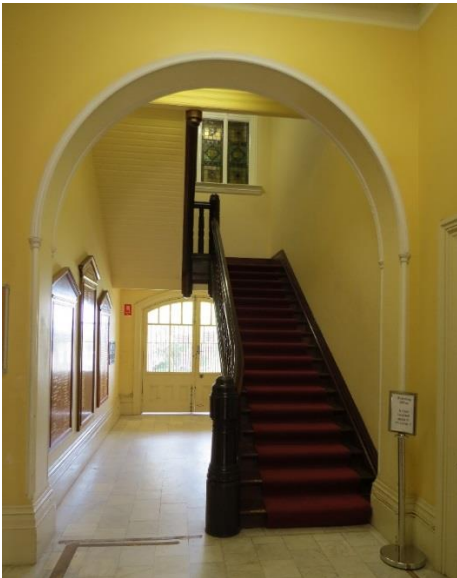
Figure 25 – Main hall and stair

Picture 7 – Main hall and stair on ground floor.

The main hall and stair is largely intact including arched openings, a main timber stair and decorative cornices. The stair is late Victorian in character; having replaced the original house stair. It has simple turned newels. There is a large stained glass window located on the landing of the main stair. It is Arts and Crafts in style with birds and flowers and occupies the northern wall above the landing. The original marble floor finishes have been retained. The original lighting has been removed throughout the main ground floor hall and vestibule (second hall).

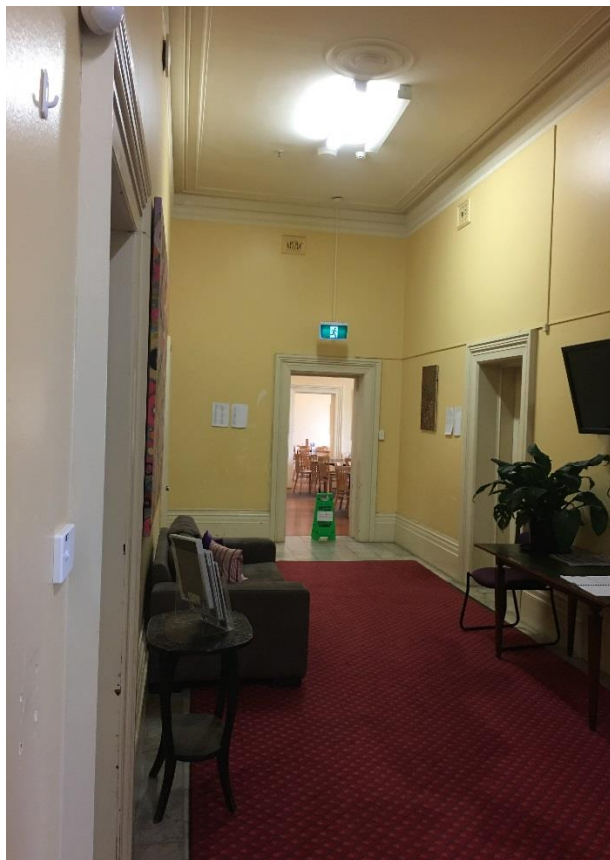
Figure 27 – The ground floor second hall vestibule

Picture 9 – Ground floor second hall vestibule

The ground floor vestibule (second hall) has generally retained the same configuration and finishes. However, new doors, of a character similar to those existing, have been added to the eastern wall. The original marble floor finishes have been retained. The original lighting has been removed throughout the main ground floor hall and vestibule (second hall).

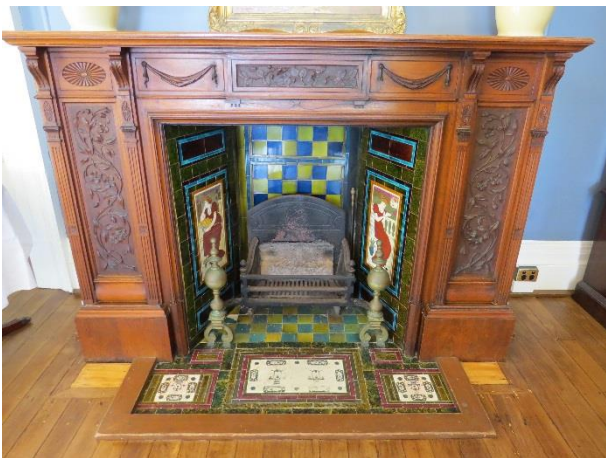
Picture 13 – Elaborate fireplace

There is an elaborate fireplace with a carved and tiled surround. The fireplace is decorated with chequer board blue and yellow tiles with side panes. The hearth extends into the room with Japonaise printed tiles. The surround is finely carved with panels of flowers

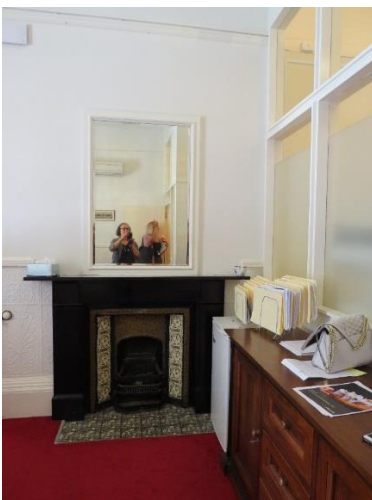
Figure 30 – Smoke room/office

Picture 15 – Fireplace and hearth

This room is substantially intact though the hardware to the internal and external doors has been modified. The fireplace surround is that shown in the 1911 photograph while a later brick insert replaces the original grate. A feature of the hearth is the 'Japanese' tiling which was high fashion in the 1880's. The original bell pull is in place in this room.

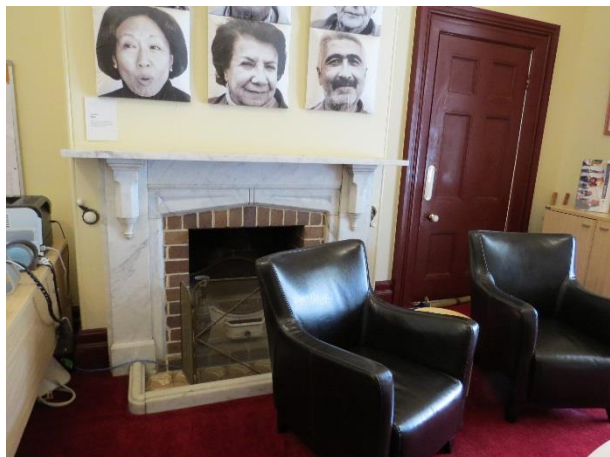
Picture 17 – Fireplace and hearth

The original fireplace and tiles survive intact, as does the pressed metal dado panelling.

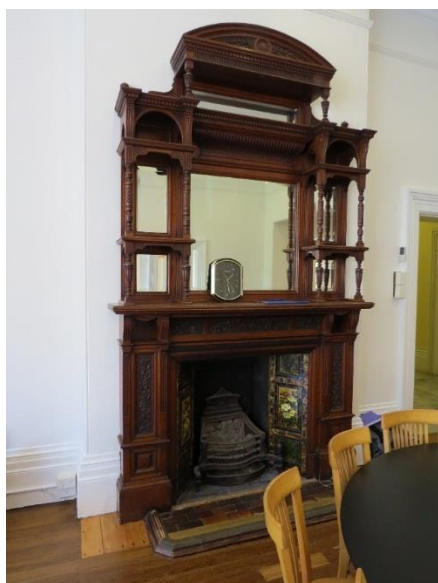
Figure 32 – Dining Room

Picture 19 – Fireplace and hearth

The dining room originally had access only from the ground floor vestibule. As part of the school modifications this room has been expanded to the south into the original service area and to the south through the original window openings into the western extension. The room retains part of its original ceiling and ceiling rose but has been modified with later false ceilings, down lights and other fittings that are intrusive. The large bay window has been modified by the removal of the central sashes and replacement with plate glass. The fireplace and overmantel are intact with some original tiling representing floral patterns.

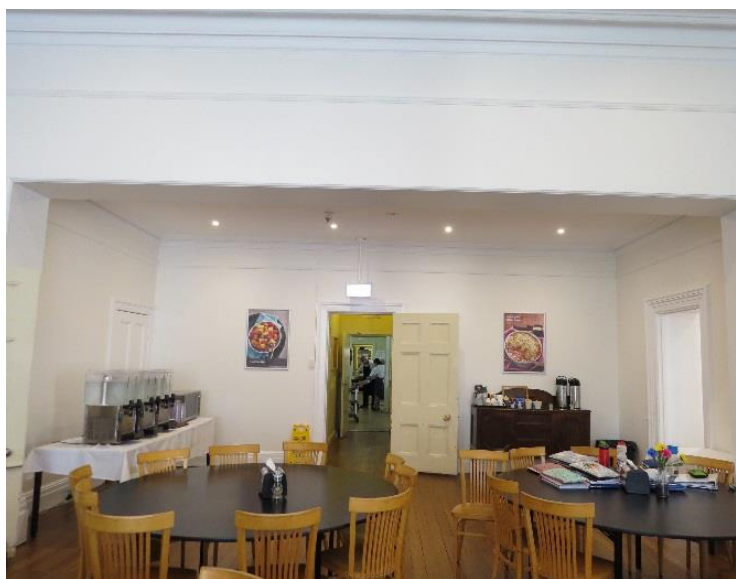
Picture 20 – Dining room. Note new opening.

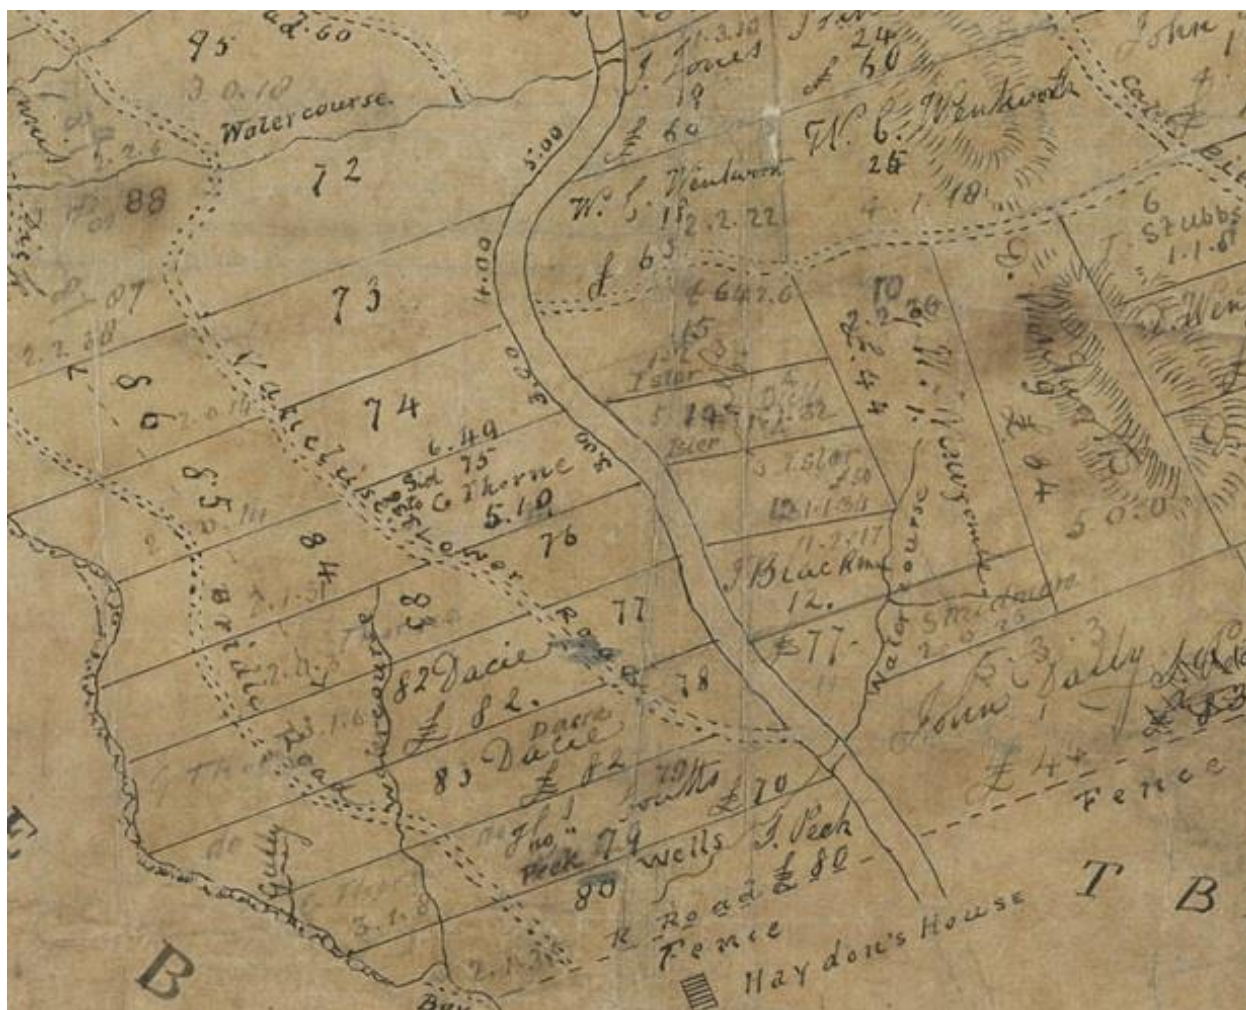
Figure 40 - Extract from the sale plan of the Vaucluse Estate prepared by Simeon Lord, showing the outline of Peter Haydon's house below the subdivision and the bridal road.

Old South Head Road had been constructed in 1811 during Governor Macquarie's term in office and can be seen on the early Parish map below (Figure 38). Thomas Mitchell laid out a new road to South Head that was constructed in the early 1830s. This new route now forms the southern boundary of Kambala School and is still known as New South Head Road. The original land grant extended to Old South Head Road. The marine villas were initially connected by a bridal trail from Rose Bay that passed below the houses (Figure 40).¹

No architect has been identified for the initial house erected by Haydon nor have any plans been located. Suggestions have previously been made that John Verge or Mortimer Lewis may have been involved.¹³ Other than the newspaper report in November 1834 mentioned above noting that the foundations having been started, no tender notices have been located. The house was probably built for Haydon by his assigned convicts and some of the buildings materials are likely to have been obtained from the site. As was common practice, stone was likely to have been quarried from the site, creating a level platform to build on and also creating a cellar and possibly additional water storage. The main roof and verandah roof is likely to have been shingled. An unpublished MS in the Kambala archives refers to an 1838 plan of the house and grounds; however, this has not been located and it is not referred to in the earlier CMP, nor is the rectangular outline of the house included on the 1840 Vaucluse Estate sale plan (Figure xx).

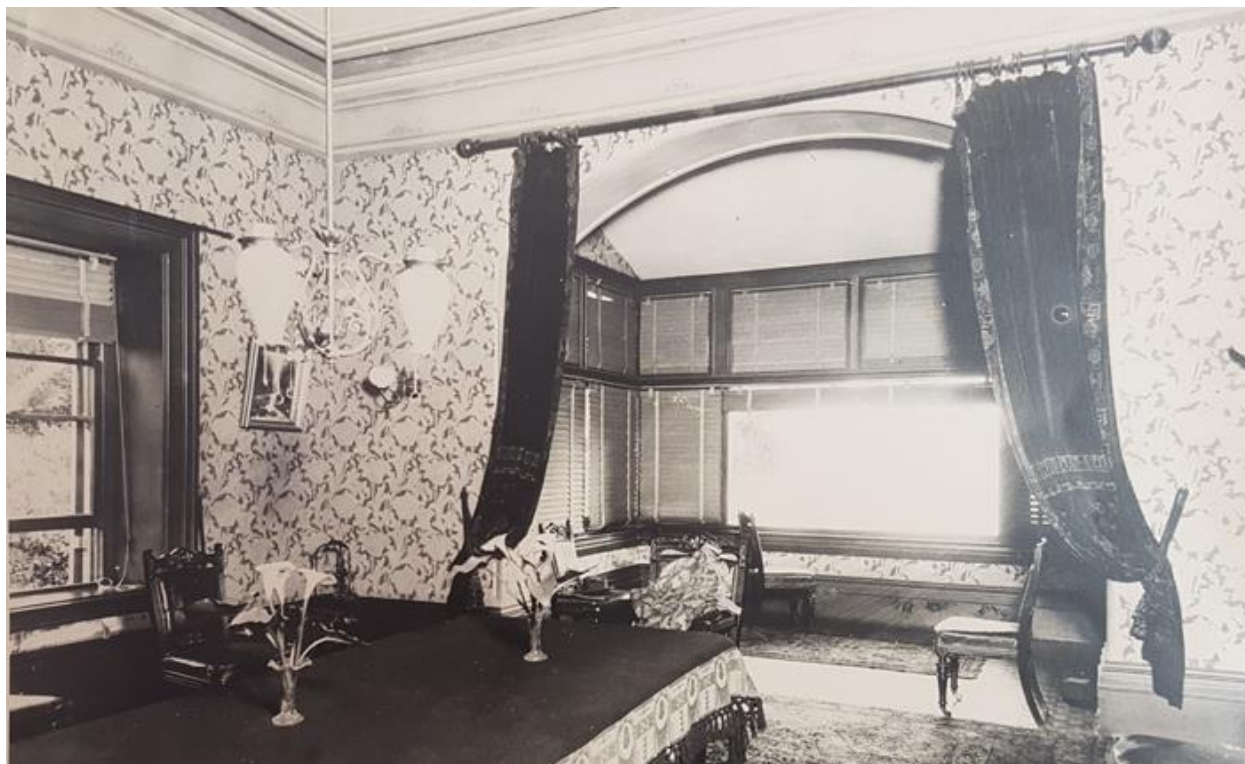
Figure 50 - Dining Room with Bay Window. Photographs taken during the Love family's occupation.

done little beyond redecorating and adding contemporary fireplace surrounds (now partly missing) and enlarged wall vents for the gas lights. He altered the western Dining room, adding the bay window and created a much larger kitchen wing to the southwest, with a large chimney and lantern. The Dining Room retains its chimney piece. The first floor was extended over the lower level rooms and the attic billiard room added.

and probably taken from engravings by Walter Crane. An art curtain, or portiere can be seen to the western bay window in the 1911 photographs (Figure 50).

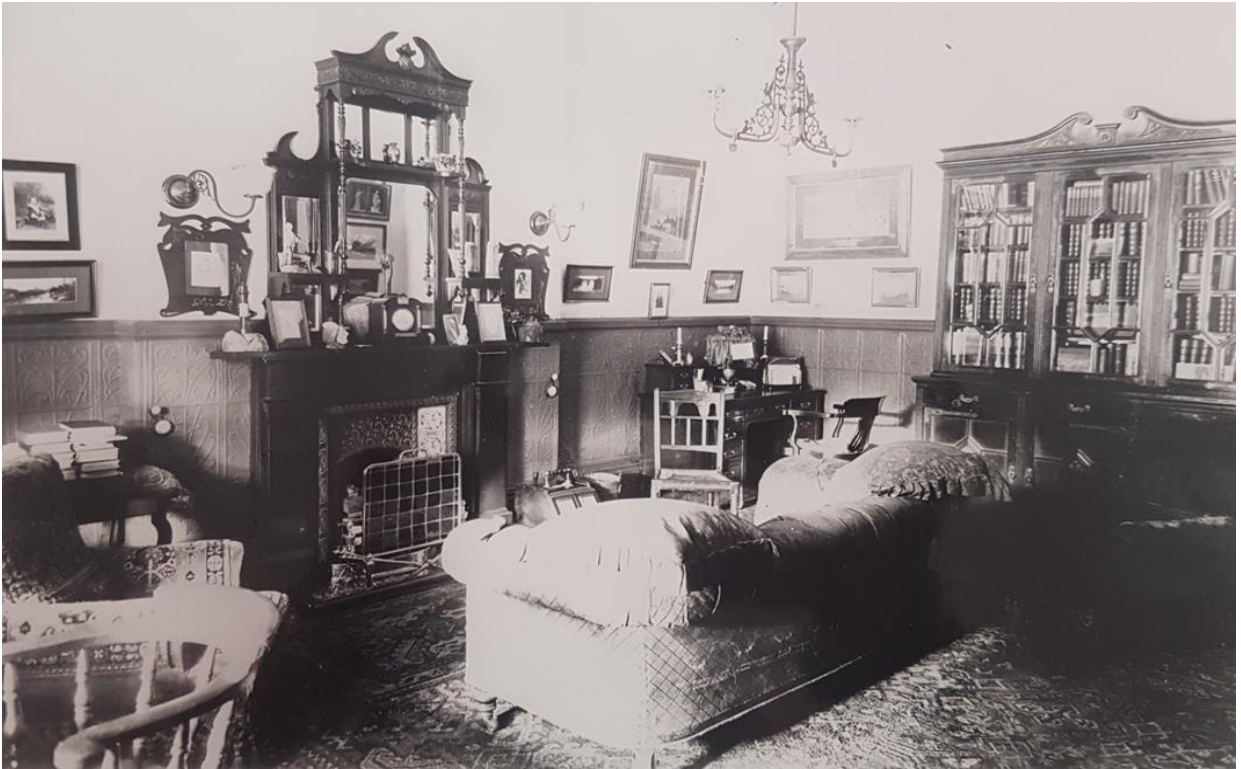
Figure 54 - South eastern room with the pressed metal dado possibly installed by the Love Family.

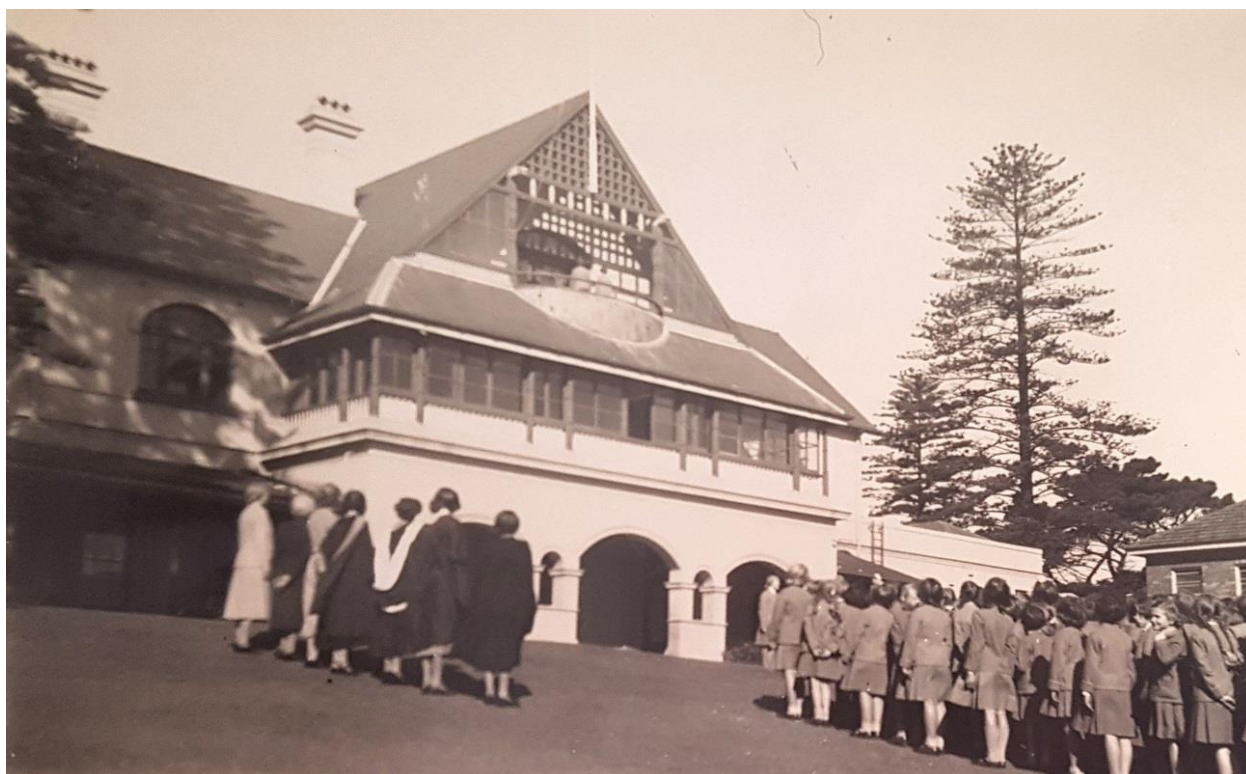
Figure 60 - Kambala/Tivoli, May 1951 showing the infilled verandah (now a dormitory).

The classroom use may have been short-lived due to the war. Boarders were sent to Sydney from Hong Kong, Shanghai and Singapore. A photograph taken in May 1951 shows the front verandah entirely enclosed by windows. More than one colour is used on timberwork, with the balusters and uprights below the lattice on the gable screen painted a pale colour/white with a darker shade used on the remainder of the timberwork including the windows added within the verandah (Figure 68).

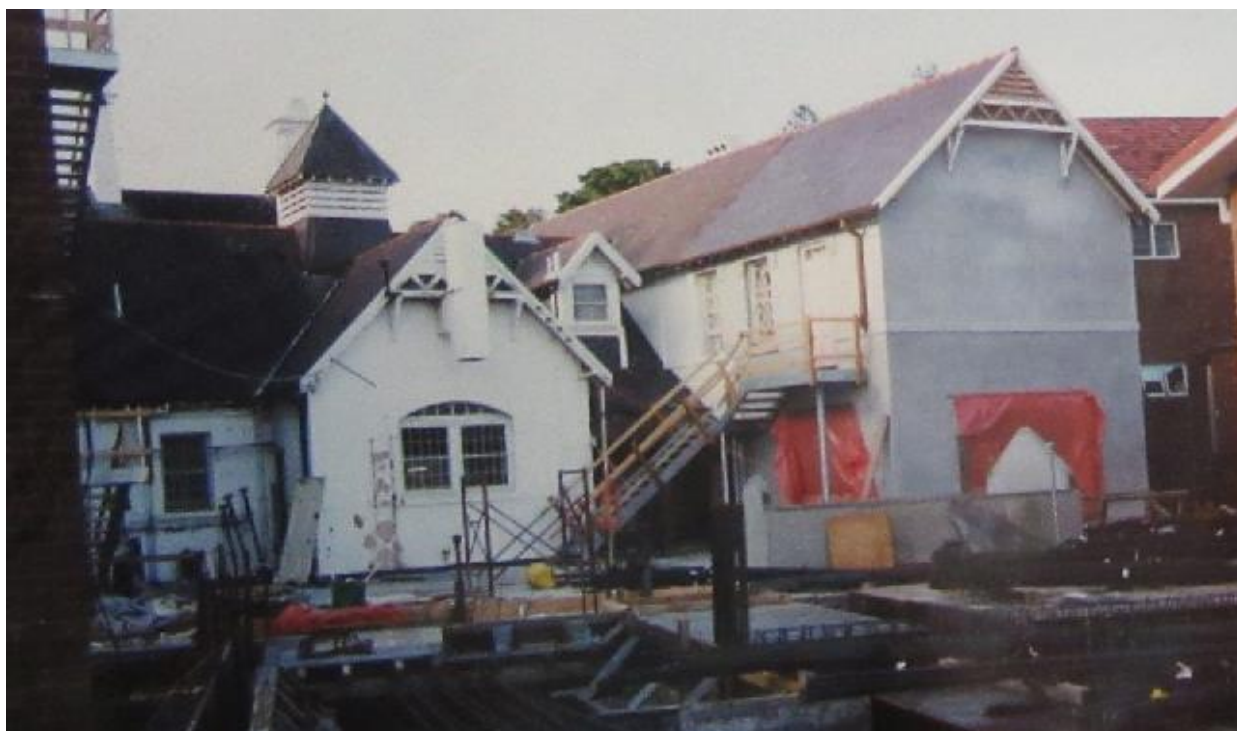
Figure 66 - Rebuilding of the servants' hall from the series of construction photographs.

In 1994 the western end of the servants wing had to be rebuilt (Figure 74). The structure had become unstable during the construction of adjacent facilities. During the 1990s a series of works were undertaken by Lawes Taylor and Associates including the construction of a photography room under Hawthorne House (1993), the extension of the Alexander Building (1995), Additions and Alterations to the E J Watt Building (the seniors building 1995), Alterations and Additions to Massie House (1996), Construction of a new Senior Boarding House and the construction of new entrance gates on New South Head Road (donated by the Old Girls Union).
