CONSERVATION MANAGEMENT PLAN

Kambala School - Tivoli

Prepared for
KAMBALA SCHOOL
23 July 2020

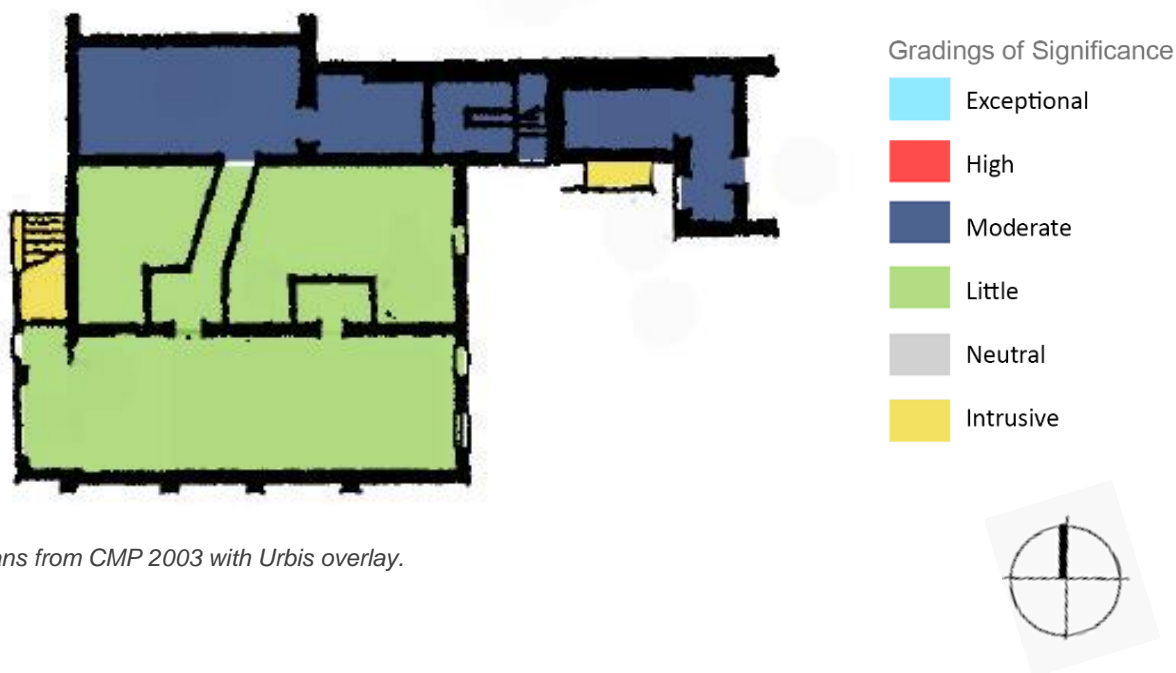
Figure 67 – Basement Floor

Source: Plans from CMP 2003 with Urbis overlay.

The following schedules of significance of components is to be read in conjunction with the significance diagrams at Section 5.5. It should be noted that there was limited access for fabric identification to some areas. Further assessment and confirmation of fabric significance should be made prior to the removal of any fabric and prior to the commencement of any building work.

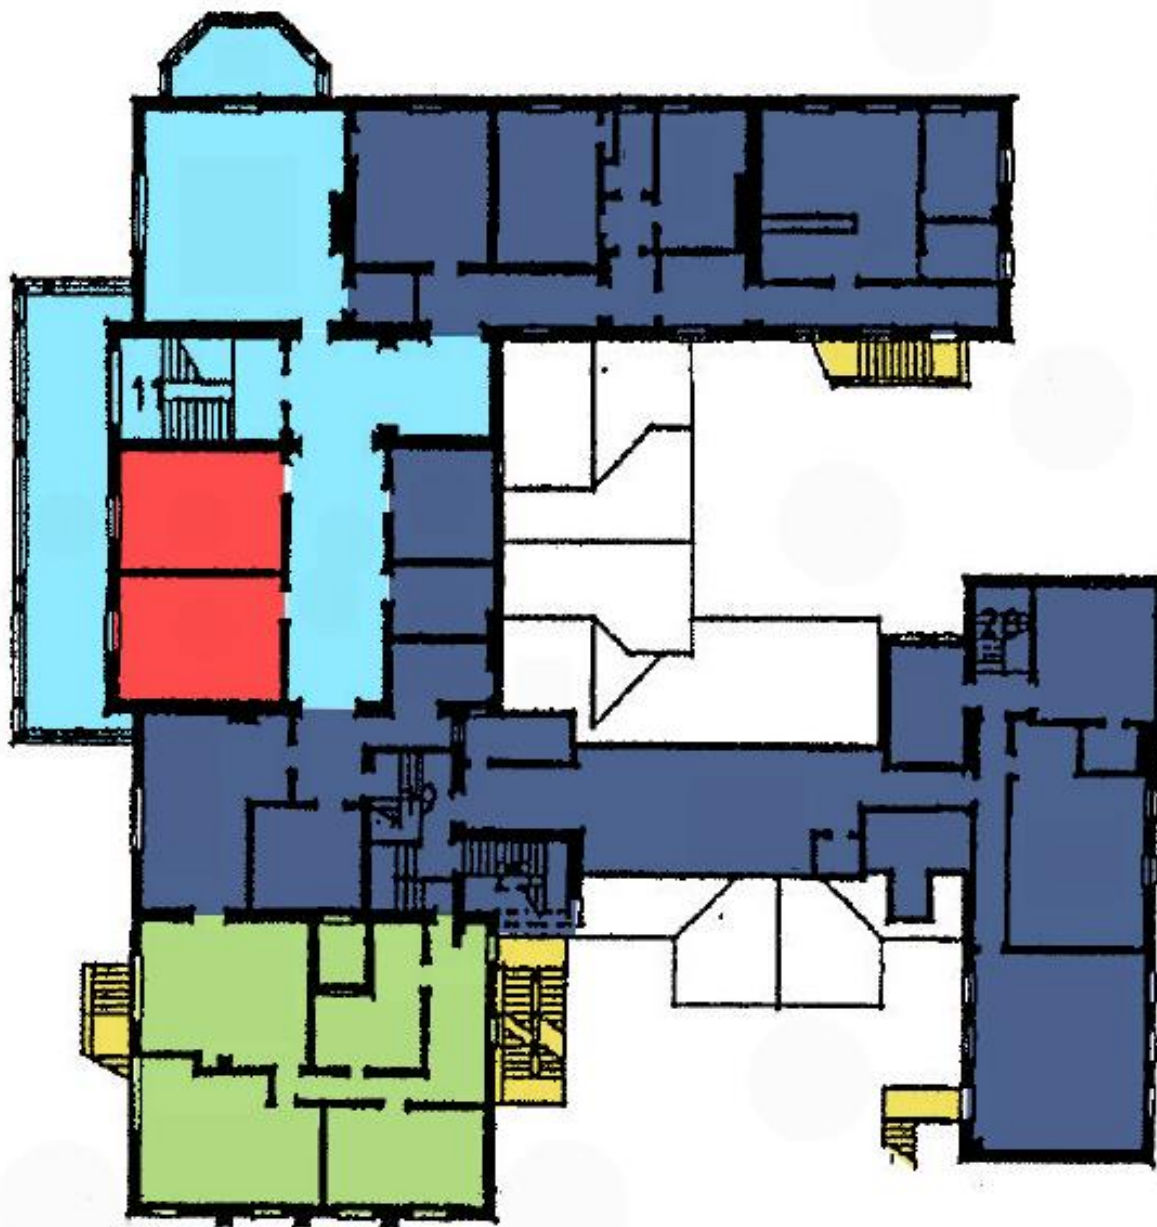
Figure 69 – First Floor

Source: Plans from CMP 2003 with Urbis overlay.

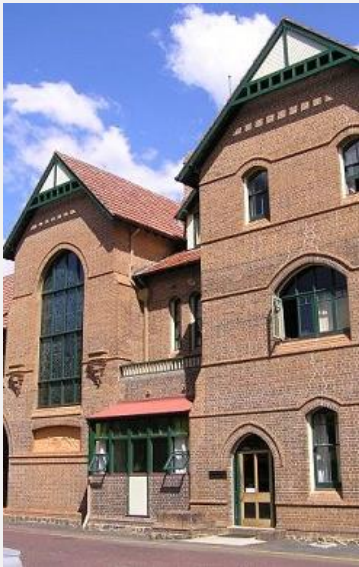
Site	Significance, integrity and other details	Images
<p>Booloominbah Armidale</p> <p>Designed by Hunt 1884-1888. 60 Madgwick Drive, Armidale, NSW 2350.</p>	<p>NSW State Heritage Register: Listing number: 01768.</p> <p>Physical Description:</p> <ul style="list-style-type: none"> • Booloominbah is probably the largest private house built in Australia in the 19th century. • The house's design by Australian standards is extremely avant-garde for its date of 1883-8. The style of the house owes much to the influence of the Arts and Crafts movement in England and, as the movement manifested itself in the USA, in the so called American Shingle Style. <p>Statement of Significance: <i>"Booloominbah is of State heritage significance as one of the largest private country houses built in Australia during the 19th century and amongst the most avant-garde domestic Arts and Crafts style designs of the time. Designed as an interpretation of an English country house, Booloominbah sits in a relatively intact landscape. As such, it is exemplary of the work of architect John Horbury Hunt. As well as being large, it is also extravagant in decoration, in particular the use of stained glass. The fabric substantially demonstrates the wealth and influence of pastoralism in NSW in late 19th century."</i></p>

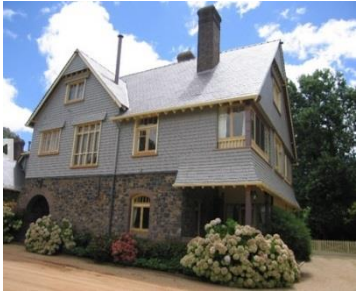
<p>House and Grounds 'Trevena'</p> <p>Designed by Hunt c1889. 60 Madgwick Drive, Armidale, NSW, 2350.</p>	<p>Armidale Local Environment Plan (LEP) (item: I235)</p> <p>Physical Description:</p> <ul style="list-style-type: none"> • Outstanding late nineteenth century mansion. Various influences evident including the American Shingle style, Queen Anne and Arts and Crafts. Complex form with four very different elevations. One and two storeys with high pitched slate roof. Tall brick chimneys. Stone foundations and stone rubble walls. Brick arches to ground floor openings. Many different window shapes and types with painted timber frames. Limited use of verandahs. • Set in large grounds with long formal driveway and beautifully planted gardens. <p>Statement of Significance:</p>

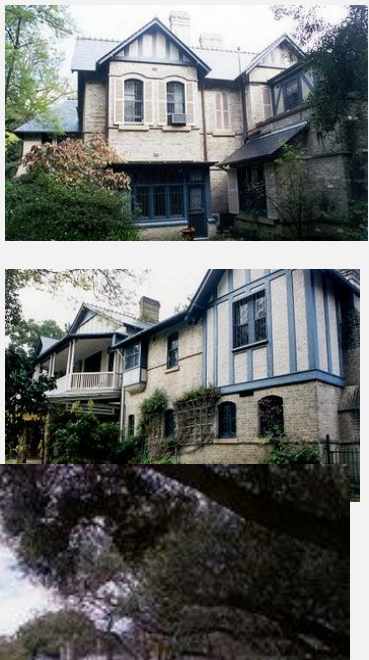
<p>Fairwater 1882-1970. Designed by Hunt but altered. 560 New South Head Road, Woollahra, NSW, 2025.</p>	<p>NSW State Heritage Register: Listing number: 01381</p> <p>Physical description:</p> <ul style="list-style-type: none"> • The residence is a double storey structure of brick construction with a timber-framed roof originally constructed in 1882 with additions c.1901, and in particular from 1910s. • The exterior appearance is characterised by the use of a brick which is pale yellow in colour. The roof is covered in slate tiles. Additions made c.1910/11 often include the use of sandstone (i.e. in the verandah and carriage porch). • The roof is a series of timbered gables with battened ends and pebble dash finish. These gables are the work of Manson and Pickering architects, c1910/11 and are in the Arts and Craft style embellishing Hunt's simple form by a series of projecting bay windows and balconies.

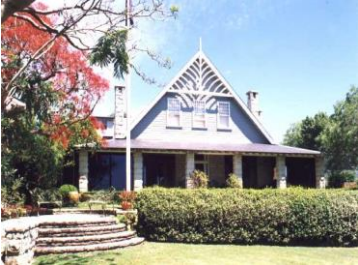
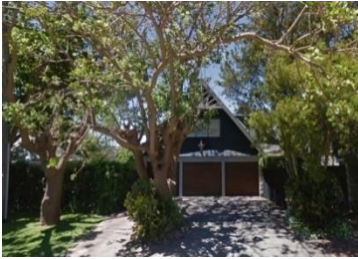
<p>Easterly House Late c1880s. 7 Upper Spit Road, Mosman, NSW, 2088.</p>	<p>Mosman Local Environment Plan (LEP) (item I305)</p> <p>Physical Description:</p> <ul style="list-style-type: none"> Victorian 'American Shingle Style'. This commodious and handsome house is accessed from Upper Spit Road but is oriented eastwards to the prospect over Rosherville Slopes, Shell Cove, Middle Harbour, Clontarf and beyond to the Heads. It is a brick house with architectural modelling, sweeping shingled roofs, detailing and internal treatment such as were typically employed by John Horbury Hunt. There have been many modifications but the building retains the essentials of its original character. Its east front is notable for its tall timber gable with a timber apex screen and for the broad shaded verandah facing a beautiful terraced garden. <p>Statement of Significance: <i>“The house has individual significance for its aesthetic values as a Horbury Hunt design, with sweeping roofs and large planes of shingles, and for the way it demonstrates building to suit a difficult site, its large size, good setback from Upper Spit Road and handsome garden, and for the way it demonstrates part of the pattern of architectural style in Australia.”</i></p>

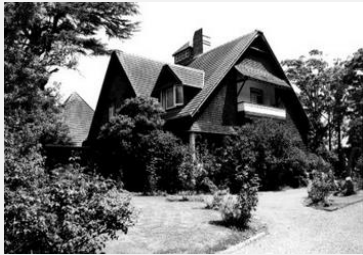
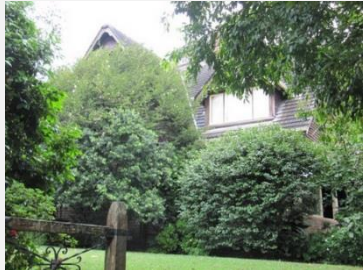
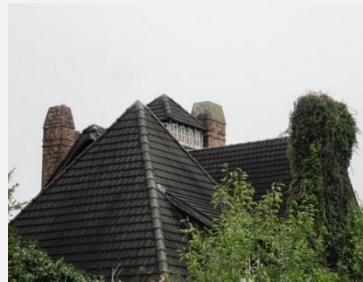
Site	Significance, integrity and other details	Images
<p>Highlands 1890-1893. 9 Highlands Avenue, Wahroonga, NSW, 2076.</p>	<p>NSW State Heritage Register: Listing number: 00034</p> <p>Physical Description:</p> <ul style="list-style-type: none"> • This distinctive two-story house comprises two conjoining components. The prominent part is the house proper, the kitchen wing sits a separate pyramidal roof. • Both roofs were originally shingled, like the walls. The wall shingles curve out over verandahs and openings, to shed water away from the walls. This is a feature of several of Hunt's Shingle Style houses. The verandahs are supported by massive timber posts, minimally decorated. The verandahs are recessed under the eaves, another design element commonly used by Hunt. • The chimney stack is another unusual feature, "a tall, buttressed slab of brickwork which appears almost freestanding." Externally, the original roof shingles have been replaced by grey roof tiles. • The house was originally situated on 13.6 hectares, but subdivisions have left it on a substantially smaller allotment, with the rear of the house to the street. The garden contains a notable period Hoop Pine and provides a sympathetic setting to the house. <p>Statement of Significance: <i>"Highlands is a fine example of John Horbury Hunt's interpretation of the Shingle Style. The house displays many of the elements common to Hunt's Shingle Style houses, including recessed verandahs and sweeping skirts to deposit water well away from the walls. In contrast to these common elements, Highlands also displays several unusual features, a half-glass door and distinctive chimney stack being the most prominent.</i> <i>Highlands is significant as evidence of women shaping architecture. Mrs Caroline Hordern was a keen cook and the two-storey kitchen wing was heavily influenced by her. The landscaping was also of her creation and Mrs. Horden introduced many exotics from the Pacific Islands to adorn the garden."</i></p>

- Hunt's later phase of domestic architecture comprises the Federation Arts and Crafts and the American "Shingle" style, with substantial houses characterised by complex elevations and building forms, stone foundations, brick chimneys, timber joinery and decoration, windows of different shapes and sizes, gabled roofs, bay windows and verandahs. Tivoli is comparable to examples 'Trevenna', 'Fairwater', 'Easterly House' and 'Highlands' which comprise similar architectural language and detailing.

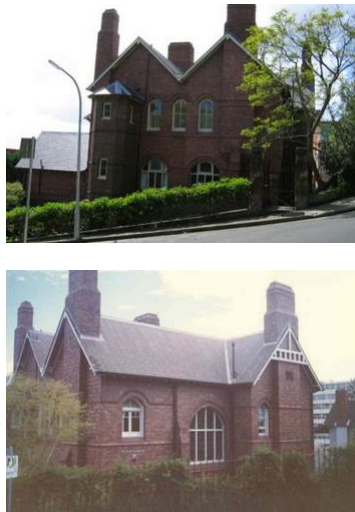
Site	Significance, integrity and other details	Images
<p>Cloncorrick 1 Annandale Street, Darling Point, NSW, 2027</p>	<p>Woollahra Local Environment Plan (LEP) (Item 76)</p> <p>Physical Description:</p> <ul style="list-style-type: none"> Three storey red face brick residence in a Victorian Free Gothic style. Roof consists of a series of steeply pitched gables, slate tiles, lead ridge cappings, and copper guttering. Four brick chimneys are mainly associated with gable ends. The northern gable end has timber detailing, and the associated chimney stack has stone motif. Eaves are timber lined. Walls are red face brick; alternate courses have header/stretcher bond. Walls have tapered brick piers, and several string courses constructed of tapered headers. Bay extension to southern side has slate tile roof, exposed rafters to eaves, and double hung windows with brick sills. stepped tower. <p>Statement of Significance: <i>“The site at Darling Point is significant as part of the original grant to Thomas Barker in 1835. Cloncorrick has historic and social significance as an early residence in the district constructed for local identity Hon. George Simpson, and for the part it has played in the development of the district. It has historic significance for its long association with the Simpson Family. Hon. G. Simpson resided here until 1906 and Lady Simpson resided at Cloncorrick from 1922 into the mid twentieth century. Cloncorrick has high historic and architectural significance as designed by the American architect John Horbury Hunt for the Hon. George Simpson. It has architectural and aesthetic significance for its prominence and stylistic detailing, and as a relatively intact example of a Victorian Free Gothic home. The building is a dominant element in the landscape and contributes strongly to the character and quality of the area.”</i></p>

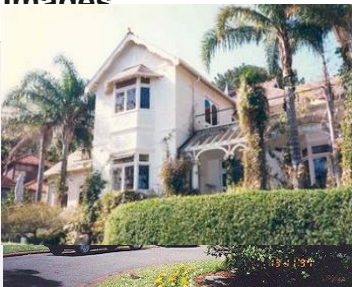
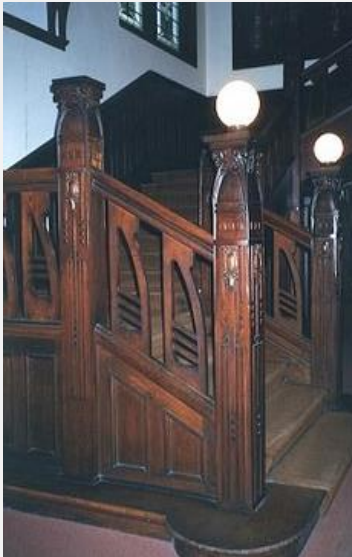
Site	Significance, integrity and other details	Images
<p>Babworth House Early 20th century. 103 Darling Point Road, Darling Point, NSW, 2027.</p>	<p>NSW State Heritage Register: Listing number: 01300</p> <p>Physical Description:</p> <ul style="list-style-type: none"> Babworth House is sited on the highest point of the Darling Point peninsula. The house is two storey with walls finished in finely worked, unpainted, cement render with beautifully detailed Art Nouveau-inspired decorations around openings and chimneys. A series of very crisp and precise indented lines surround the house, adding strength and balance to the numerous and varied openings, balconies and other architectural elements. The house asymmetrical with broad gabled areas juxtaposed with bold projecting covered balconies, some with bowed or circular fronts. The east, north and west elevations are each different but use the same architectural language and decoration. The joinery is all timber with French doors generally containing tapered glass panels. The roof is broken into many parts and covered with slate, mostly with terracotta ridges and occasionally copper. The guttering, rainwater heads and downpipes are all in copper and of consistent detail designed especially for the house. Internally the house displays a variety of architectural styles, from Edwardian, Classical Revival to Art Nouveau and early Art Deco. <p>Statement of Significance: “<i>Babworth House is one of the largest, finest and most intact examples of an early twentieth century grand house in Australia. It is of national significance both historically and aesthetically. Babworth House is an excellent and rare example of the Federation Arts and Crafts style in grand domestic architecture in Australia. The quality and uniqueness of the exterior and interior detailing, incorporating both Art Nouveau and neoclassical motifs and forms is of a standard and scale rarely seen in domestic architecture.</i>”</p>

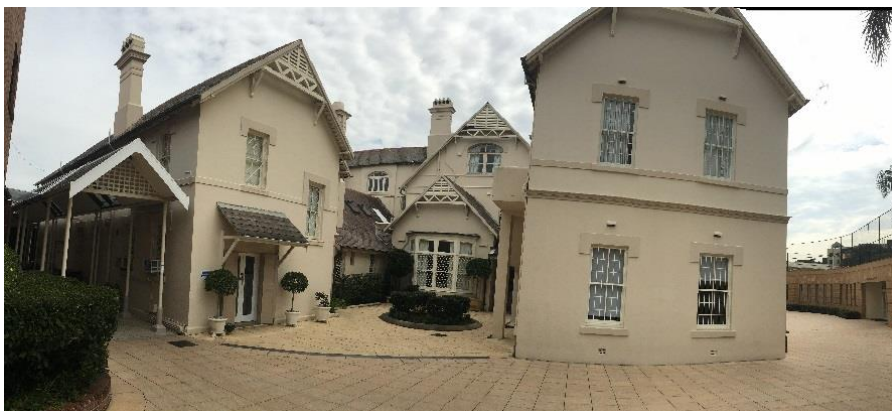
Figure 2. View from the East showing multiple roof gables with timber detailing.

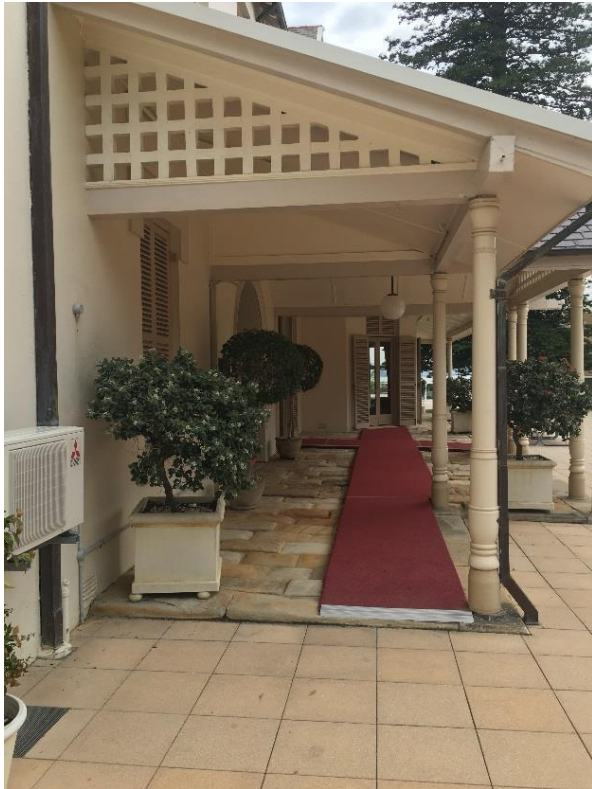
Figure 3: View of the northern verandah

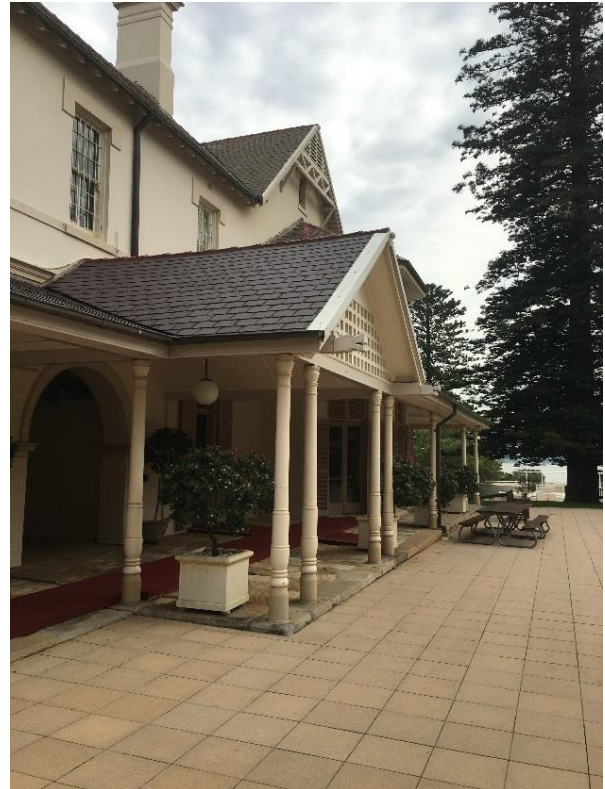
Figure 4: View of the western verandah

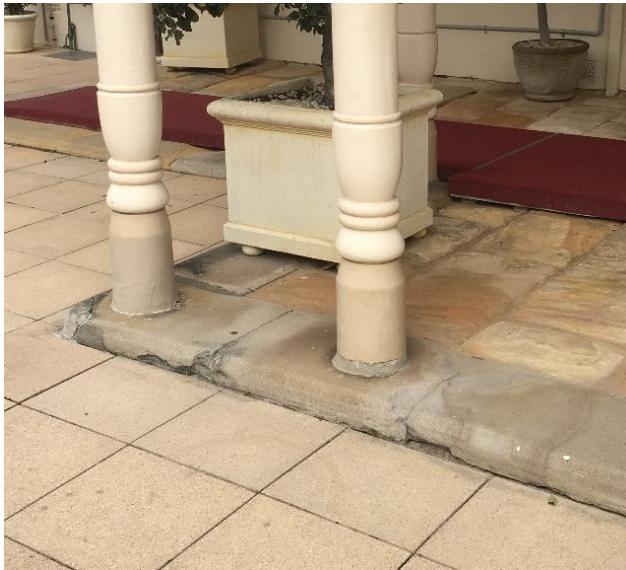
Figure 5: Vernadah flagging detail

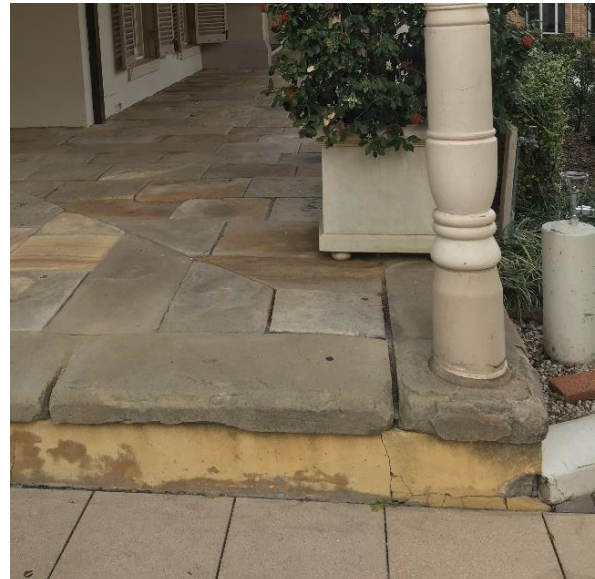
Figure 6: Vernadha Flagging Detail

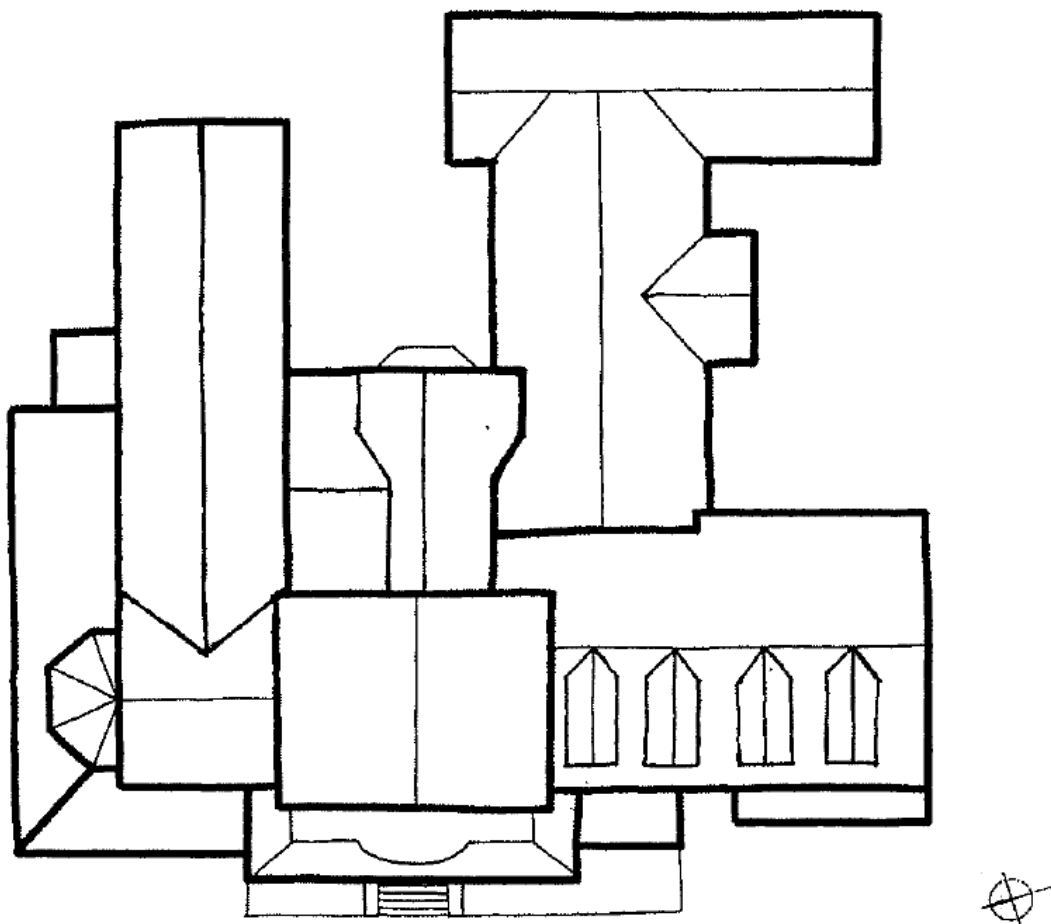
Figure 1: Roof Plan for Tivoli (CMP 2004 Noel Bell Ridley Smith & Partners Architects)

Lay a length of underlay over ridge to overlap general underlay by not less than 150mm. Finish slating with a head-nailed short course to maintain gauge. Make weathertight with ridge tiles laid to a true line with edges and joints solidly bedded in mortar, neatly struck off flush as the work proceeds. Fill ends of ridges at gables with mortar and slips of slate finished flush. Mortar for bedding ridge tiles, 1:3 cement: sand pigmented to approved colour. Where it is necessary to adjust gauges to ensure adequate ridge covering overlap, the last two courses may be cut providing that the minimum headlap (150 mm) is maintained.

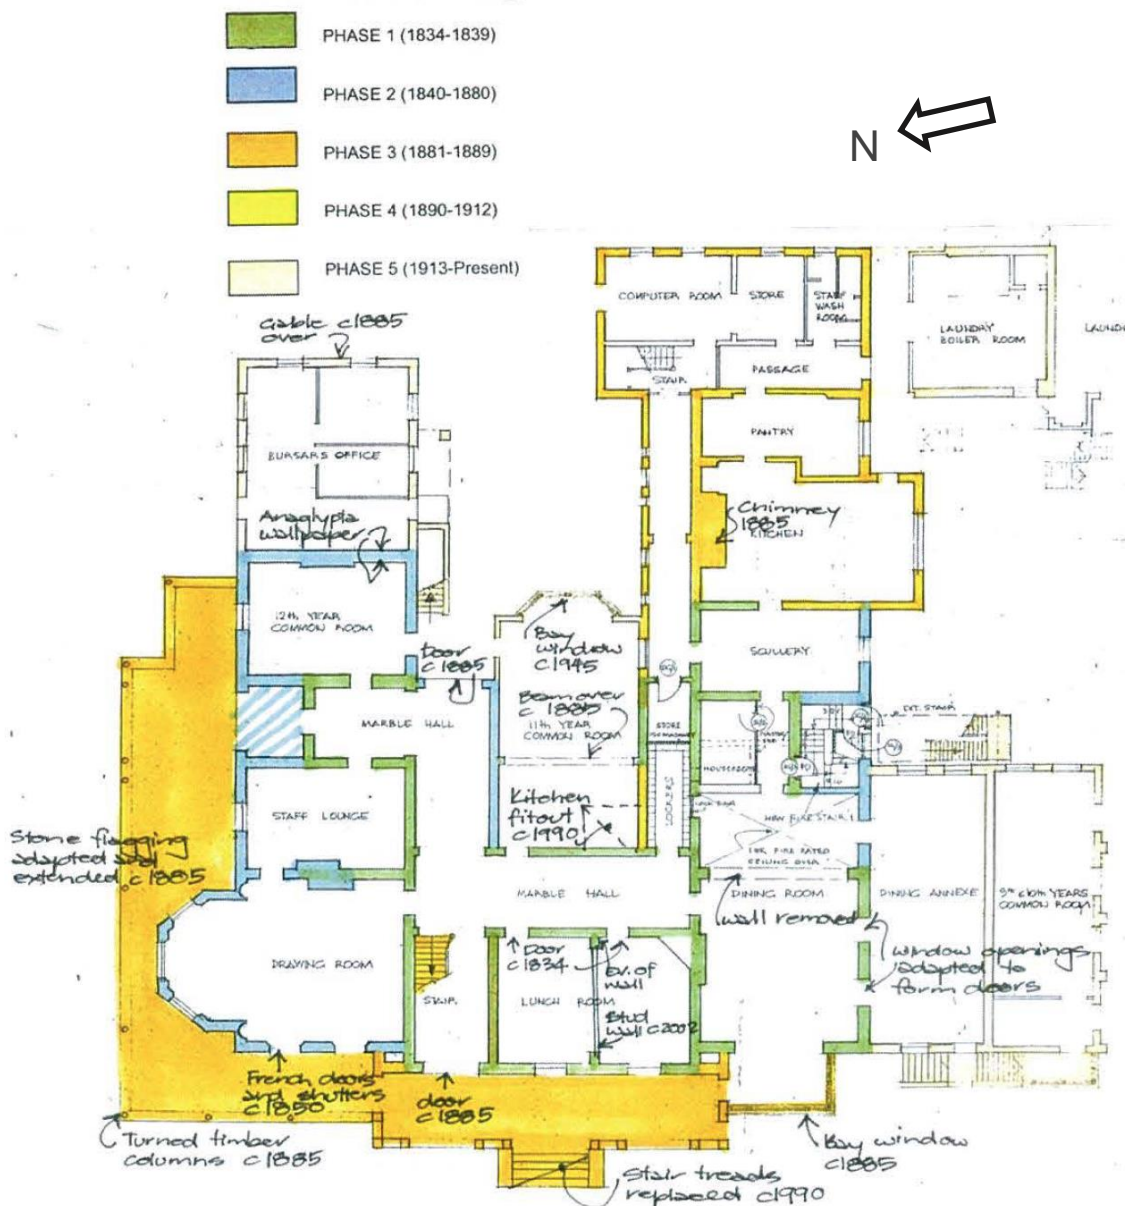
Figure 1: Analysis of the Ground Floor Fabric at Tivoli (CMP 2004 Noel Bell Ridley Smith & Partners Architects). Note that the verandah sandstone paving to the north and to the west dates from Phase 4 (1890 – 1912).

Allow for expansion joints as appropriate to the paving pattern. Seek approval on layout prior to implementation.
