Kambala School
c/- Carmichael Tompkins Property Group
Detailed Site Investigation

Kambala School Sports Precinct
794 New South Head Road
Rose Bay, NSW

25 June 2020

58081/129431 (Rev A)

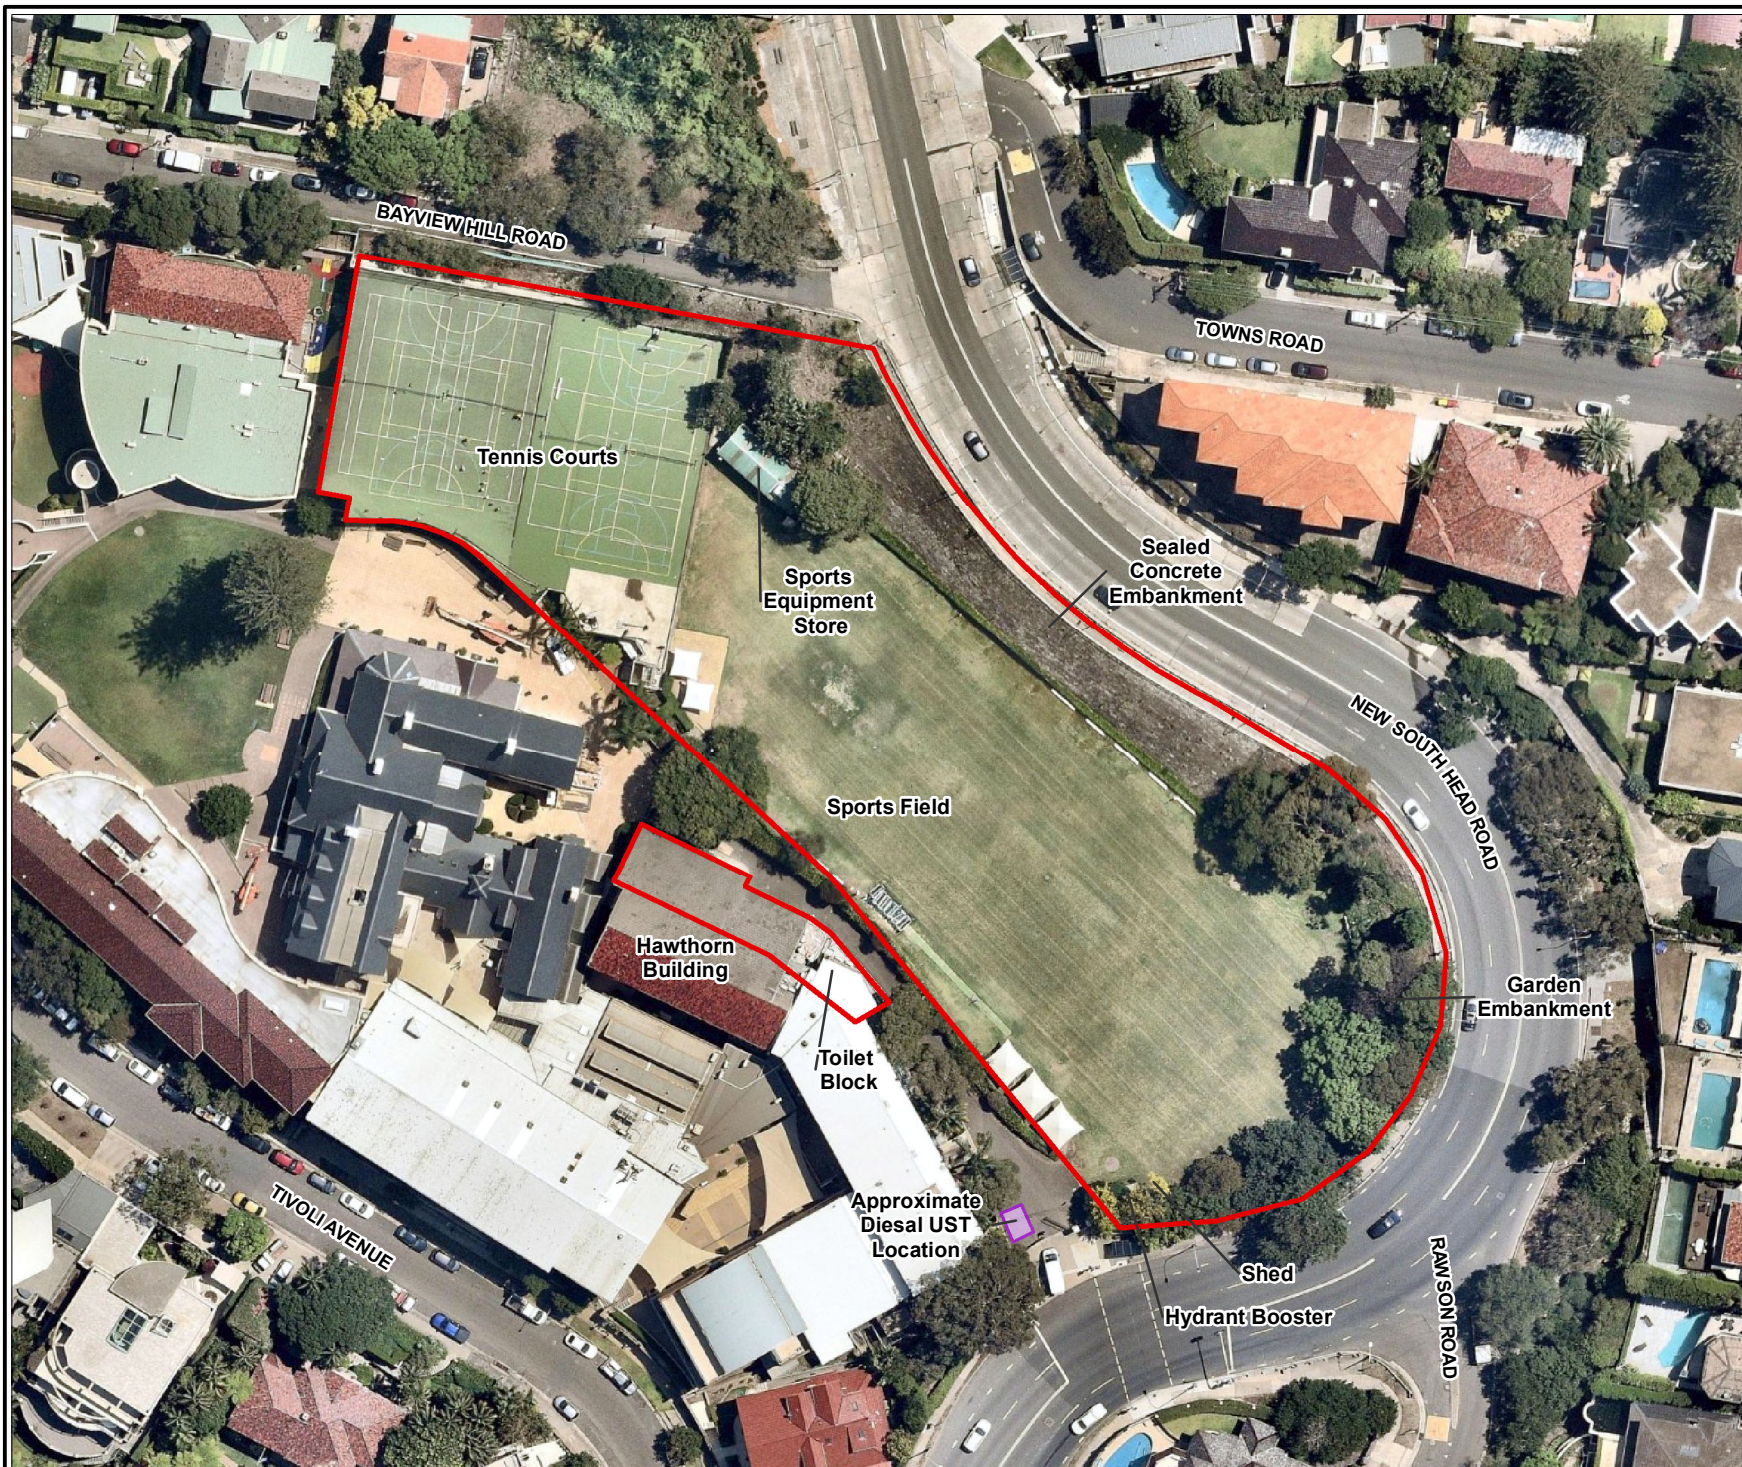
FIGURE 2

- Approximate Site Boundary
- Approximate Diesel UST Location

SITE LAYOUT

A detailed site inspection was undertaken on 7th, 20th and 21st April 2020 by an experienced JBS&G environmental. The layout of the site was observed to be consistent with that described in the PSI (JBS&G 2020a). Site features observed during site inspections are shown on **Figure 2**.

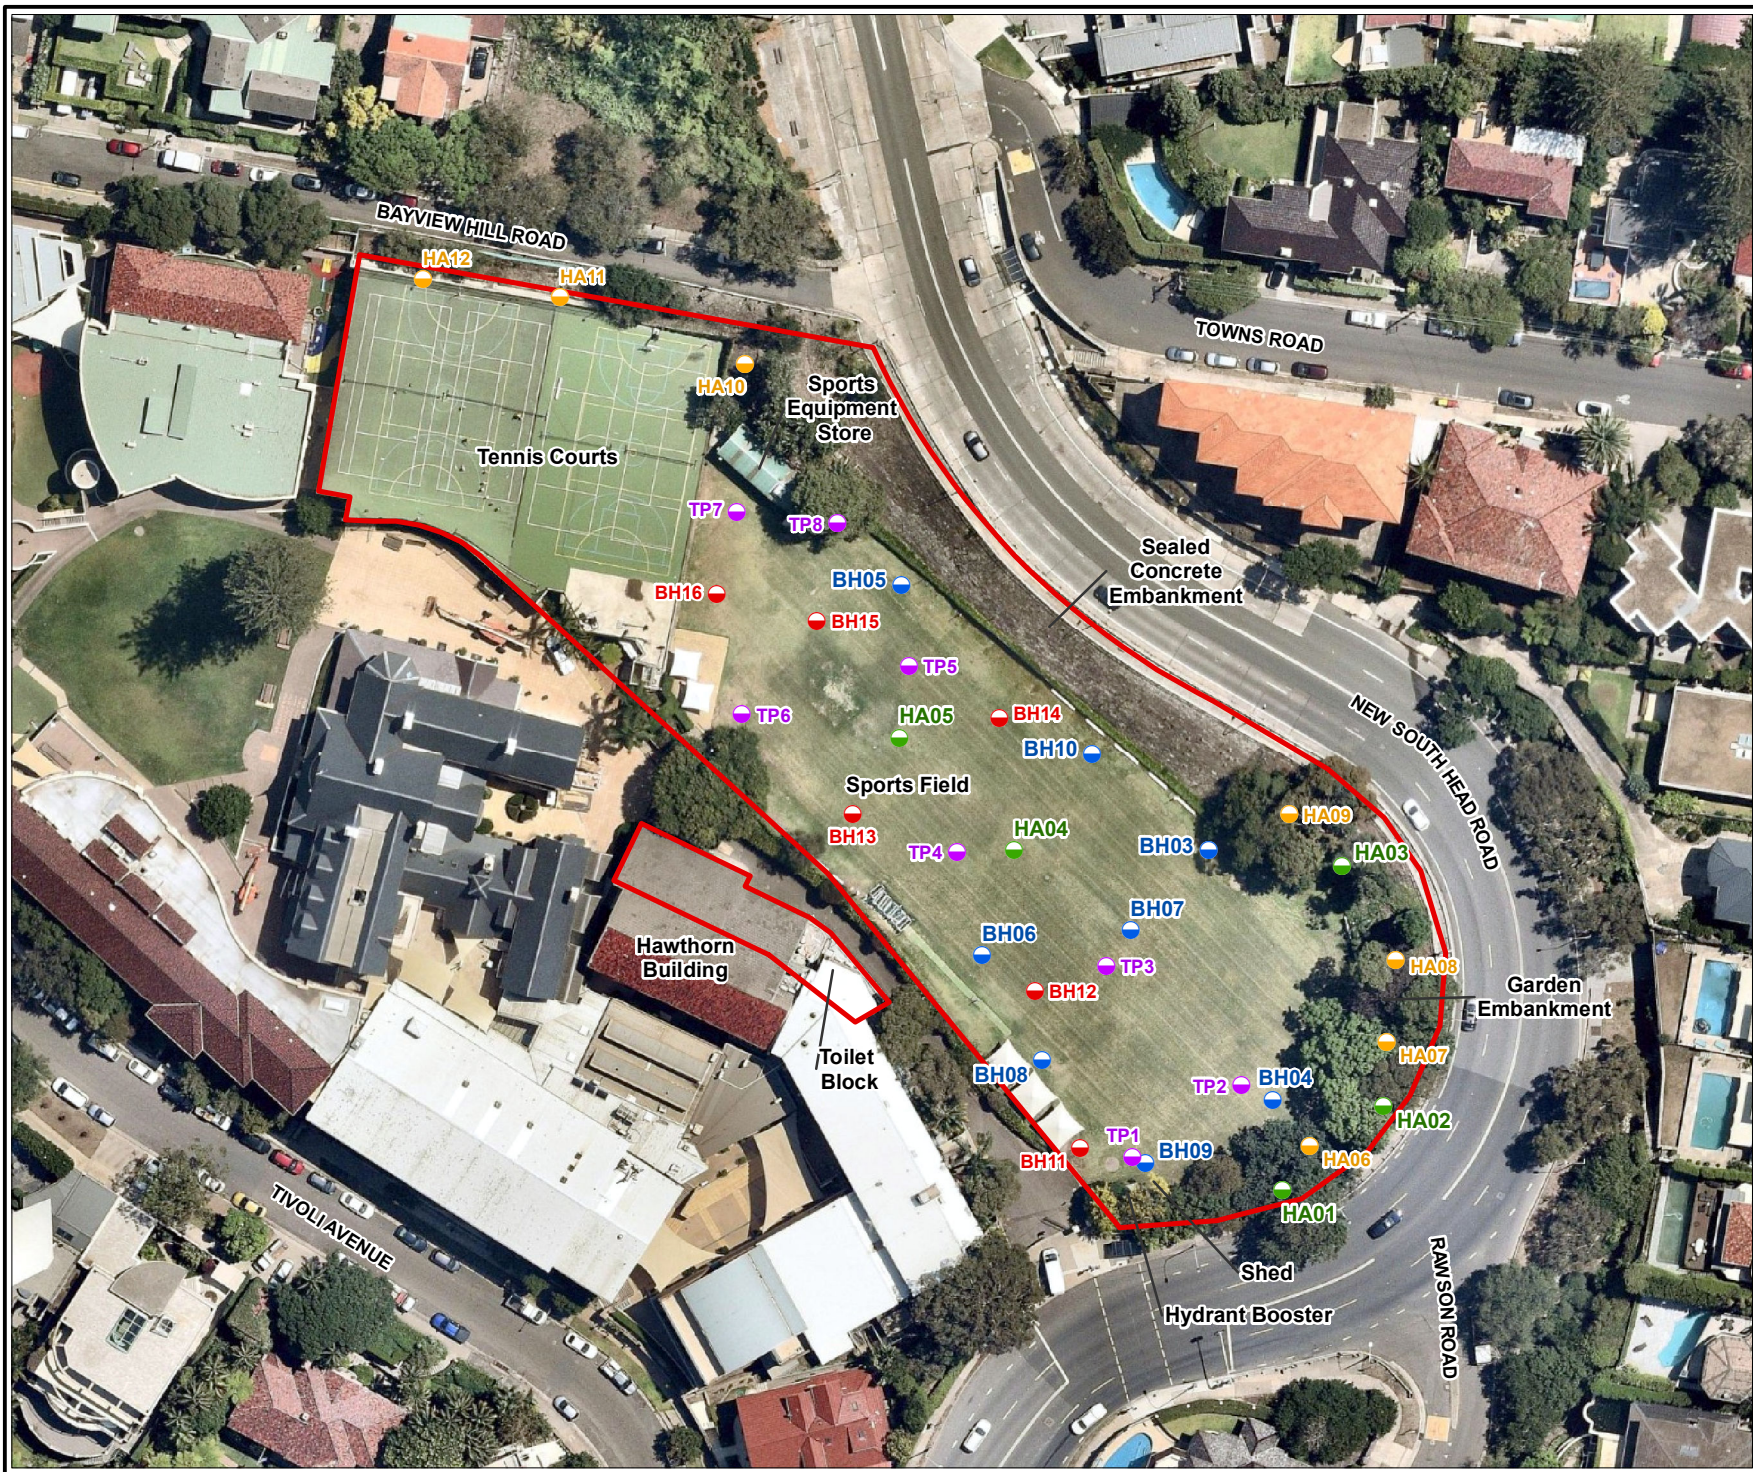
FIGURE 3

Coord. Sys. GDA 1994 MGA Zone 56
Kambala
794 New South Head Rd,
Rose Bay NSW 2029
SAMPLE LOCATIONS

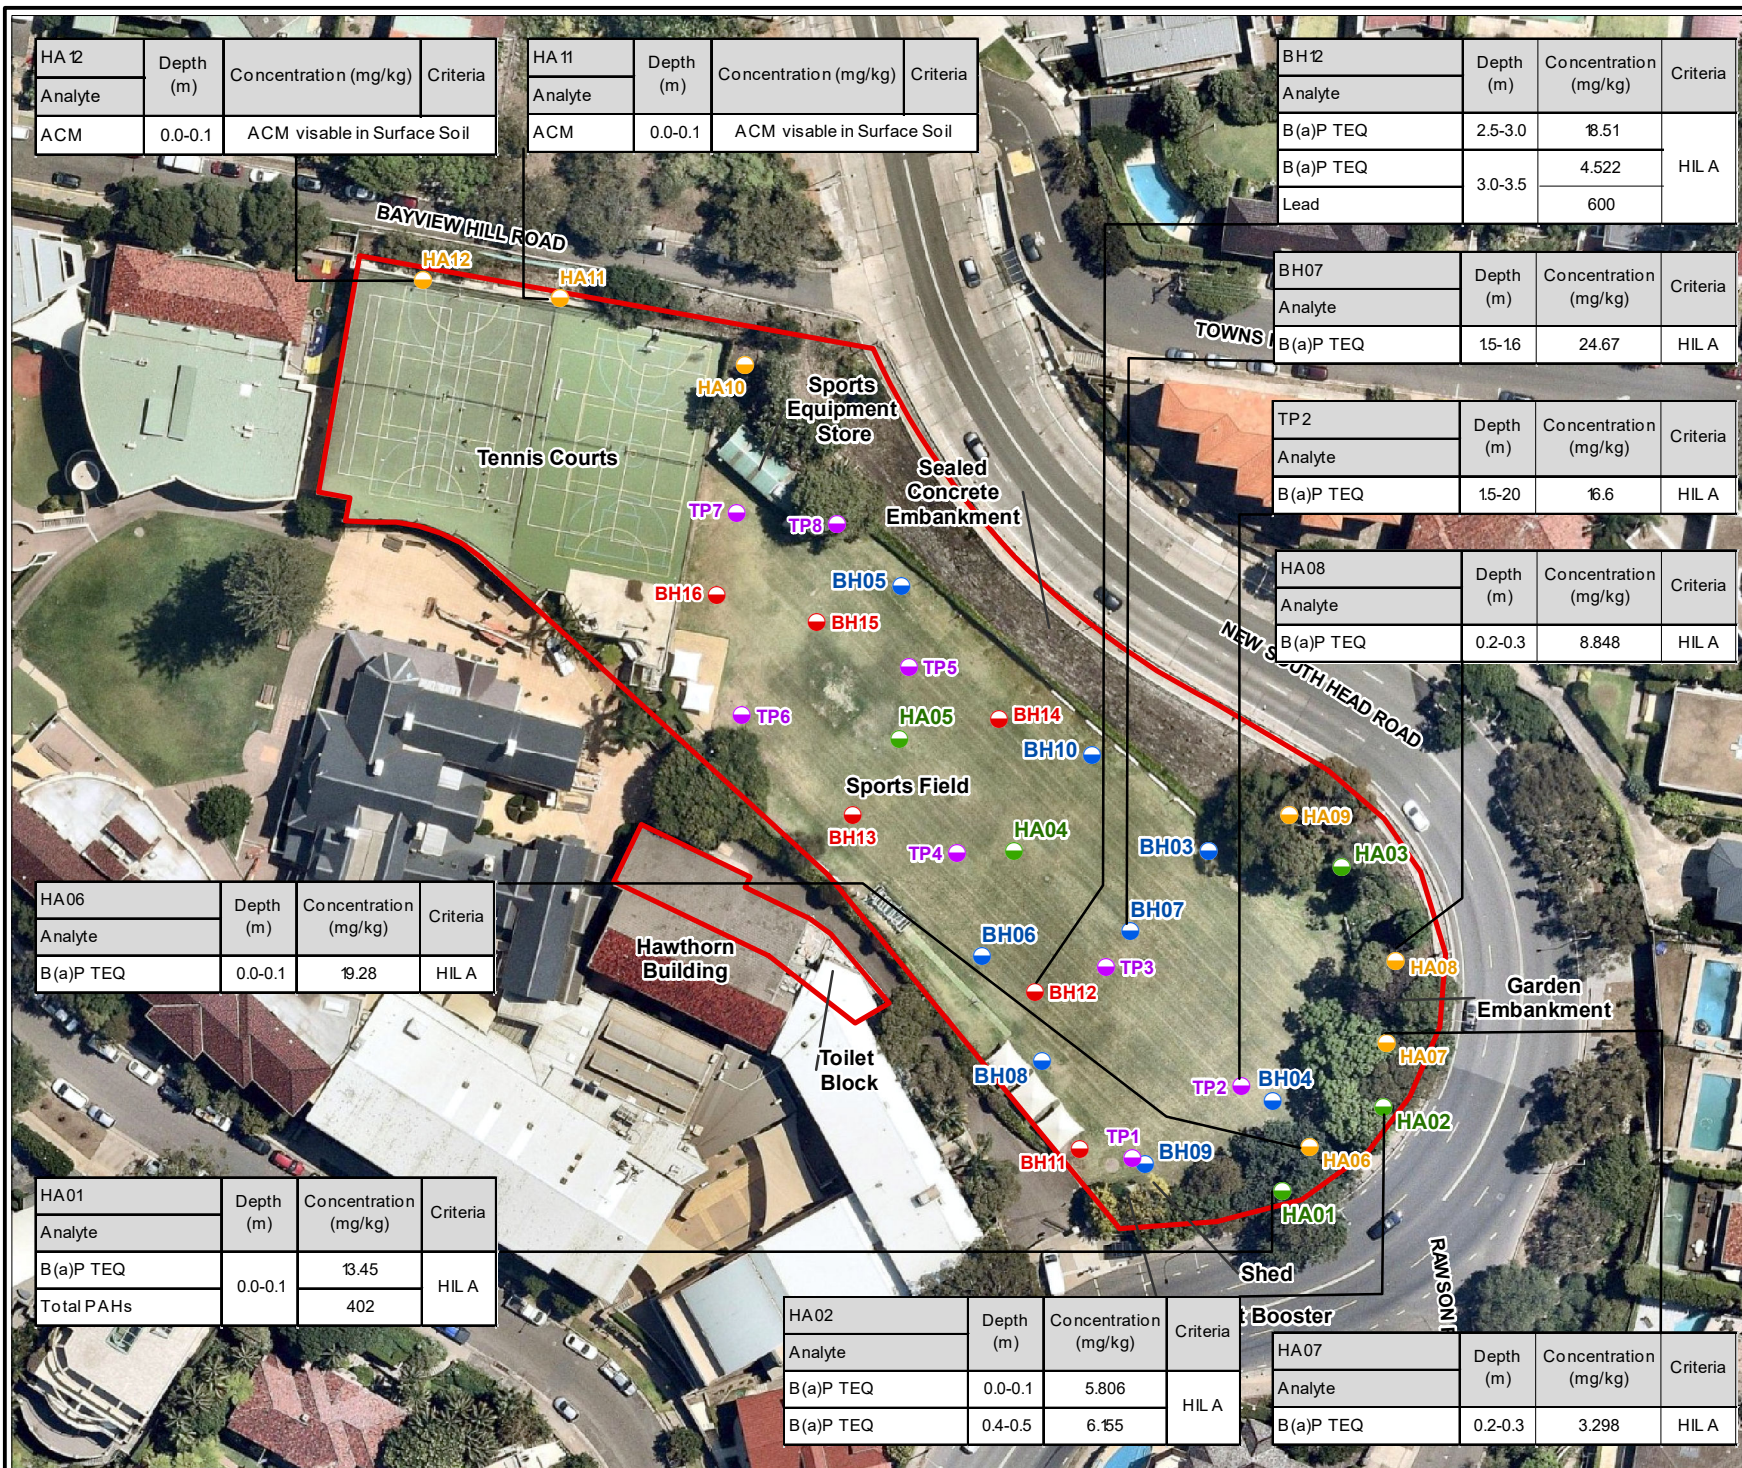
- Approximate Site Boundary
- Sample Locations (JBS&G 2019)**
- Borehole
- Hand Auger
- Sample Locations (JBS&G 2020)**
- Borehole
- Hand Auger
- Test Pit

Two isolated fragments of ACM were identified at locations HA11 and HA12 within a narrow garden strip north of the tennis courts and on the north-western boundary of the site as shown on **Figure 4**. The fragments potentially were discarded into the garden over the site fence, the fragments were collected and submitted for laboratory confirmation analysis. No further fragments including no ACM observed in fill material was identified at the site.

- The eastern garden embankment adjacent with the site's eastern boundary adjacent to the bend on New South Head Road; and
- The south-eastern portion of the sports field within locations BH07, BH12 and TP2 as shown on **Figure 4**. It is further noted that impact within the sports field has been identified at a depth of 1.5 m or more from the surface.
