Kambala School
c/- Carmichael Tompkins Property Group
Remedial Action Plan

Kambala School Sports Precinct

794 New South Head Road,
Rose Bay, NSW
25 September 2020

58081/130541 (Rev 0)
JBS&G

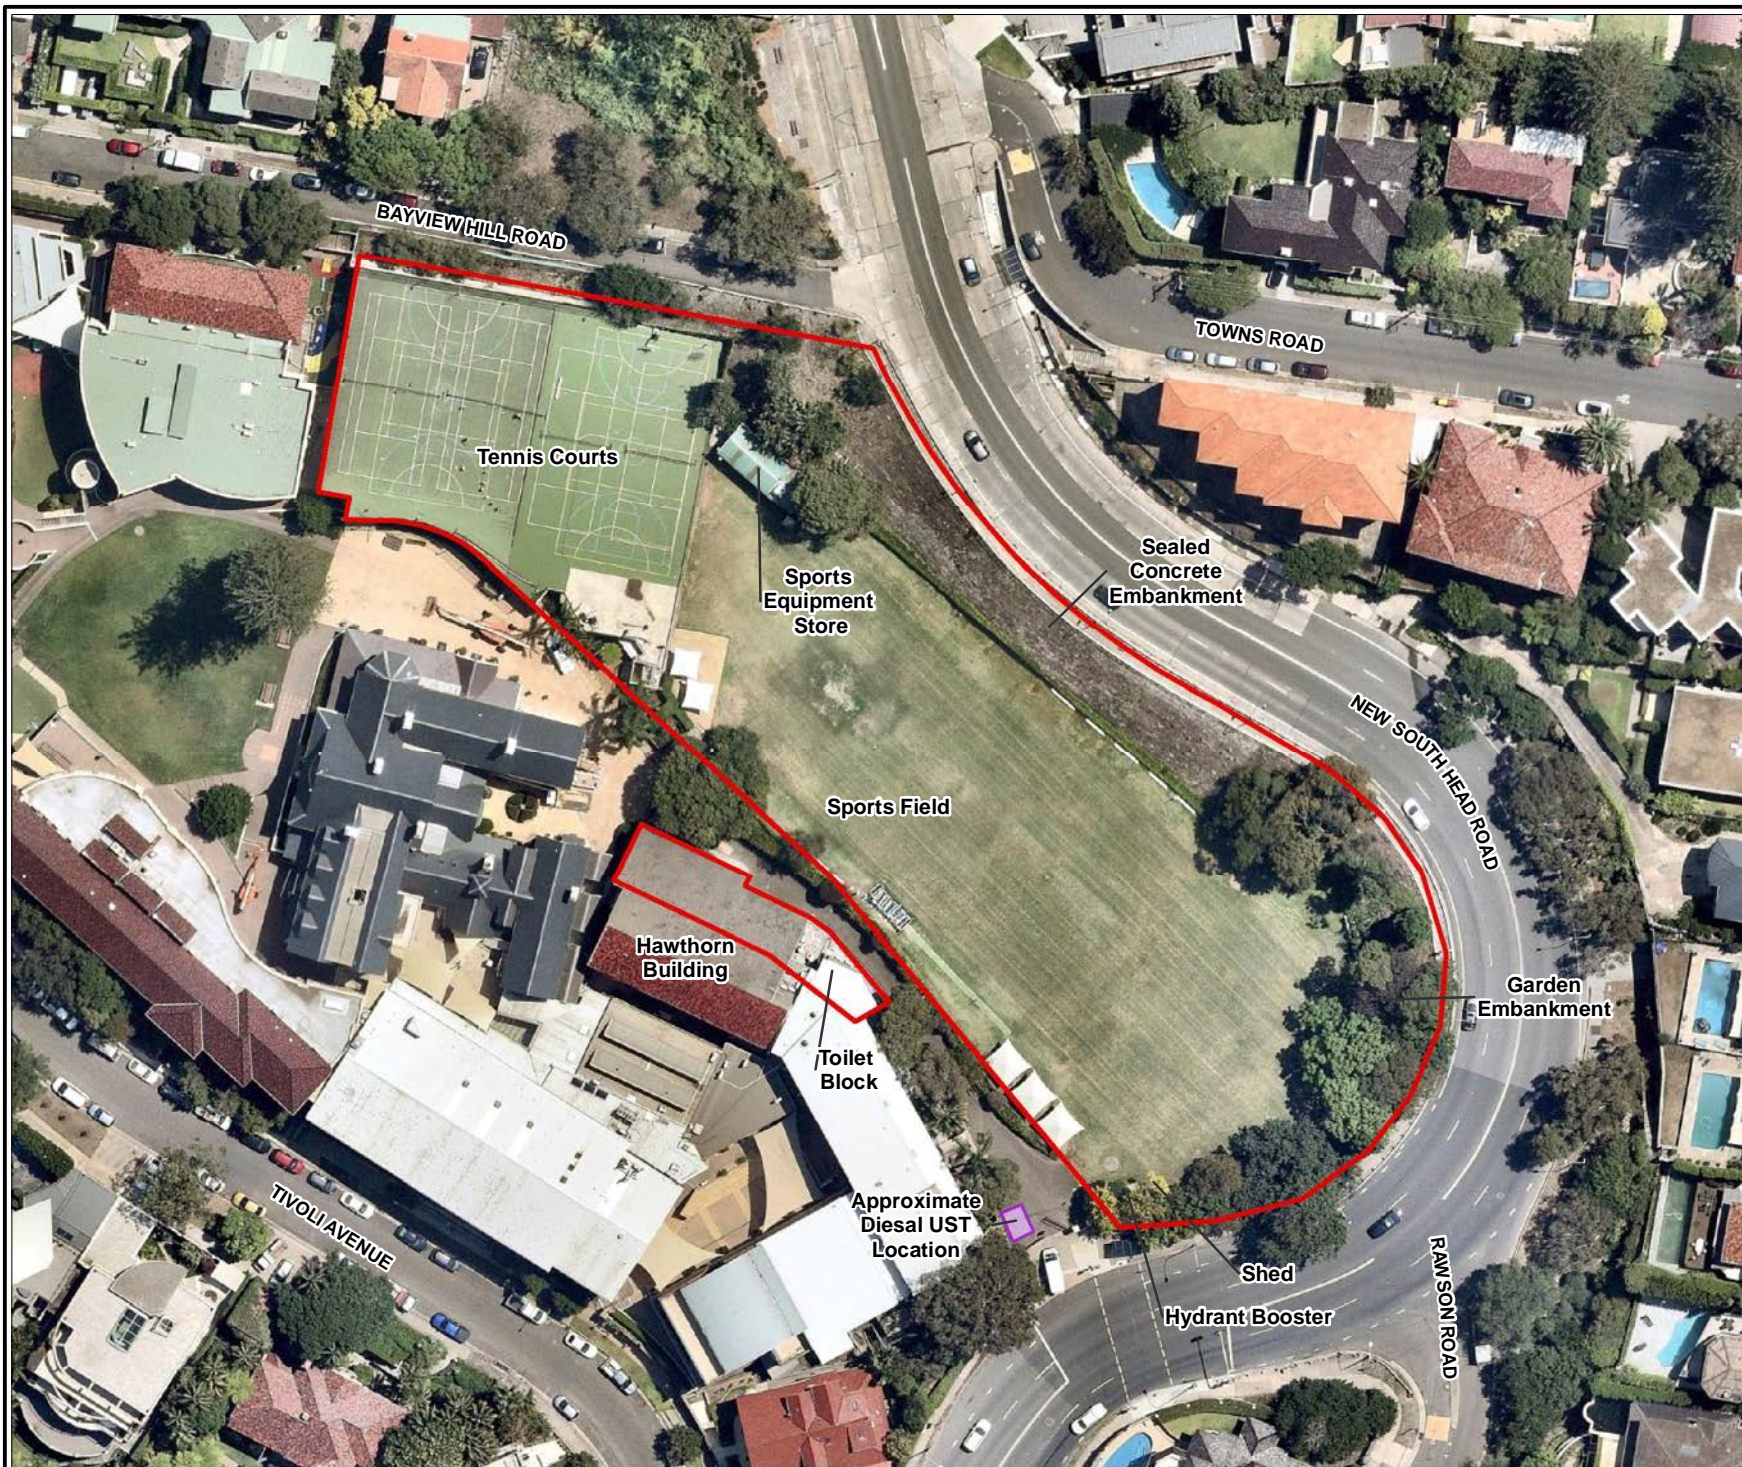
FIGURE 2

- Approximate Site Boundary
- Approximate Diesel UST Location

SITE LAYOUT

A detailed site inspection was undertaken on 7th, 20th and 21st April 2020 by an experienced JBS&G environmental. The layout of the site was observed to be consistent with that described in the PSI (JBS&G 2020a). Site features observed during site inspections are shown on **Figure 2**.

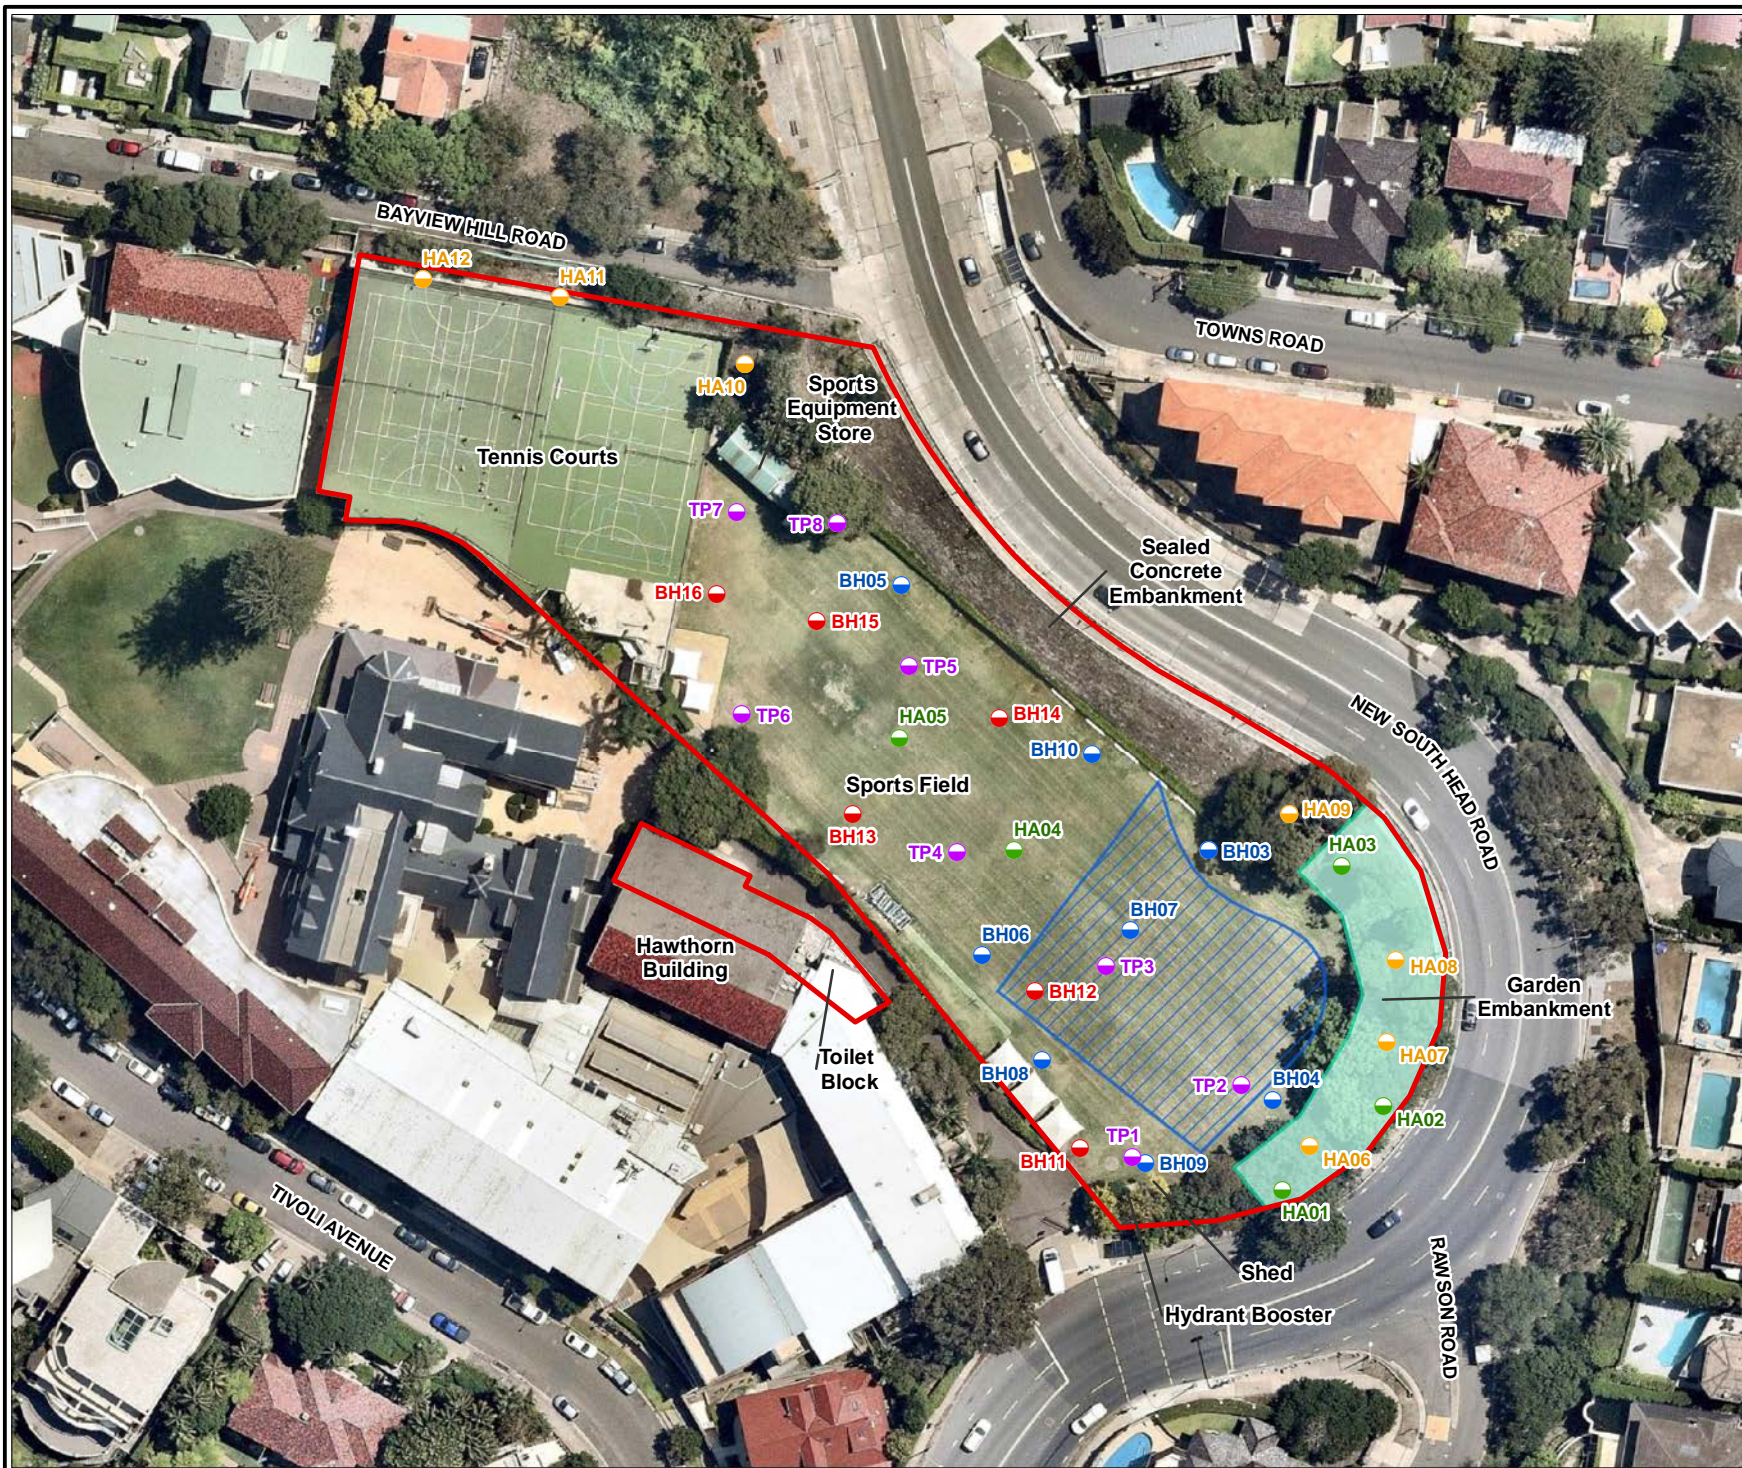
FIGURE 3

- Legend:**
- Approximate Site Boundary
 - Potential Remedial Area within the Sportsfield at a depth of 1m or more
 - Remedial Area within Embankment
- Sample Locations (JBS&G 2019)**
- Borehole
 - Hand Auger
- Sample Locations (JBS&G 2020)**
- Borehole
 - Hand Auger
 - Test Pit
