## Appendix C4 Cultural Heritage Assessment Report for Road Upgrades

**Subject:** **22894 Daroobalgie Solar Farm: Addendum to Aboriginal Cultural Heritage Assessment for Proposed Road Upgrades**

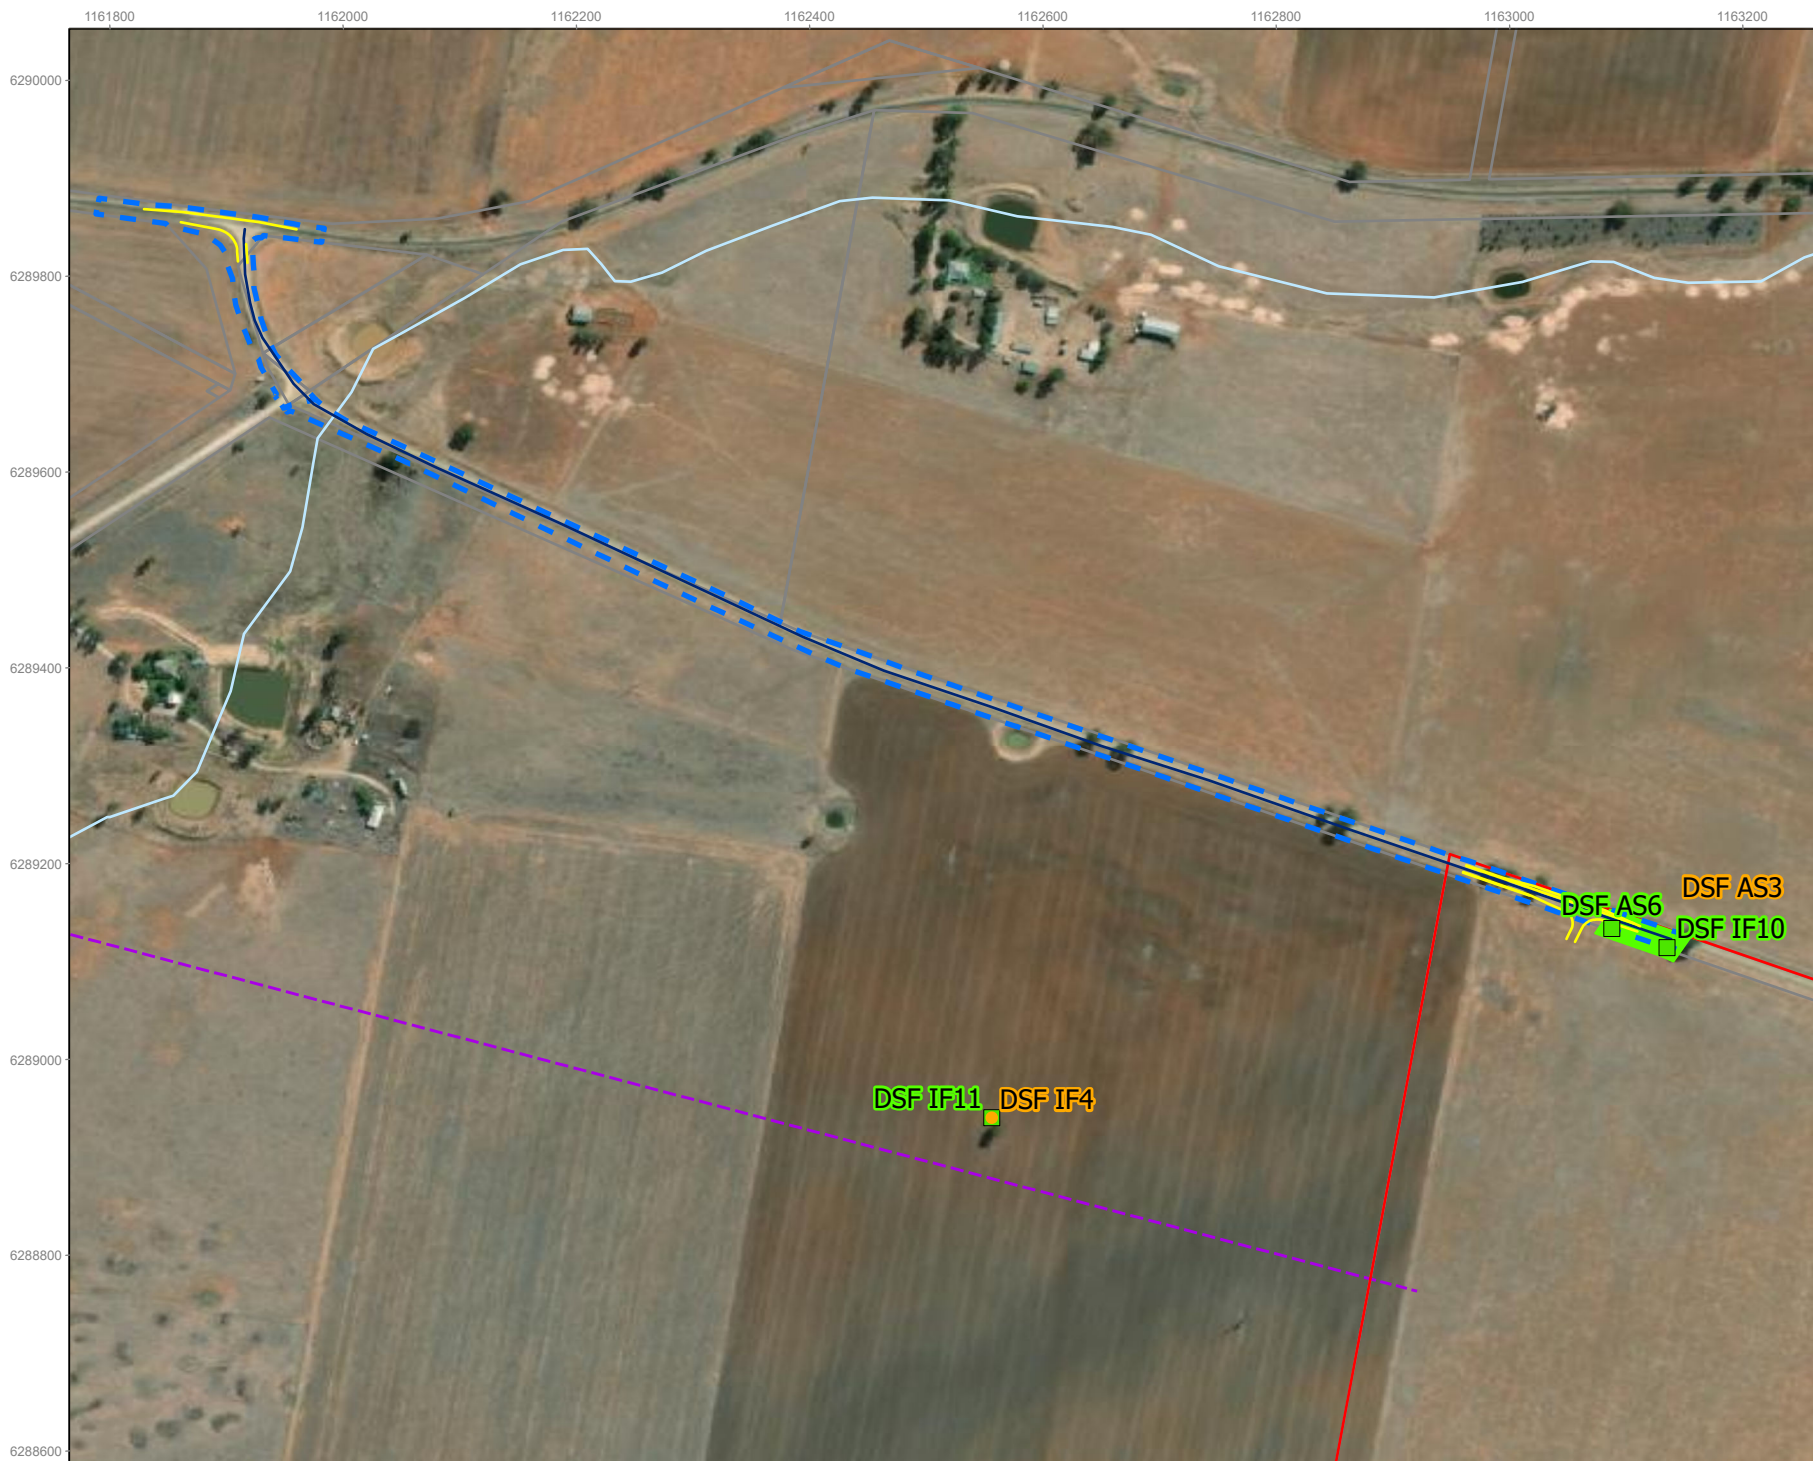
Figure 1.1

Site Layout

The Project is proposed to comprise installation of approximately 420,000 solar photovoltaic (PV) panels, associated infrastructure (i.e., substation, Battery Energy Storage System, inverters, power cabling, site offices, car parking, and new access tracks) and a 132kV Electricity Transmission Line (ETL) to connect the solar farm to an existing 132kV powerline west of Newell Highway. For the purposes of assessment, the Project has been divided into the core development area (CDA) within which the photovoltaic infrastructure will be concentrated and an ETL which will provide connection from the core development area to existing the existing power distribution network. The Project location and proposed site layout are shown on **Figure 1.1**.

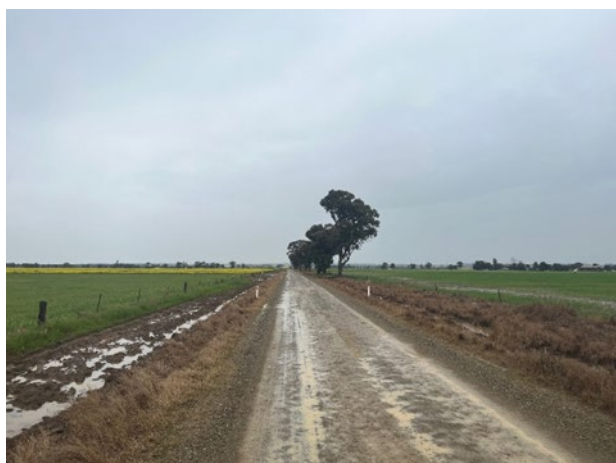
**Photo 5.1** Troubalgie Road from the eastern end of the survey corridor, facing west.

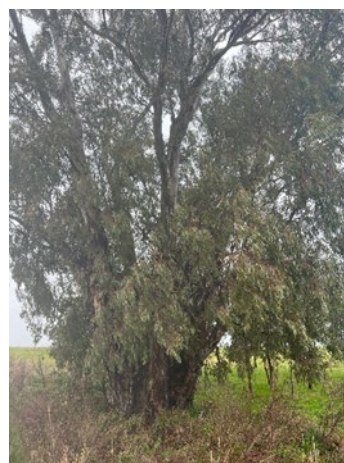
**Photo 5.2** Mature Red Gum (?) located on the southern side of Troubalgie Road, facing south.

It was observed that the majority of the vegetation along the road corridor comprised exotic grasses, as native vegetation had been extensively cleared or modified as a result of agricultural land use activities. Several mature native trees were observed. One mature native tree, possibly a red gum tree, was adjacent to the unnamed drainage line immediately adjacent to the survey area on the southern side of Troubalgie Road (**Photo 5.2**). Three relatively mature native trees were also observed along the central portion of Troubalgie Road, on the northern side of the road.

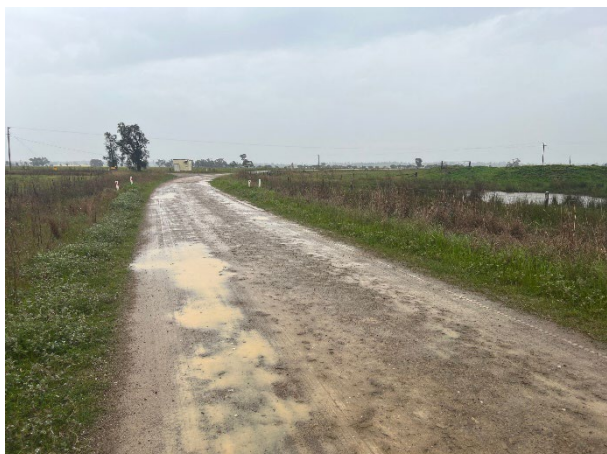
**Photo 5.3** Troubalgie Road adjacent to unnamed drainage line, facing west.

An unnamed first order drainage line was observed toward the western end of the survey area, crossing the Study Area in an approximately north-south alignment. In its observed morphology, the drainage line was ephemeral and discontinuous, due in part to being dammed at multiple places along its natural course. At the place it passed through the survey corridor, the drainage line was directed through a subsurface concrete pipe under Troubalgie Road.

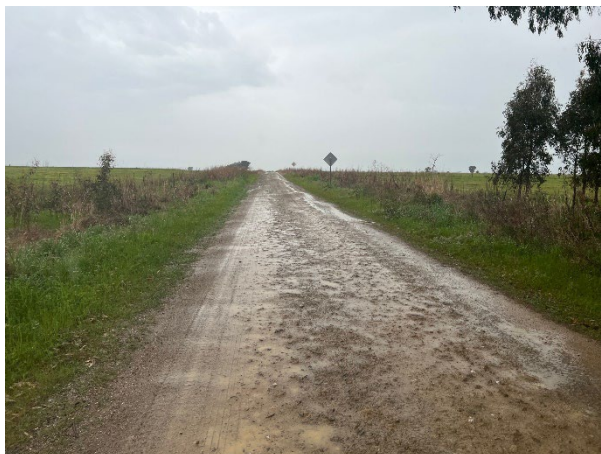
**Photo 5.4** Troubalgie Road from the central end of the survey corridor, facing east.

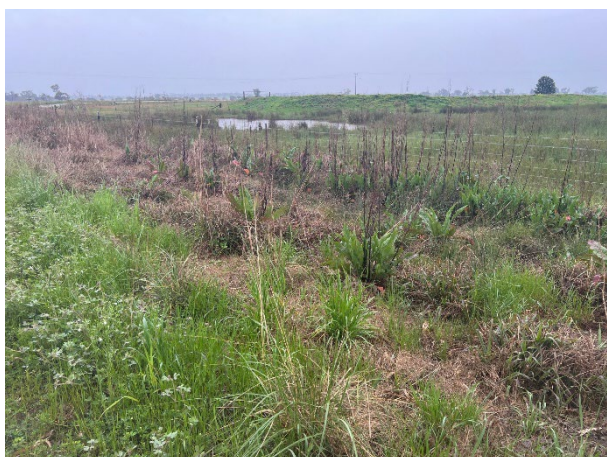
**Photo 5.5** Troubalgie Road verge, central end of the survey corridor, facing south at exotic vegetation growth.

The inspected areas along the survey corridor were generally noted as being consistently flat with little to no topographic variation, consistent with the distal floodplain environs of the Lachlan River. Ground surface visibility was variable across the Study Area. Visibility on the northern side of Troubalgie Road was variably good, the land surface comprising exposed clayey soils which exhibited signs of stock trampling and some areas of poor visibility associated with exotic grass growth. Visibility on the southern side of Troubalgie Road was generally poor due to consistent overgrowth of exotic grasses.

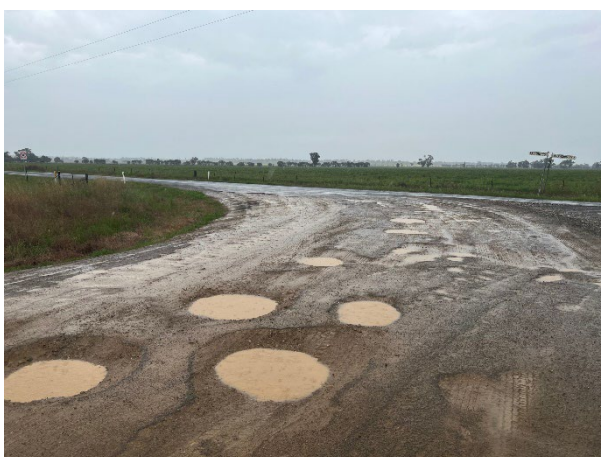
**Photo 5.6** Troubalgie Road at the western end of the survey corridor at the intersection with Back Yamma Rd, facing east.

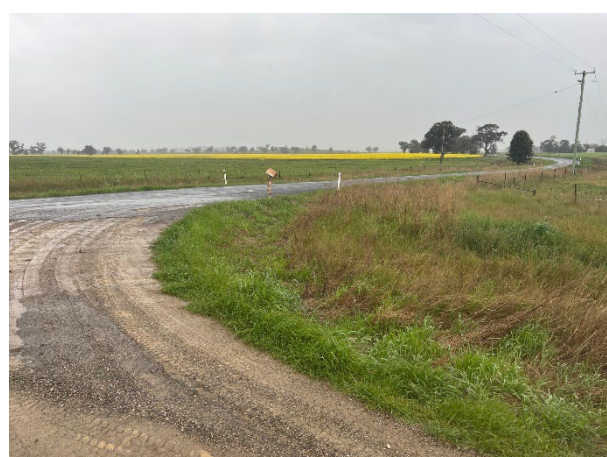
**Photo 5.7** Troubalgie Road at the western end of the survey corridor at the intersection with Back Yamma Rd, looking northeast along Back Yamma Rd.

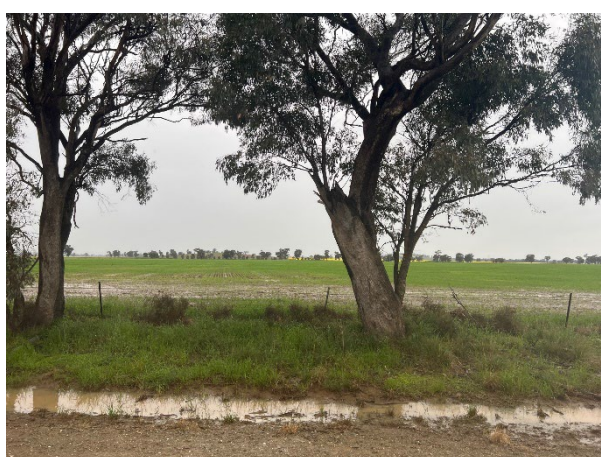
**Photo 5.8** Troubalgie Road verge, central end of the survey corridor, looking north at remnant native trees.

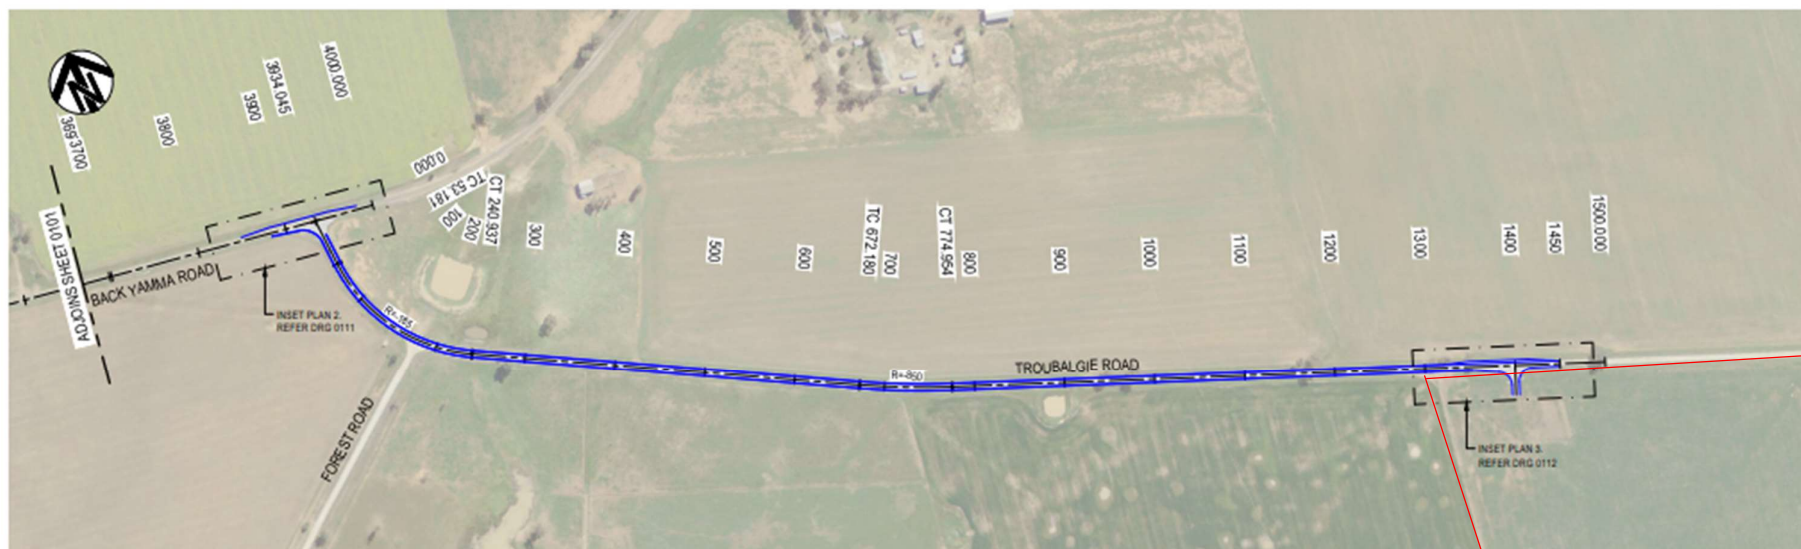
**Figure 1** Close up of proposed road upgrade areas (blue) in relation to project Core Development Area (red)

- an upgrade of the Back Yamma Road/Troubalgie Road intersection, and
- widening of approximately 1.5 km of Troubalgie Road (approx. additional 1.5 m of widening from current width of 7 m to 8.5 m).
