**Our ref: PR141576**

## **Update to the Excavation Methodology at the Liverpool Health and Academic Precinct (LHAP) (SSD 10389)**

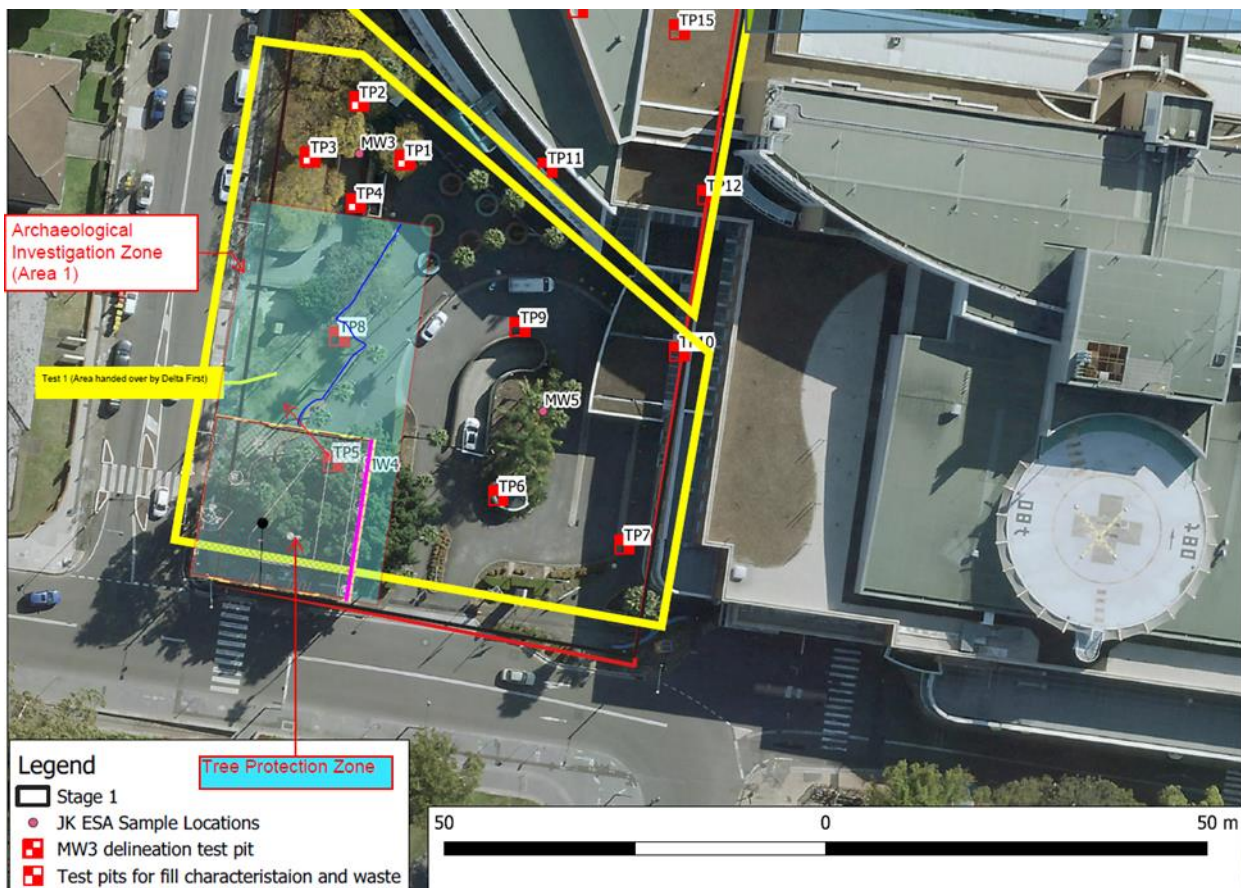
**Figure 1 - Location of the TPZ and TP locations within Area 1. Note, TP5 was relocated to be outside the TPZ. The blue line is the approximate edge of the concrete roadway.**

Based on the results of these two test pits, re-examination of the area, and the maximum depth of excavation being 0.5m below the surface RPS no longer recommends a program of archaeological testing and instead suggests that monitoring is an appropriate methodology for Area 1 of the site.

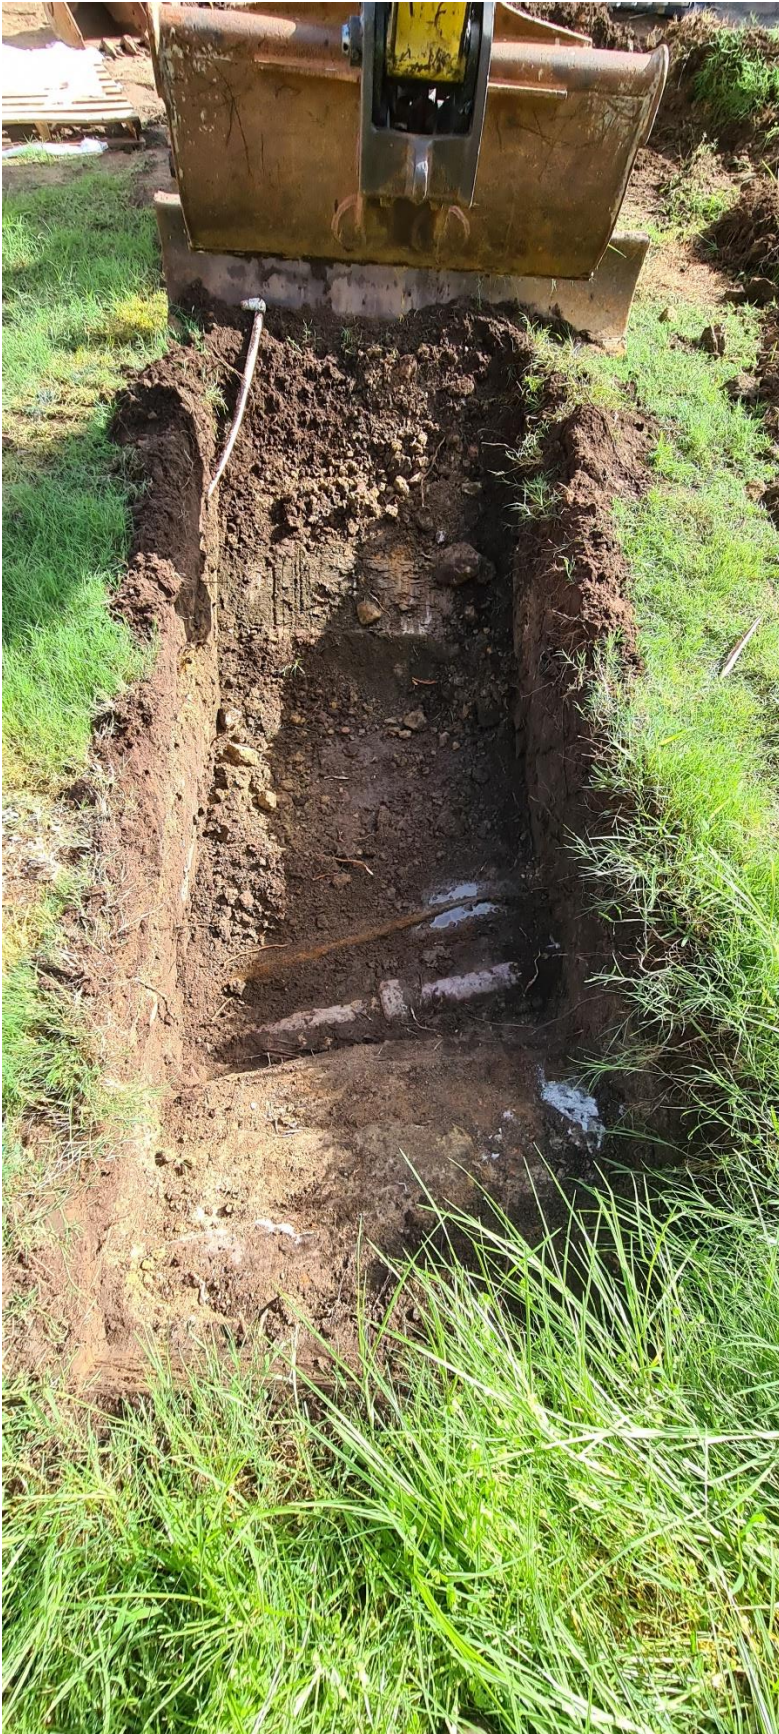
Test Pit 05 Plan view

Test pit 05 was excavated 5.5m north of the TPZ in the approximate centre of Area 1. It was moved to the northwest so as not to impact the trees. The pit measured 3.2 x 1.3m and was excavated to a maximum depth of 1.15m. A 20<sup>th</sup> century building foundation consisting of a portland cement concrete with dry-pressed bricks was located at the southern end of this trench running east to west. Around 300mm north of this on the same alignment was a ceramic service pipe which had portland cement mortar joints and a metal water pipe. A further 1m north was a larger concrete stormwater pipe, again on the same alignment. No cuts for these services were visible within the upper 0.5m of the profile and all appeared to have been cut through to the underlying B horizon clay. This clearly indicates that the upper 0.5m of the profile which will be disturbed by future works has been deposited after these services were laid during the mid-later twentieth century. The section profile consisted of:

View to the north

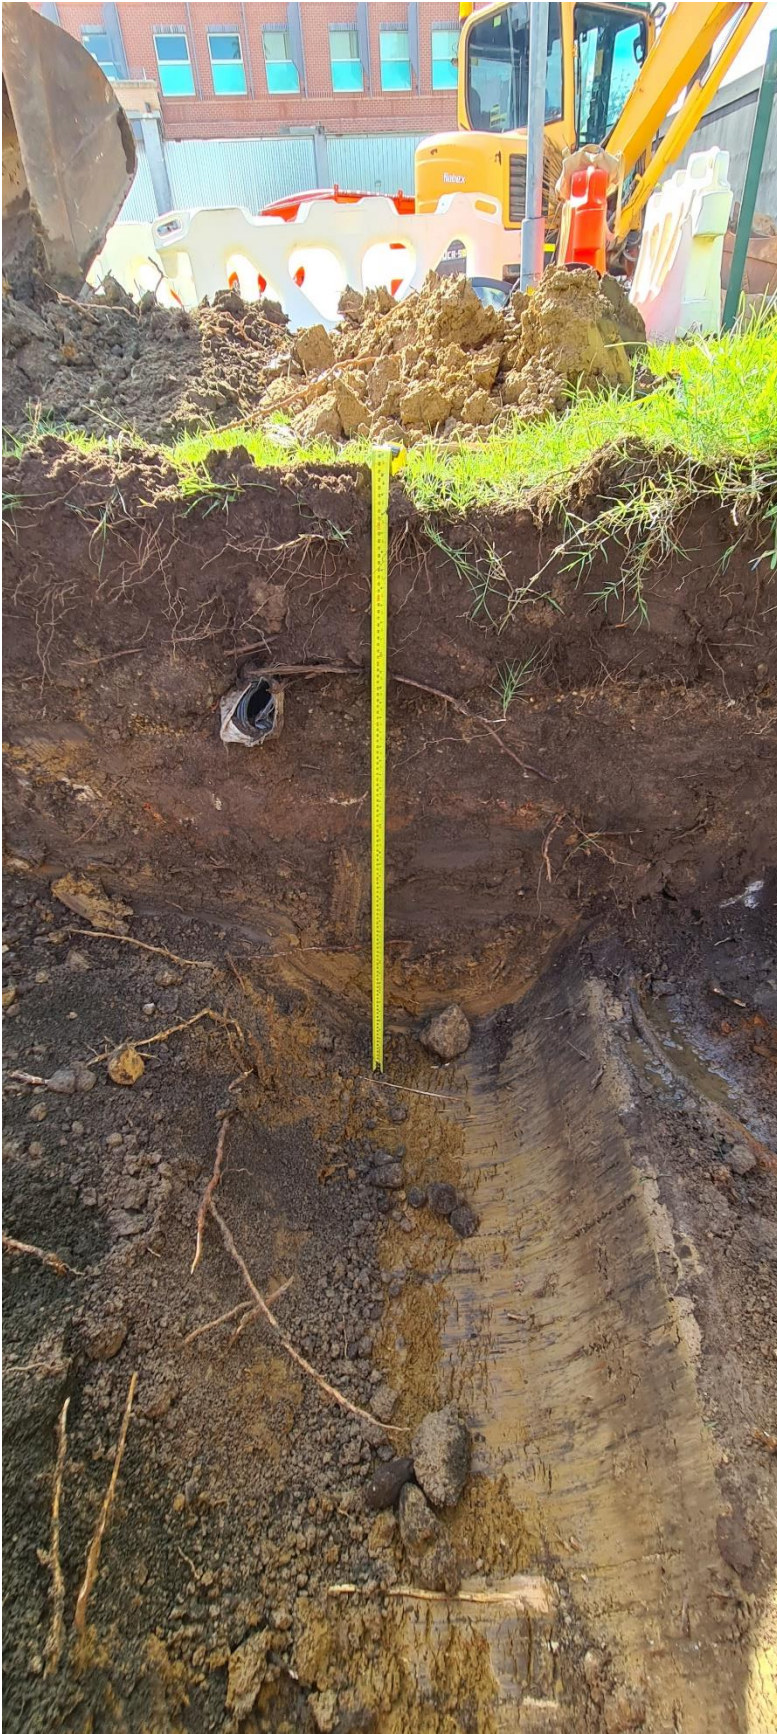
Test Pit 05 Section

Depth	Thickness	Description
0 – 0.25m	250mm	Medium compacted dark brown sandy silt topsoil with frequent rooting and rare rounded gravel
		Current topsoil

Depth	Thickness	Description
0.25 – 0.50m	250mm	Mixed lenses of 3-8mm subrounded dark greyish green gravel, mottled grey/yellow/pink clay with rare broken and crushed sandstone and dry-pressed brick and crushed sandstone Imported 20 <sup>th</sup> century fill
0.50 – 0.80m	350mm	Medium compacted dark blackish brown silty sand with fine rooting. Services visible in this layer. 19 <sup>th</sup> century lower A horizon
0.80m+	>350mm	Moderately compacted brownish yellow sandy clay B horizon

East facing section

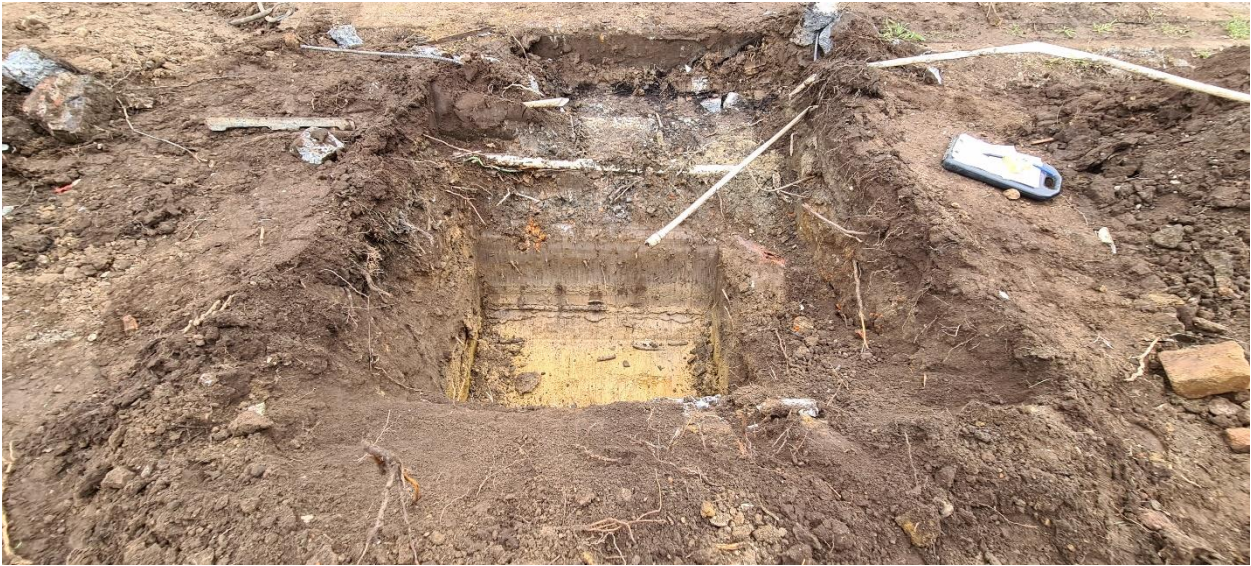
Test Pit 08 Plan View

Test pit 08 was located around 8m north of TP05 adjacent to the edge of the extant concrete road surface. It measured 2.5 x 2m and was excavated to a maximum depth of 0.8m. As with TP05 numerous services were located within the TP; they were closer to the present surface. The concrete footing of the extant road surface was exposed at the northern end. It consisted of a substantial >400mm thick reinforced concrete slab with services laid immediately adjacent to it. This concrete slab is large and covers around a third of the remaining excavation area. It was not possible to directly examine the depth of the slab as an electrical cable was found adjacent to it however as it did not easily move when pulled by a 5tn excavator it is likely to be thicker than the 400mm examined. These features indicate that this portion of the proposed test area has also been extensively removed and disturbed at depth by the mid-later twentieth century works. The section profile consisted of:

View to the east

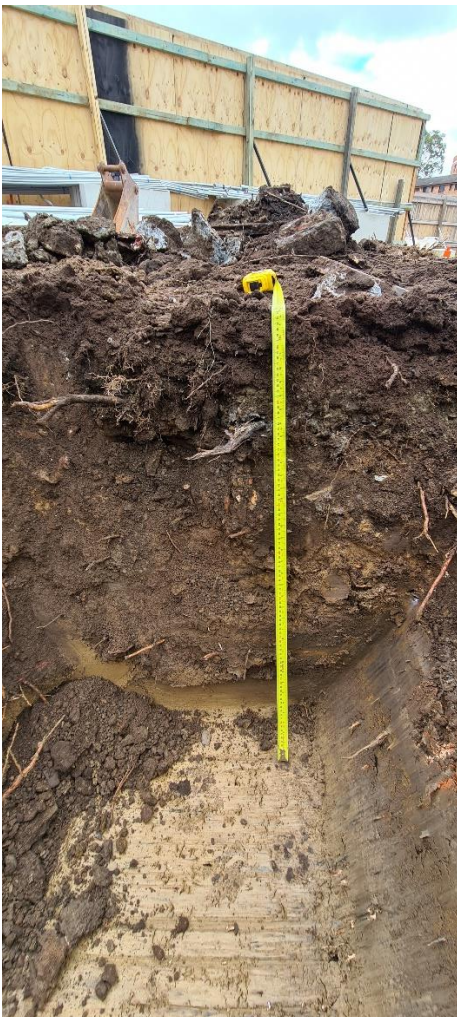
Test Pit 08 Section

Depth	Thickness	Description
0 – 0.3m	300mm	Mixed loose dark brown sandy silt, with 20 <sup>th</sup> century building rubble and rooting Recently truncated current topsoil
0.3 – 0.7m	400mm	Slightly compacted mixed brown sandy silt with patches of 3-7mm rounded gravel, rare dry-pressed brick fragments and wood fragments Imported 20 <sup>th</sup> century fill
0.7 – 0.8m	100mm	Light greyish brown clayey sand with rooting 19 <sup>th</sup> century lower A horizon
0.80m+	-	Moderately compacted brownish yellow sandy clay B horizon

East facing section
