Our ref: SYDEN231101-R04-Rev0

## **Supplementary Contamination Assessment, New Liverpool Primary School**

| title:<br>DELINEATION SAMPLING (TP07) | | |

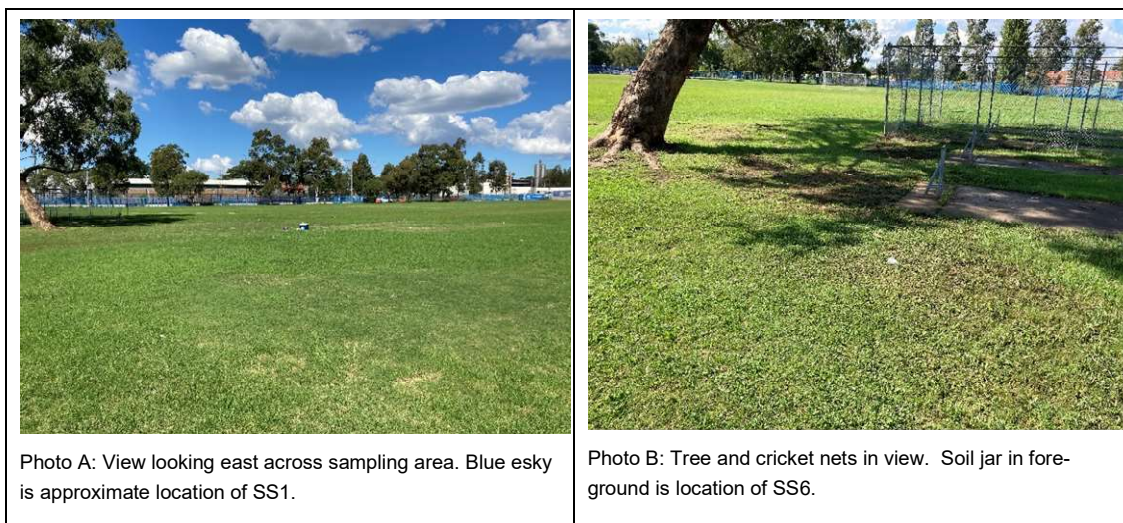
**Table 2:** Selected Site Photographs

The soil description at each location is included within **Table 1**. All material is described as fill material. All locations comprised a grassed surface with approximately 0.05 to 0.1m of topsoil. Most locations were relatively moist following the significant rainfall encountered during the weeks leading up to sampling. Worms were present at most locations and ants' nests were also plentiful across the sampling area. SS1 and SS3 appeared to be located in an area of different coloured grass. SS1, SS2, SS6, SS8 and SS9 were located in low-lying areas where ponding of water is more likely. These locations tend to correlate well with locations where clay was observed. The remaining locations were observed to contain more sandy soils. From a contamination perspective, sample location SS1 included material that appeared to be remnants of bottom ash or clinker from the combustion of coal (refer to Photo E). Selected photographs of the site and subsurface conditions are provided in **Table 2**.

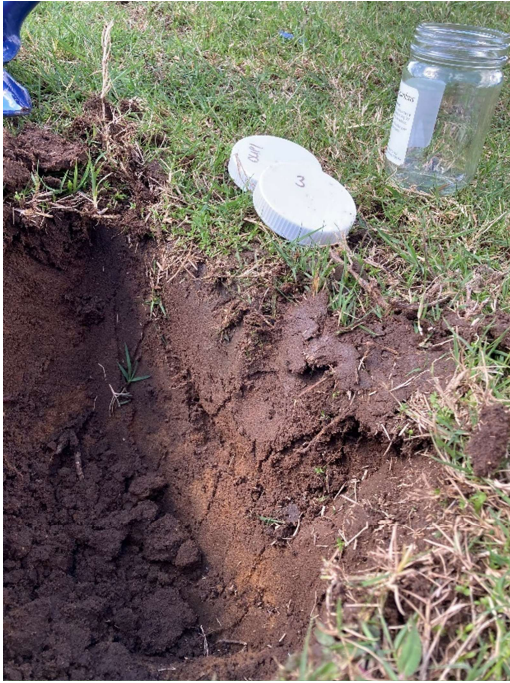
Photo C: Soil profile at SS3

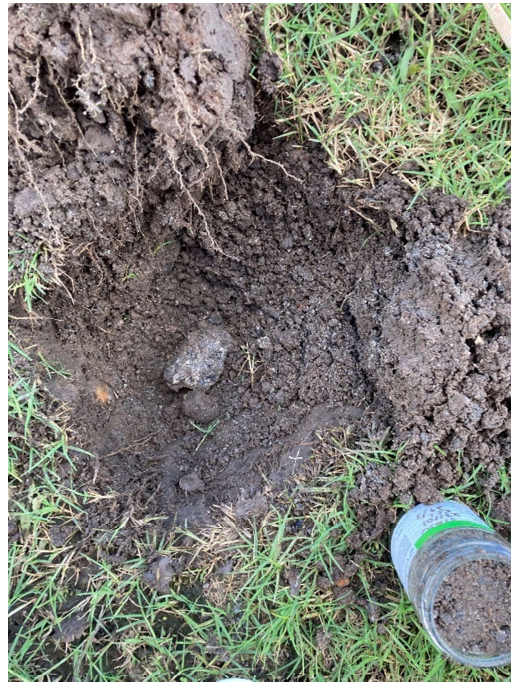
Photo D: Soil at SS1

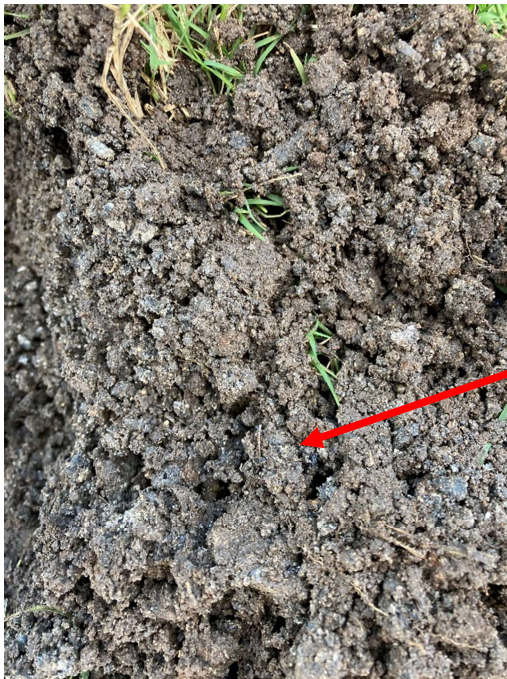
Photo E: Close up of soil at SS1

Bottom  
ash

Resulting shallow soil sampling reported elevated arsenic concentrations at the previous test pit TP07 location (SS1 at 74 mg/kg) and lower arsenic concentrations within the delineation sampling (up to 23 mg/kg). The following conclusions were made:

Based on these conclusions, it is recommended that the area adjacent to and including TP07 (approximately 4m x 4m square x 1m depth) be relocated through either excavation and either disposal offsite or relocated to a suitable area on the secondary school oval. Validation of the base of the excavation (ie TP07) should be carried out to ensure contamination does not extend vertically. Relocation works should be supervised by an environmental consultant. The coordinates of the excavation are as follows (GDA 1994 MGA Zone 56).
