Report on
Geotechnical Investigation

Proposed New Liverpool Primary School
Lachlan Street, Liverpool

Prepared for
School Infrastructure NSW

Project 92370.01
December 2019

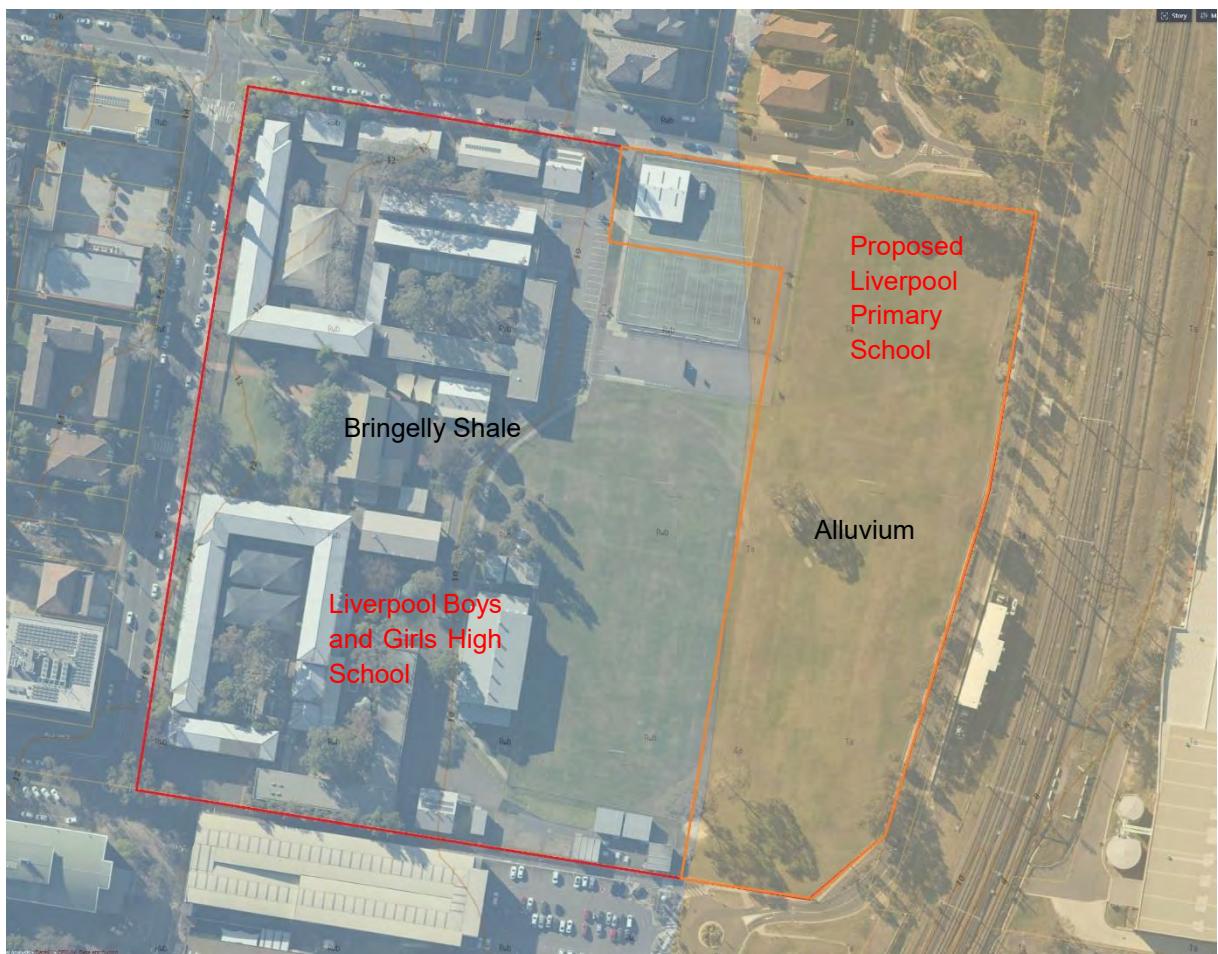
Figure 1: Extract from the Penrith 1:100 000 Geology Map and the approximate site boundary. The locations of the tests are shown in Drawing 1 in Appendix A.

Reference to the Penrith 1:100 000 Geology Map for Penrith indicates that the western portion of the site is probably underlain by Bringelly Shale of Triassic age. Bringelly Shale typically comprises siltstone, fine grained sandstone and laminitic with some shale bands. The eastern portion is shown on the map as being underlain by more recent alluvium comprising clayey quartzose sand and sand laid down in the floodplain of the nearby Georges River. The geological mapping is shown in Figure 1 below. The detailed logging of the boreholes confirms the mapping with the western area of the site underlain by a relatively shallow depth of filling and silty clay and then weathered siltstone to the full depth of testing. The boreholes in the eastern area of the site encountered extensive alluvial deposits over Bringelly Shale.

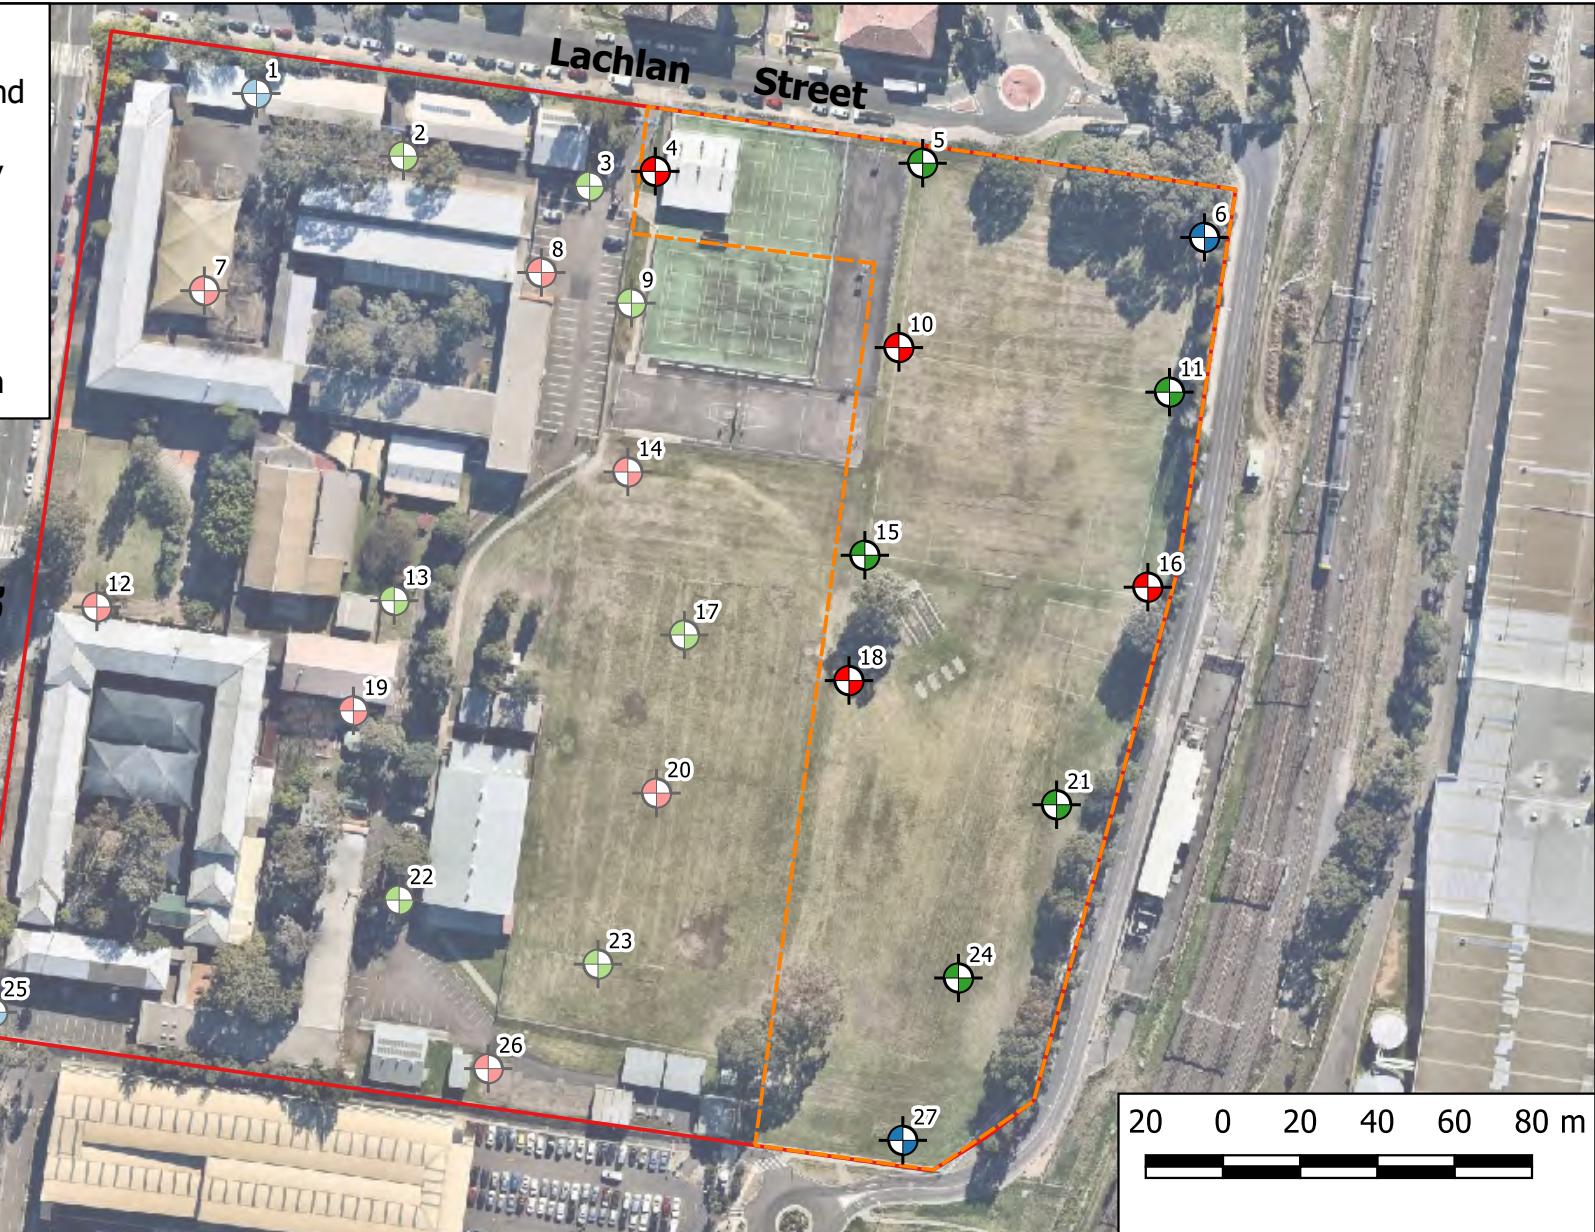
TITLE: Borehole Location Plan
Proposed Liverpool Primary School
Lachlan and Forbes St, Liverpool
