ARBORICULTURAL DEVELOPMENT IMPACT ASSESSMENT REPORT

**New Liverpool Primary School NSW
SSDA**

**REVISION C
29th May 2021**

**Prepared for
School Infrastructure NSW**

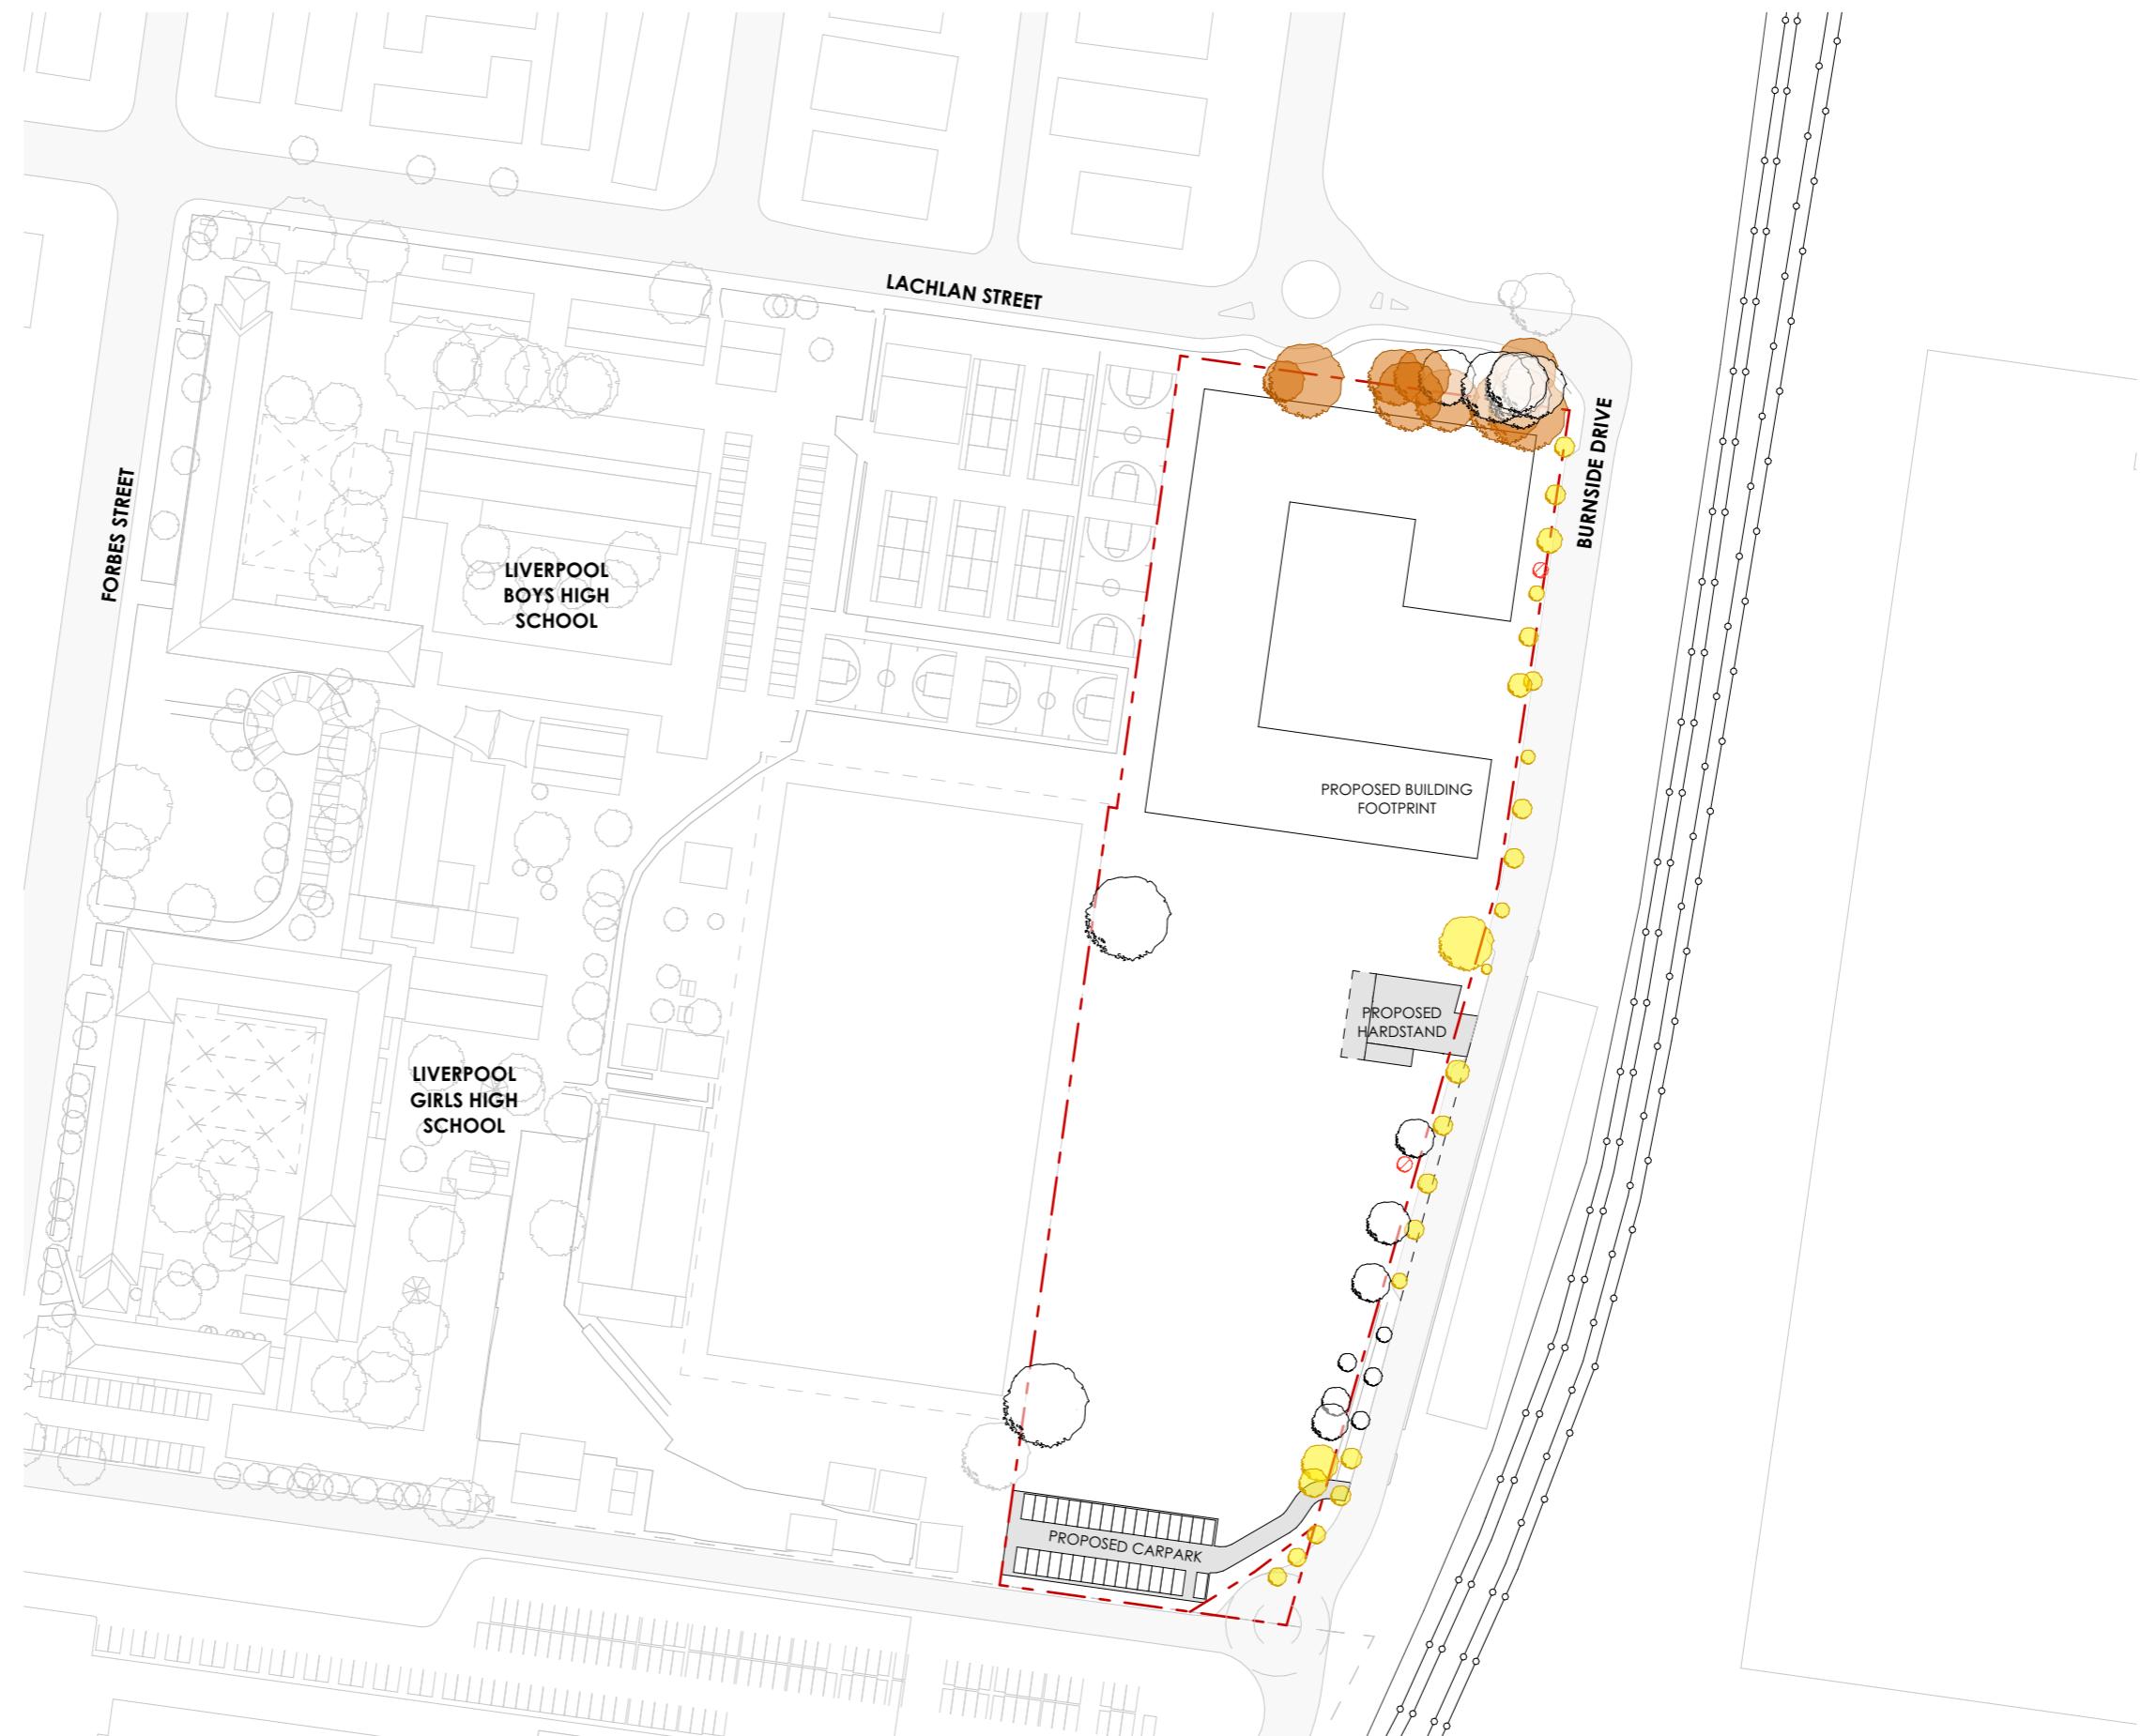
STAGING DIAGRAM - TREE STAGING

There are additional works at the site including roadworks to Burnside Drive and infrastructure works or the proposed services works to the site. These works are included within separate Review of Environmental Factors (REF) for these projects. Refer to Birds Tree Consultancy Arboricultural Development Impact Assessment Report for New Liverpool Public School Infrastructure Works dated 10 May 2021 Rev B and Arboricultural Development Impact Assessment Report for New Liverpool Public School Roadworks dated 10 May 2021 Rev B for details of impact assessment for these works. The extent of the boundaries of these works are defined within Fitzpatrick Design Staging Diagram within Appendix E.
