Report on  
Geotechnical Investigation

Monte Scientia Project  
128 Miller Street, North Sydney

Prepared for  
Monte Sant' Angelo Mercy College  
c/- Bloompark Consulting Pty Ltd

Project 73019.03  
February 2020

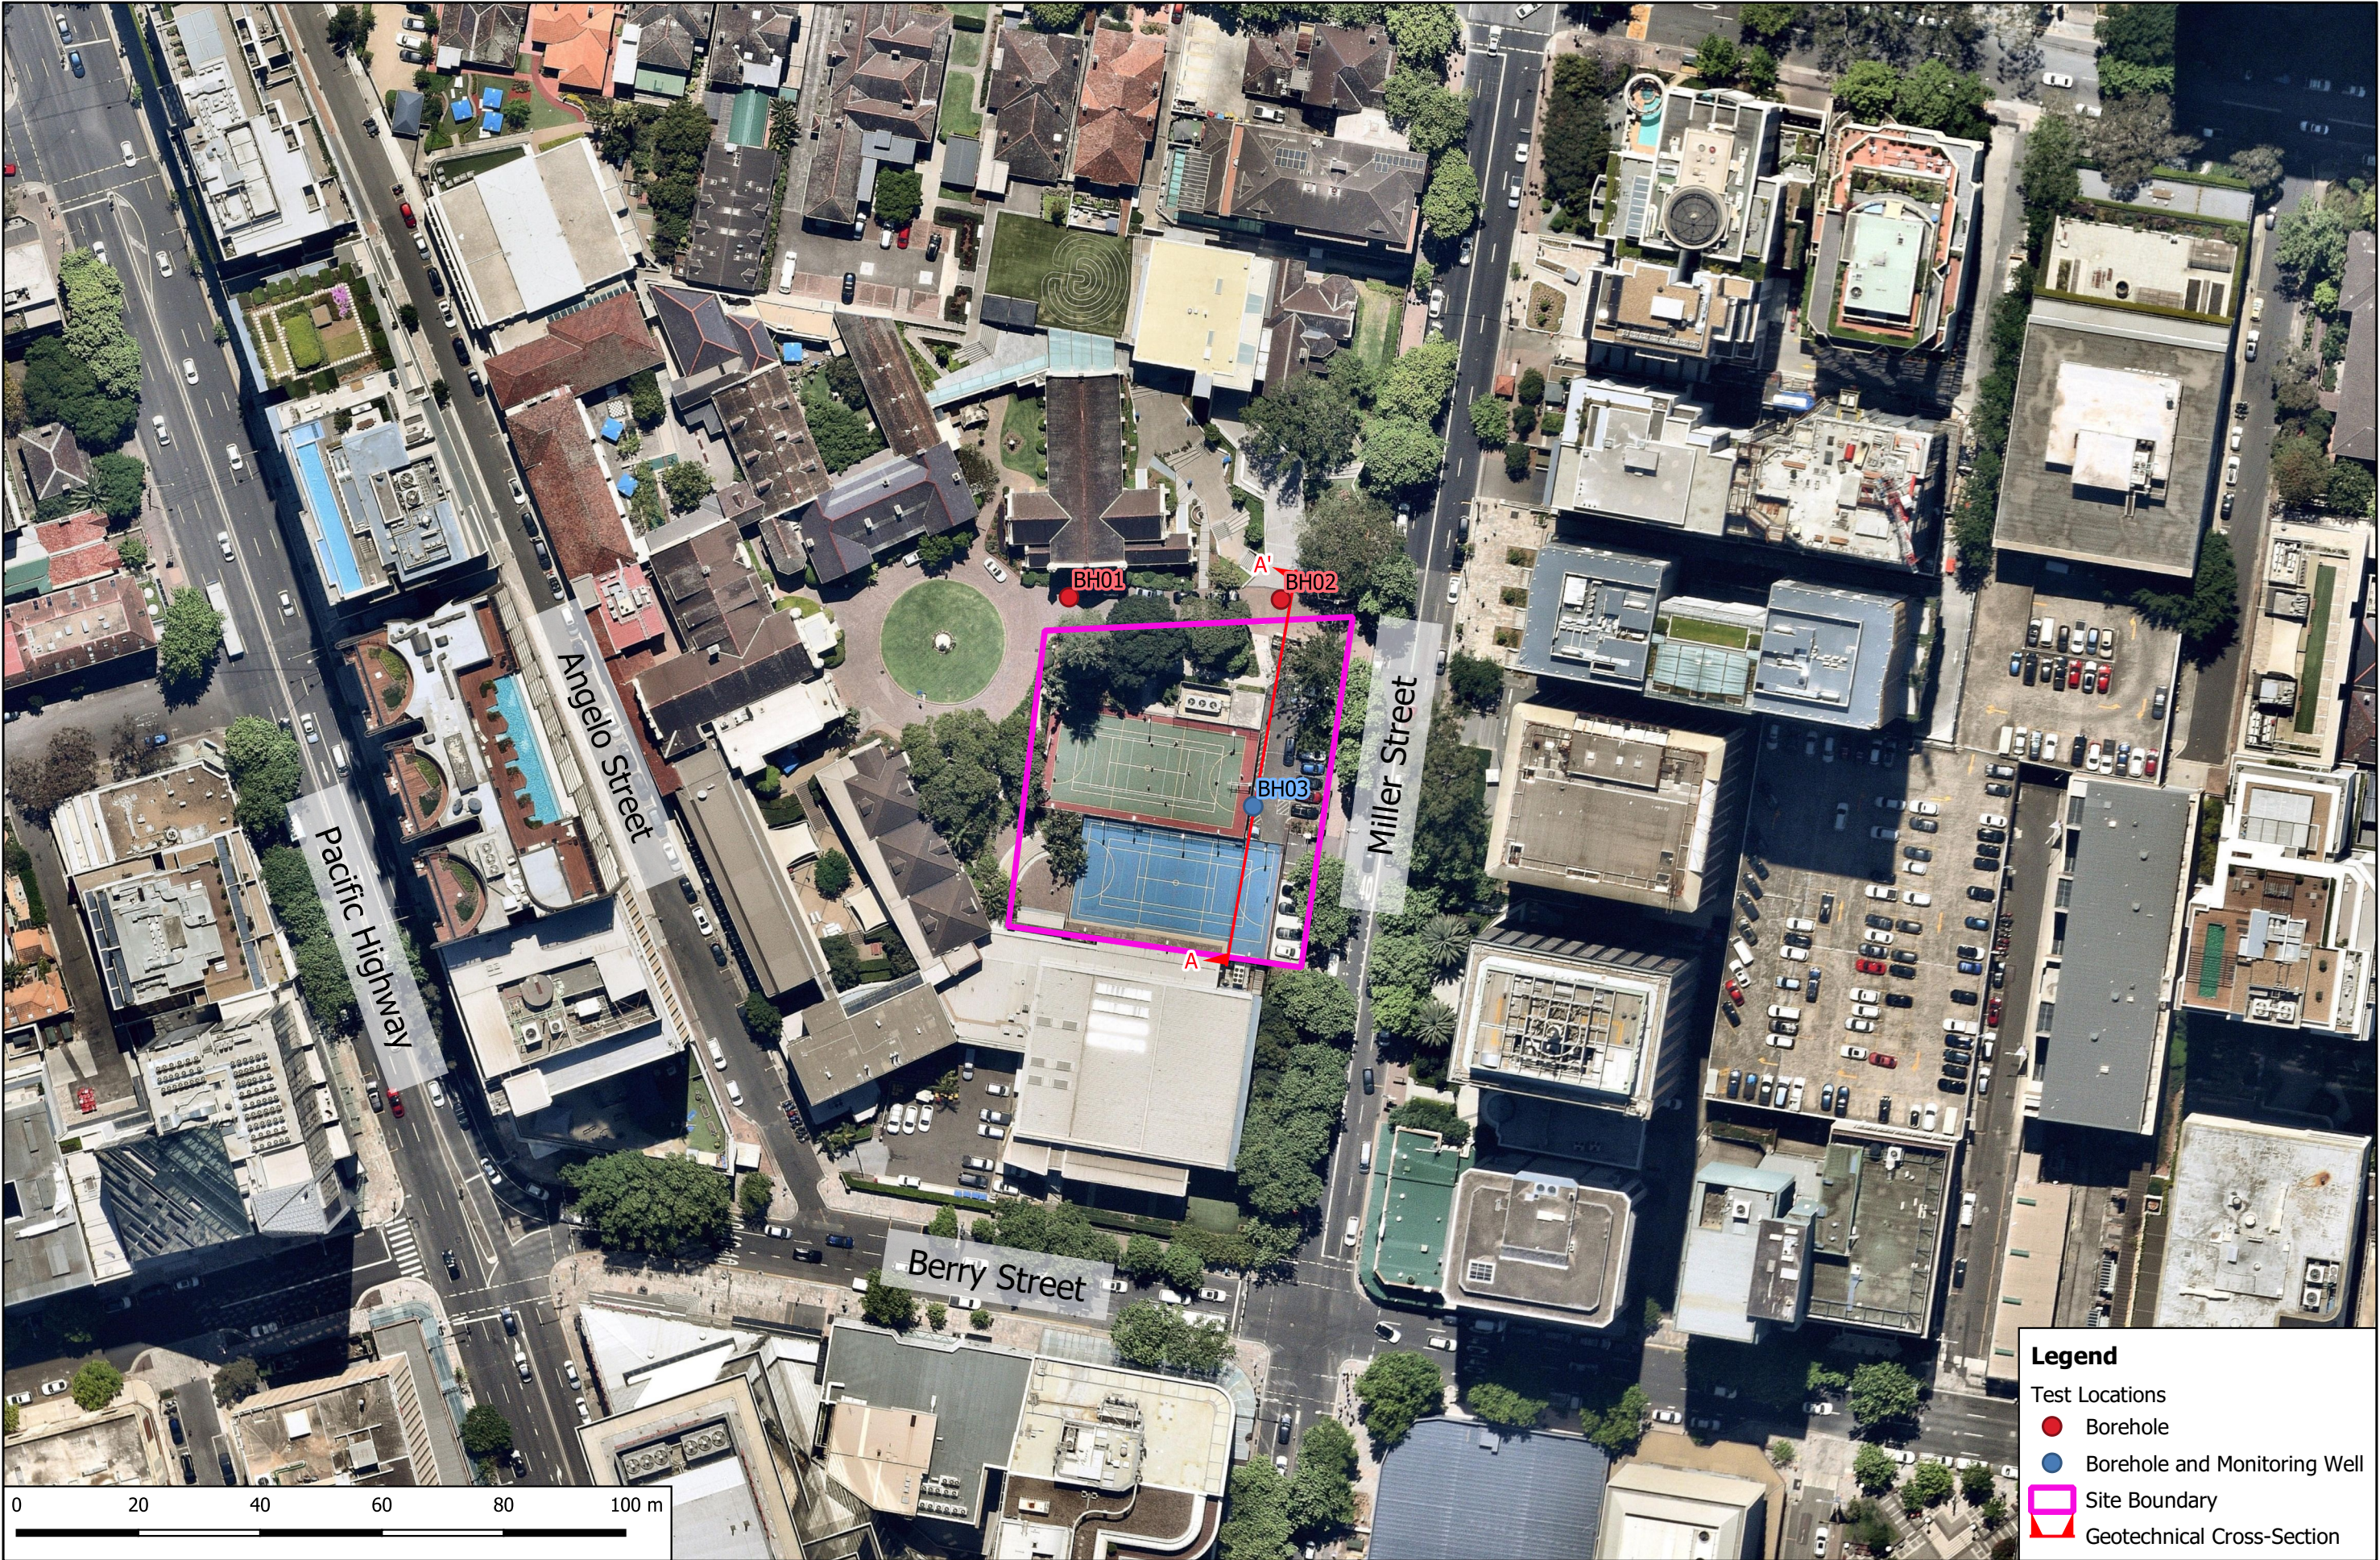
Borehole

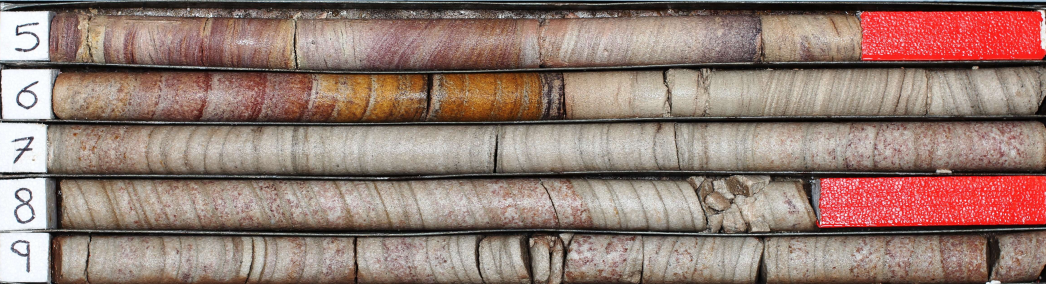
Project No: 73019-03  
BH ID: BH01  
Depth: 5.00 - 10.00 m  
Core Box No.: 2

5.00 - 10.00m

BORE: 01

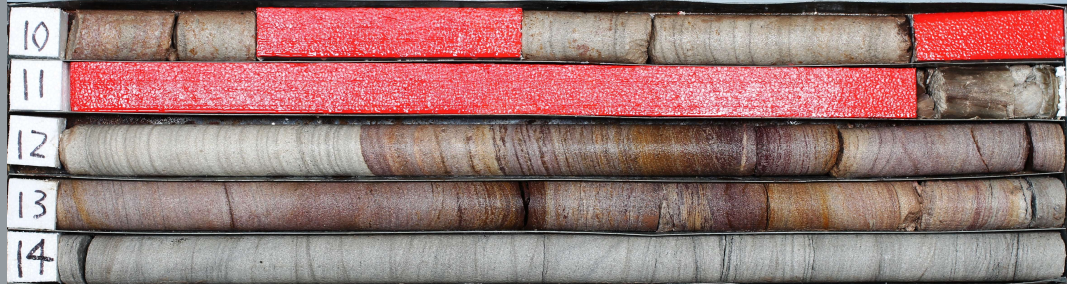
Core Box No.: 3

10.00 - 15.00m

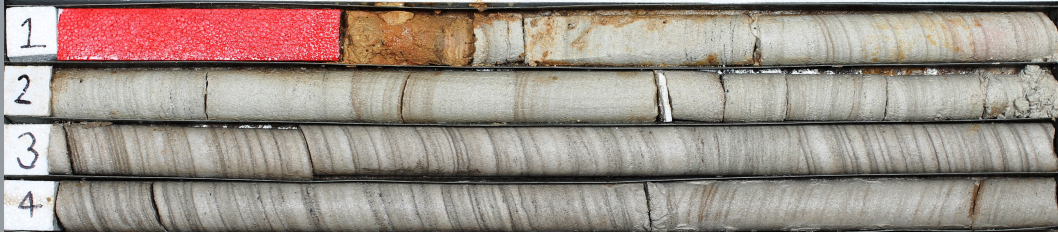
73019-03 NORTH SYDNEY 9/11/09 BH02 START 1.00m

1.00 - 5.00m

BORE: 02

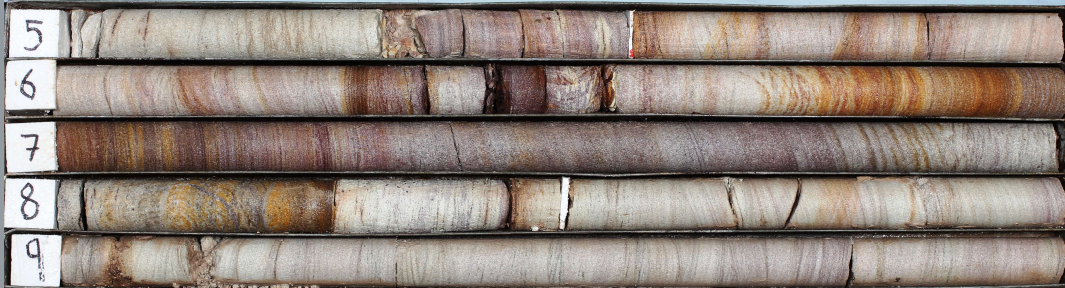
Project No: 73019-03  
BH ID: BH02  
Depth: 5.00 - 10.00 m  
Core Box No.: 2

5.00 - 10.00m

BORE: 02

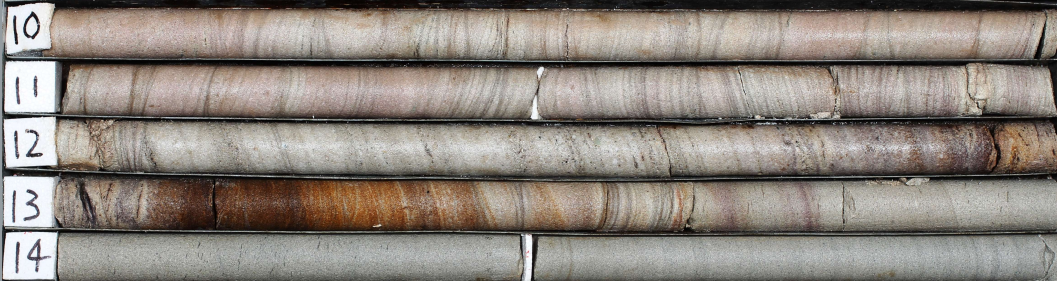
Core Box No.: 3

10.00 - 15.00m

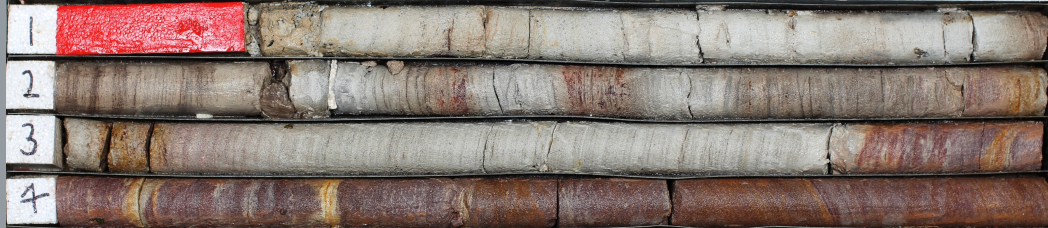
73019-03 NORTH SYDNEY 9.11.19 BH03 START 1.00m

1.00 - 5.00m

BORE: 03

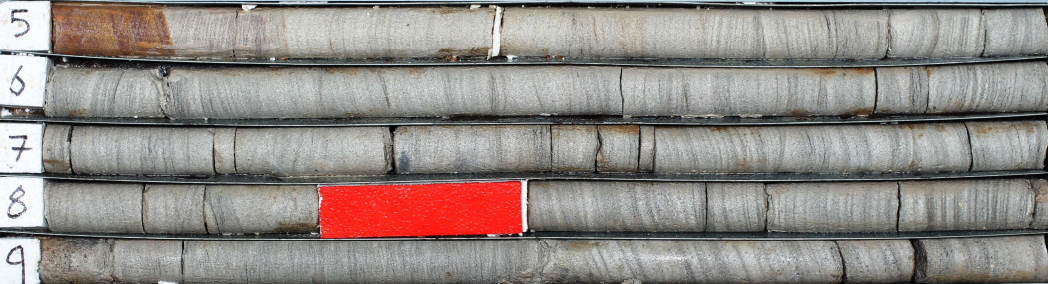
Project No: 73019-03  
BH ID: BH03  
Depth: 5.00 - 10.00 m  
Core Box No.: 2

5.00 - 10.00m

BORE: 03

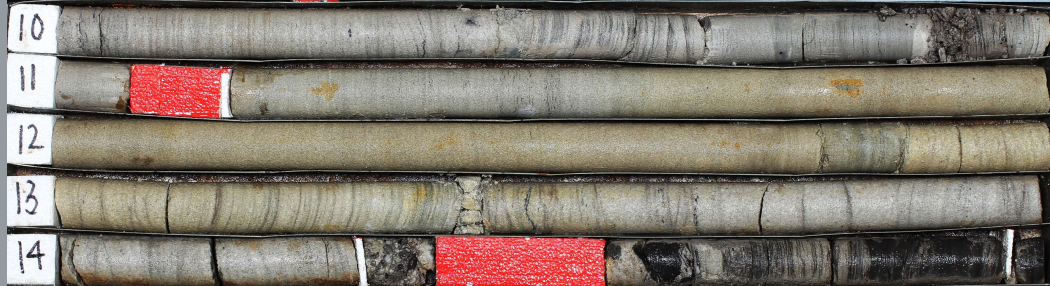
Core Box No.: 3

10.00 - 15.00m

BORE: 03

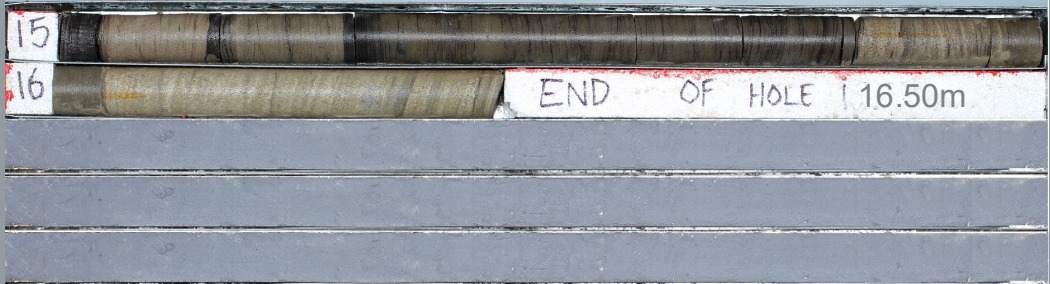
Core Box No.: 4

15.00 - 16.45m
