Report on
Preliminary Site Investigation (Contamination)

Monte Scientia Project
Monte Sant' Angelo Mercy College
128 Miller Street, North Sydney

Prepared for
Monte Sant' Angelo Mercy College
c/- Bloompark Consulting Pty Ltd

Project 73019.03
January 2020

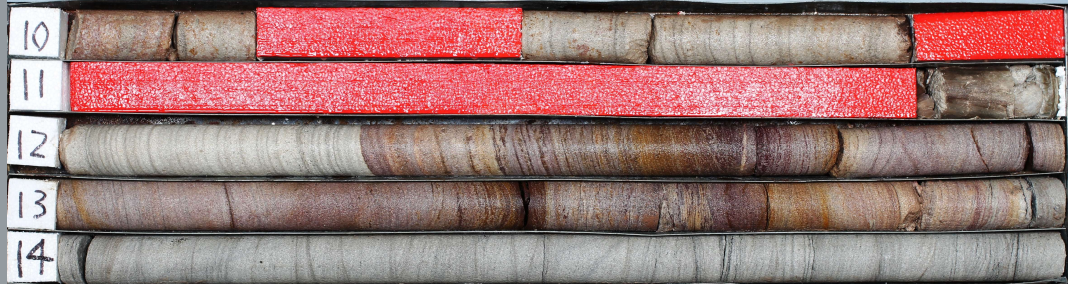
Project No: 73019.03
BH ID: BH01
Depth: 10.00 - 15.00m
Core Box No.: 3

10.00 - 15.00m

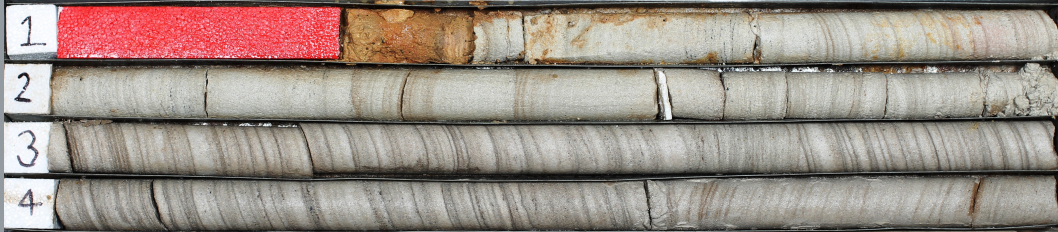
73019-03 NORTH SYDNEY 9/11/09 BH02 START 1.00m

1.00 - 5.00m

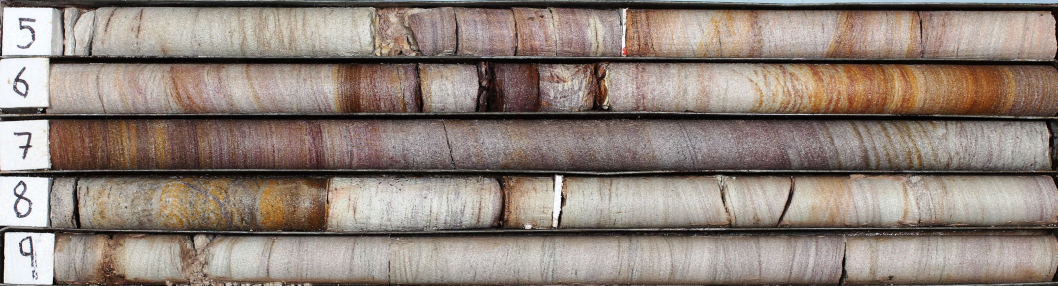
Project No: 73019-03
BH ID: BH02
Depth: 5.00 - 10.00 m
Core Box No.: 2

5.00 - 10.00m

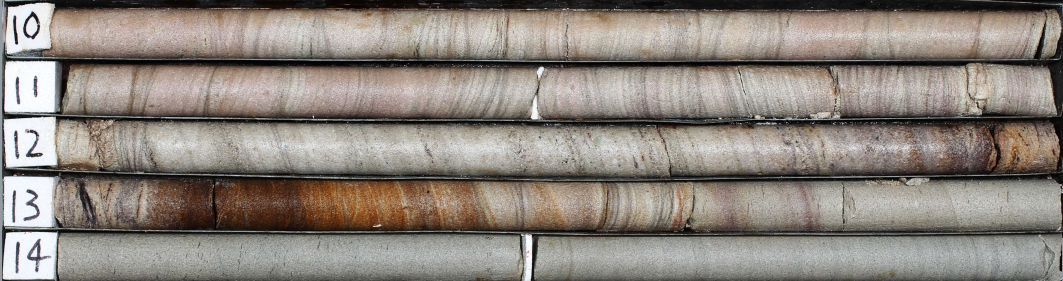
Project No: 73019-03
BH ID: BH02
Depth: 10.00 - 15.00 m
Core Box No.: 3

10.00 - 15.00m

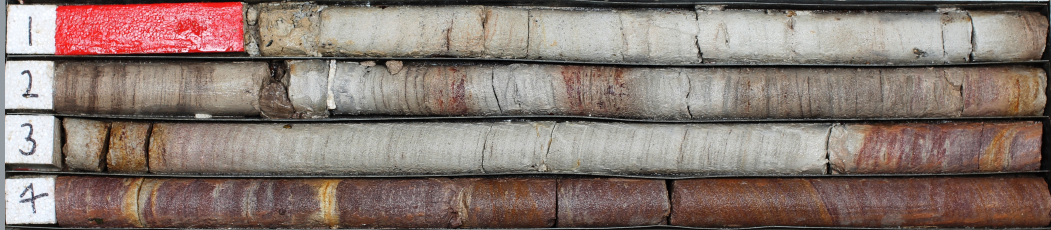
73019-03 NORTH SYDNEY 9.11.19 BH03 START 1.00m

1.00 - 5.00m

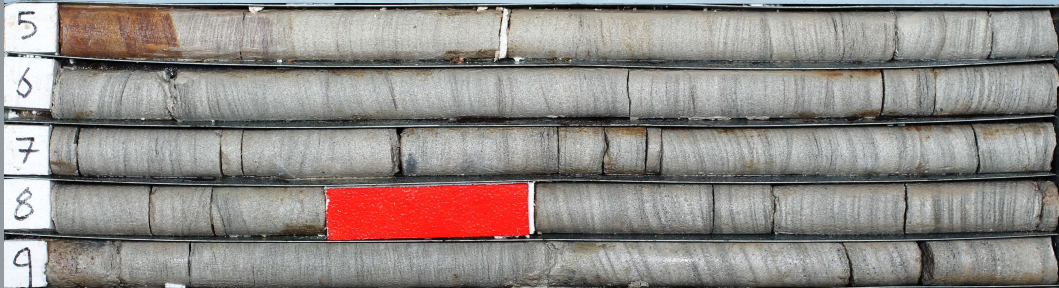
Project No: 73019-03
BH ID: BH03
Depth: 5.00 - 10.00 m
Core Box No.: 2

5.00 - 10.00m

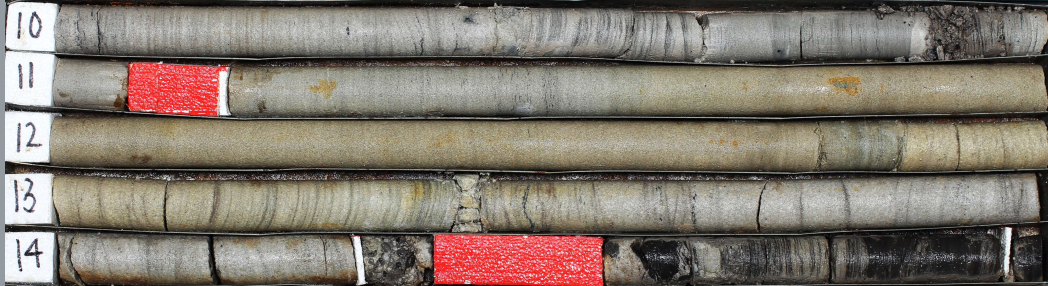
Project No: 73019-03
BH ID: BH03
Depth: 10.00 - 15.00 m
Core Box No.: 3

10.00 - 15.00m

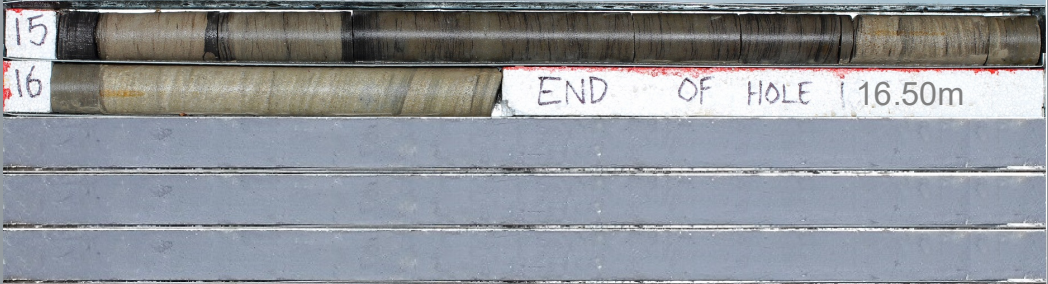
Project No: 73019-03
BH ID: BH03
Depth: 15.00 - 16.45 m
Core Box No.: 4

15.00 - 16.45m
