Factual Report on
Geotechnical Investigation

Green Waratah
339 Wallgrove Road, Eastern Creek

Project 84822.04
June 2020

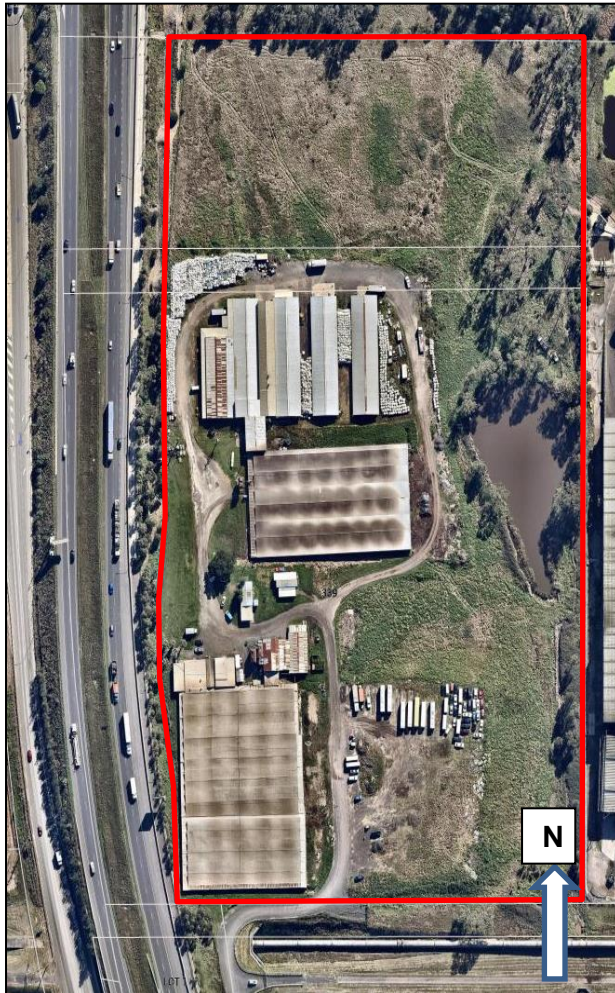
Figure 1 – Subject site location and approximate site boundary (red)

Figure 1 (following page) shows the approximate site boundaries and an east-west oriented easement running through the site.

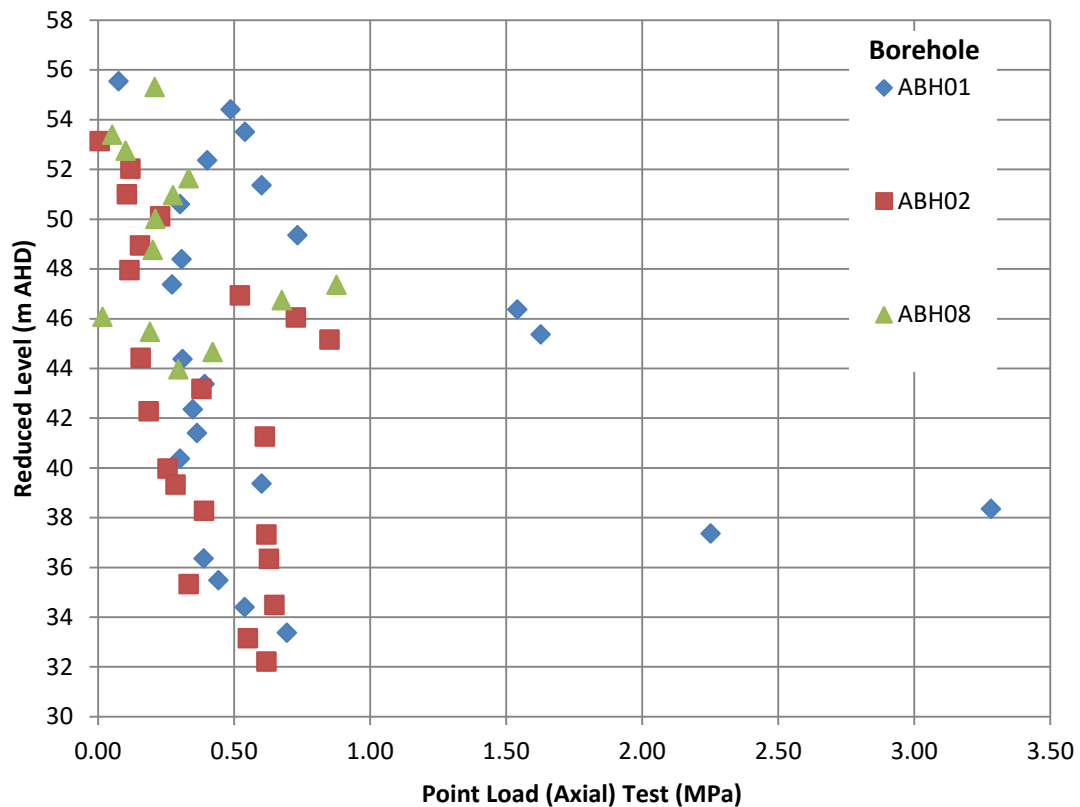
Figure 3: Point Load Test Results relative to Reduced Level (m AHD)

Diametrical Point loads were carried out at regular intervals within the rock core. The results are included on the test bore log reports. Some samples fractured along bedding planes within the siltstone bedrock and may not reflect the diametrical strength of the rock.

Uniaxial Point Load Strength Index (IS_{50}) testing and Unconfined Compressive Strength Testing was carried out on selected rock core specimens. The results of the tests are given on the borehole logs at the appropriate depths. Figure 3 (following page) shows the range of IS_{50} results at the various depths (shown as Reduced Levels relative to AHD). The results of Unconfined Compressive Strength Testing is summarised in Table 10 and the test report sheets are provided in Appendix E.

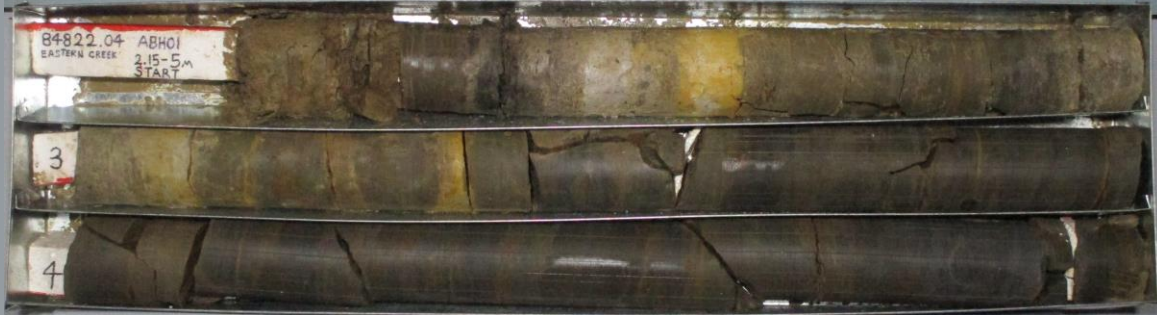
Project No: 84822.04
BH ID: ABH01
Depth: 2.1- 5m
Core Box No.: 1/8

2.1 – 5.0 m

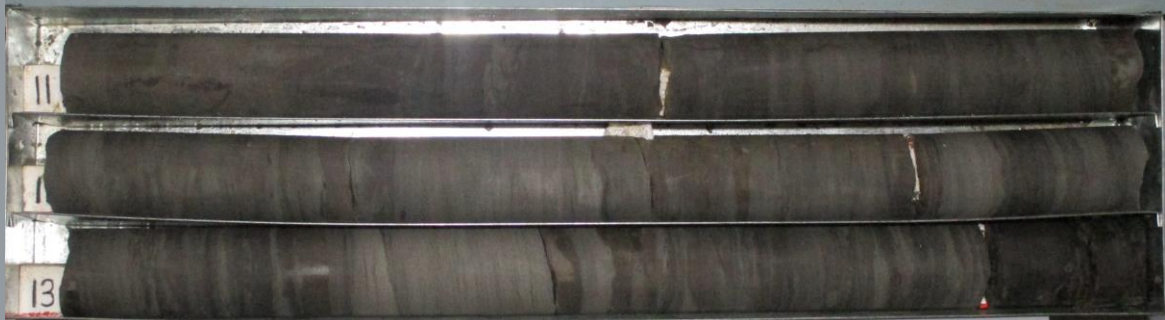
Project No: 84822.04
BH ID: ABH01
Depth: 11-14m
Core Box No.: 4/8

11.0 – 14.0 m

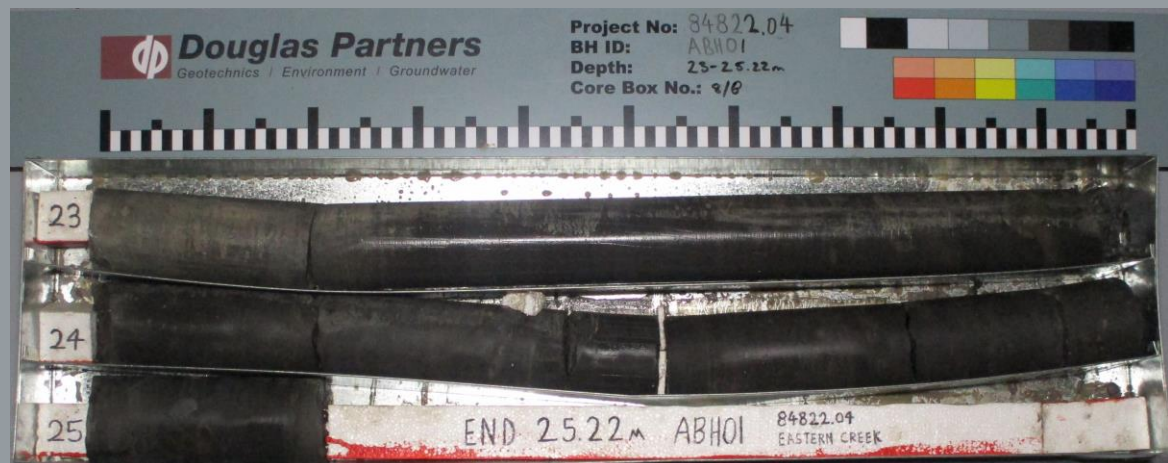
23.0 – 25.22 m

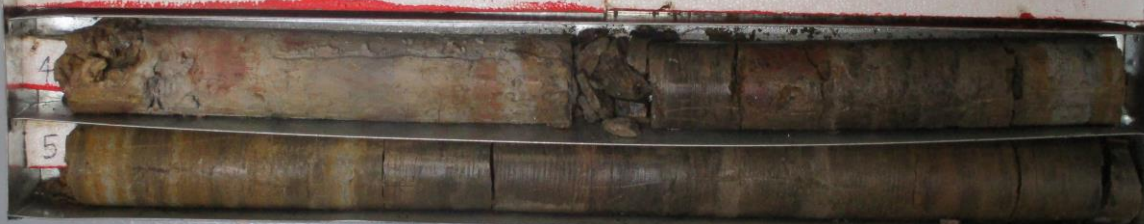
84822.04 EASTERN CREEK ABH02 START 4m

4.0 – 6.0 m

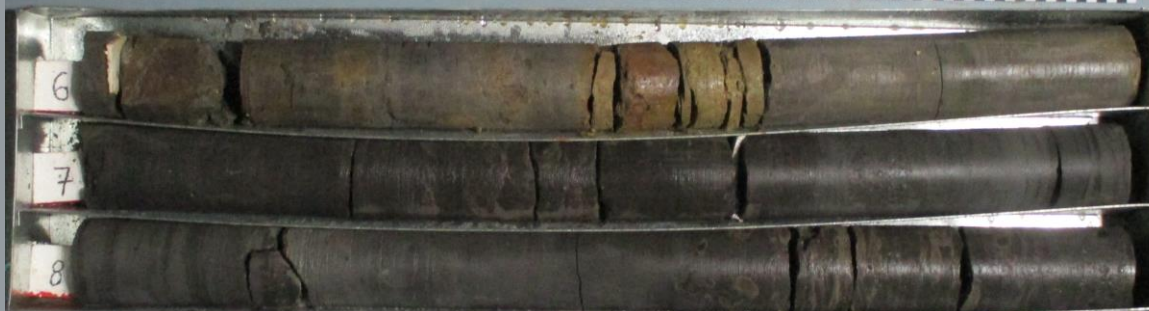
Project No: 84822.04
BH ID: ABH02
Depth: 6-9m
Core Box No.: 2/8

6.0 – 9.0 m

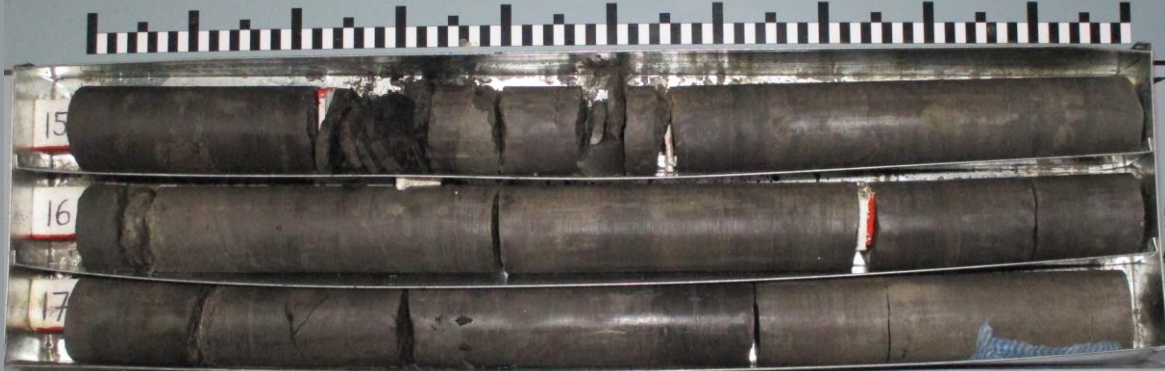
Project No: 84822.04
BH ID: ABH02
Depth: 15-18m
Core Box No.: 5/8

15.0 – 18.0 m

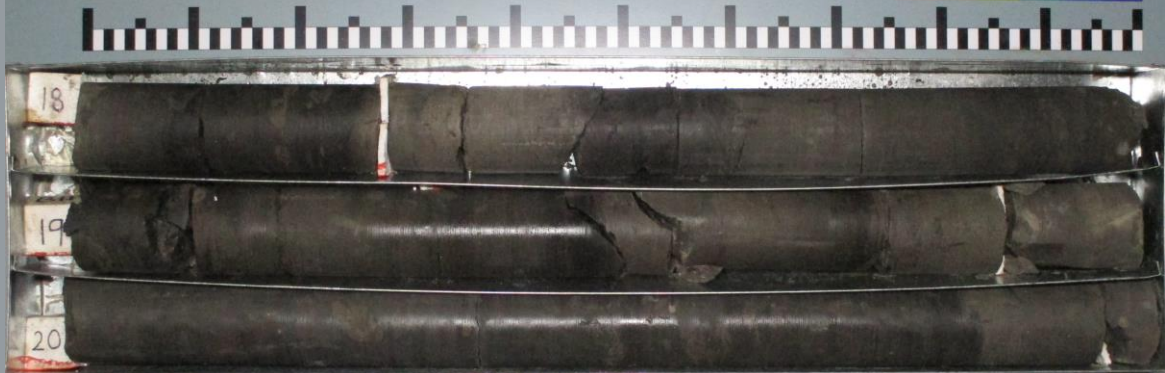
Project No: 84822.04
BH ID: ABH02
Depth: 18-21m
Core Box No.: 6/8

18.0 – 21.0 m

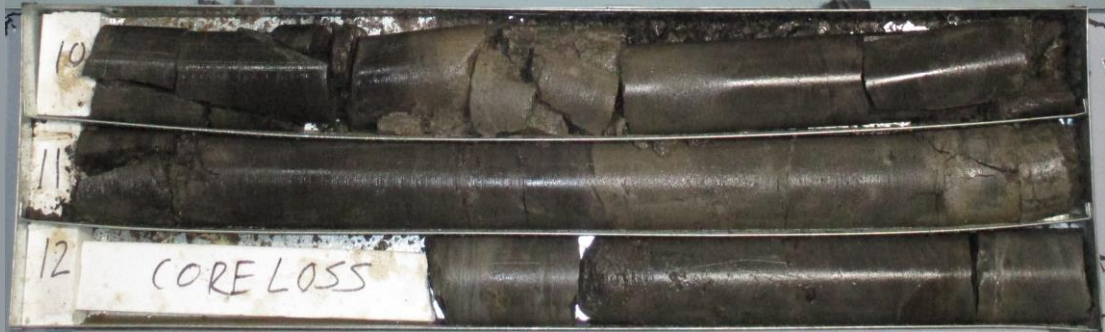
Project No: 84822.04
BH ID: ABH08
Depth: 10-13m
Core Box No.: 3/5

10.0 – 12.0 m

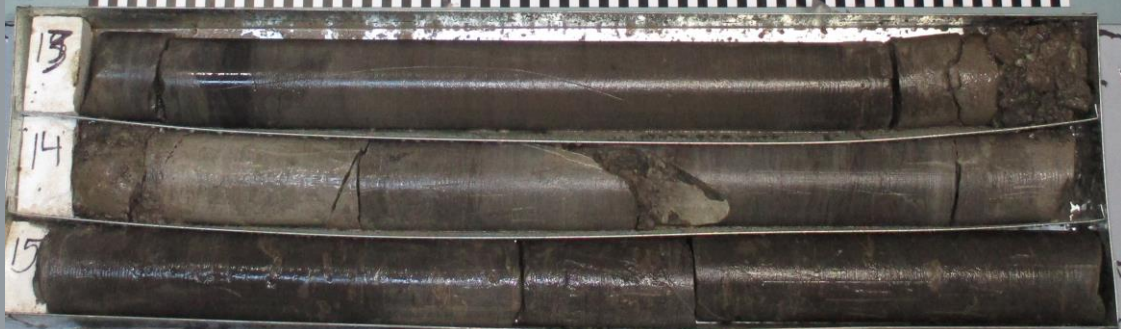
Project No: 84822.04
BH ID: ABH08
Depth: 13-16m
Core Box No.: 4/5

13.0 – 16.0 m

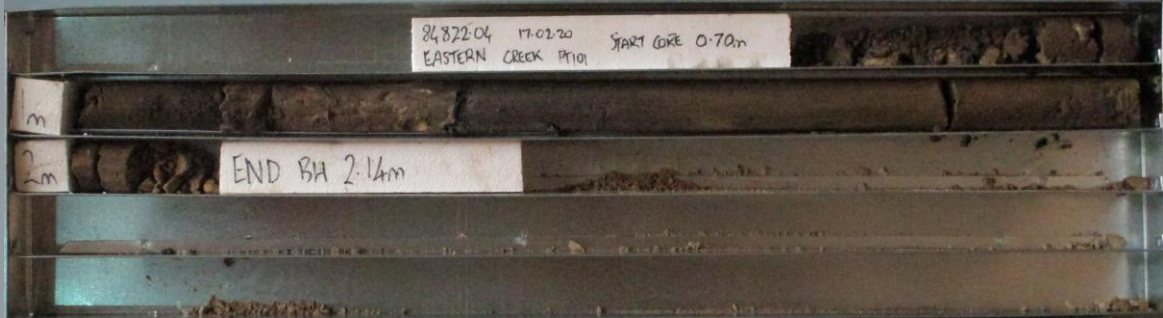
Project No: 84822.04
BH ID: PT101
Depth: 0.70-2.14m
Core Box No.: 1 of 1

0.70 - 2.14 m

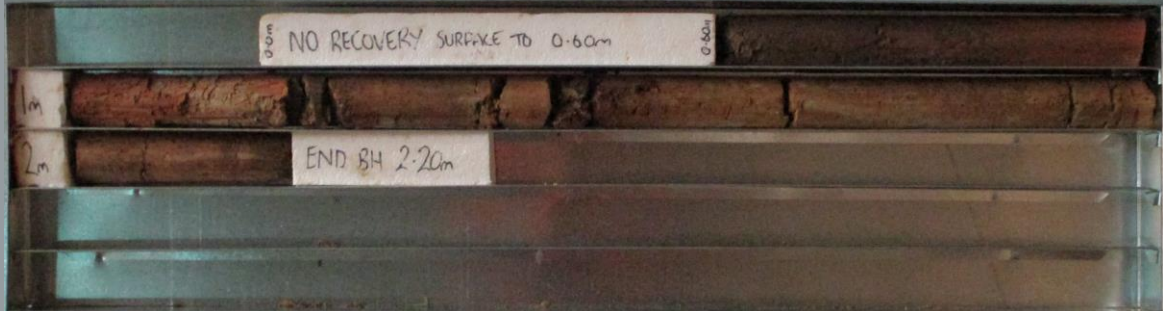
Project No: 84822.04
BH ID: PT103
Depth: 0.00 - 2.20m
Core Box No.: 1 of 1

0.00 - 2.20 m

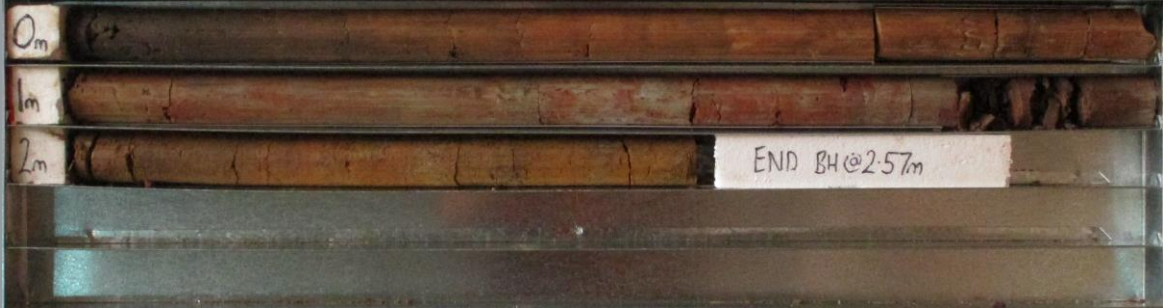
Project No: 84822.04
BH ID: PT104
Depth: 0.00 - 2.57m
Core Box No.: 1 of 1

0.00 - 2.57 m

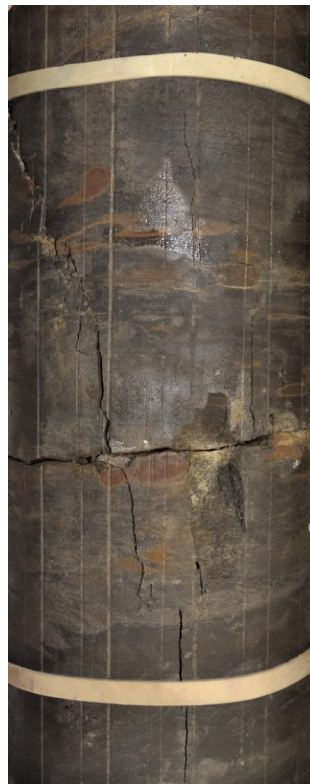
Sample Number	NC-4598A
Sample Location	ABH01
Depth (m)	4.24 - 4.59
Rock Description	Siltstone
Storage History and Environment	Tested as Received
Orientation to Bedding	-
Compression Machine	Automax Multitest
Date of Testing	24.02.2020
Duration of Test (seconds)	136
Average Diameter (mm)	82.8
Average Height (mm)	209
Height to Diameter Ratio	2.5 : 1
Moisture Content (%)	4.7
Wet Mass / Unit Volume (t/m^3)	2.47
Dry Mass / Unit Volume (t/m^3)	2.36
Uniaxial Compressive Strength (MPa)	9.5
Comments

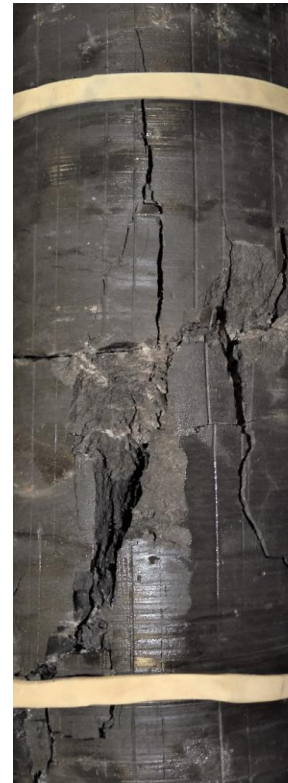
Sample Number	NC-4598B
Sample Location	ABH01
Depth (m)	9.54 - 9.94
Rock Description	Siltstone
Storage History and Environment	Tested as Received
Orientation to Bedding	-
Compression Machine	Automax Multitest
Date of Testing	24.02.2020
Duration of Test (seconds)	64
Average Diameter (mm)	82.8
Average Height (mm)	211
Height to Diameter Ratio	2.5 : 1
Moisture Content (%)	5.2
Wet Mass / Unit Volume (t/m^3)	2.49
Dry Mass / Unit Volume (t/m^3)	2.37
Uniaxial Compressive Strength (MPa)	4.8
Comments

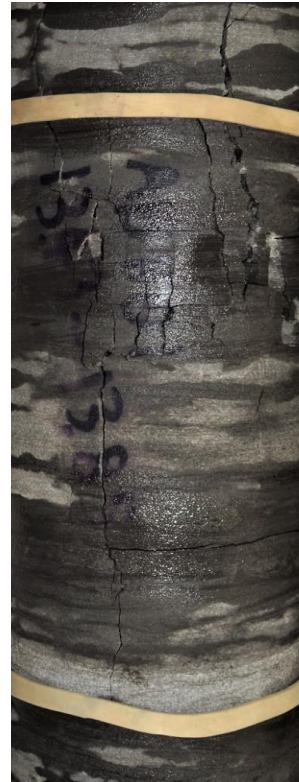
Sample Number	NC-4598C
Sample Location	ABH01
Depth (m)	13.42 - 13.85
Rock Description	Siltstone
Storage History and Environment	Tested as Received
Orientation to Bedding	-
Compression Machine	Autamax Multitest
Date of Testing	24.02.2020
Duration of Test (seconds)	194
Average Diameter (mm)	82.8
Average Height (mm)	210
Height to Diameter Ratio	2.5 : 1
Moisture Content (%)	3.0
Wet Mass / Unit Volume (t/m^3)	2.54
Dry Mass / Unit Volume (t/m^3)	2.47
Uniaxial Compressive Strength (MPa)	12.3
Comments

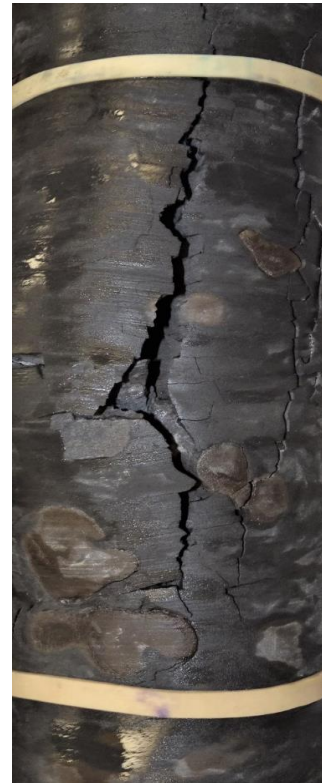
Sample Number	NC-4598D
Sample Location	ABH01
Depth (m)	18.56 - 18.91
Rock Description	Siltstone
Storage History and Environment	Tested as Received
Orientation to Bedding	-
Compression Machine	Automax Multitest
Date of Testing	24.02.2020
Duration of Test (seconds)	91
Average Diameter (mm)	82.8
Average Height (mm)	207
Height to Diameter Ratio	2.5 : 1
Moisture Content (%)	3.4
Wet Mass / Unit Volume (t/m^3)	2.59
Dry Mass / Unit Volume (t/m^3)	2.51
Uniaxial Compressive Strength (MPa)	6.8
Comments

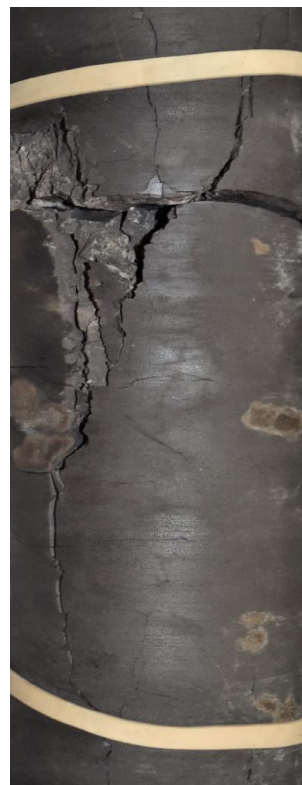
Sample Number	NC-4598E
Sample Location	ABH01
Depth (m)	22.13 - 22.42
Rock Description	Siltstone
Storage History and Environment	Tested as Received
Orientation to Bedding	-
Compression Machine	Autamax Multitest
Date of Testing	24.02.2020
Duration of Test (seconds)	78
Average Diameter (mm)	207.0
Average Height (mm)	82.8
Height to Diameter Ratio	2.5 : 1
Moisture Content (%)	6.7
Wet Mass / Unit Volume (t/m^3)	2.55
Dry Mass / Unit Volume (t/m^3)	2.38
Uniaxial Compressive Strength (MPa)	5.8
Comments

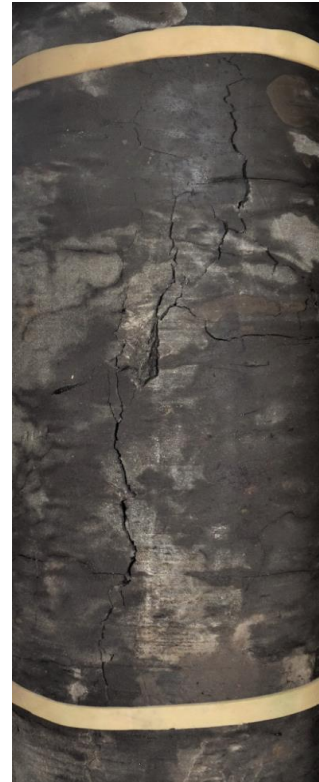
Sample Number	NC-4598F
Sample Location	ABH01
Depth (m)	23.54 - 23.78
Rock Description	Siltstone
Storage History and Environment	Tested as Received
Orientation to Bedding	-
Compression Machine	Automax Multitest
Date of Testing	24.02.2020
Duration of Test (seconds)	126
Average Diameter (mm)	82.8
Average Height (mm)	210
Height to Diameter Ratio	2.5 : 1
Moisture Content (%)	3.1
Wet Mass / Unit Volume (t/m^3)	2.54
Dry Mass / Unit Volume (t/m^3)	2.46
Uniaxial Compressive Strength (MPa)	8.1
Comments

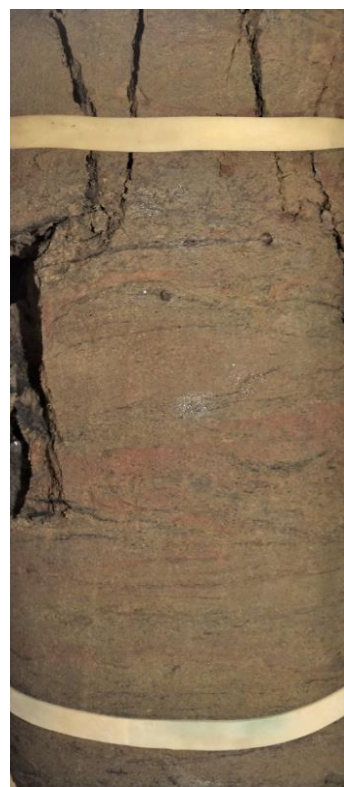
Sample Number	NC-4633A
Sample Location	ABH08
Depth (m)	6.41 - 6.65
Rock Description	Siltstone
Storage History and Environment	Tested as Received
Orientation to Bedding	-
Compression Machine	Automax Multitest
Date of Testing	28.02.2020
Duration of Test (seconds)	27
Average Diameter (mm)	82.3
Average Height (mm)	178
Height to Diameter Ratio	2.2 : 1
Moisture Content (%)	6.0
Wet Mass / Unit Volume (t/m^3)	2.44
Dry Mass / Unit Volume (t/m^3)	2.30
Uniaxial Compressive Strength (MPa)	4.2
Comments

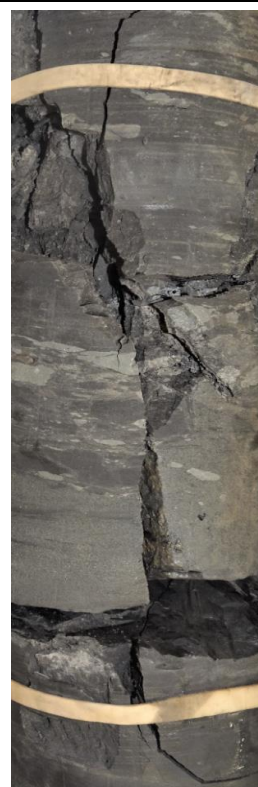
Sample Number	NC-4633B
Sample Location	ABH08
Depth (m)	9.02 - 9.3
Rock Description	Siltstone
Storage History and Environment	Tested as Received
Orientation to Bedding	-
Compression Machine	Automax Multitest
Date of Testing	28.02.2020
Duration of Test (seconds)	28
Average Diameter (mm)	82.5
Average Height (mm)	213
Height to Diameter Ratio	2.6 : 1
Moisture Content (%)	3.8
Wet Mass / Unit Volume (t/m^3)	2.48
Dry Mass / Unit Volume (t/m^3)	2.39
Uniaxial Compressive Strength (MPa)	2.8
Comments

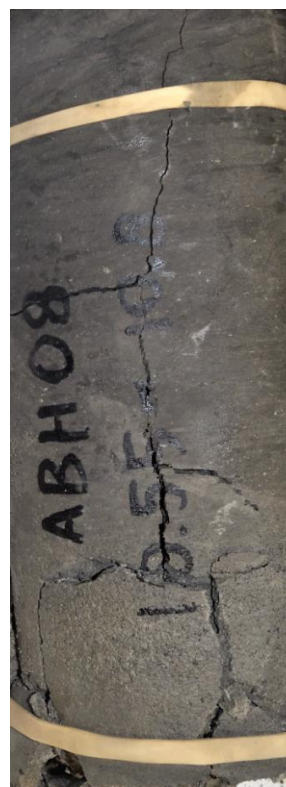
Sample Number	NC-4633C
Sample Location	ABH08
Depth (m)	10.55 - 10.8
Rock Description	Siltstone
Storage History and Environment	Tested as Received
Orientation to Bedding	-
Compression Machine	Automax Multitest
Date of Testing	28.02.2020
Duration of Test (seconds)	17
Average Diameter (mm)	82.0
Average Height (mm)	217
Height to Diameter Ratio	2.6 : 1
Moisture Content (%)	3.4
Wet Mass / Unit Volume (t/m^3)	2.48
Dry Mass / Unit Volume (t/m^3)	2.39
Uniaxial Compressive Strength (MPa)	2.1
Comments

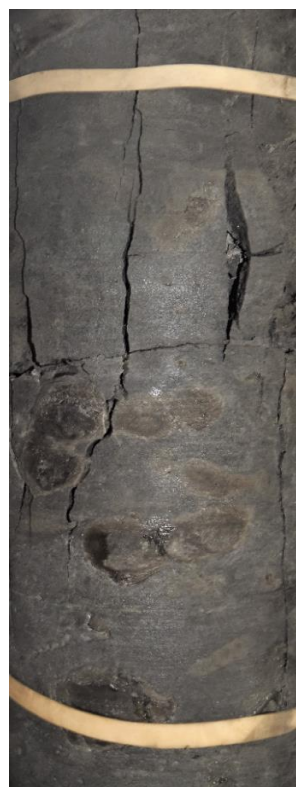
Sample Number	NC-4633D
Sample Location	ABH08
Depth (m)	12.56 - 12.89
Rock Description	Siltstone
Storage History and Environment	Tested as Received
Orientation to Bedding	-
Compression Machine	Automax Multitest
Date of Testing	28.02.2020
Duration of Test (seconds)	76
Average Diameter (mm)	82.7
Average Height (mm)	212
Height to Diameter Ratio	2.6 : 1
Moisture Content (%)	3.1
Wet Mass / Unit Volume (t/m^3)	2.61
Dry Mass / Unit Volume (t/m^3)	2.53
Uniaxial Compressive Strength (MPa)	6.9
Comments

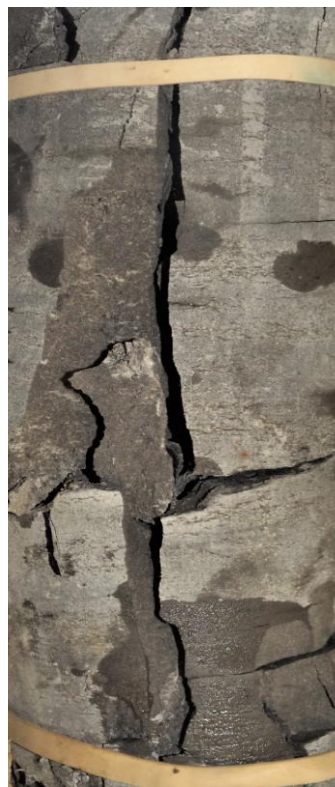
Sample Number	NC-4633E
Sample Location	ABH08
Depth (m)	13.2 - 13.5
Rock Description	Siltstone
Storage History and Environment	Tested as Received
Orientation to Bedding	-
Compression Machine	Automax Multitest
Date of Testing	28.02.2020
Duration of Test (seconds)	29
Average Diameter (mm)	82.6
Average Height (mm)	198
Height to Diameter Ratio	2.4 : 1
Moisture Content (%)	3.0
Wet Mass / Unit Volume (t/m^3)	2.53
Dry Mass / Unit Volume (t/m^3)	2.45
Uniaxial Compressive Strength (MPa)	2.6
Comments

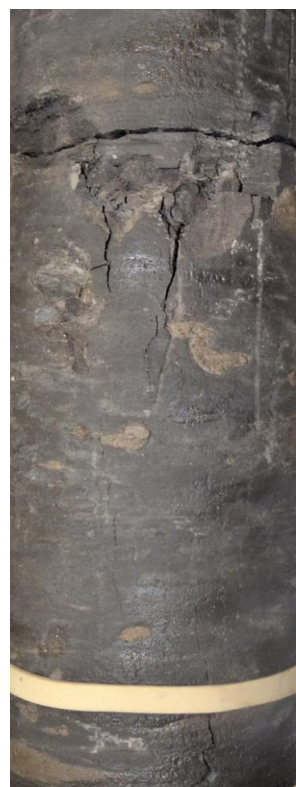
Sample Number	NC-4633F
Sample Location	ABH08
Depth (m)	15.7 - 16.0
Rock Description	Siltstone
Storage History and Environment	Tested as Received
Orientation to Bedding	-
Compression Machine	Automax Multitest
Date of Testing	28.02.2020
Duration of Test (seconds)	34
Average Diameter (mm)	82.6
Average Height (mm)	207
Height to Diameter Ratio	2.5 : 1
Moisture Content (%)	3.1
Wet Mass / Unit Volume (t/m^3)	2.52
Dry Mass / Unit Volume (t/m^3)	2.45
Uniaxial Compressive Strength (MPa)	3.6
Comments

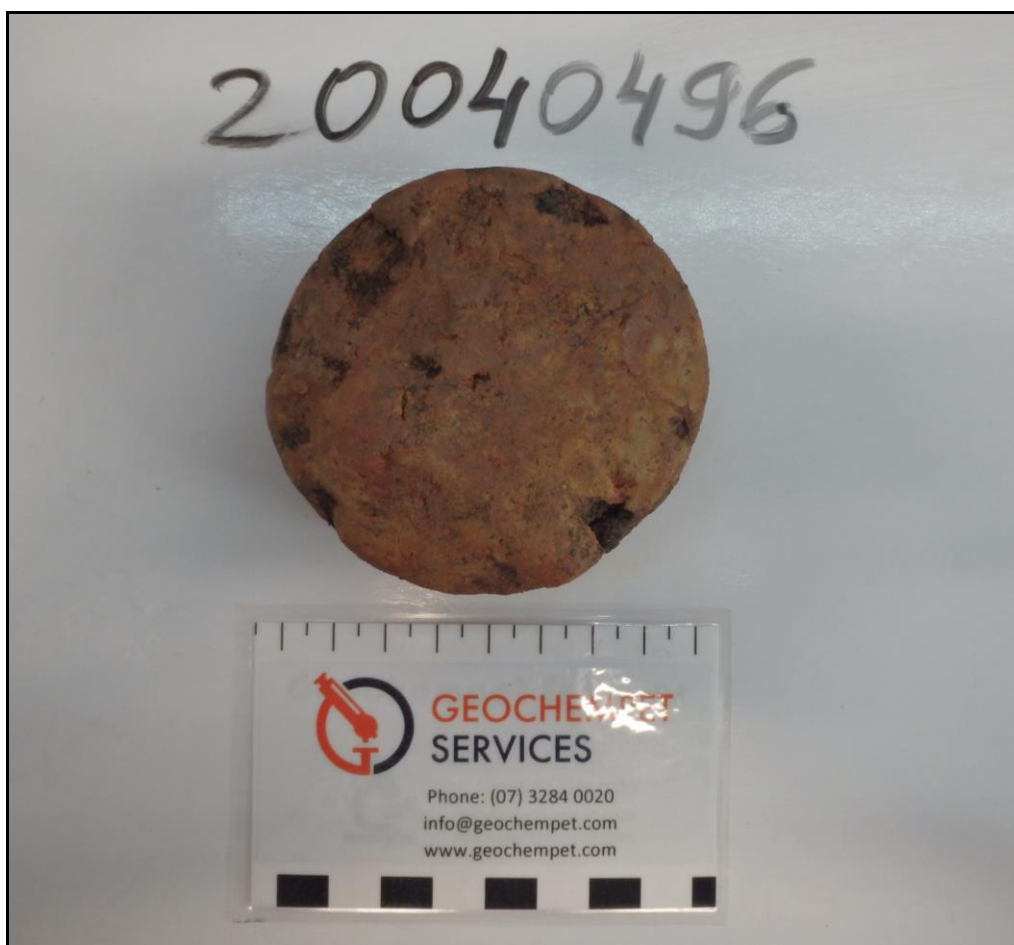
Plate 1: Photograph of the supplied drill core.

The drill core specimen consists of light reddish to light yellowish-grey, soft, stiff, argillic material interpreted to be silty claystone. The rock carries disrupted lenses of reddish secondary iron oxides along undulating bedding surfaces and small disrupted patches of carbonaceous matter.

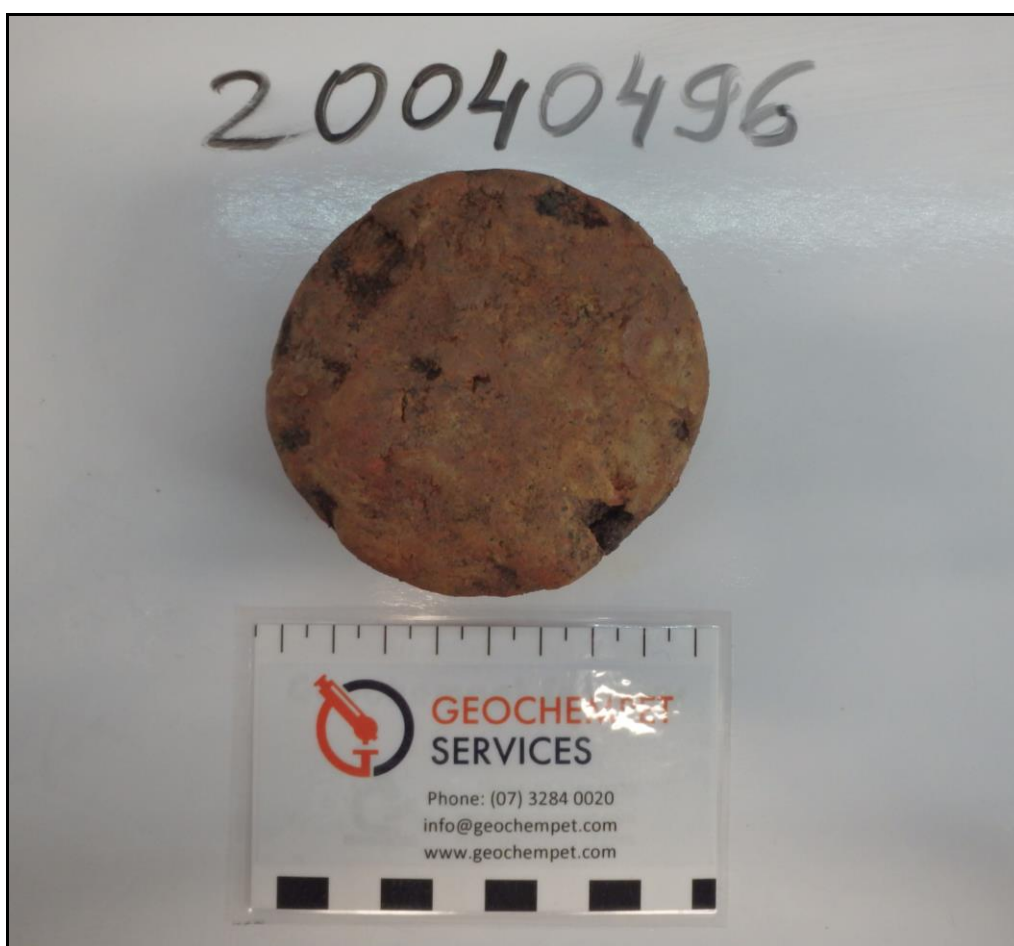
Plate 1: Photograph of the supplied drill core.

<u>TriLab #:</u>	20040496	<u>Date Sampled:</u>	Unknown
<u>Sample Type:</u>	Drill Core	<u>Date Received:</u>	23/04/2020
<u>Borehole No.:</u>	ABH02	<u>Depth:</u>	2.5 – 2.88 m
<u>Project:</u>	Eastern Creek		
<u>Work Requested</u>	Qualitative X-ray diffraction analysis of the drill core sample for mineralogy.

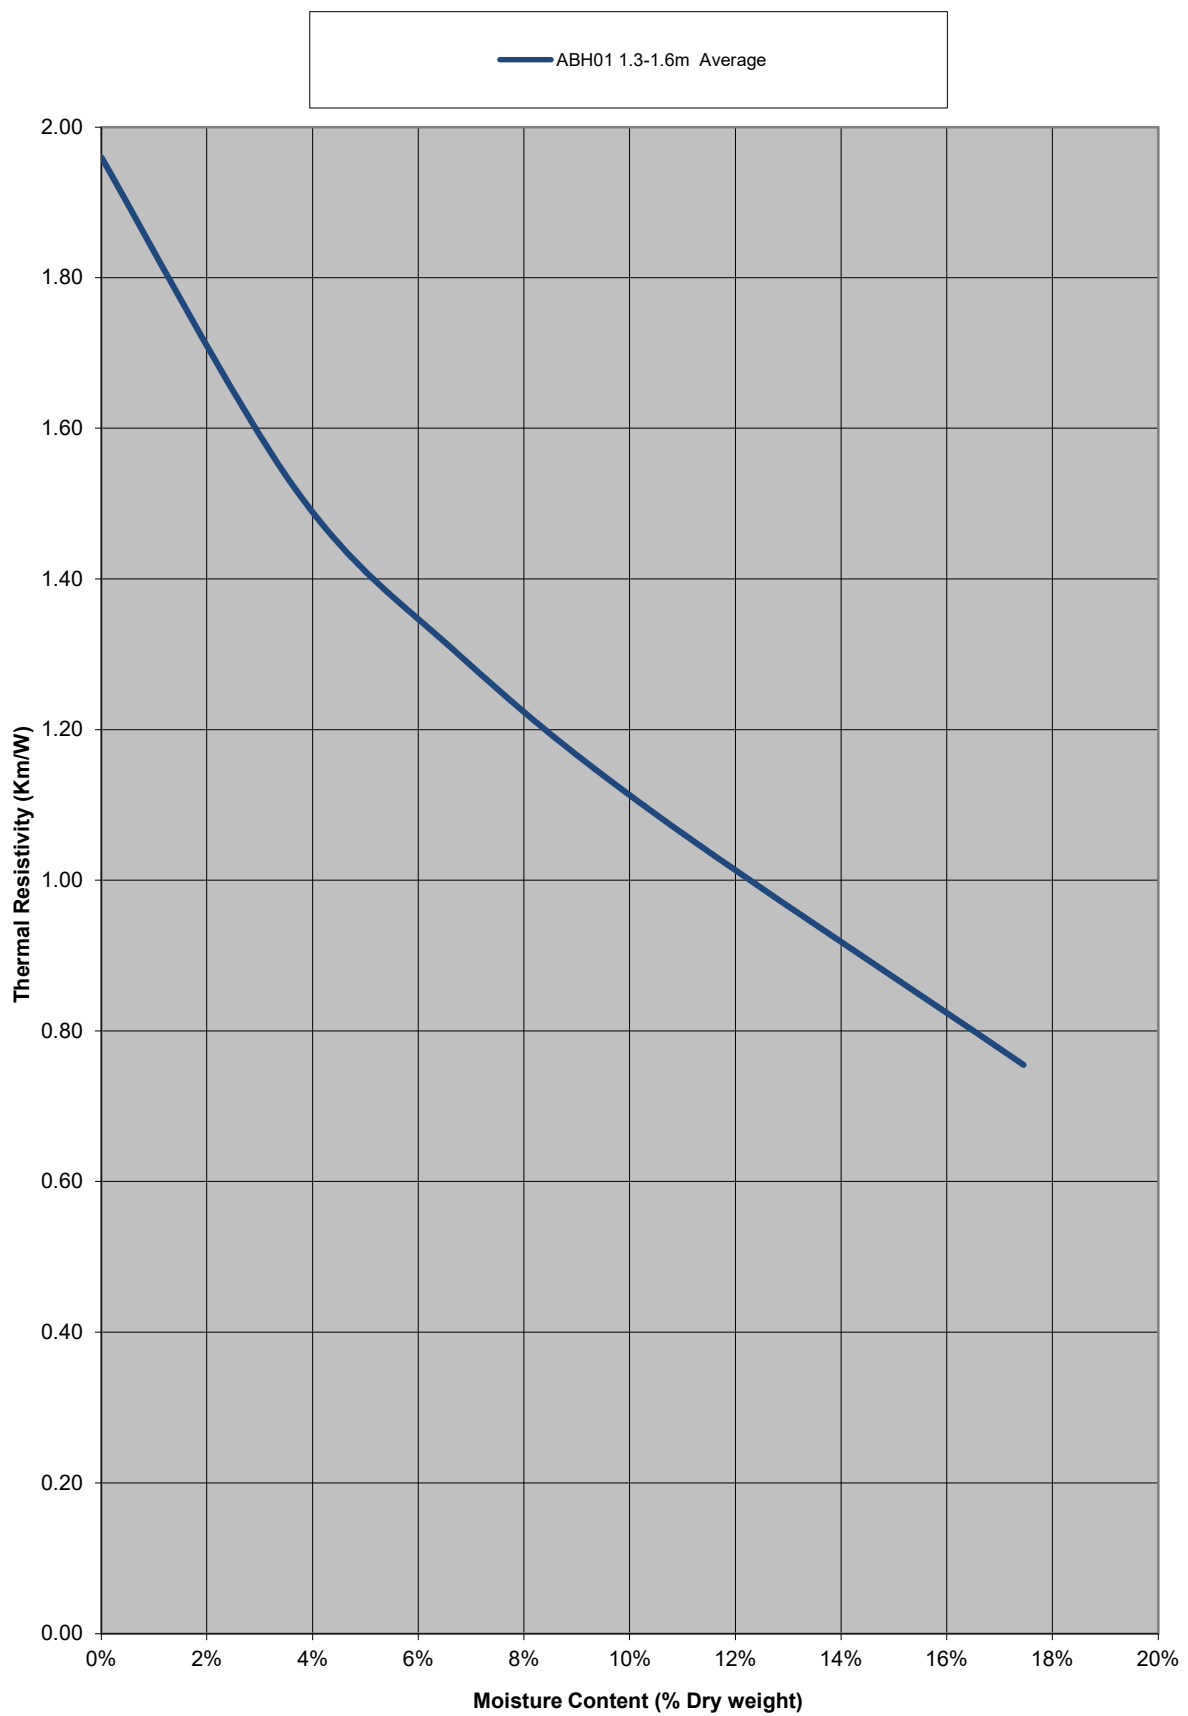
Dry-out Curve

Soil samples recovered from test bores were re-compacted to a maximum dry density of 98% relative to standard compaction at optimum moisture content and then tested for Thermal Resistivity. The samples were tested by Geotherm Australasia Pty Ltd (Geotherm) in accordance with ASTM D5334 to obtain Thermal Resistivity (TR) values from the field moisture content to the fully dried out state (zero moisture content).
