Our Ref: PSM4010-003L Rev2

**44 CLUNIES ROSS STREET, PROSPECT.
DESKTOP STUDY AND RESULTS OF GEOTECHNICAL INVESTIGATION**

This letter provides the results of desktop study, factual results of site investigation between 8 and 10 January 2020 and interim geotechnical design advice (IGDA) for the proposed industrial development and associated earthworks at Clunies Ross Street, Prospect NSW.

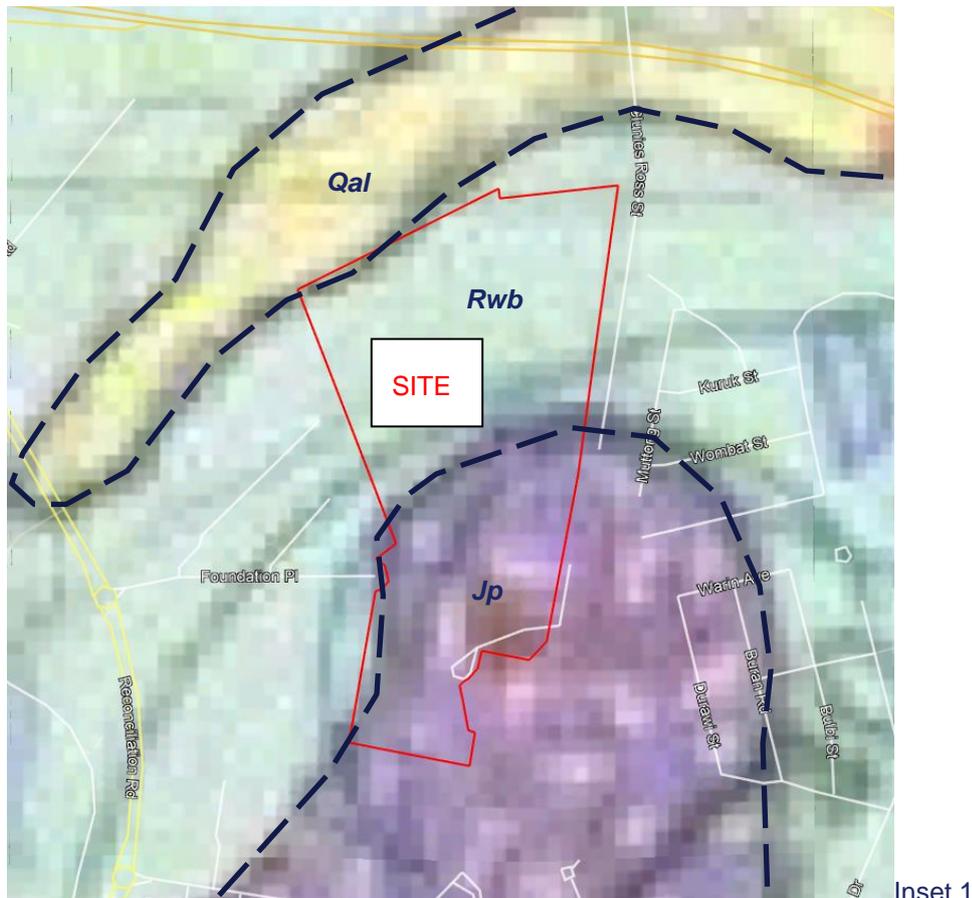
Inset 1: Geological Map

- Prospect Picrite (*Jp*) which typically comprises picrite, dolerite, minor basalt
- Bringelly shale of the Wianamatta group formation (*Rwb*) typically comprises shale, carbonaceous claystone, claystone, laminate, fine to medium grained lithic sandstone, rare coal and tuff
- Qal which typically comprises fine-grained sand, silt and clay.

Inset 1 presents the geological map of the site. Note that given the Dolerite unit (*Jp*) is an intrusion, it is possible for sills and dykes of this material to be located beyond the boundaries depicted in Inset 1.

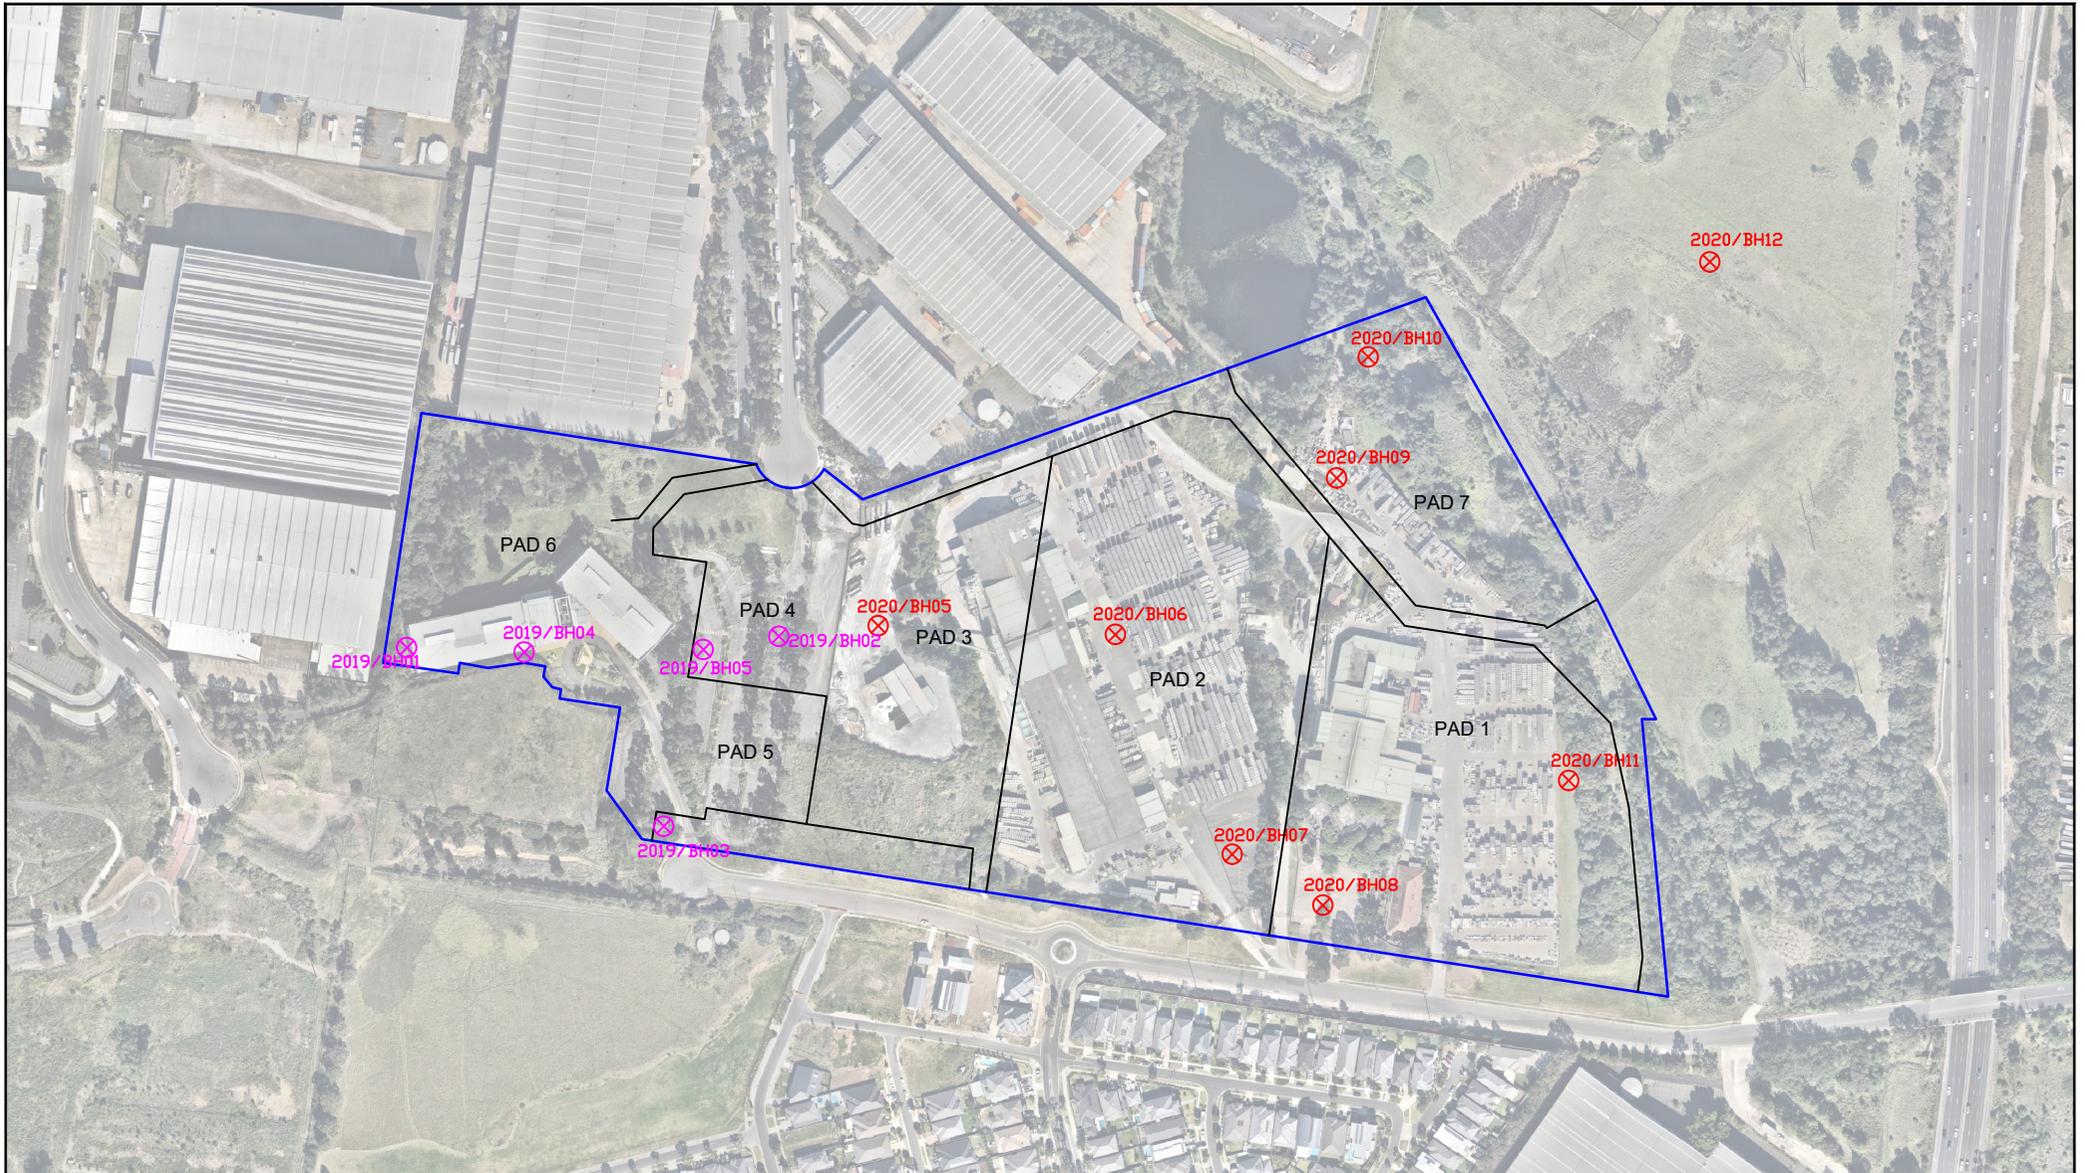
Figure 1 presents the site locality plan with the proposed pad boundaries (Pad 1 to 7).

- 1 Particle-Size Distribution Testing
- 2 California Bearing Ratio Testing
- 3 Aggressivity Testing, including Salinity and Corrosivity
- 4 Refers to the site locality plan in Figure 1

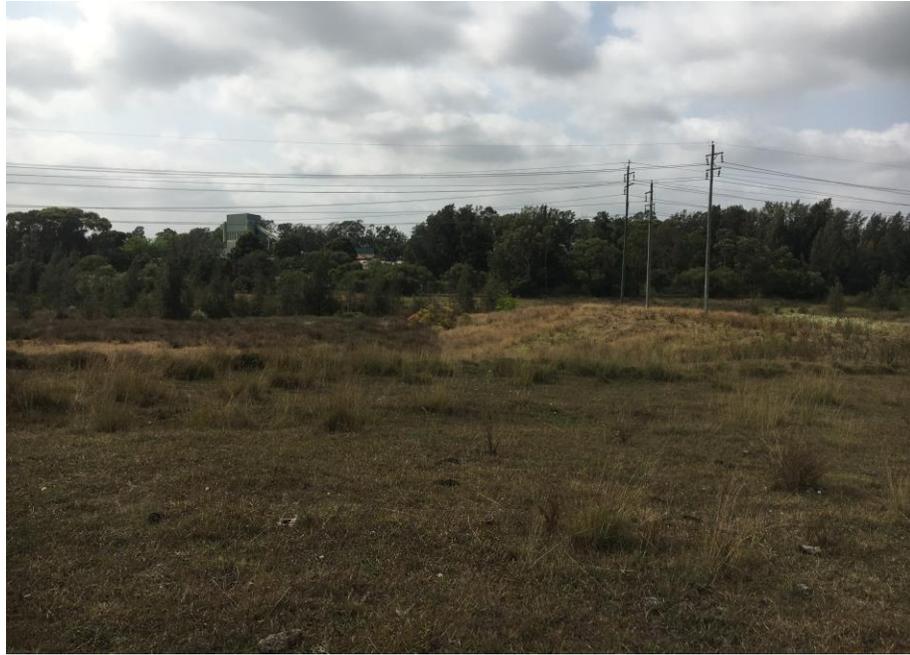
Photo 1: Looking south east from borehole BH12

Site photographs including photos of typical landmarks and observed material are included in Figure 2 to 5.

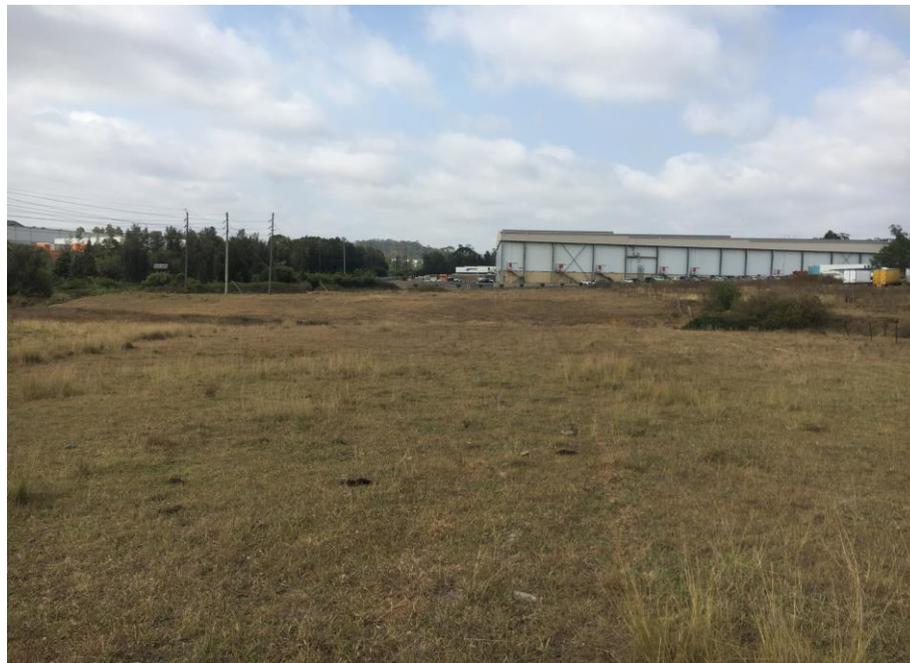
Photo 2: Looking south from borehole BH12

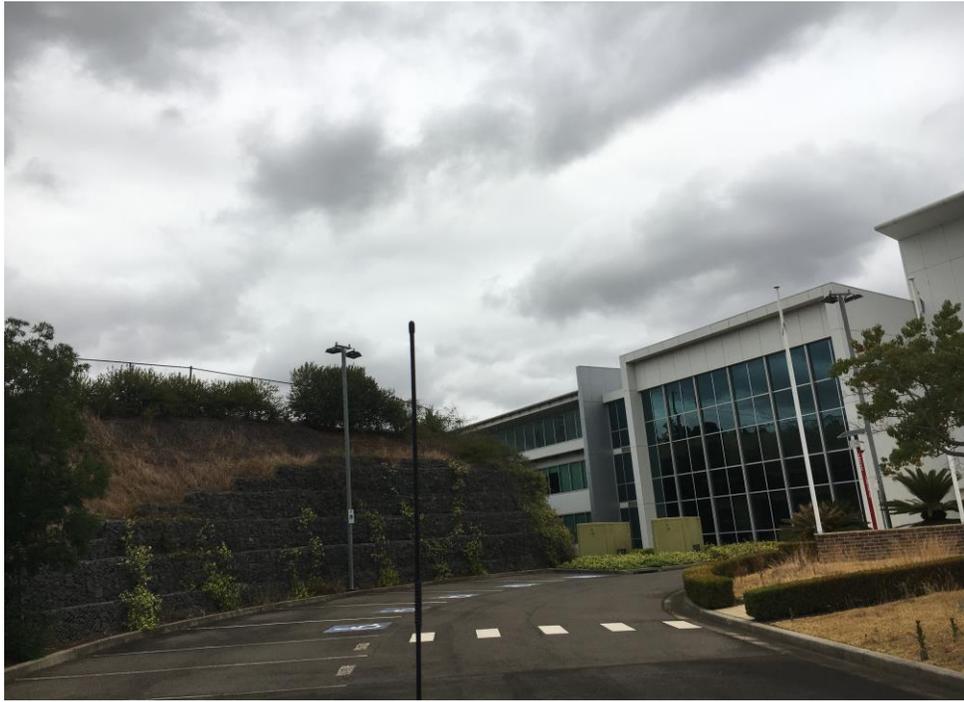
Photo 3: Gabion Wall at Boral House looking south west

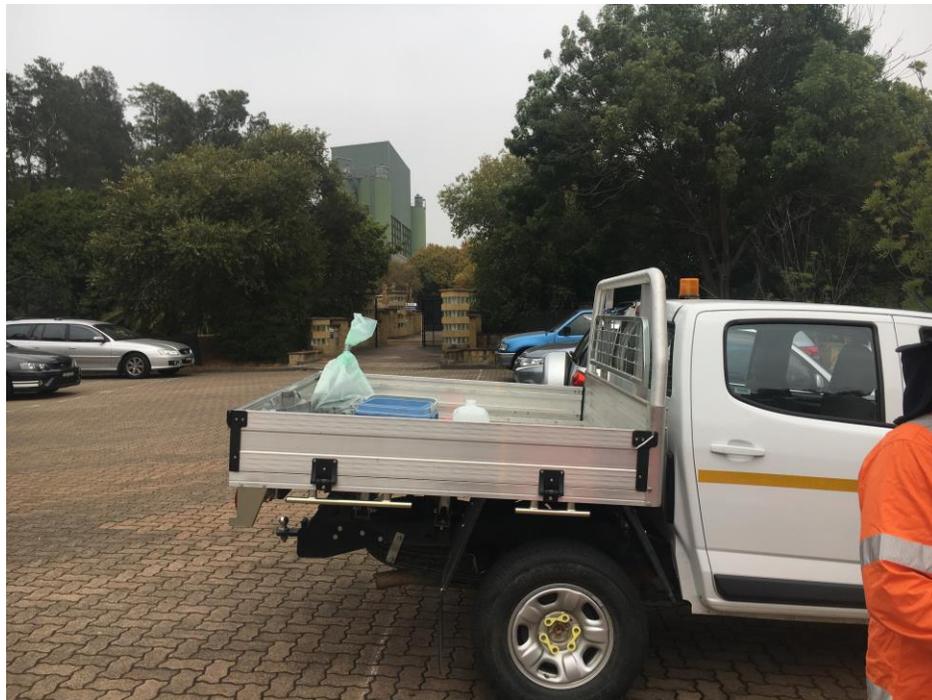
Photo 6: Austral site looking west from borehole BH08

- Girraween Creek runs sub-parallel to the northern property boundary, Photo 1
- The council reserve is typically grassed with gentle convergent slopes falling towards the creek, Photo 2
- An existing dam is located in the north west corner of the Austral site
- The Boral House site is characterised by significant retaining walls and cut fill, Photos 3 to 5
- The Austral site is characterised by a series of warehouses, offices, and asphalt and brick hardstand areas, Photos 6 to 8.

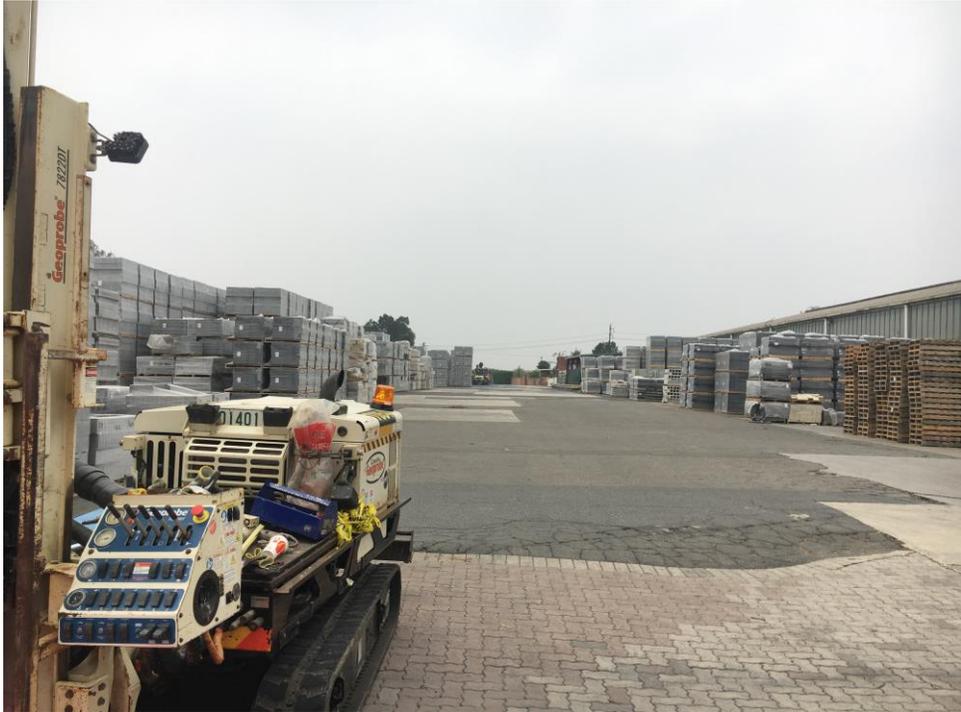
Photo 7: Borehole BH6 looking east

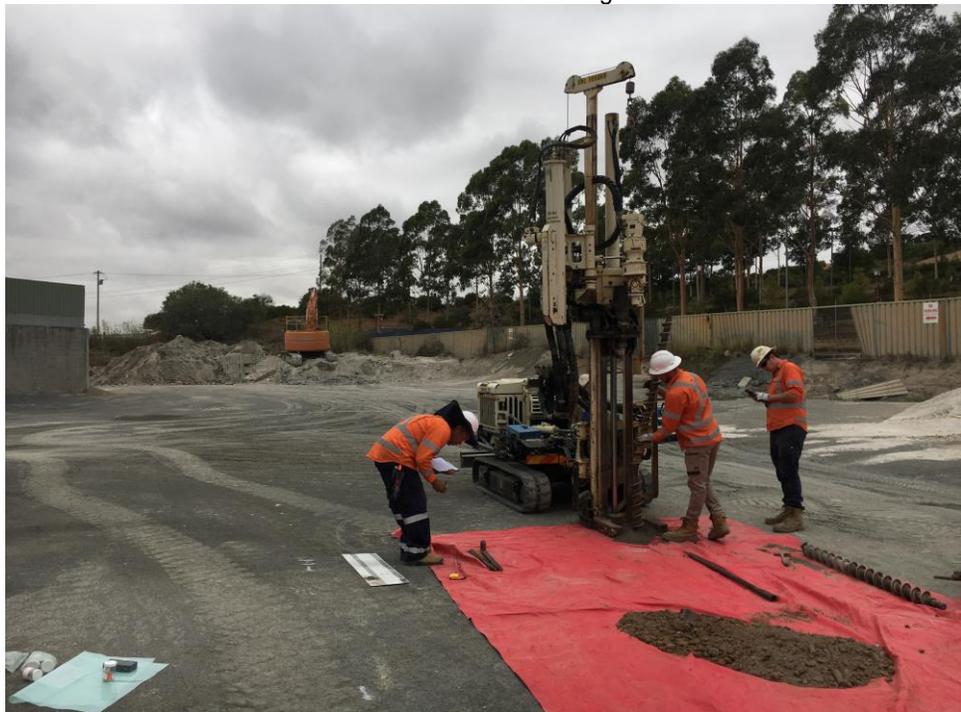
Photo 8: Borehole BH5 looking south west

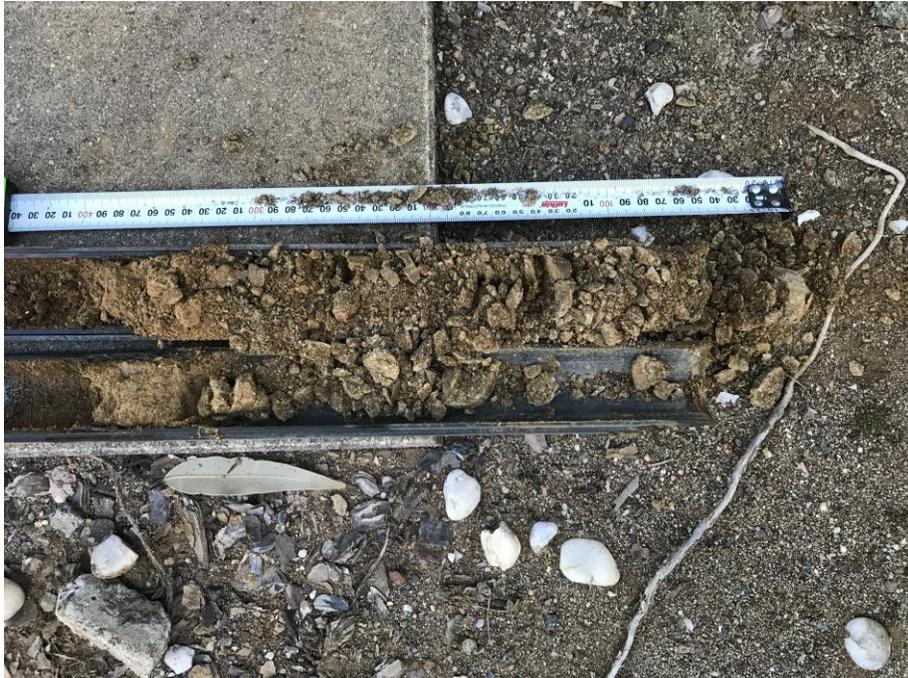
Typical Residual Dolerite (Residual B)

We note that it is difficult to determine fill and natural in-situ material in augered boreholes where the fill is composed of locally excavated natural material. It is possible that some of the SOIL units are fill placed under controlled conditions and therefore the fill may be thicker than interpreted. Typical photos of residual shale and dolerite are presented in Figure 6.

RESIDUAL A	0.3 to 3.2	CLAY/Silty CLAY trace/with gravel: high plasticity, pale grey, dark brown, red brown; gravel sub-rounded to sub-angular up to 20mm, firm to very stiff consistency, dry to moist, sometimes wet. Inferred weathered Shale/Sandstone.
RESIDUAL B	0.2 to 3.0	SAND with gravel: fine grained, dark brown to orange brown; gravel fine to medium grained (up to 15mm), sub-angular, typically dry, medium dense to very dense. Inferred weathered Dolerite.
BEDROCK A	4.9 to 7.4	SHALE: pale/dark grey to brown, very low strength, highly weathered, iron staining.
BEDROCK B	1.7 to 6.2	DOLERITE: pale brown, very low to medium strength, highly weathered.
BEDROCK C	4.4 to 5.3	SANDSTONE: fine grained, pale yellow, very low strength, highly weathered.

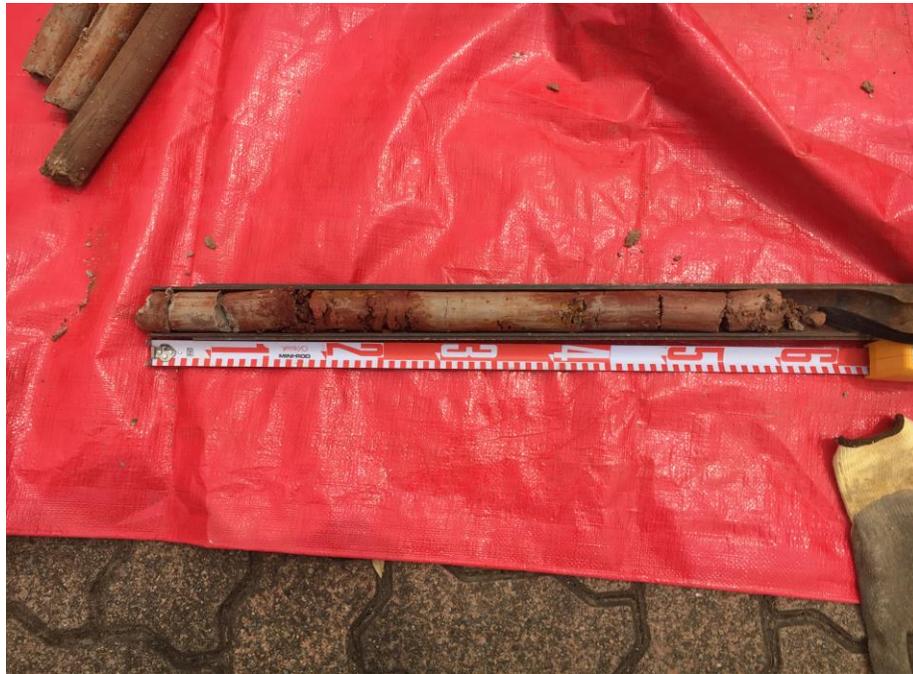
Typical Residual Shale (Residual A)

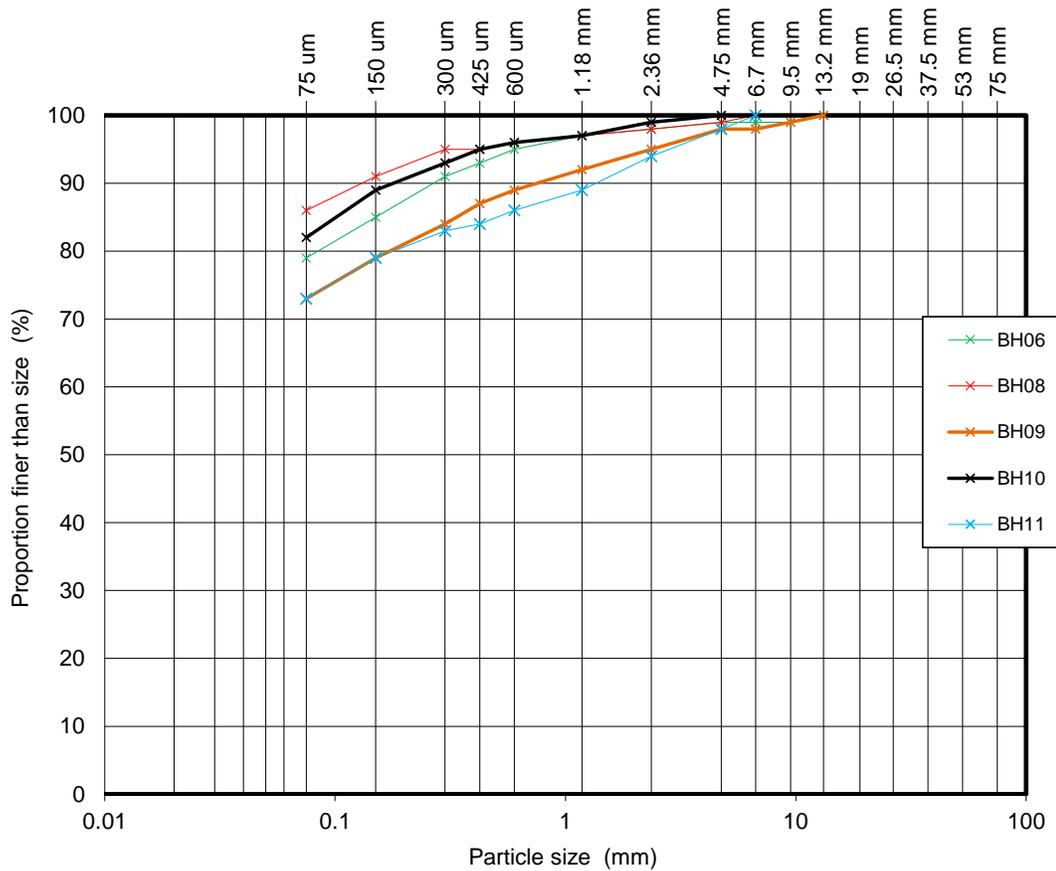
FIGURE 7

Particle Size Distribution of SOIL Samples

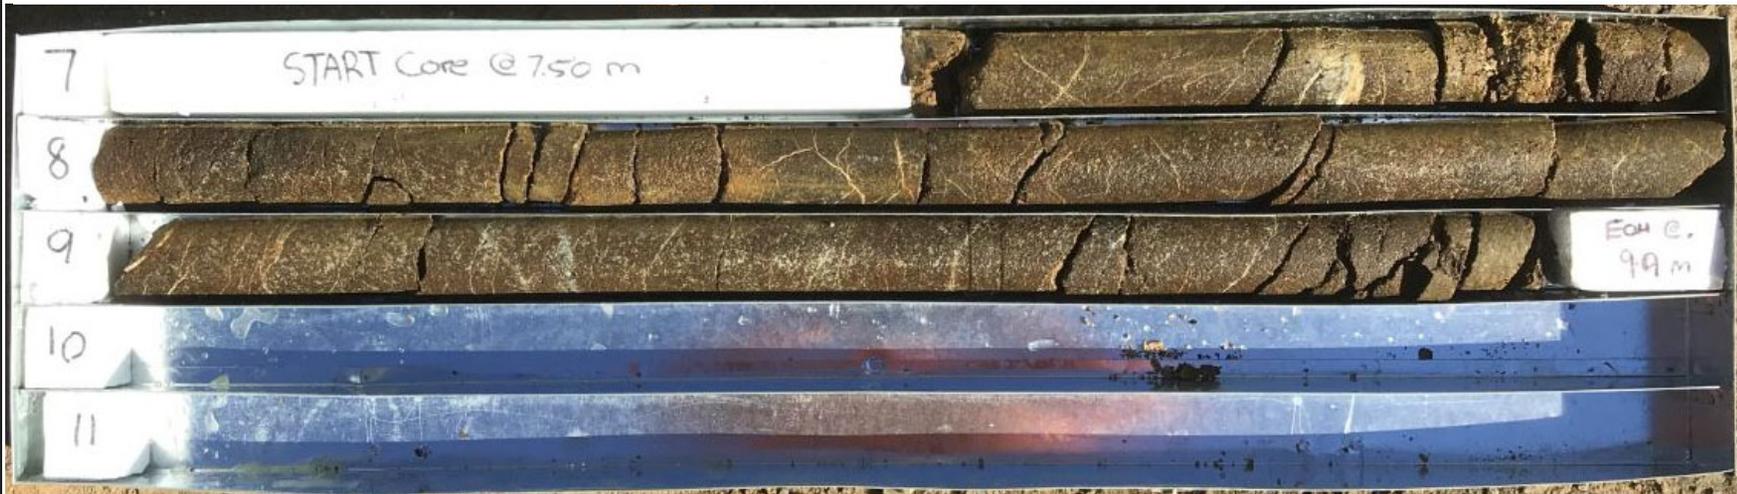
Aliro Management Pty Ltd
Boral House
Clunies Ross Street, Pemulwuy NSW
CORE PHOTO 2019/BH04
(PHOTO 1 OF 1)

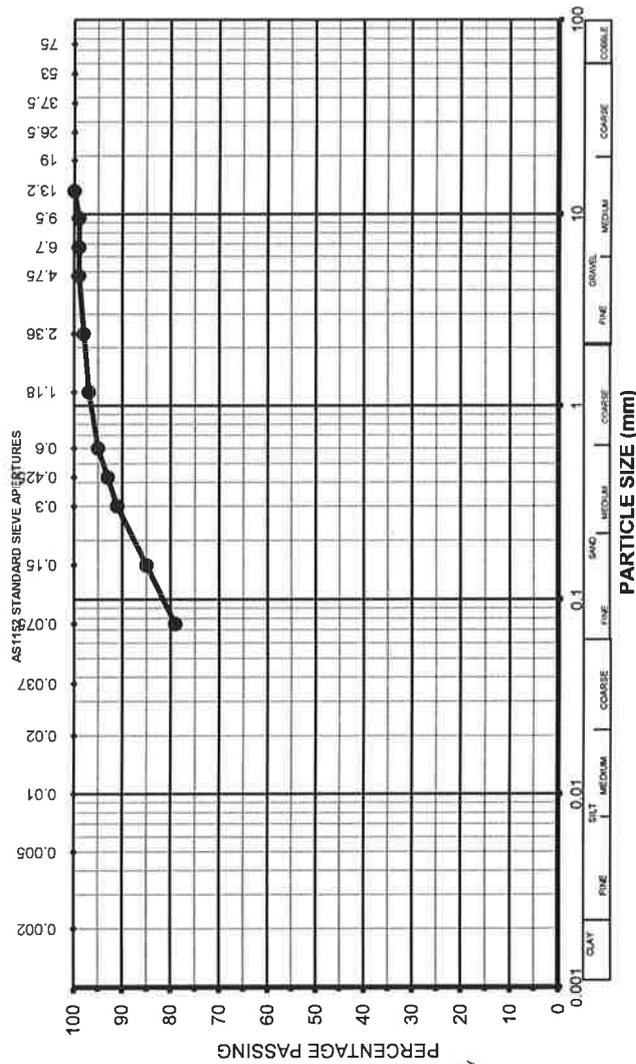
SIEVE ANALYSIS RESULTS

SIEVE SIZE	% PASSING
13.2 mm	100
9.50 mm	99
6.70 mm	99
4.75 mm	99
2.36 mm	98
1.18 mm	97
600 µm	95
425 µm	93
300 µm	91
150 µm	85
75 µm	79

Test Method: AS1289.3.6.1 & 3.6.3 Dry Sieve (washed)

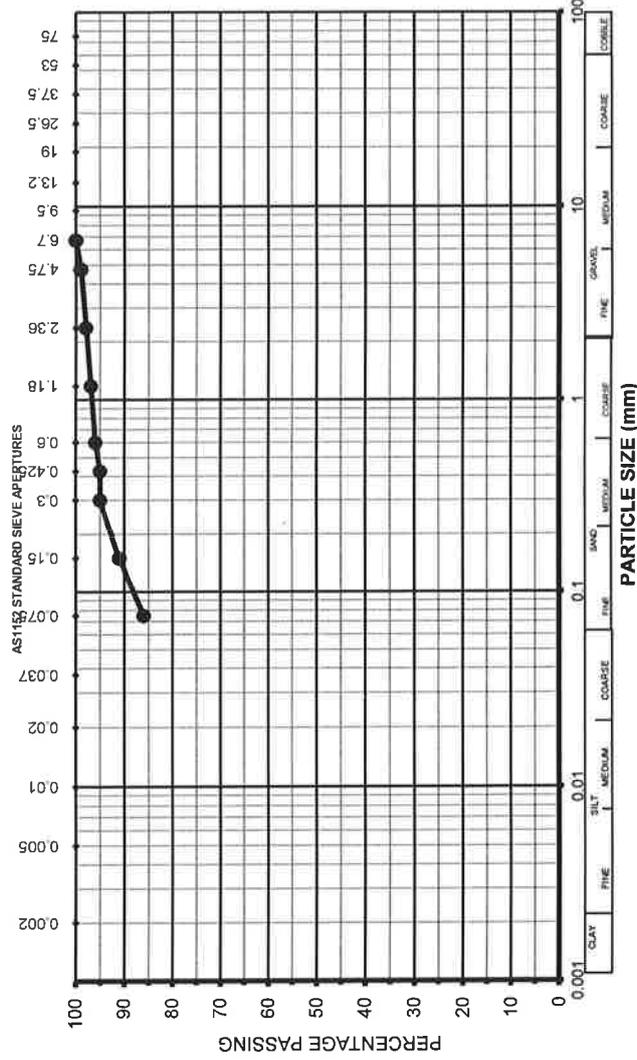
SIEVE ANALYSIS RESULTS

SIEVE SIZE	% PASSING
6.70 mm	100
4.75 mm	99
2.36 mm	98
1.18 mm	97
600 µm	96
425 µm	95
300 µm	95
150 µm	91
75 µm	86

Test Method: AS1289.3.6.1 & 3.6.3 Dry Sieve (washed)

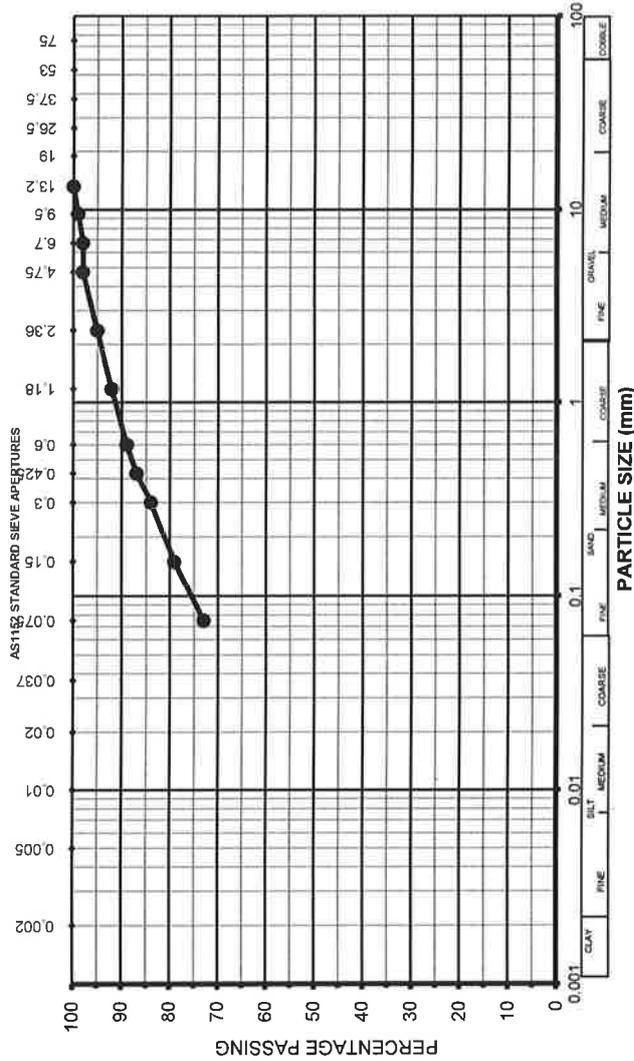
SIEVE ANALYSIS RESULTS

SIEVE SIZE	% PASSING
13.2 mm	100
9.50 mm	99
6.70 mm	98
4.75 mm	98
2.36 mm	95
1.18 mm	92
600 µm	89
425 µm	87
300 µm	84
150 µm	79
75 µm	73

Test Method: AS1289.3.6.1 & 3.6.3 Dry Sieve (washed)

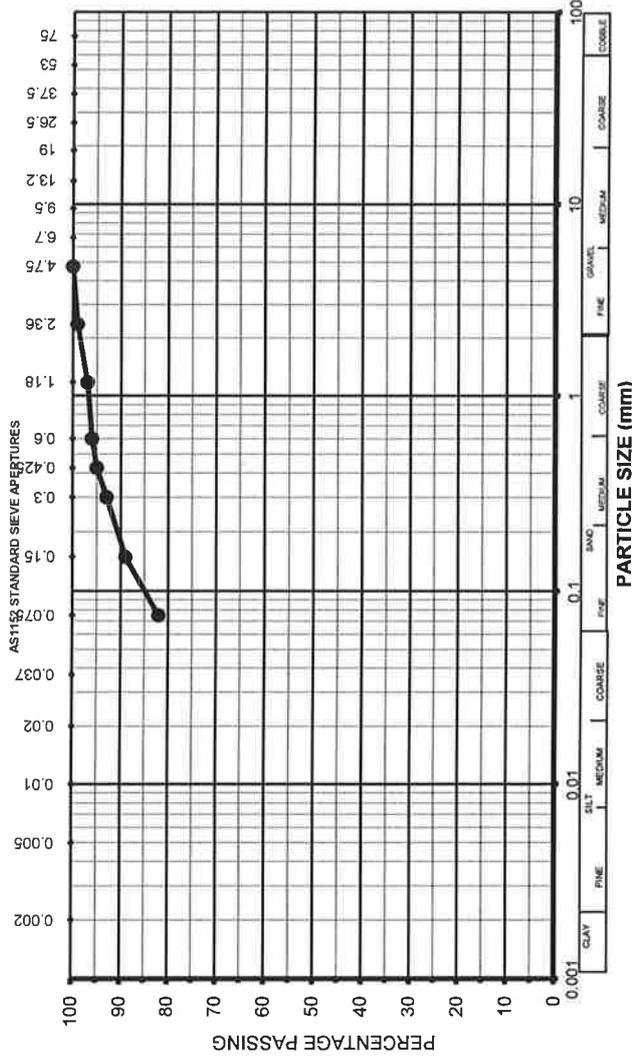
SIEVE ANALYSIS RESULTS

SIEVE SIZE	% PASSING
4.75 mm	100
2.36 mm	99
1.18 mm	97
600 µm	96
425 µm	95
300 µm	93
150 µm	89
75 µm	82

Test Method: AS1289.3.6.1 & 3.6.3 Dry Sieve (washed)

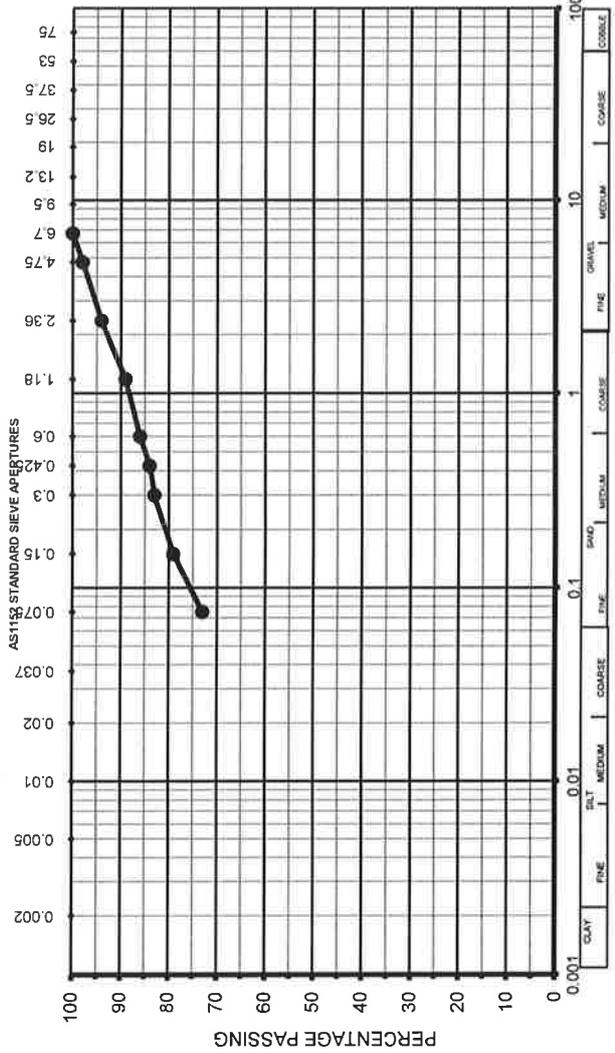
SIEVE ANALYSIS RESULTS

SIEVE SIZE	% PASSING
6.70 mm	100
4.75 mm	98
2.36 mm	94
1.18 mm	89
600 µm	86
425 µm	84
300 µm	83
150 µm	79
75 µm	73

Test Method: AS1289.3.6.1 & 3.6.3 Dry Sieve (washed)

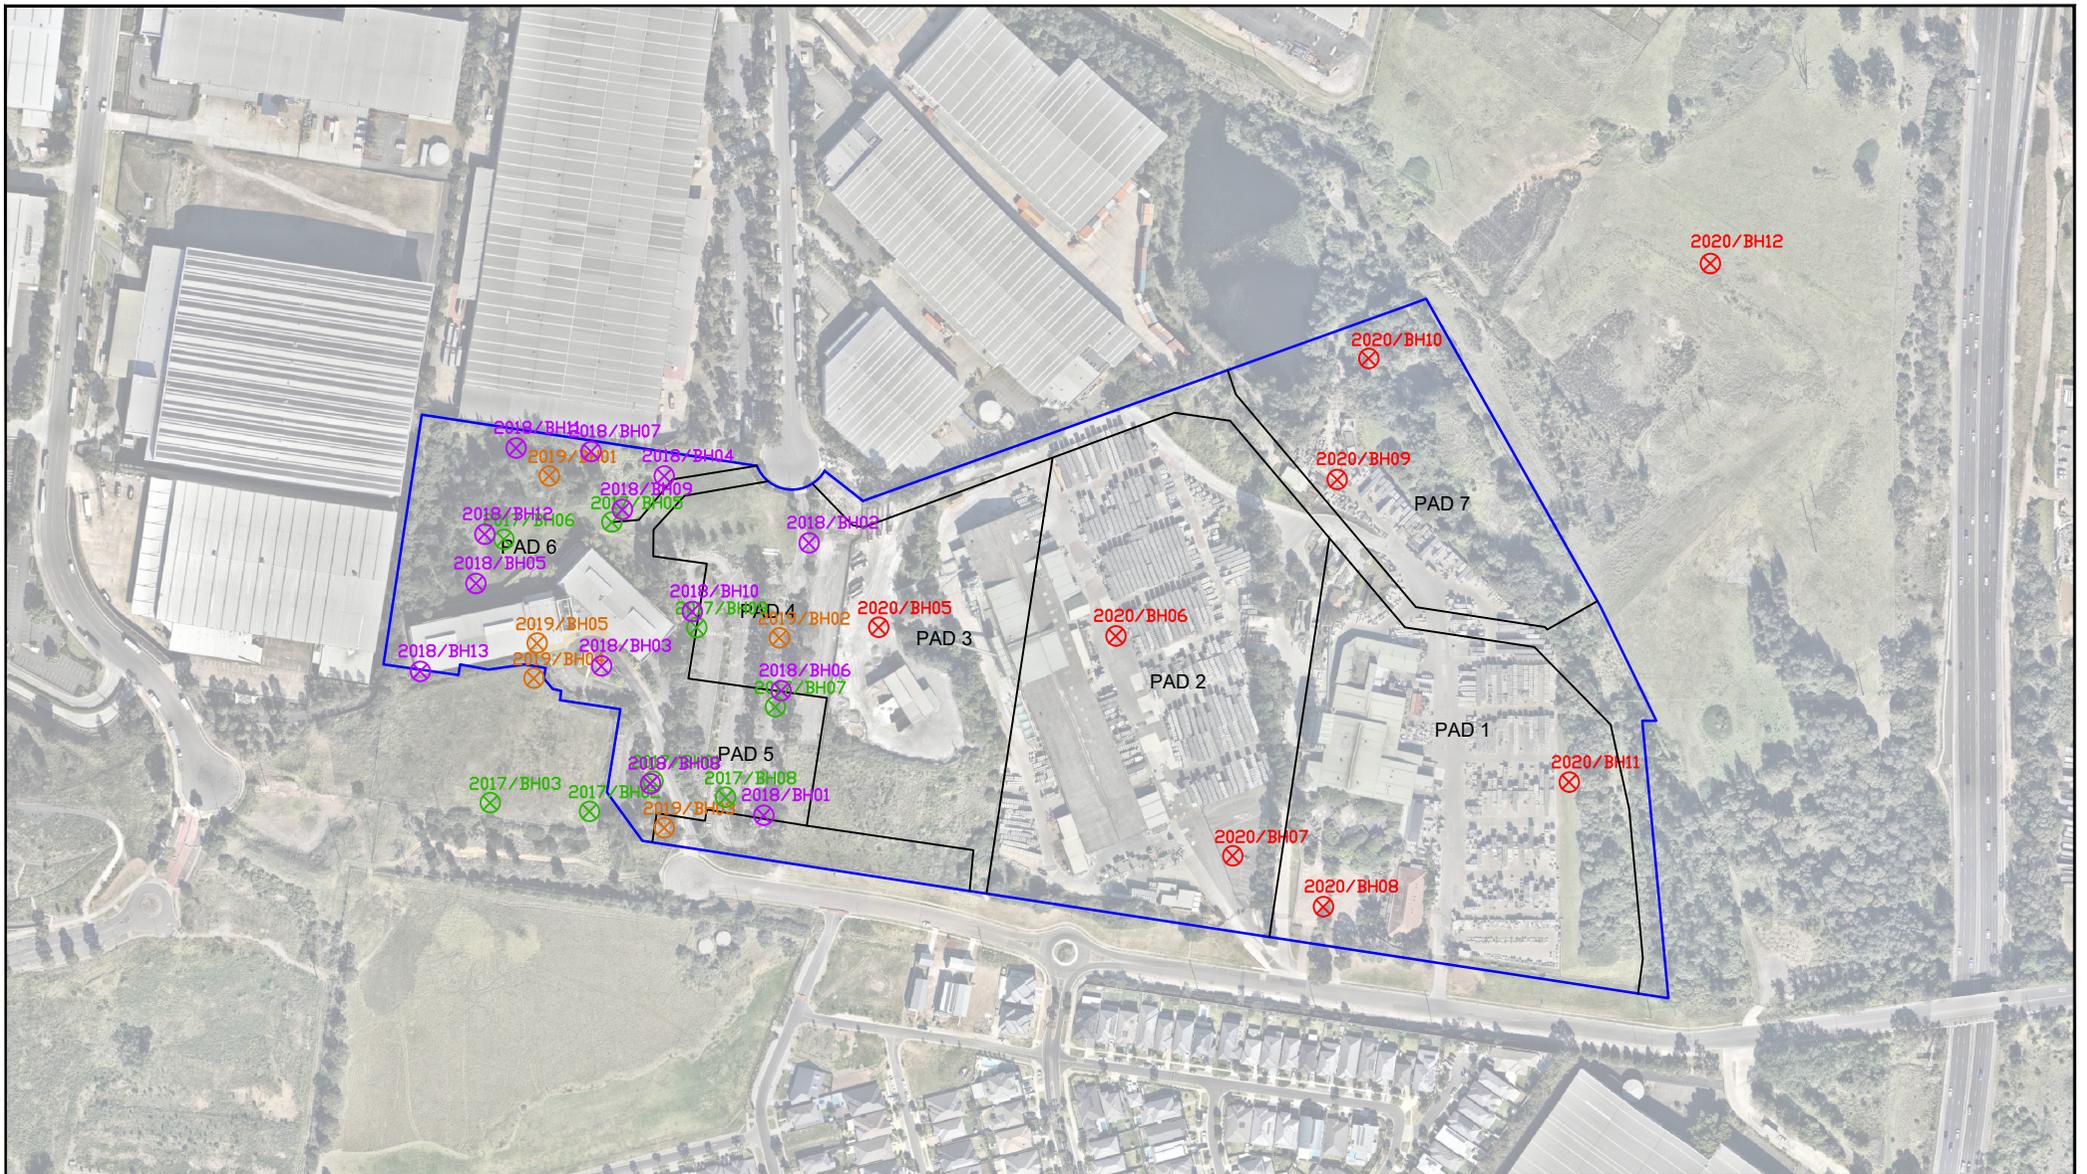
- ⊗ 2020/BH - Boreholes undertaken in 2020
- ⊗ 2019/BH - Boreholes undertaken in 2019
- ⊗ 2018/BH - Boreholes undertaken in 2018
- ⊗ 2017/BH - Boreholes undertaken in 2017
- Approximate boundary of proposed development
- Approximate pad boundaries
