Report on
Geotechnical Investigation

St Patrick's College
Francis Street, Strathfield

Prepared for
St Patrick's College

Project 86967.00
January 2020

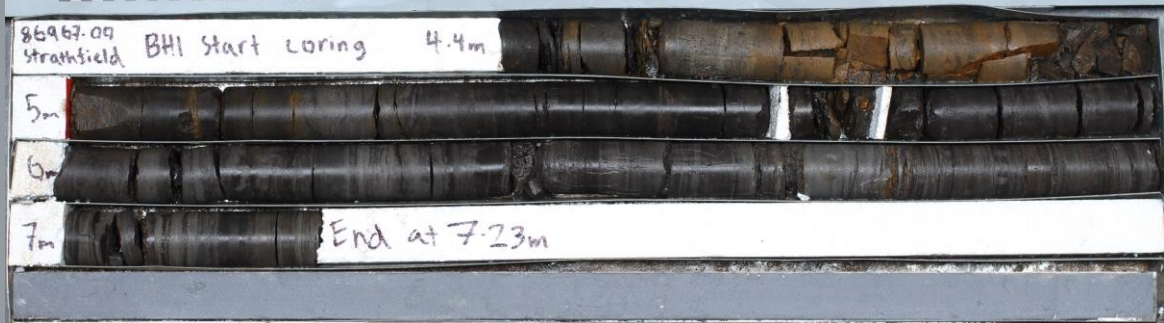
Project No: 86967.01
BH ID: 1
Depth: 4.4 - 7.23
Core Box No.: 1/1

4.40 - 7.23m

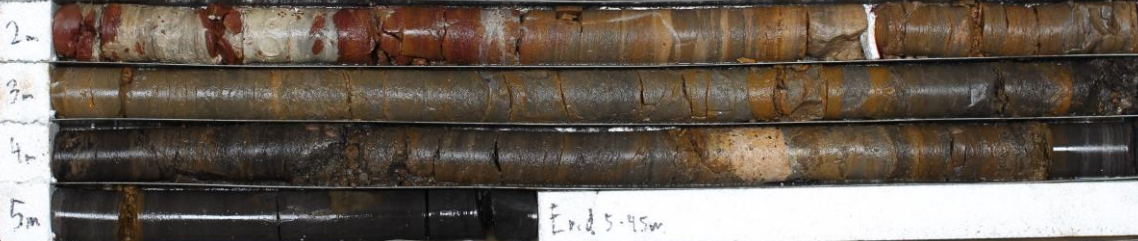
86967.00 Strathfield BH3 Start coring at 1.95m

1.95 - 5.45m

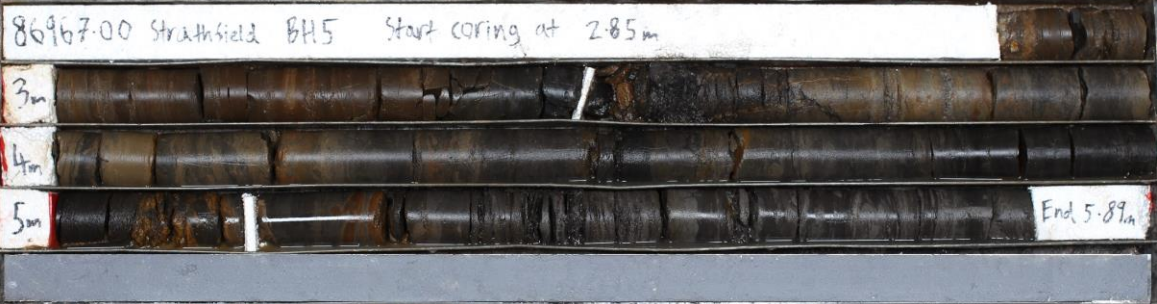
Project No: 86967.01
BH ID: 5
Depth: 2.85 - 5.89
Core Box No.: 1/1

2.85 – 5.89m
