ARBORICULTURAL IMPACT ASSESSMENT

Saint Patricks College-Strathfield.

Prepared for: St. Patricks
College, Strathfield.

Date: November 24, 2019.

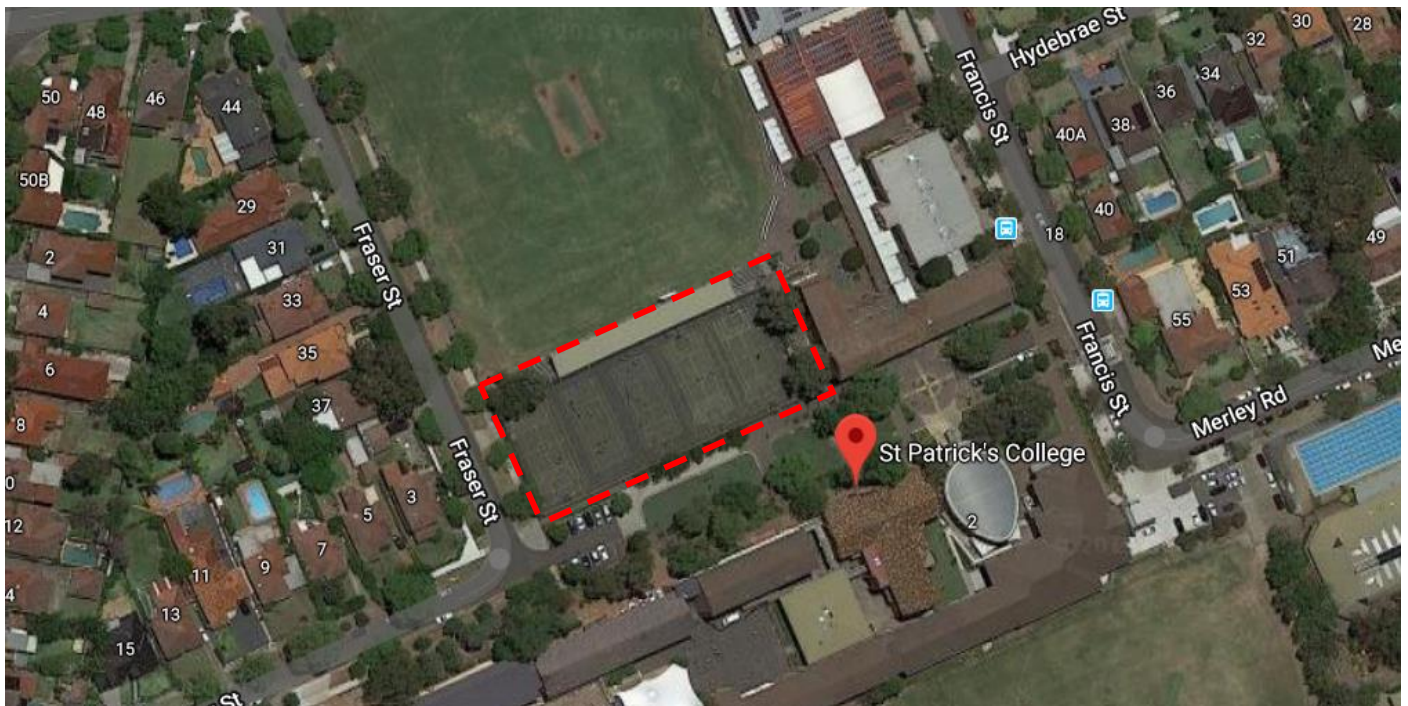
The site is at St. Patricks College, Strathfield, adjacent to the corner of Fraser Street and Edgar Street, Strathfield.

Figure 5- The subject site and surrounding area, Image taken from Google Maps 2019⁴.

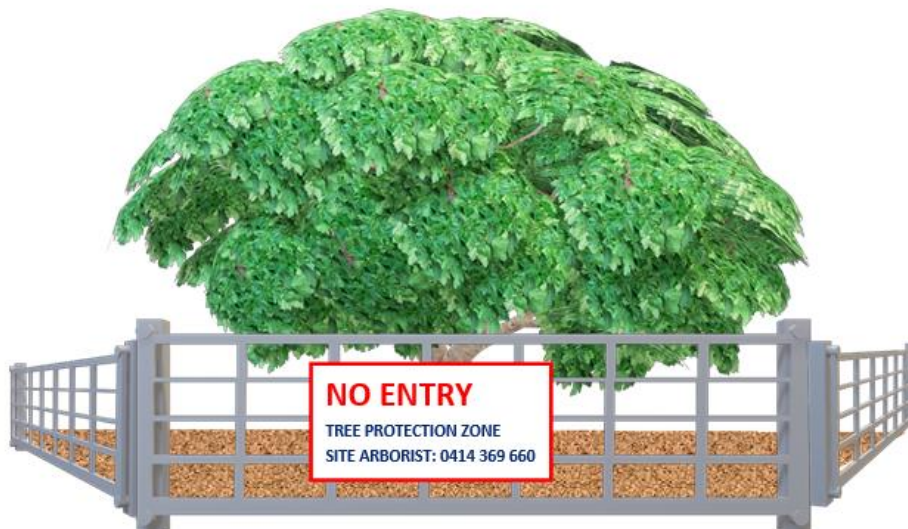
Ground protection: Access road within TPZ- Figure 2.

Tree root protection is generally achieved with the allocation and delineation of a tree protection zone (TPZ) in accordance with AS4970-2009- The Protection of Trees on Development Sites. Temporary fencing is used to isolate the area from construction activity and restrict unauthorized access. Where access into the TPZ is required and unavoidable, ground protection measures may be recommended to ensure that the tree roots which are to be protected remain undamaged during works within the TPZ. Any works within the allocated tree protection zones must be directly supervised by a project Arborist with a minimum AQF level 5 qualification. In situations where there are low lying tree branches to be protected, the TPZ may be extended beyond the calculated TPZ in order to incorporate canopy protection as shown below.

All fencing must be chainmesh fencing 1.8m in height, secured with concrete 'feet' and in accordance with AS4678-Temporary Fencing and Hoardings. Depending on the type of development, shade cloth or similar may be recommended to reduce the spread of dust, particulate matter and liquids into the protected area. Silt fencing may also be required and may be incorporated into the TPZ fencing if required. Once the TPZ fencing has been installed the site Arborist must provide a letter of certification of tree protection measures to the client which may be forwarded on to the private certifier or council. Tree protection fencing is not to be moved, realigned, dismantled or tampered with in any way and shall only be relocated under instruction of the project Arborist. (See Figure 1) If the protective fencing requires temporary removal, trunk, branch and ground protection must be installed and must comply with AS 4970-2009 - Protection of trees on development sites. Existing fencing and site hoarding may be used as tree protection fencing, providing the TPZ remains isolated from construction activities. The purpose of ground protection is to prevent root damage and soil compaction within the TPZ. Ground protection may include a permeable membrane such as geotextile fabric beneath a layer of mulch, crushed rock or rumble boards.
