Report on Supplementary Geotechnical Investigation

Proposed Commercial Development 8-10 Lee Street, Haymarket

> Prepared for Vertical First Pty Ltd

> > Project 86767.00 November 2020

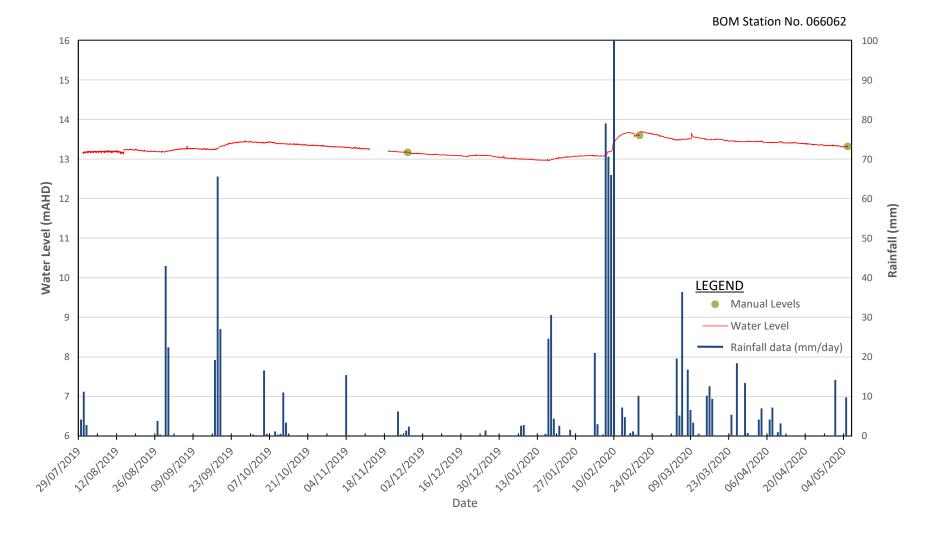
BH8 Groundwater Levels

16.0 100 15.5 90 15.0 80 14.5 70 14.0 Water Level (mAHD) 60 13.5 Rainfall (mm) LEGEND 13.0 50 - Water Level Manual Levels 12.5 40 - Rainfall data (mm/day) 12.0 30 11.5 20 11.0 10 10.5 12020 2110712020 2810712020 0410872020 1210872020 2510872020 0210972020 Date 10.0 0 0510512020 20 12/05/2020 13/05/2020 16/05/2020 03/06/2020 05/06/2020 16/06/2020 30/06/2020 07/07/2020

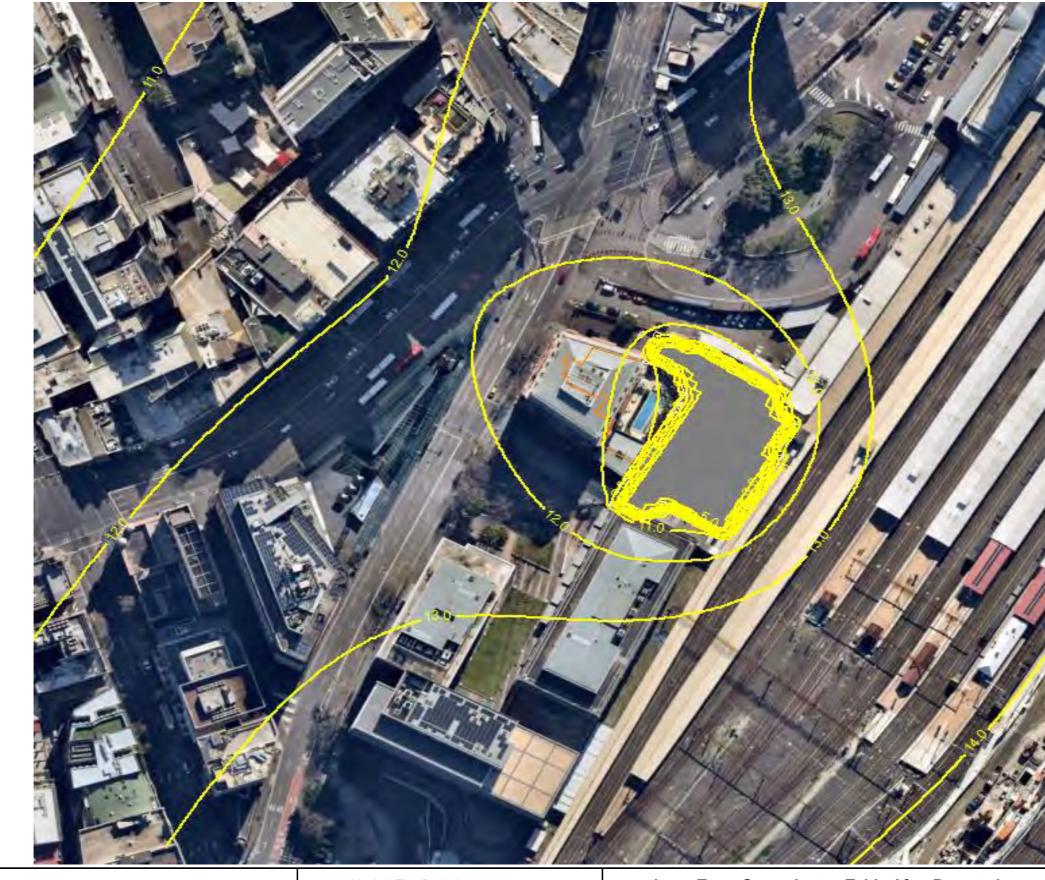
TITLE: Long Term Groundwater Table After Dewatering Proposed Commerical Development 8-10 Lee Street, Haymarket

Groundwater modelling of the proposed basement and required dewatering (refer Groundwater Modelling Report: 86767.04.R.003.Rev1, dated 30 October 2020) indicates that potential settlements induced by the dewatering will not be noticeable beneath neighbouring structures or pavements founded on fill or alluvial soils, and will be negligible for neighbouring structures founded on medium to high strength sandstone. This report has been included in Appendix I for ready reference. The results of a groundwater contamination assessment are presented in the supplementary contamination investigation report (Douglas Partners Report 86767.06.R.001.Rev1, dated 25 September 2020), and are not further discussed within this report.
