Report on Supplementary (Contamination) Site Investigation

Proposed Commercial Development 8-10 Lee Street, Haymarket

Project 86767.06 September 2020

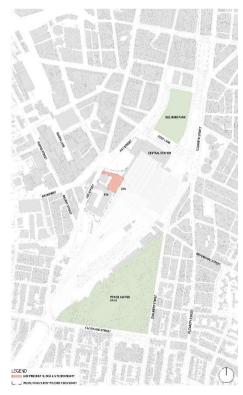
Figure 1: Site Location and Dimensions Image Source: BVN / SHoP

The Site has an area of approximately 3,764 sqm which includes 277 sqm of air rights that apply from RL40.

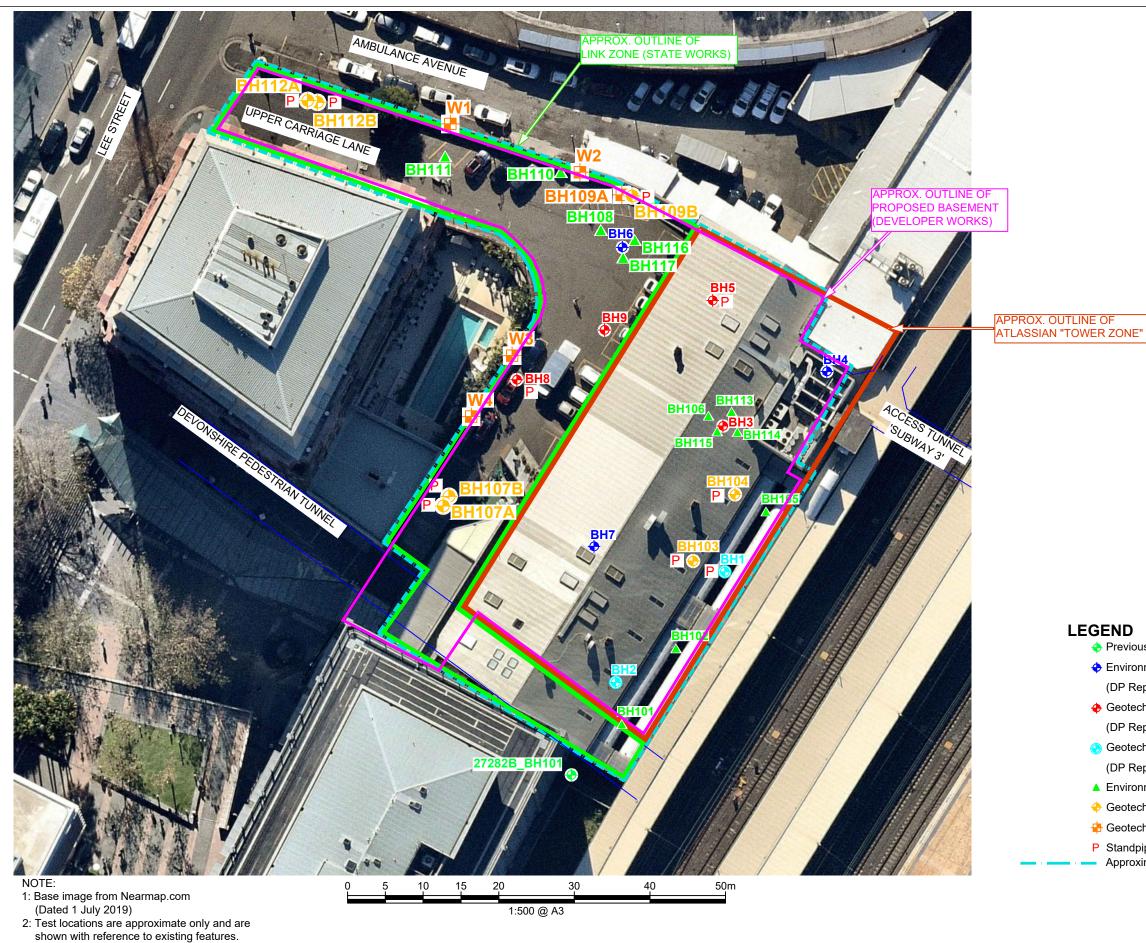
Site Drawing

The groundwater monitoring well network at the Site involved two hydraulically up-gradient wells (BH103 and BH104), two down-gradient wells (BH112A and BH112B) along with three mid-gradient wells (BH107A, BH107B, 109B). The up-gradient wells are most likely to be indicative of the groundwater condition in the greater surrounding area, while the down-gradient wells are most likely to pick up any contaminants leached from on-site sources. The seven groundwater monitoring well locations together with the two sampling locations used for DP (2019) were considered adequate to characterise the groundwater contamination status beneath the Site at the time of sampling. Monitoring well locations are shown on Drawing 1, Appendix B.

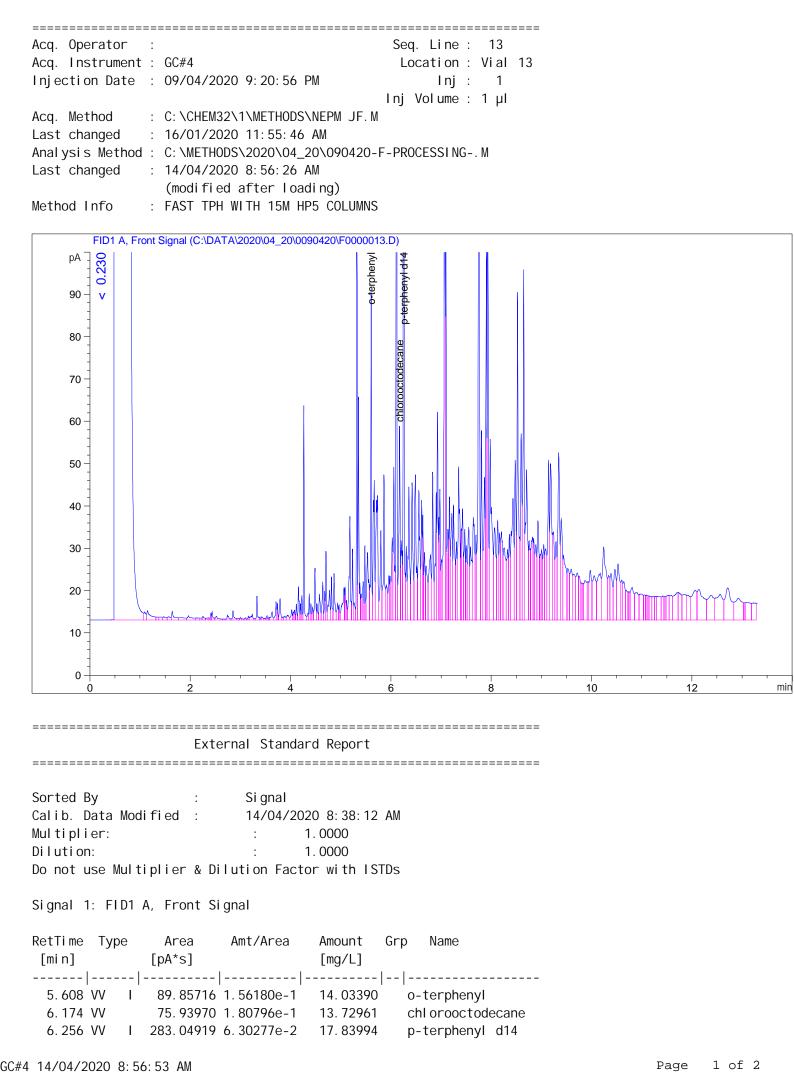
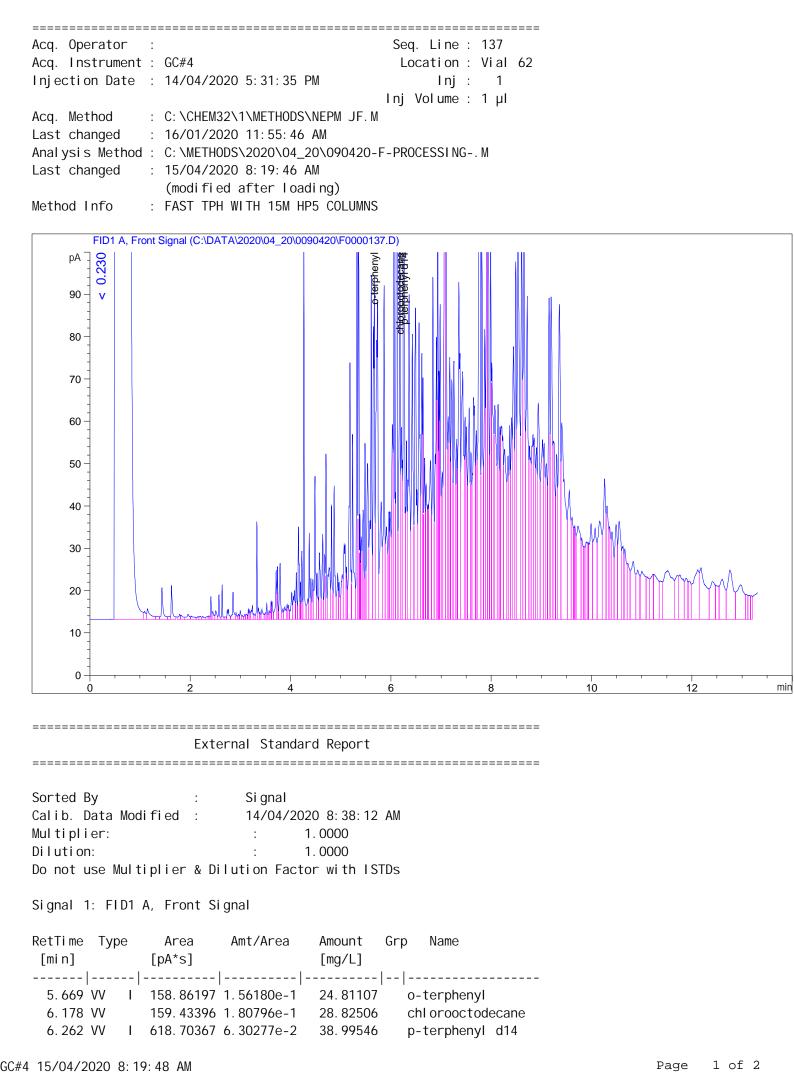
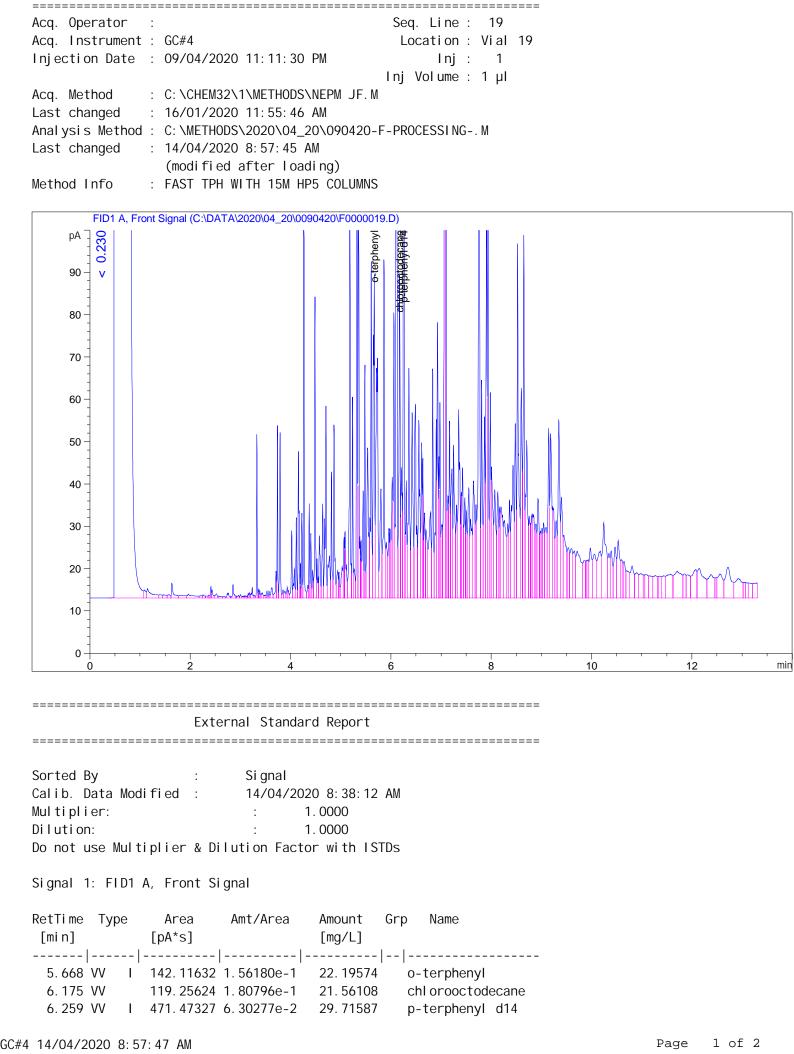
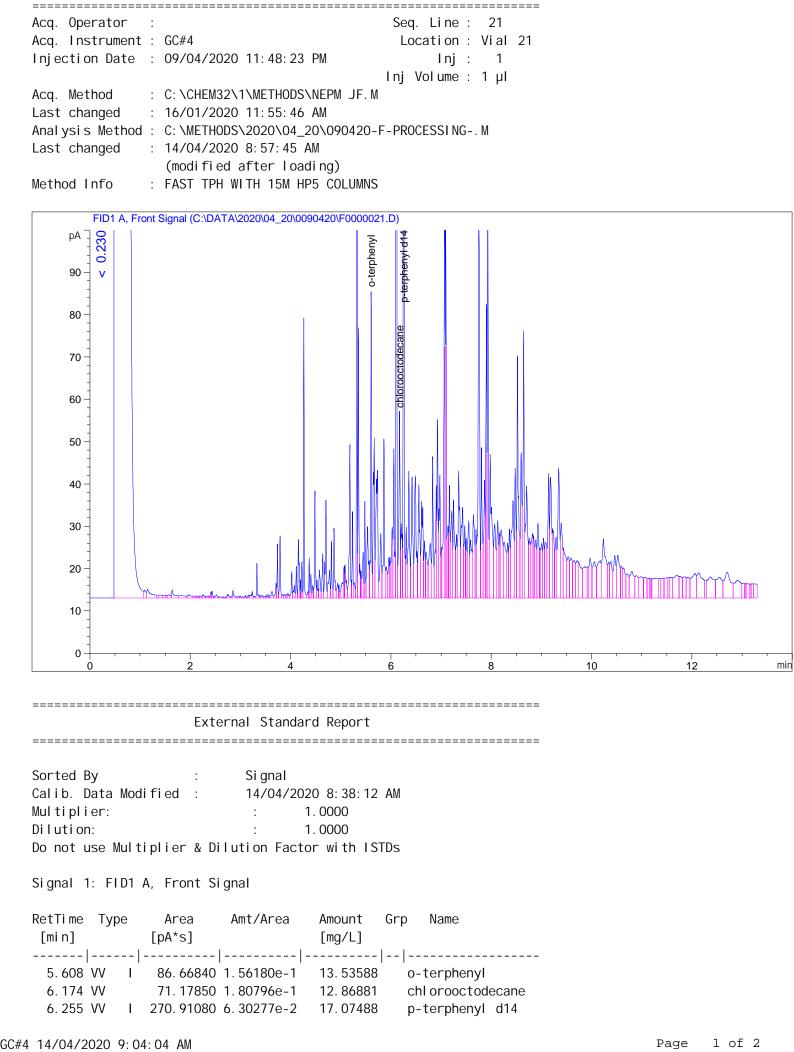
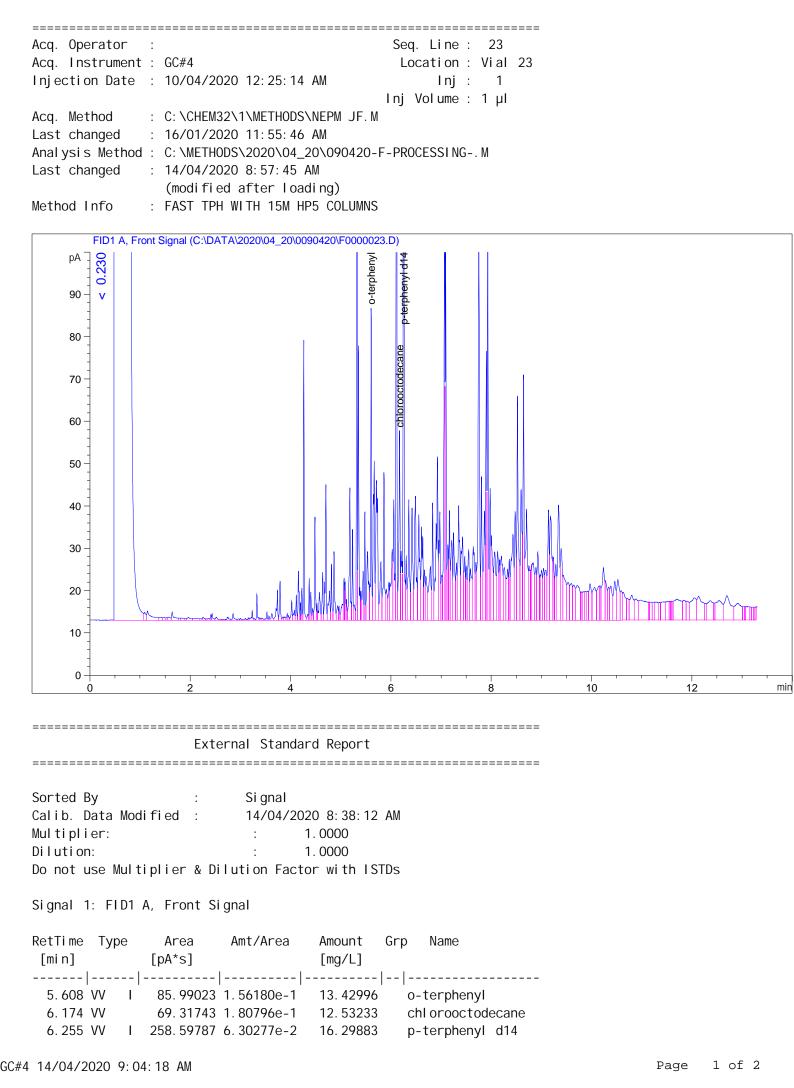
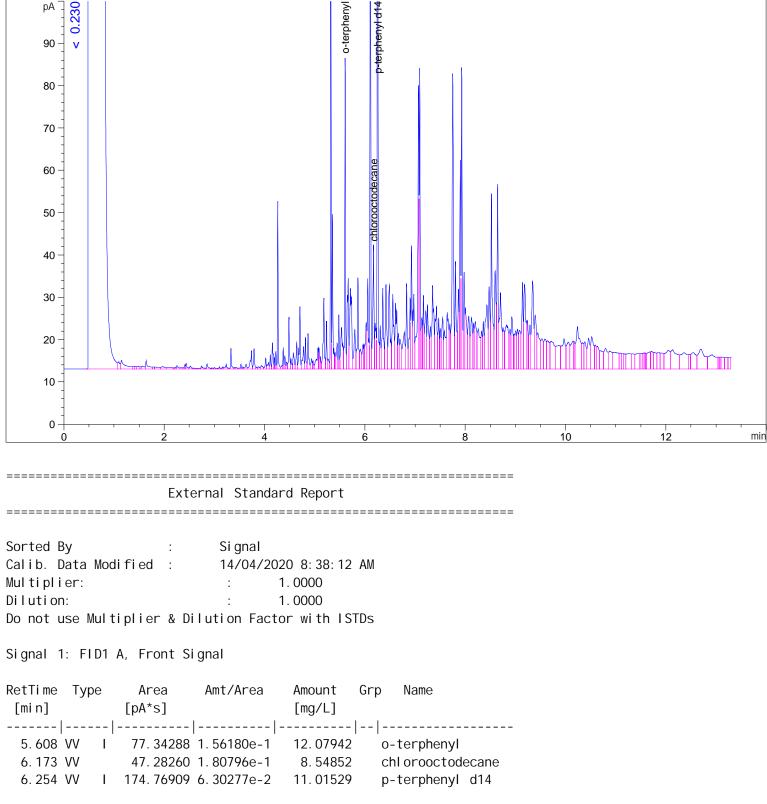
Chromatograms

It is considered likely that the B(a)P TEQ and TRH F3 (>C16-C34) contamination is from the coal observed in the fill. This is further supported by the chromatograms ordered for seven samples with elevated concentrations of TRH, provided in Appendix H.
