Memorandum

То	Atlassian Pty C/- Avenor Pty Ltd	Ltd,	Andrew Kyriacou Allison Mahlberg		cou@avenor.com.au erg@avenor.com.au
From	Huw Smith			Date	15 May 2020
Subject	Interim Data Release: Site Plan, Factual Data and Interpreted Cross-Sections, for a Proposed Commercial Development		Project No.	86767.00	
Site Location	8-10 Lee Street, Haymarket		Document No.	86767.00.C.004.Rev0

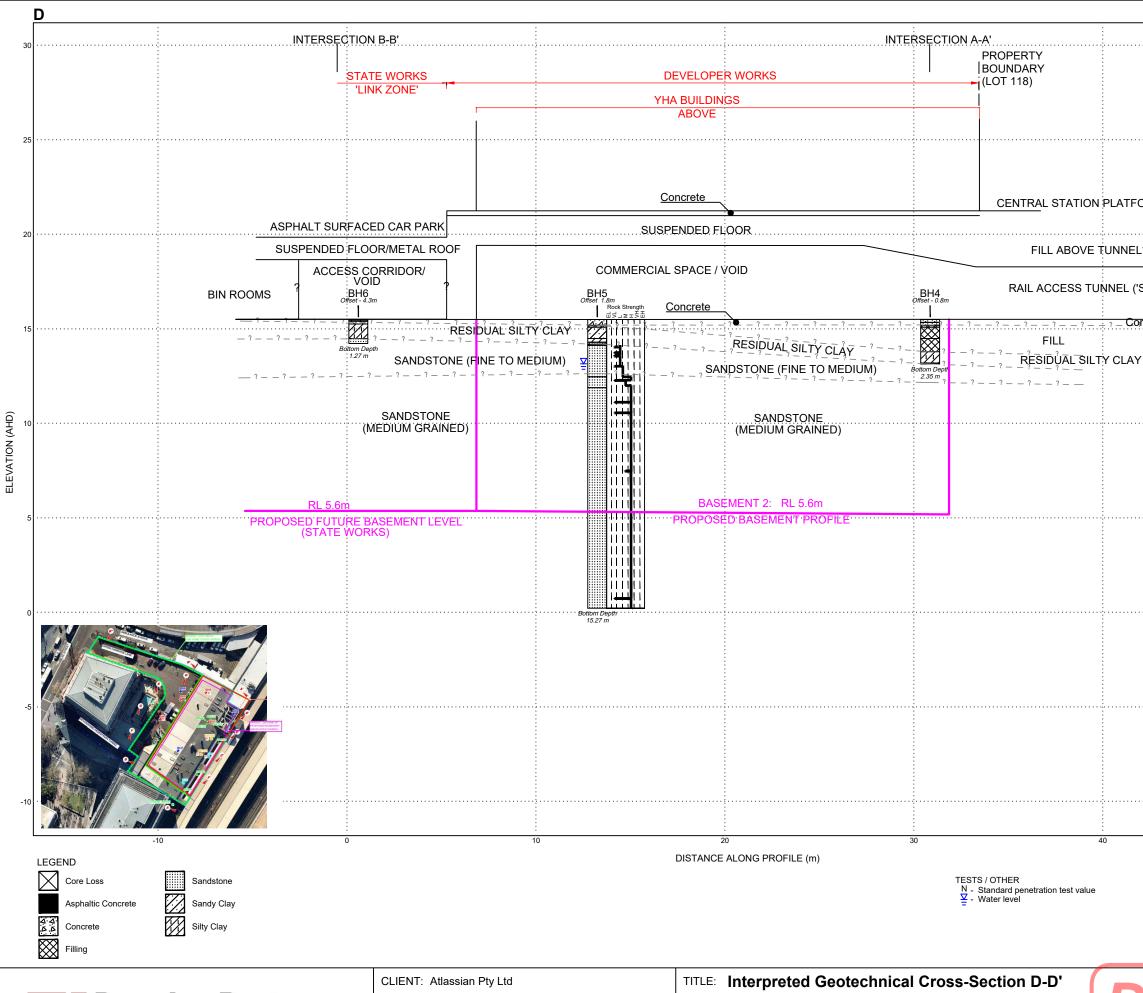
Interpreted Geotechnical Cross-Section D-Proposed Commercial Development 8-10 Lee Street, HAYMARKET

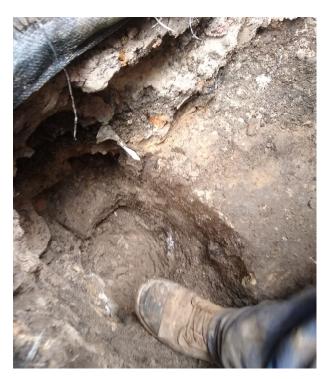
Photo D1 – View within borehole BH101, showing the sand and gravel fill encountered at shallow depth below the rail ballast / ground surface level between the rail carriage dormitories.

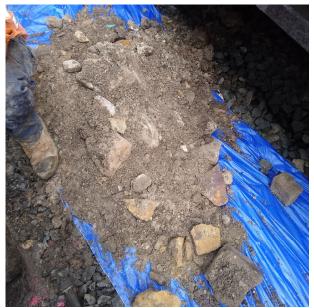
Photo D2 – View of fill obtained from Borehole BH101.
