ATLASSIAN DEVELOPMENT

Archaeological Test
Excavation Report - Lower
Ground Floor, Adina Ramp
and Upper Ground
Floor/Platform 0

Prepared for
BOJV - DEXUS
30 November 2022

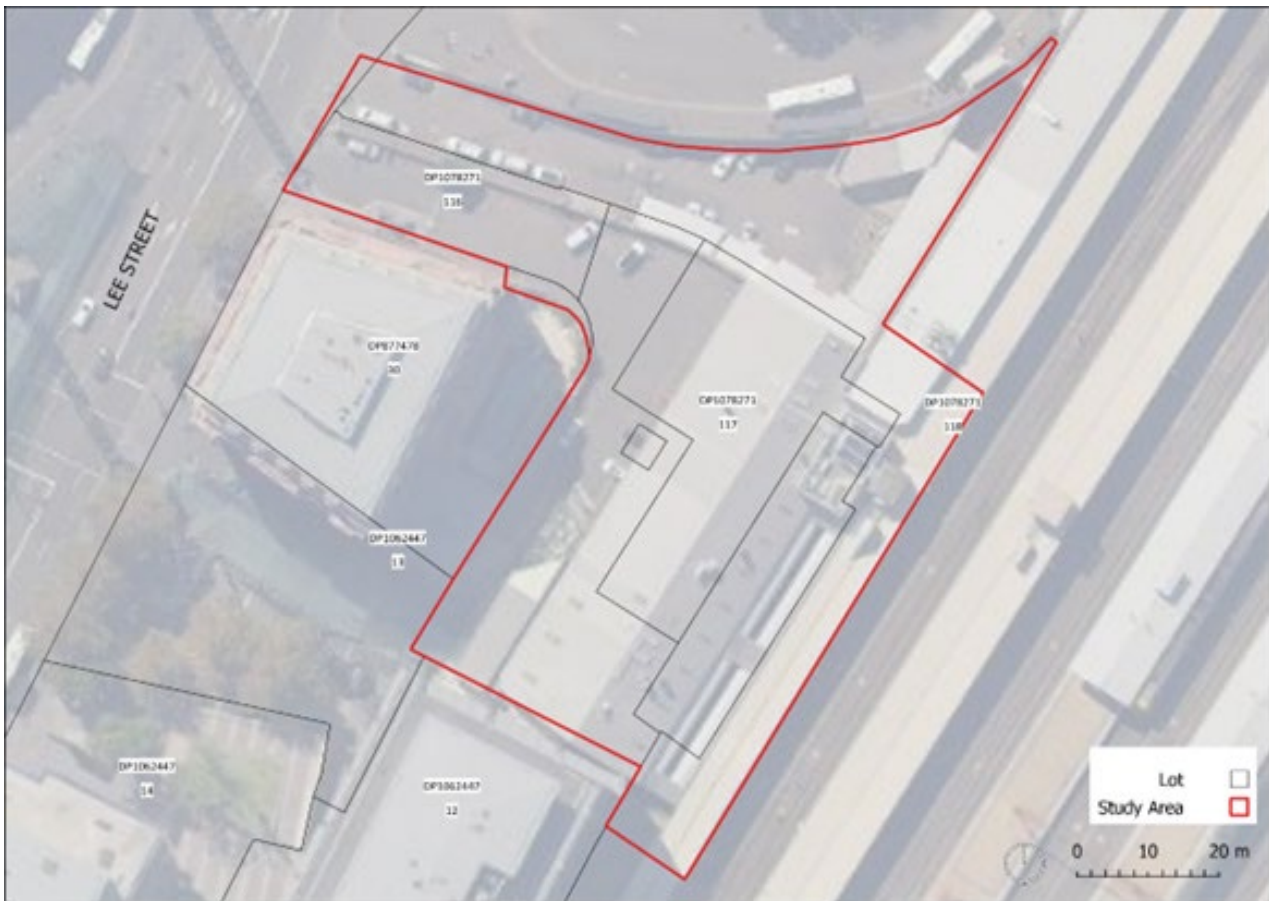
Figure 1 – Site location and boundary.

SSD 10405 refers to the site at 8-10 Lee Street, Haymarket, Lots 116, 117 and 118 in DP 1078271 and Lot 13 in DP 10662447. The site is known as 8-10 Lee Street, Haymarket. It is an irregular shaped allotment with a small street frontage to Lee Street; however, this frontage is limited to the width of the upper access road and that of Ambulance Avenue. The site location and boundary are shown in Figure 1.

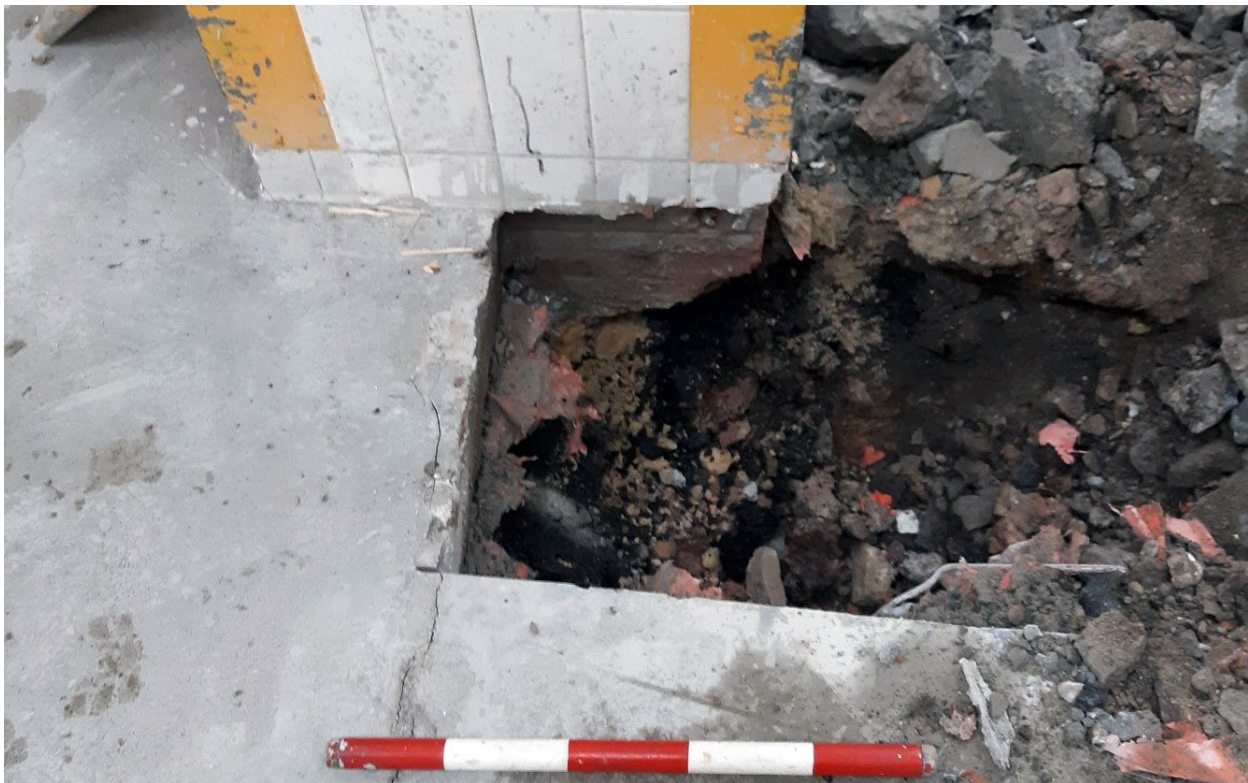
Test Pit 4.2 was 950mm long and 900mm wide and was excavated through the slab of the central open space of the lower ground floor, at a distance of 12m from the Ambulance Ave loading dock entrance. The start level for the excavation was 15.35m AHD. The pit was excavated to 180mm within the concrete slab bedding material, where excavation stopped due to the risk of undermining the column footing. No units that pre-dated the construction of the existing building were encountered in this test pit.

Figure 9 – Excavation stopped at this point because of the risk of undermining the column. TP4.2 was not excavation below the construction fills.

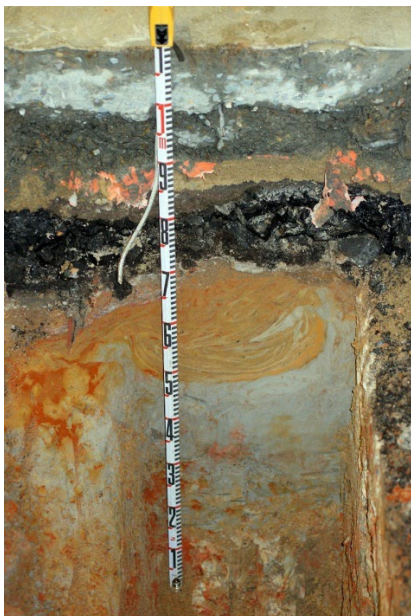
The edge of a feature was present in the north-facing section. The feature was roughly semi-circular in profile, was 240mm deep and 310mm wide with blurred, bleeding edges at the top and an indistinct boundary with the iron staining at the top of the truncated unit. The feature was filled with medium to coarse-grained mottled sandy clay in swirling lenses. There was no cultural material or exotic soils within the feature. It is possible that the feature was natural in origin, representing a collapsed void. It was not able to be definitively interpreted from the limited evidence at the edge of the pit.

Figure 10 – The edge of a feature shown in the north-facing section of TP4.4.

Figure 11 – Detail of the unidentified feature in TP4.4. Numbers are 100mm increments.

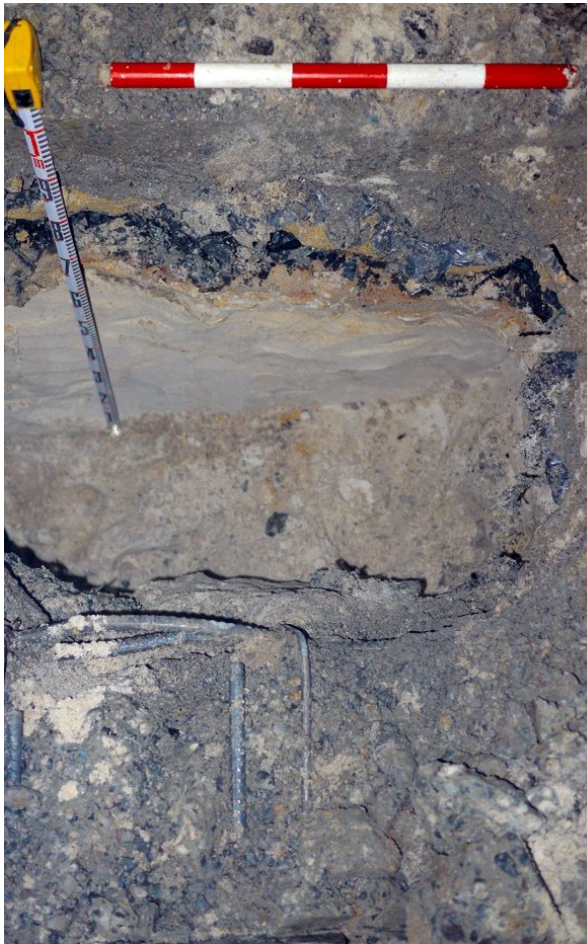
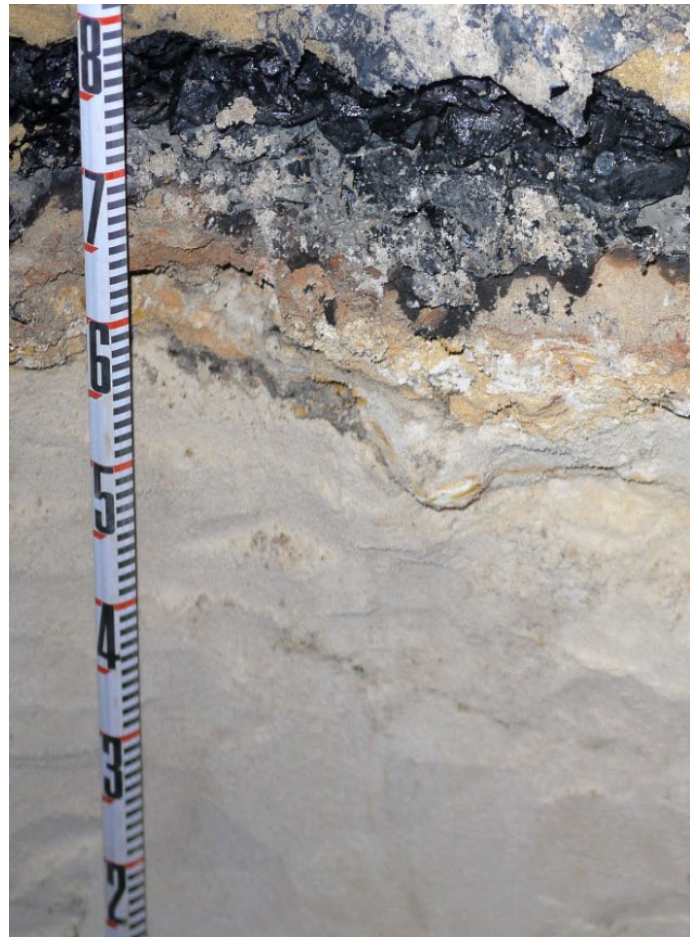
Figure 12 – TP4.12 showing bleached sands beneath the construction fills.

Figure 13 – Detail of the east-facing section showing bleached sands beneath the construction fills in TP4.12. Numbers are in 100m increments.

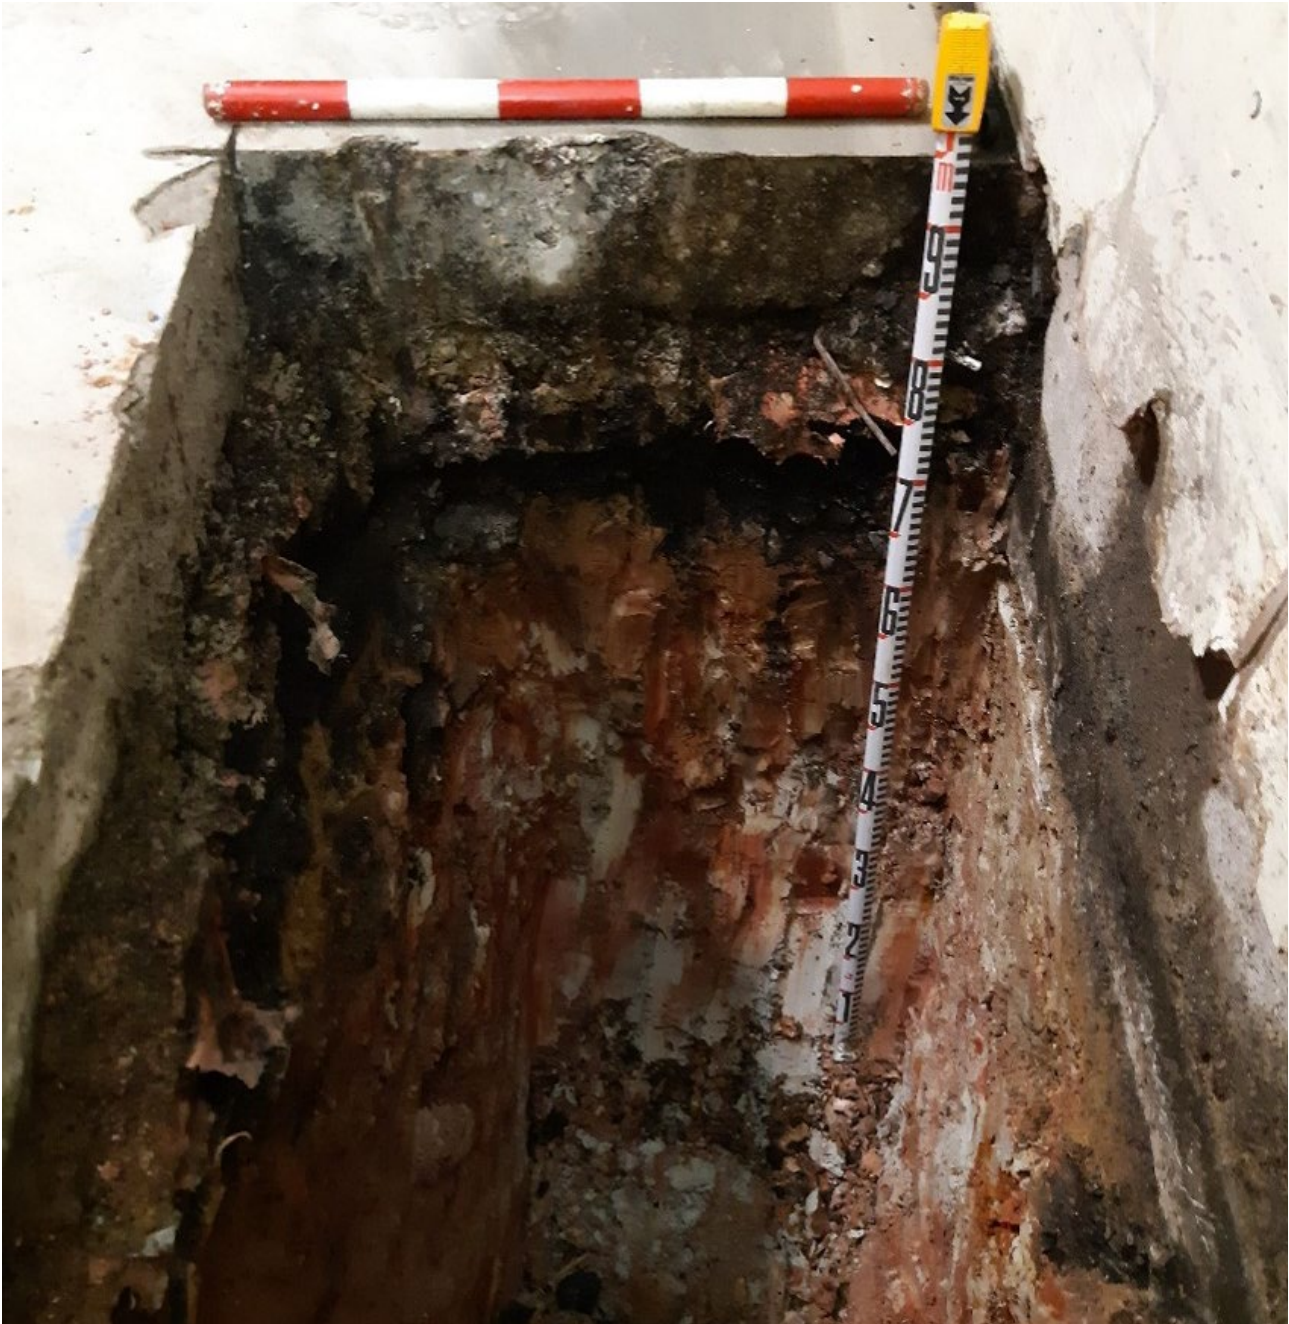
TP5.1 was located in the rail access corridor on the southern side and measured 950mm x 550mm. Excavation encountered red and light grey strongly pedal clays below 240mm of concrete slab and construction fill. There was no evidence of activity that pre-dated the construction of the existing building.

Figure 14 – West-facing section of TP5.1 showing grey and red clays beneath the slab and construction fills. Numbers are in 100mm increments. Red and white scale 500mm.

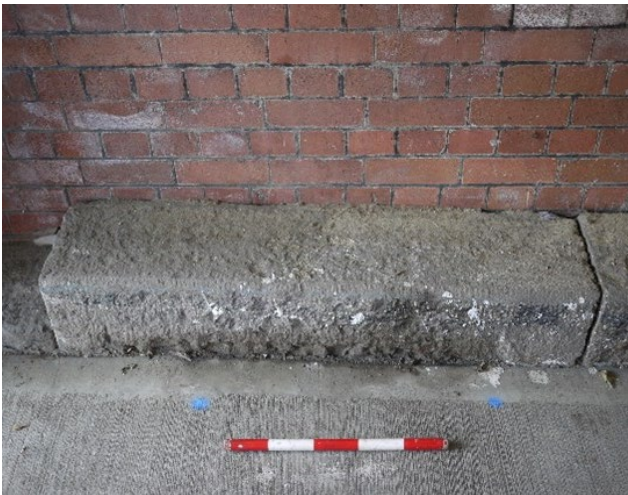
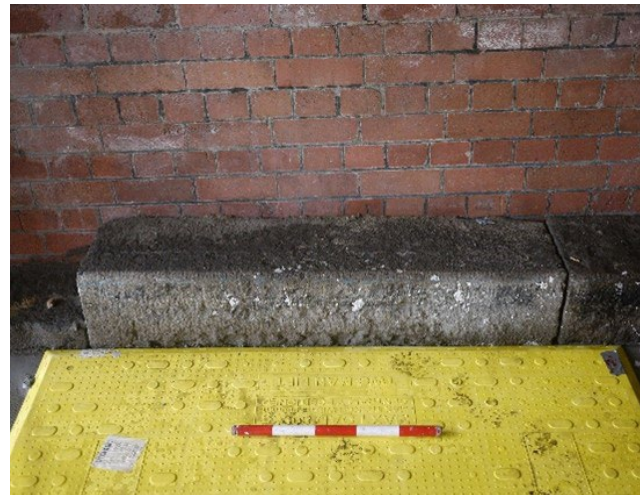
Test Pit 6.1 was 850mm long and 800mm wide and was excavated through the driveway entrance to the Adina Hotel carpark at a depth of 4m, off Ambulance Ave. The sandstone block kerbing lining the walls of the carpark entrance had been identified as significant fabric. The pit was therefore offset, and the sandstone block was partially undermined to avoid damage and removal.

Figure 16 – Sandstone kerbing pre-excitation.

Figure 17 – Sandstone kerbing post-excitation.

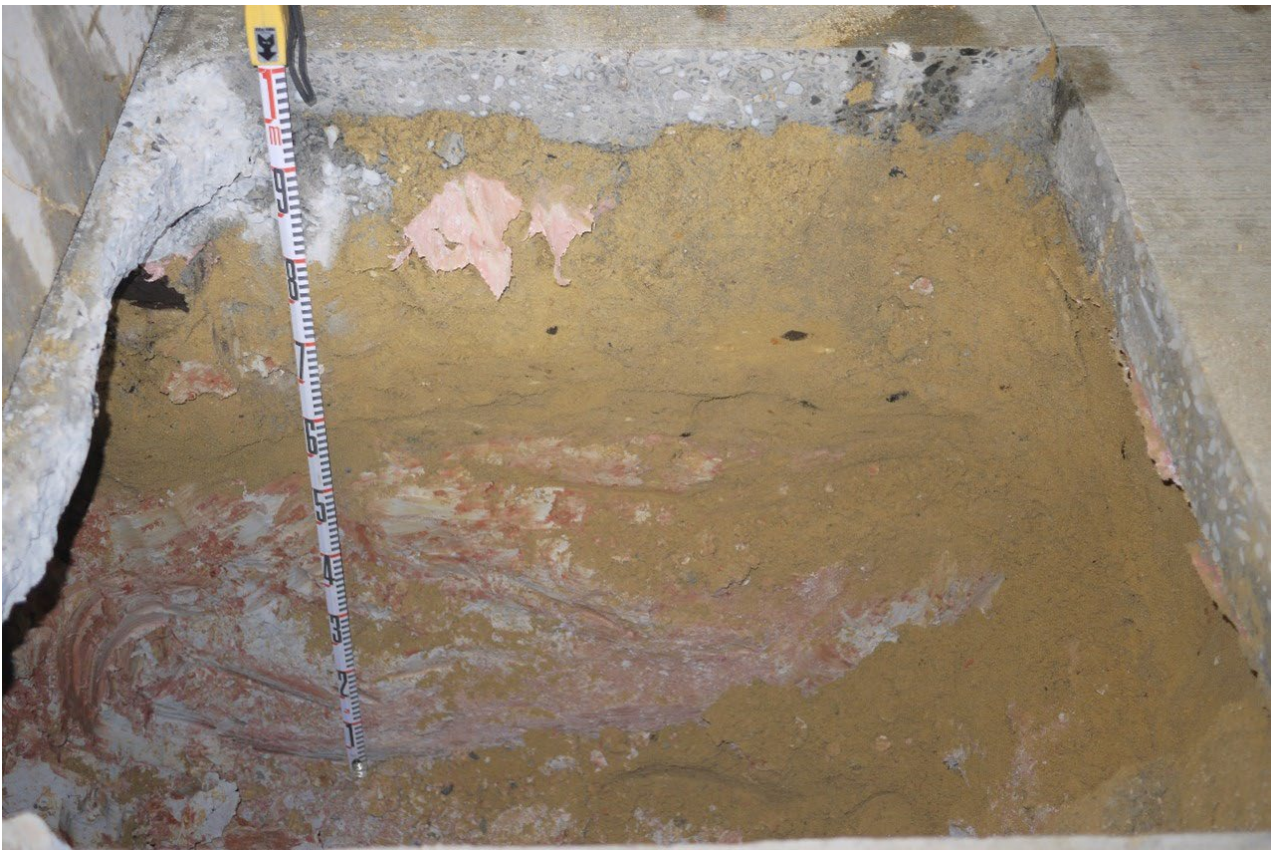
Figure 18 – North-facing section in TP6.1 showing 320mm of construction sand bedding beneath the concrete slab.

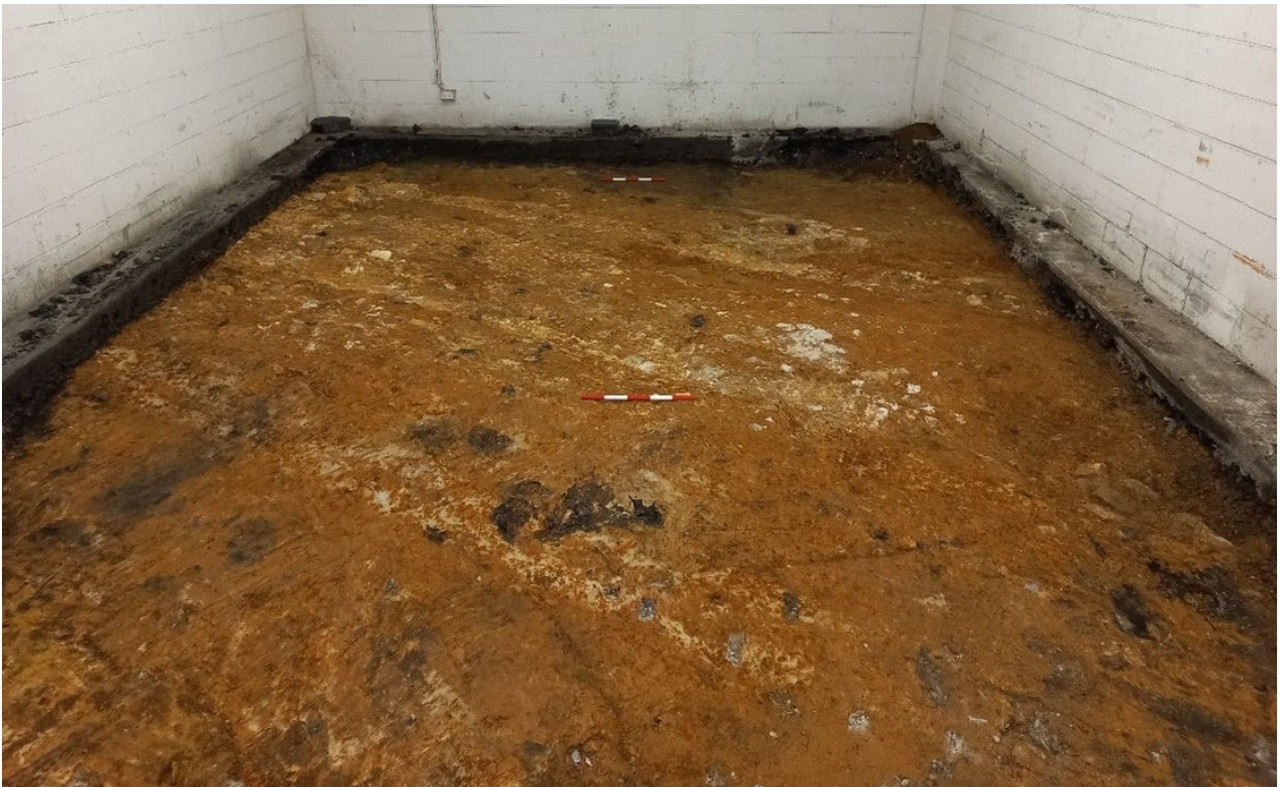
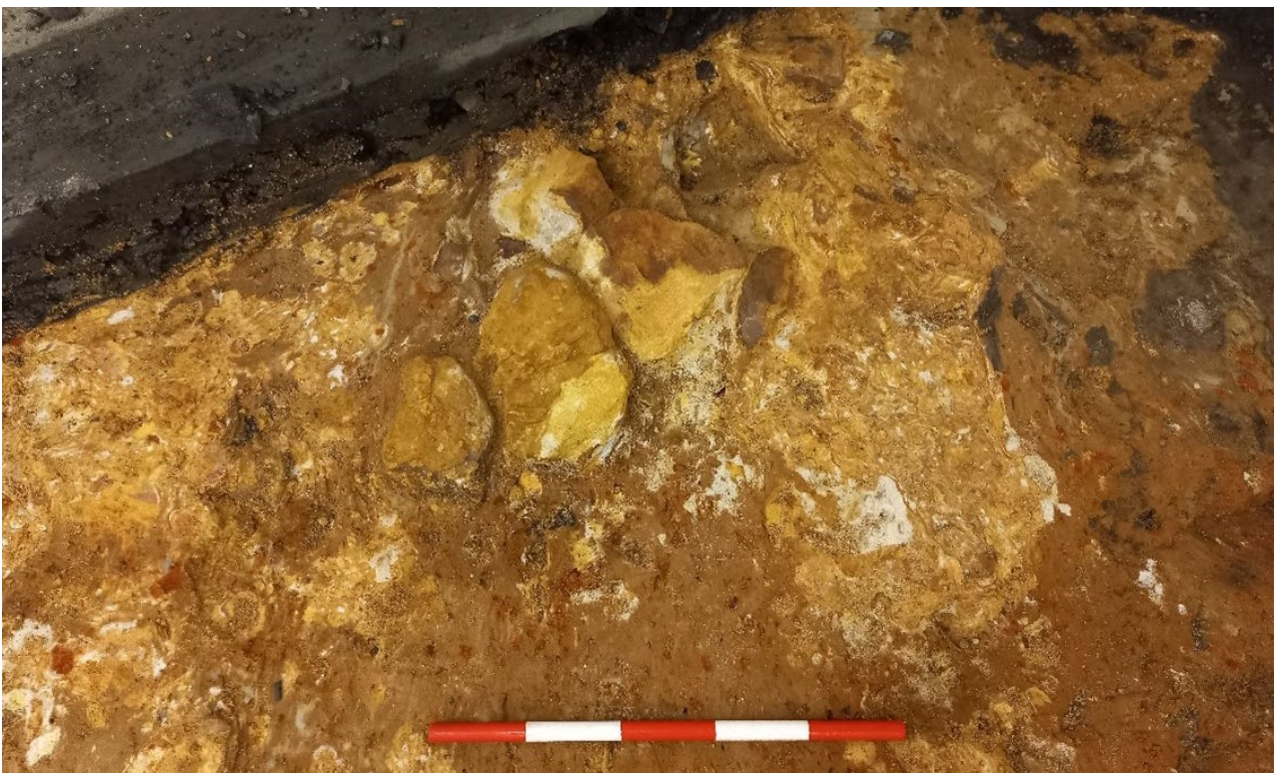
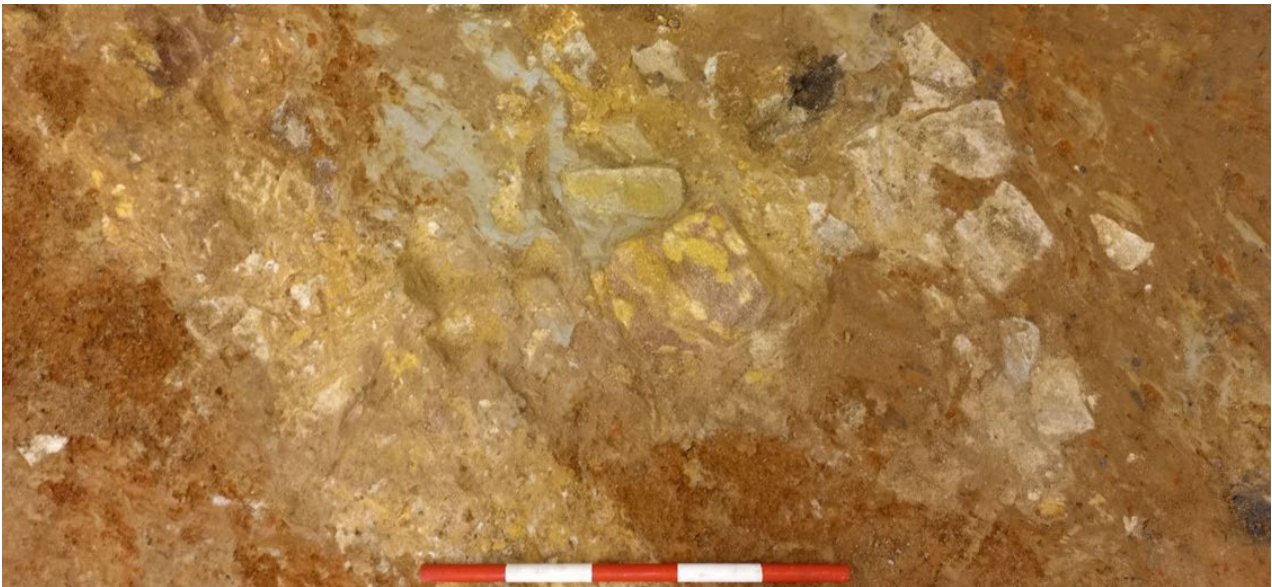
Figure 19 – Linear impressions containing crushed and fragmented sandstone in the truncated clays in Trench LGF T1.

Figure 20 – Sandstone rubble and crushed sandstone embedded in the truncated clays in the south-east corner of Trench LGF T1.

Figure 21 – Mix of sandstone rubble, crushed sandstone and clay embedded into the truncated red-orange clays in LGF T1. View to the south. Scale 500mm.

The slab and underlying construction fill were the same across both parts of the trench and consisted of 120mm-150mm of concrete poured over a 150mm-180mm thick base of coal tar and broken stone aggregate. In some locations, cut sections of steel rail (railway tracks) had been set into the concrete to act as reinforcement. These were inconsistently placed and seemed to have been used opportunistically rather than by design.

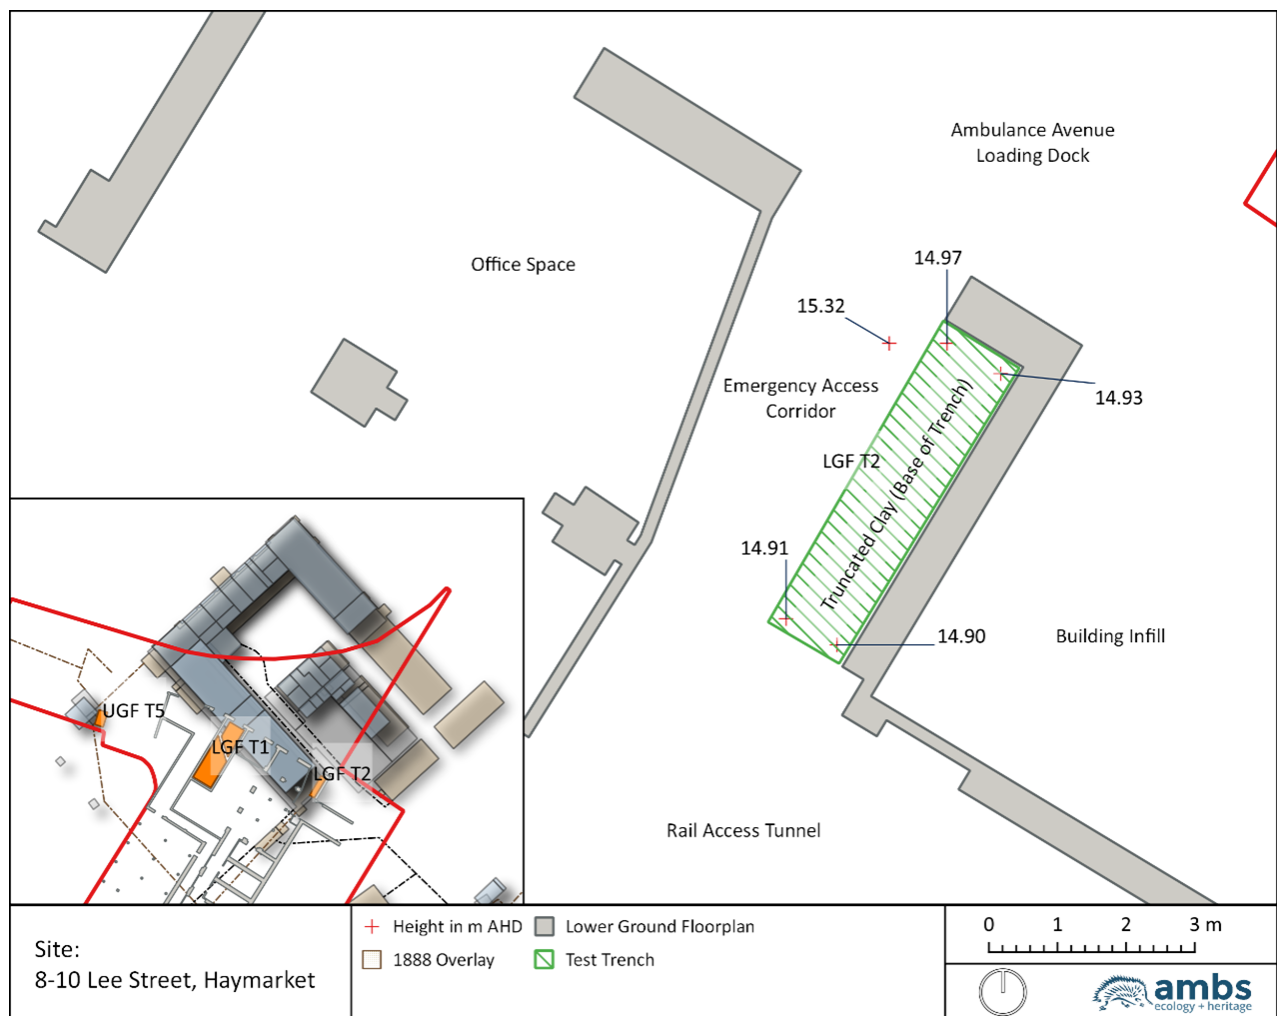
Figure 23 – Locations and final depths of Trench LGF T2.

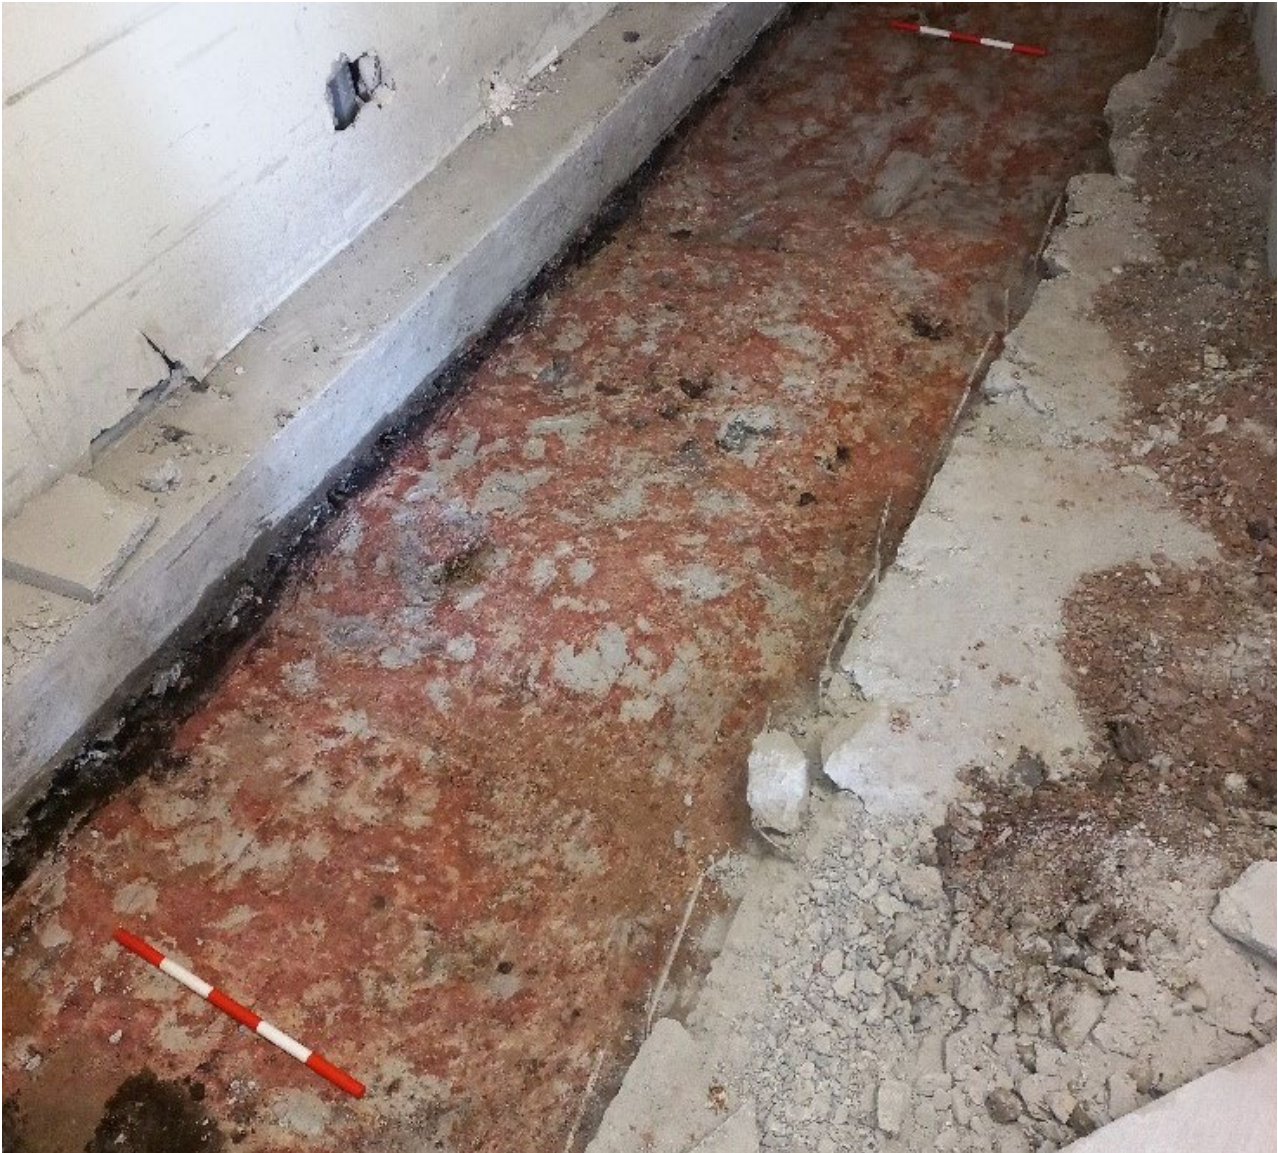
Figure 24 – Base of Trench LGF T2 showing truncated clays beneath the coal tar levelling fill. View to the south. Scale 500mm.

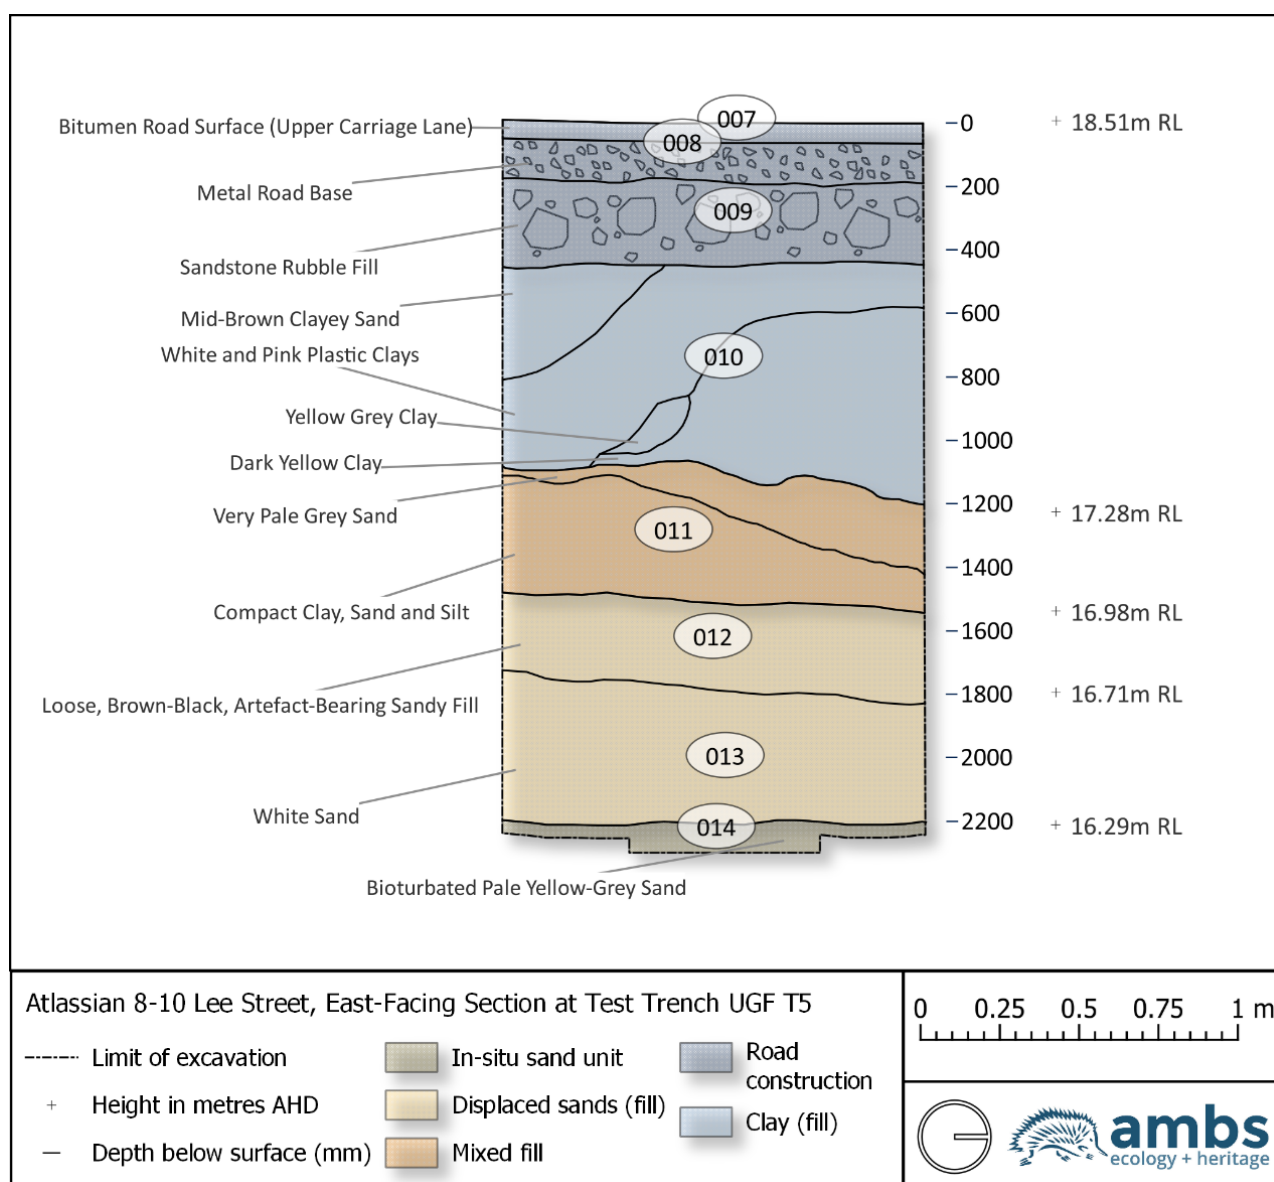
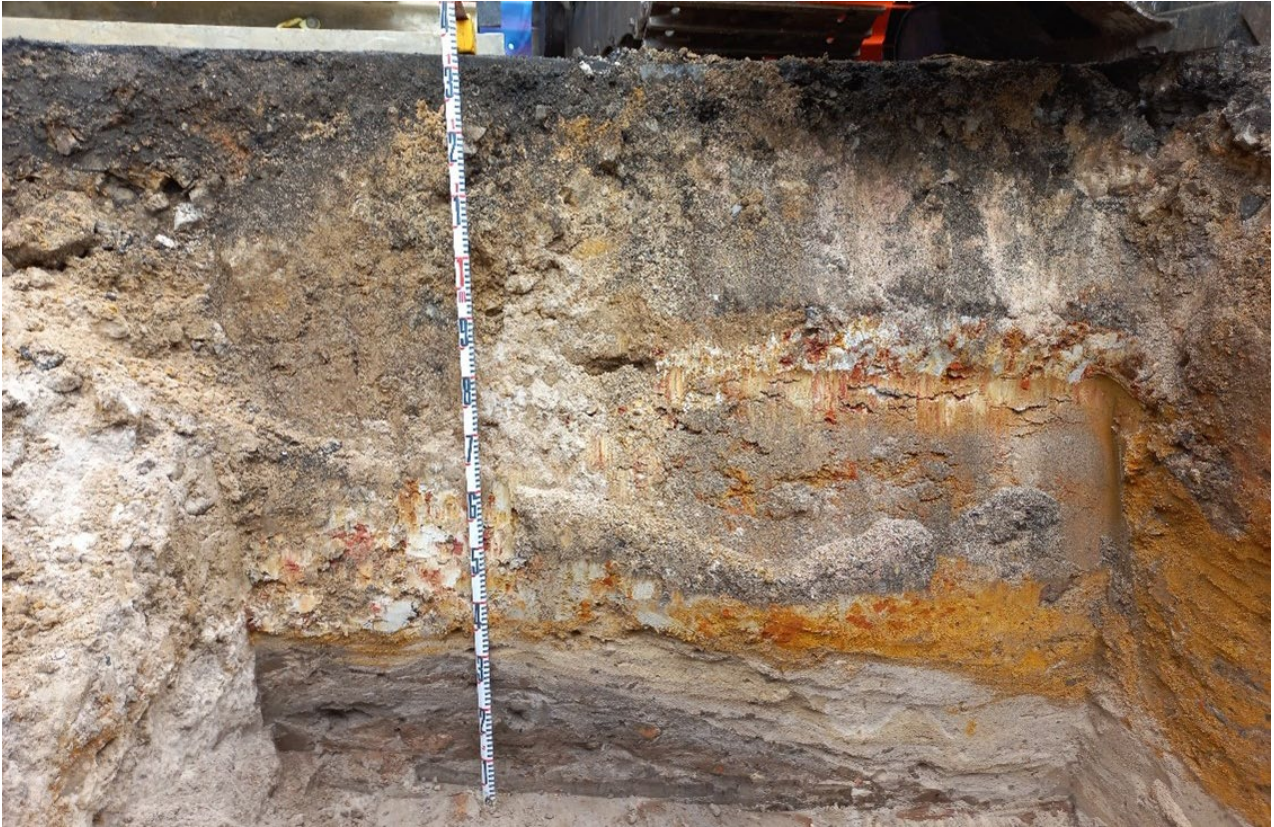
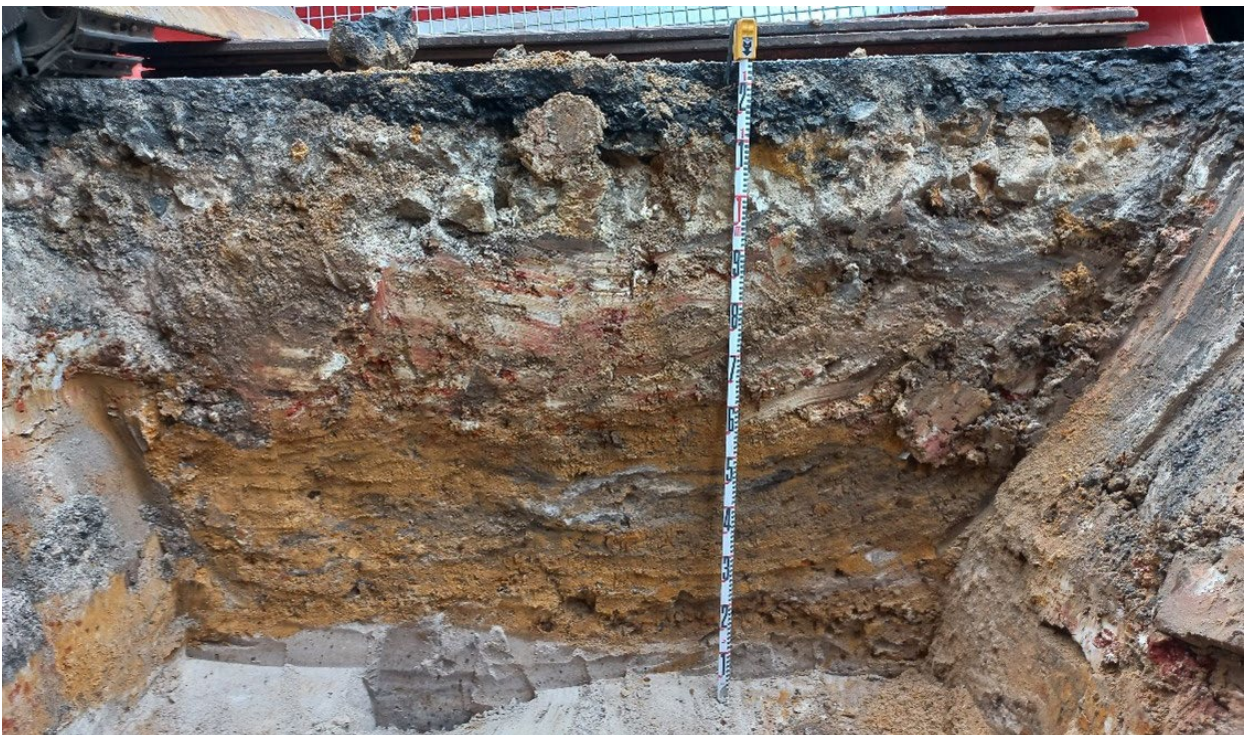
Figure 26 – East-facing section of Adina Ramp Trench UGF T5 to the top of the nineteenth-century near-surface soil unit (context 014).

Figure 27 – East-facing section of Adina Ramp Trench UGF T5 at -1300mm. Numbers are in 100mm increments

Figure 28 – South-facing section of Adina Ramp Trench UGF T5 at -1200. Numbers are in 100mm increments.

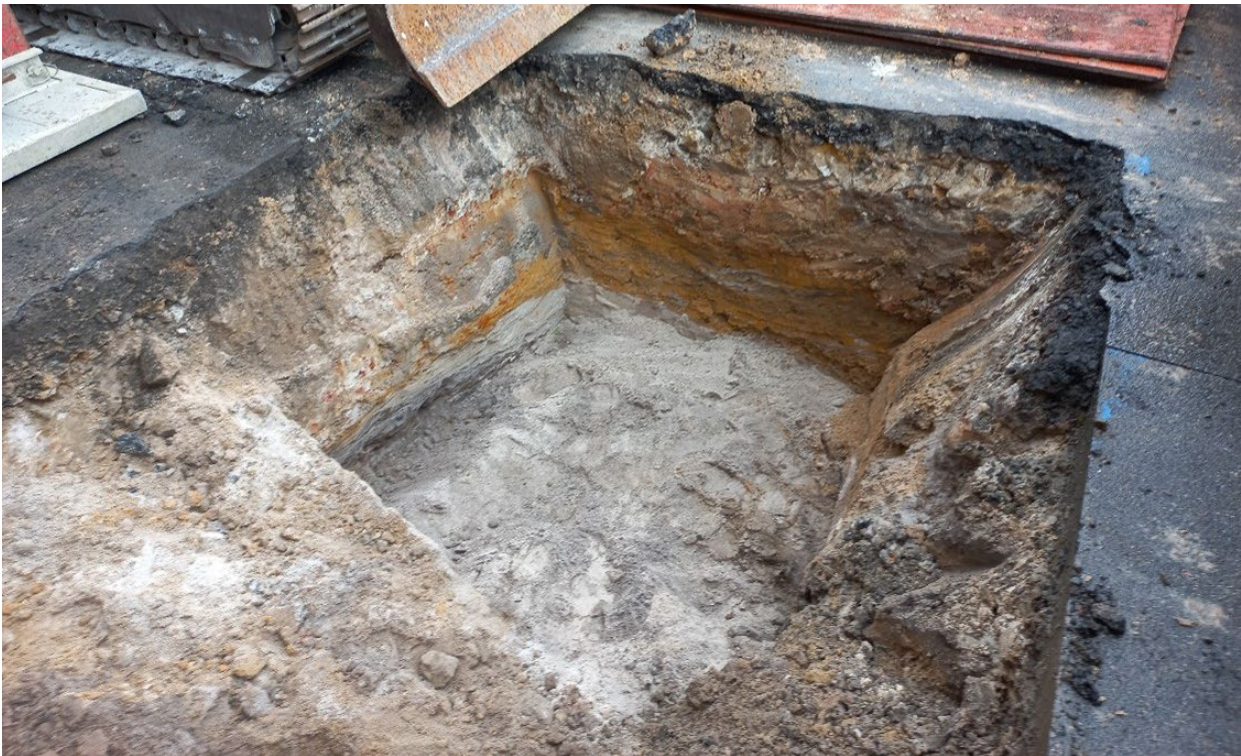
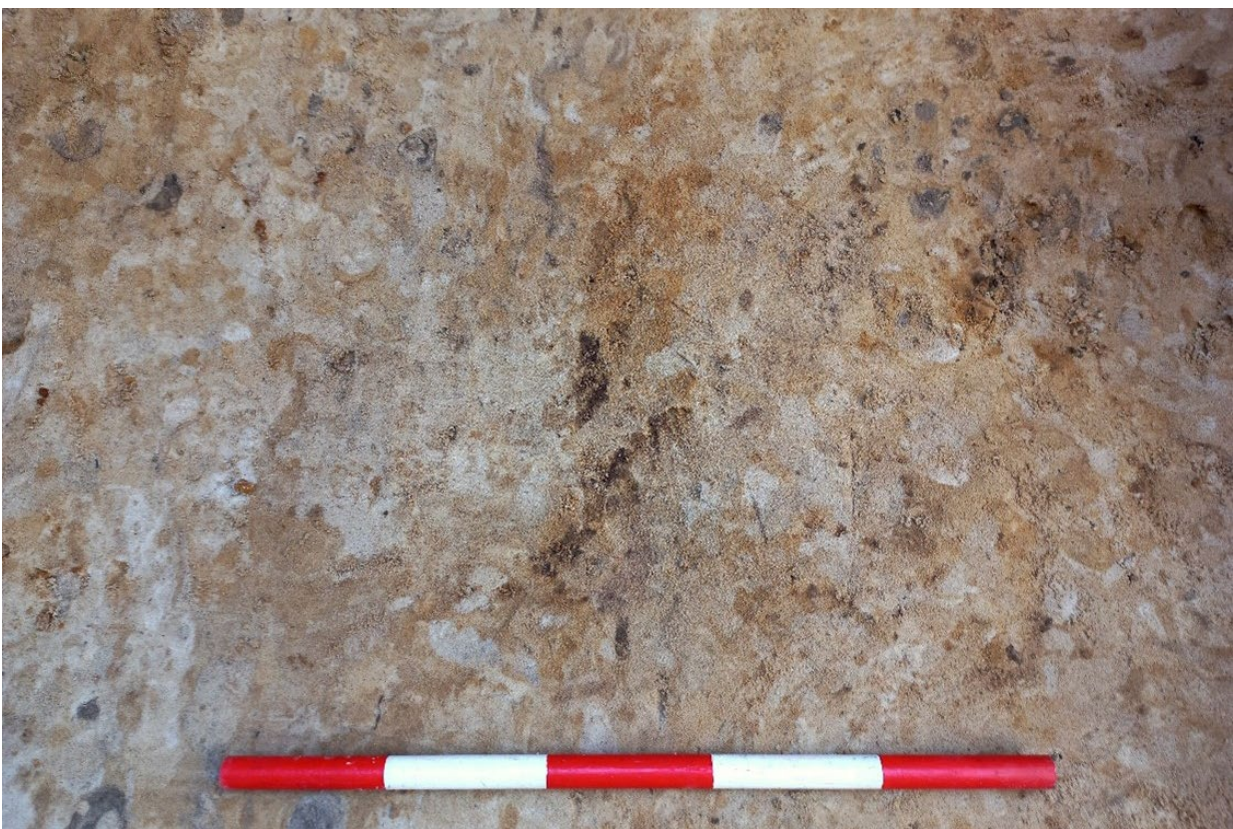
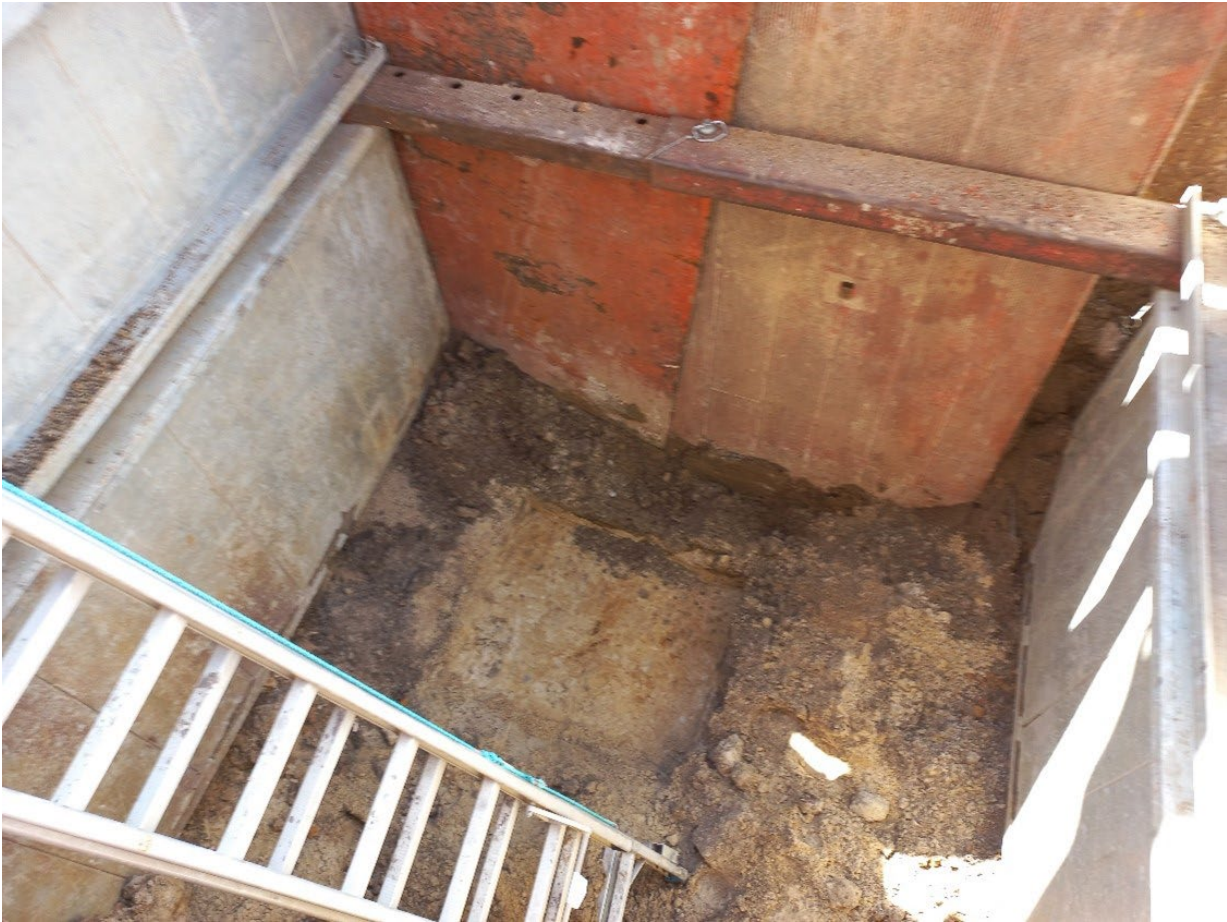
- Adina Ramp test trench UGF T5 encountered a truncated A2 sand unit with evidence of near-surface bioturbation. However, the nineteenth century A1 unit was missing, and no cultural features or structural material relating to the Benevolent Asylum period was found in T5. The evidence of bioturbation suggests that the trench was outside the footprint of the shed, and that its foundations may still be present elsewhere beneath Upper Carriage Lane. However, the description of this structure as a shed, the truncation of the A2 unit, and the removal of the nineteenth century A1 unit means that there may not be any intact occupation material associated with the interior, or with outside surface activity.

Figure 29 – Mixed sandy fill at -1300mm in Adina Ramp Trench UGF T5. View to the north.

Figure 30 – Bioturbated sands at -2200mm that are thought to represent a near-surface nineteenth century soil unit. Scale 500mm. North is at the top of the image.

Figure 31 – Exposed intact sand unit at -2200mm (base of historical archaeological investigations). View to the north.

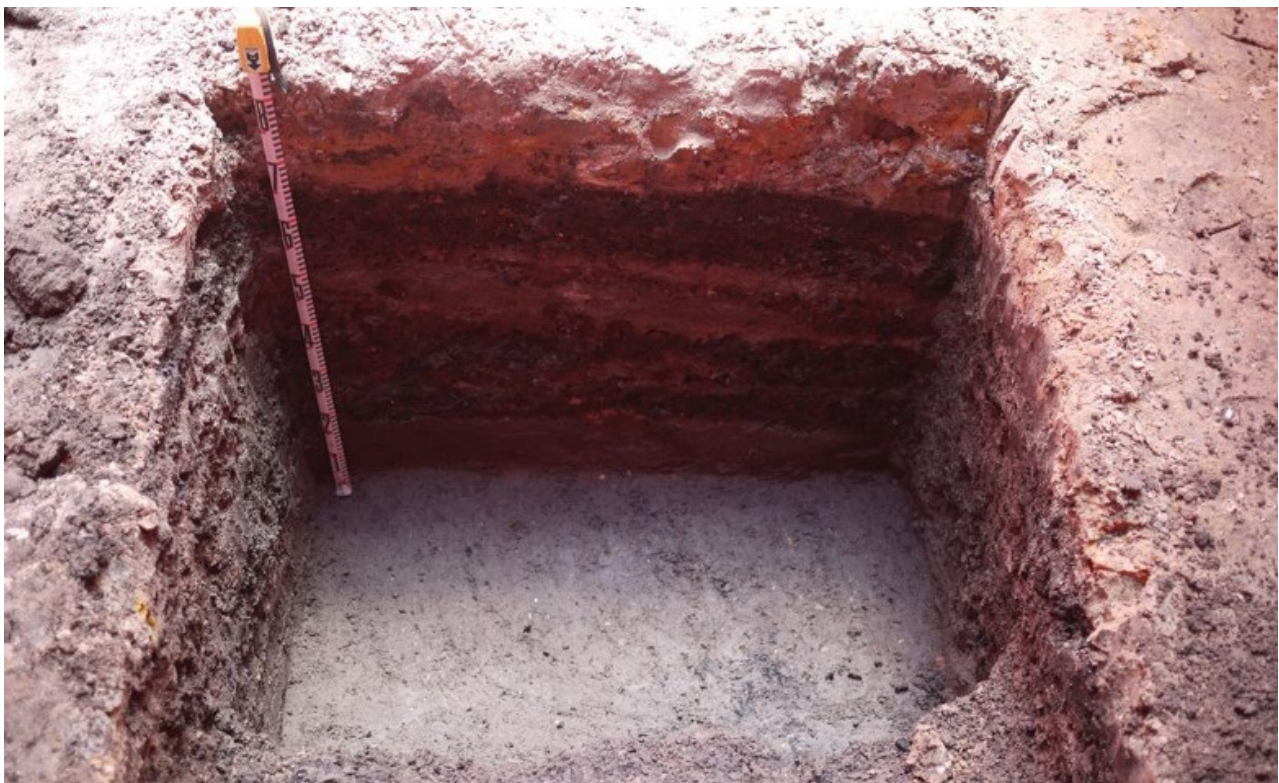
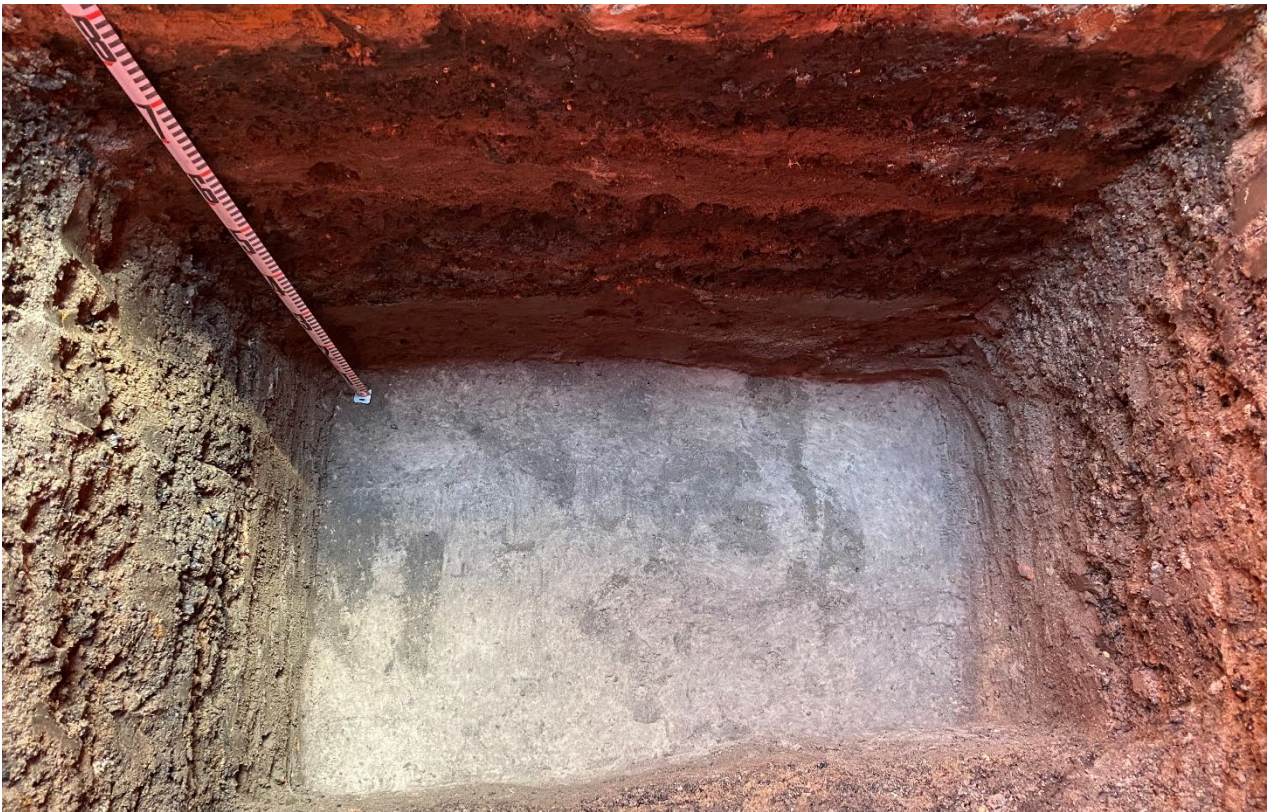
- Test trench UGF T3 encountered what is likely to be an intact A1 unit at around 3.8m below the rail ballast in the parcels shed dock. The soil contained an East India Company coin minted between 1844 and 1862, and a modified ceramic disc (often called a token and strongly linked to subaltern populations, institutionalisation and conditions of confinement). A sandy A2 unit was present below the A1 horizon and contained evidence of bioturbation and tool marks. The integrity of these units and the artefacts recovered confirm that archaeology associated with the Benevolent Asylum grounds is likely to survive in good condition in this area.

Figure 33 – Silty soil (context 019) at RL 16.26 in UGF T3. View to the south.

Figure 34 – Sandy A2 unit (context 020) exposed at RL 16.01m in UGF T3. View to the south.

Figure 35 – Tool marks in the sandy A2 unit at RL 16.01m. Scale 500mm.
