ATLASSIAN DEVELOPMENT

Archaeological Test
Excavation Report - Lower
Ground Floor, Adina Ramp
and Upper Ground
Floor/Platform 0

Prepared for
BOJV - DEXUS
30 November 2022

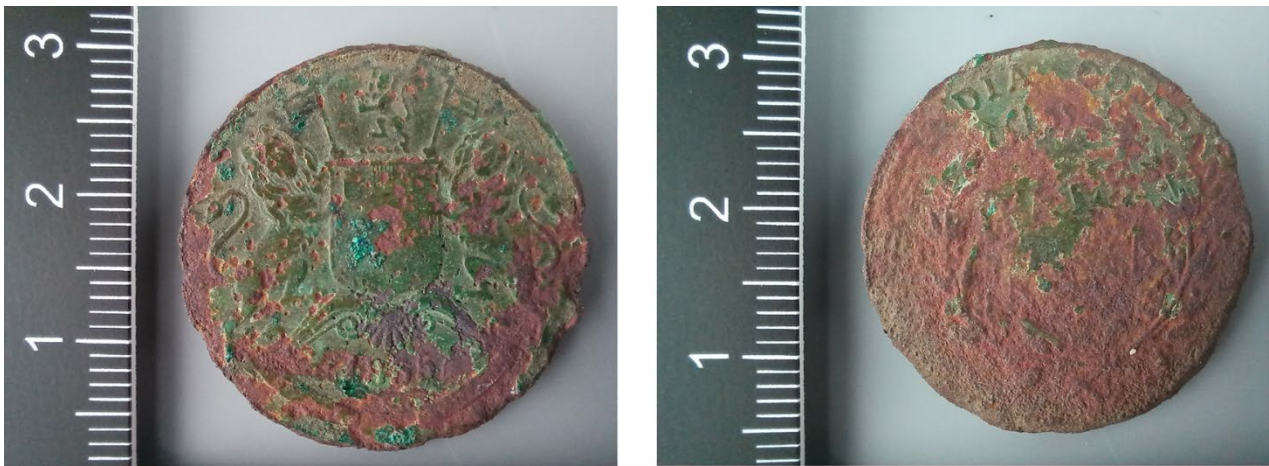
Figure 36 – 1835 East India Company half anna found in context 019. Scale in mm, numbers in cm.

Figure 37 – Modified ceramic object found in context 019. Scale in mm, numbers in cm.

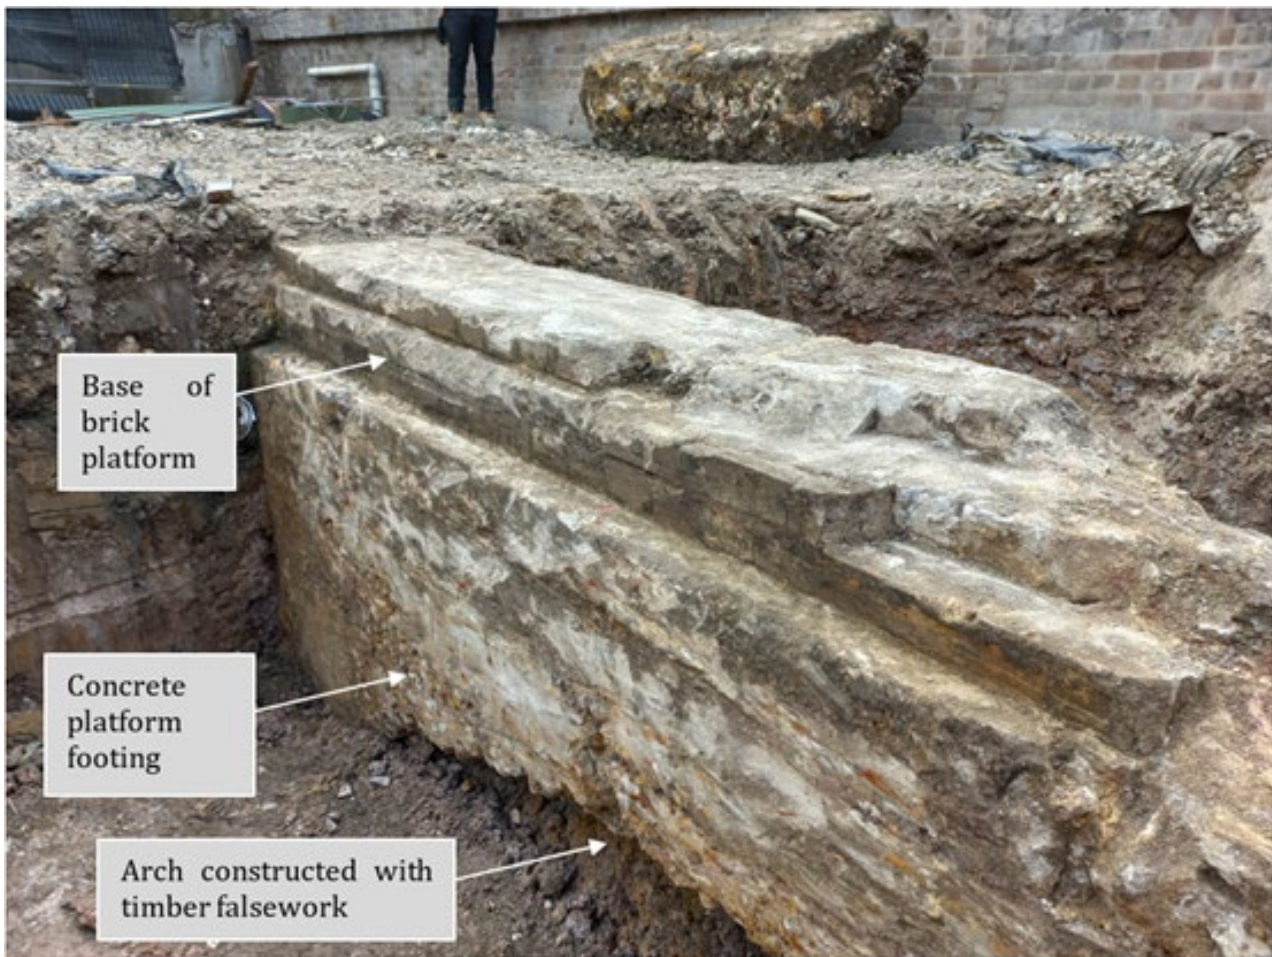
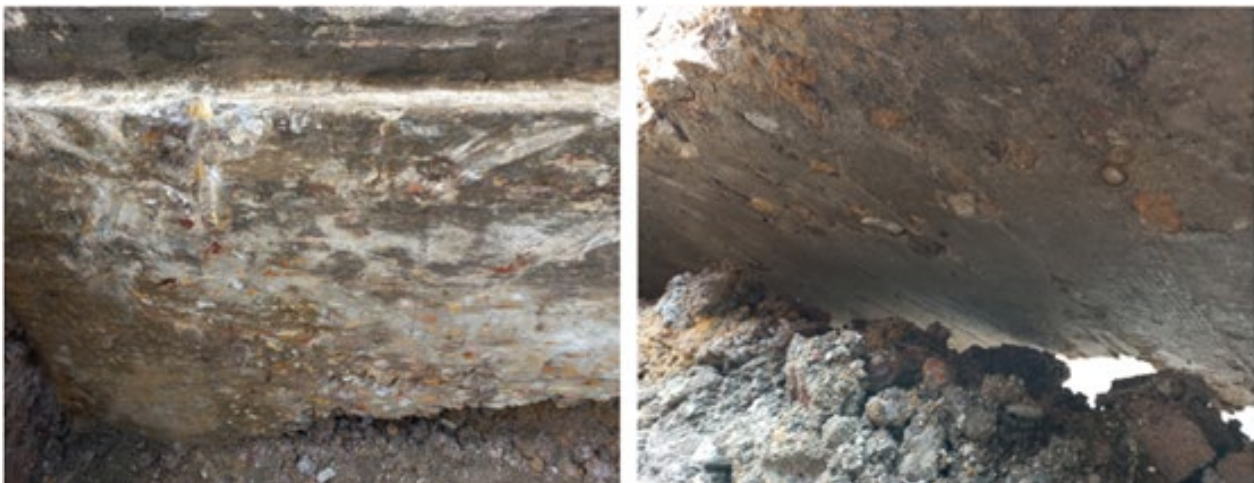
The footing had an arched base constructed with formwork (Figure 39 and Figure 40). Based on its location, the structure was identified as being the base of the wall for the original dock platform on the eastern side of the Inward Parcels Shed, adjacent to Platform 1 of Central Railway Station.

Figure 39 - Platform wall base identified in UGF T4.

Figure 40 – Exposed cyclopean concrete (L) and underside of the arch showing timber formwork impressions (R).

The presence of an intentionally formed arch is an unusual aspect of the footing, and not a standard component of this platform design. The exposed section of the arch has a low, wide profile and was constructed with timber falsework based on the impressions left by the timber in the concrete (Figure 40). The profile of the arch is similar to other arches observed throughout Central Station, and in particular the surviving luggage tunnels underneath the station (Figure 41). It is possible that the arch in the footing was created to accommodate a tunnel or services beneath, which may never have been realised or may have been redesigned for construction elsewhere in the station.

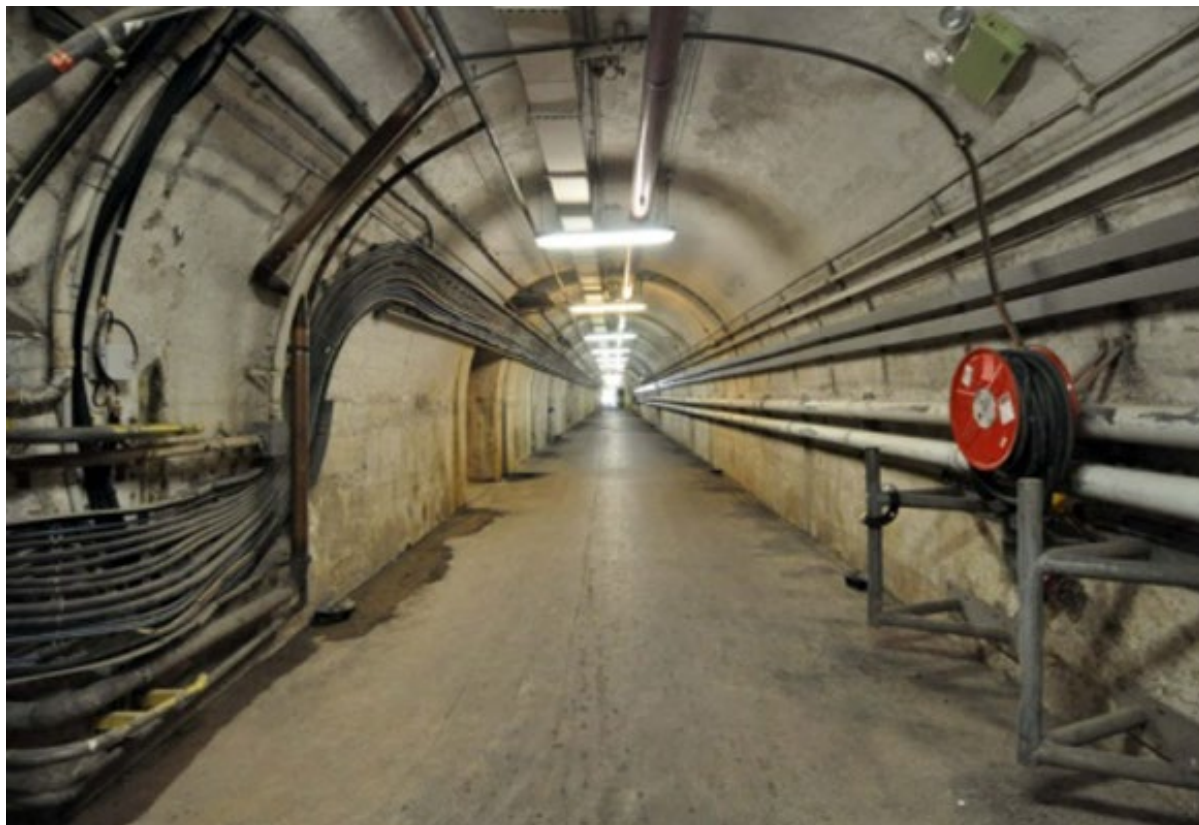
Figure 41 – Typical view of tunnels originally constructed beneath platform level to move parcels and baggage around.
