Soil Quality Assessment

Assessment Site: "Yarran Hut" Mitchell Highway, Nyngan NSW

Client: BayWa r.e. Projects Australia Pty Ltd

Project Name:	Soil Quality Assessment
Client:	BayWa r.e. Projects Australia Pty Ltd
Project No.	32626
Report Reference	32626 ER-00
Date:	22/04/2020
Revision:	Final

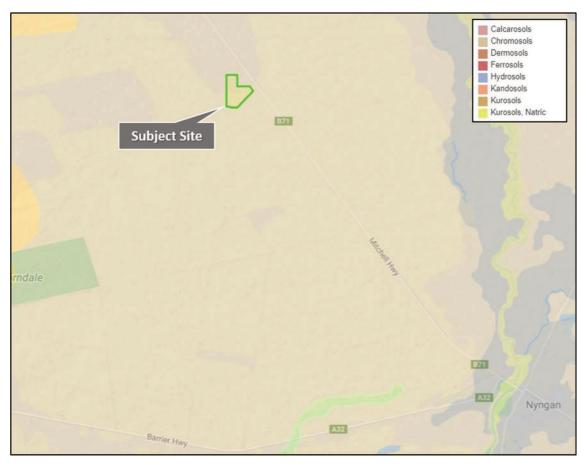
Figure 2.2 – Soil type at the subject site.

Figure 2.2 presents mapped soil type data from the NSW Soil and Land information system, indicating the location of the subject site and the extent of the Chromosoil soil type.

Information from the NSW Soil and Land information system (OEH 2016) indicates the soil type where the subject site is located as Brown Chromosoil and describes it as fragile and medium textured with low organic matter content.

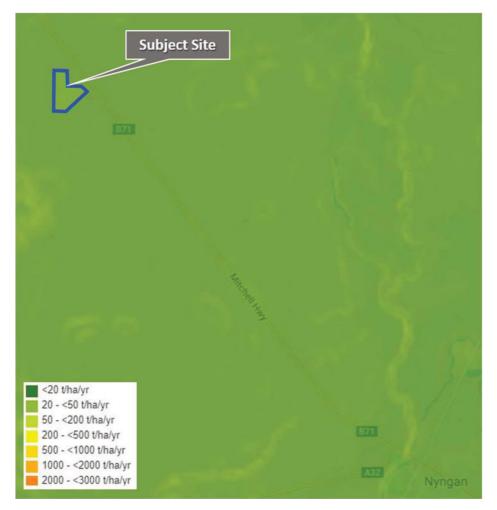
Figure 3.2 – Bare soil erosion rate.

The NSW Soil and Land information system (OEH 2016) publishes soil erosion rates for the Nyngan area. The estimated soil erosion rates are determined using the RUSTLE model and values are presented for erosion of bare soil as well as soil with a vegetation cover. Figure 3.2 and Figure 3.3 show the mapped soil erosion rates for the two conditions. At the subject site (indicated in both Figures) the erosion rate for bare soil is estimated at 20 to 50 tons/hectare per year, while the rate for covered soil is 0.2 to 0.5 tons/hectare per year.

Considering the high erodibility of the sandy clay-loam surface soil type present at the site, the soil erosion rates estimated for the subject site are relatively low. This is likely attributable to the land being mostly flat, thereby avoiding high velocity rainwater runoff. Although there is some debate as to what can be considered a low soil erosion rate, a value of 6 tons/hectare per year is generally accepted as tolerable.

The values estimated for the subject site indicate that under bare soil conditions, soil erosion potential is unacceptable. However, with vegetation cover the rate of soil erosion can be reduced by a factor of 100 to well below tolerable rates.
