# APPENDIX S GEOTECHNICAL DESKTOP ASSESSMENT

REPORT TO  
**INFRASTRUCTURE NSW**

ON  
**GEOTECHNICAL DESKTOP ASSESSMENT**

FOR  
**POWERHOUSE PARRAMATTA**

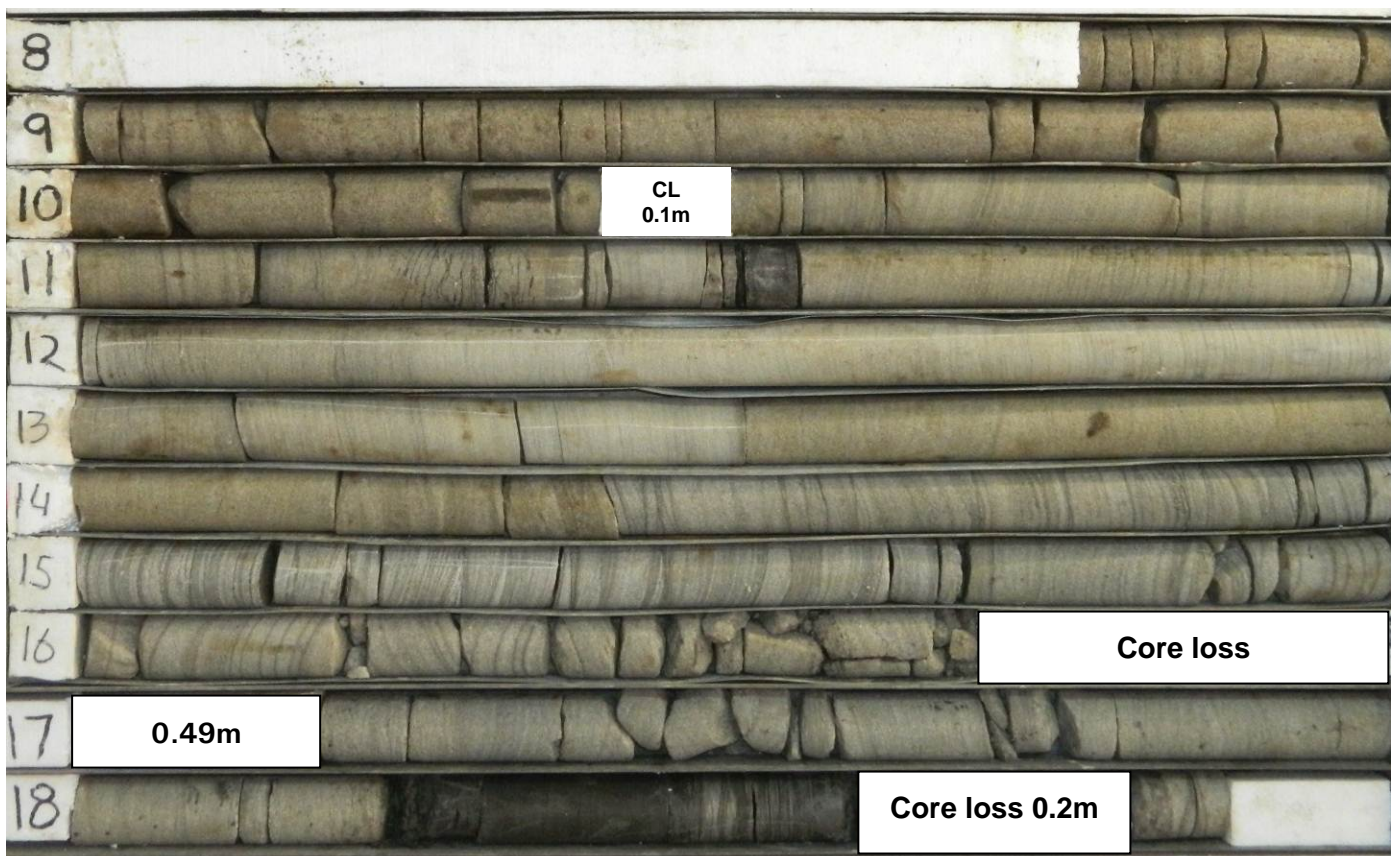
**BH106**

**Start Coring at 8.76m**

**End of hole at 18.87m**

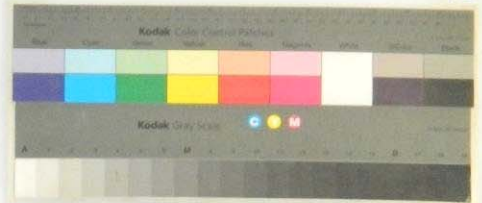
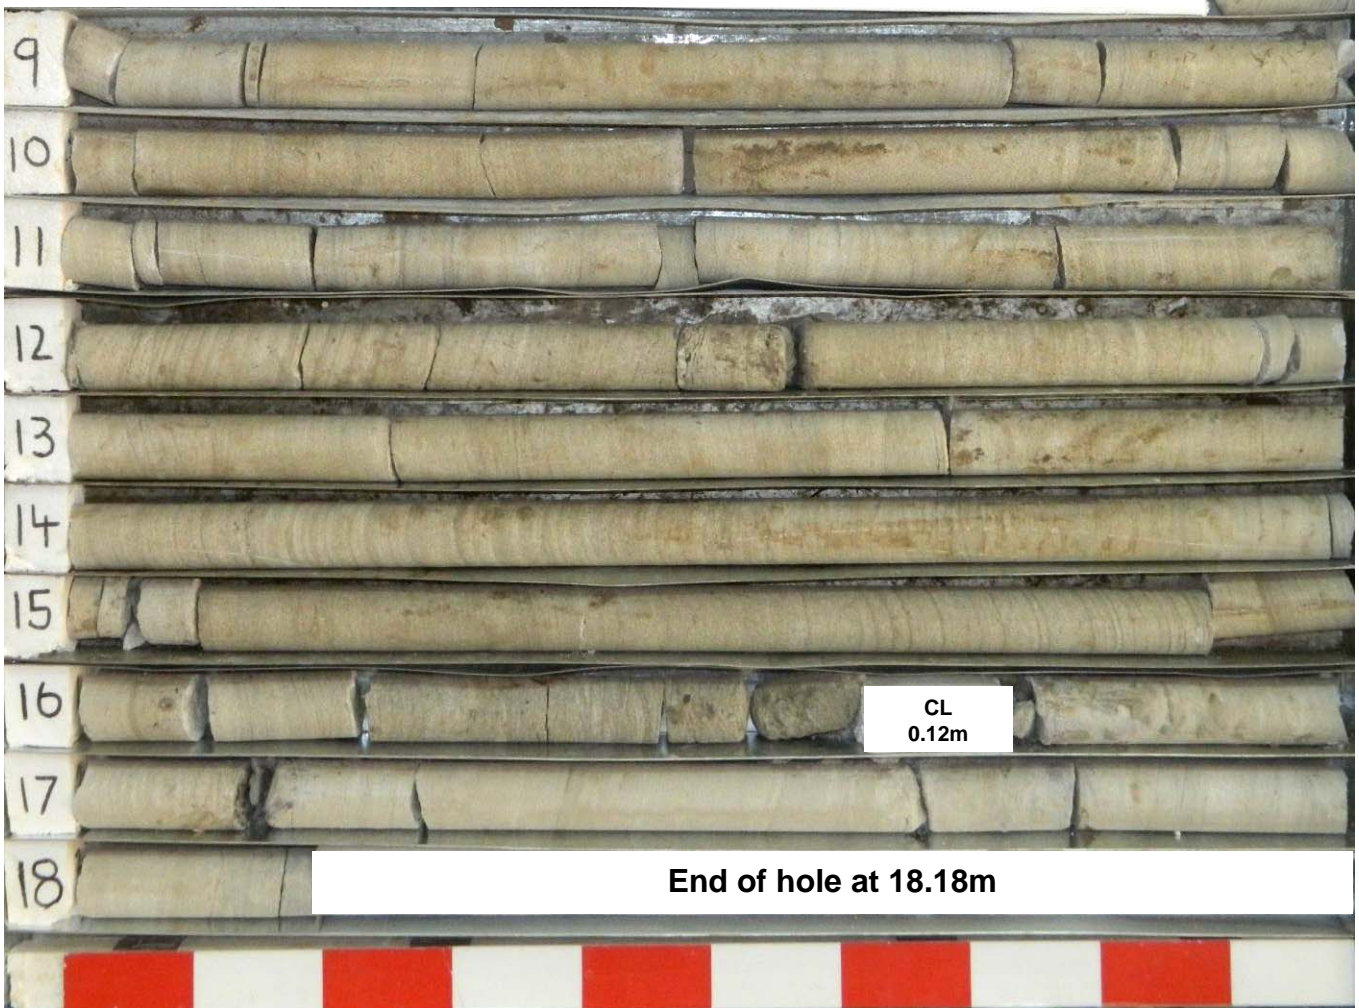
BH108

Start Coring at 8.87m
