**Powerhouse Parramatta- SSD10416- HARDEM**

# Historical Archaeological Research Design and Excavation Methodology

Parramatta Powerhouse site

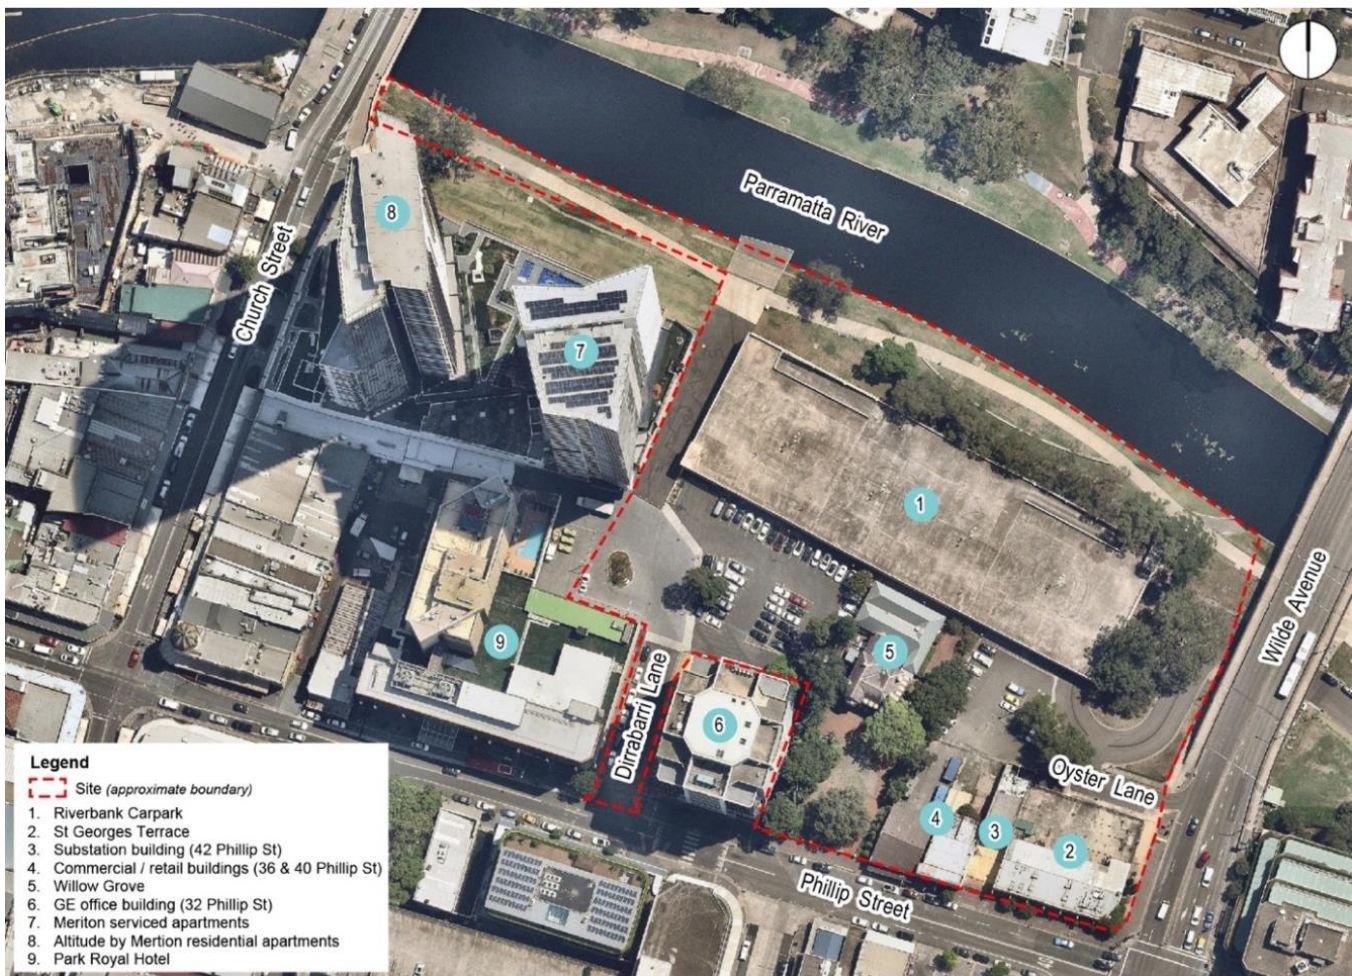
Figure 1-1 Study area boundary, key features (prior to demolitions), and immediate local context. (Source: Ethos Urban 2020)

The study area is located at the northern edge of the Parramatta CBD on the southern bank of the Parramatta River (Figure 1-1). It occupies an area of approximately 2.5 hectares and has extensive frontages to Phillip Street, Wilde Avenue and the Parramatta River. A small portion of the study area extends along the foreshore of the Parramatta River to the west, close to the Lennox Street Bridge on Church Street. The study area boundary is identified in. The study area excludes the GE Office Building at 32 Phillip Street. The site has been subject to the demolition of the car park and the rear of St Georges terrace and many of the features identifiable in 2020 no longer remain (Figure 1-2).

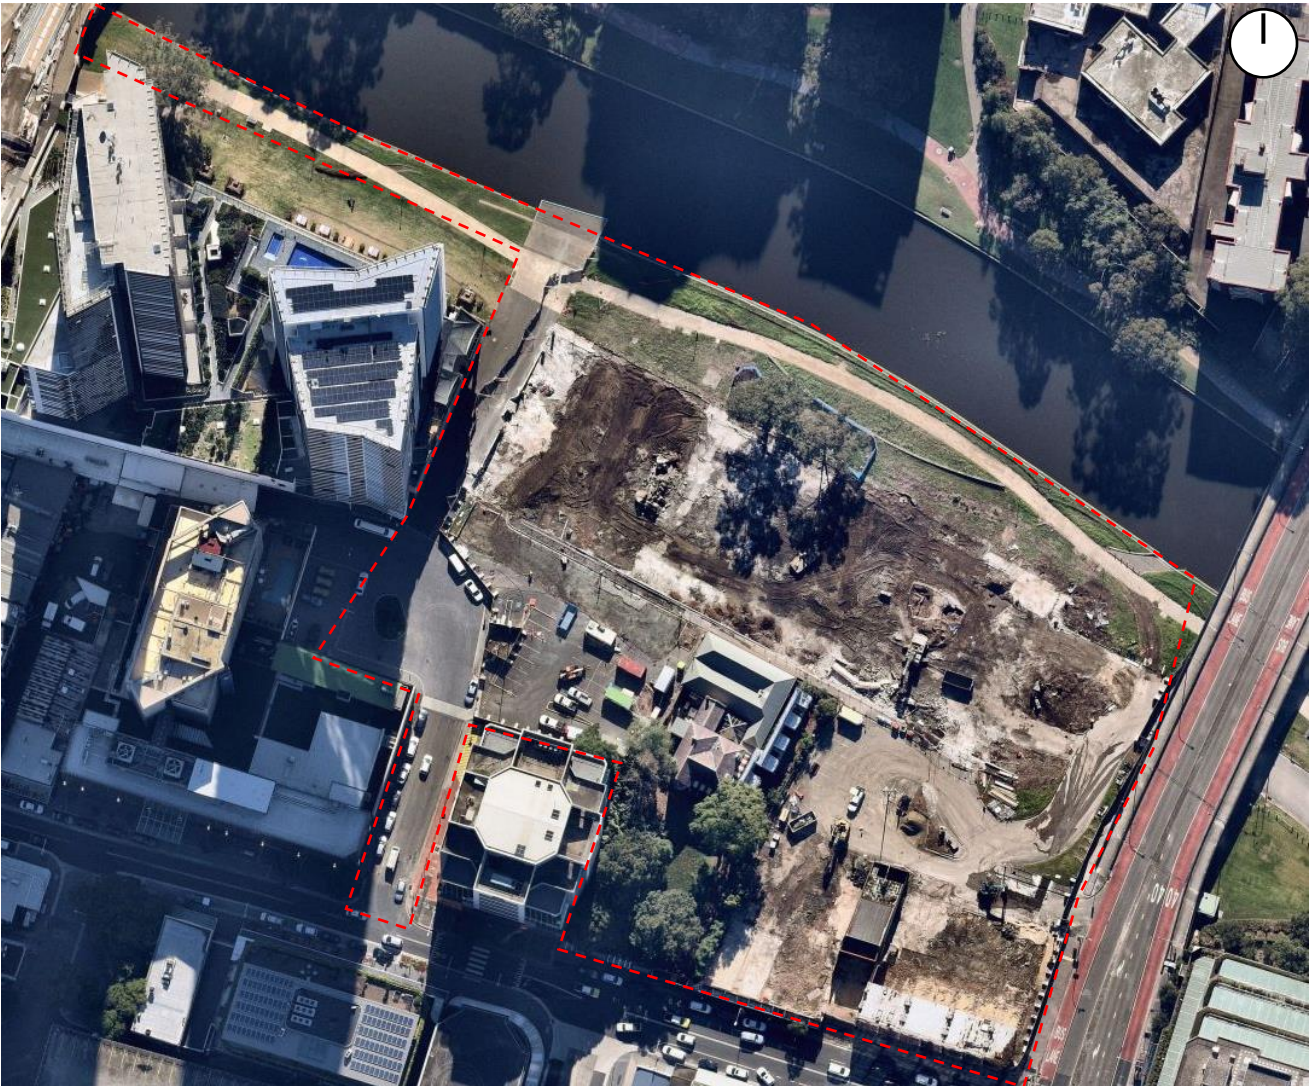
Figure 1-2 The site in early June 2021 with the car park in the process of demolition. (Source: Near Map)

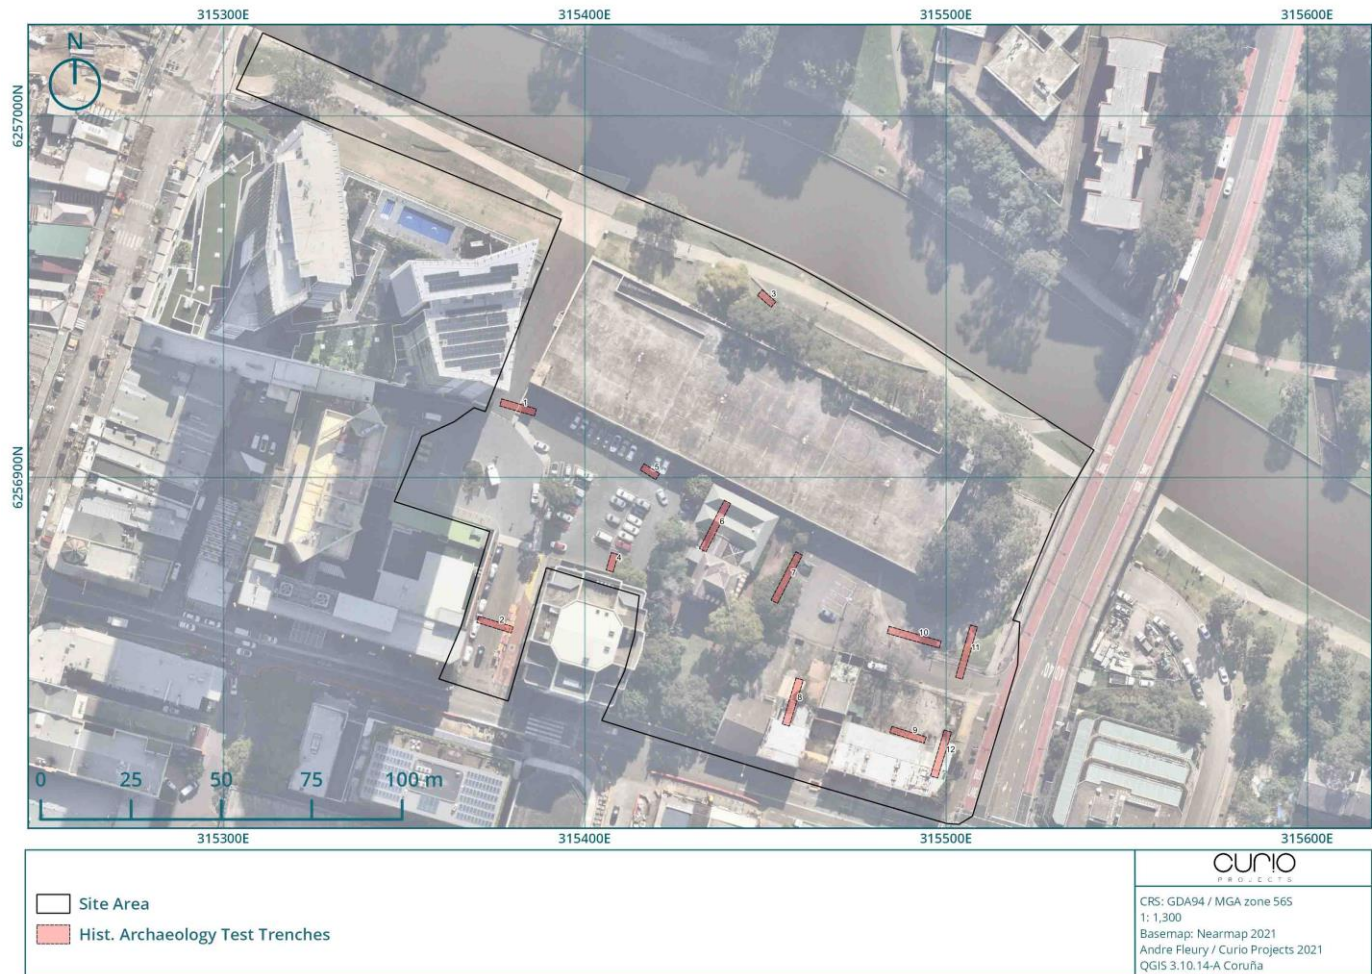
Figure 2-1 Test Trench locations on the Powerhouse site. (Source: Curio 2021)

As noted above an ARD Addendum was completed based on revised impacts for the Powerhouse Museum design. That Addendum proposed that 12 test trenches be undertaken across the site based on the assessed level of archaeological potential and development impacts upon that potential (see Figure 2-1). Those test trenches were:

The specific test trench locations set out in the ARD Addendum had to be refined on site after consultation with the contractor due to contamination concerns.

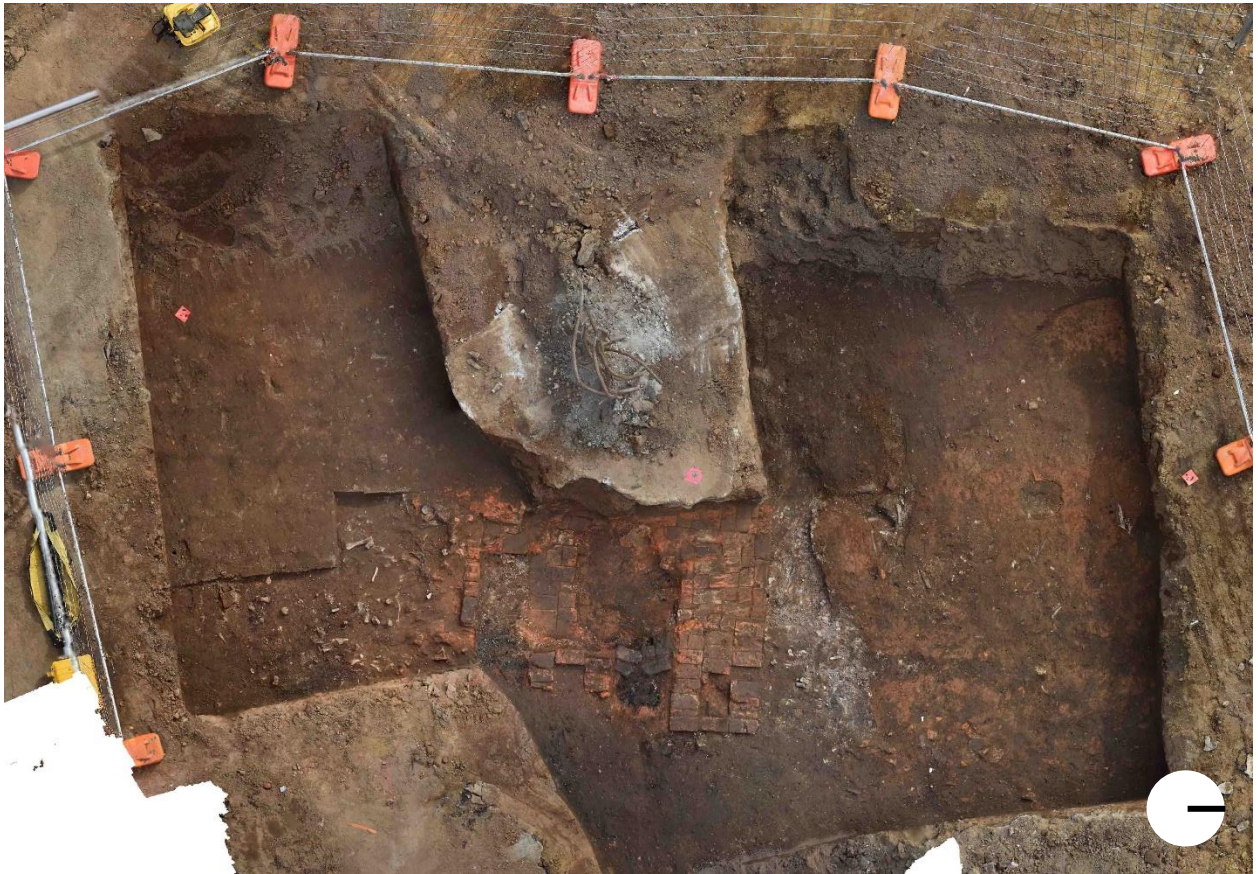
Archaeological monitoring was undertaken in the area of the former car park. Here the bitumen surface was lifted and the concrete support piles of the car park were removed under archaeological supervision. During this monitoring a sandstock brick feature was exposed and recorded over several days commencing June 3, adjacent to pile location K3 (see Figure 2-2 and Figure 2-3).

The structure was constructed of sandstock bricks bonded with a thin lime mortar. Surrounding the structure was a substantial deposit composed of large bone fragments (primarily lower limbs of beef). The structure showed evidence of two small fire pits and some charring on the bricks. This and the bone deposit provide a tentative interpretation of the structure as a form of small-scale industrial building, possibly dating between 1820 and 1850.

Figure 2-2 Brick structure in car park area prior to full exposure. Note bone deposit at either end.

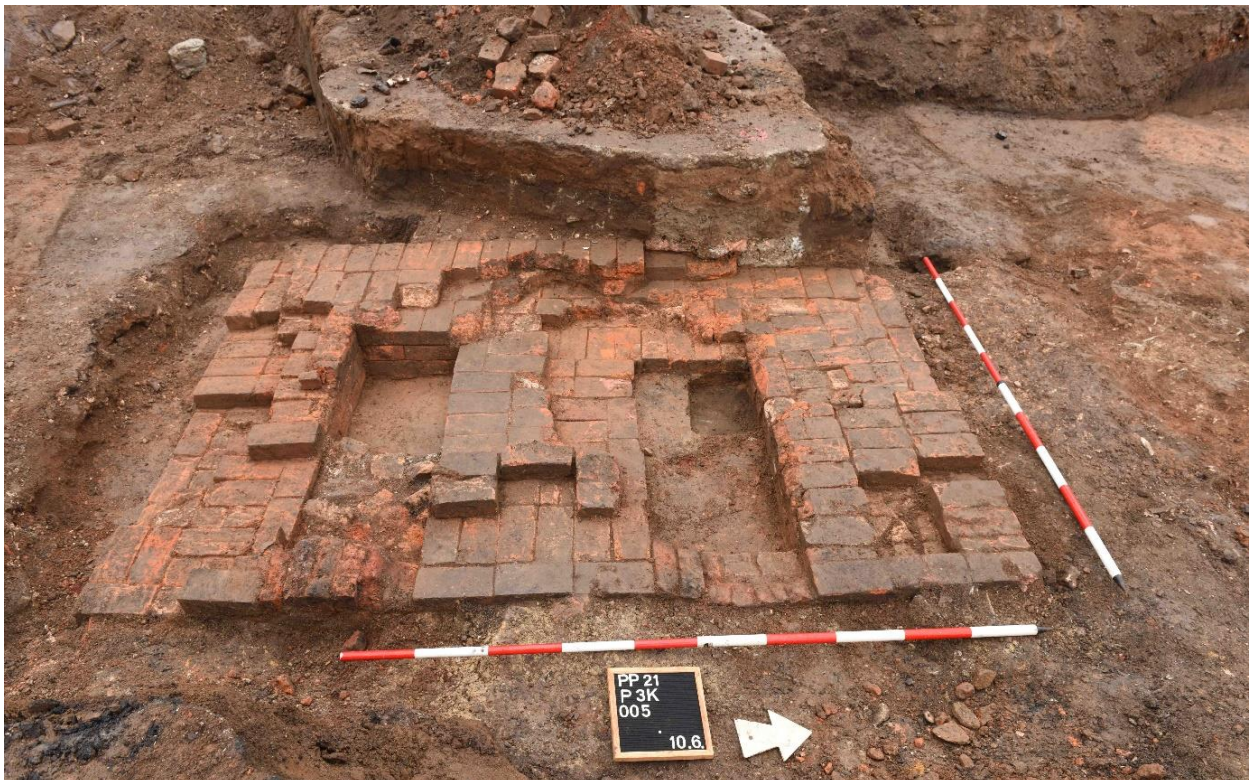
Figure 2-3 Possible industrial brick structure adjacent to pile location K3.

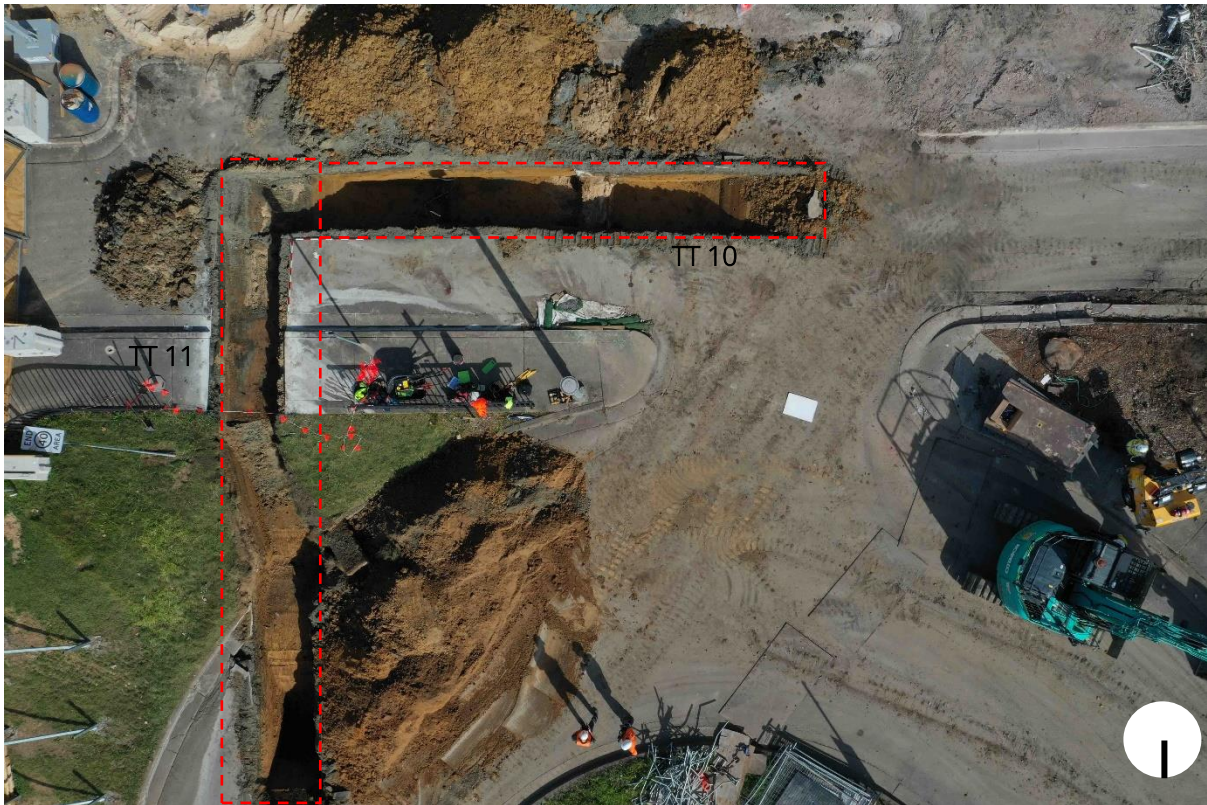
TT 10 and TT11 were excavated on June 7 by machine to a maximum depth of 3 m in TT 11 and 1.5 m in TT 10 (see Figure 2-4 and Figure 2-5). Both trenches were eventually closed due to OH&S considerations (i.e. maximum safe depth had been reached). The deposit revealed in both trenches was a yellow brown clayey silt used to create the on-ramp for access onto the Barry Wilde bridge. A former surface composed of thin bitumen was exposed at the base of TT 11. Below this surface a rubbish deposit containing numerous stoneware bottles was recovered. Despite the depth of the excavations, the early 19th Century surface was not identified. The area of these trenches may still retain archaeological potential.

Figure 2-4 Aerial photo showing TT 10 and TT 11.

- TT 10 and TT11 have produced inconclusive results and further trenching, or monitoring is warranted in this area to determine if features survive the construction of the Barry Wilde Bridge, the abutments and approach ramps. Structures from both the 1804 and 1822 plans of Parramatta are indicated in this part of the site.

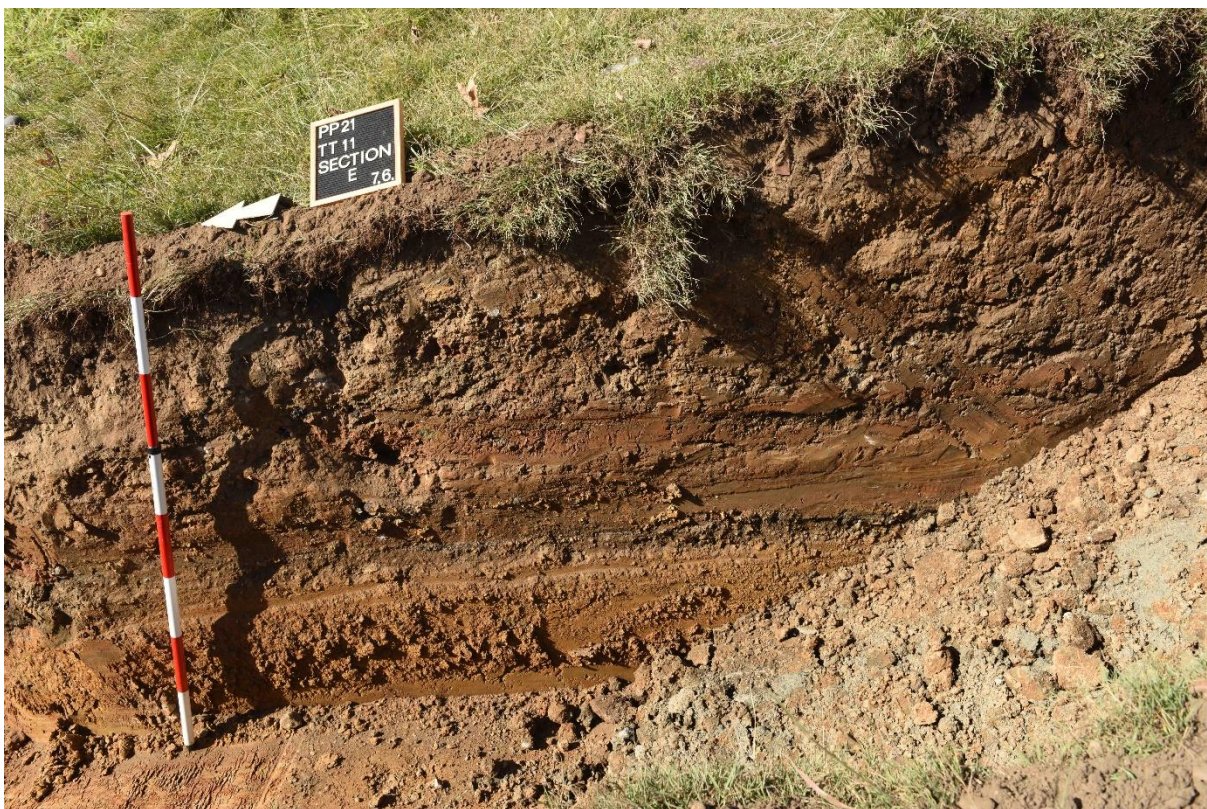
Figure 2-5 East Section of TT 11 showing clayey fill over 1.5 m deep.

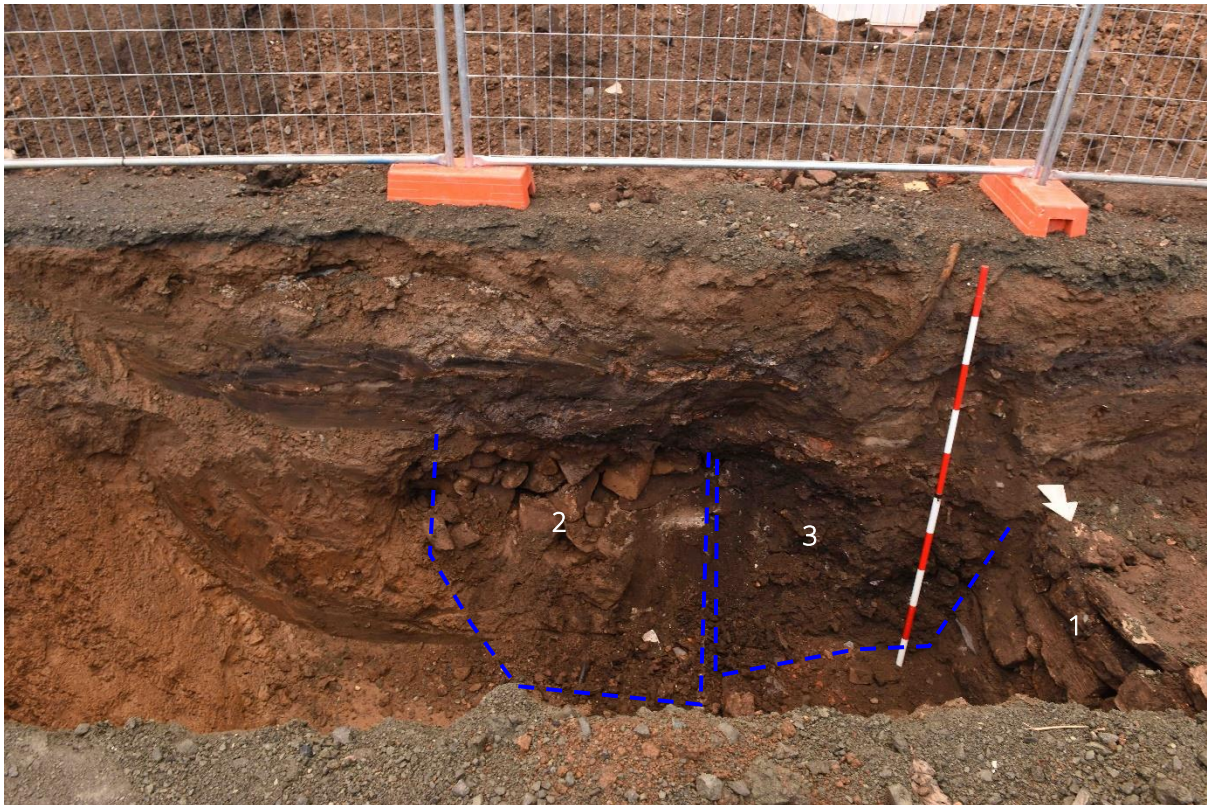
TT 05 was excavated by machine on June 8. This was excavated to a maximum depth of 3 m. The sides of the sandstone drain were encountered approximately 1.6 m below the current car park surface. The walls of the drain were composed of sandstone rubble set in uncoursed dry stone construction (Figure 2-8). Within the drain was a dark brown to black sandy deposit containing numerous artefacts of the later 19th and 20th centuries. The drain was identified as a dry-stone sandstone open drain that remained open and possibly active well into the 20th century.

Figure 2-6 TT 05 showing western wall (1) of stone lined open drain with eastern wall (2) and internal fill (3) removed.

- TT 05 has demonstrated that the drain crossing the site south to north survives at depth, at least in the southern portion of the site. The current identification and testing conclude the recording of this feature.

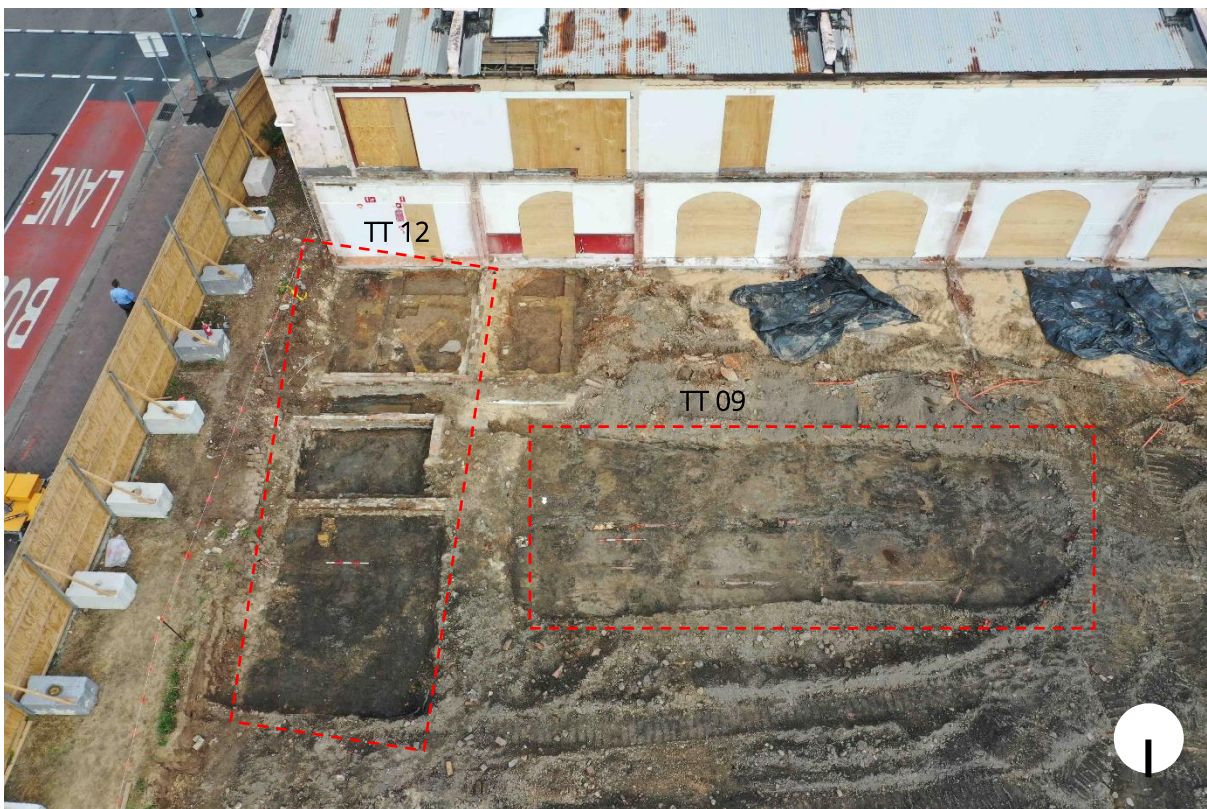
Building remains within the areas of TT 08, TT 09 and TT 12 were cleared by machine under the supervision of an archaeologist beginning on May 31 (see Figure 2-9 and Figure 2-11). Further machine and hand clearance revealed sandstone structures, early brick surfaces in TT 09 and TT 12 corresponding to structures shown in the 1823 and 1844 plans of the area (see Figure 2-10). Within a room of the stone structure in TT 08 the top of a brick well was exposed (Figure 2-12). Its location within the room suggests it probably pre-dates the construction of the building and may currently be the oldest building remains on the site. The clearance of TT 09 revealed a modified natural deposit (possibly a bleached A2 part of the soil profile), indicating the potential survival of early surfaces and deposits in this area. No substantial structure was exposed in TT 09 however two clay packed post holes were exposed indicating the location of a former timber structure here. The results suggest that the area behind St George's Terrace and to the west of the substation have substantial archaeological potential. It also highlights the potential for survival of similar remains around Willow Grove.

Figure 2-9 Aerial photo showing relationship of TT 09 and TT 12 at rear of St Georges Terrace.

- TT 08, TT 09 and TT 12 have revealed structures and deposits that warrant archaeological salvage excavations at the rear of St George's Terrace and to the west of the substation. The remains in these areas correspond to structures shown in plans from the 1820s and 1840s with some features (i.e., the well and post holes) reflecting occupation dating even earlier.

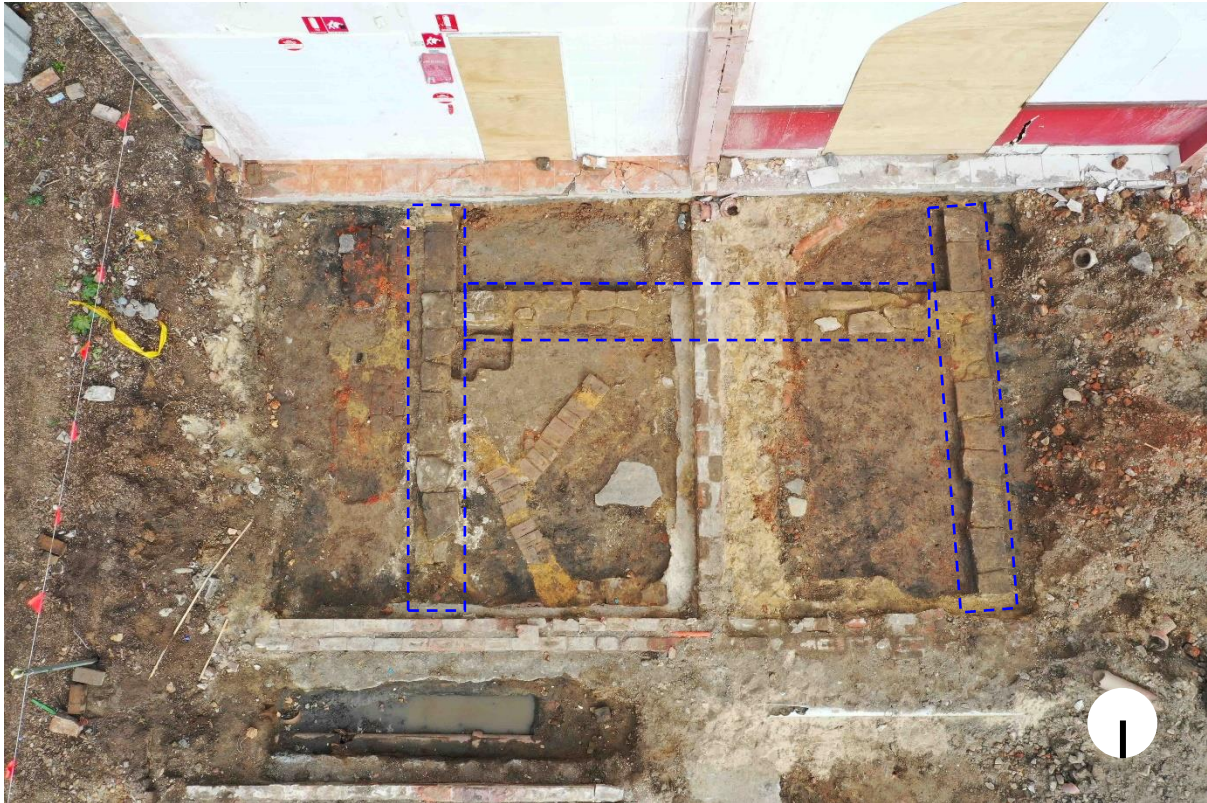
Figure 2-10 Detail of TT 12 showing stone footing two roomed structure (blue dotted line) corresponding to a structure shown in the 1823 plan of Parramatta.

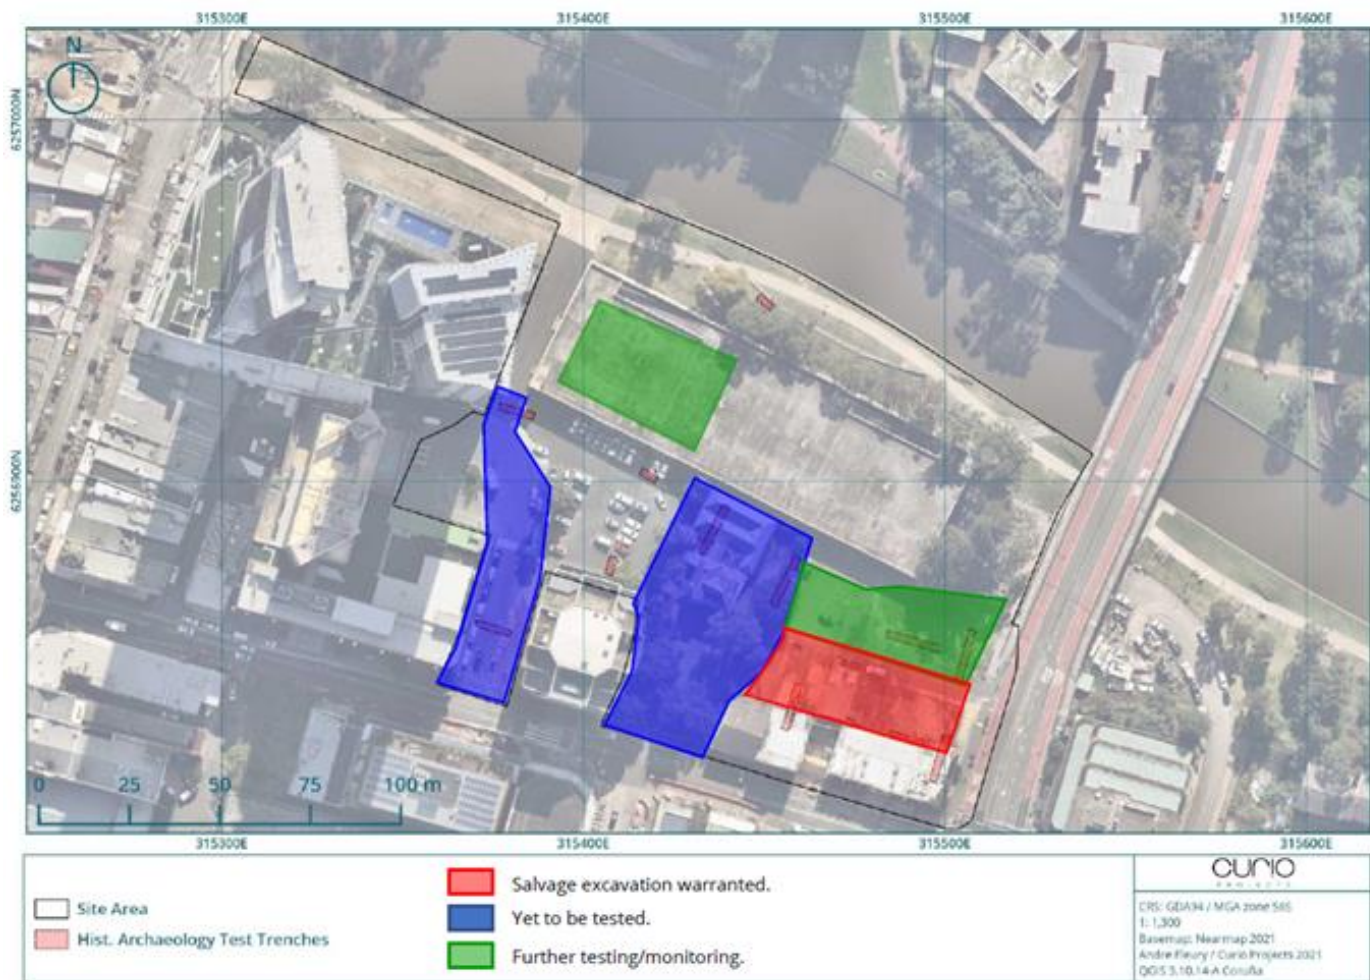
The archaeological testing and monitoring that has been completed demonstrates that the site retains areas of substantial archaeological potential (refer to Figure 2-13).

Figure 2-13 Areas of future recommended archaeological work on the Powerhouse site

It is therefore recommended that further testing, archaeological monitoring and salvage be undertaken on the site as set out in Figure 2-13 (see Section 3).

Test trenches 1, 2, 6 and 7 shown in the blue area of Figure 2-13 should be excavated as set out in the ARD Addendum when these areas become available. That methodology was set out in the 2020 Addendum.

Areas indicated as green in Figure 2-13 should be subject to archaeological monitoring during excavation works. In addition, the Unexpected Finds procedure will continue to operate on the remainder of the site. That procedure comprised:

The area indicated as red in Figure 2-13 should be subject to archaeological salvage excavations.

At this stage salvage excavation would be proposed for the area coloured red in Figure 2-13 after the demolition of the EEC but prior to the commencement of the piling program and would
