Aquatic Ecology Assessment

MOUNT PLEASANT OPTIMISATION PROJECT AQUATIC ECOLOGY ASSESSMENT

**PREPARED FOR
MACH Energy Australia Pty Ltd**

13 November 2020

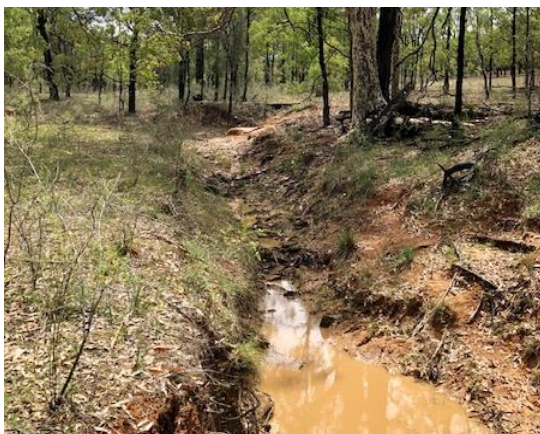
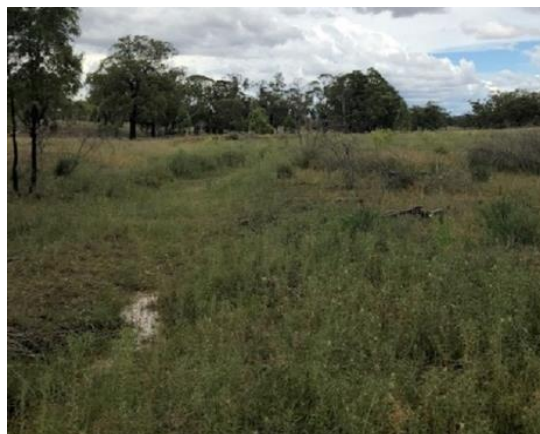
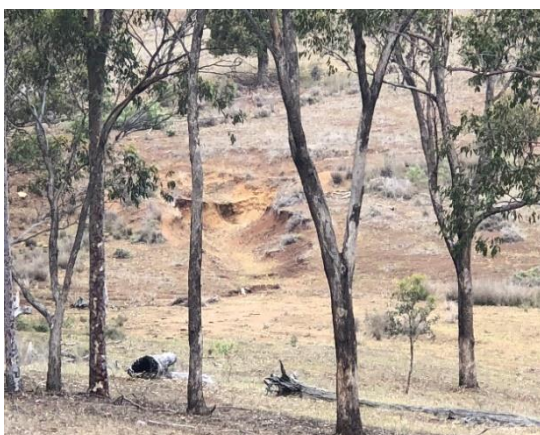
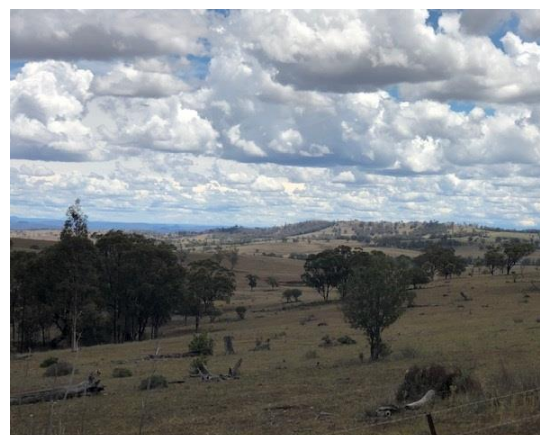
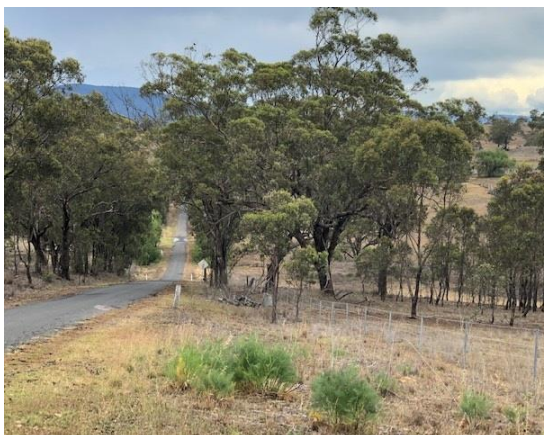
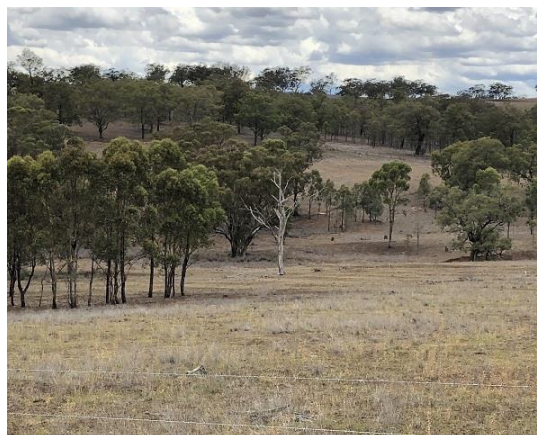
Plate 1: Unnamed Drainage Line – UD1.
Near WRA1L, looking upstream
(28/11/18).

Plate 2: Unnamed Drainage Line – UD1.
Near WRA1L, looking downstream
(28/11/18).

Plate 3: Unnamed Drainage Line – UD2.
View downstream from Castlerock
Road (28/11/18).

Plate 4: Unnamed Drainage Line – UD2.
View upstream from Castlerock Road
(28/11/18).

Plate 5: Unnamed Drainage Line – UD3.
View west along Castlerock Road
(28/11/18).

Plate 6: Unnamed Drainage Line – UD3.
View west from Castlerock Road
(28/11/18).

The banks of these drainage lines were largely cleared of trees and riparian vegetation and there was evidence that livestock regularly grazed and trampled the stream bank and channel (Plates 1-6). Habitat for aquatic fauna, such as rocks, snags and aquatic macrophytes was largely absent.

Several ill-defined ephemeral drainages cross the Study Area (Figure 3, Plates 1-6). After sufficient rainfall, surface water in the unnamed drainage lines surveyed within the Study Area and from Castlerock Road (Sites UD1, UD2 and UD3) mostly drains east to west into Sandy Creek.

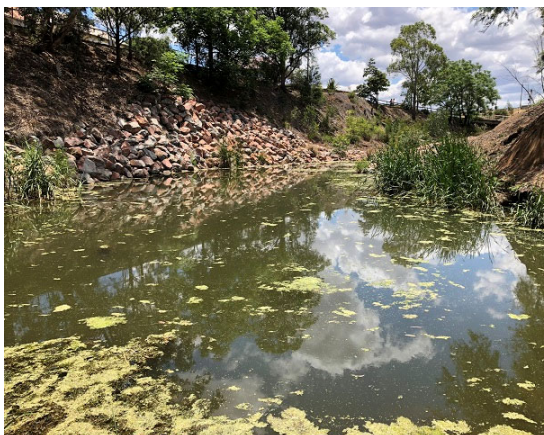
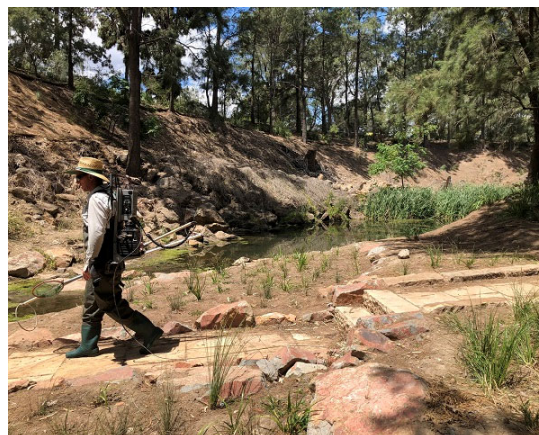
Plate 7: Musle Creek – MC. View downstream (26/11/18).

Plate 8: Musle Creek – MC. View upstream (26/11/18).

The stream bank is mostly clear of vegetation with the exception of some well-established trees (River Oak and River Red Gum) and shrubs (such as Mat Rush) that appear to have been planted to stabilise the stream bank and reduce erosion (Plates 7 and 8). Emergent macrophytes, including Phragmites, Bulrush and Mat Rush, are moderately abundant in-stream. The small floating fern *Azolla* (*Azolla* sp.), Duckweeds (*Lemna* sp.) and aggregations of green macro-algae are often present. Conductivity levels have been as high as 1,589 $\mu\text{S}/\text{cm}$.

The site sampled in Muscle Creek is situated on the floodplain approximately 1 km upstream of the confluence with the Hunter River (Figure 6). The stream channel is highly modified with imported rock used in places to stabilise the bank (Plates 7 and 8). Average stream width was approximately 10 m, but approximately 0.5 m wide immediately downstream of a small pedestrian crossing across the middle of the study reach and up to 16 m in the larger, relatively deep (up to approximately 2 m deep) pool at the downstream end of the site. The substratum has been dominated by silt and gravel with some cobble, pebble and rock. A submerged species of macrophyte, Blunt Pondweed (*Potamogeton ochreatus*) has commonly been present.

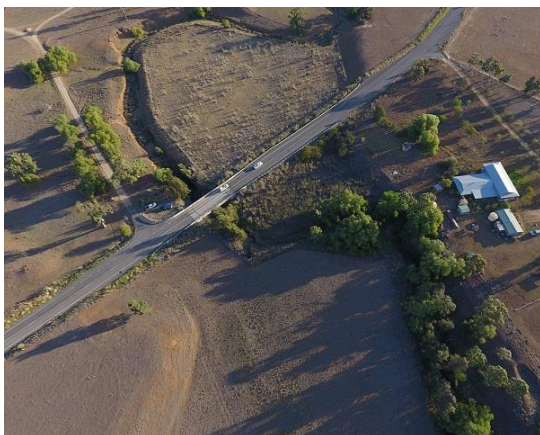
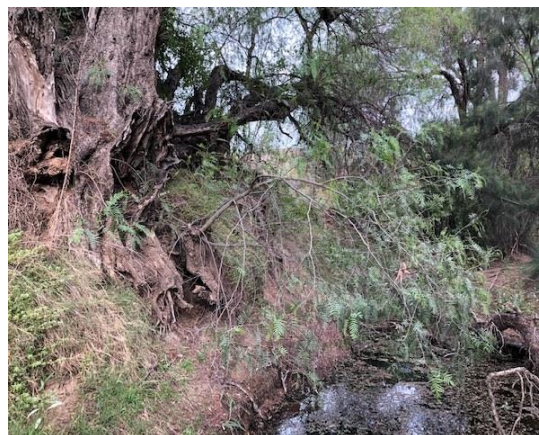
Plate 9: Sandy Creek – SC. Aerial view (10/5/18).

Plate 10: Sandy Creek – SC. View upstream (27/11/18).

The stream banks are approximately 3 m high and heavily disturbed on either side by historical agricultural activities. Erosion and undercutting of the stream bank are apparent in areas not bound by River Oak or exotic trees and grasses (Plates 9 and 10).

The site sampled in Sandy Creek is located downstream of the MPO and upstream of Mangoola Coal (Figure 6). Wybong Road crosses the stream immediately downstream of the Study Area. Stream width ranged from 1 m to greater than 7 m (Plates 9 and 10). The maximum depth of the largest pool has been up to approximately 0.5 m, the substratum of which is predominantly clay and silt with an anoxic layer. Dense stands of *Typha* and *Phragmites* have colonised the stream channel downstream of the pool.

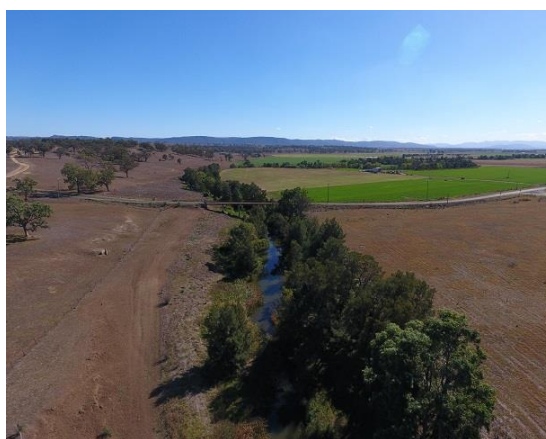
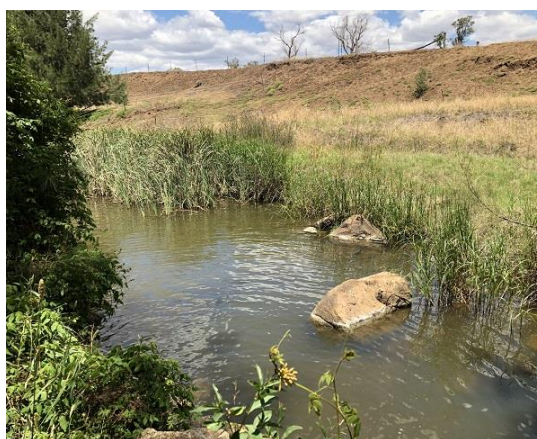
The stream banks are approximately 3 m high and heavily disturbed on either side by historical agricultural activities. Erosion and undercutting of the stream bank are apparent in areas not bound by River Oak or exotic grasses (Plates 11 and 12). Emergent macrophytes, including Phragmites, Typha and Mat Rush, are moderately abundant (Plates 11 and 12).

Plate 11: Dart Brook – DB. Aerial view (9/5/18).

Plate 12: Dart Brook – DB. View across stream (26/11/18).

Sampling site Dark Brook is situated at a road crossing approximately 1 km upstream from the confluence with the Hunter River (Figure 6). The surrounding land use is mostly agriculture. This section of the stream consisted of pools up to approximately 5 m wide and 1.5 m deep (Plates 11 and 12). The substratum has been dominated by accumulations of silt, pebble and gravel and some boulders. No submerged macrophytes have been observed.

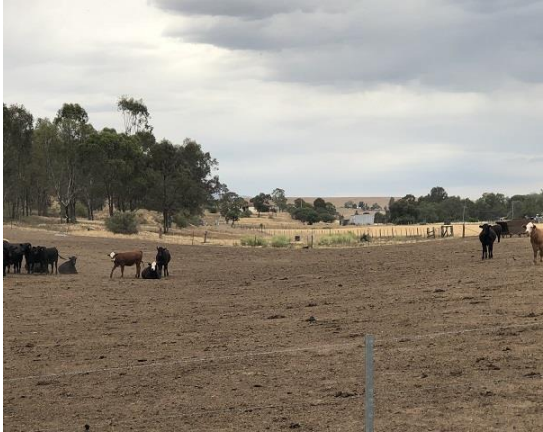
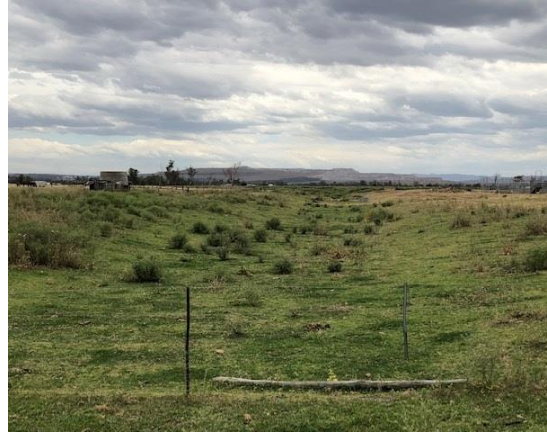
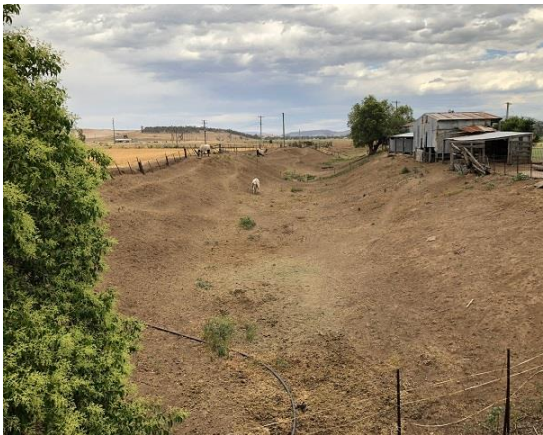
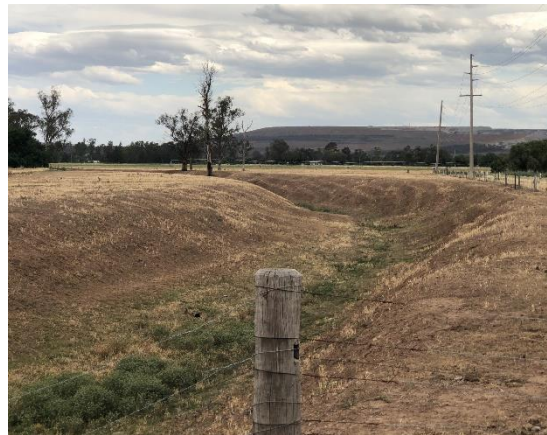
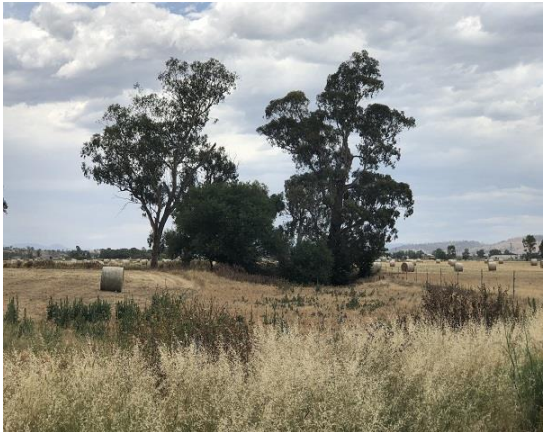
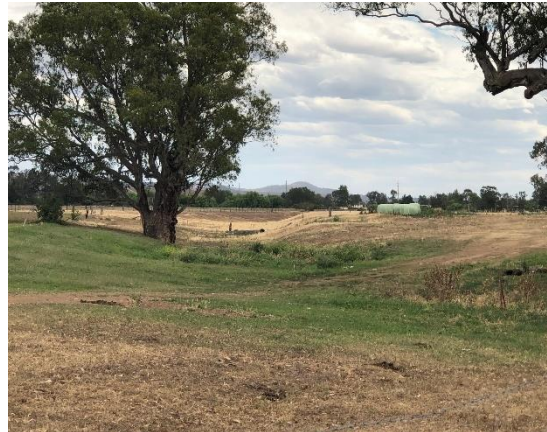
Plate 13: Rosebrook Creek – RC1. View upstream at Rose Lane (27/11/18).

Plate 14: Rosebrook Creek – RC1. View downstream at Rose Lane (27/11/18).

Plate 15: Rosebrook Creek – RC2. Midstream reaches at Wybong Road, looking upstream (27/11/18).

Plate 16: Rosebrook Creek – RC2. Midstream reaches at Wybong Road, looking downstream (27/11/18).

Plate 17: Rosebrook Creek – RC3. Downstream reaches at Logues Lane, looking upstream (27/11/18).

Plate 18: Rosebrook Creek – RC3. Downstream reaches at Logues Lane, looking downstream (27/11/18).

At the time of the survey, the creek was dry. The banks of the creek were almost entirely cleared of trees and riparian vegetation and there was evidence that livestock regularly grazed and trampled the stream bank and channel. The creek channel was mostly colonised by pasture grasses and habitat for aquatic fauna, such as rocks, snags and aquatic macrophytes, was absent (Plates 13-18). The creek received an RCE score of 19. The mid- to lower-reaches of Rosebrook Creek (i.e. downstream from Site RC1) are mapped as Key Fish Habitat under the DPI Key Fish Habitat mapping for the Muswellbrook LGA (DPI, 2017a).

Rosebrook Creek is a small (approximately 7.5 km long), ephemeral creek that drains eastwards into the Hunter River approximately 1 km from the MPO boundary (Figure 6). The source of the creek is within the Study Area. Three sites were surveyed along Rosebrook Creek in November 2018, approximately 8.2 km (Site RC1), 2.7 km (Site RC2) and 1.2 km upstream from its confluence with the Hunter River (Site RC3) (Figure 6, Plates 13-18).

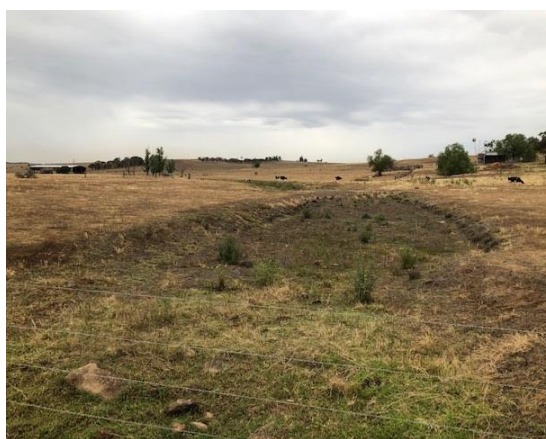
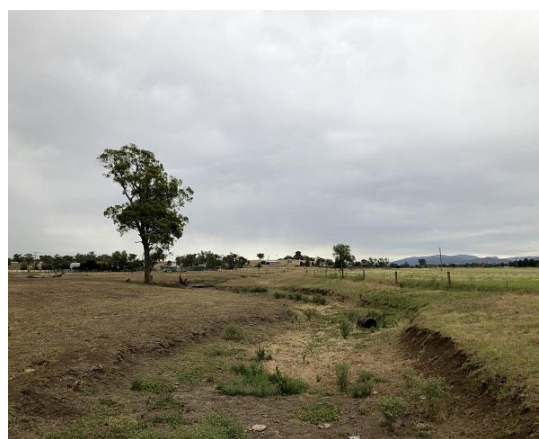
Plate 19: Unnamed Tributary – UT1.
Downstream reaches at Lawrie Lane,
looking upstream (27/11/18).

Plate 20: Unnamed Tributary – UT1.
Downstream reaches at Lawrie Lane,
looking downstream (27/11/18).

Several unnamed drainage paths flow from the Study Area east towards Kayuga, where they form an ephemeral unnamed tributary, approximately 3.8 km in length (Figure 6). The tributary flows through agricultural land on the Hunter River floodplain, joining the Hunter River approximately 2.8 km downstream from the MPO (Figure 3, Plates 19 and 20). The banks of the tributary have been almost entirely cleared of trees and riparian vegetation (Plates 19 and 20). The tributary was dry at the time of sampling (Plates 19 and 20).

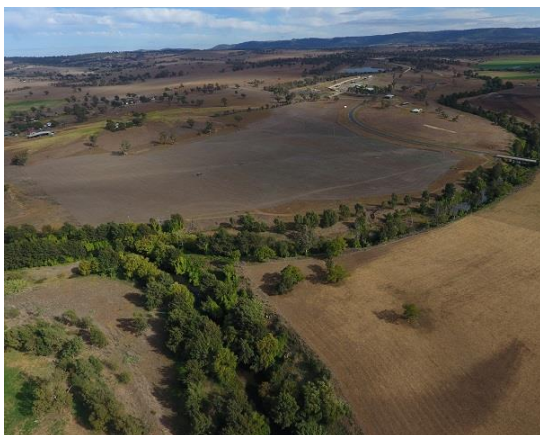
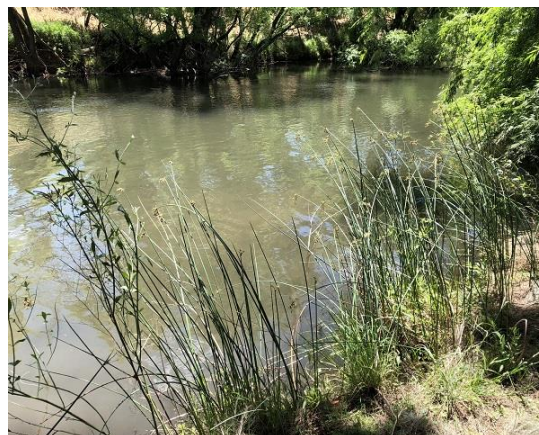
Plate 21: Hunter River – HR1. Aerial view (9/5/18).

Plate 22: Hunter River – HR1. View upstream (26/11/18).

Vegetation of the riparian zone was dense, comprising mixed native and exotic trees and shrubs including River Oak, Willow and River Red Gum. Mat Rush, Common Rush, Marsh Club-rush, Wandering Jew and exotic grasses were abundant along the edge of the banks.

The most upstream site (HR1) was situated within farming land, approximately 200 m upstream of the confluence with Dart Brook (Figure 6, Plate 21). The site consisted of a large (approximately 8 m to 13 m wide and up to 1 m deep) flowing pool with a heavily silted gravel bed (Plates 21 and 22). A relatively large (up to approximately 1 m wide and 3 m long) bed of the submerged, native species of macrophyte, Clasped Pondweed, has been present and woody debris scattered throughout.

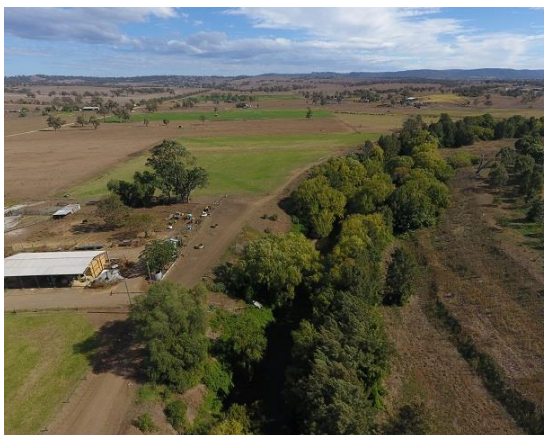
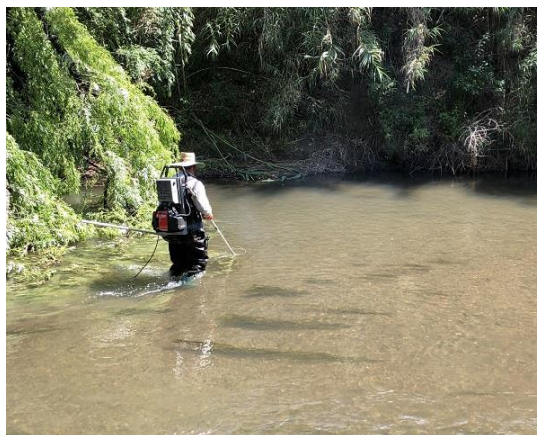
The right bank (when facing downstream) was steep and eroded where riparian vegetation was not present whilst the left bank was densely vegetated. Willow, River Oak, River Red Gum, Typha, Marsh Club-rush, Balloon Vine and exotic grasses were common.

Plate 23: Hunter River – HR2. Aerial view (10/5/18).

Plate 24: Hunter River – HR2. View across stream (26/11/18).

Site HR2 was situated approximately 900 m downstream of the confluence of the Hunter River with Dart Brook (Figure 6). Similar to Site HR1, the site consisted of a large (up to approximately 25 m wide and 1.5 m deep), and generally slow flowing pool (Plates 23 and 24). The substratum in the edge habitat is predominantly cobble, pebble and silt. Fish hotels are present within the river channel and small patches (up to approximately 1 m long) of Clasper Pondweed have been observed on occasion.

Despite exotic plant invasion and bank degradation, the RCE score has been as high as 45 (range = 38 to 45 between the spring 2017 and spring 2019 surveys), indicating good quality aquatic habitat.

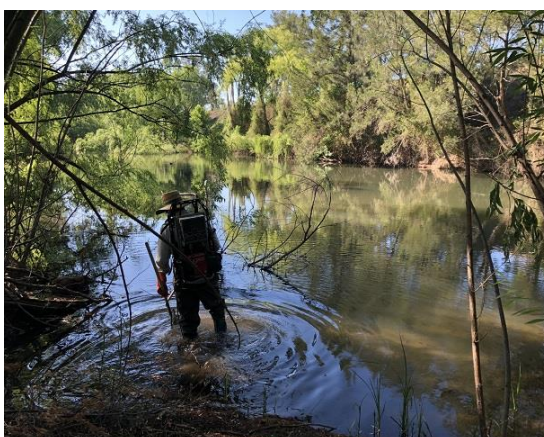
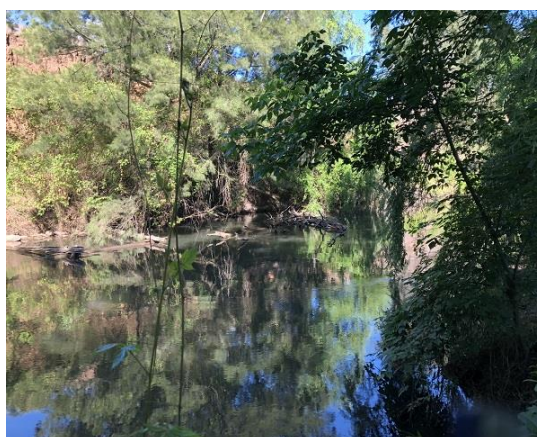
Plate 25: Hunter River – HR3. View downstream (26/11/18).

Plate 26: Hunter River – HR3. View upstream (26/11/18).

Site HR3 was situated approximately 6.8 km downstream of Site HR2 (Figure 6). This site consisted of a large (up to approximately 28 m wide and >1.7 m deep), continuous pool (Plates 25 and 26). The substratum in the edge habitat was predominantly pebble and gravel with a mixture of sand and silt. Bank erosion was apparent, particularly of the right bank, in several places and riparian vegetation was dominated by exotic trees, shrubs and vines. A number of fish hotels were present within the river channel.

The RCE score has ranged between 40 and 42 between the spring 2017 and spring 2019 surveys.

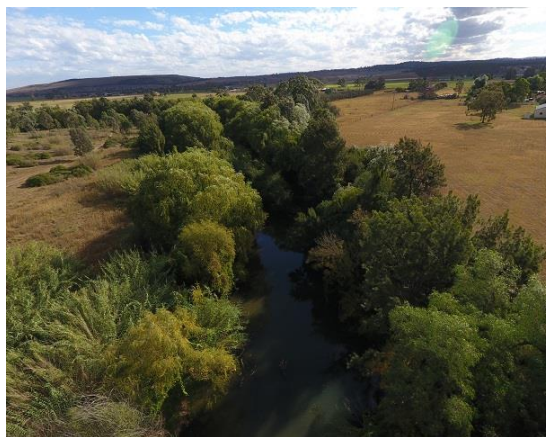
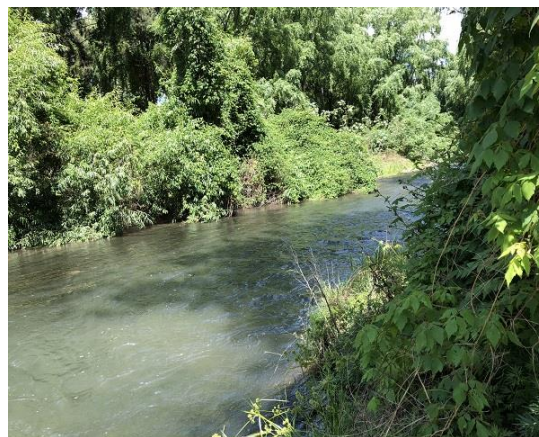
Plate 27: Hunter River – HR4. Aerial view upstream (10/5/18).

Plate 28: Hunter River – HR4. View upstream (26/11/18).

Site HR4 is situated approximately 1 km downstream of the confluence of Sandy Creek with the Hunter River (Figure 6). The study reach consisted of a continuous, slow flowing pool with steep banks either side, which were fully stabilised by trees (mostly Willow and River Oak) and shrubs, including Typha and Marsh Club-rush, Wandering Jew, Balloon Vine and exotic grasses (Plates 27 and 28). Small numbers of sheep were seen grazing the right bank in spring 2019.

The substratum in the edge habitat was predominantly gravel, pebble and silt. The submerged, native species of macrophyte, Clasper Pondweed, has been noted on several occasions. Water clarity has generally been fair. The RCE score has ranged between 41 and 43 between the autumn 2018 and spring 2019 surveys.

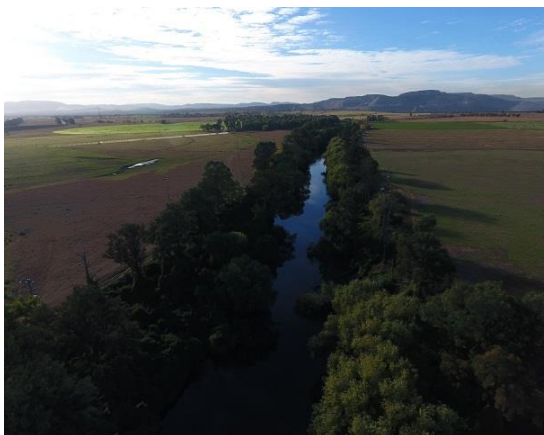
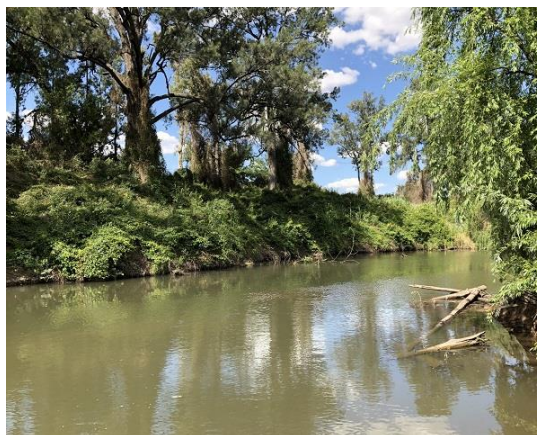
Plate 29: Hunter River – HR5. Aerial view downstream (10/5/18).

Plate 30: Hunter River – HR5. View downstream (26/11/18).

The right bank (when facing downstream) is steep and eroded in some sections where riparian vegetation is not present, whilst the left bank is densely vegetated. There has been evidence of stock access to the river. Trees within the riparian habitat include Willow, River Oak and River Red Gum. Balloon Vine and exotic grasses are common.

Site HR5 is situated immediately downstream of the approved discharge point from the MPO and the existing discharge point from Bengalla Mine (Figure 6). This site consists of a long, relatively deep pool with a short section of riffle habitat at the top of the study reach (Plates 29 and 30). Fish hotels are present. The substratum in the edge habitat is predominantly a silt, pebble, gravel matrix. Submerged macrophytes have not been recorded at this site.

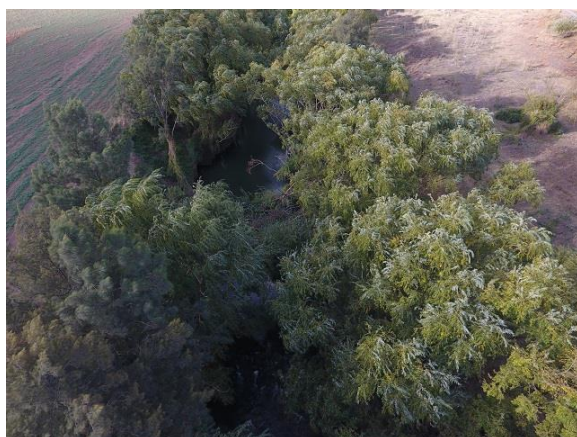
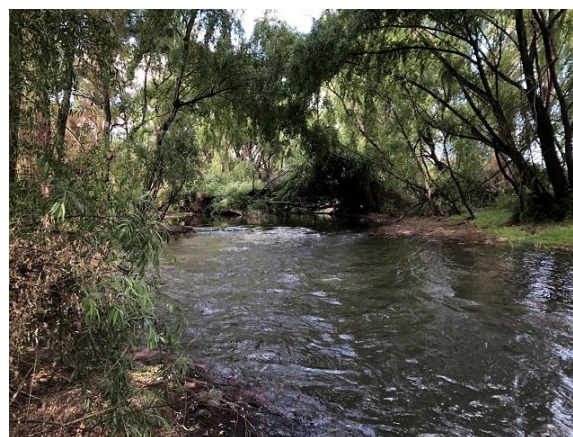
The width of the riparian strip is relatively narrow (i.e. between 5 and 30 m) and comprised of Willow, River Oak and River Red Gum trees and shrubs (Plates 31 and 32). Balloon Vine and exotic grasses are common. Water clarity is commonly fair and flow moderate. The RCE score has ranged between 38 and 40 between the spring 2017 and spring 2019 surveys.

Plate 31: Hunter River – HR6. Aerial view (9/5/18).

Plate 32: Hunter River – HR6. View upstream (26/11/18).

Site HR6 is situated approximately 4 km downstream of the approved discharge point from the MPO and the existing discharge point from Bengalla Mine (Figure 6). The substratum in the edge habitat is predominantly a silt, gravel matrix. The submerged, native species of macrophyte, Curly Pondweed (*Potamogeton crispus*), has been observed on occasion.

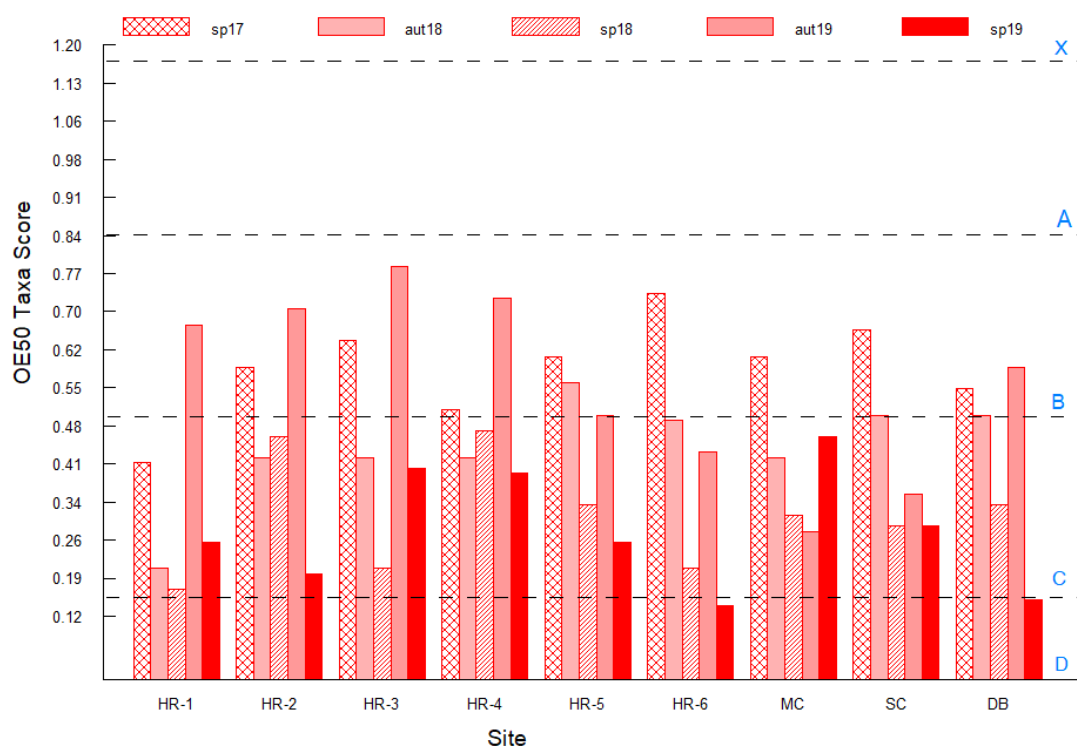
Figure 9. OE50 Taxa Scores and Their Respective Band Scores (B-D) for AUSRIVAS Samples Collected Between Spring 2017 and Spring 2019.

The OE50 Taxa Scores have ranged from 0.14 (Site HR6 in spring 2019) to 0.78 (Site HR3 in autumn 2019) (Figure 9). All of the OE50 Taxa scores have been below 1.00 (Figure 9), indicating that the number of taxa observed was less on all occasions than would be expected relative to the AUSRIVAS reference watercourses. Locations HR6 and DB dropped from Band C to Band D between autumn and spring 2019 (Figure 9).

*Note that the bands displayed are relevant to spring edge habitat, these being slightly different to autumn

Results from the AUSRIVAS analyses indicate that the Hunter River and its associated tributaries are in poor condition. In spring 2019, seven locations (HR1, HR2, HR3, HR4, HR5, MC and SC) were classified as severely impaired (Band C) and two locations (HR6 and DB) as impoverished (Band D). This finding is almost certainly related to the compounding effects from exposure to multiple stressors (e.g. flow alteration, sedimentation, increased salinity, nutrients and drought) that can adversely affect riverine condition.
