PRELIMINARY GEOTECHNICAL INVESTIGATION REPORT
6A WATSFORD ROAD, CAMPBELLTOWN, NEW SOUTH WALES
PREPARED FOR IBIZ DESIGN AND CONSTRUCTION PTY LTD
CES DOCUMENT REFERENCE: CES180704-IDC-AB

Client: Ibiz Design and Construction Pty Ltd

Date: 18 October 2018

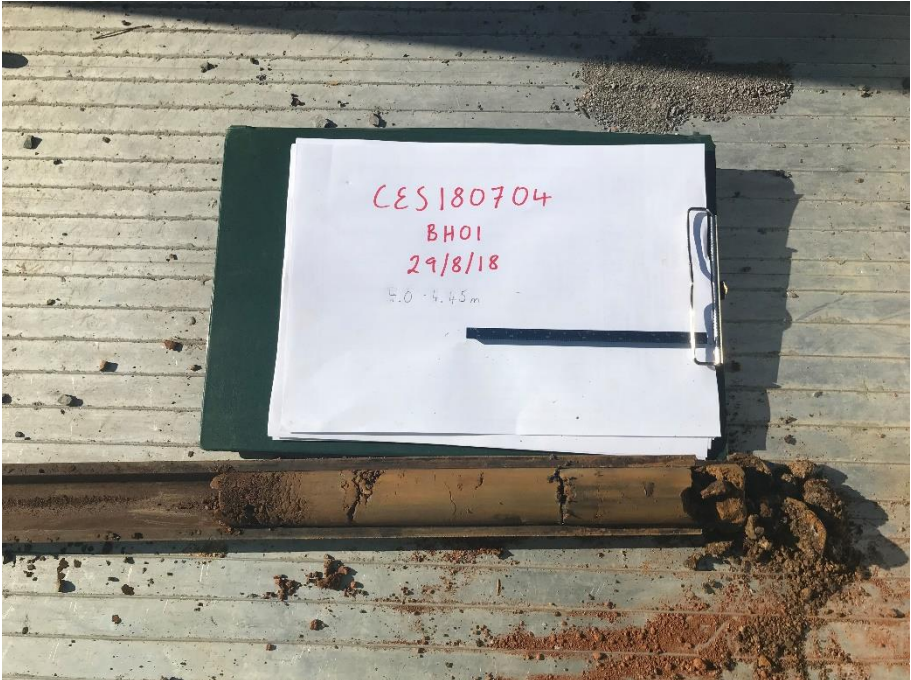
Client Name: Ibiz Design and Construction		Site Location: 6A Watsford Road, Campbelltown, New South Wales	Project Number: CES180704-IDC
Date: 29/08/2018	Plate 3

Description: Typical SPT sample taken from the fill layer consistent across the Site.

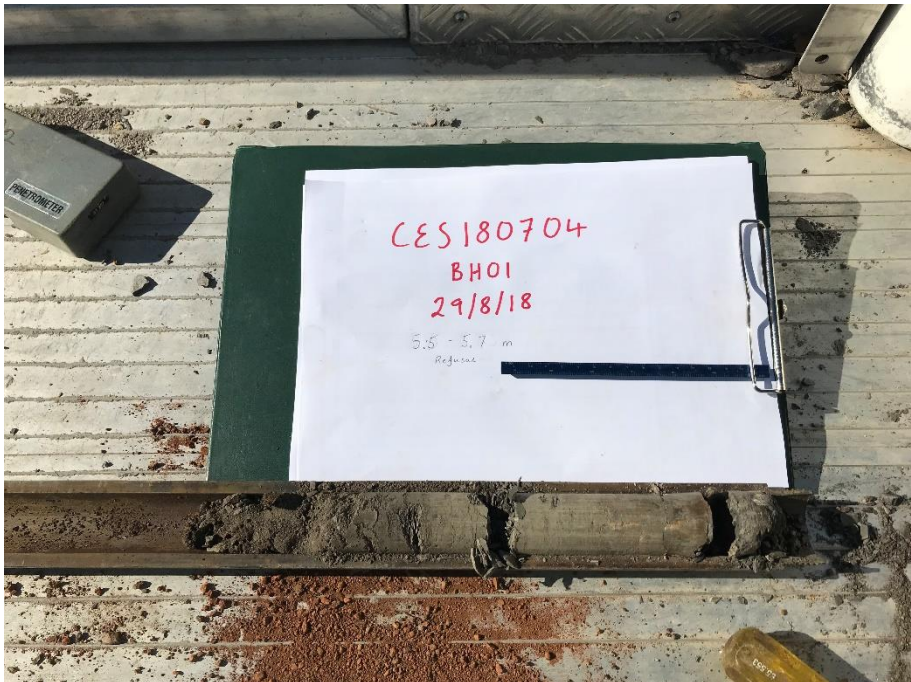
Client Name: Ibiz Design and Construction		Site Location: 6A Watsford Road, Campbelltown, New South Wales	Project Number: CES180704-IDC
Date: 29/08/2018	Plate 4

Description: Typical SPT sample taken from the residual silty clay layer consistent across the Site.

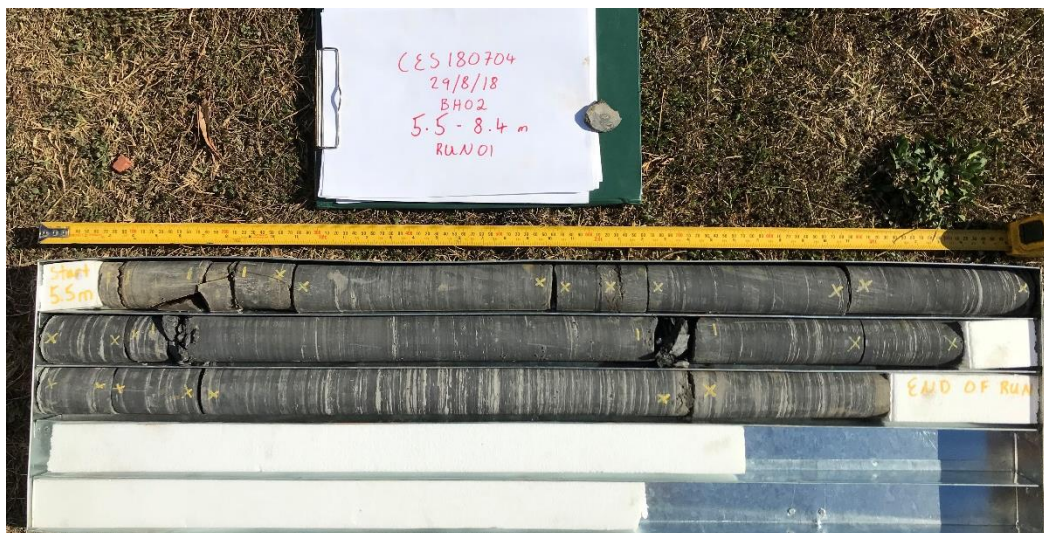
Client Name: Ibiz Design and Construction		Site Location: 6A Watsford Road, Campbelltown, New South Wales	Project Number: CES180704-IDC
Date: 29/08/2018	Plate 6

Description: Ashfield Shale sample core drilled from Borehole 02. Note the increased frequency of fine, sandstone laminations at the base of the hole.
