**REPORT TO
HEALTH INFRASTRUCTURE**

**ON
GEOTECHNICAL INVESTIGATION**

**FOR
PROPOSED STAGE 2 REDEVELOPMENT,
MULTI STOREY CAR PARK (MSCP)**

**AT
THE CHILDREN'S HOSPITAL AT WESTMEAD,
HAWKESBURY ROAD, WESTMEAD, NSW**

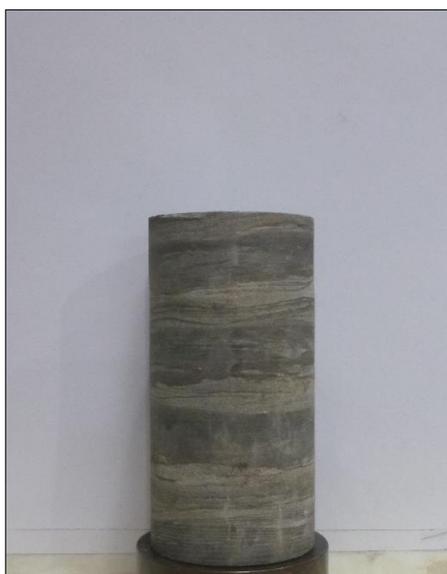
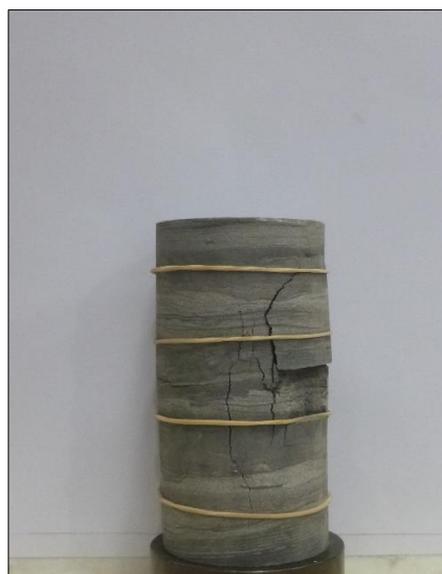
Client:	JK Geotechnics	Sample Source:	BH14 5.34-5.47m
Address:	PO Box 976, North Ryde BC, NSW 1670	Sample Description:	Sandstone/Siltstone
Project:	The Children's Hospital at Westmead Stage 2 Redevelopment - Hawkesbury Road Westmead NSW (33303BT)	Report No.:	S64073-UCS
Job No.:	S20460-2	Lab No.:	S64073
Test Procedure:	AS 4133.4.2.2 Determination of uniaxial compressive strength-Rock strength less than 50 MPa		
Testing Machine:	Matest 2000 kN Compression Machine	Sample Curing:	-
Sampling Method:	Sampled by Client - results apply to the sample as received	Date Sampled:	Unknown
Storage History:	Sealed	Storage Environment:	Sealed at as received moisture condition

Uniaxial Compressive Strength 27 MPa

Date Tested:	26/10/2020	Moisture Content:	2.0 %
Specimen Height:	128.1 mm	Duration of Test:	624 seconds
Average Specimen Diameter:	51.9 mm	Rate of Displacement:	< 0.1 mm/min

Failure Type: Mixed mode

Based on the Atterberg limits a linear shrinkage test results, the residual silty clay samples tested from BH16 and BH18 are of medium plasticity. The moisture content test results on samples of the weathered rock recovered from the augered portions of the boreholes showed reasonably good correlation with our field assessment of rock strengths.

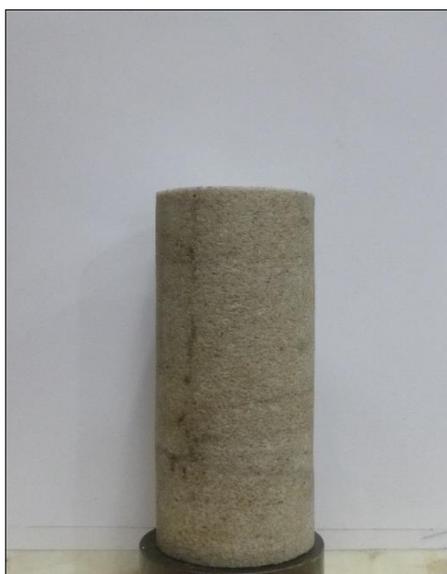
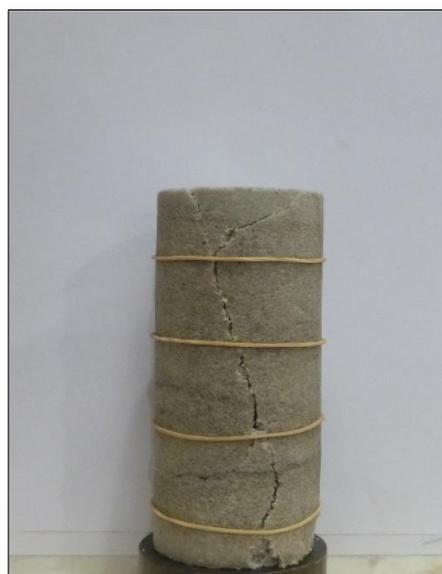
Client:	JK Geotechnics	Sample Source:	BH15 11.53-11.67m
Address:	PO Box 976, North Ryde BC, NSW 1670	Sample Description:	Sandstone
Project:	The Children's Hospital at Westmead Stage 2 Redevelopment - Hawkesbury Road Westmead NSW (33303BT)	Report No.:	S64074-UCS
Job No.:	S20460-2	Lab No.:	S64074
Test Procedure:	AS 4133.4.2.2 Determination of uniaxial compressive strength-Rock strength less than 50 MPa		
Testing Machine:	Matest 2000 kN Compression Machine	Sample Curing:	-
Sampling Method:	Sampled by Client - results apply to the sample as received	Date Sampled:	Unknown
Storage History:	Sealed	Storage Environment:	Sealed at as received moisture condition

Uniaxial Compressive Strength 28 MPa

Date Tested: 26/10/2020	Moisture Content: 8.3 %
Specimen Height: 147.3 mm	Duration of Test: 629 seconds
Average Specimen Diameter: 52.0 mm	Rate of Displacement: < 0.1 mm/min

Failure Type: Single shear plane

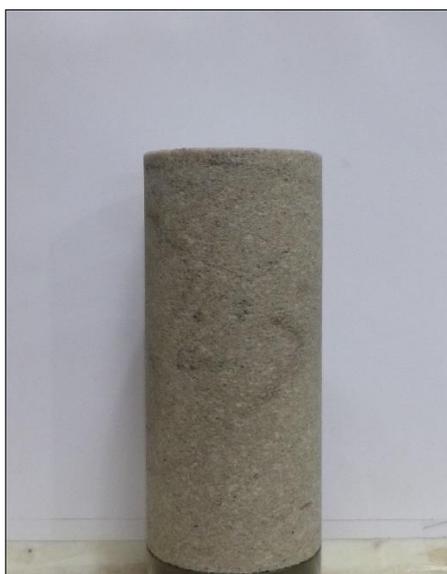
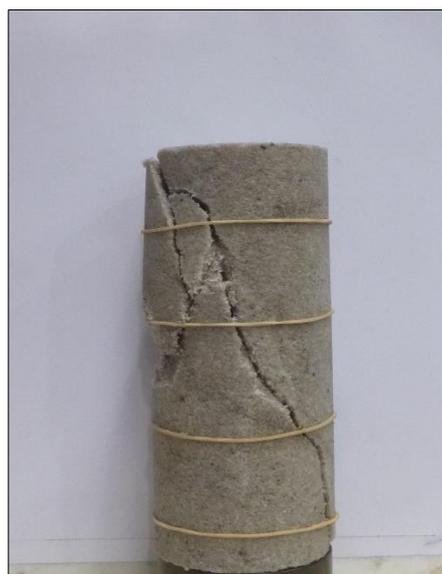
Client:	JK Geotechnics	Sample Source:	BH16 10.26-10.45m
Address:	PO Box 976, North Ryde BC, NSW 1670	Sample Description:	Sandstone
Project:	The Children's Hospital at Westmead Stage 2 Redevelopment - Hawkesbury Road Westmead NSW (33303BT)	Report No.:	S64075-UCS
Job No.:	S20460-2	Lab No.:	S64075
Test Procedure:	AS 4133.4.2.2 Determination of uniaxial compressive strength-Rock strength less than 50 MPa		
Testing Machine:	Matest 2000 kN Compression Machine	Sample Curing:	-
Sampling Method:	Sampled by Client - results apply to the sample as received	Date Sampled:	Unknown
Storage History:	Sealed	Storage Environment:	Sealed at as received moisture condition

Uniaxial Compressive Strength 31 MPa

Date Tested:	26/10/2020	Moisture Content:	7.9 %
Specimen Height:	175.8 mm	Duration of Test:	651 seconds
Average Specimen Diameter:	60.9 mm	Rate of Displacement:	< 0.1 mm/min
Failure Type:	Single shear plane		
Other Pertinent Observations:

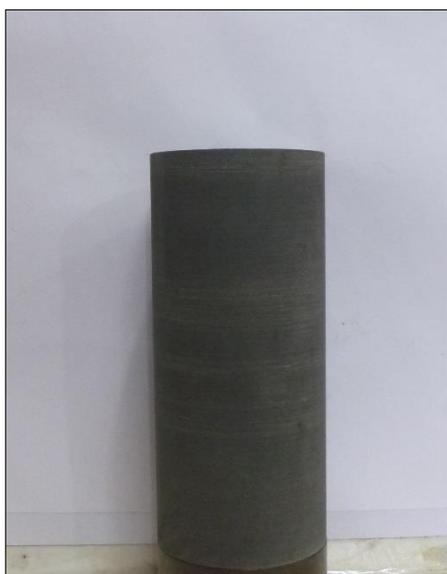
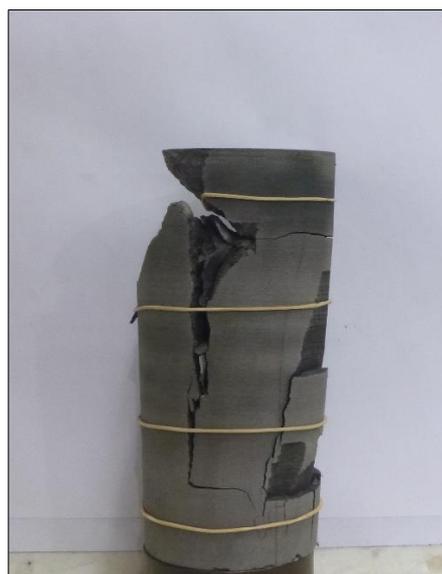
Client:	JK Geotechnics	Sample Source:	BH17 6.59-6.78m
Address:	PO Box 976, North Ryde BC, NSW 1670	Sample Description:	Sandstone/Siltstone
Project:	The Children's Hospital at Westmead Stage 2 Redevelopment - Hawkesbury Road Westmead NSW (33303BT)	Report No.:	S63964-UCS
Job No.:	S20460-1	Lab No.:	S63964
Test Procedure:	AS 4133.4.2.2 Determination of uniaxial compressive strength-Rock strength less than 50 MPa		
Testing Machine:	Matest 2000 kN Compression Machine	Sample Curing:	-
Sampling Method:	Sampled by Client - results apply to the sample as received	Date Sampled:	Unknown
Storage History:	Sealed	Storage Environment:	Sealed at as received moisture condition

Uniaxial Compressive Strength 26 MPa

Date Tested:	19/10/2020	Moisture Content:	2.3 %
Specimen Height:	178.8 mm	Duration of Test:	658 seconds
Average Specimen Diameter:	60.8 mm	Rate of Displacement:	< 0.1 mm/min
Failure Type:	Mixed mode		
Other Pertinent Observations:

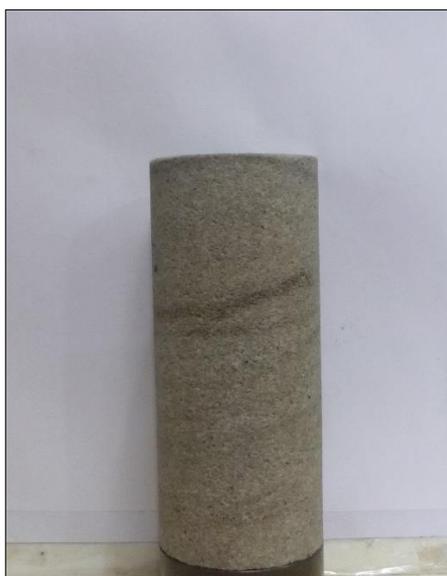
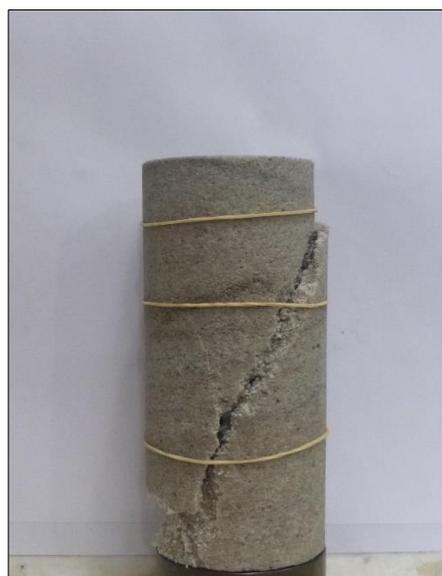
Client:	JK Geotechnics	Sample Source:	BH18 14.39-14.57m
Address:	PO Box 976, North Ryde BC, NSW 1670	Sample Description:	Sandstone
Project:	The Children's Hospital at Westmead Stage 2 Redevelopment - Hawkesbury Road Westmead NSW (33303BT)	Report No.:	S63965-UCS
Job No.:	S20460-1	Lab No.:	S63965
Test Procedure:	AS 4133.4.2.2 Determination of uniaxial compressive strength-Rock strength less than 50 MPa		
Testing Machine:	Matest 2000 kN Compression Machine	Sample Curing:	-
Sampling Method:	Sampled by Client - results apply to the sample as received	Date Sampled:	Unknown
Storage History:	Sealed	Storage Environment:	Sealed at as received moisture condition

Uniaxial Compressive Strength 25 MPa

Date Tested:	19/10/2020	Moisture Content:	9.4 %
Specimen Height:	176.7 mm	Duration of Test:	649 seconds
Average Specimen Diameter:	60.8 mm	Rate of Displacement:	< 0.1 mm/min

Failure Type: Single shear plane

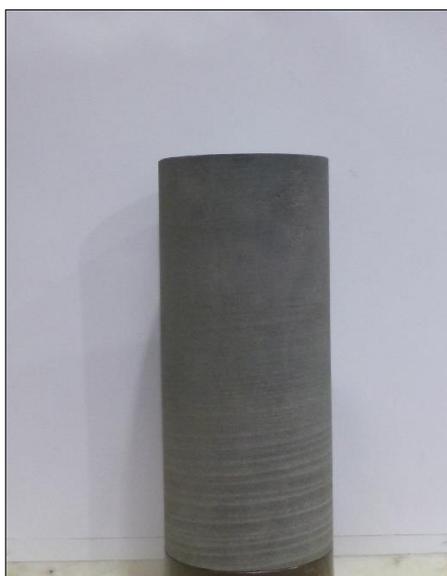
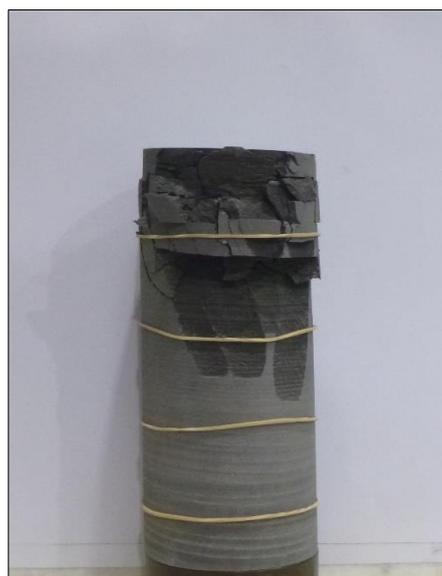
Client:	JK Geotechnics	Sample Source:	BH19 7.64-7.82m
Address:	PO Box 976, North Ryde BC, NSW 1670	Sample Description:	Siltstone
Project:	The Children's Hospital at Westmead Stage 2 Redevelopment - Hawkesbury Road Westmead NSW (33303BT)	Report No.:	S64076-UCS
Job No.:	S20460-2	Lab No.:	S64076
Test Procedure:	AS 4133.4.2.2 Determination of uniaxial compressive strength-Rock strength less than 50 MPa		
Testing Machine:	Matest 2000 kN Compression Machine	Sample Curing:	-
Sampling Method:	Sampled by Client - results apply to the sample as received	Date Sampled:	Unknown
Storage History:	Sealed	Storage Environment:	Sealed at as received moisture condition

Uniaxial Compressive Strength 30 MPa

Date Tested: 27/10/2020	Moisture Content: 2.0 %
Specimen Height: 178.0 mm	Duration of Test: 647 seconds
Average Specimen Diameter: 61.0 mm	Rate of Displacement: < 0.1 mm/min
Failure Type: Mixed mode	
Other Pertinent Observations:

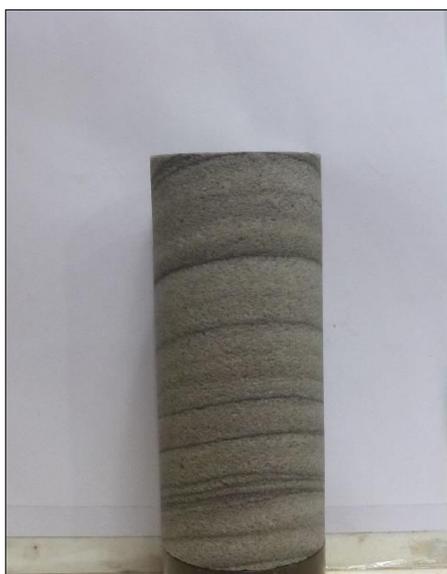
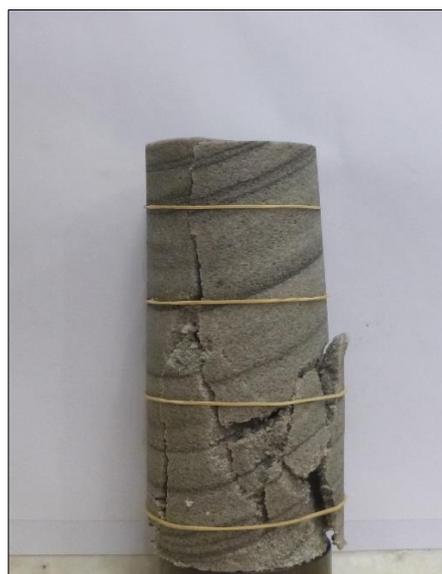
Client:	JK Geotechnics	Sample Source:	BH20 13.40-13.59m
Address:	PO Box 976, North Ryde BC, NSW 1670	Sample Description:	Sandstone
Project:	The Children's Hospital at Westmead Stage 2 Redevelopment - Hawkesbury Road Westmead NSW (33303BT)	Report No.:	S63966-UCS
Job No.:	S20460-1	Lab No.:	S63966
Test Procedure:	AS 4133.4.2.2 Determination of uniaxial compressive strength-Rock strength less than 50 MPa		
Testing Machine:	Matest 2000 kN Compression Machine	Sample Curing:	-
Sampling Method:	Sampled by Client - results apply to the sample as received	Date Sampled:	Unknown
Storage History:	Sealed	Storage Environment:	Sealed at as received moisture condition

Uniaxial Compressive Strength 32 MPa

Date Tested:	19/10/2020	Moisture Content:	7.5 %
Specimen Height:	179.7 mm	Duration of Test:	672 seconds
Average Specimen Diameter:	60.8 mm	Rate of Displacement:	< 0.1 mm/min
Failure Type:	Mixed mode		
Other Pertinent Observations:

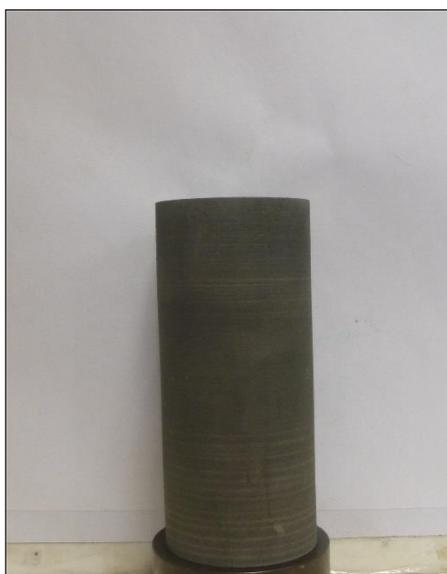
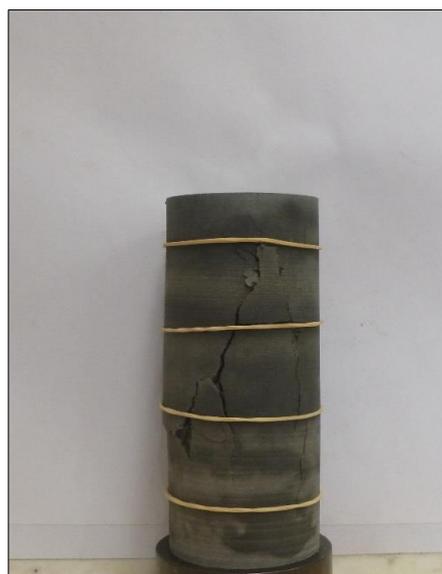
Client:	JK Geotechnics	Sample Source:	BH22 7.52-7.68m
Address:	PO Box 976, North Ryde BC, NSW 1670	Sample Description:	Sandstone/Siltstone
Project:	The Children's Hospital at Westmead Stage 2 Redevelopment - Hawkesbury Road Westmead NSW (33303BT)	Report No.:	S63967-UCS
Job No.:	S20460-1	Lab No.:	S63967
Test Procedure:	AS 4133.4.2.2 Determination of uniaxial compressive strength-Rock strength less than 50 MPa		
Testing Machine:	Matest 2000 kN Compression Machine	Sample Curing:	-
Sampling Method:	Sampled by Client - results apply to the sample as received	Date Sampled:	Unknown
Storage History:	Sealed	Storage Environment:	Sealed at as received moisture condition

Uniaxial Compressive Strength 21 MPa

Date Tested: 19/10/2020	Moisture Content: 2.5 %
Specimen Height: 150.5 mm	Duration of Test: 619 seconds
Average Specimen Diameter: 51.7 mm	Rate of Displacement: < 0.1 mm/min
Failure Type: Mixed mode	
Other Pertinent Observations:

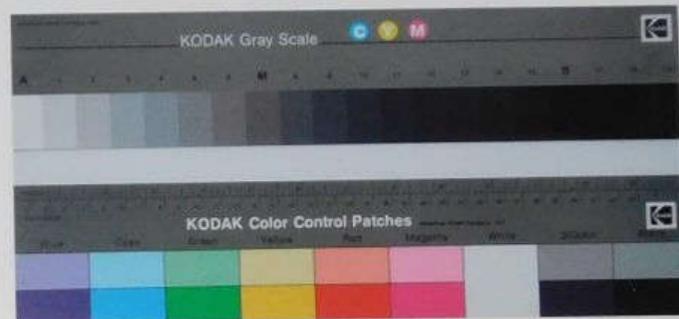
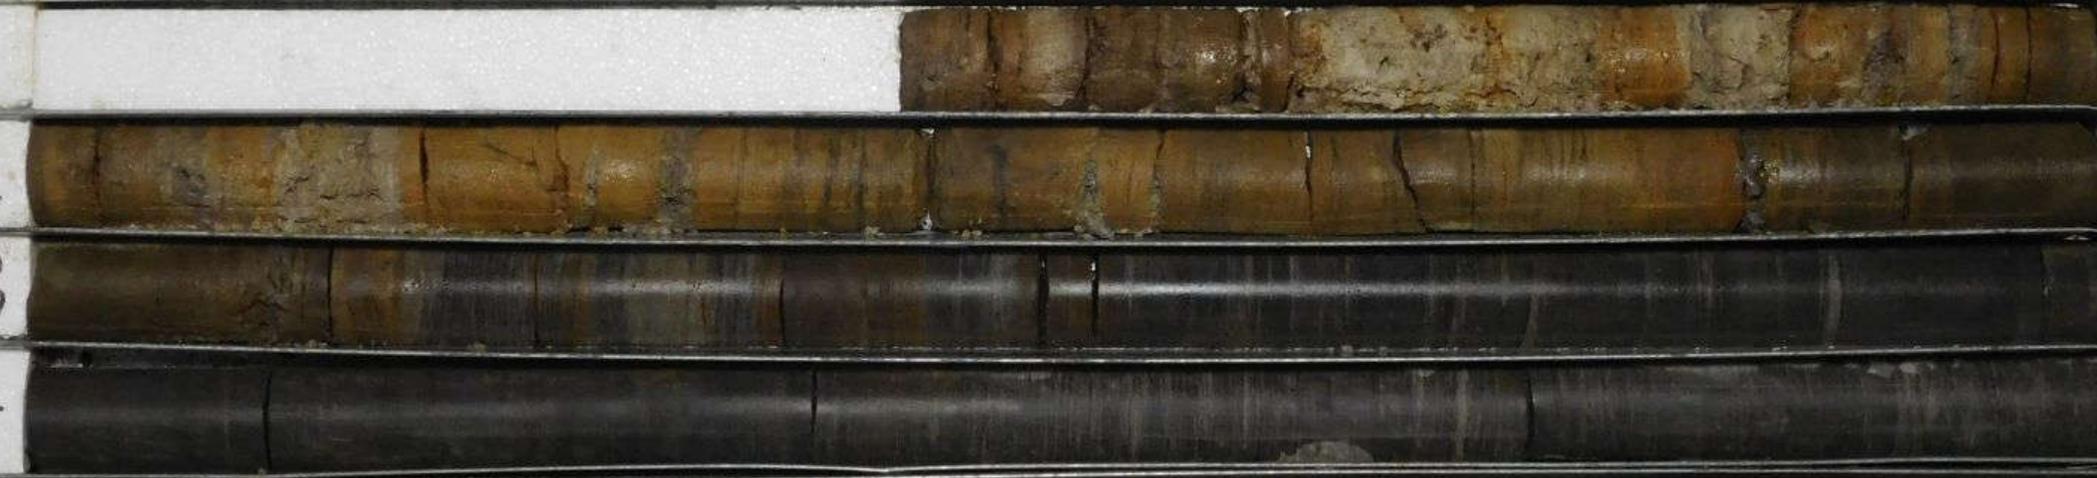
Job No: 33033BT
Borehole No: BH14
Depth: 1.42_m - 5.00_m

33303BT BH14 START CORING AT 1.42m

Our geotechnical engineers, set out the borehole locations, nominated the testing and sampling locations and logged the subsurface conditions encountered. The boreholes logs, including photographs of the recovered core, are attached, together with a set of Report Explanation Notes which describe the investigation techniques, and their limitations, and define the logging terms and symbols used.

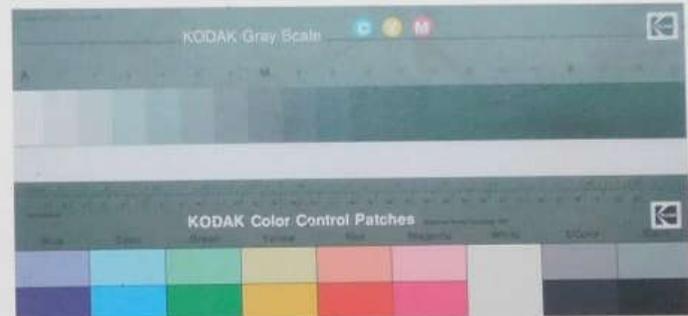
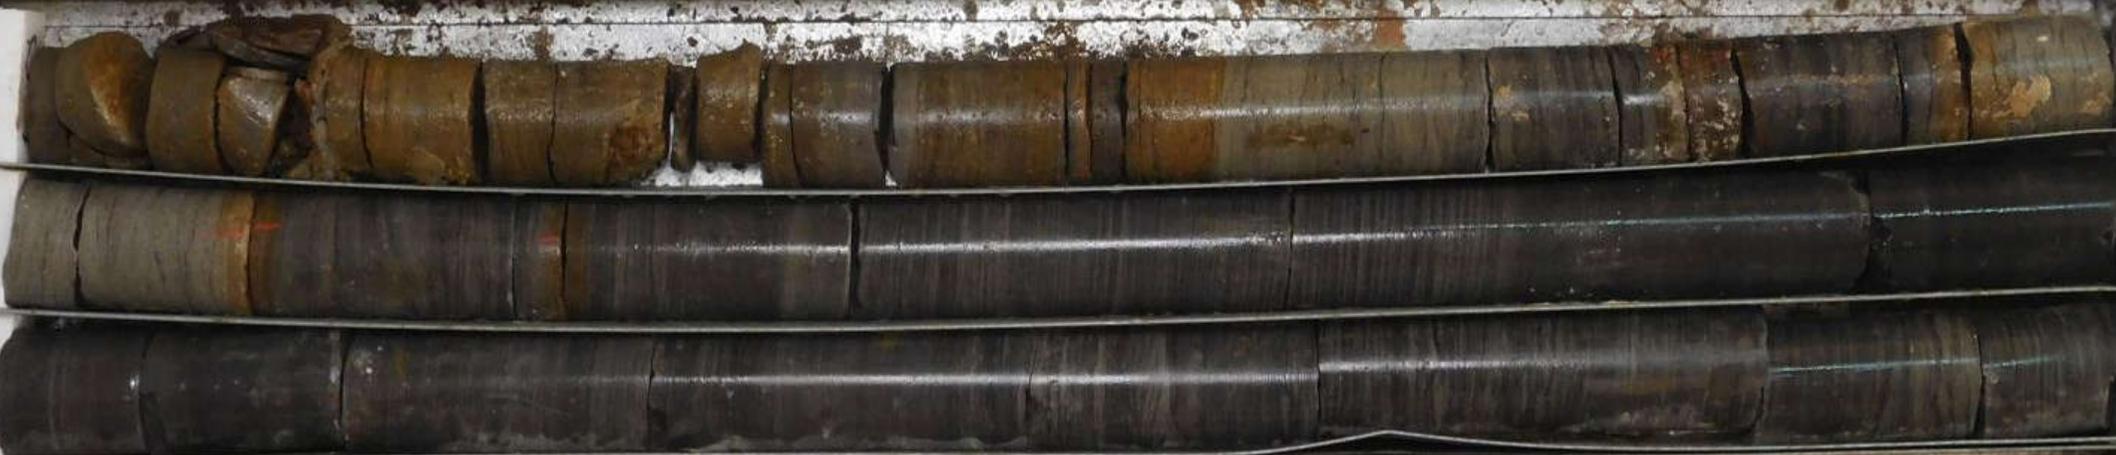
Job No: 33303BT
Borehole No: BH19
Depth: 6.00m to 9.00m

33303BT, BH19, CORING STARTS AT: 6.0m

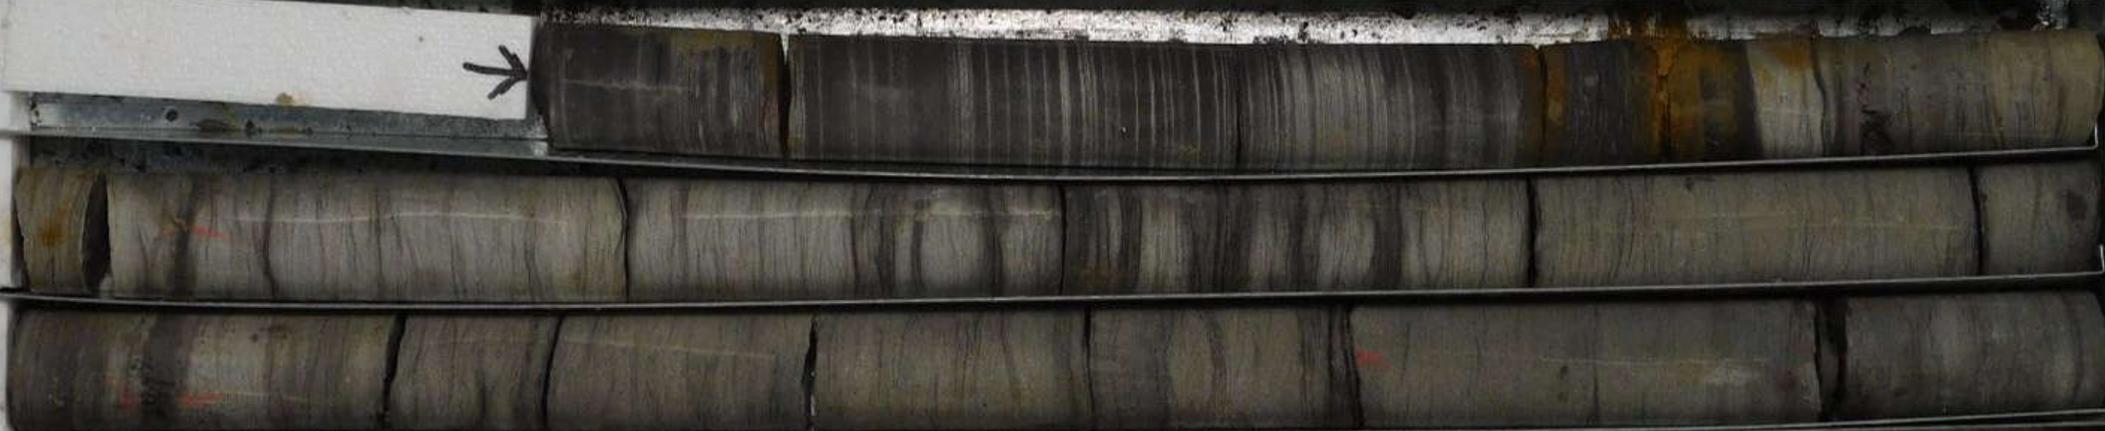
Job No: 33303BT
Borehole No: BH20
Depth: 7.25m - 10.00m

33303BT, BH20, START CORING AT 7.25m

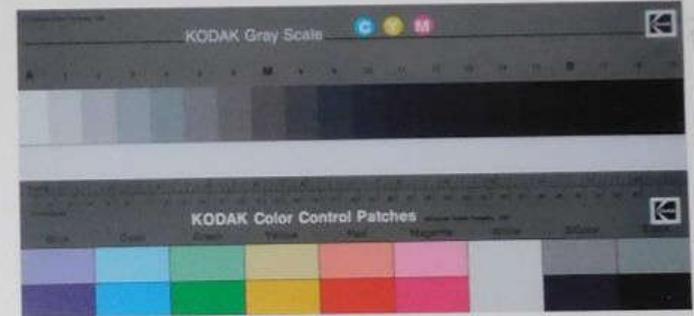
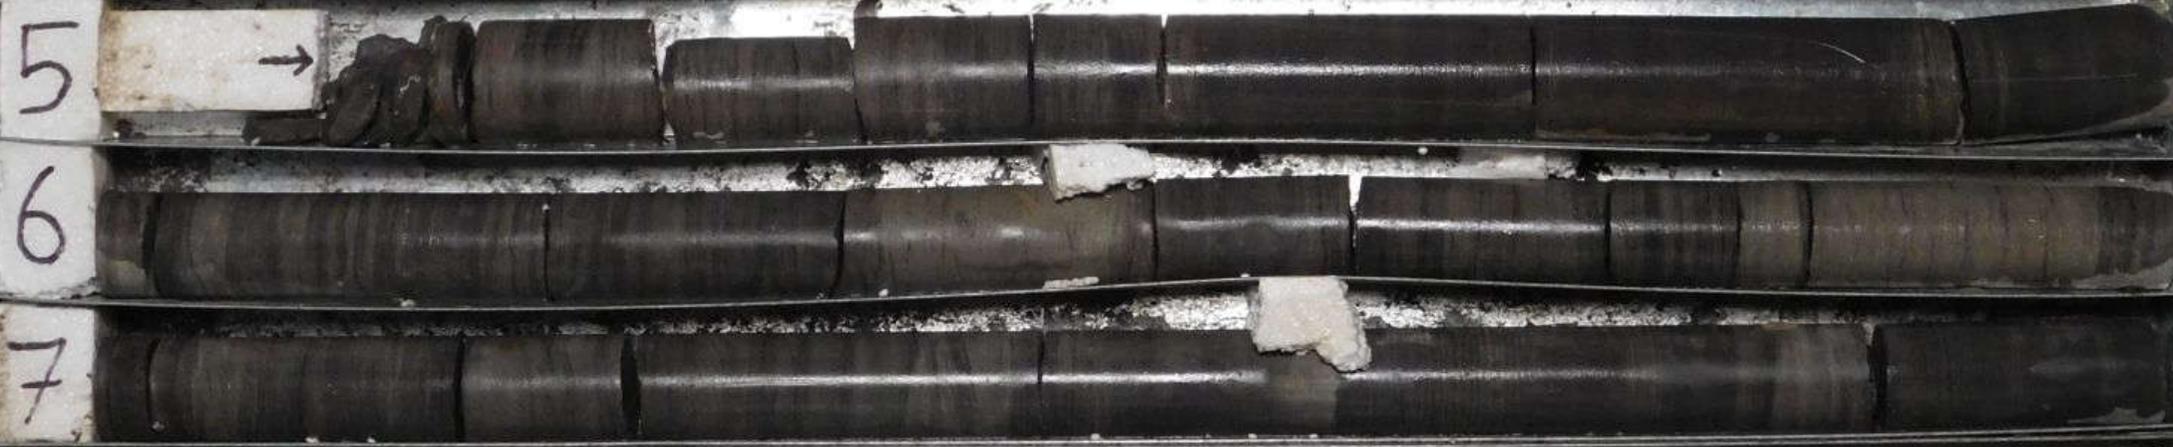
Job No: 33303BT
Borehole No: BH22
Depth: 5.10m - 8.00m

33303BT. BH22. START CORING AT 5.1m

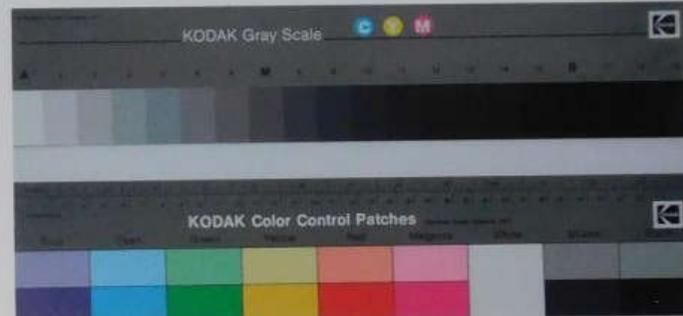
Job No: 33303BT
Borehole No: BH22
Depth: 20.00 m - 20.66 m

END OF HOLE AT 20.66
