The Multi-storey Car Park at
The Children's Hospital at Westmead
Stage 2 Redevelopment

Remedial Action Plan

Labyrinth Way,
Westmead NSW

9 February 2021
56200/131434 (Rev C)
JBS&G Australia Pty Ltd

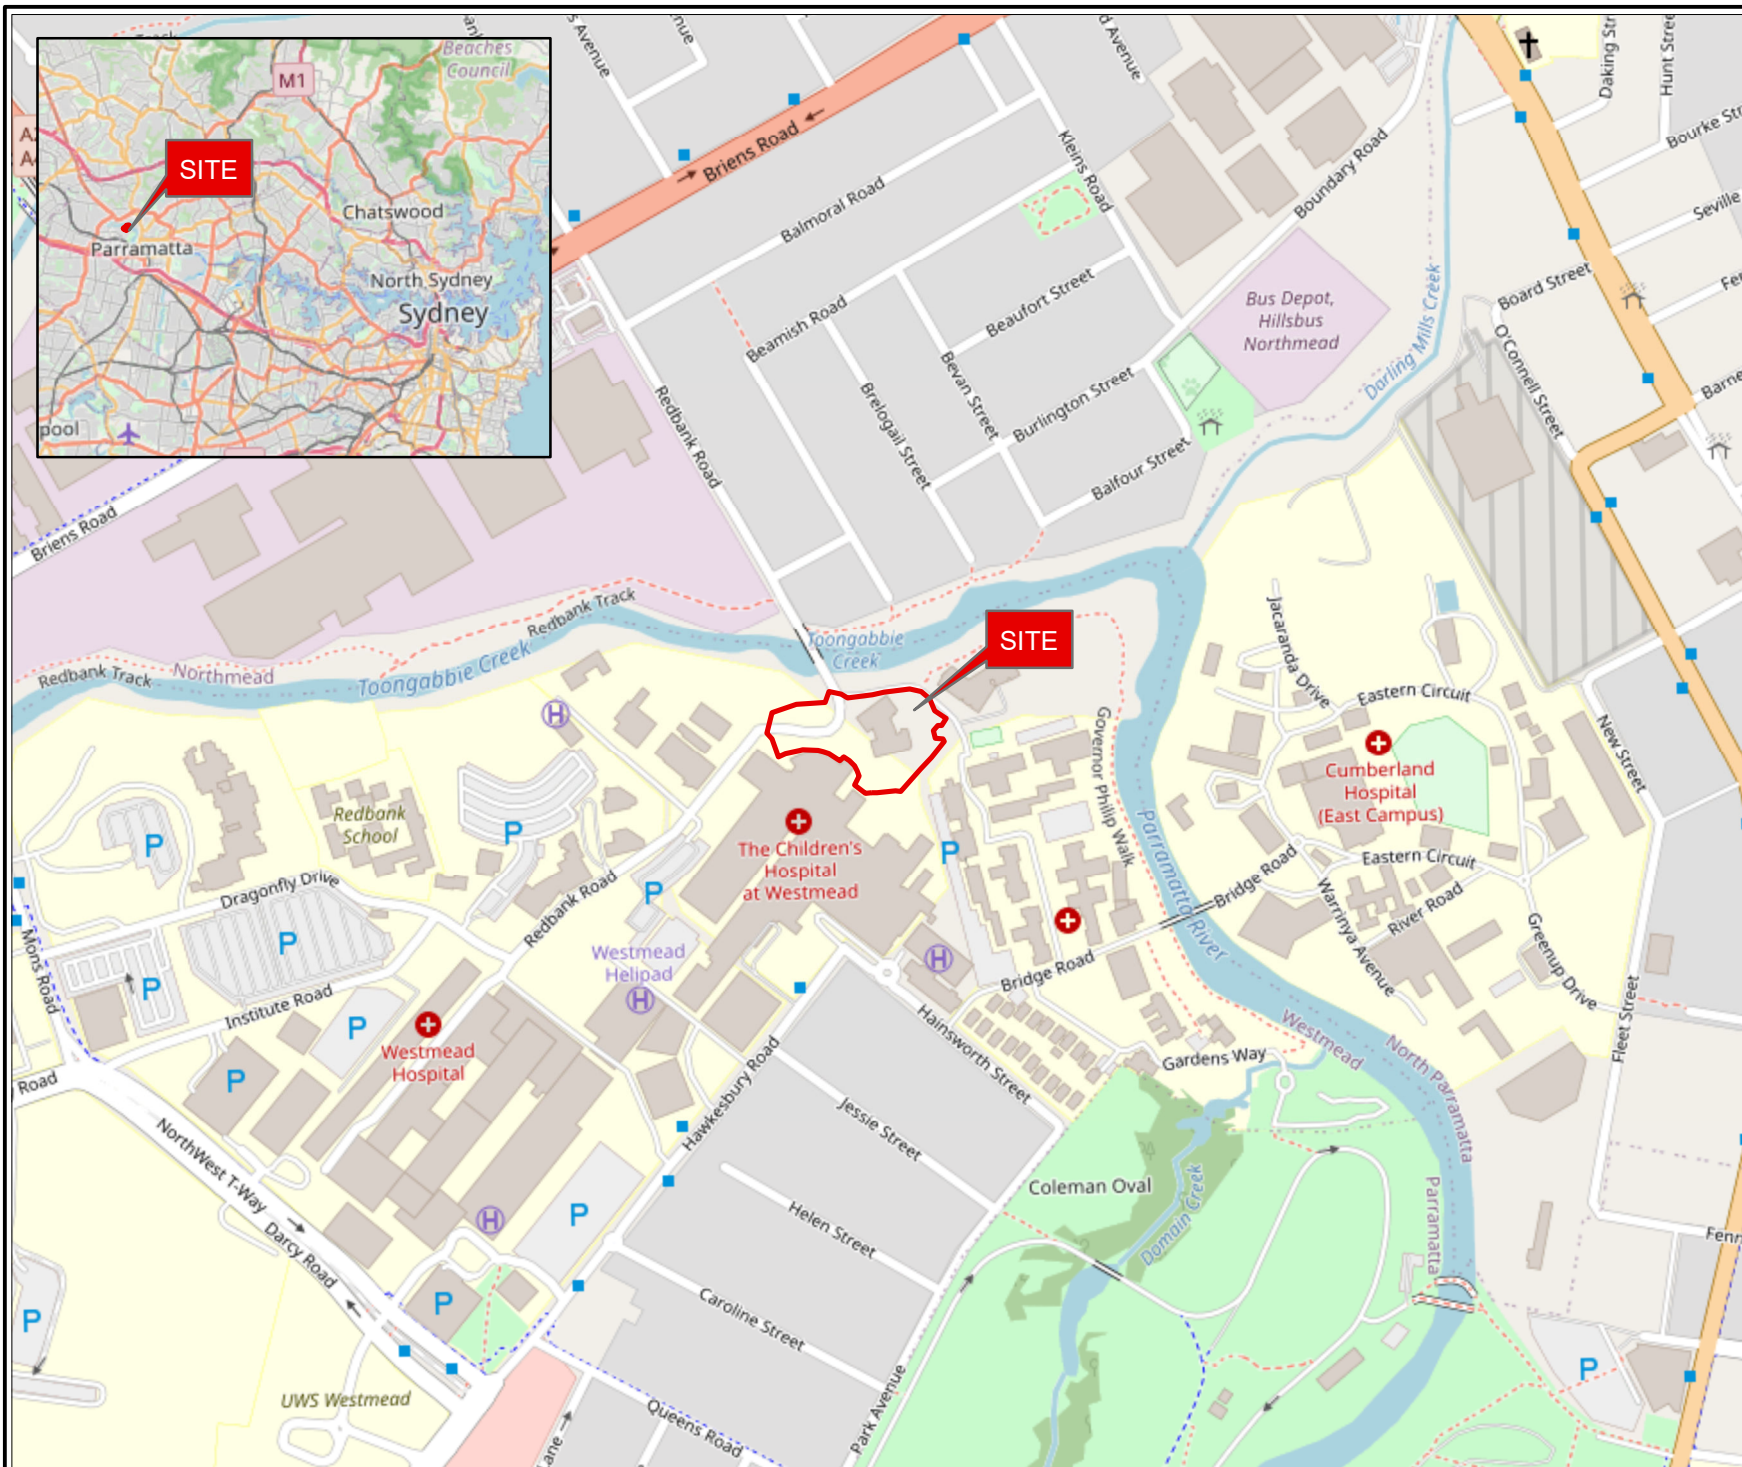
FIGURE 1

SITE LOCATION

JBS&G Australia Pty Ltd (JBS&G) was engaged by Health Infrastructure NSW (HI, the Client) to prepare a Remedial Action Plan (RAP) for the proposed Multi-Storey Car Park (MSCP) development at The Children's Hospital at Westmead (CHW), part of the overall Westmead Precinct, located on Labyrinth Way, Westmead, NSW 2145 (the site). The site is formally identified as mainly Part Lot 101 in DP 1119583 and slightly encroaches onto Lot 1 in DP 1194390 and Lot 1 in DP 808447, and comprises an area of approximately 1.27 hectares (ha). **Figure 1** presents the site location and **Figure 2** presents the detailed site layout.

The location of the site is shown on **Figure 1**. The layout of the site is shown on **Figure 2**. The site details are summarised in **Table 2.1**.

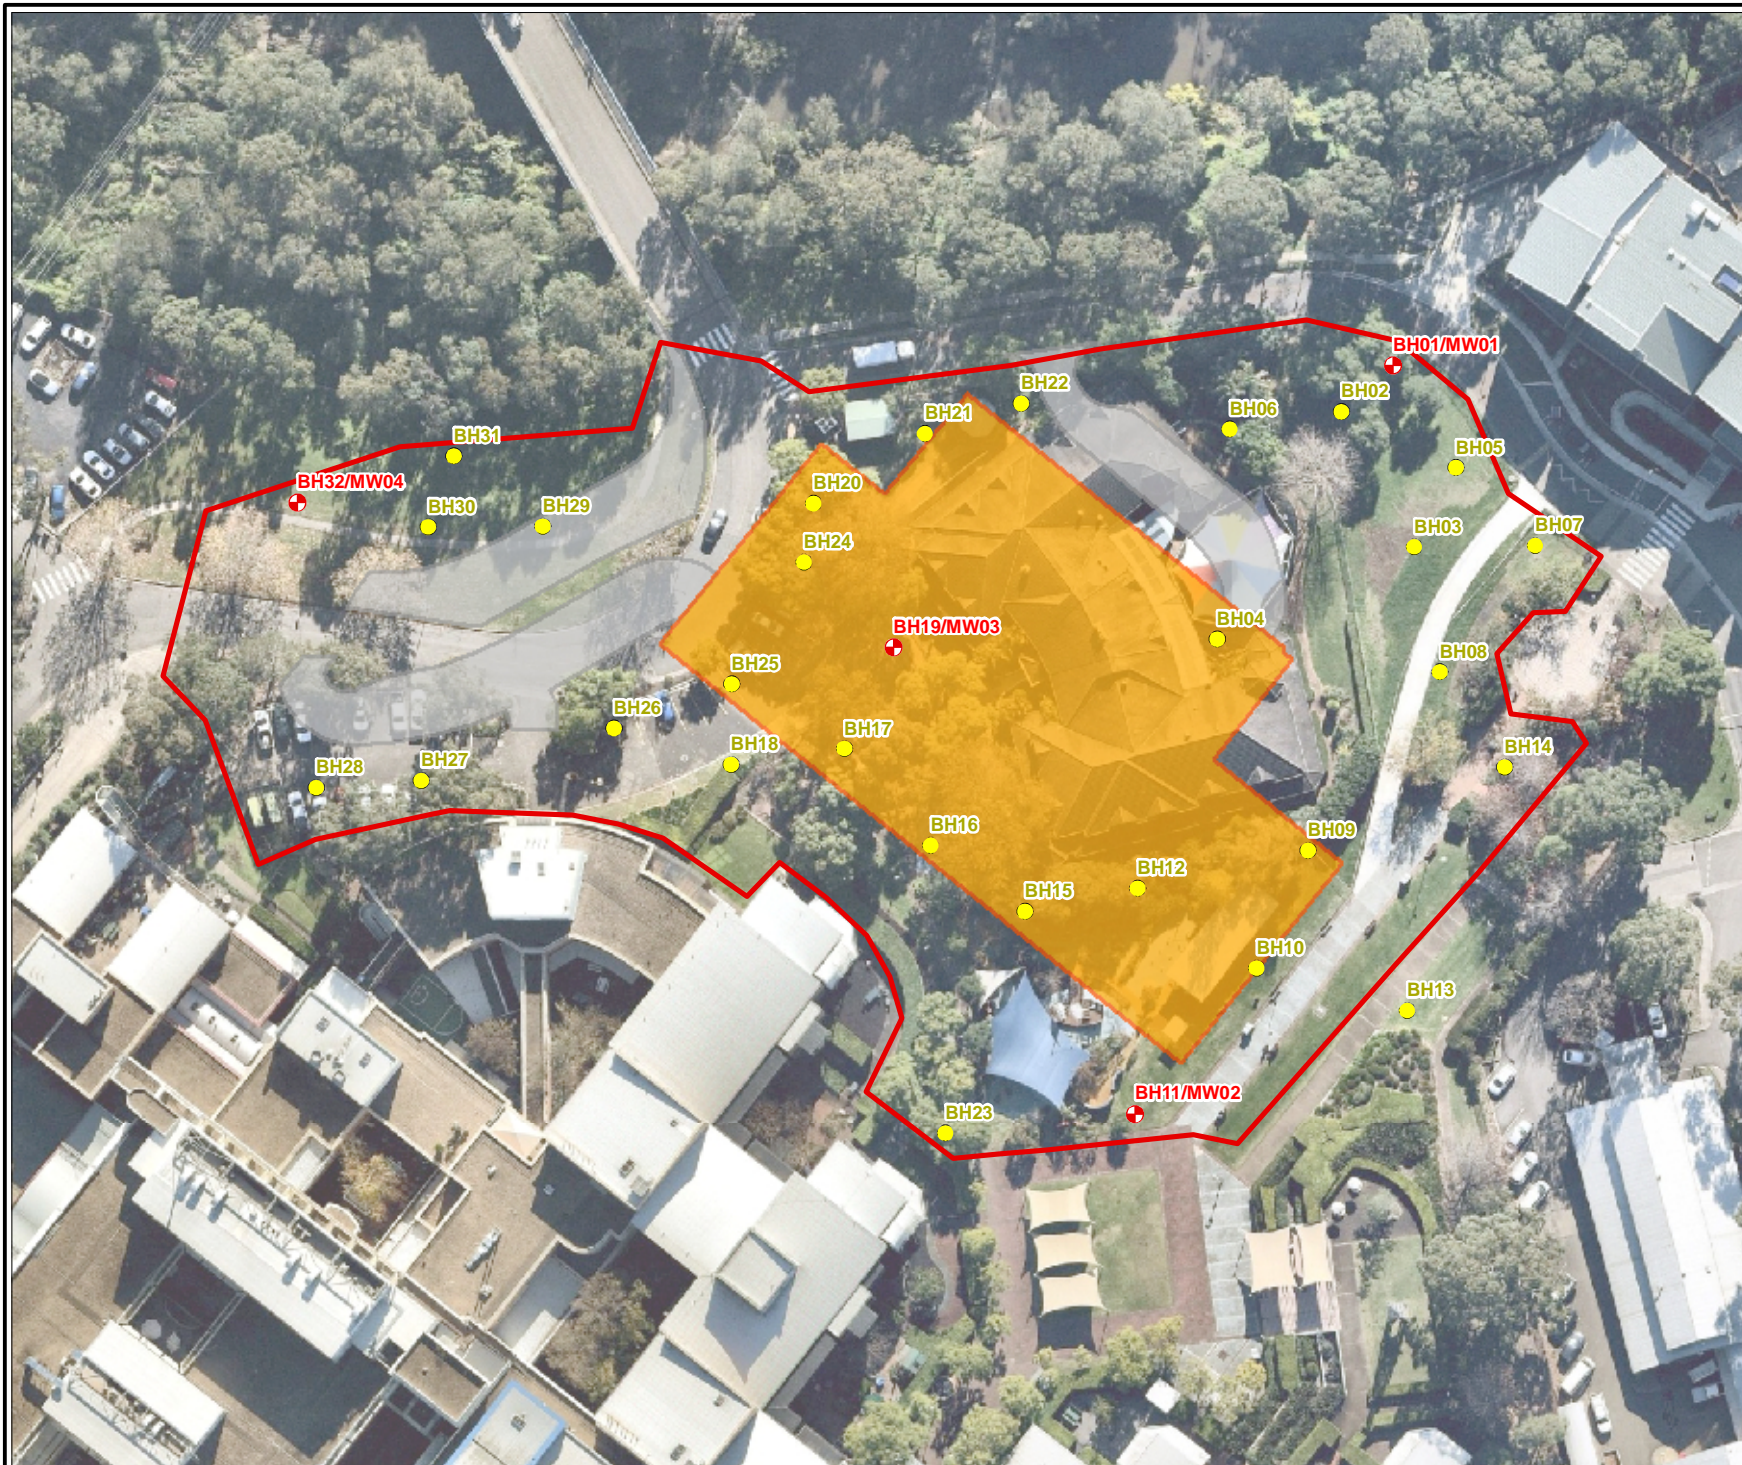
FIGURE 3

- Proposed MSCP Site Boundary
- Sampling Locations (JBS&G, 2020)**
- Soil Bore
- ⊕ Soil Bore/Monitoring Well
- MSCP Building Footprint
- Proposed Road Upgrade

SAMPLING LOCATIONS

The investigation works comprised a detailed site inspection and advancement of 32 soil sampling locations across the site, with four locations converted into monitoring wells, as shown on **Figure 3**. Soil and groundwater were subsequently analysed from these locations to characterise site conditions.

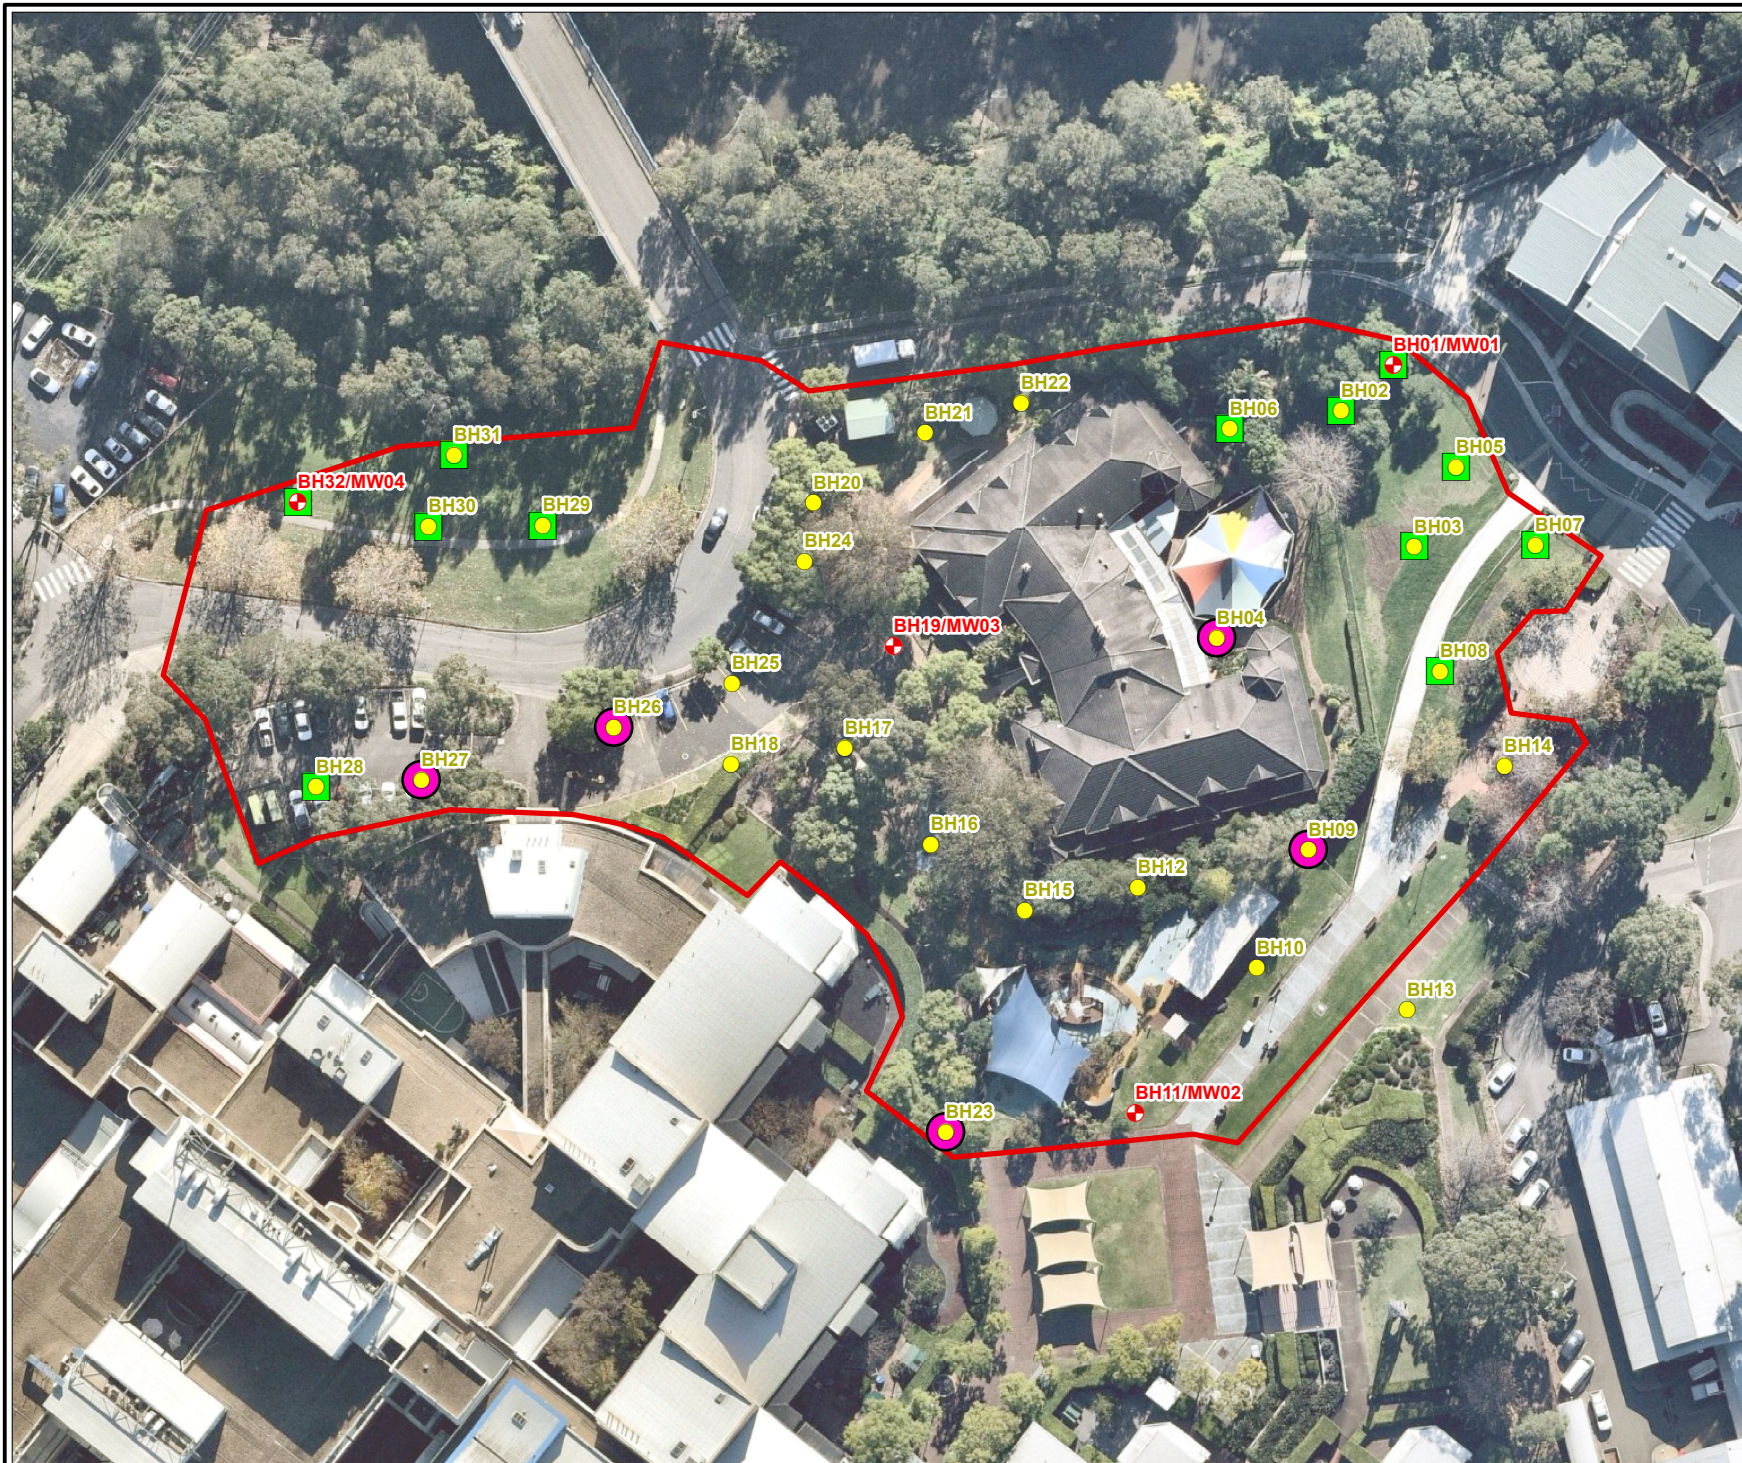
FIGURE 4A

- Proposed MSCP Site Boundary
- Soil Bore
- ⊕ Soil Bore/Monitoring Well
- Asbestos Detected**
- ACM & FA/AF
- FA/AF

ASBESTOS DETECTS

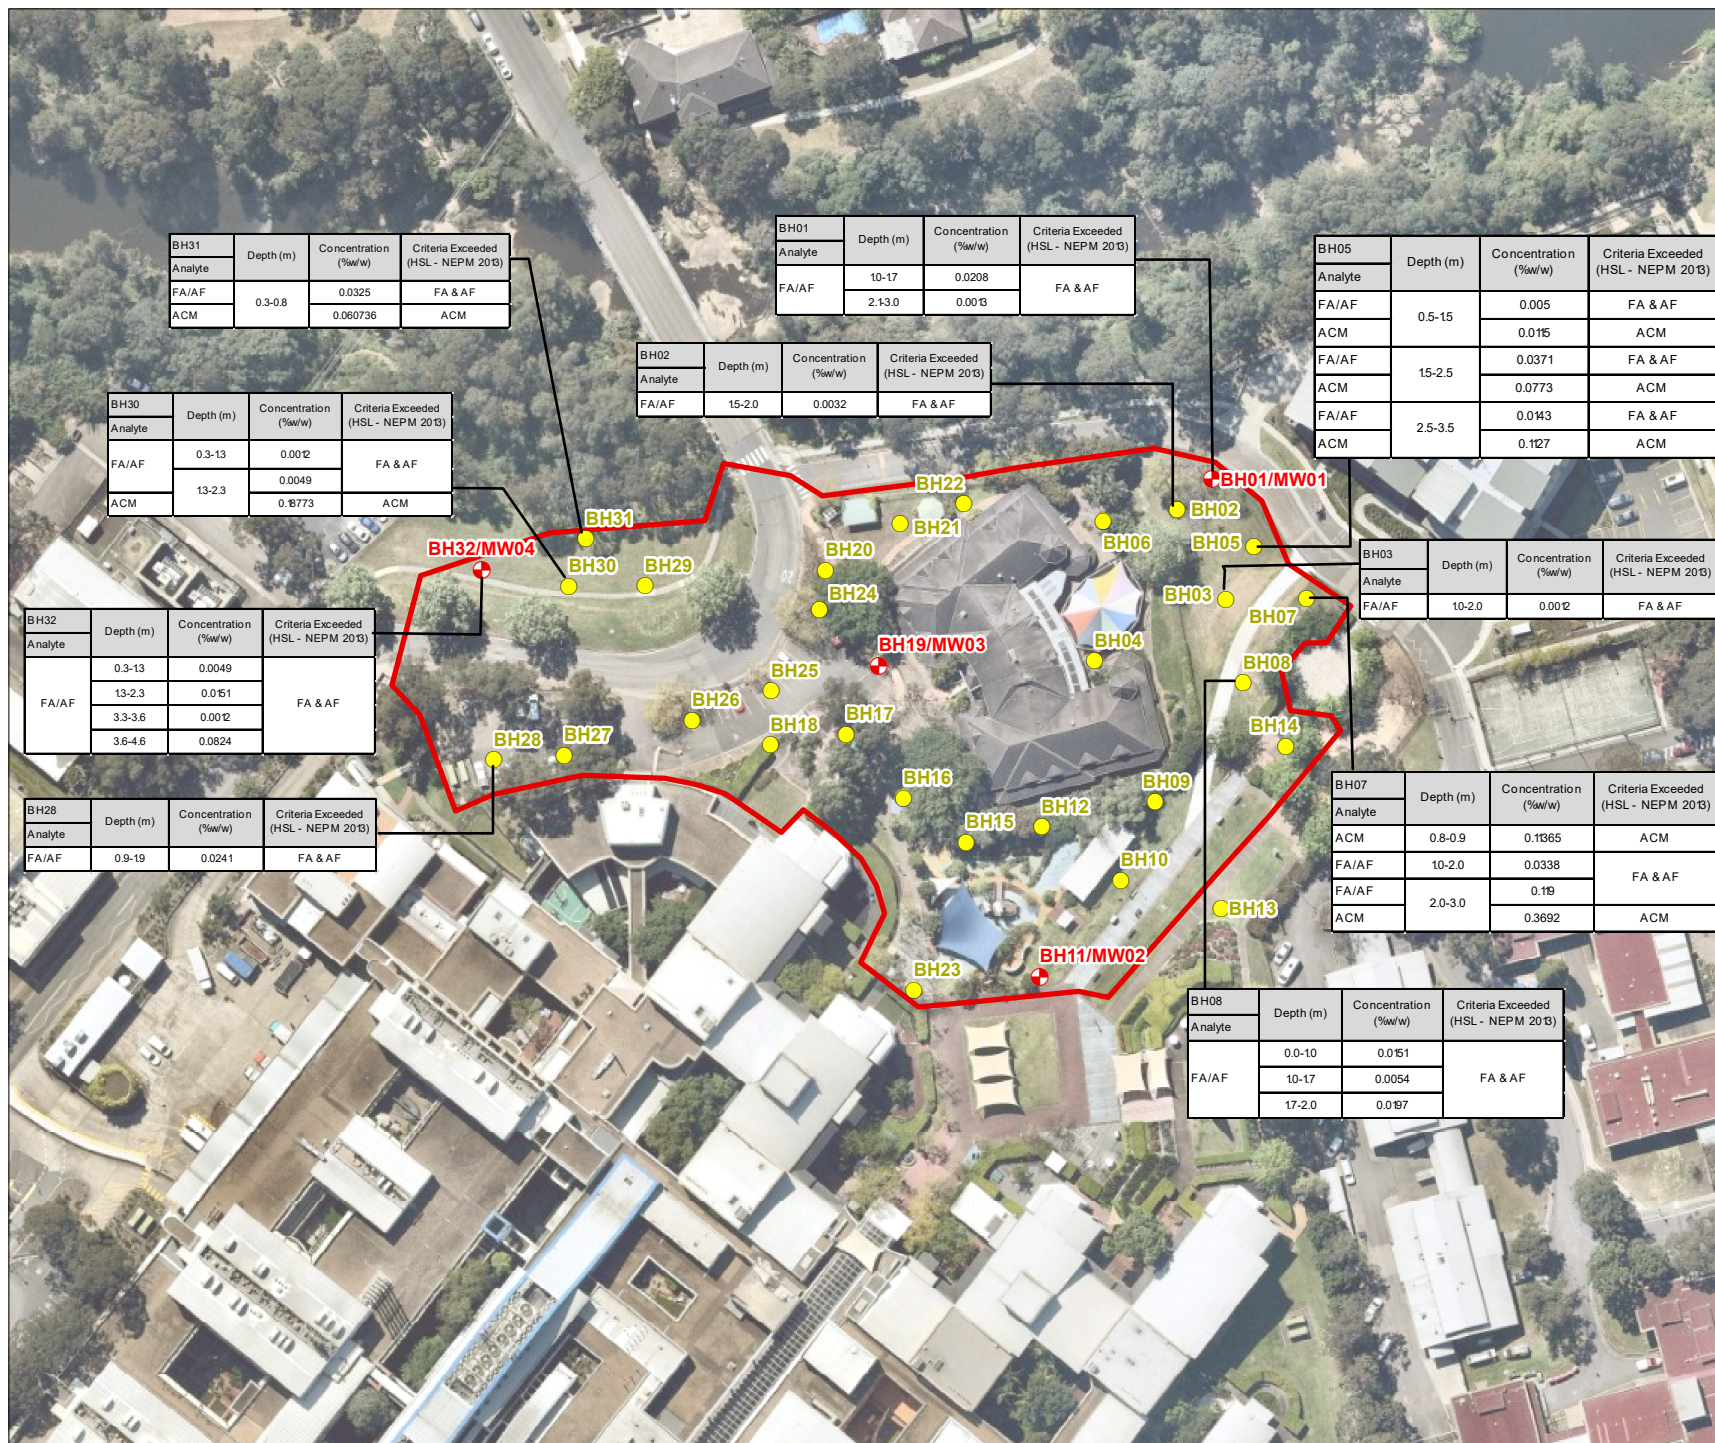
FIGURE 4B

ASBESTOS EXCEEDANCES

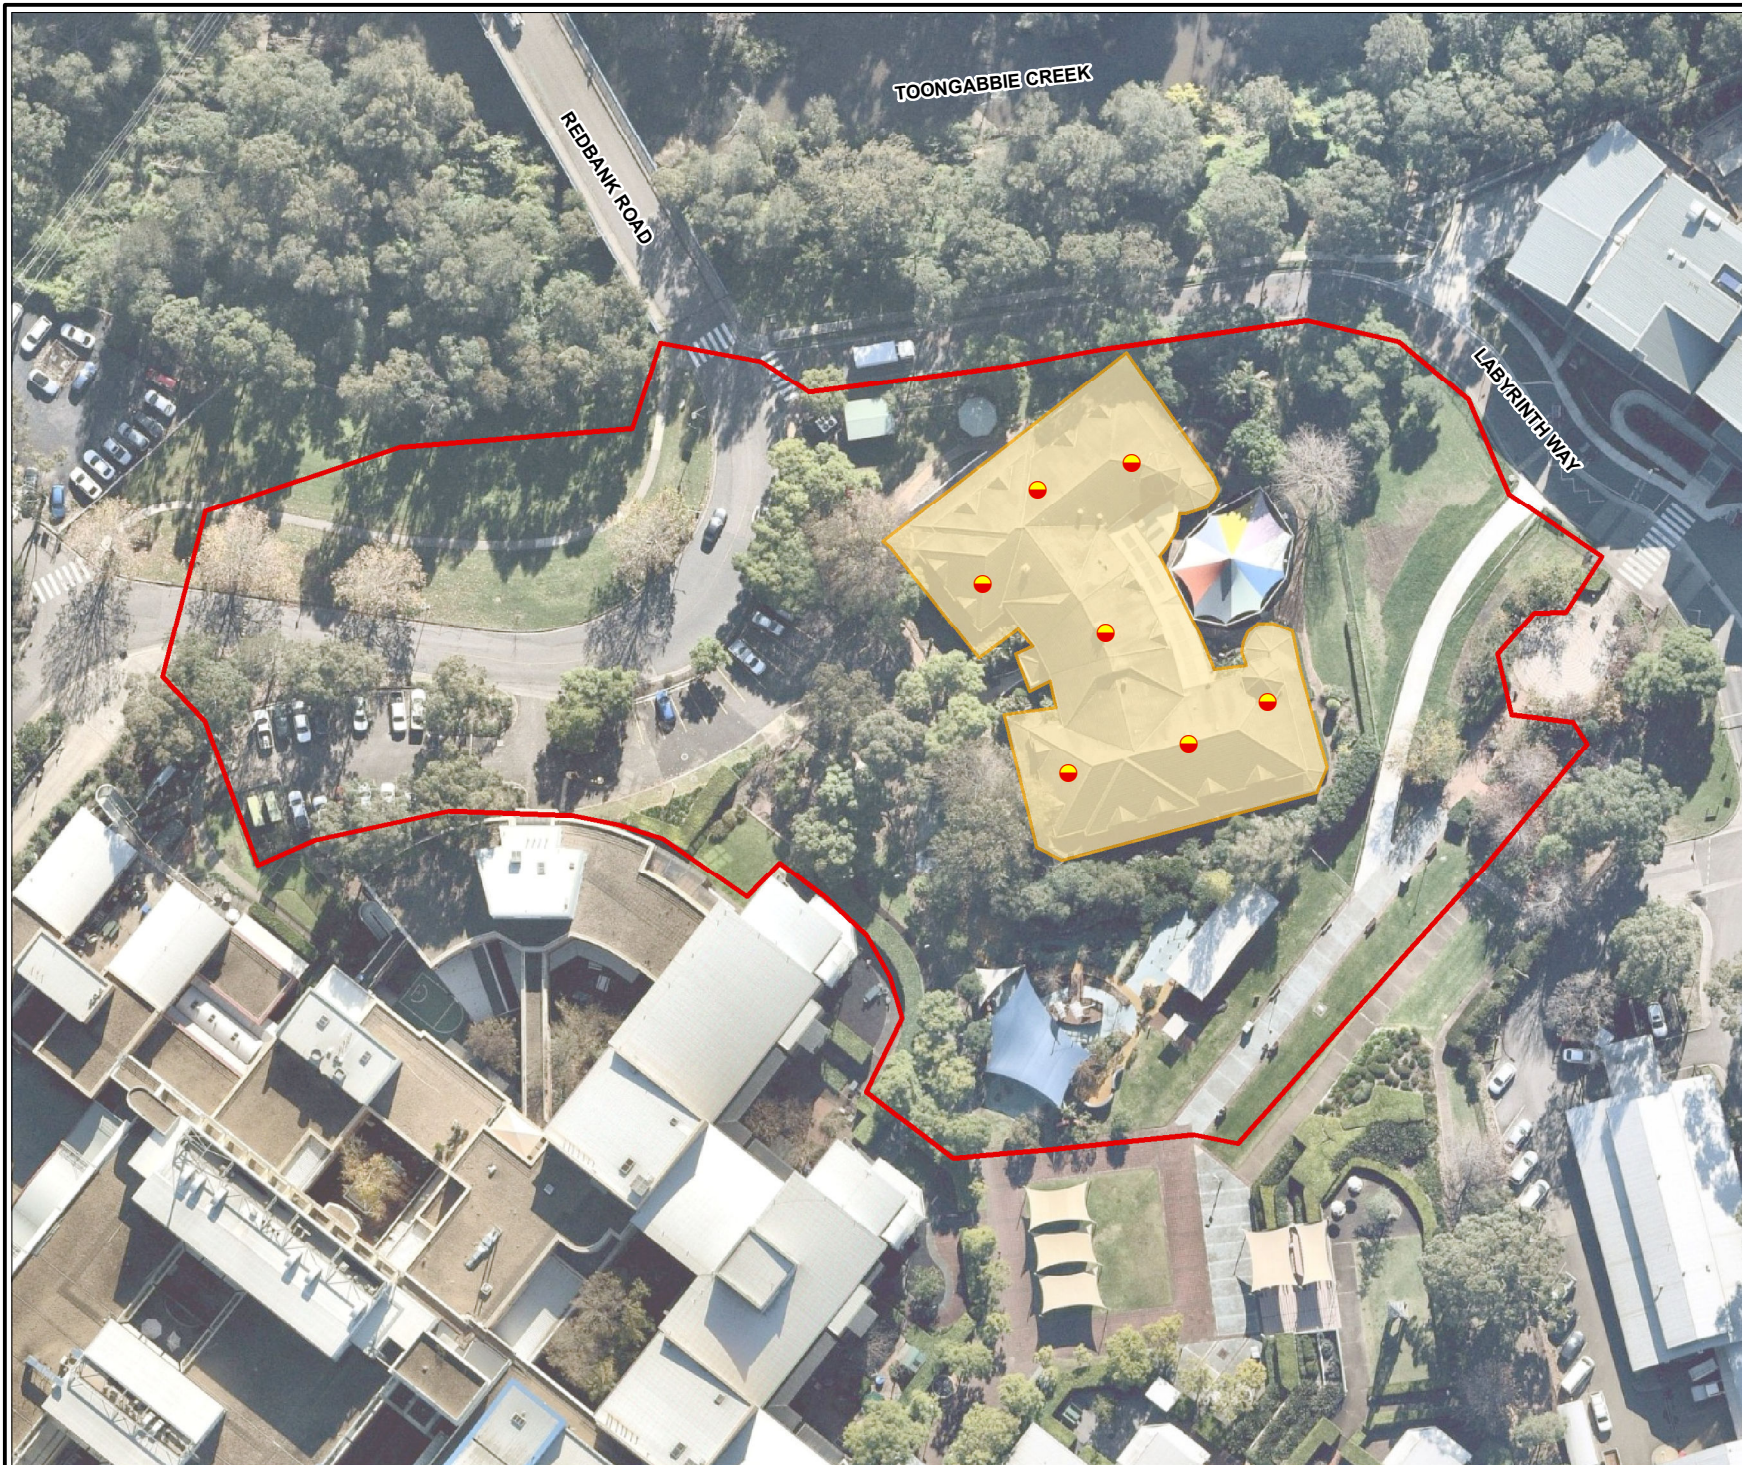
FIGURE 5

- Proposed MSCP Site Boundary
- The Lodge Building Footprint
- Proposed Data Gap Soil Sampling Locations – 20 m grid

DATA GAP ASSESSMENT

Soil validation sampling for asbestos and chemical constituents will be conducted by the Remediation Consultant under The Lodge footprint. An approximate 20 m grid sampling density will be applied (refer **Figure 5**), with sample locations targeting identified areas of concern. The sample locations will comprise both chemical constituent sampling and asbestos quantification sampling. If gross soil contamination observed following the removal of the slab or during boreholes, consideration to additional sample locations will be given. All results will be compared to the adopted site soil validation criteria as presented in **Table 9.3**.

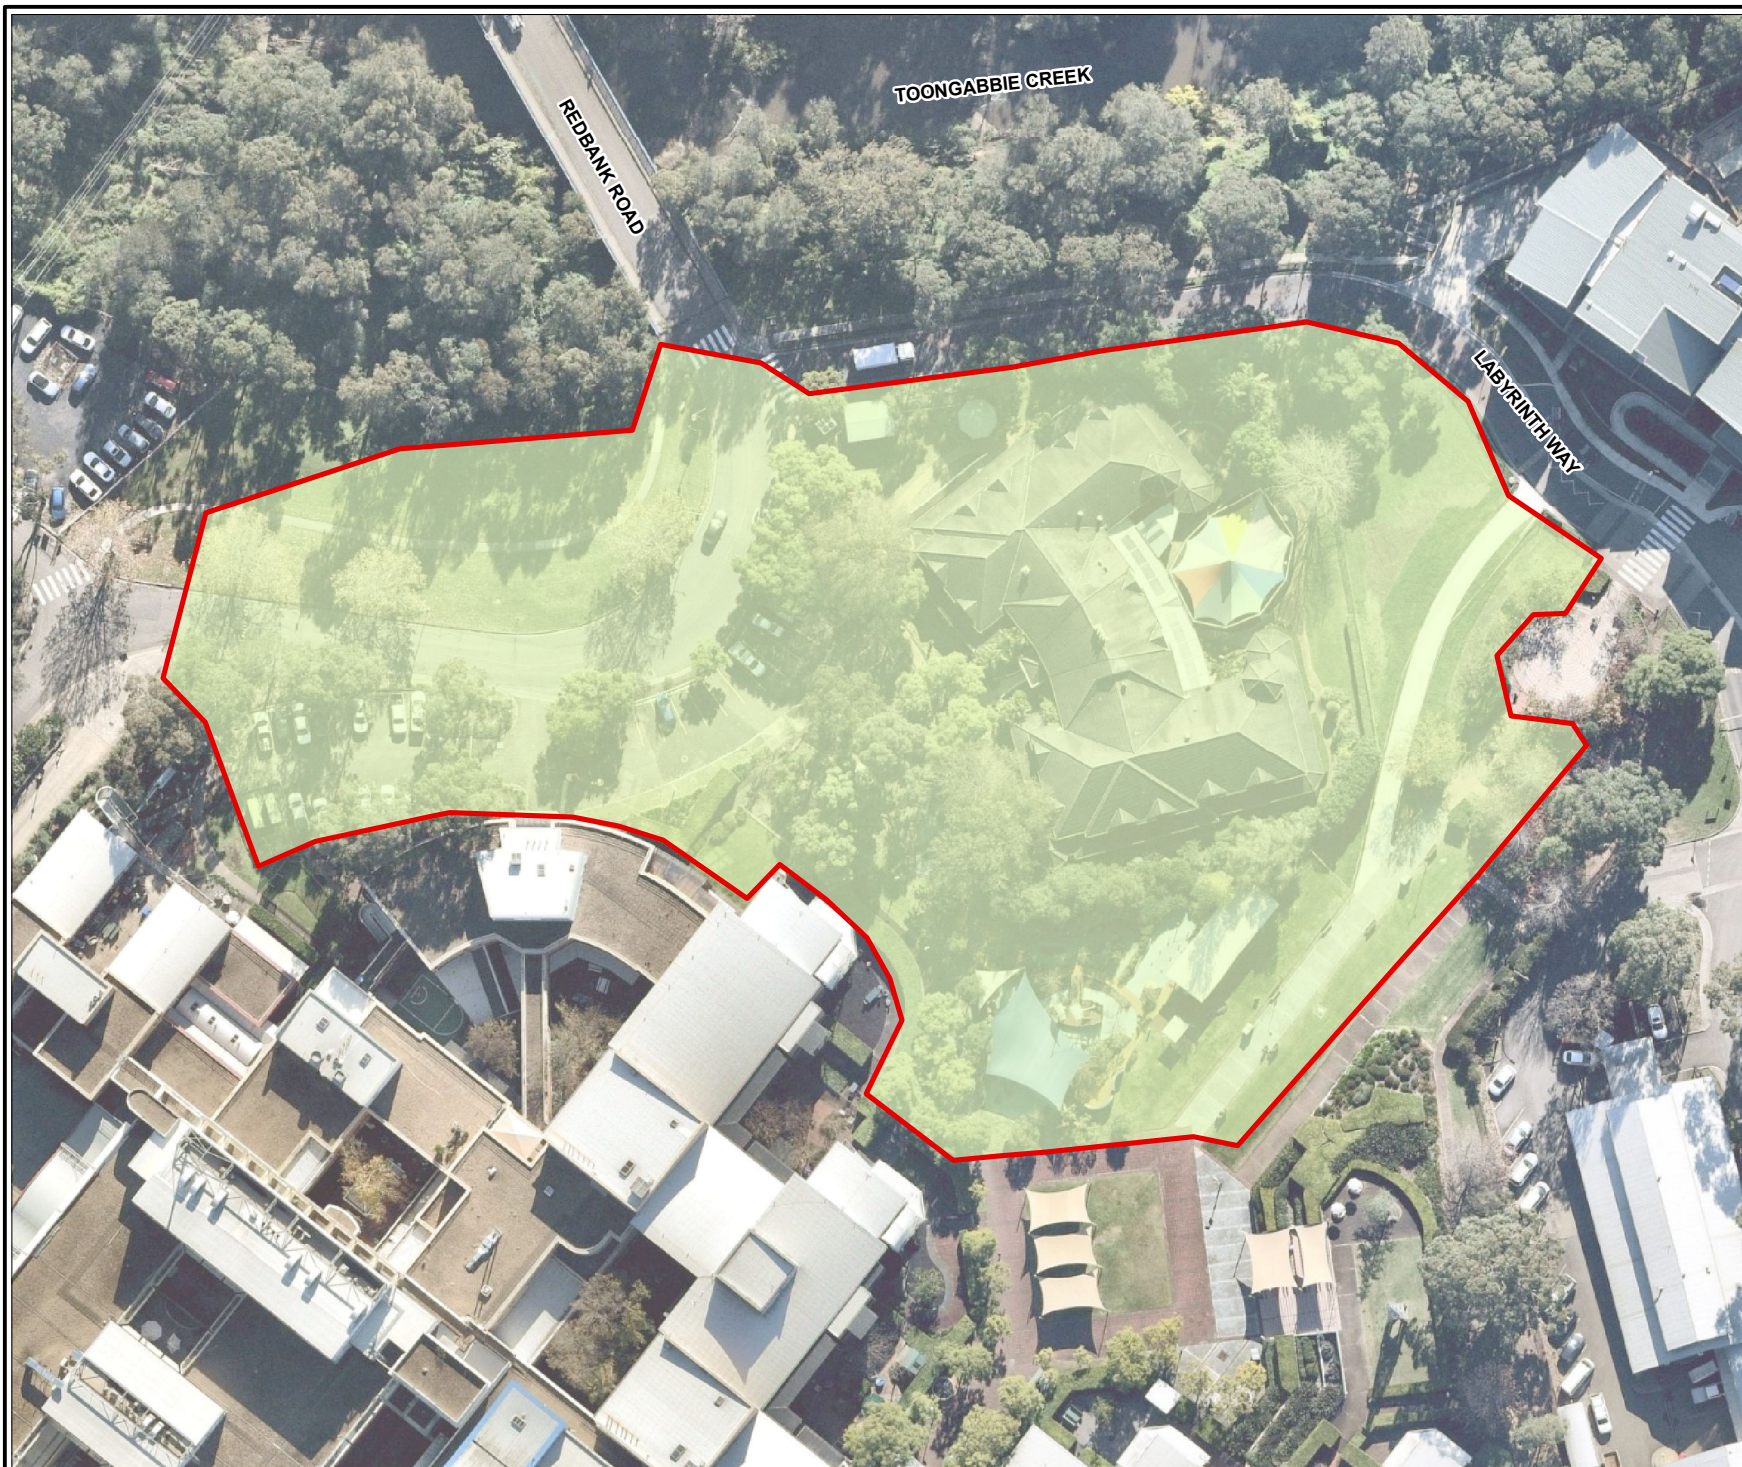
- Proposed MSCP Site Boundary
- Approximate Extent of Remediation**
- Approximate Extent of Asbestos Contaminated Fill

The lateral extent of known asbestos contamination is shown in **Figure 6**, comprising locations of brown gravelly clay fill observed across the site, including locations where this fill material was identified across the western portion. Differing fill materials observed across the south-western portion have been assumed to be impacted with asbestos for the purposes of this RAP, with potential for further assessment if surplus to site requirements. Fill materials beneath The Lodge building footprint have also been assumed to be impacted with asbestos for the purposes of this RAP and will be further defined during the data gap assessment as noted in **Section 5.2**.

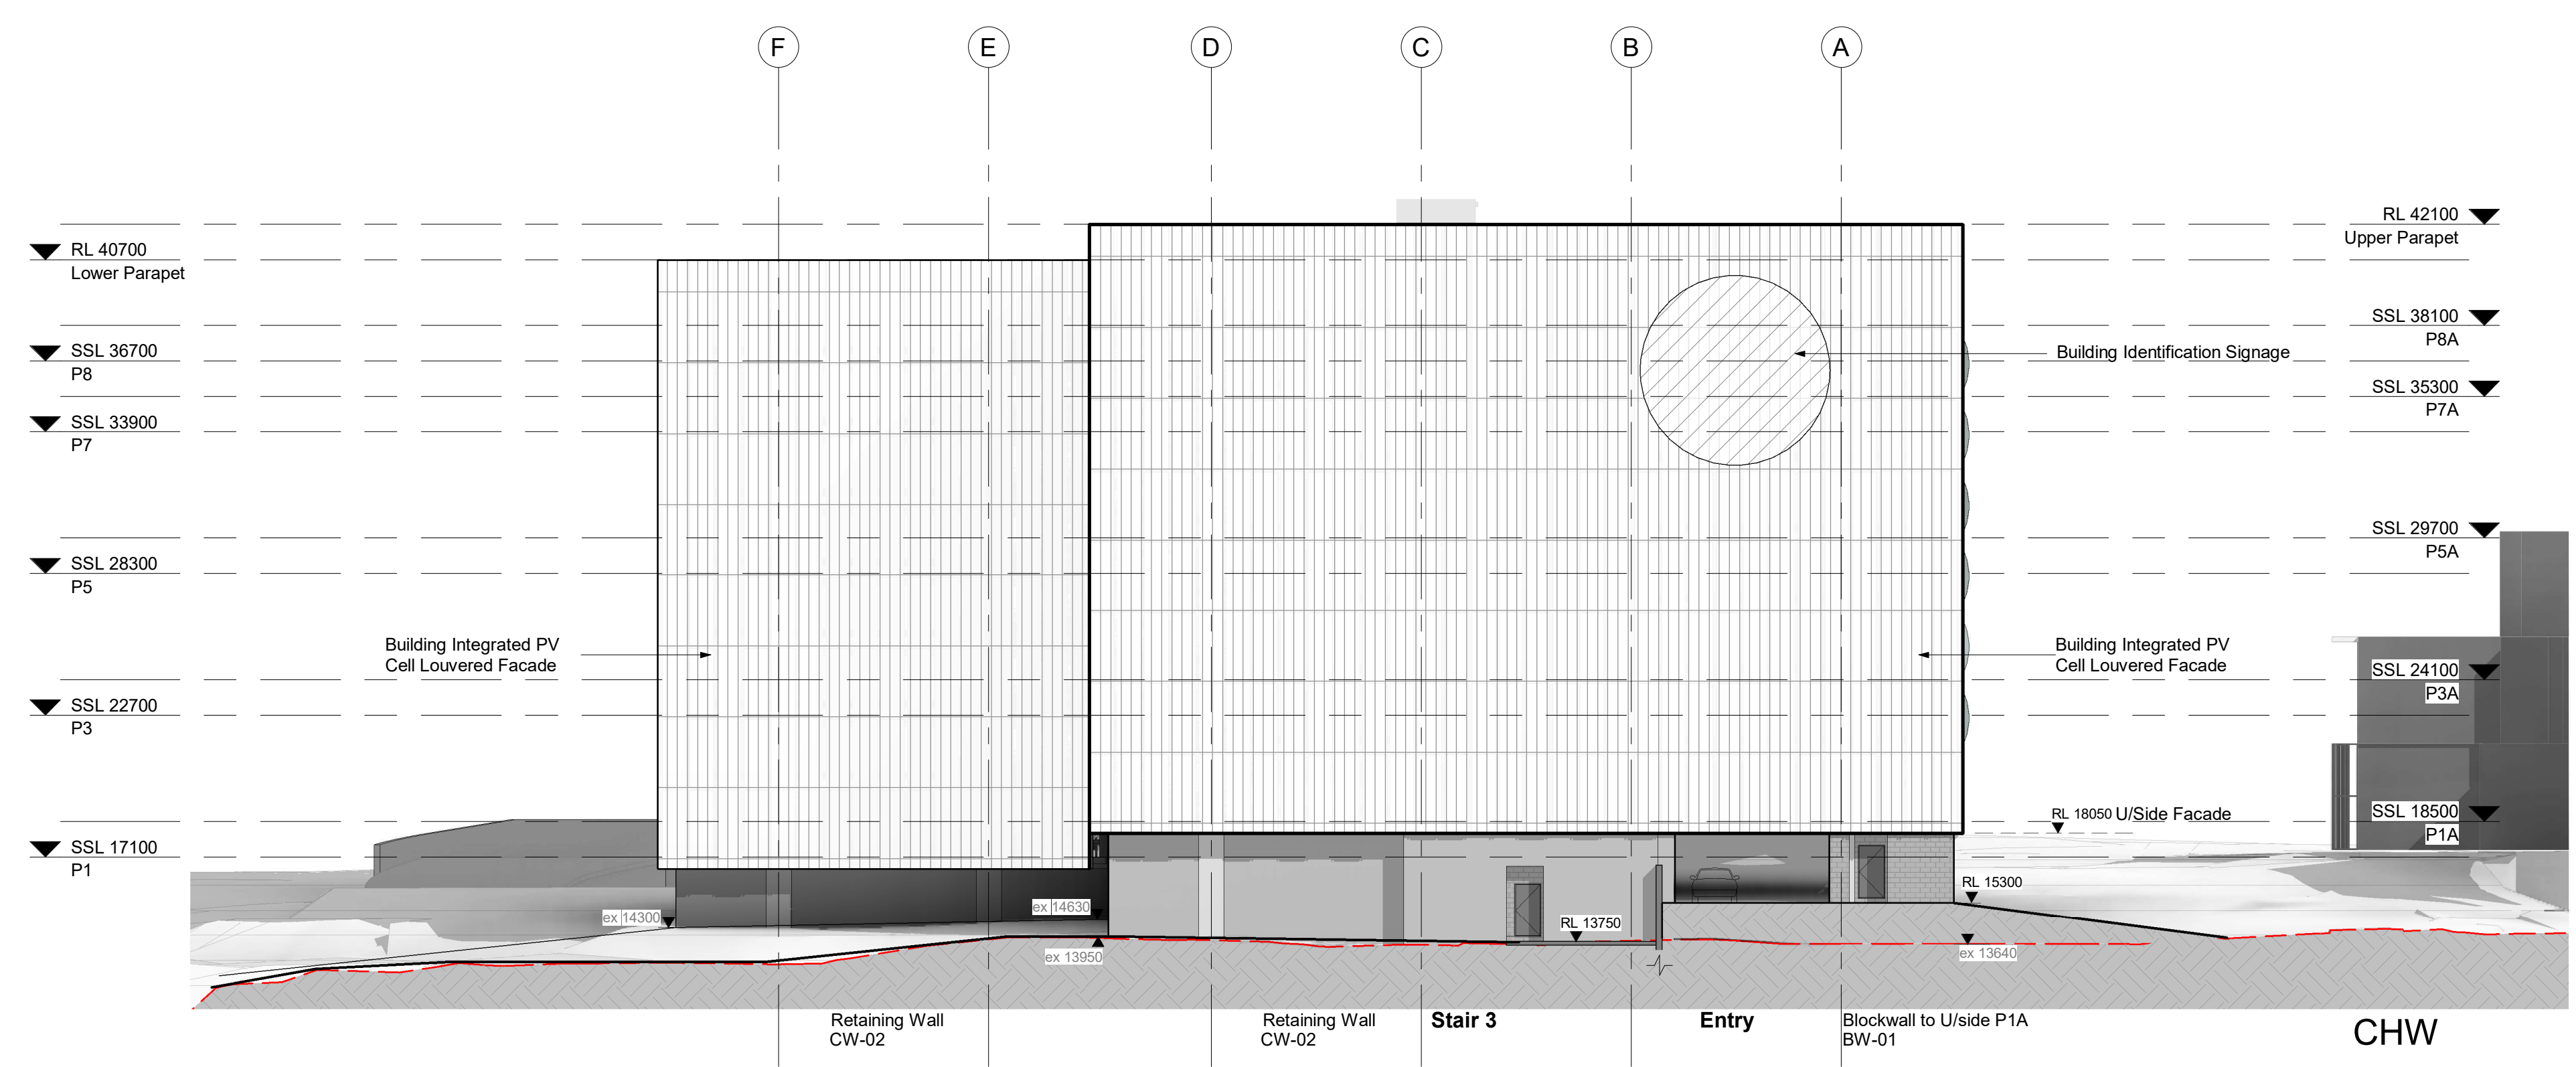
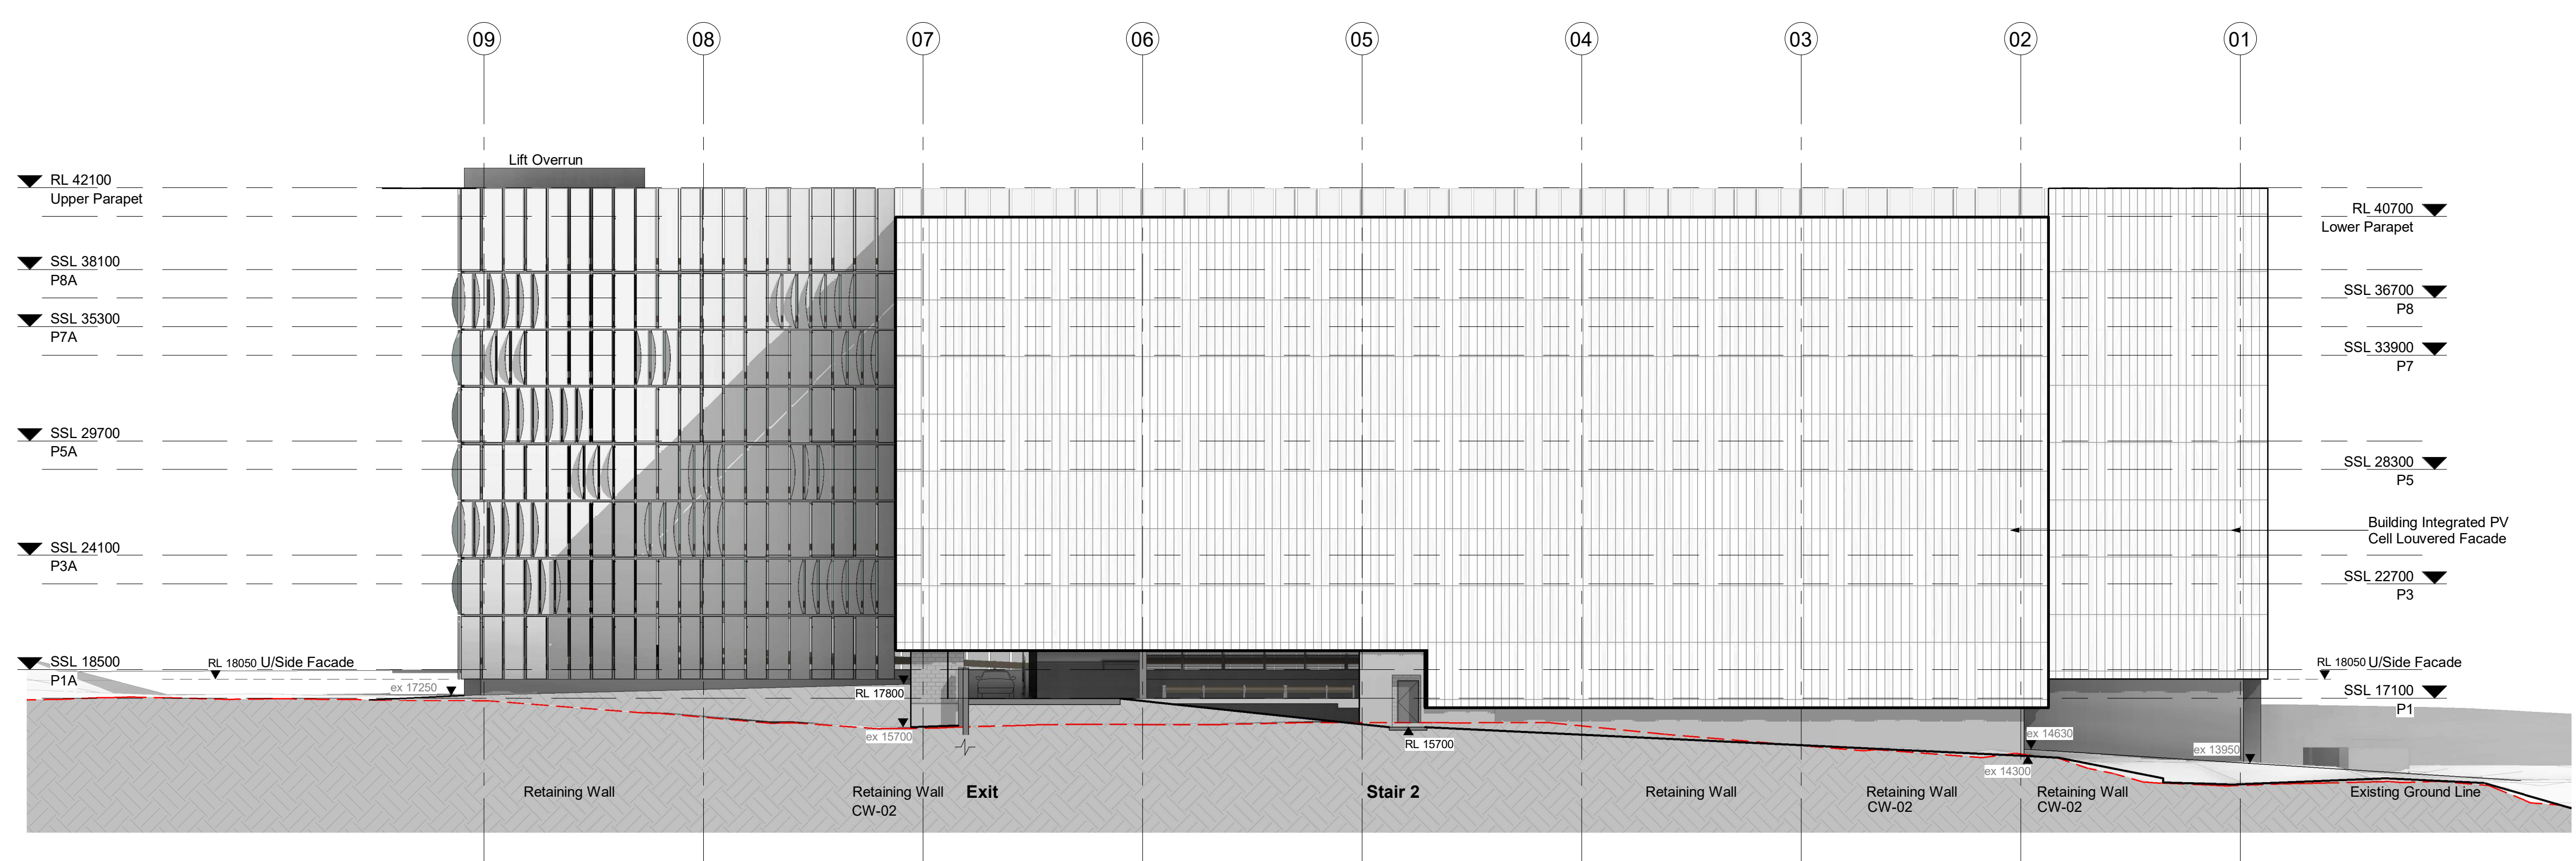
KEY:
AS MARKED IN GREEN ON THE KEY
PLAN ABOVE, BIPV CELL LOUVRED
FACADE APPLIED TO THE NORTH AND
EAST ELEVATIONS.

1 PROPOSED ELEVATION - NORTH
North

2 PROPOSED ELEVATION - EAST
East
