ABORIGINAL OBJECTS DUE DILIGENCE ASSESSMENT

**327-335 BURLEY ROAD,
HORSLEY PARK**

27 MARCH 2020
P0020568
DRAFT
PREPARED FOR ESR

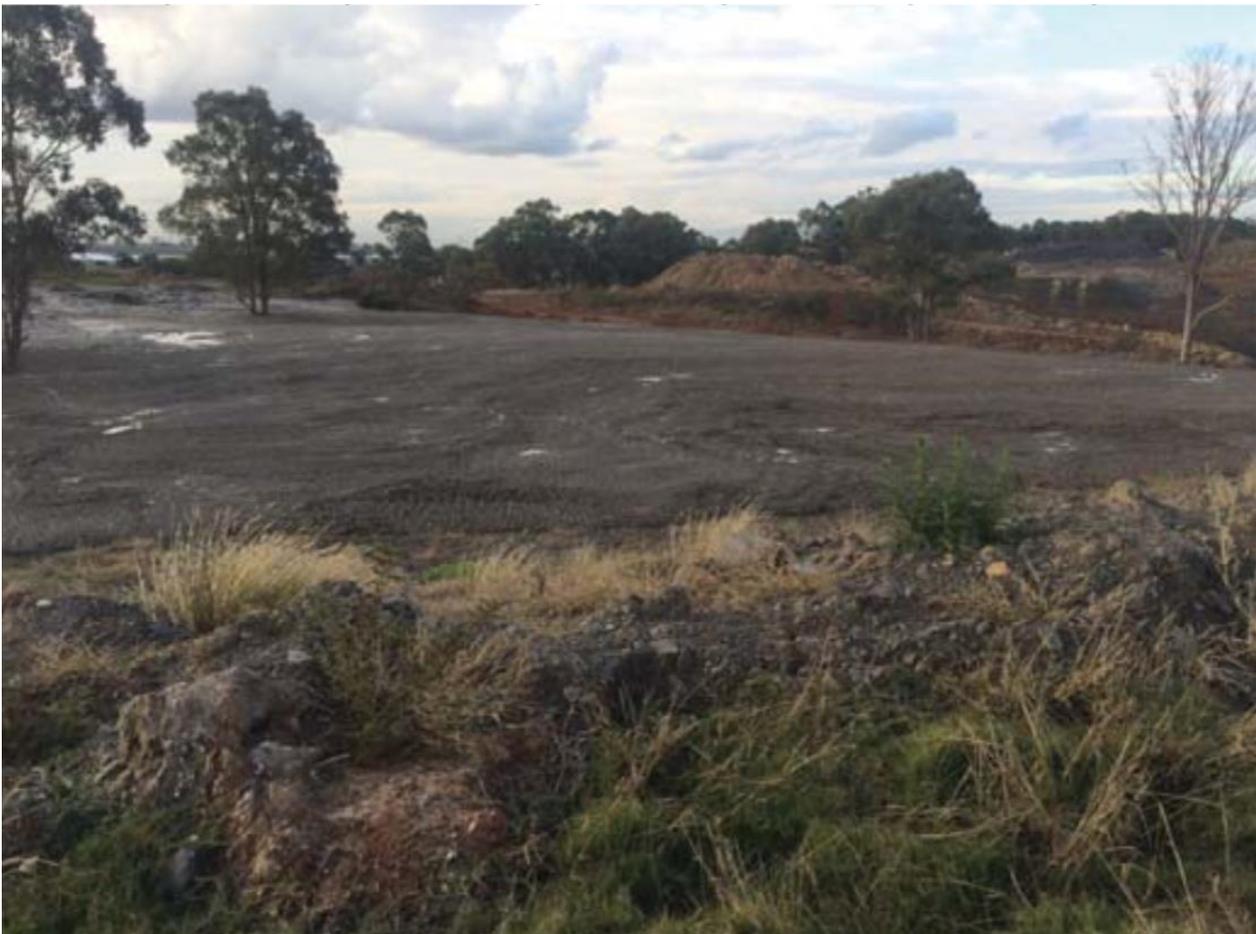
AHIMS ID#45-5-2046 was an isolated find located within the subject area. The site consisted of one chert undiagnostic piece of debitage, which was identified on a highly disturbed track between landfill and a slush dump.

Figure 4 – View to the north of AHIMS ID#45-5-2046 site (from haul road)

An Aboriginal Site Impact Recording Form (ASIRF) for AHIMS ID#45-5-2046 was completed by Dr Matthew Kelleher (Kelleher Nightingale Consulting Pty Ltd) in August 2016. Dr Kelleher assessed the site as representing low significance and archaeological potential due to the degree of land-use disturbance (Figure 4 and Figure 5). The stone artefact was identified by Dr Kelleher in 2016 approximately 250m south west of the AHIMS registered location, adjacent to the haul road in the south of the subject area. The original AHIMS site location was in an area of redeposited sediment and gravels that was heavily disturbed. No other artefacts were observed upon inspection of the site and an assessment found that there is no potential for intact subsurface archaeological deposits in this location.

Following the above findings by Dr Kelleher the then Office of Environment and Heritage (OEH) advised that the lodgement of said ASIRF be made to update the status of the site to 'destroyed'.

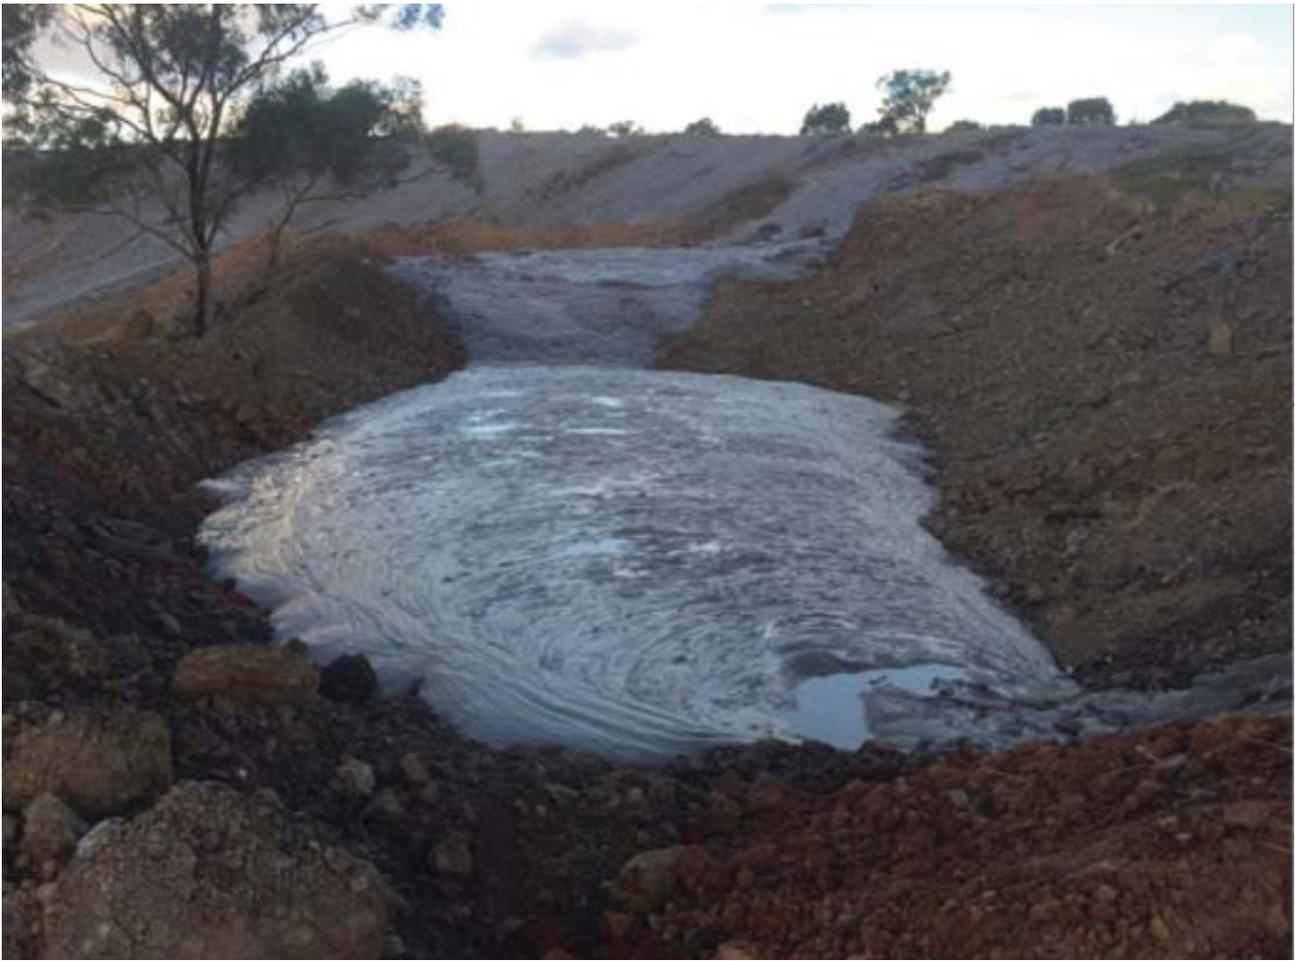
Figure 5 – View to the east of AHIMS ID#45-5-2046 site showing adjacent disturbance.

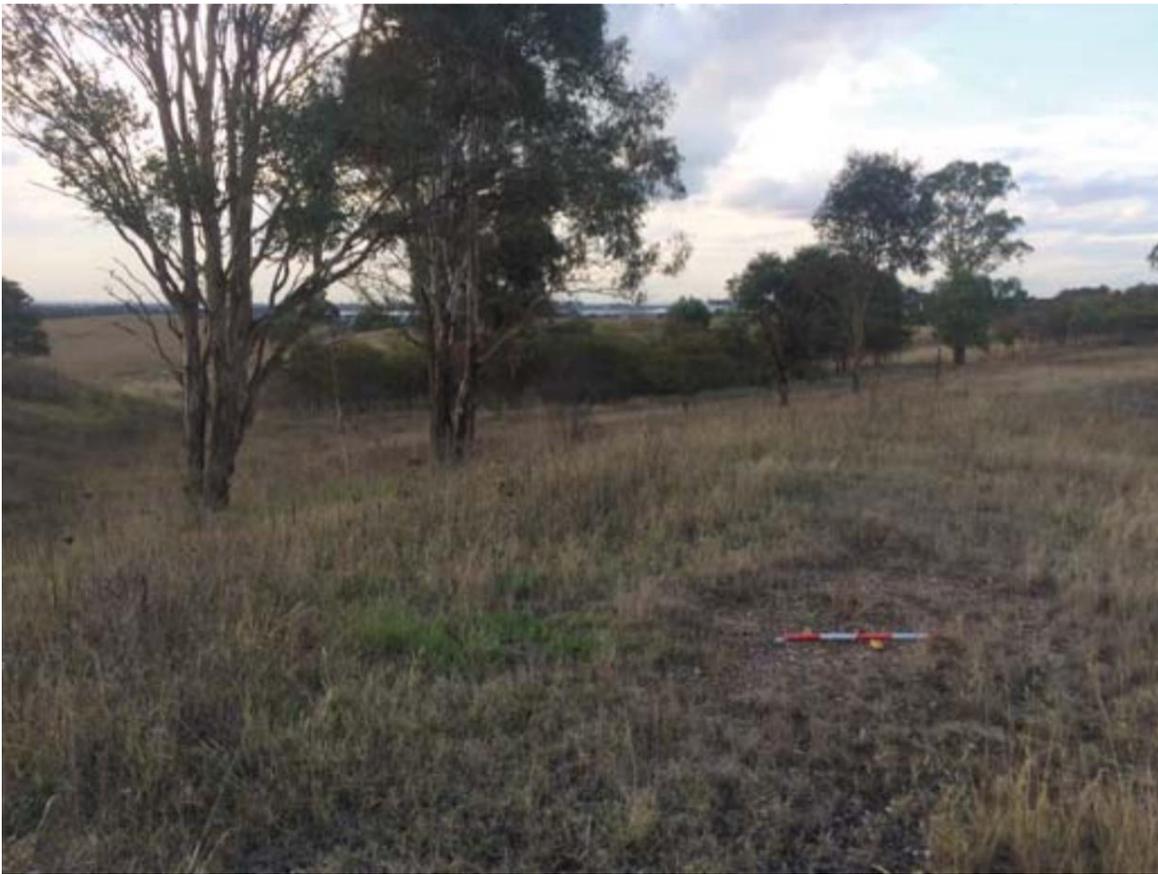
AHIMS ID#45-5-2057 was an isolated find located within the subject area. The site consisted of one chert undiagnostic piece of debitage, which was located on overburden spoil from a large graded landfill area.

Figure 6 – View to the north of AHIMS ID#45-5-2047 site showing graded fill.

An ASIRF for AHIMS ID#45-5-2057 was complete by Dr Matthew Kelleher (Kelleher Nightingale Consulting Pty Ltd) in August 2016. Dr Kelleher assessed the site as representing low significance and archaeological potential due to the degree of land-use disturbance (Figure 6 and Figure 7). The stone artefact was identified by Dr Kelleher in 2016 approximately 300m south west of the AHIMS registered location. The site was located adjacent to a graded unsealed vehicle track along the southern boundary of the subject area. The site was located in an area of redeposited and graded fill, overgrown with grasses and revegetated trees. No other artefacts were observed upon inspection of the site. An assessment found that the site was heavily disturbed with no potential for intact subsurface archaeological deposits in this location.

Following the above findings by Dr Kelleher the then OEH advised that the lodgement of said ASIRF be made to update the status of the site to 'destroyed'.

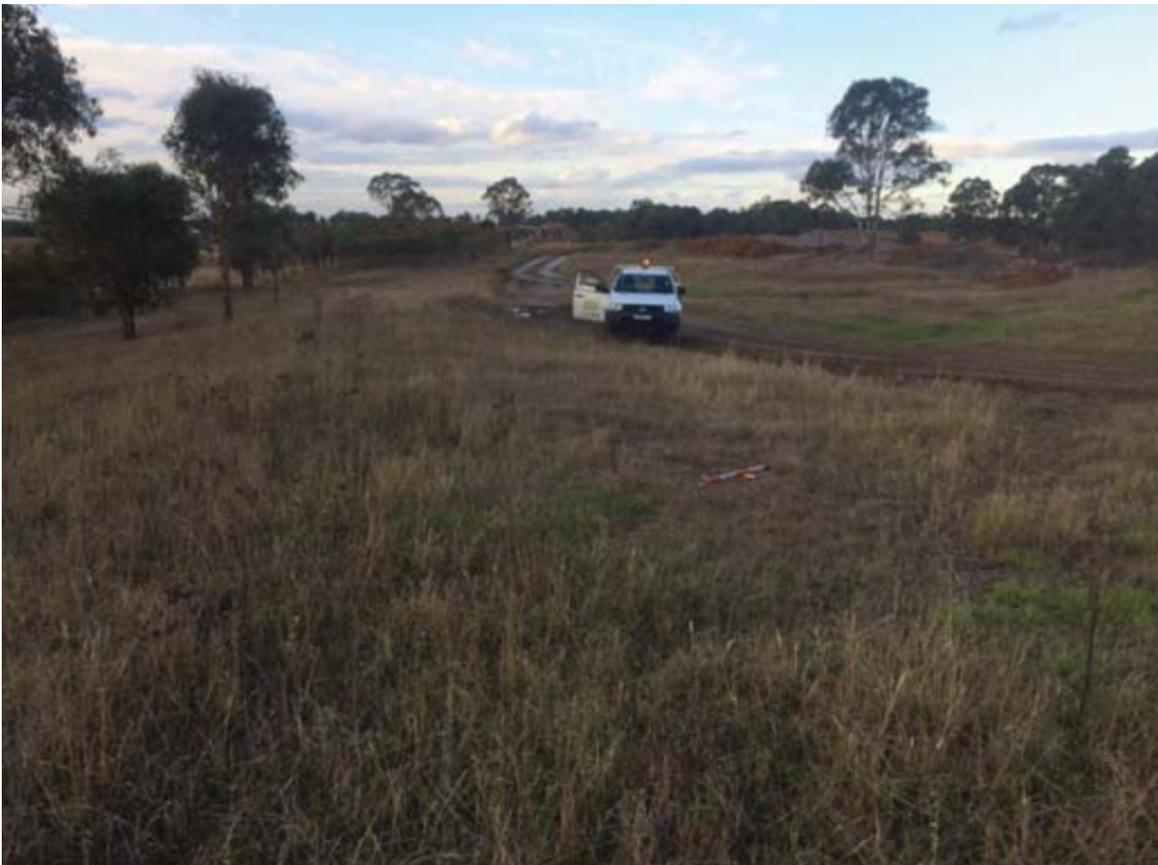
Figure 7 – View to the north-east of AHIMS ID#45-5-2047 site showing quarry track.

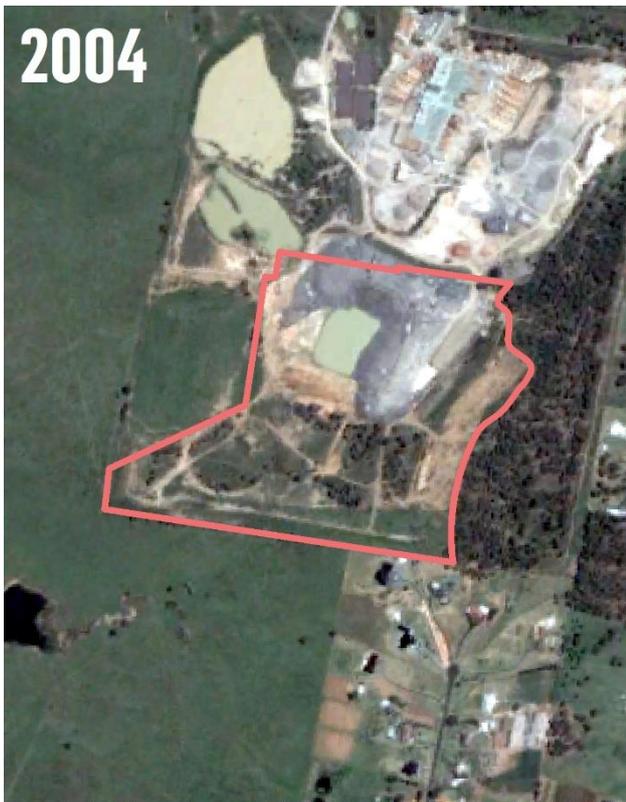
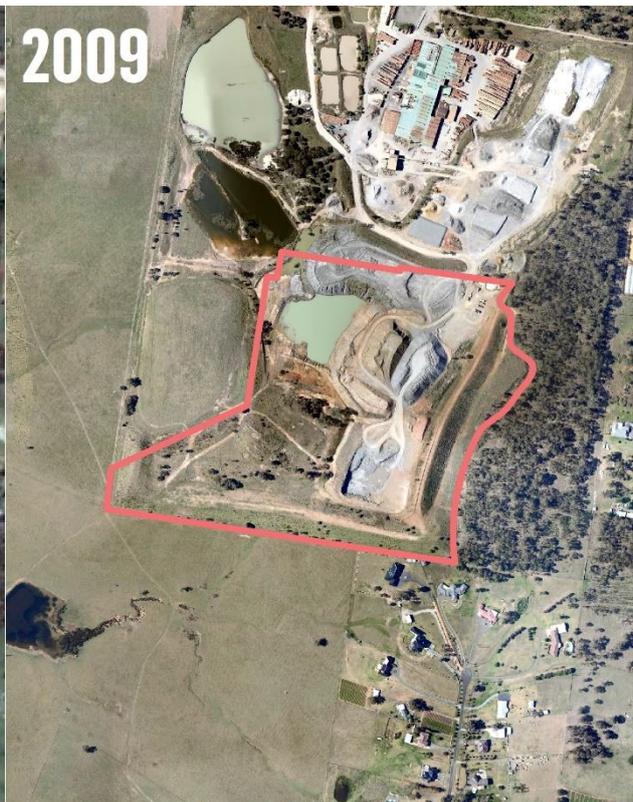
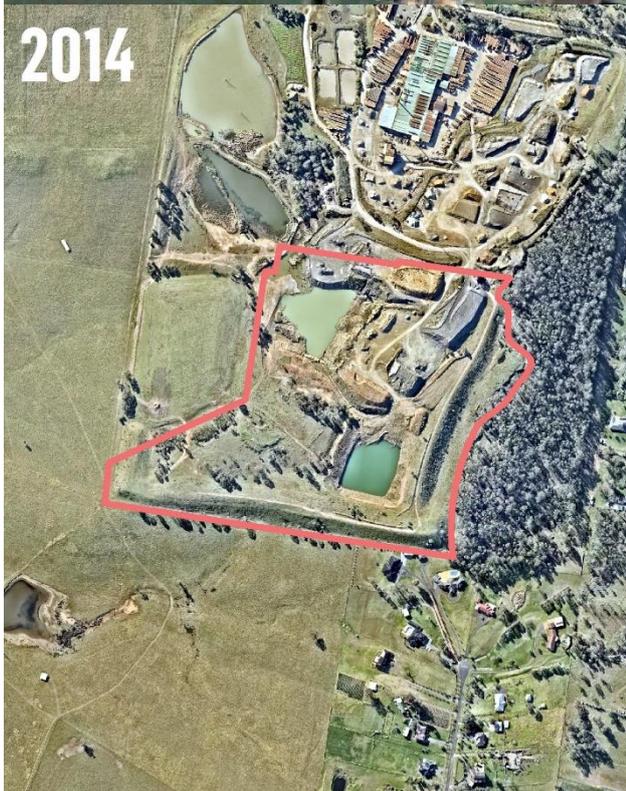
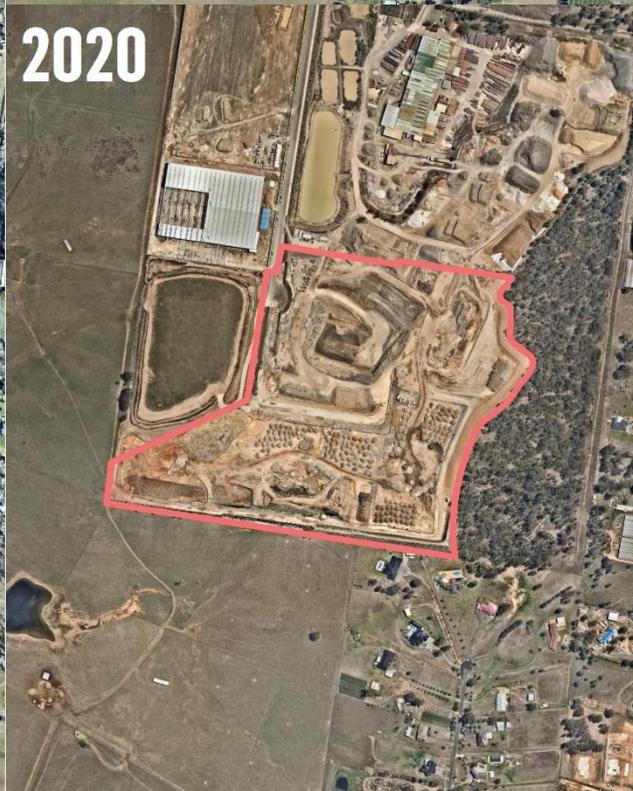
The level of impact across the majority of the subject area up until 2014 was moderate to high as a result of historical land use associated with quarrying and brick making. This would have completely removed the natural topsoil/stratigraphy as a result and impacted adjacent areas through fill and machine modification.

The impact identified within the 2020 aerial shows that following the cessation of quarrying activities the cutting and filling of the subject area by CSR has entirely removed any potential for natural top and subsoils to remain within the subject area. As a result, the archaeological potential within the subject area is considered nil-low.
