# Aspect Industrial Estate State Significant Development Application - Riparian Assessment

**Mirvac Projects**

<b>Project Name</b>	Aspect Industrial Estate State Significant Development Application - Riparian Assessment
<b>Project Number</b>	18SYD-11929
<b>Project Manager</b>	Rebecca Ben-Haim
<b>Prepared by</b>	Claire Wheeler
<b>Reviewed by</b>	Ian Dixon
<b>Approved by</b>	David Bonjer
<b>Status</b>	<b>Final</b>
<b>Version Number</b>	<b>4</b>
<b>Last saved on</b>	<b>29 September 2020</b>

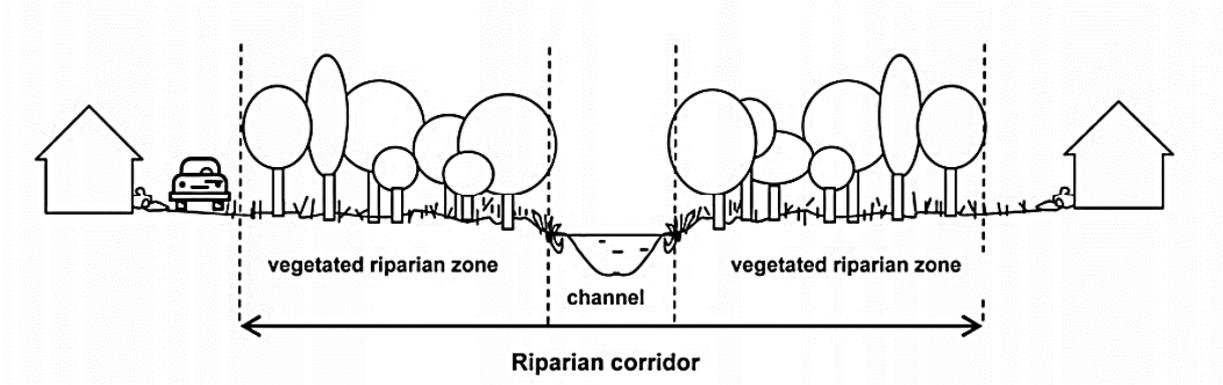
NRAR's *Guidelines for Controlled Activities on waterfront land—Riparian corridors* (NRAR, 2018) outlines the need for a Vegetated Riparian Zone (VRZ) adjacent to the channel to provide a transition zone between the terrestrial environment and watercourse. This vegetated zone helps maintain and improve the ecological functions of a watercourse whilst providing habitat for terrestrial flora and fauna. The VRZ plus the channel (bed and banks of the watercourse to the highest bank) constitute the 'riparian corridor' (Figure 4). NRAR recommends a VRZ width based on watercourse order as classified under the Strahler System of ordering watercourses and using Hydroline Spatial Data which is published on the department's website (Table 2).

Figure 4: Vegetated Riparian Zone and watercourse channel comprising the riparian corridor (NRAR, 2018).

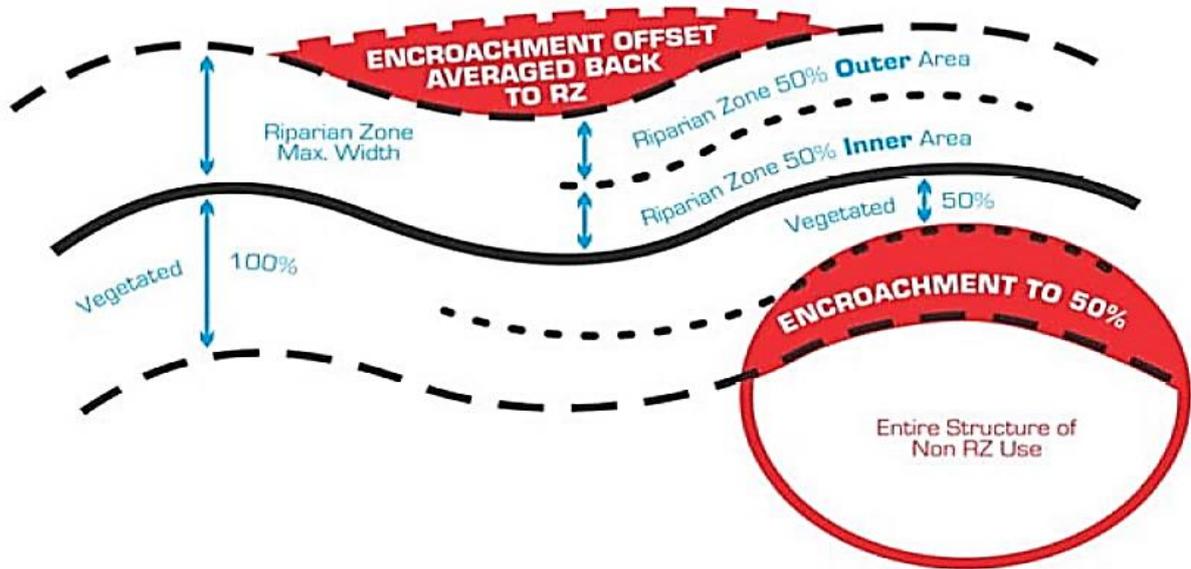
Figure 5: Riparian 'averaging rule' for offsetting encroachment into the outer 50% of the VRZ (NRAR 2018).

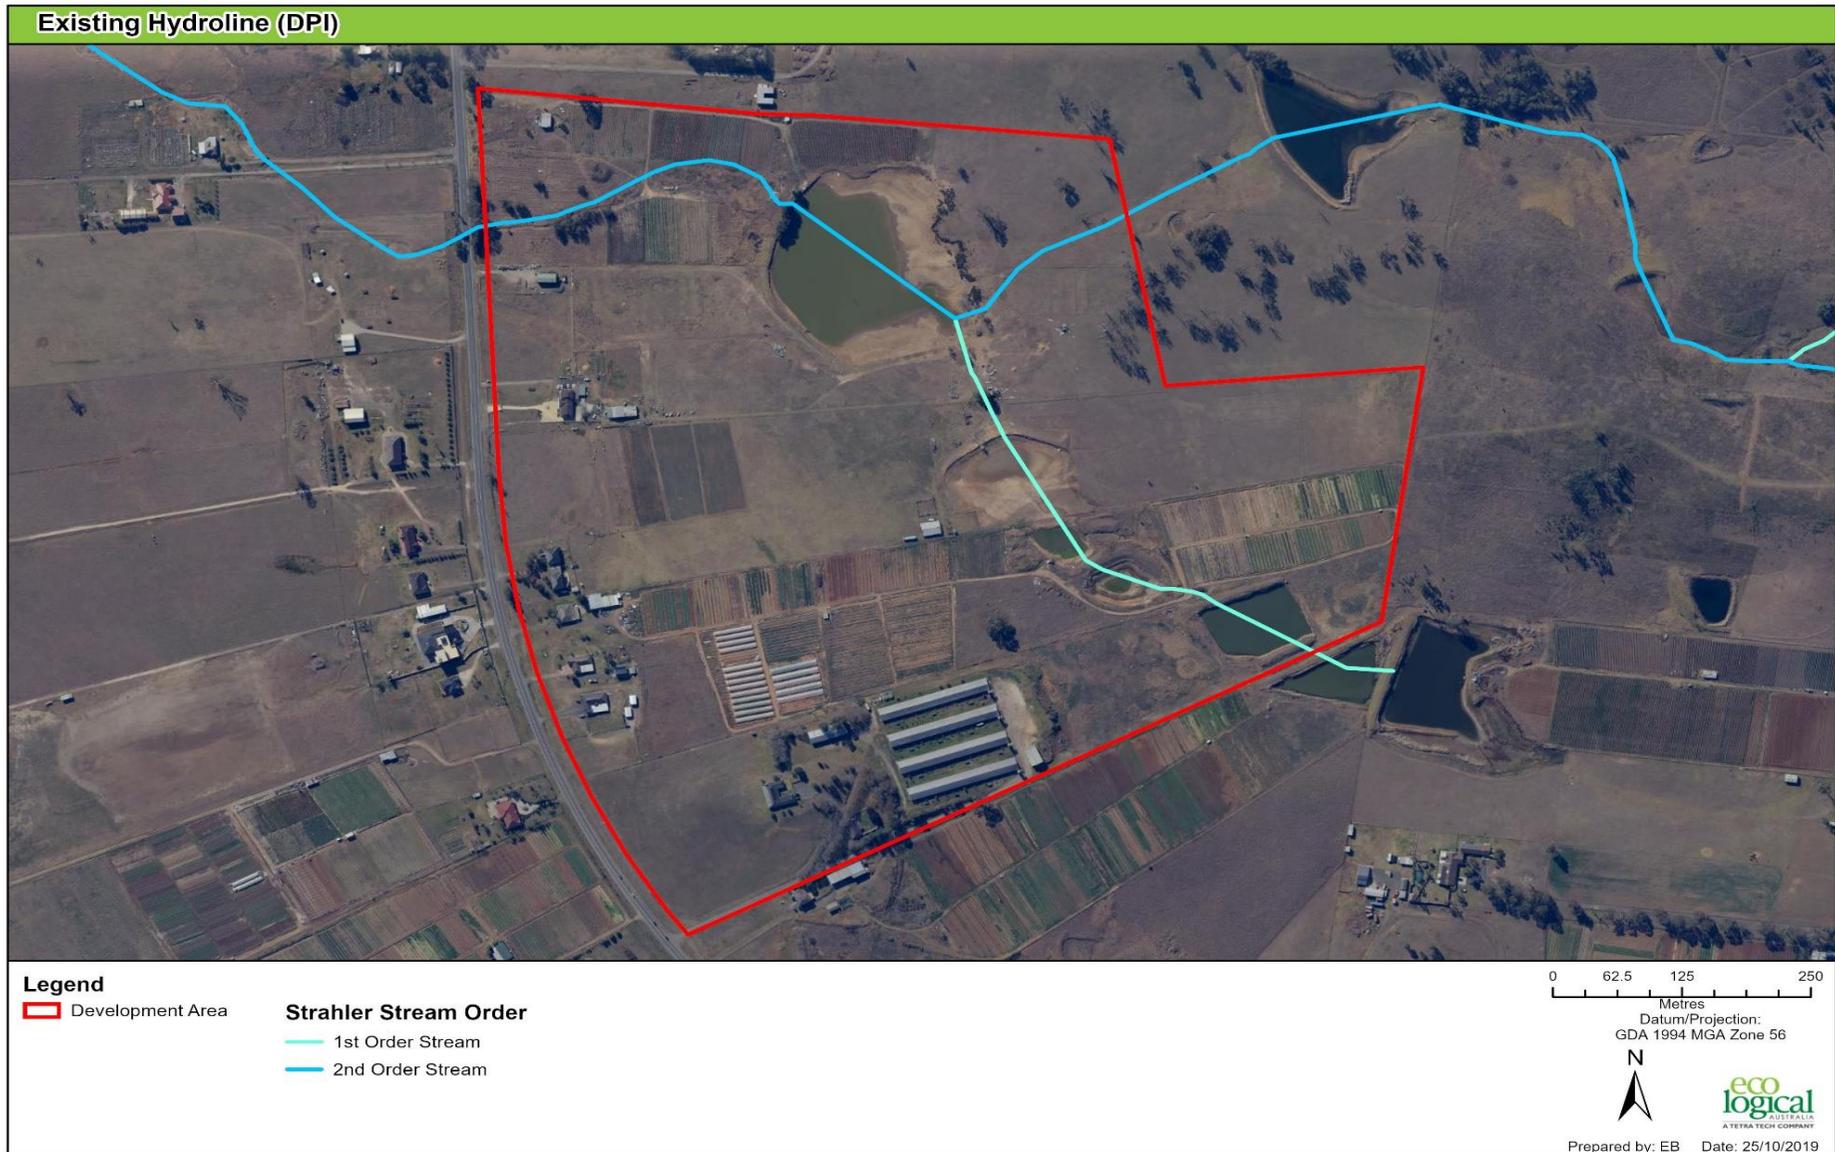
The 1<sup>st</sup> order watercourse mapped within the south east and centre of the development area passed through five farm dams within the site and no indicative features of a waterway (such as defined bed and banks or geomorphic features such as erosion and deposition) were observed along the length of this mapped watercourse.

The mapped 2<sup>nd</sup> order watercourse that originated to the north east of the development area passed through one farm dam in a roughly east-west direction and flowed towards Mamre Road. A defined channel was observed within the north western section of the development area.

Figure 7: Watercourses mapped within development area, extracted from DPI dataset

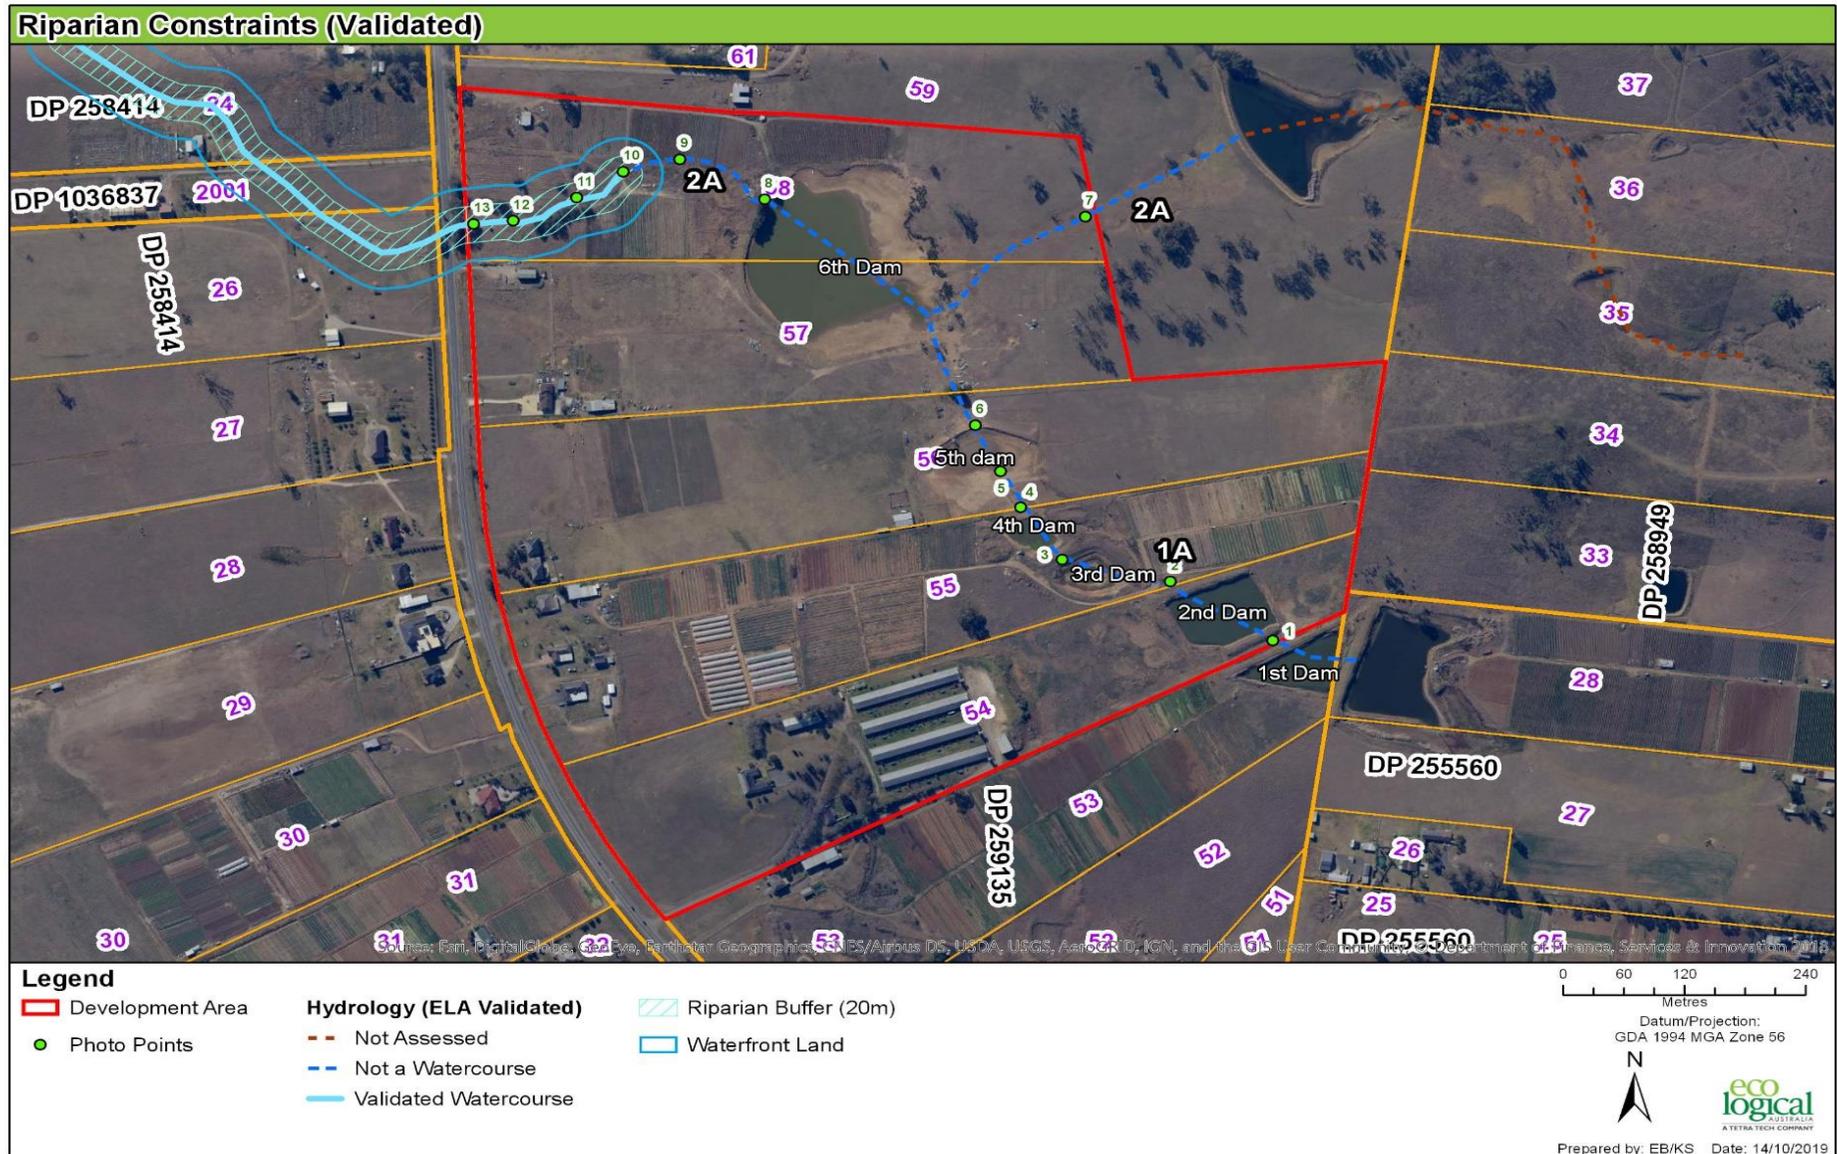
Figure 8: Validated riparian areas and photo point locations

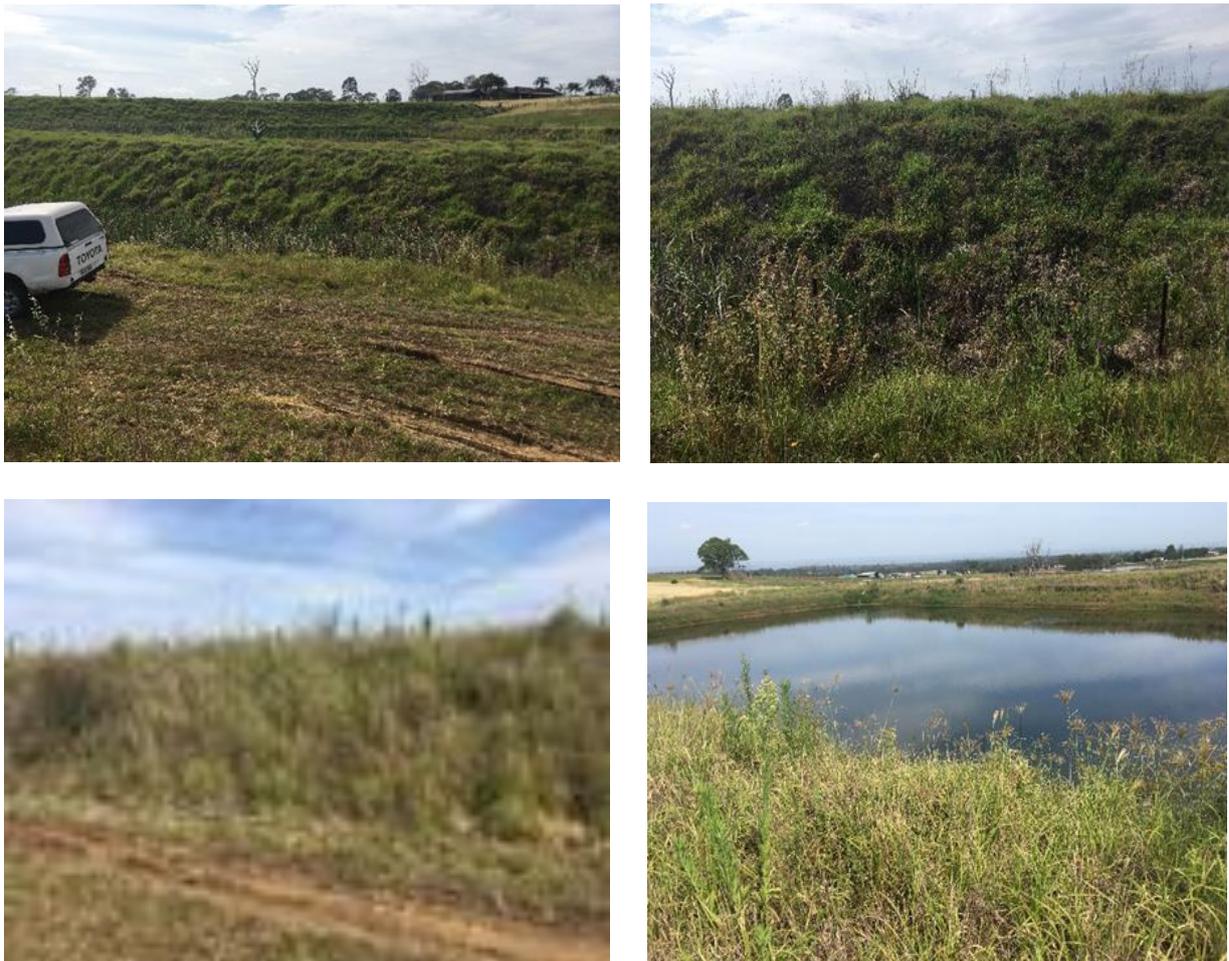
Figure 9 shows that there was no defined channel evident upstream or downstream of Photo Point 1. An informal access road existed between the 1<sup>st</sup> and 2<sup>nd</sup> dams. The 2<sup>nd</sup> dam occupied an area of approximately 5,680 m<sup>2</sup> and was surrounded by a thin buffer of herbaceous weed species, including *Verbena bonariensis* (Purple Top), *Onopordum acanthium* (Scotch Thistle), *Avena sativa* (Oats) and a small amount of *Juncus* sp. There was a small amount of *T. orientalis* on the south eastern corner of this 2<sup>nd</sup> dam. A small overflow pond was located adjacent to the north western corner of the dam and was covered in dense *T. orientalis*. The 2<sup>nd</sup> dam had poor aquatic habitat, with no overhanging vegetation and no macrophytes apart from the *T. orientalis* in the south eastern corner.

Figure 9: Photo point 1: Top left: upstream, top right: upstream at dam wall on Lot 53, bottom left: downstream on the upstream wall on Lot 54, bottom right: downstream from top of dam wall on Lot 54

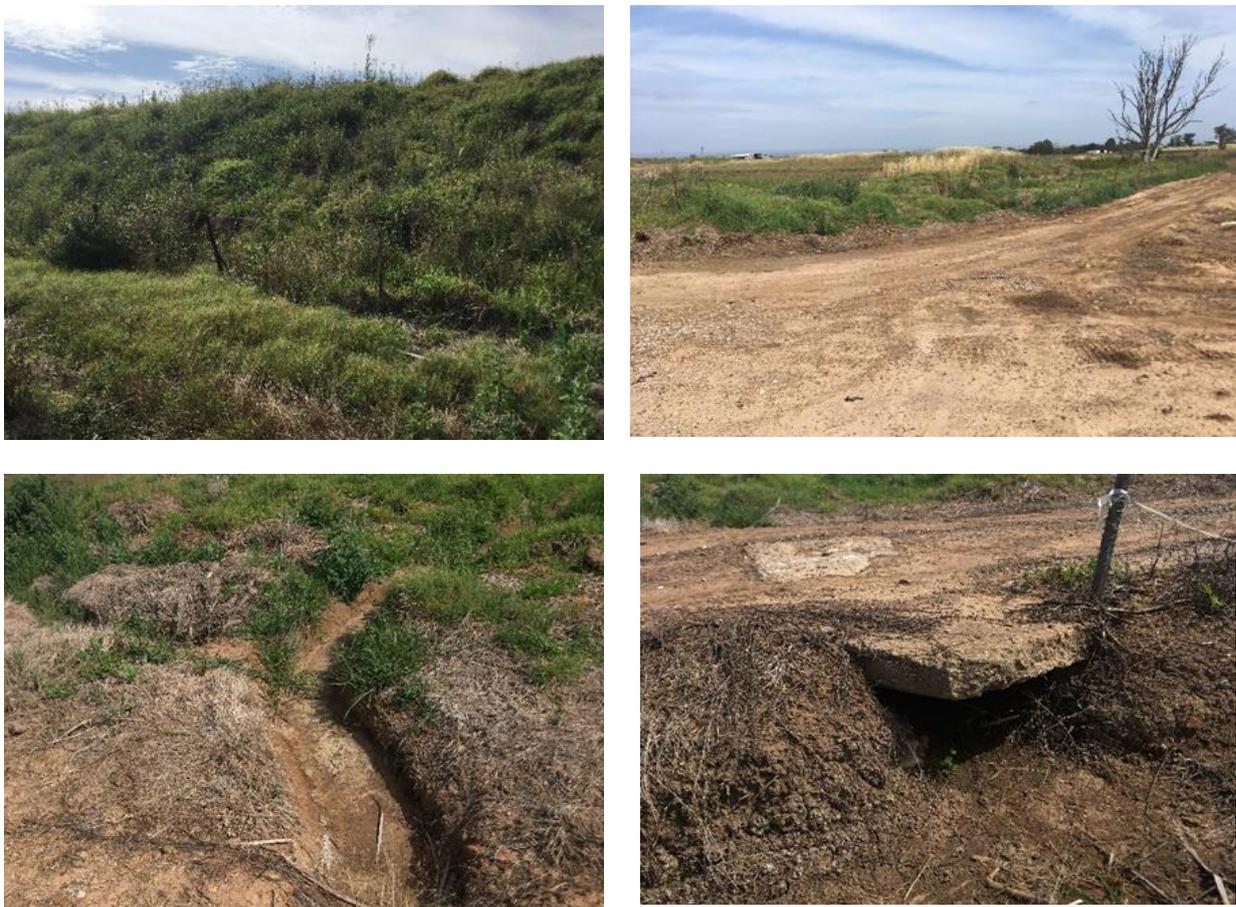
Between the 2<sup>nd</sup> and 3<sup>rd</sup> dams, an unvegetated dirt road was orientated in an east-west direction and a small drainage culvert had been installed underneath this road to convey overland flow beneath rather than over the road (Figure 10). The 3<sup>rd</sup> dam occupied an area of approximately 516 m<sup>2</sup> and similarly to the 2<sup>nd</sup> dam, was surrounded by a thin layer of herbaceous weed species and no native canopy or shrub species. A shallow drainage channel had been constructed in an east-west orientation to convey runoff from within the market garden, located to the east of the 3<sup>rd</sup> dam (Figure 10). This drainage channel was not connected to the 2<sup>nd</sup> or 3<sup>rd</sup> dams and appeared to be for the purposes of controlling overland flow or irrigation through and around the market garden area only.

Figure 10: Photo point 2: Top left: looking upstream at downstream wall of the 2<sup>nd</sup> dam; top right: looking downstream towards 3<sup>rd</sup> dam in Lot 55, no defined channel; bottom left: dug out drainage channel to convey uphill runoff; bottom right: drainage culvert under unformed road.

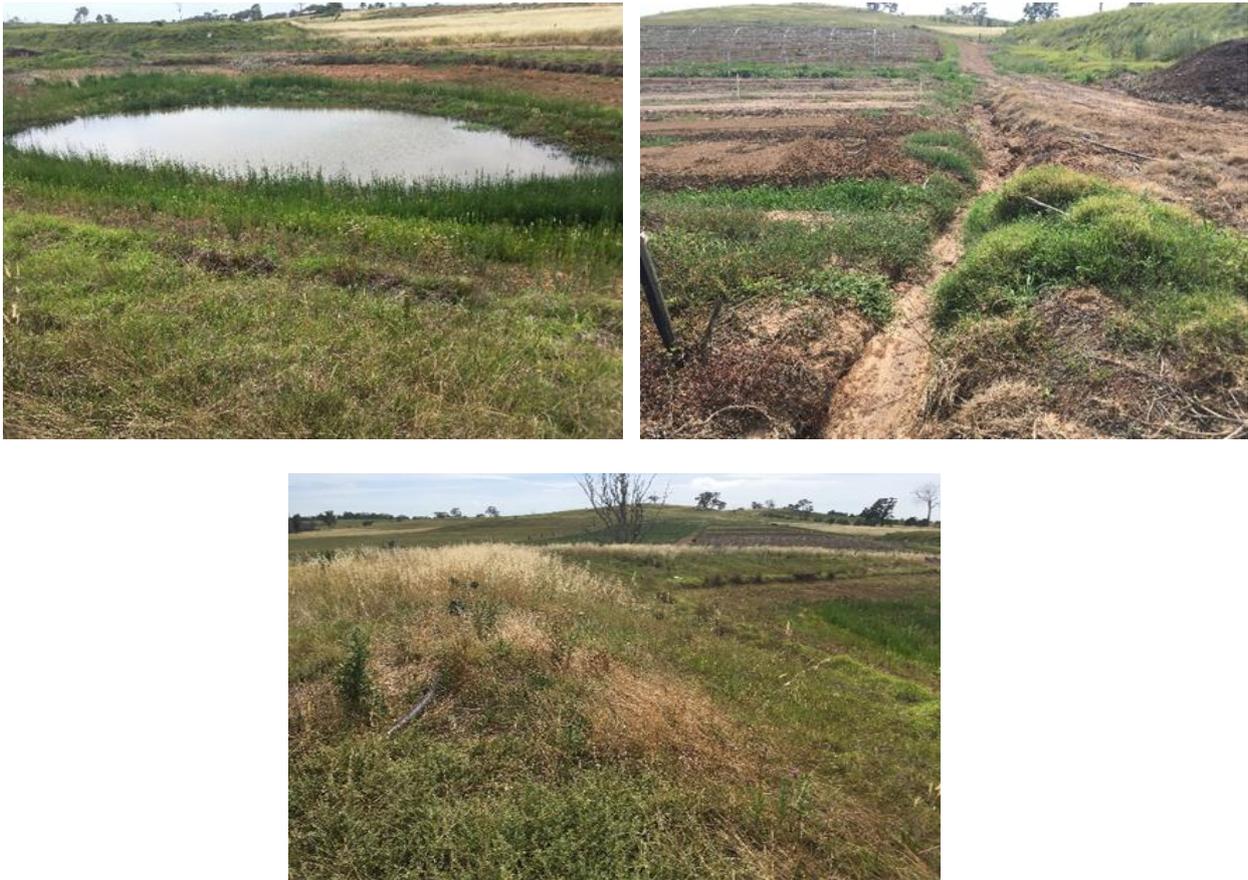
No overhanging vegetation was surrounding the 3<sup>rd</sup> dam and there was a small amount of *T. orientalis* on the south east corner of the dam. There were no other native macrophyte species within or surrounding the dam and aquatic habitat within and surrounding the dam was poor.

Figure 11: Photo point 2: Top left: looking downstream north-west at 3<sup>rd</sup> dam; top right: drainage channel dug to convey water from market garden; bottom: east along downstream wall of 3<sup>rd</sup> dam.

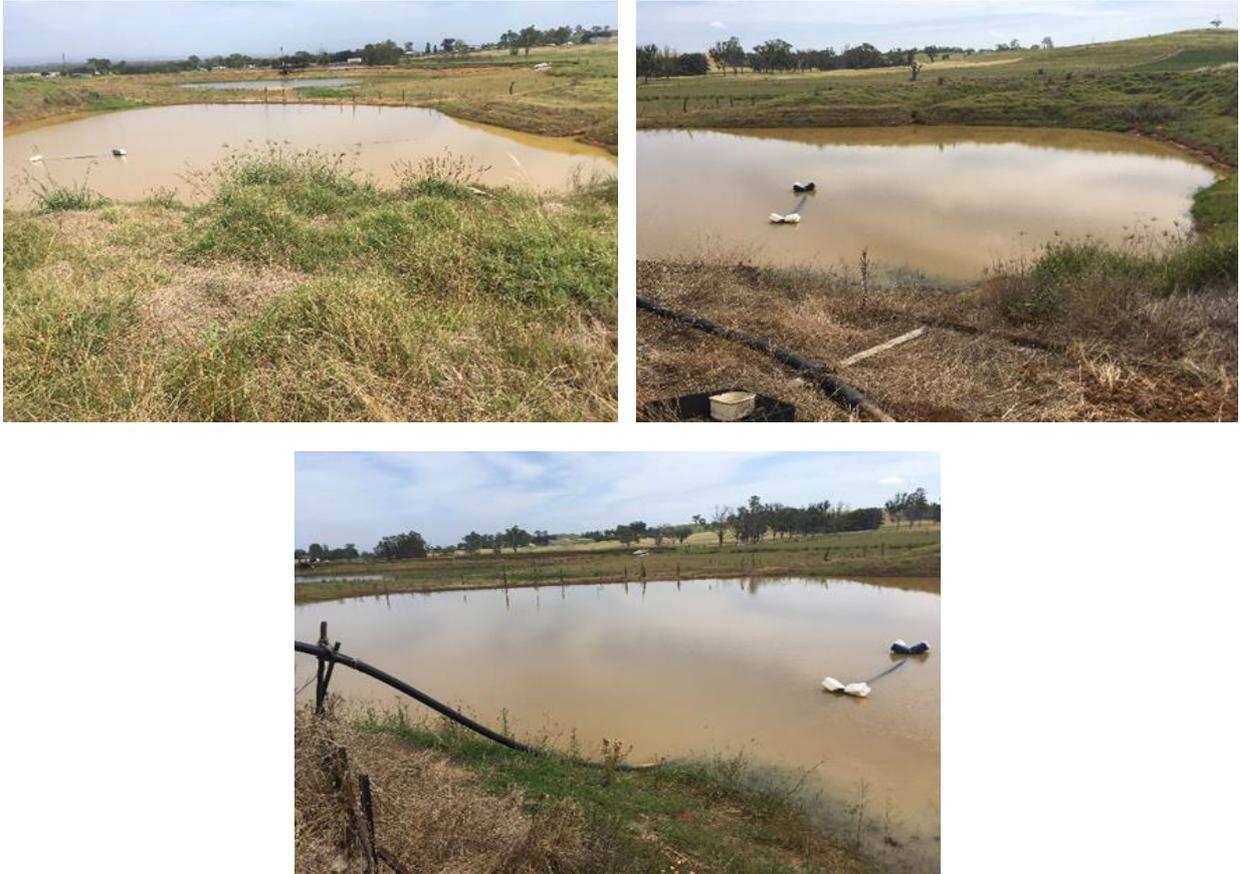
The 4<sup>th</sup> dam, located on Lot 55, covered an area of approximately 1,360 m<sup>2</sup>. There was no defined channel between the 3<sup>rd</sup> and 4<sup>th</sup> dams. The 4<sup>th</sup> dam had no defined spillway or wall on the downstream side and in periods of high rainfall it is likely that the boundary between this dam and the 5<sup>th</sup> dam could disappear. Dam walls had been constructed on the eastern and southern sides of the dam (Figure 12). The wall on the eastern side of the dam had a cut-out section to allow water to enter the dam. A thin buffer of herbaceous exotic species surrounded the dam, as well as some pasture grasses on the downstream end of the dam that were growing within the water. No riparian canopy or shrub species were observed surrounding the dam and aquatic habitat in this area was limited, with no overhanging vegetation and no visible in-stream woody debris.

**Figure 12: Photo point 3: Top left: looking north west (downstream) towards 4<sup>th</sup> dam; top right: looking east across 4<sup>th</sup> dam; bottom: looking south across 4<sup>th</sup> dam**

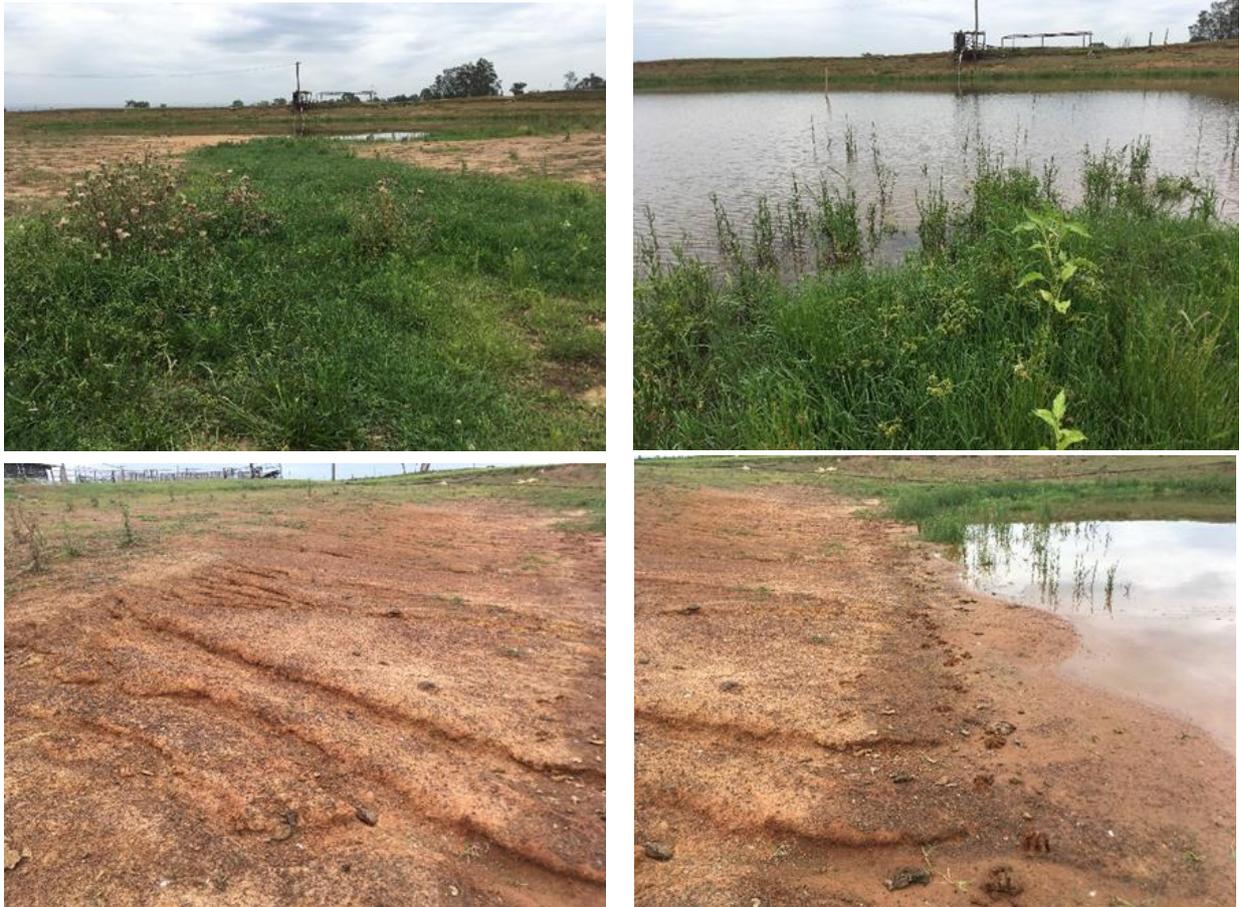
Covering an area of approximately 2,236 m<sup>2</sup>, the 5<sup>th</sup> dam was fringed on the upstream side by a mix of native and exotic vegetation and contained a small amount of emergent macrophytes as shown in Figure 13. Additionally, on the upstream side of the 5<sup>th</sup> dam, there was evidence of rill erosion where the clay soil around the dam was unvegetated and evidence of stock access to the dam was observed (Figure 13). The 5<sup>th</sup> dam had a defined dam wall on the northern side, with no spillway or cut-out overflow area on the downstream side. No defined channel existed below the 5<sup>th</sup> dam.

**Figure 13: Photo point 5: top left: looking downstream toward dam 5; top right: looking downstream across dam 5; bottom left: looking west at rill erosion upstream of dam 5; bottom right: cattle disturbance along upstream side of dam 5, looking west.**

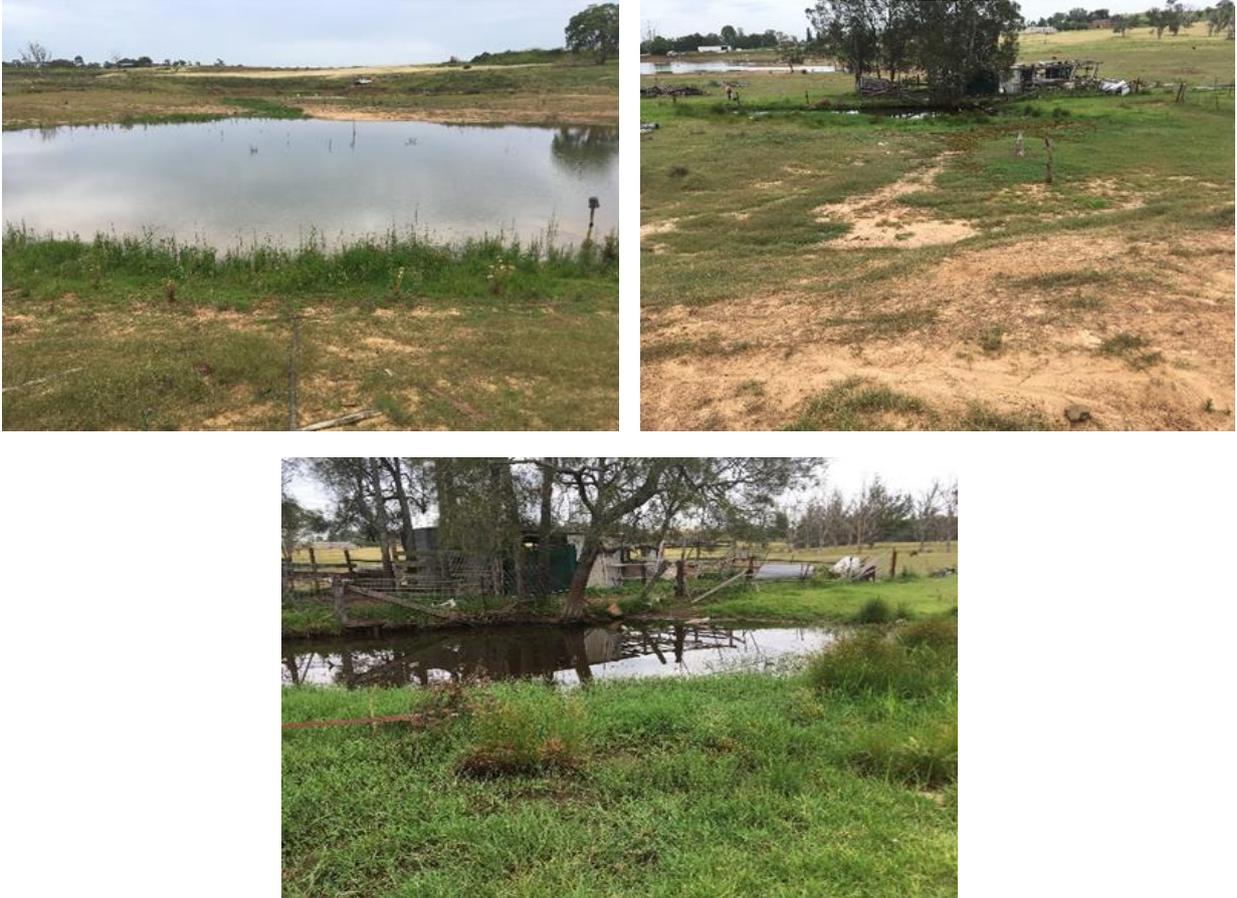
There was an area adjacent to a small stand of *Casuarina glauca* (Swamp Oak) downstream of the 5<sup>th</sup> dam where there was pooled water on the day of the site visit on 10<sup>th</sup> December 2018 (Figure 14). There was no defined channel upstream or downstream of this area of pooled water, however it was surrounded by a few *J. usitatus* and *C. eragrostis* plants as well as pasture grasses.

Figure 14: Photo point 6: Top left: upstream from below dam 5; top right: downstream from below dam 5; bottom left: ponded water between dam 5 and 6.

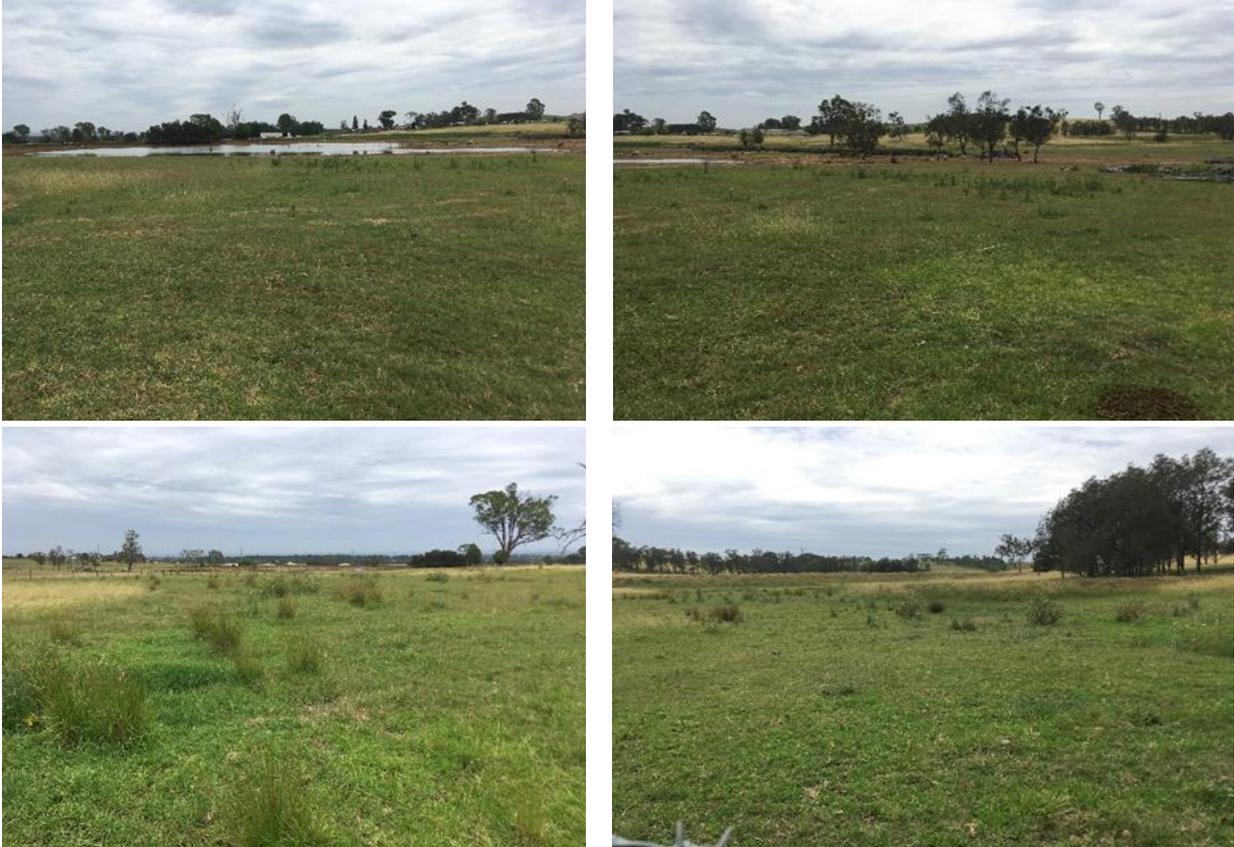
There was no defined channel to the east of the 6<sup>th</sup> dam. The area where 2A is mapped (according to the hydroline dataset) to the east of the dam was an area of grassed paddocks, with grazed pasture grasses and evidence of a possible overland flow path between the dam upstream on Lot 59 and the 6<sup>th</sup> dam (Figure 15).

Figure 15: Photo point 7: top left: looking downstream towards dam 6; top right: looking downstream towards mapped confluence of two waterways; bottom left: looking downstream towards dam 6; bottom right: looking upstream towards dam on Lot 59.

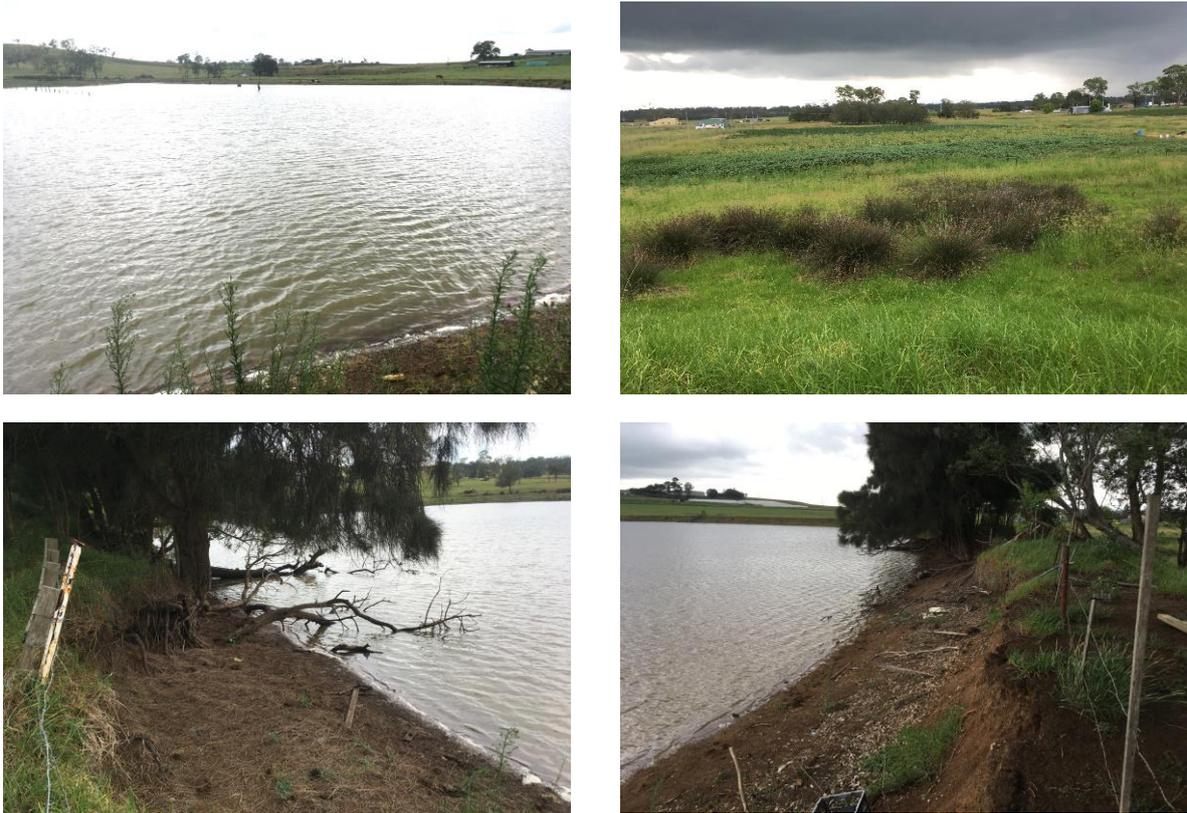
The 6<sup>th</sup> dam was located at the north of the study area spanning Lots 57 and 58. It covered an area of approximately 1.89 ha. Immediately below the 6<sup>th</sup> dam there was a 2<sup>nd</sup> order watercourse mapped (Figure 16). During the site visit, there was no defined channel observed in this area or the immediate surrounds. There was no overflow or spillway on the downstream side of this dam. A few *C. glauca* trees and saplings were located on the downstream side of the dam and erosion around the base of these trees and sections of the downstream dam wall (which was nearly vertical in most areas) was observed Figure 16. There was very little other vegetation surrounding the 6<sup>th</sup> dam, apart from a small area of *J. usitatus* on the eastern side of the dam and exotic herbaceous species including *Conyza bonariensis* (Fleabane) and *O. acanthium*.

Figure 16: Photo point 8: Top left: looking upstream across 6<sup>th</sup> dam; top right: looking downstream from 6<sup>th</sup> dam; bottom left and right: dam wall erosion and *C. glauca* trees.

In the area immediately downstream of the 6<sup>th</sup> dam, there were a few *J. usitatus* plants (Figure 16) that indicated that the area may be occasionally inundated or have standing water present, however there was no defined channel in this area. Figure 17 shows that there was no defined channel within the central portion of Lot 58 at Photo point 9. The area was covered by exotic species, primarily herbaceous grasses.

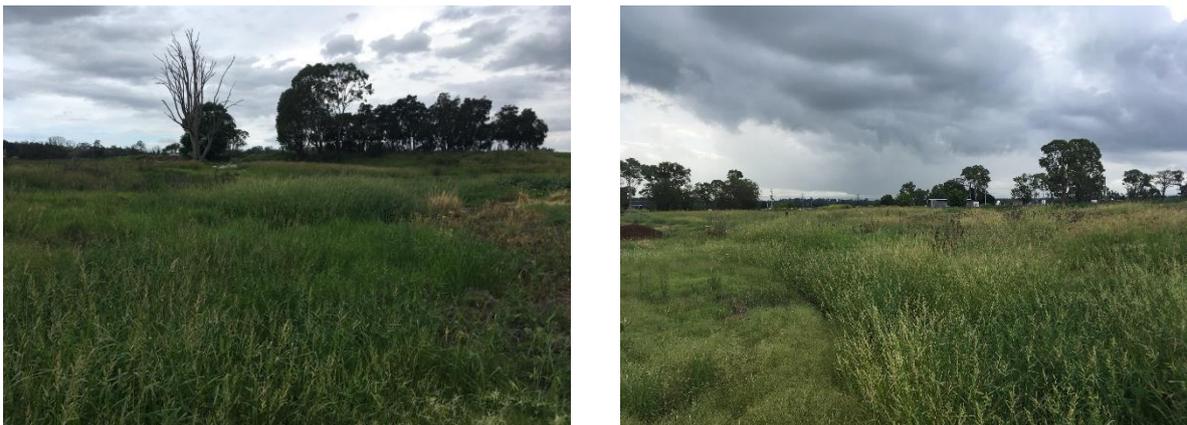
Figure 17: Photo point 9: Left, looking upstream towards 6<sup>th</sup> dam; right, looking downstream towards Mamre Rd.

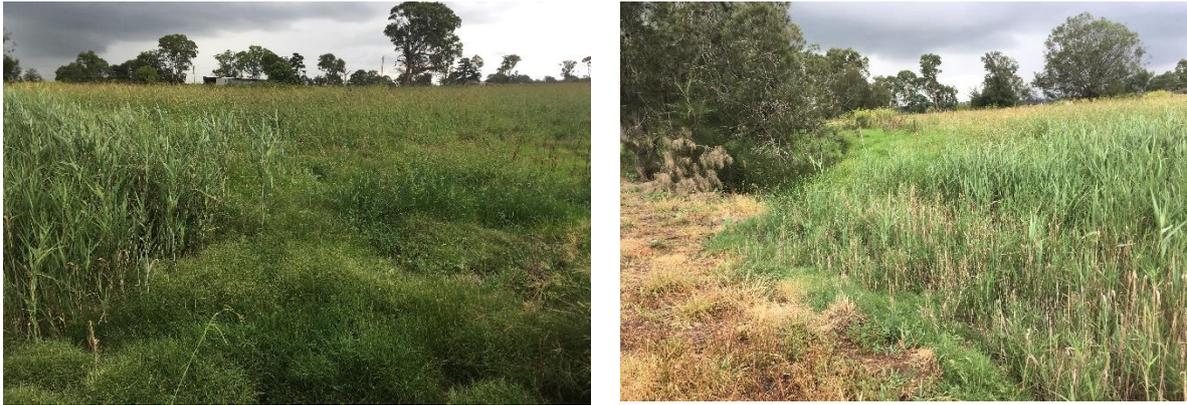
There was part of a mapped watercourse downstream of the 6<sup>th</sup> dam (Figure 18) that did meet the definition of a 'river' under the WM Act. The defined watercourse started at a patch of *Phragmites australis* (Common Reed) and flowed through the site in a westerly direction towards Mamre Road (Figure 18). Frogs could be heard calling within this area however there were no exposed areas of open water that were observed.

Figure 18: Photo point 10: Left, looking upstream towards 6<sup>th</sup> dam; right, looking downstream towards Mamre Road.

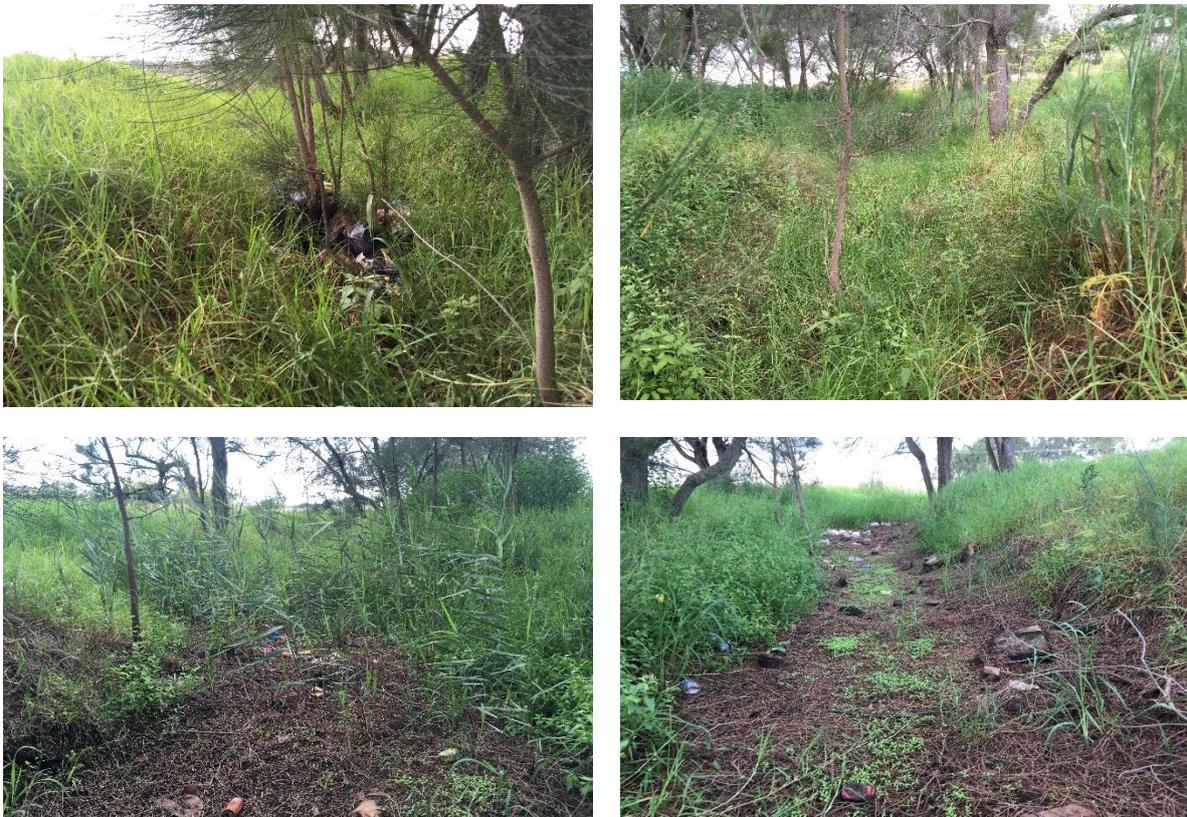
Downstream of the area of *P. australis*, the channel passed through an area of dense *Cenchrus clandestinus* (Kikuyu Grass) and where there were a few *C. glauca* trees at the top of the creek bank. Sections of the bed of the channel within this area were hard to see as they were covered in long *C. clandestinus*. Small *C. glauca* trees were located within the channel in this area and household rubbish was scattered through the channel. Photo point 11 was an area where the channel became wider and more defined (Figure 19) and there was no longer dense exotic species growing on the bed of the watercourse. Another patch of *P. australis* was growing within the channel, which at this location was approximately 1.5 m wide and 1.2 m deep.

Figure 19: Photo Point 11: Top left, looking upstream towards *Phragmites*; top right, looking downstream towards Mamre Rd; bottom left, looking upstream towards next *Phragmites* patch; bottom right, looking upstream at exposed channel bed.

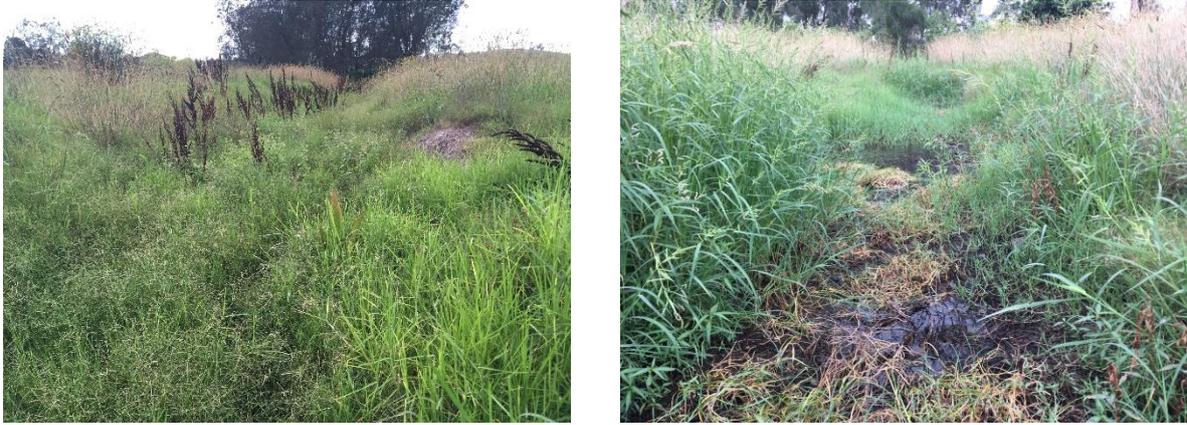
Approximately 20 m upstream of the Lot 58 boundary fence, the channel became wider (approximately 2.5 m wide) and there was a small amount of standing water in the creekline. There was a break in the riparian vegetation in this section of the watercourse, with no *C. glauca* species on the top of the banks. However, there was more instream vegetation including the natives *P. decipiens*, and *Alternanthera* sp. and the exotic species *Rumex crispus* (Curled Dock) (Figure 20).

Figure 20: Photo point 12: Left, looking upstream with vegetation growing within creekline; right, looking downstream towards standing water in creekline.

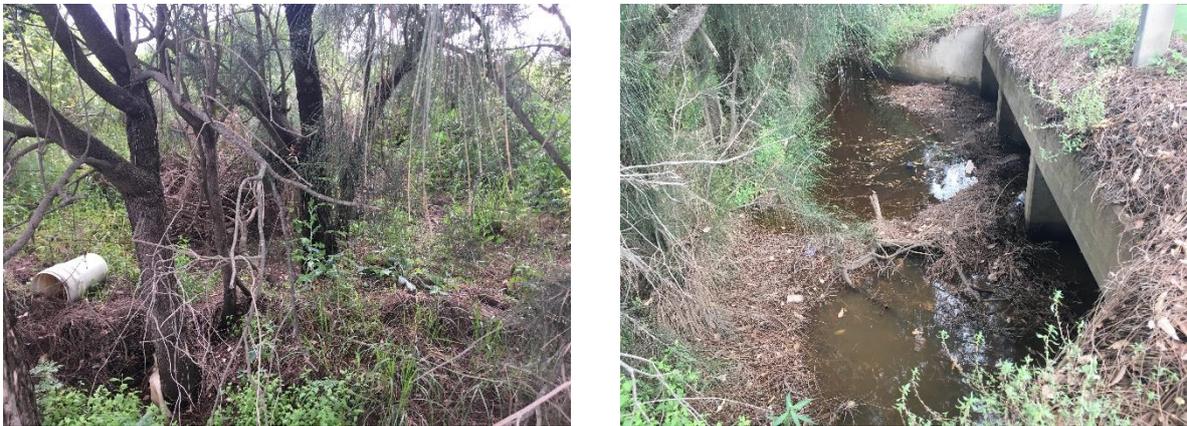
At the western extent of Lot 58, the creek flowed under Mamre Road through three box culverts, each approximately 0.8 m high and 1.5 m wide with a concrete wingwall extending out to the northern and southern ends of the culverts. This area also appeared to collect roadside drainage from the north and south of Lot 58 along Mamre Road. Upstream of this point, the vegetation was densely covering the channel (Figure 21).

Figure 21: Photo Point 13: Left, looking upstream through dense vegetation; right, culverts that carry creek flow under Mamre Road, looking south.

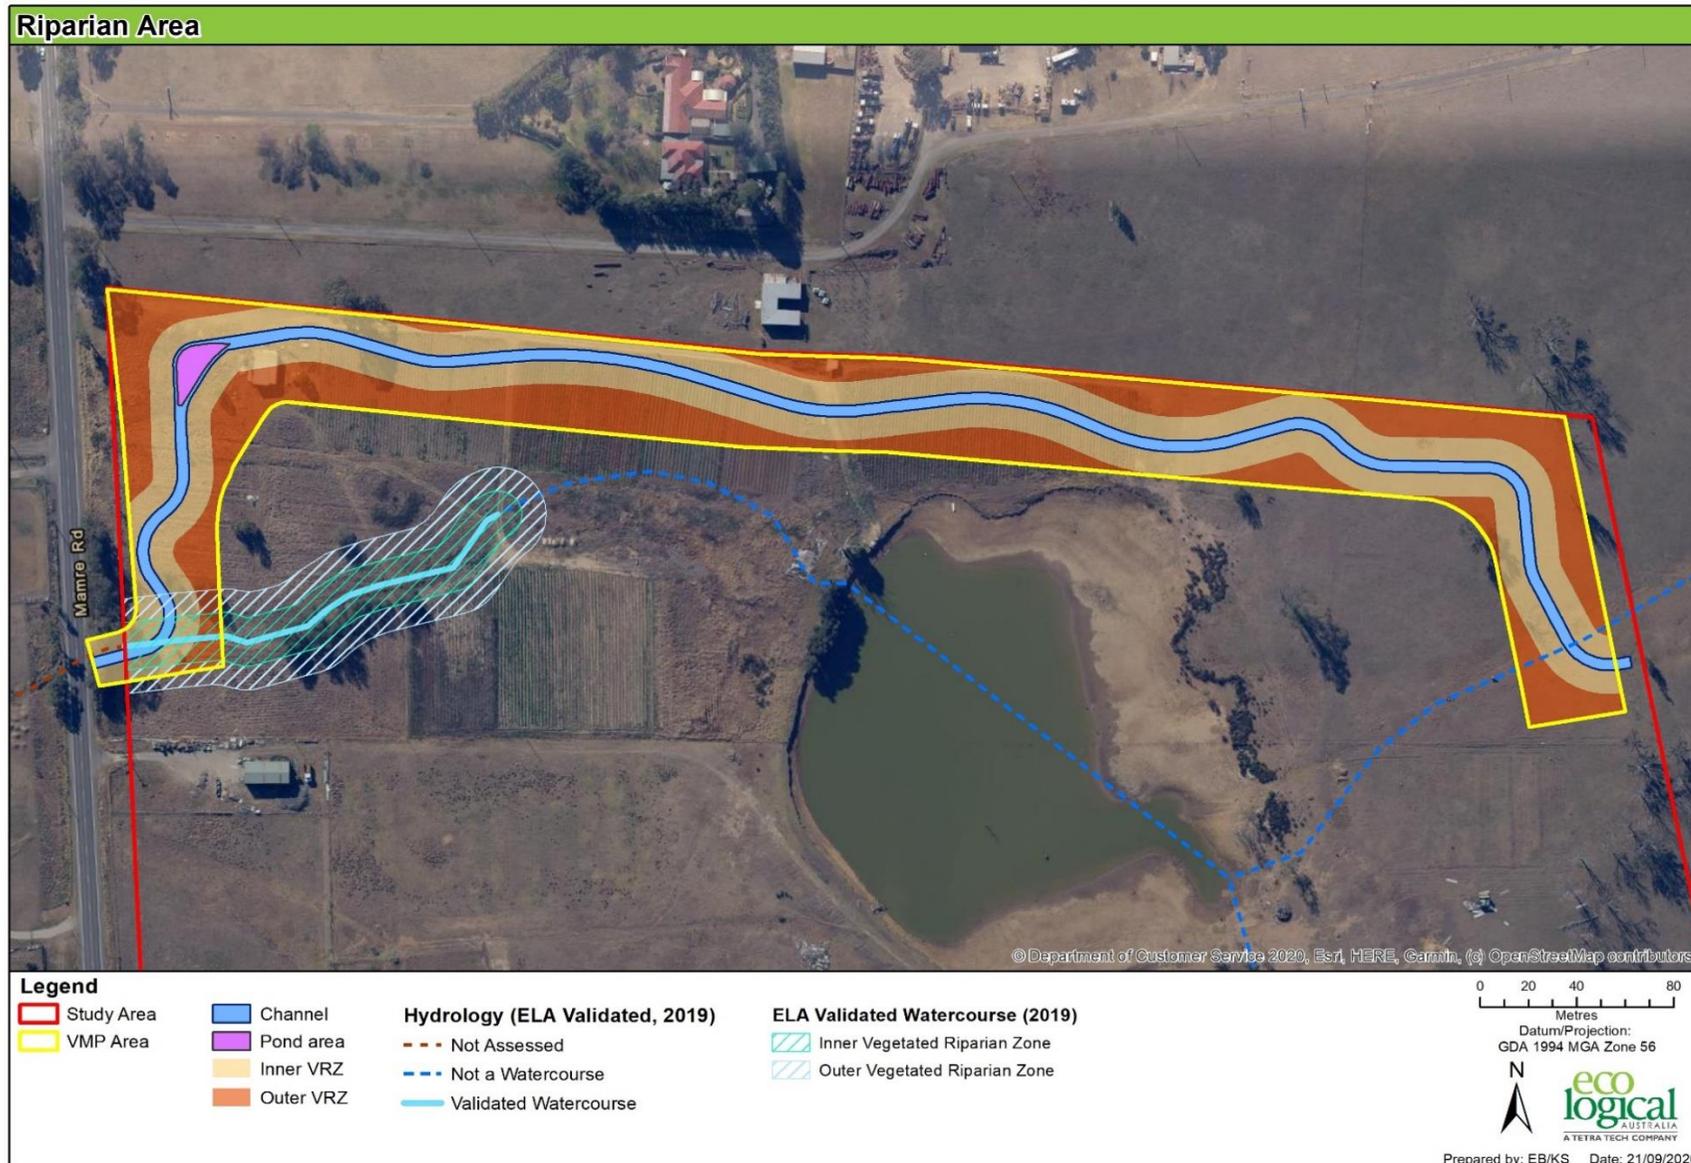
The proposed development at Aspect Industrial Estate will involve the removal of the 2<sup>nd</sup> order watercourse currently located towards the northern part of the site and the construction of a channel at the very northern extent of the site as a replacement waterway (see Figure 22). It will also involve the removal of the five farm dams within the site. The Aspect Industrial Estate Riparian Corridor Concept Plan (AT&L, 4/9/2020, Issue P3) has been used to identify potential impacts to the riparian and aquatic habitat and water quality as a result of the proposed development.

Figure 22: Proposed location of new vegetated channel

The channel is to be constructed from material that is conducive to the ongoing stability of the waterway. Materials such as sandstone should be used to construct the channel so that the banks remain stable and no excess sediment is contributed to the channel. While erosion and deposition are natural processes within waterways, these processes can be exacerbated in urban areas and altered flow regimes can contribute to degradation of the waterway. It is recommended that rough cut sandstone blocks are used as part of the construction materials as these can create habitat within the bank as well as provide roughness to the channel which will slow down the flow and reduce the chance of erosion within the waterway. The banks of the existing 2<sup>nd</sup> order watercourse are mainly bare soil, so the use of rough sandstone blocks will ensure stability of the new channel.
