Aspect Industrial Estate State Significant Development Application - Riparian Assessment

Mirvac Projects

Project Name	Aspect Industrial Estate State Significant Development Application - Riparian Assessment
Project Number	18SYD-11929
Project Manager	Rebecca Ben-Haim
Prepared by	Claire Wheeler
Reviewed by	Ian Dixon
Approved by	David Bonjer
Status	Final
Version Number	5
Last saved on	18 February 2021

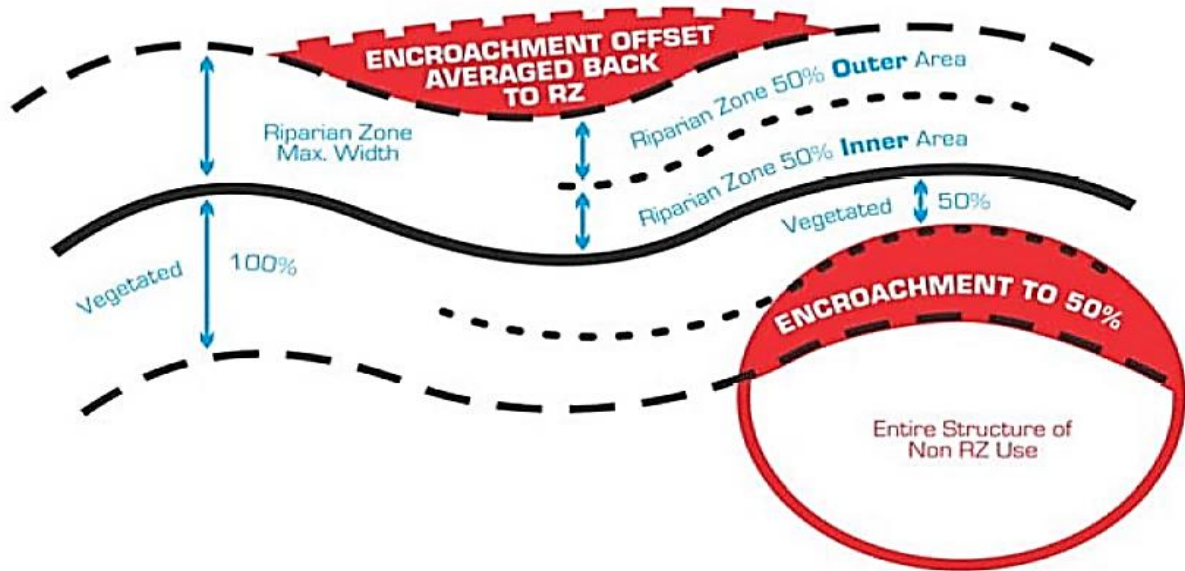
Figure 5: Riparian 'averaging rule' for offsetting encroachment into the outer 50% of the VRZ (NRAR 2018).

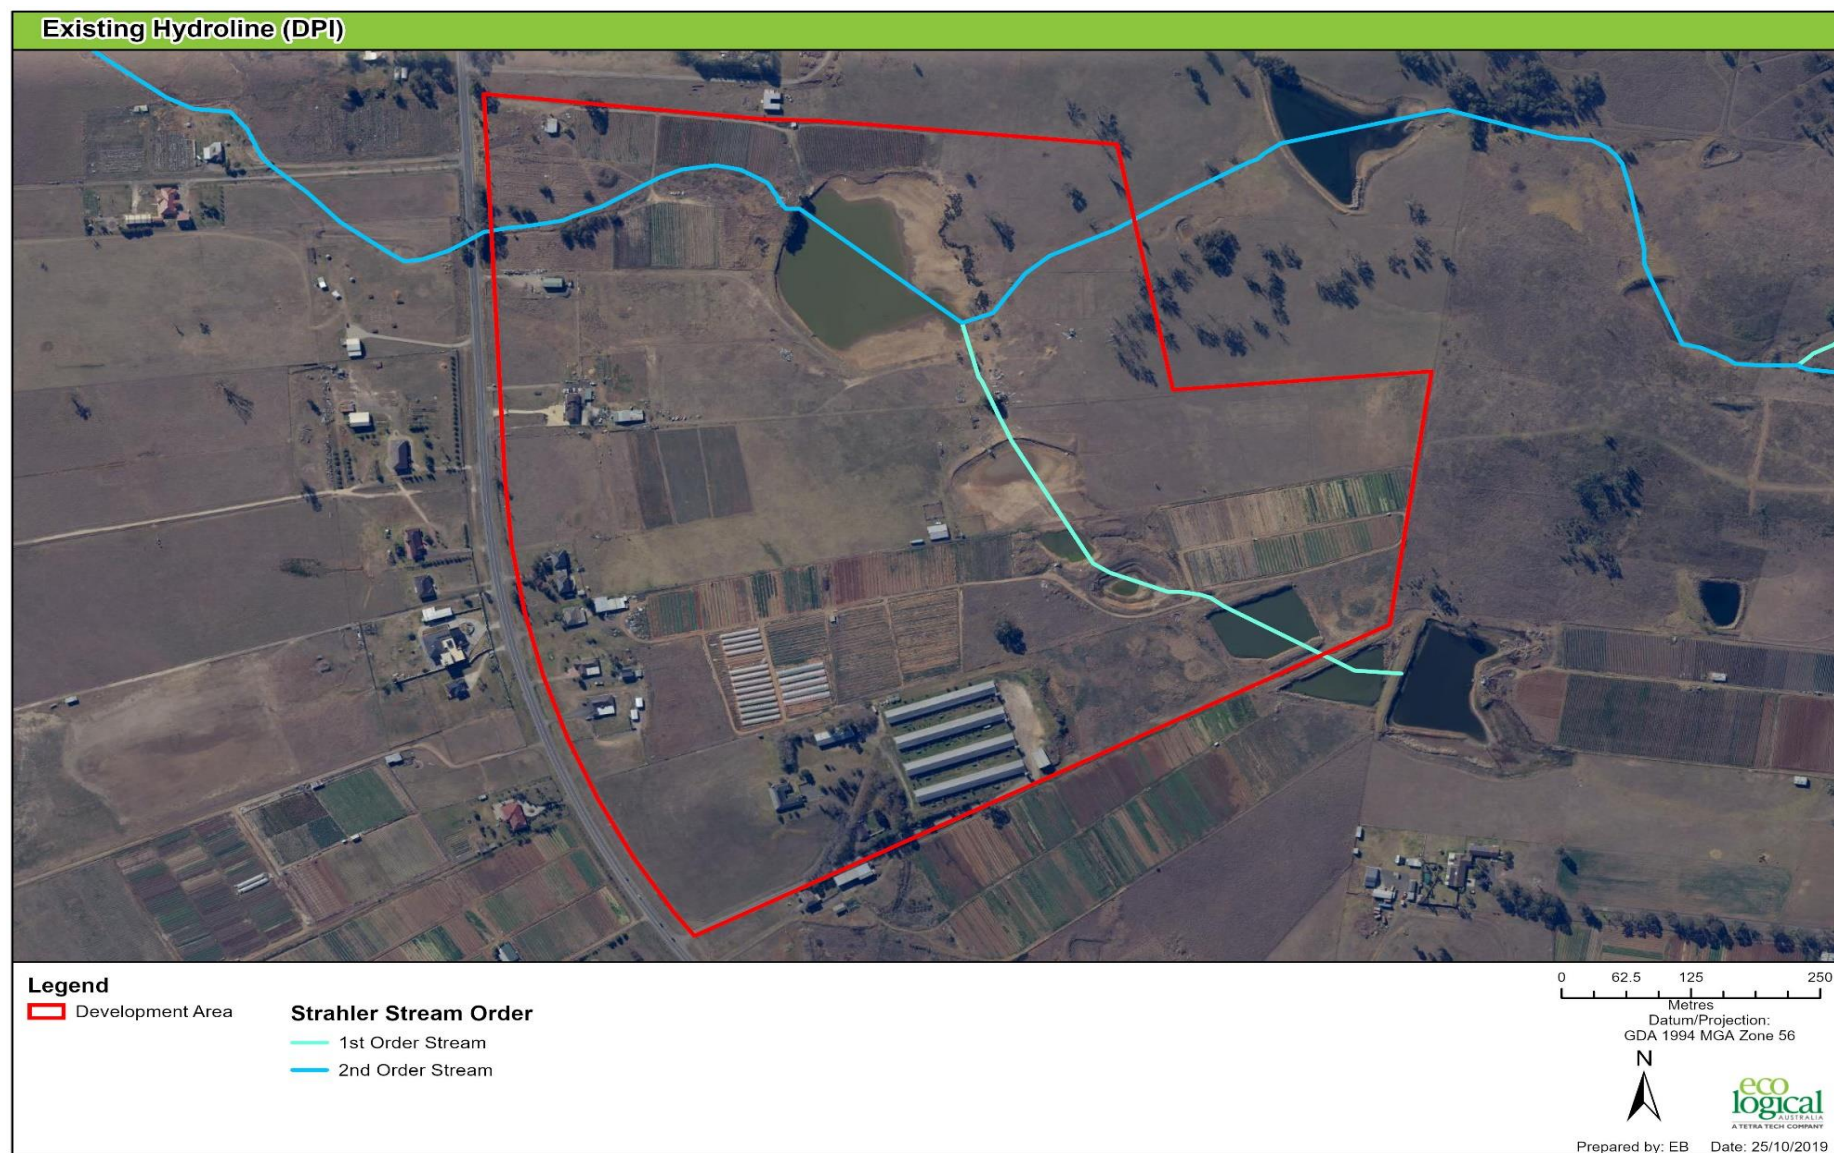
The mapped 2nd order watercourse that originated to the north east of the development area passed through one farm dam in a roughly east-west direction and flowed towards Mamre Road. A defined channel was observed within the north western section of the development area.

Figure 7: Watercourses mapped within development area, extracted from DPI dataset

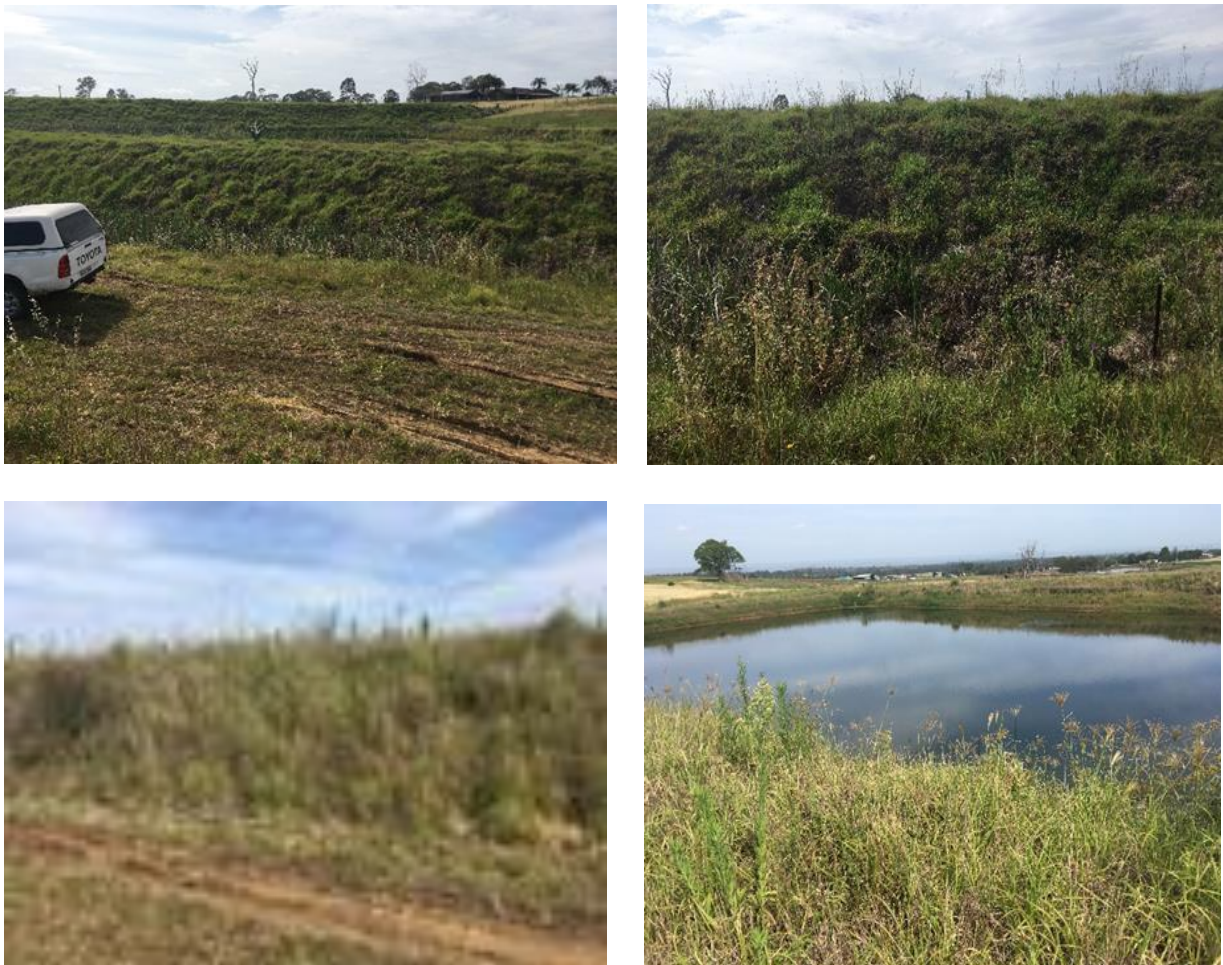
Figure 9 shows that there was no defined channel evident upstream or downstream of Photo Point 1. An informal access road existed between the 1st and 2nd dams. The 2nd dam occupied an area of approximately 5,680 m² and was surrounded by a thin buffer of herbaceous weed species, including *Verbena bonariensis* (Purple Top), *Onopordum acanthium* (Scotch Thistle), *Avena sativa* (Oats) and a small amount of *Juncus* sp. There was a small amount of *T. orientalis* on the south eastern corner of this 2nd dam. A small overflow pond was located adjacent to the north western corner of the dam and was covered in dense *T. orientalis*. The 2nd dam had poor aquatic habitat, with no overhanging vegetation and no macrophytes apart from the *T. orientalis* in the south eastern corner.

Figure 9: Photo point 1: Top left: upstream, top right: upstream at dam wall on Lot 53, bottom left: downstream on the upstream wall on Lot 54, bottom right: downstream from top of dam wall on Lot 54

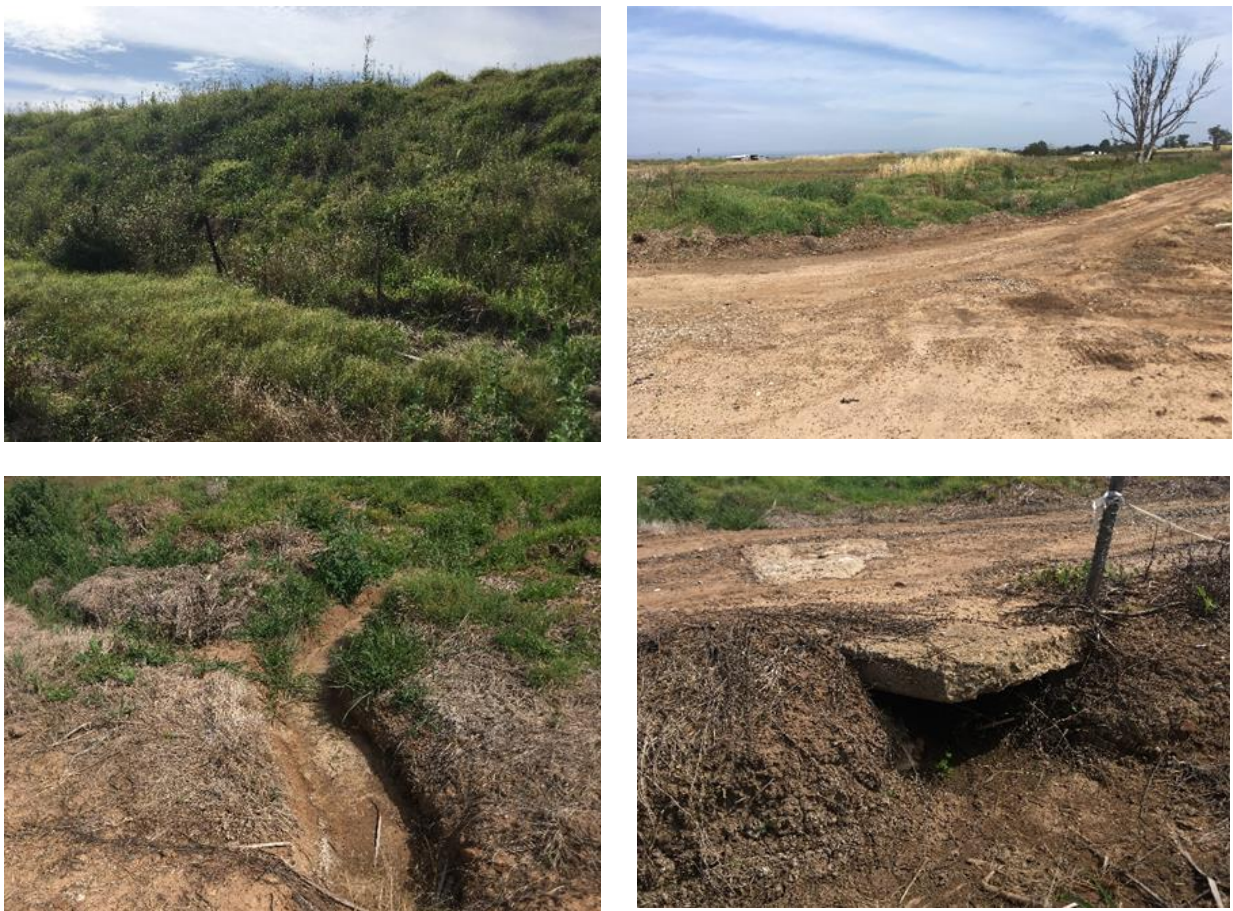
Between the 2nd and 3rd dams, an unvegetated dirt road was orientated in an east-west direction and a small drainage culvert had been installed underneath this road to convey overland flow beneath rather than over the road (Figure 10). The 3rd dam occupied an area of approximately 516 m² and similarly to the 2nd dam, was surrounded by a thin layer of herbaceous weed species and no native canopy or shrub species. A shallow drainage channel had been constructed in an east-west orientation to convey runoff from within the market garden, located to the east of the 3rd dam (Figure 10). This drainage channel was not connected to the 2nd or 3rd dams and appeared to be for the purposes of controlling overland flow or irrigation through and around the market garden area only.

Figure 10: Photo point 2: Top left: looking upstream at downstream wall of the 2nd dam; top right: looking downstream towards 3rd dam in Lot 55, no defined channel; bottom left: dug out drainage channel to convey uphill runoff; bottom right: drainage culvert under unformed road.

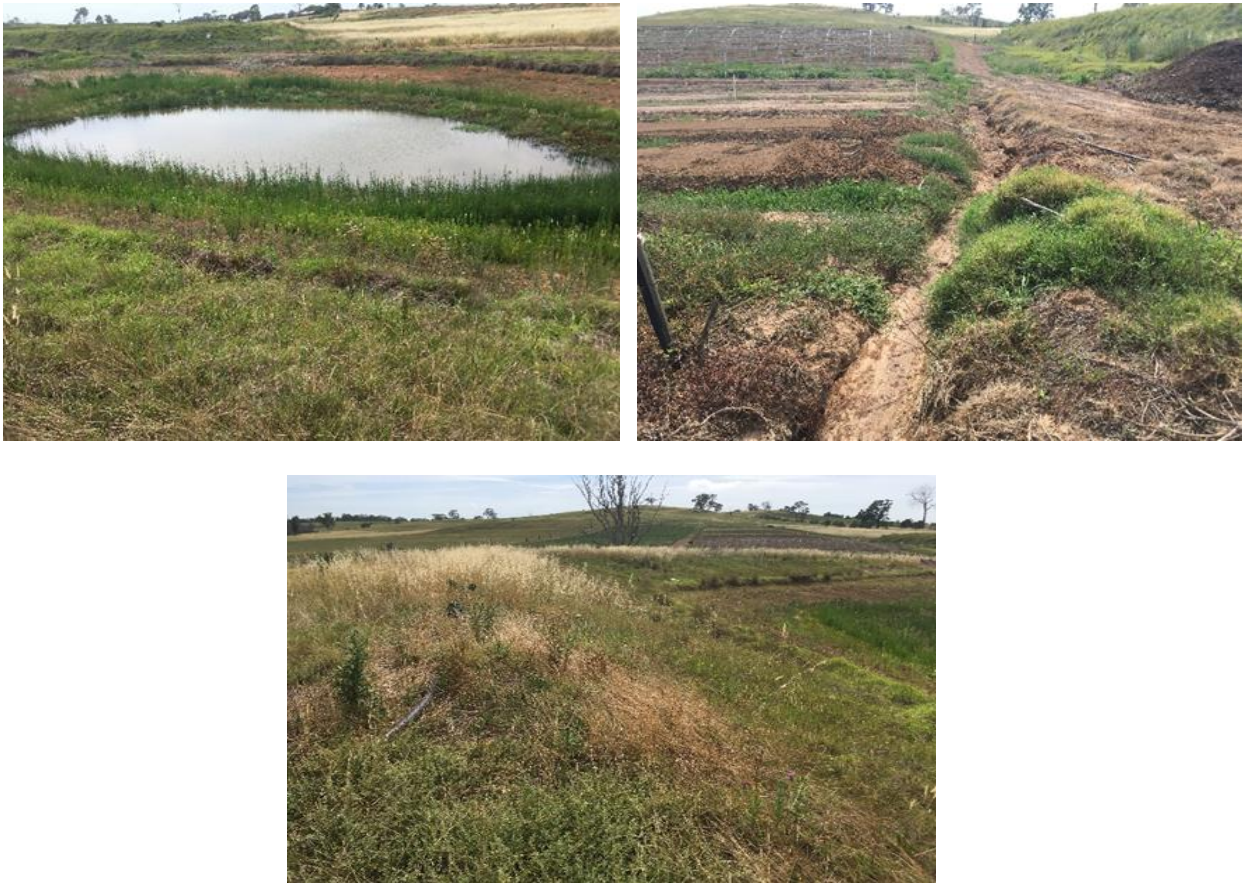
No overhanging vegetation was surrounding the 3rd dam and there was a small amount of *T. orientalis* on the south east corner of the dam. There were no other native macrophyte species within or surrounding the dam and aquatic habitat within and surrounding the dam was poor.

Figure 11: Photo point 2: Top left: looking downstream north-west at 3rd dam; top right: drainage channel dug to convey water from market garden; bottom: east along downstream wall of 3rd dam.

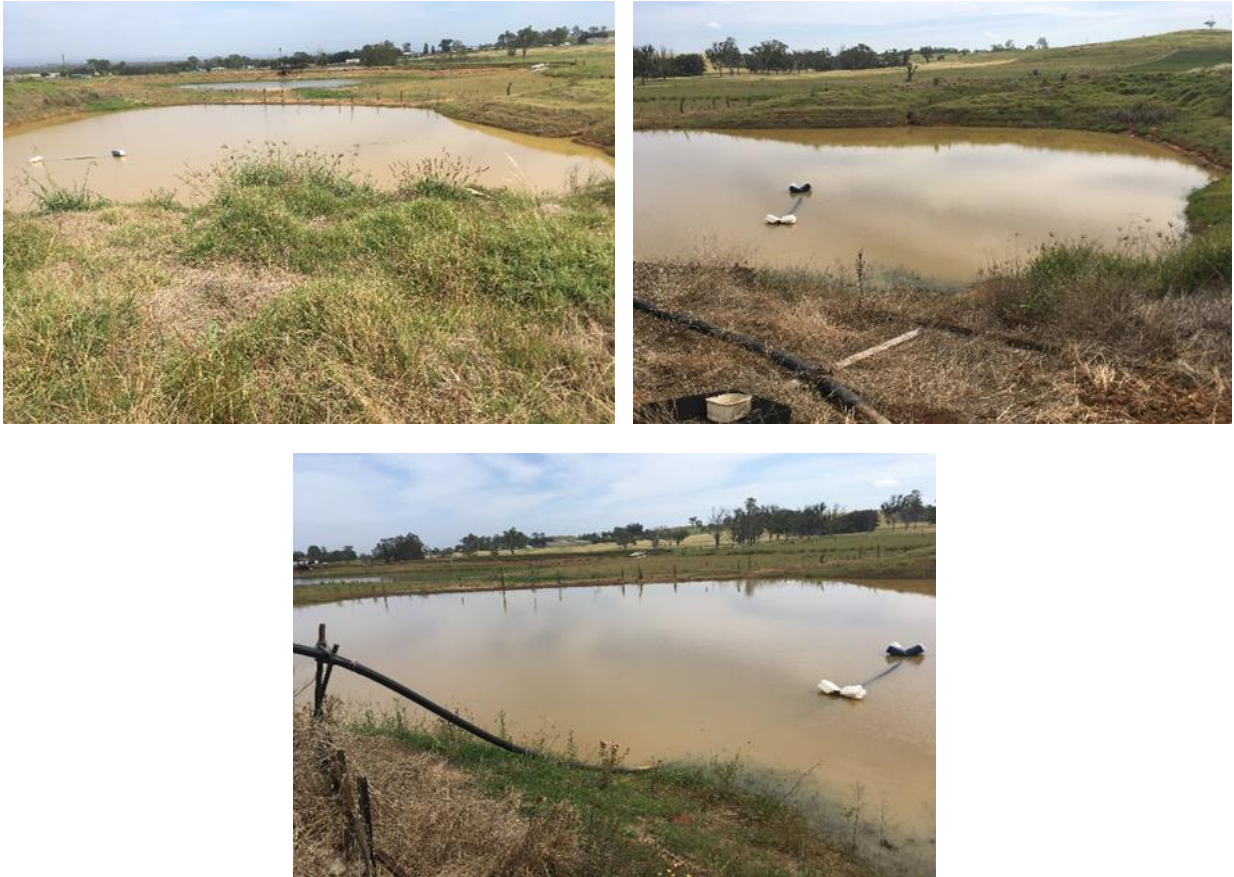
The 4th dam, located on Lot 55, covered an area of approximately 1,360 m². There was no defined channel between the 3rd and 4th dams. The 4th dam had no defined spillway or wall on the downstream side and in periods of high rainfall it is likely that the boundary between this dam and the 5th dam could disappear. Dam walls had been constructed on the eastern and southern sides of the dam (Figure 12). The wall on the eastern side of the dam had a cut-out section to allow water to enter the dam. A thin buffer of herbaceous exotic species surrounded the dam, as well as some pasture grasses on the downstream end of the dam that were growing within the water. No riparian canopy or shrub species were observed surrounding the dam and aquatic habitat in this area was limited, with no overhanging vegetation and no visible in-stream woody debris.

Figure 12: Photo point 3: Top left: looking north west (downstream) towards 4th dam; top right: looking east across 4th dam; bottom: looking south across 4th dam

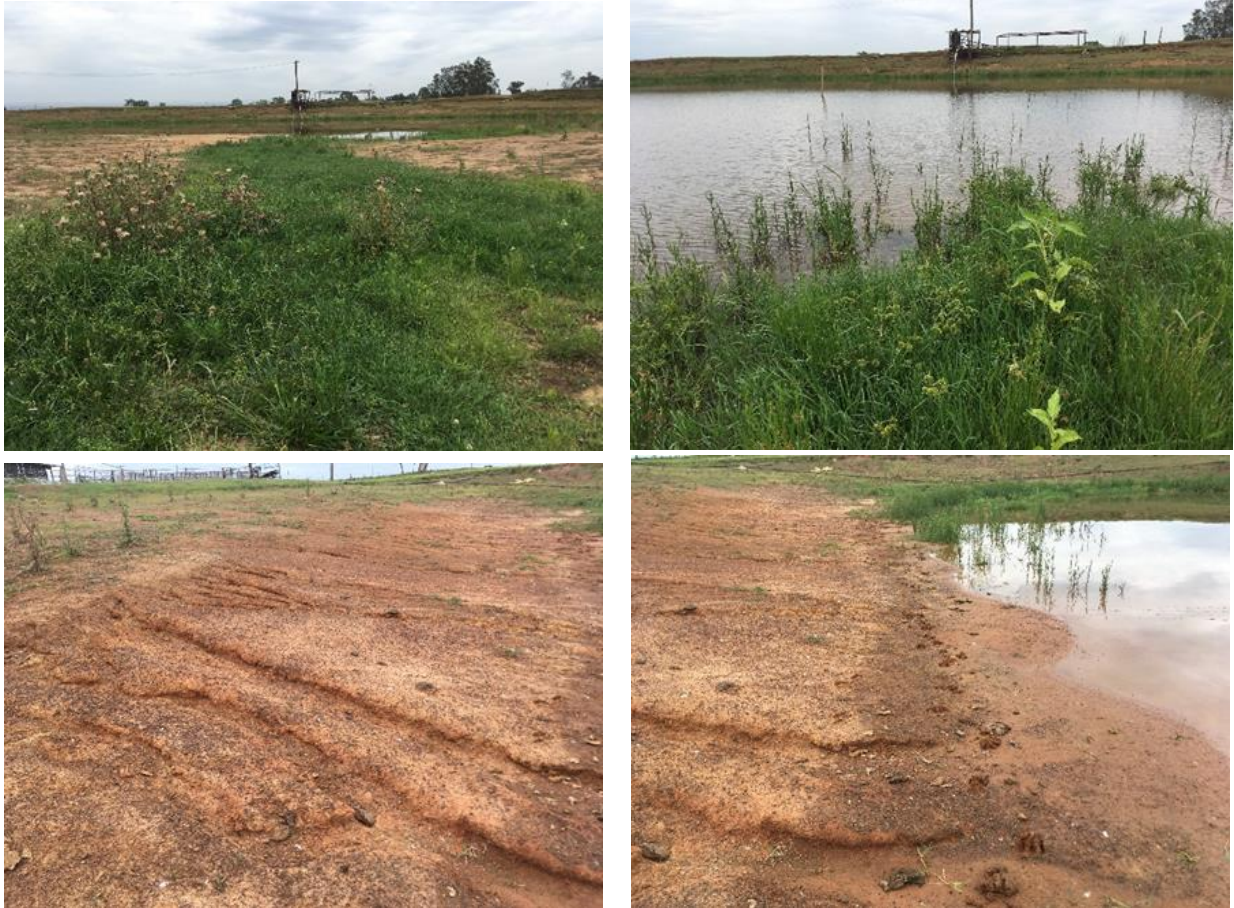
Covering an area of approximately 2,236 m², the 5th dam was fringed on the upstream side by a mix of native and exotic vegetation and contained a small amount of emergent macrophytes as shown in Figure 13. Additionally, on the upstream side of the 5th dam, there was evidence of rill erosion where the clay soil around the dam was unvegetated and evidence of stock access to the dam was observed (Figure 13). The 5th dam had a defined dam wall on the northern side, with no spillway or cut-out overflow area on the downstream side. No defined channel existed below the 5th dam.

Figure 13: Photo point 5: top left: looking downstream toward dam 5; top right: looking downstream across dam 5; bottom left: looking west at rill erosion upstream of dam 5; bottom right: cattle disturbance along upstream side of dam 5, looking west.

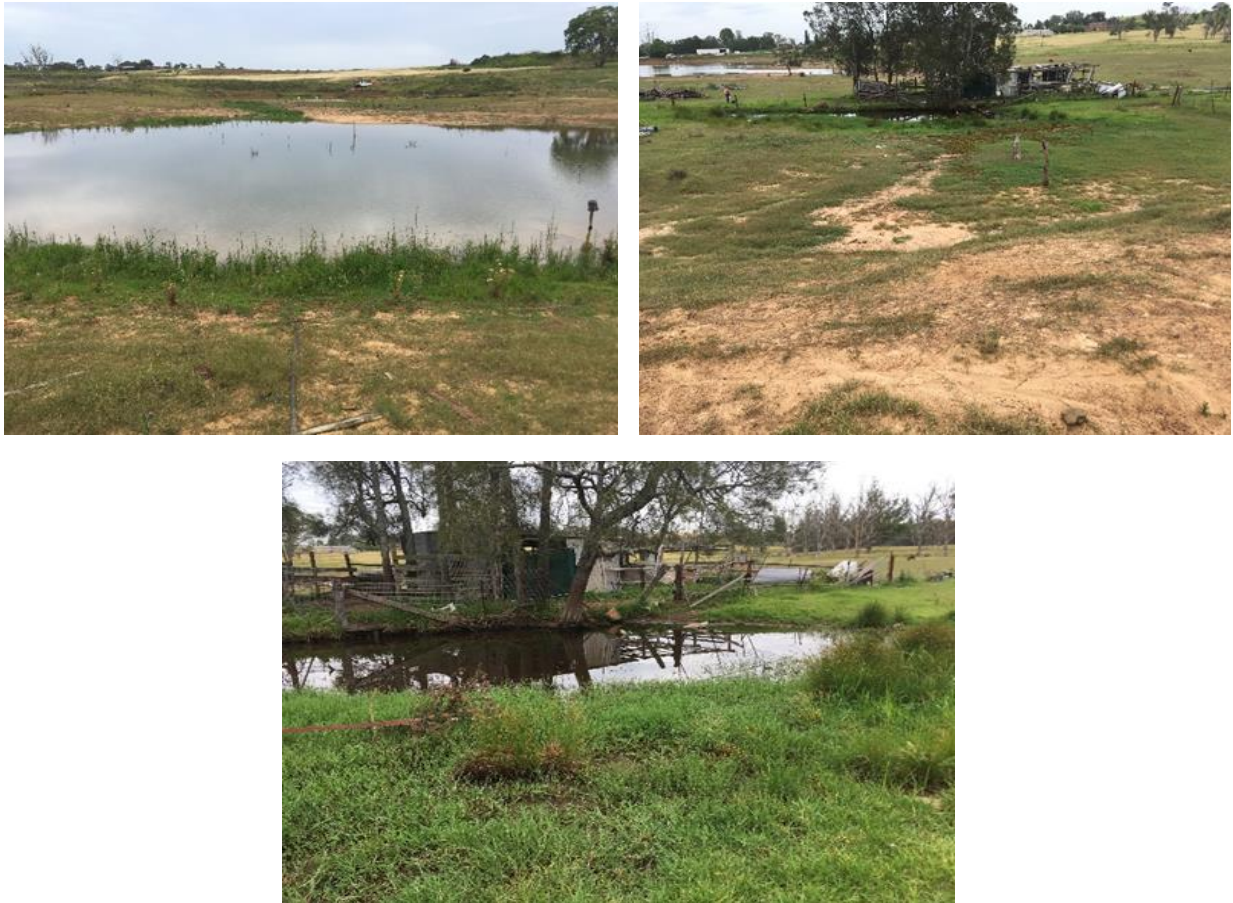
There was an area adjacent to a small stand of *Casuarina glauca* (Swamp Oak) downstream of the 5th dam where there was pooled water on the day of the site visit on 10th December 2018 (Figure 14). There was no defined channel upstream or downstream of this area of pooled water, however it was surrounded by a few *J. usitatus* and *C. eragrostis* plants as well as pasture grasses.

Figure 14: Photo point 6: Top left: upstream from below dam 5; top right: downstream from below dam 5; bottom left: ponded water between dam 5 and 6.

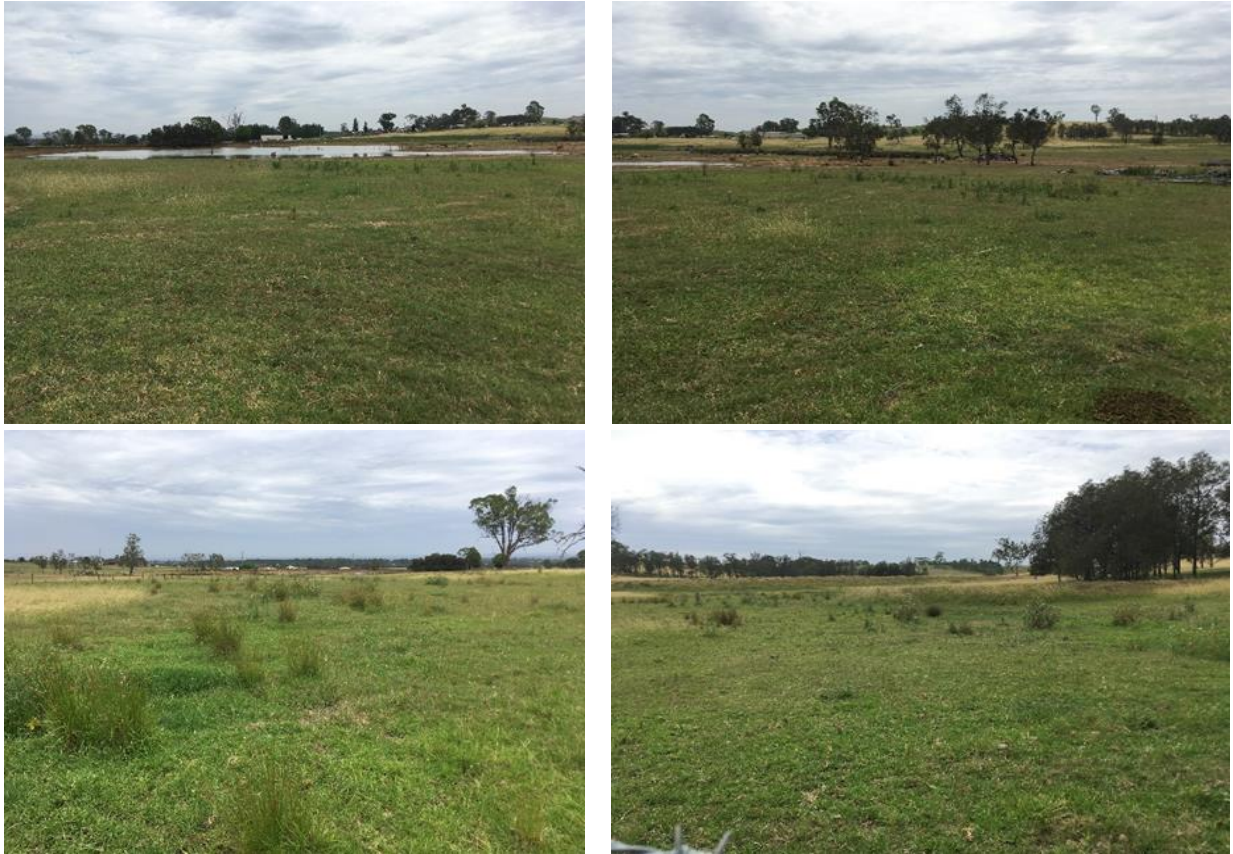
There was no defined channel to the east of the 6th dam. The area where 2A is mapped (according to the hydroline dataset) to the east of the dam was an area of grassed paddocks, with grazed pasture grasses and evidence of a possible overland flow path between the dam upstream on Lot 59 and the 6th dam (Figure 15).

Figure 15: Photo point 7: top left: looking downstream towards dam 6; top right: looking downstream towards mapped confluence of two waterways; bottom left: looking downstream towards dam 6; bottom right: looking upstream towards dam on Lot 59.

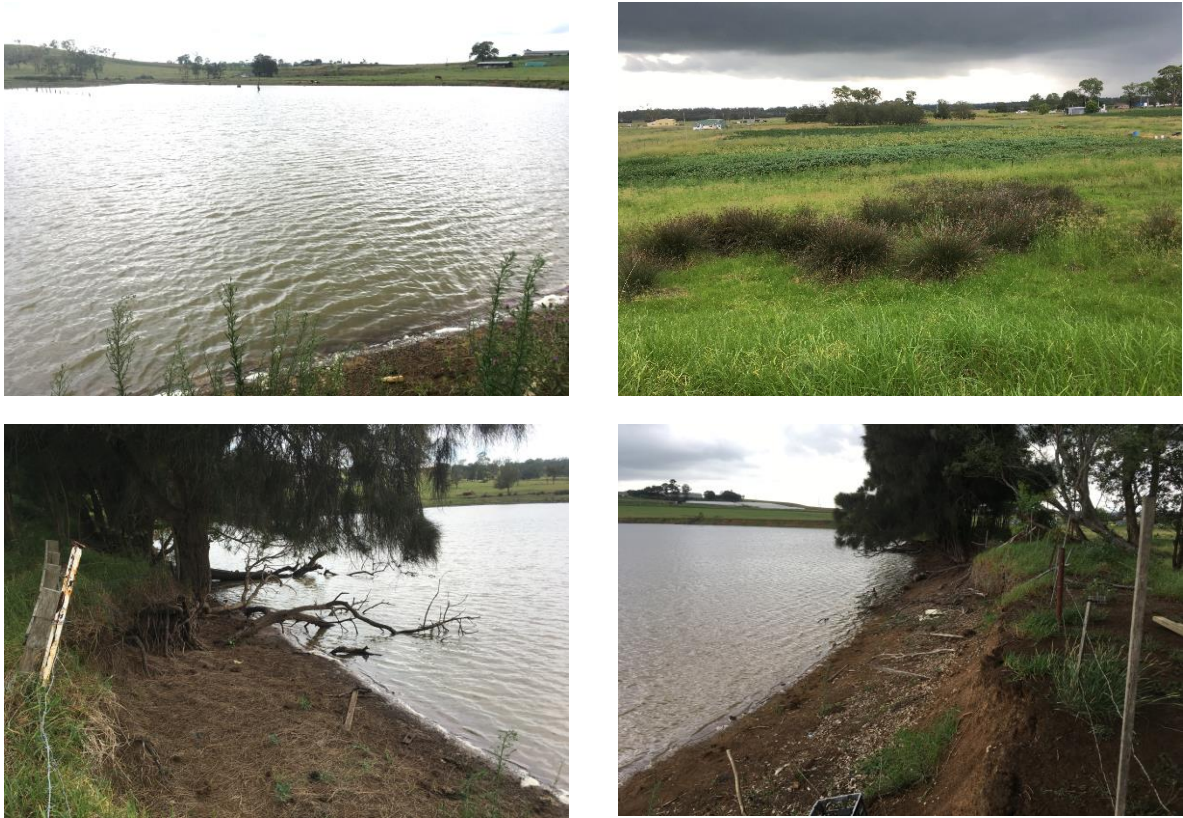
The 6th dam was located at the north of the study area spanning Lots 57 and 58. It covered an area of approximately 1.89 ha. Immediately below the 6th dam there was a 2nd order watercourse mapped (Figure 16). During the site visit, there was no defined channel observed in this area or the immediate surrounds. There was no overflow or spillway on the downstream side of this dam. A few *C. glauca* trees and saplings were located on the downstream side of the dam and erosion around the base of these trees and sections of the downstream dam wall (which was nearly vertical in most areas) was observed Figure 16. There was very little other vegetation surrounding the 6th dam, apart from a small area of *J. usitatus* on the eastern side of the dam and exotic herbaceous species including *Conyza bonariensis* (Fleabane) and *O. acanthium*.

Figure 16: Photo point 8: Top left: looking upstream across 6th dam; top right: looking downstream from 6th dam; bottom left and right: dam wall erosion and *C. glauca* trees.

In the area immediately downstream of the 6th dam, there were a few *J. usitatus* plants (Figure 16) that indicated that the area may be occasionally inundated or have standing water present, however there was no defined channel in this area. Figure 17 shows that there was no defined channel within the central portion of Lot 58 at Photo point 9. The area was covered by exotic species, primarily herbaceous grasses.

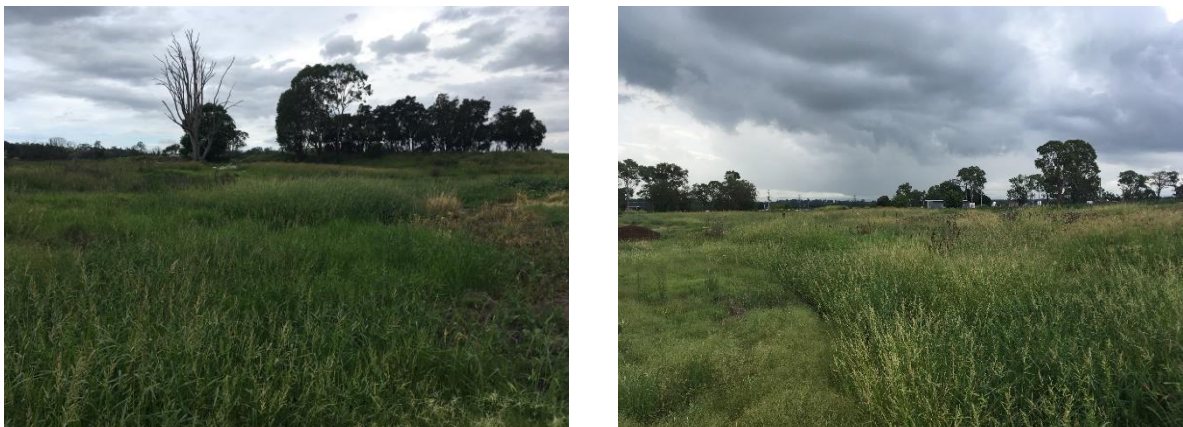
Figure 17: Photo point 9: Left, looking upstream towards 6th dam; right, looking downstream towards Mamre Rd.

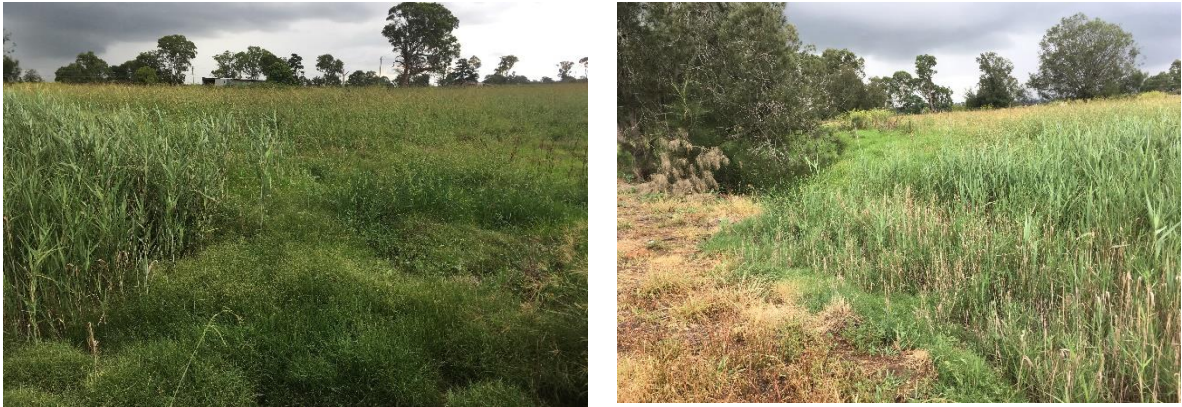
There was part of a mapped watercourse downstream of the 6th dam (Figure 18) that did meet the definition of a 'river' under the WM Act. The defined watercourse started at a patch of *Phragmites australis* (Common Reed) and flowed through the site in a westerly direction towards Mamre Road (Figure 18). Frogs could be heard calling within this area however there were no exposed areas of open water that were observed.

Figure 18: Photo point 10: Left, looking upstream towards 6th dam; right, looking downstream towards Mamre Road.

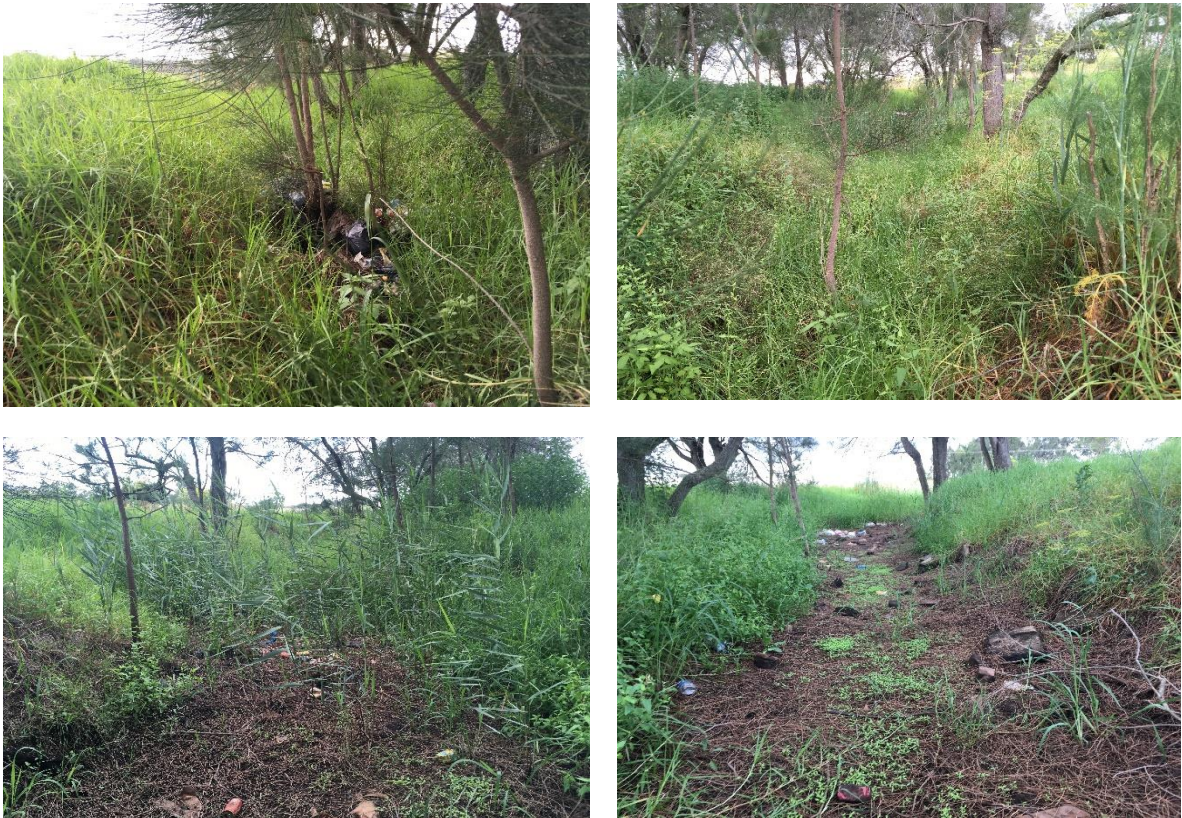
Downstream of the area of *P. australis*, the channel passed through an area of dense *Cenchrus clandestinus* (Kikuyu Grass) and where there were a few *C. glauca* trees at the top of the creek bank. Sections of the bed of the channel within this area were hard to see as they were covered in long *C. clandestinus*. Small *C. glauca* trees were located within the channel in this area and household rubbish was scattered through the channel. Photo point 11 was an area where the channel became wider and more defined (Figure 19) and there was no longer dense exotic species growing on the bed of the watercourse. Another patch of *P. australis* was growing within the channel, which at this location was approximately 1.5 m wide and 1.2 m deep.

Figure 19: Photo Point 11: Top left, looking upstream towards *Phragmites*; top right, looking downstream towards Mamre Rd; bottom left, looking upstream towards next *Phragmites* patch; bottom right, looking upstream at exposed channel bed.

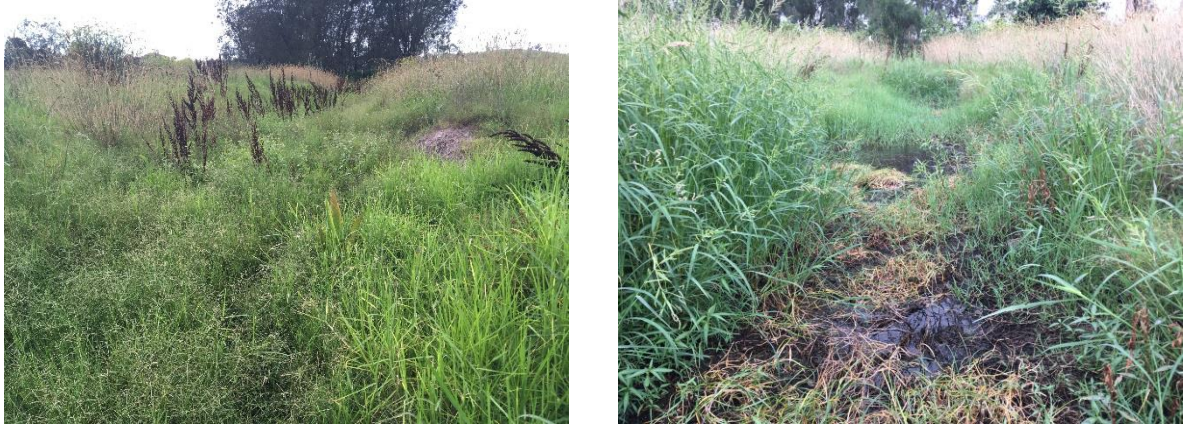
Approximately 20 m upstream of the Lot 58 boundary fence, the channel became wider (approximately 2.5 m wide) and there was a small amount of standing water in the creekline. There was a break in the riparian vegetation in this section of the watercourse, with no *C. glauca* species on the top of the banks. However, there was more instream vegetation including the natives *P. decipiens*, and *Alternanthera* sp. and the exotic species *Rumex crispus* (Curled Dock) (Figure 20).

Figure 20: Photo point 12: Left, looking upstream with vegetation growing within creekline; right, looking downstream towards standing water in creekline.

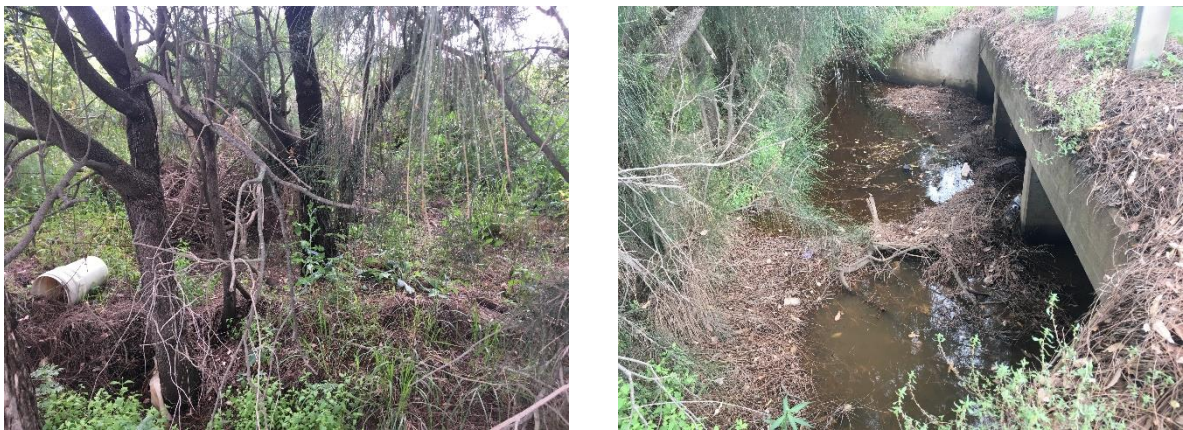
At the western extent of Lot 58, the creek flowed under Mamre Road through three box culverts, each approximately 0.8 m high and 1.5 m wide with a concrete wingwall extending out to the northern and southern ends of the culverts. This area also appeared to collect roadside drainage from the north and south of Lot 58 along Mamre Road. Upstream of this point, the vegetation was densely covering the channel (Figure 21).

Figure 21: Photo Point 13: Left, looking upstream through dense vegetation; right, culverts that carry creek flow under Mamre Road, looking south.
