### TREASURY CMP – SSD-10454

The Conservation Management Plan prepared by Urbis (most recent version dated 21 July 2020) for the Former Treasury Buildings is integral to the management of the place's significance in the face of proposed change. The CMP is in draft form but generally complete at the moment, and is awaiting formal endorsement from the Heritage Council of NSW after an extensive review process.

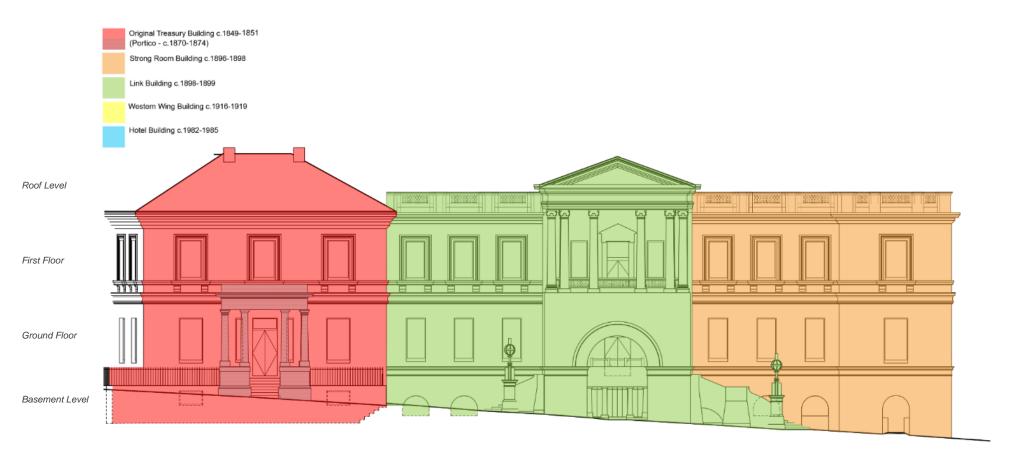
Figure 16 – Extract of 'as built' plans showing period of construction – Macquarie Street elevation Source: Hassell Architects with Urbis annotations and overlay

The existing configuration of the improvements is shown in the phase of development diagrams below, noting the general period for spaces and overall built form. While elements shown may have been reconstructed or altered at later dates, these diagrams are meant to provide a high level holistic indication of the period to which each building dates. The following sections of this report (Sections 2.4.3 to 2.4.6) provide a brief overview of the form, materiality and condition of the buildings. A detailed assessment of principal rooms is included in the Room Data Sheets in Appendix B. Full historical analysis of the development of the buildings, including alterations and additions, is located in Section 3.3 of this report.

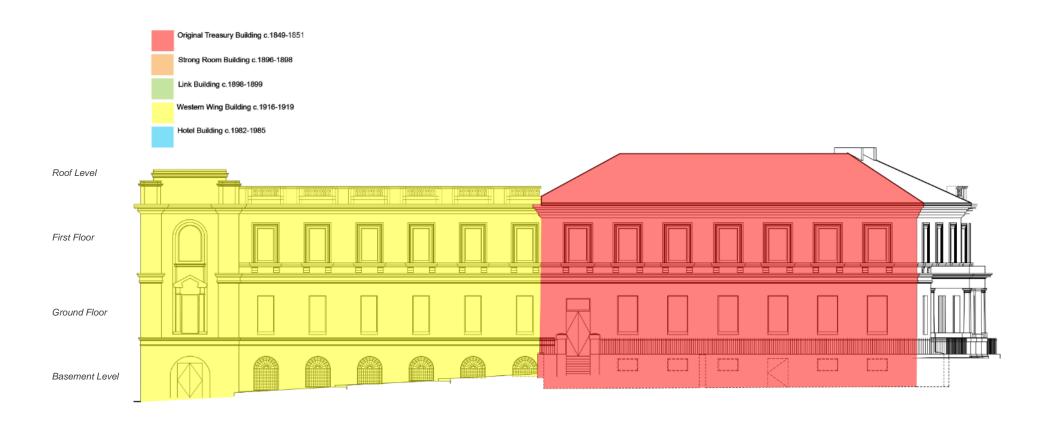
Figure 17 – Extract of 'as built' plans showing period of construction – Bridge Street elevation. Note that the entrance steps to the Bridge Street elevation of the Original Treasury Building were reconstructed in the 1980s, however they are shown in 'red' above, to indicate that they were an original element to the building.

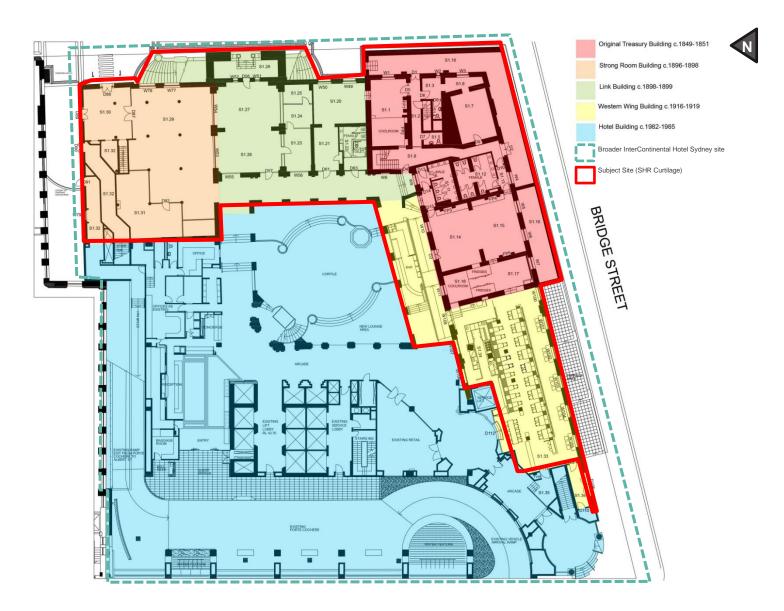
Figure 18 – Extract of 'as built' plans showing period of construction – Basement Floor Source: Hassell Architects with Urbis annotations and overlay

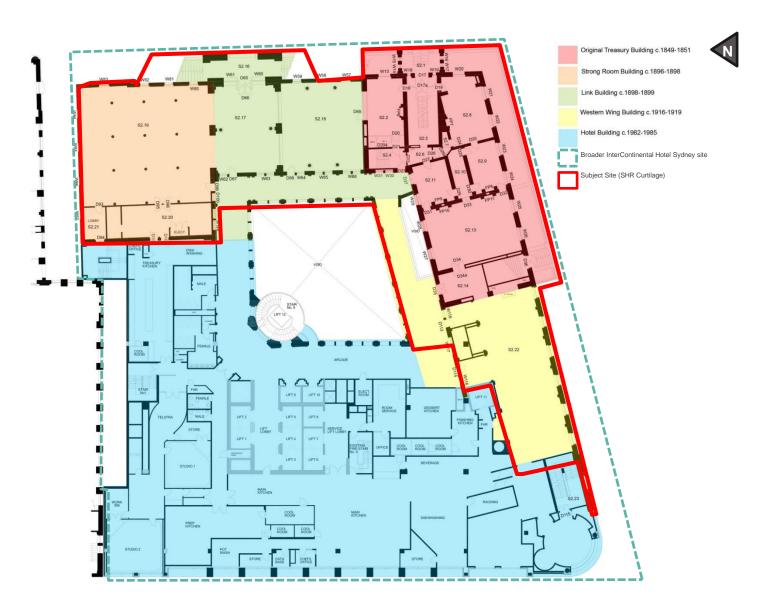
Figure 19 – Extract of 'as built' plans showing period of construction – Ground Floor Source: Hassell Architects with Urbis annotations and overlay

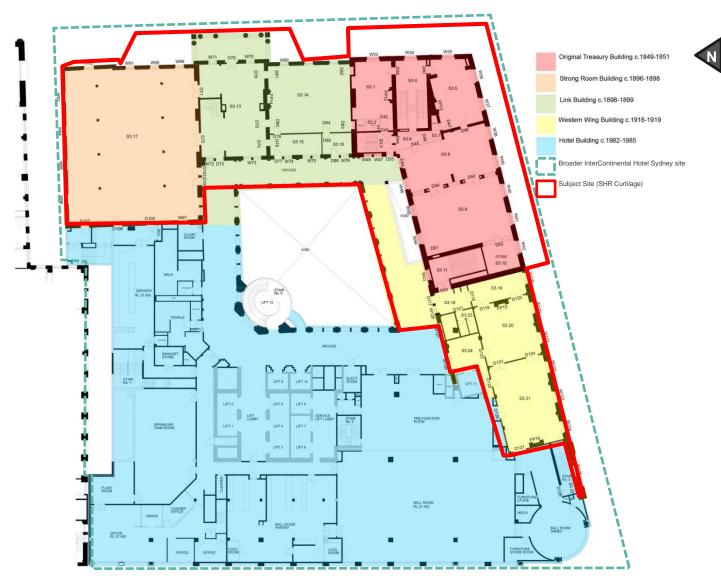
Figure 20 – Extract of 'as built' plans showing period of construction – First Floor

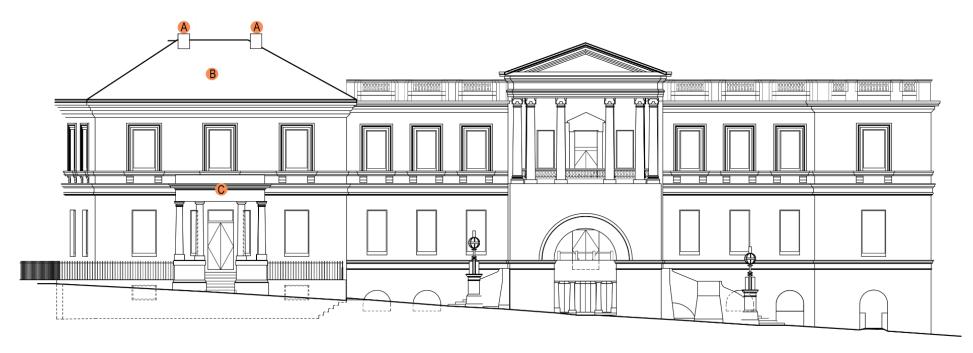
- A Original chimney pots missing
- B Slate roof, new slates
- C Front portico added c.1870-74

Figure 21 – Annotated Diagram (Macquarie Street Façade)

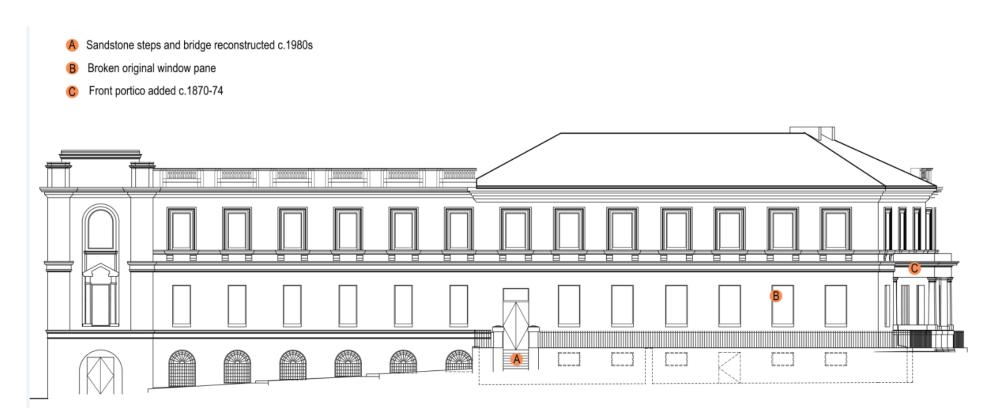
Figure 22 – Annotated Diagram (Bridge Street Façade)

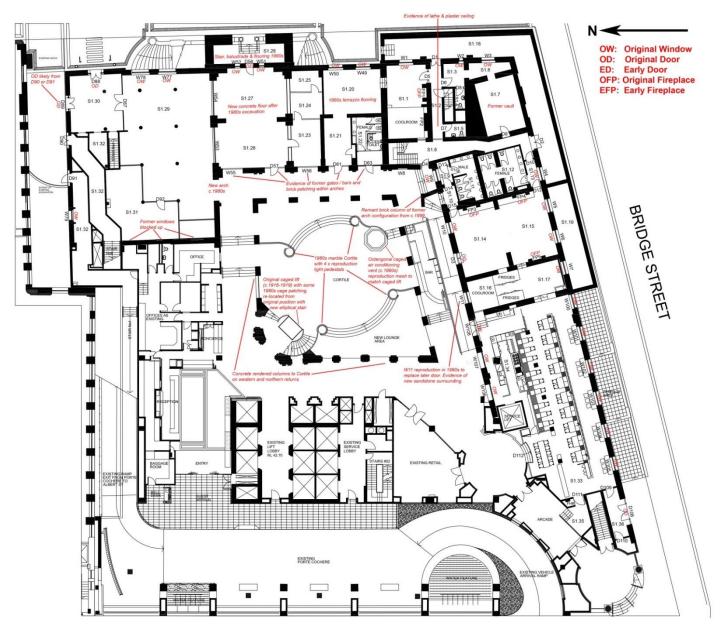
Figure 23 – Annotated Diagram (Basement Level)

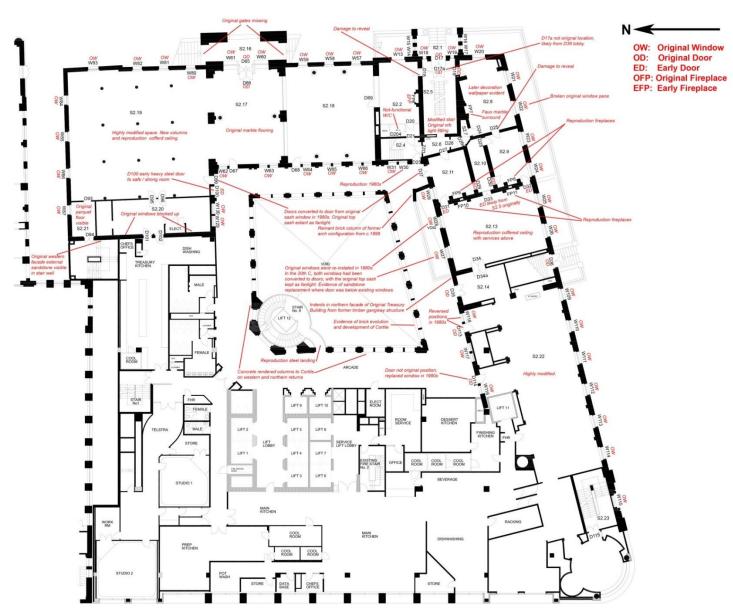
Figure 24 – Annotated Diagram (Ground Floor)

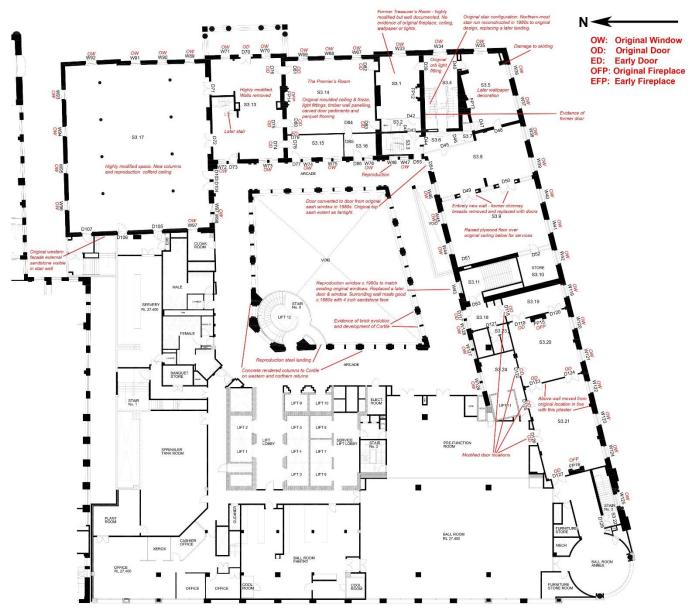
Figure 25 – Annotated Diagram (First Floor)

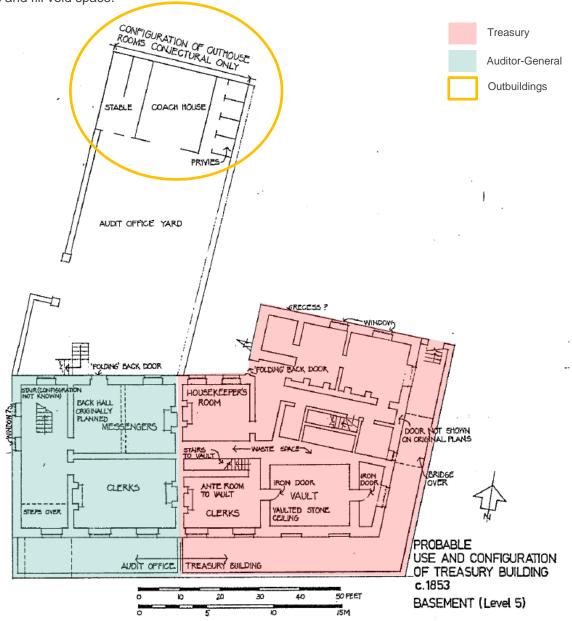
Figure 190 – Probable use and configuration of Treasury Building c.1853 (Basement Floor)

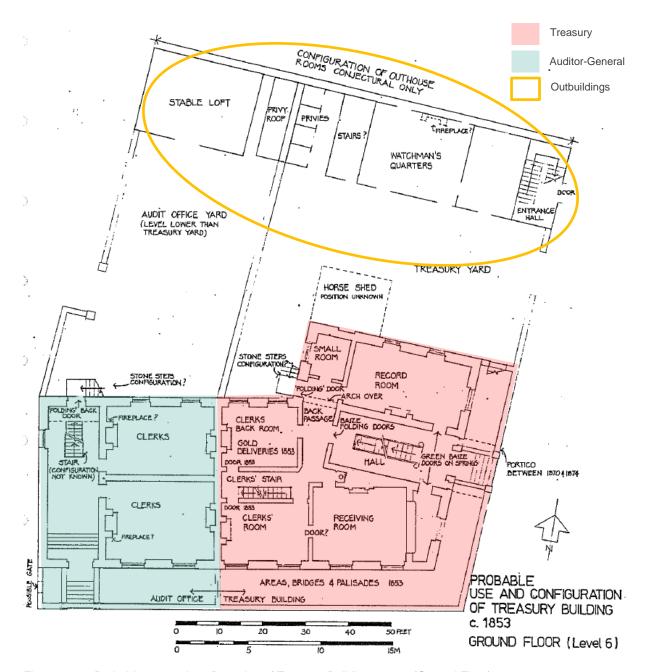
Figure 191 – Probable use and configuration of Treasury Building c.1853 (Ground Floor)

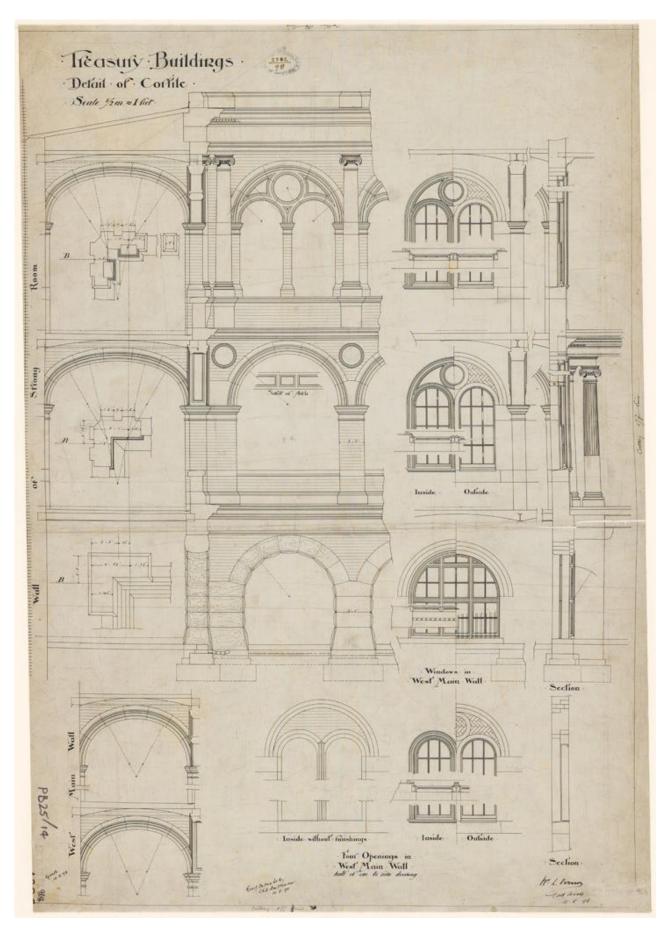
Figure 239 – Treasury Building – Detail of Cortile (arcade) to rear of Link Building, dated 1898 Source: NSW State Records, PB25/14, 1898

One of the most elaborate and significant features of the northern Link Building additions was the inclusion of a colonnaded arcade along the western elevation of the Link Building. The arcade also extended for one bay west, along the southern façade of the Strong Room. The arcade provided brick and sandstone arched openings of varying detail on each level. The following architectural plan prepared by Vernon identifies this detail.

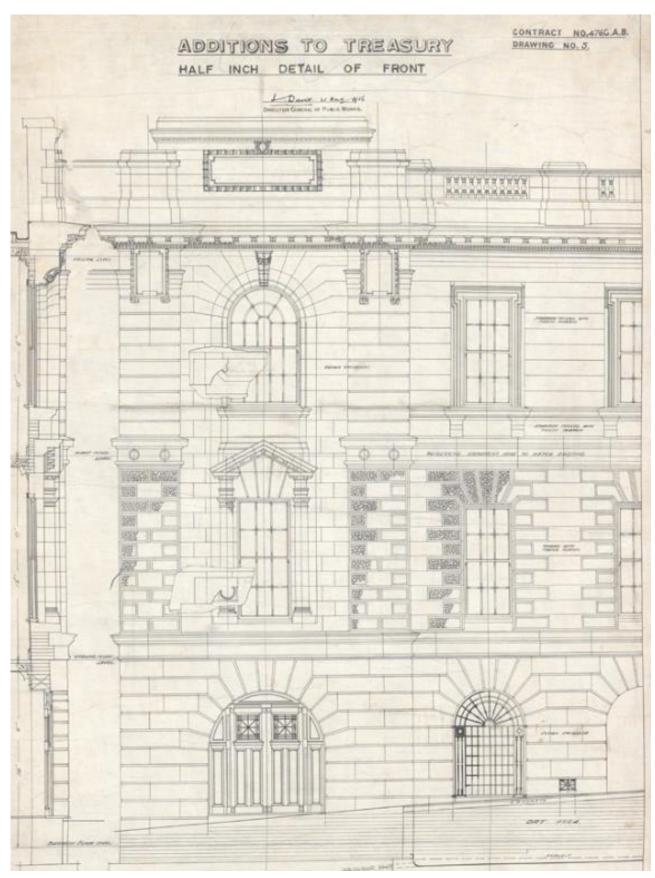
Figure 265 - Additions to Treasury by George McRae in 1916 (Half inch detail of front – Bridge Street elevation) showing elevation as constructed

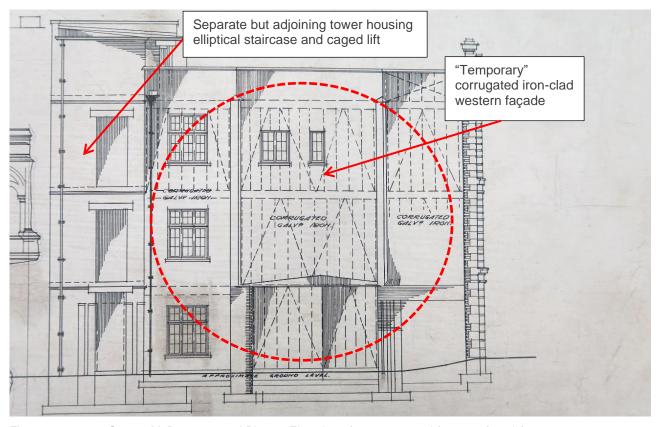
Figure 269 - 1916 George McRae proposed Plans – Elevation of temporary end (western façade)

The full proposed scheme was still intended to be constructed in the future, as the western façade of the new building was detailed as 'temporary' and being clad in corrugated iron. Also at the western portion of the building, an elliptical staircase was constructed with a central caged lift shaft, located within a three-storey brick tower at the Bridge and Phillip Street corner (refer Figure 269).

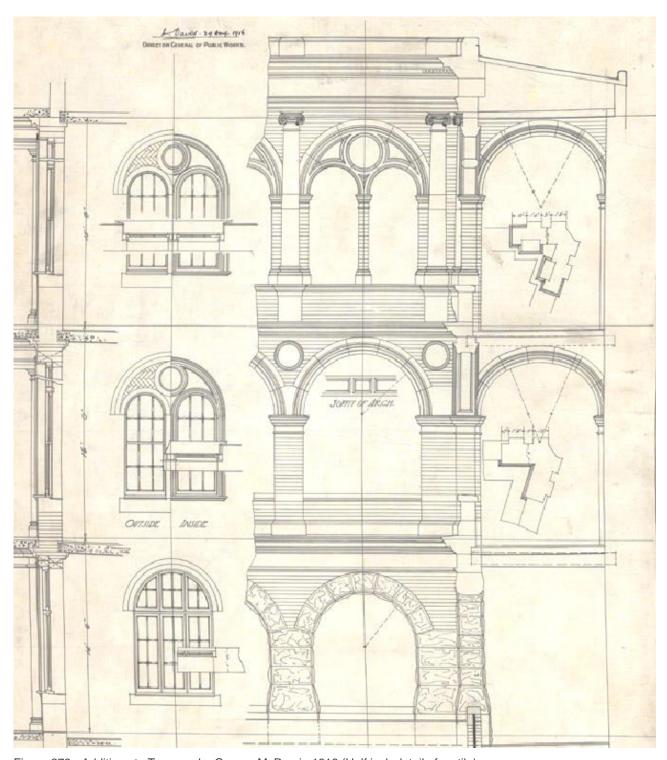
Figure 273 - Additions to Treasury by George McRae in 1916 (Half inch detail of cortile)

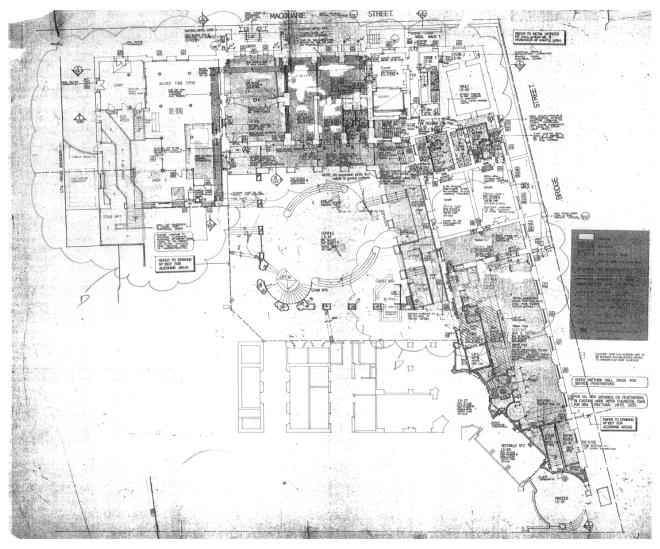
Figure 307 – Extract proposed plans from 1983: Basement Floor (Treasury section)

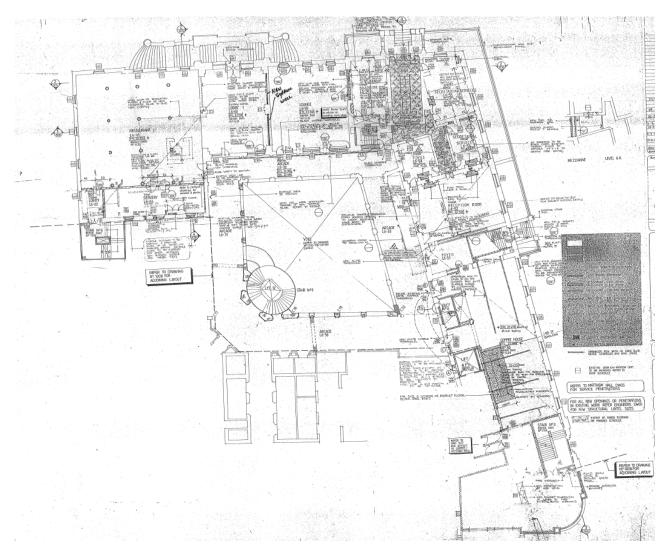
Figure 308 – Extract proposed plans from 1983: Ground Floor (Treasury section)

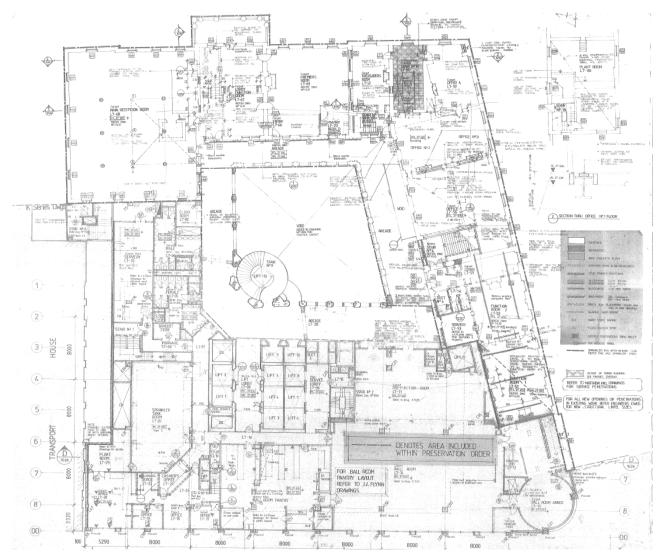
Figure 309 – Extract proposed plans from 1983: First Floor (Treasury section)

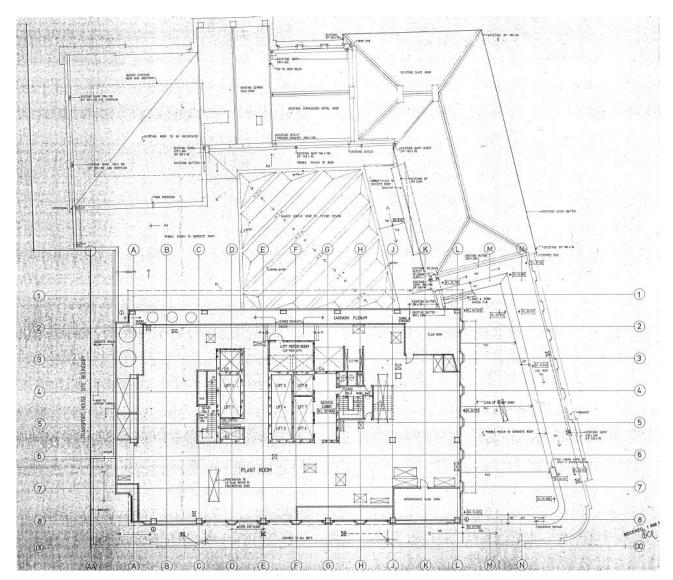
Figure 310 – Extract proposed plans from 1983: Roof plan

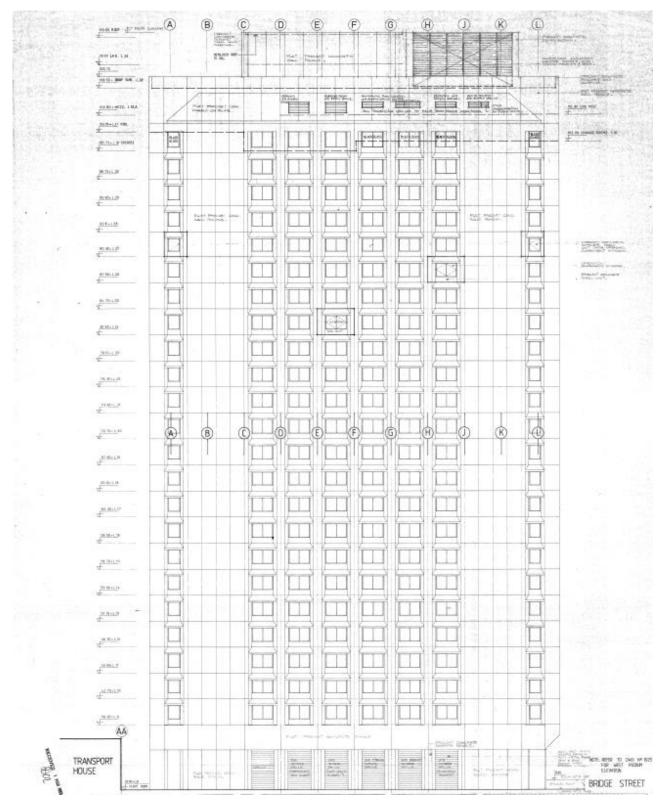
Figure 312 – Extract proposed plans from 1983: Tower western elevation Source: Sydney City Council, Stamps DA plans dated 30 September 1983

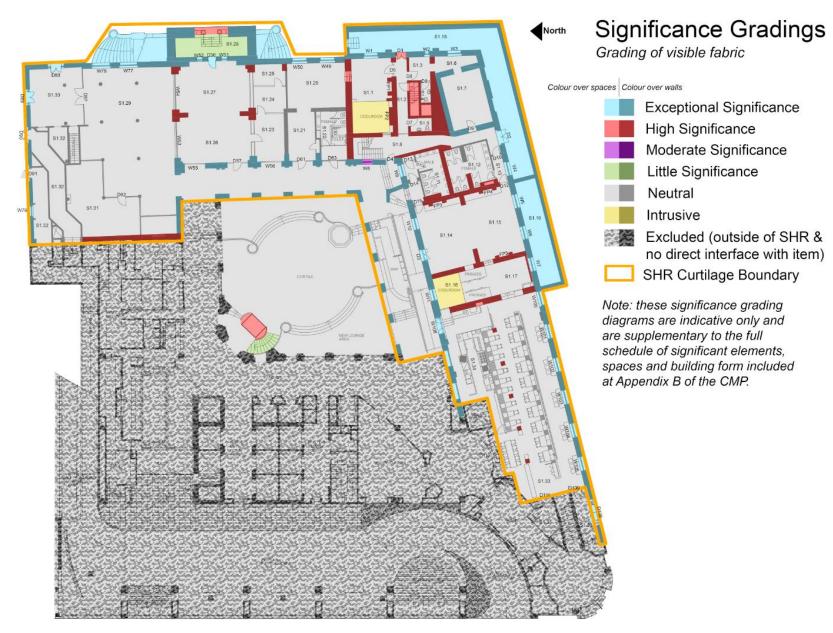
Figure 330 – Grading Diagrams – Grading of Visible Fabric (Basement Level)

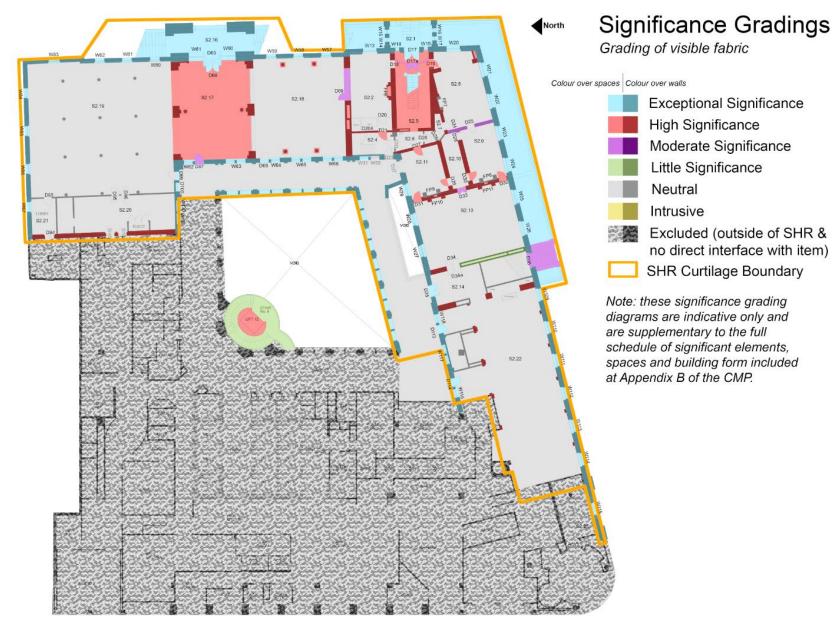
Figure 331 – Grading Diagrams – Grading of Visible Fabric (Ground Floor)

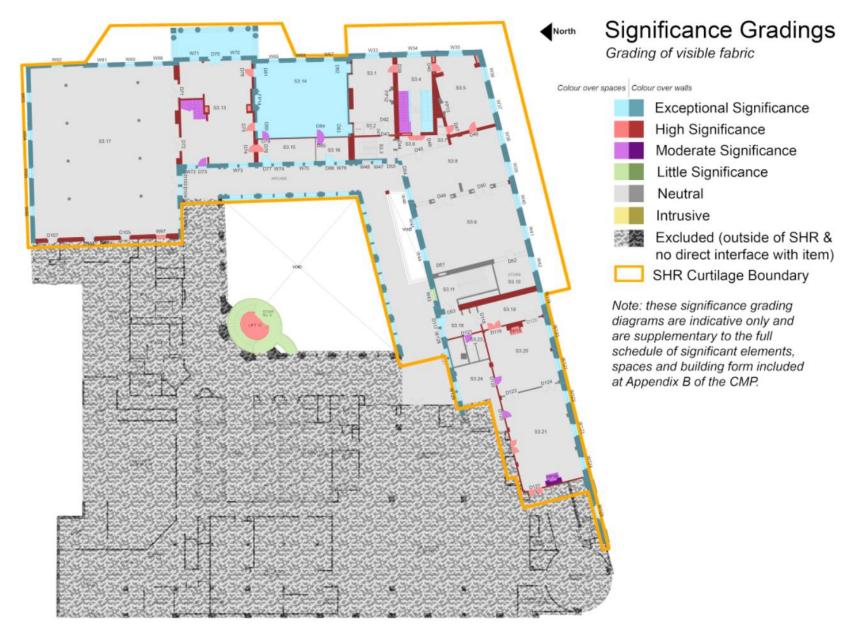
Figure 332 – Grading Diagrams – Grading of Visible Fabric (First Floor)

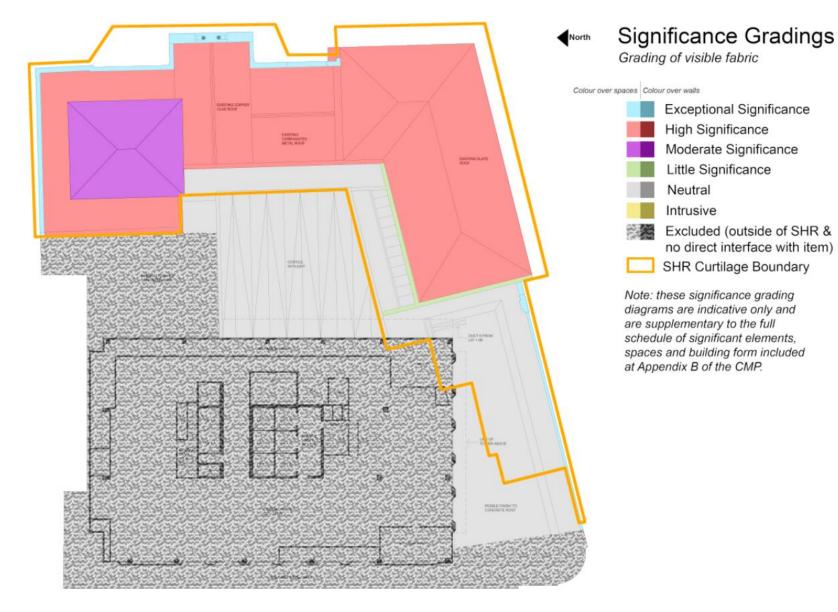
Figure 333 – Grading Diagrams – Grading of Visible Fabric (Roof Plan)

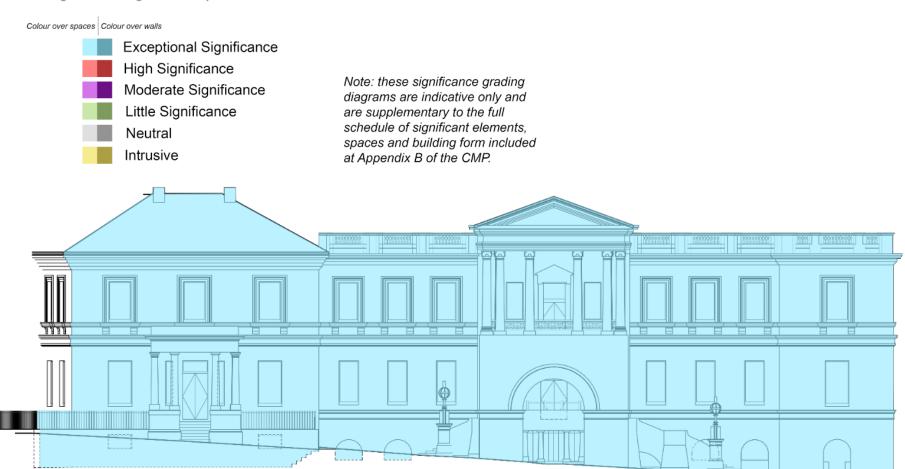
Figure 334 – Grading Diagrams – Grading of Building Form and Spaces (Macquarie Street Façade)

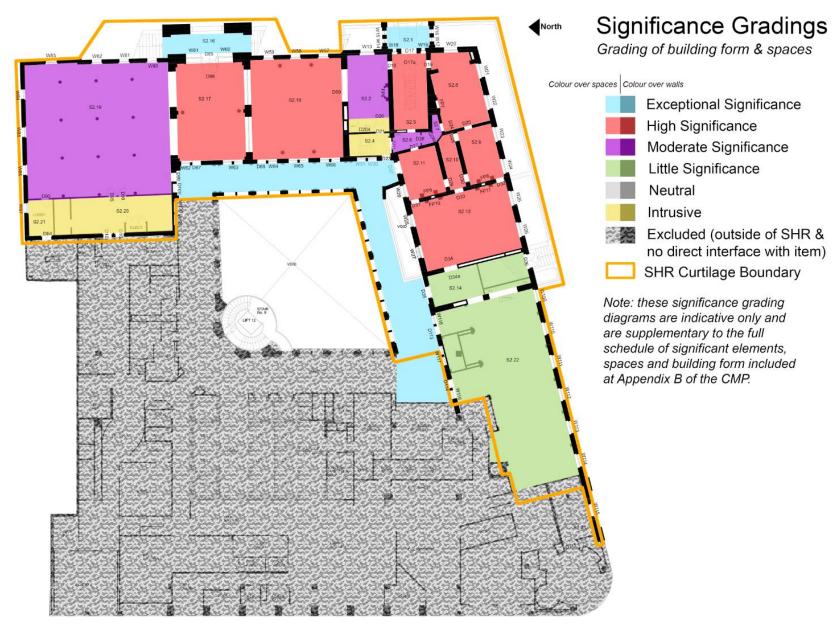
Figure 337 – Grading Diagrams – Grading of Building Form and Spaces (Ground Floor)

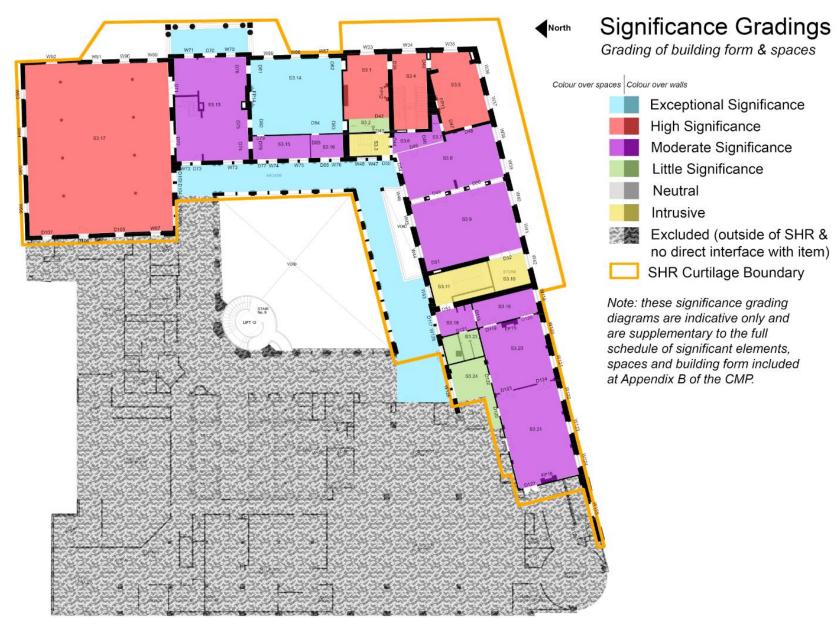
Figure 338 – Grading Diagrams – Grading of Building Form and Spaces (First Floor)

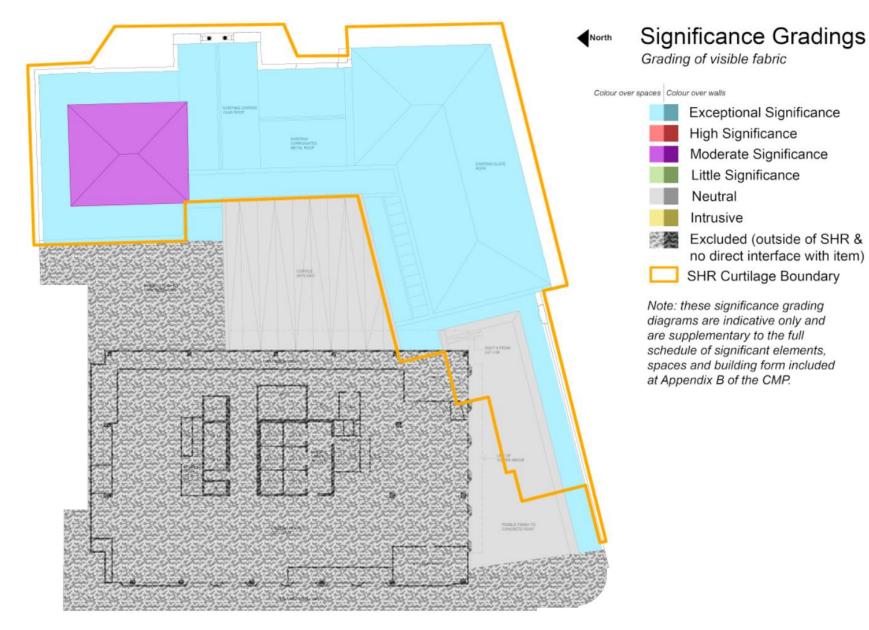
Figure 339 – Grading Diagrams – Grading of Building Form and Spaces (Roof Plan)

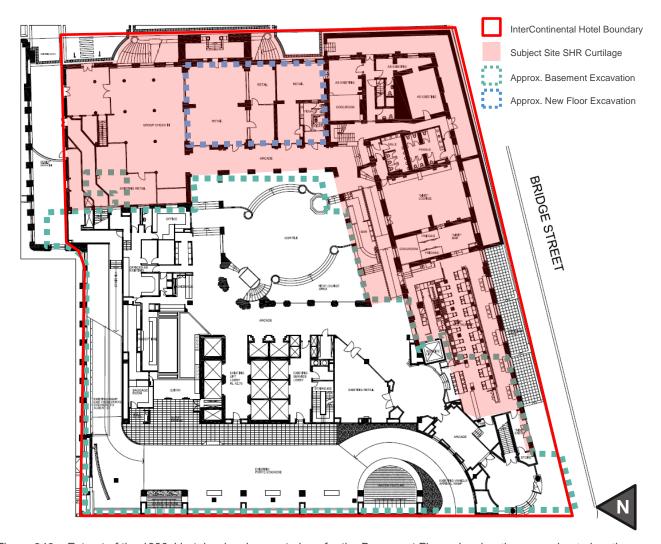
Figure 346 – Extract of the 1980s' hotel redevelopment plans for the Basement Floor, showing the approximate location of the largest sub-basement floor (Hotel Basement Level 4) shown in dotted green, as an approximate indication of the extent of excavation undertaken to provide basement space. The approximate area of the Link Building which was excavated and replaced with a new concrete floor is outlined in dotted blue. The broader InterContinental Hotel site boundary is shown in a solid red outline, and the Former Treasury Buildings SHR curtilage (the subject site) is shown shaded red.

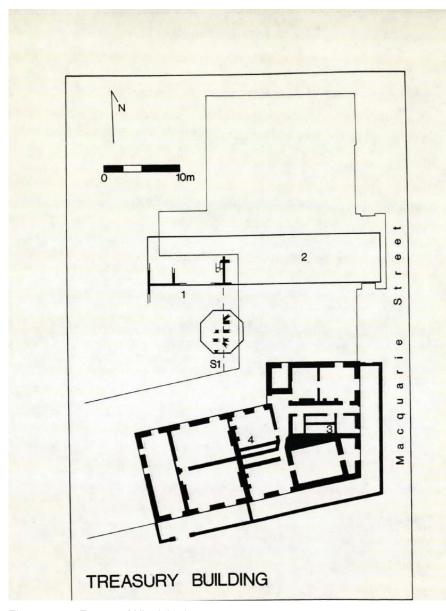
Figure 1. The Treasury Building, Macquarie and Bridge Streets, Sydney. Site plan showing areas of archaeological interest, as follows: 1. Stables (1851-1853) and courtyard, with toilet block (by 1872); 2. Land sale room (1851-1853); 3 and 4. Cavities under main staircase and under hallway (S1 section 1, illustrated in figure 2). The original offices and out-buildings are shown in heavy outline, along with the present room plan of the basement for the former. The remains of walling for the stables and toilet block were discovered during the archaeological investigation. The extent of buildings in 1982 is illustrated in light outline.

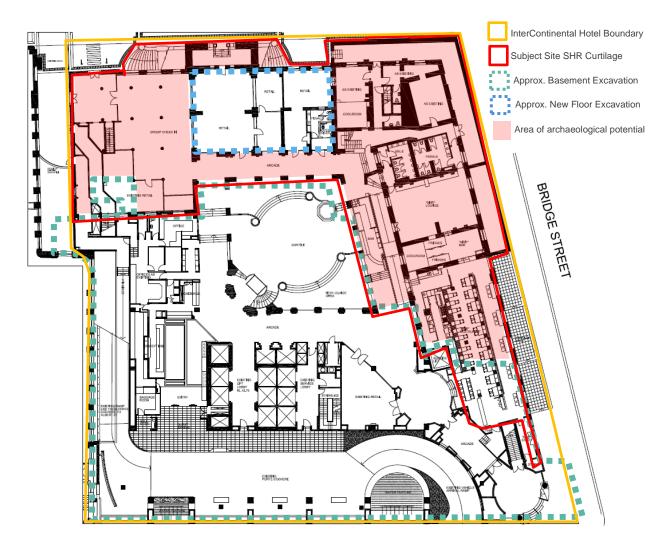
Figure 348 – Area of archaeological potential.

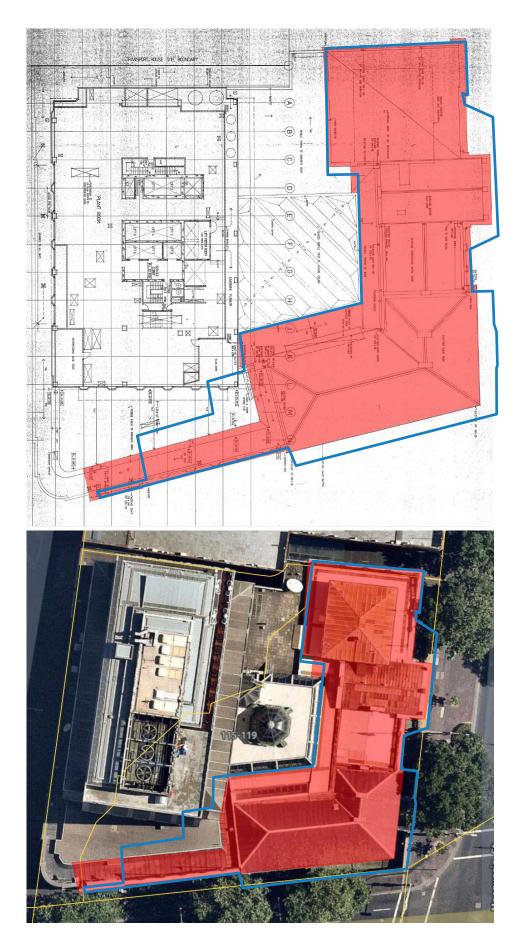
Figure 355 – Non-developable roof zone map – 1980s' roof plan & aerial with Urbis overlay *Source: Urbis*
