HISTORICAL ARCHAEOLOGICAL ASSESSMENT

Upper Australia Precinct,
Taronga Zoo

TARONGA CONSERVATION SOCIETY AUSTRALIA

23 July 2020

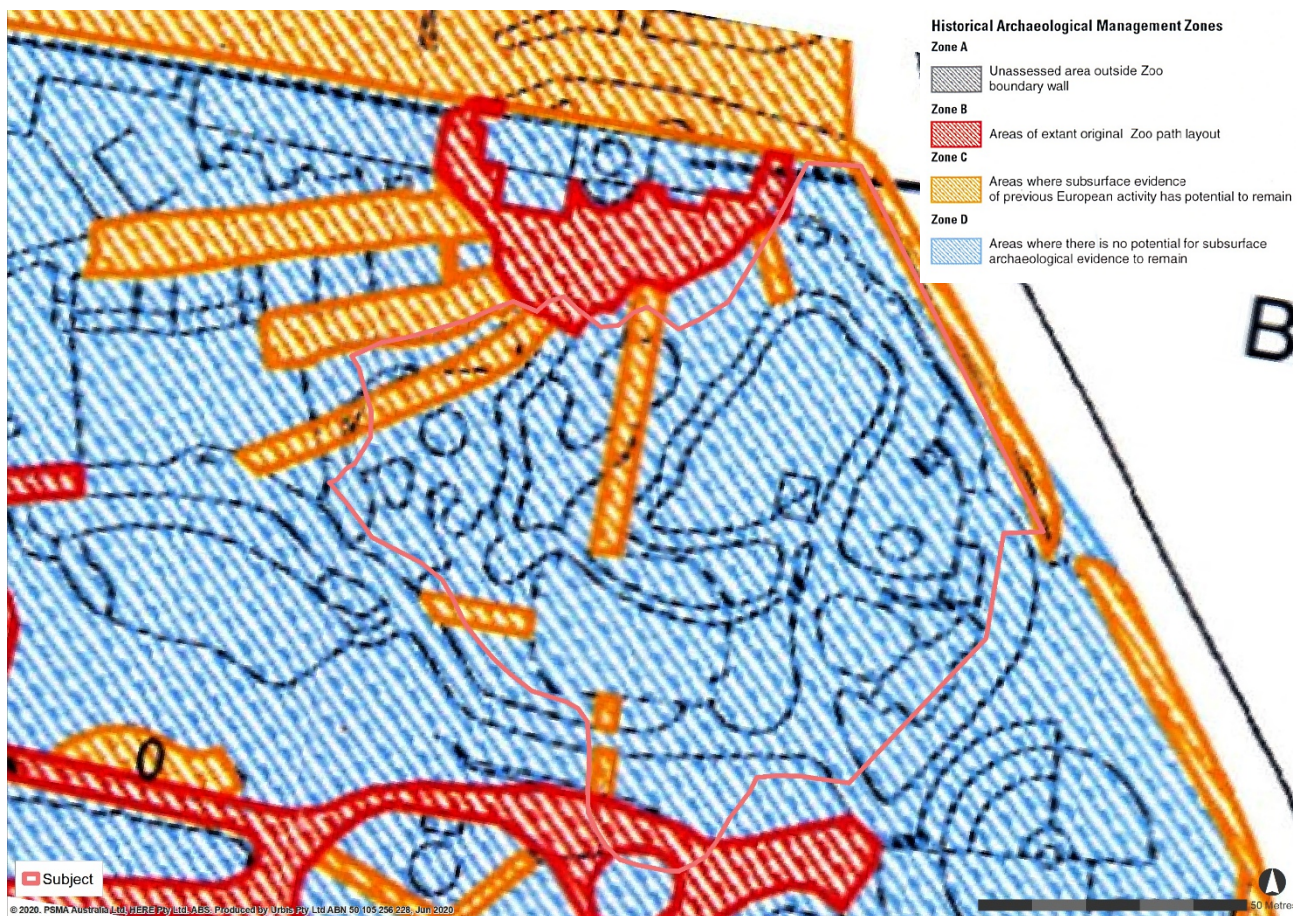
- **Zone B:** Areas of extant original Zoo path layout
- **Zone C:** Areas where subsurface evidence of previous European activity has potential to remain
- **Zone D:** Areas where there is no potential for subsurface archaeological evidence to remain

Figure 7 – Historical archaeological management zones

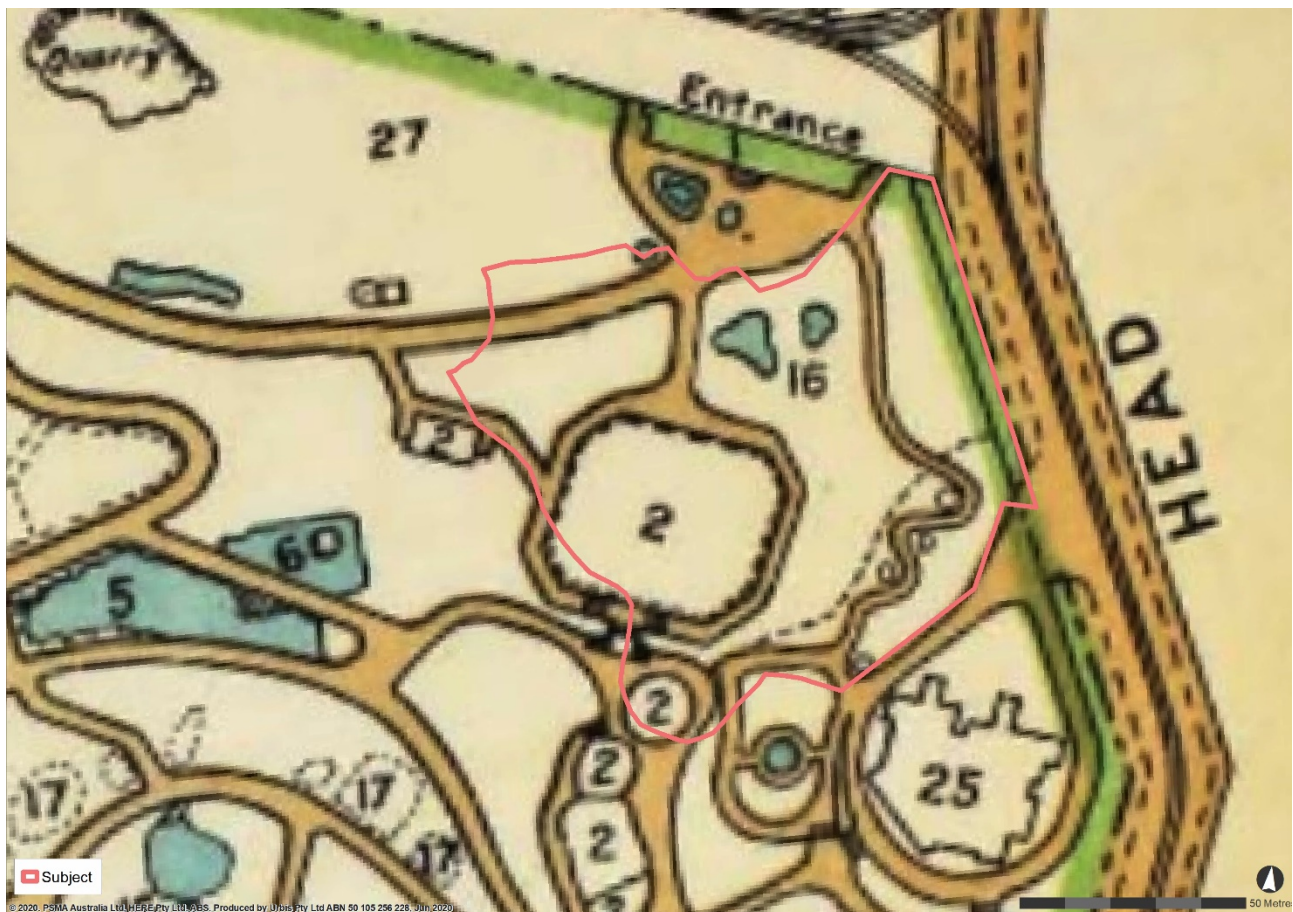
Figure 11 -1916 plan of Taronga Zoological Park, approximate location of the subject area is indicated in red outline. Structures within the subject area as follows: 2 (north) – Baboon Pit; 2 (south) – Monkey Pit; 2 (west) – Orangutan and Monkey Pit; 15 – Waterfowl Ponds;

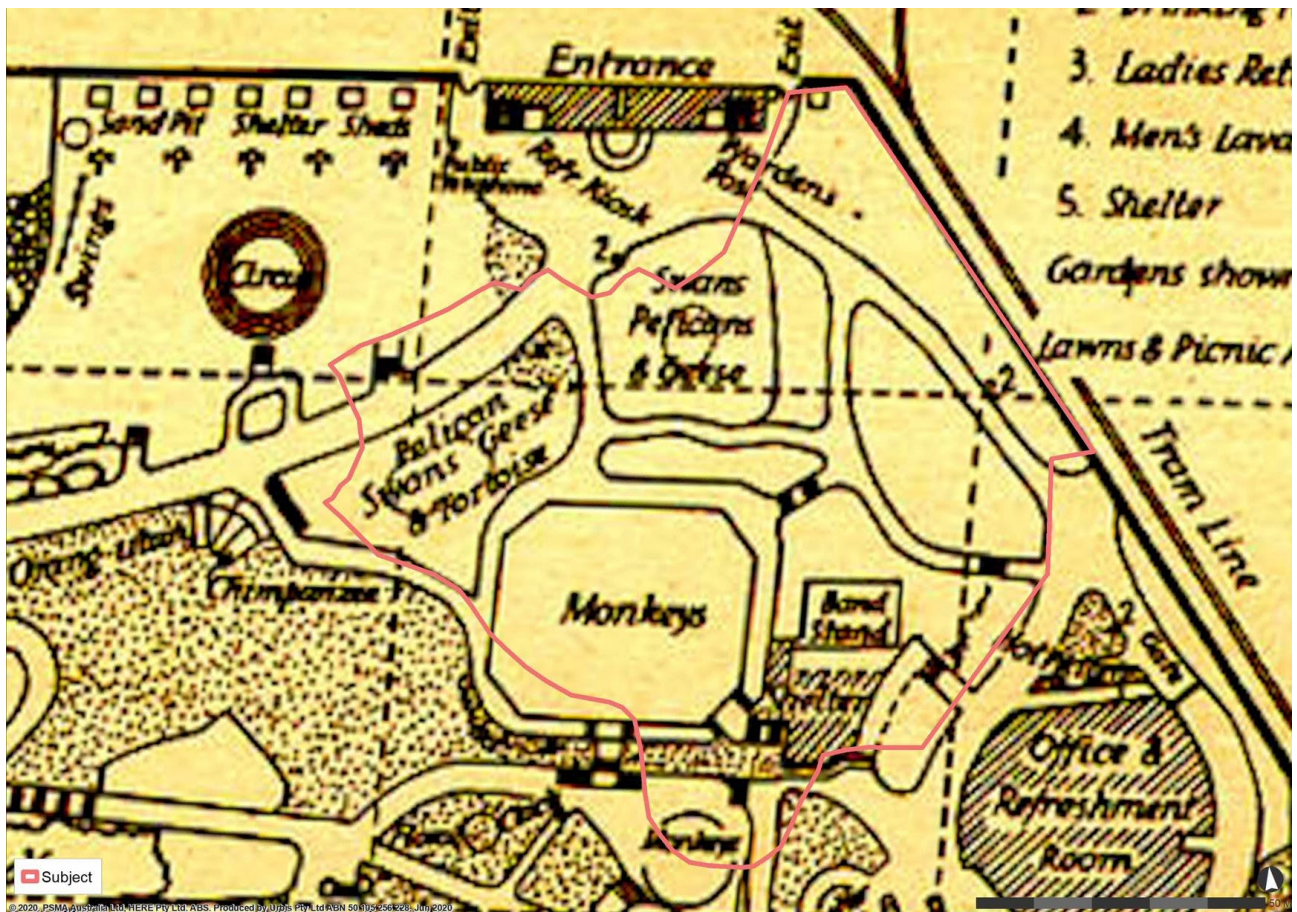
Figure 12 – 1940 Guidebook indicating changes to paths and configuration of enclosures as well as the erection of the Bandstand building to the east of the Baboon Pit. Approximate location of the subject area indicated in red outline.

Following the departure of Le Souef in 1939, Taronga Zoo underwent a number of changes under the new director Sir Edward Hallstrom. Rather than the focus on barless exhibits with moats, the moats began to be filled in and chain and wire fences installed to allow visitors to get closer to the animals. Animal enclosures had concrete floors and walls installed (GML, 2006). Enclosures for swans, pelicans and tortoises had been established to the north and west of the Baboon Pit by this time and a Bandstand had been erected to the east. Some additional paths had also been established within the northern component of the subject area (Figure 12).

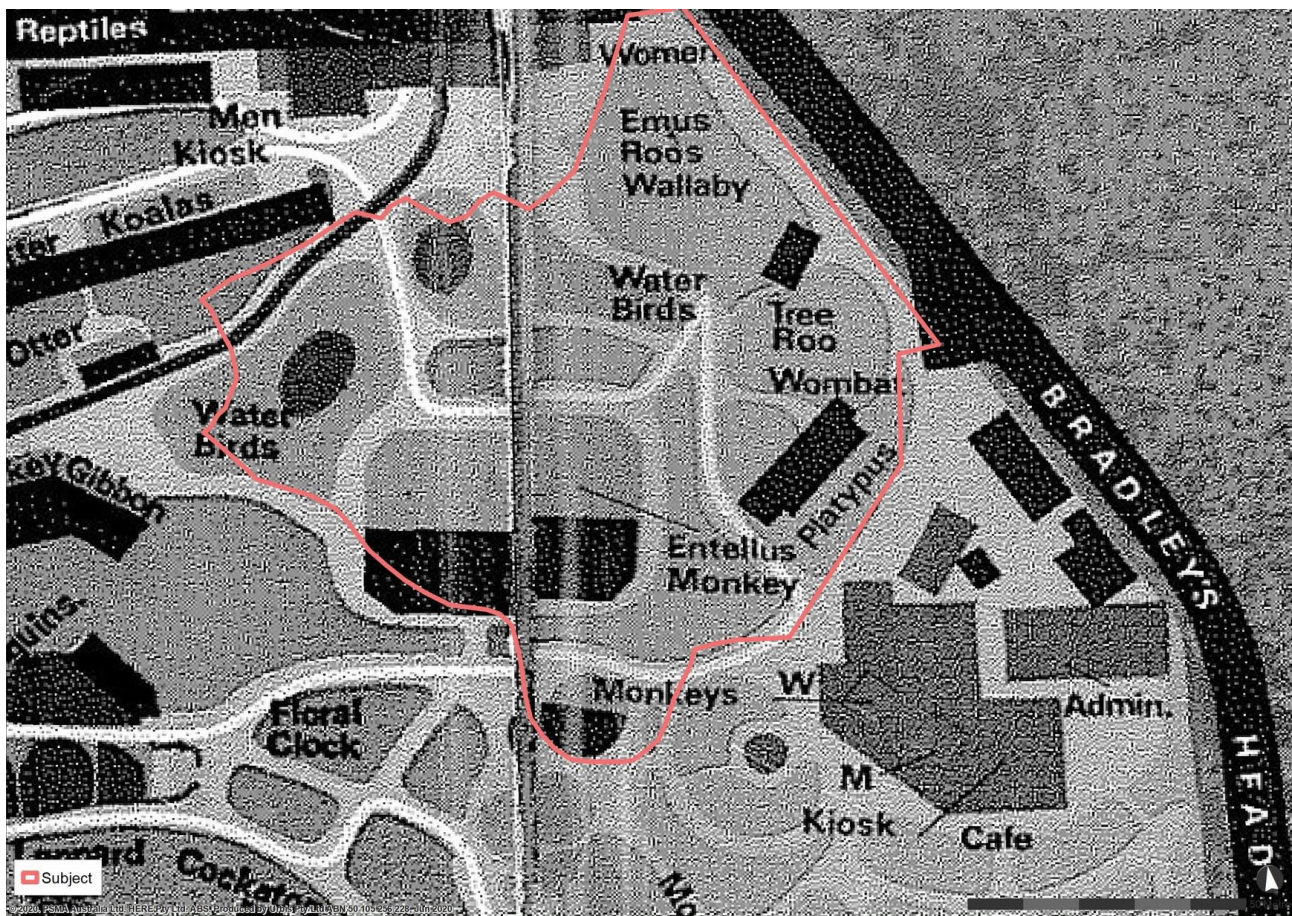
Figure 16 – Taronga Zoo plan, 1968. Approximate location of the subject area indicated in red polygon.
Source: Taronga Zoo Archives

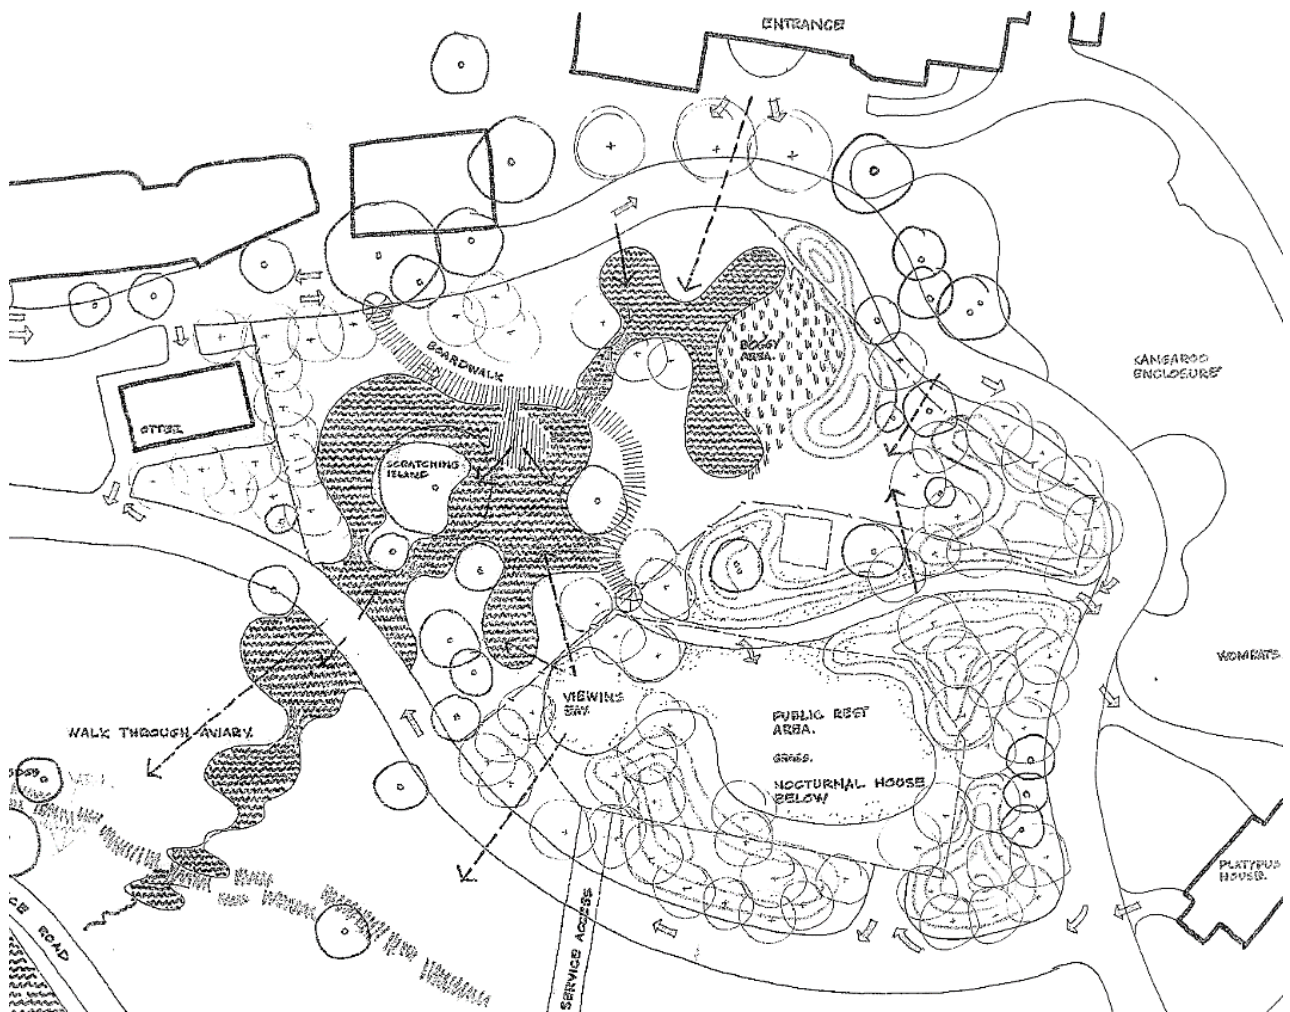
Figure 17 -1969 Waterfowl Enclosure concept plan indicating replacement of the northern and western Duck Ponds within expansive wetland exhibits

Figure 14 indicates the partial demolition of the northern Duck Pond, which was later incorporated within a 'boggy area' (Figure 17). The Duck Pond within the western section of the precinct (Figure 14) was removed completely and a larger pond excavated in this location. The outline of the western pond can still be made out in the 1969 concept plan (Figure 17). The footprint of the Waterfowl Ponds had thus significantly increased by this time, necessitating significant earthworks and disturbance within the north-western component of the subject area.

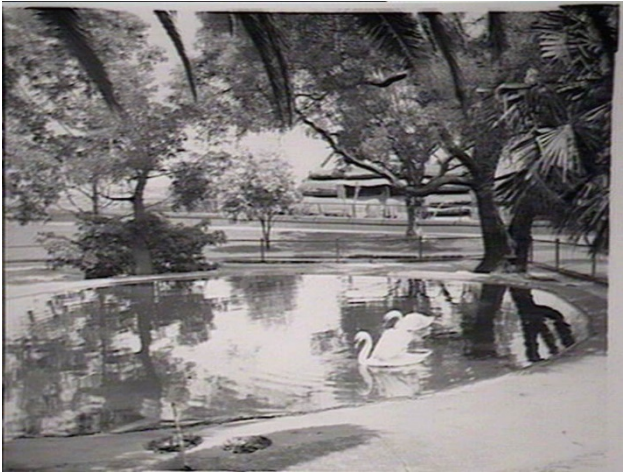
Figure 18 – waterfowl exhibit prior to redevelopment, a series of circular ponds.

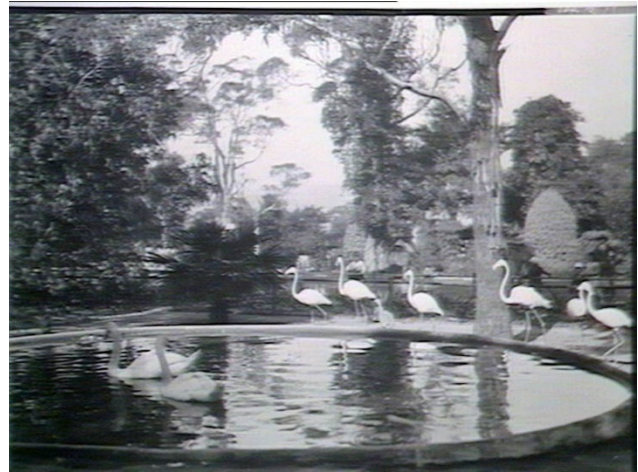
Figure 19 – waterfowl exhibit prior to redevelopment, a series of circular ponds.

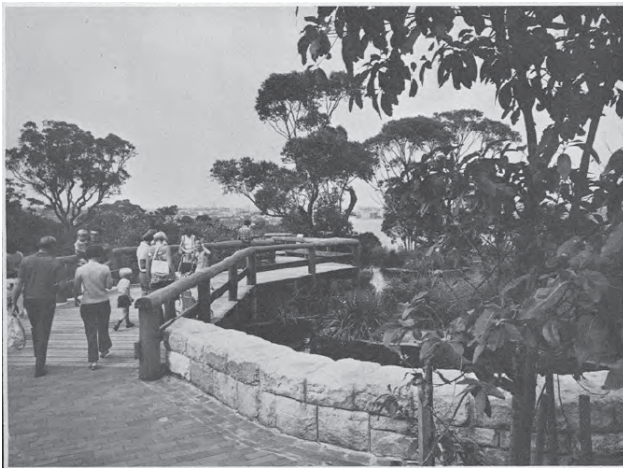
Figure 20 – bridge over the wetlands ponds section.

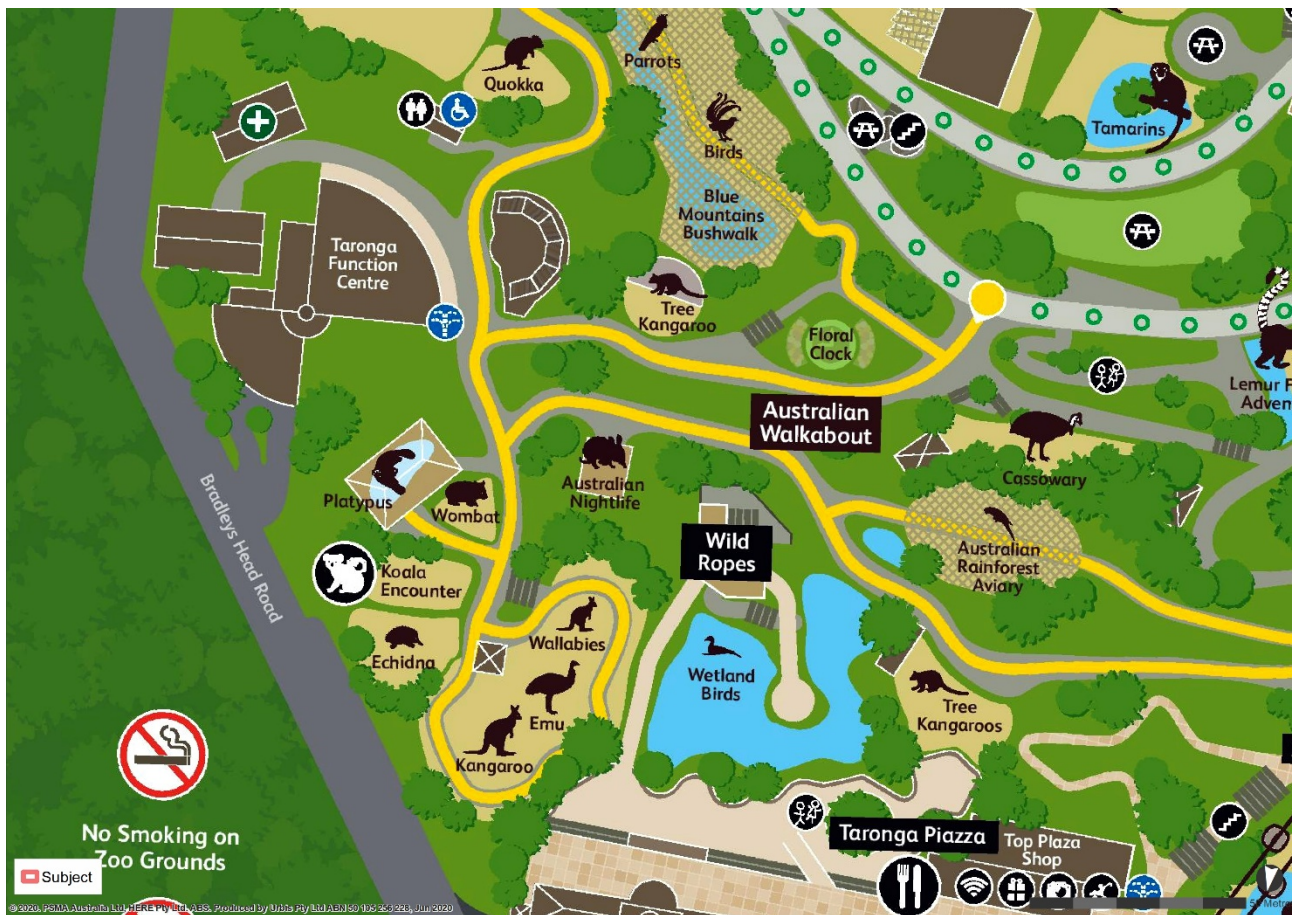
Figure 22 - 2016 Guidebook indicating extent of Wetland Ponds and addition of koala, wombat and echidna enclosures within the eastern component of the site. Approximate location of the subject area indicated in red outline.

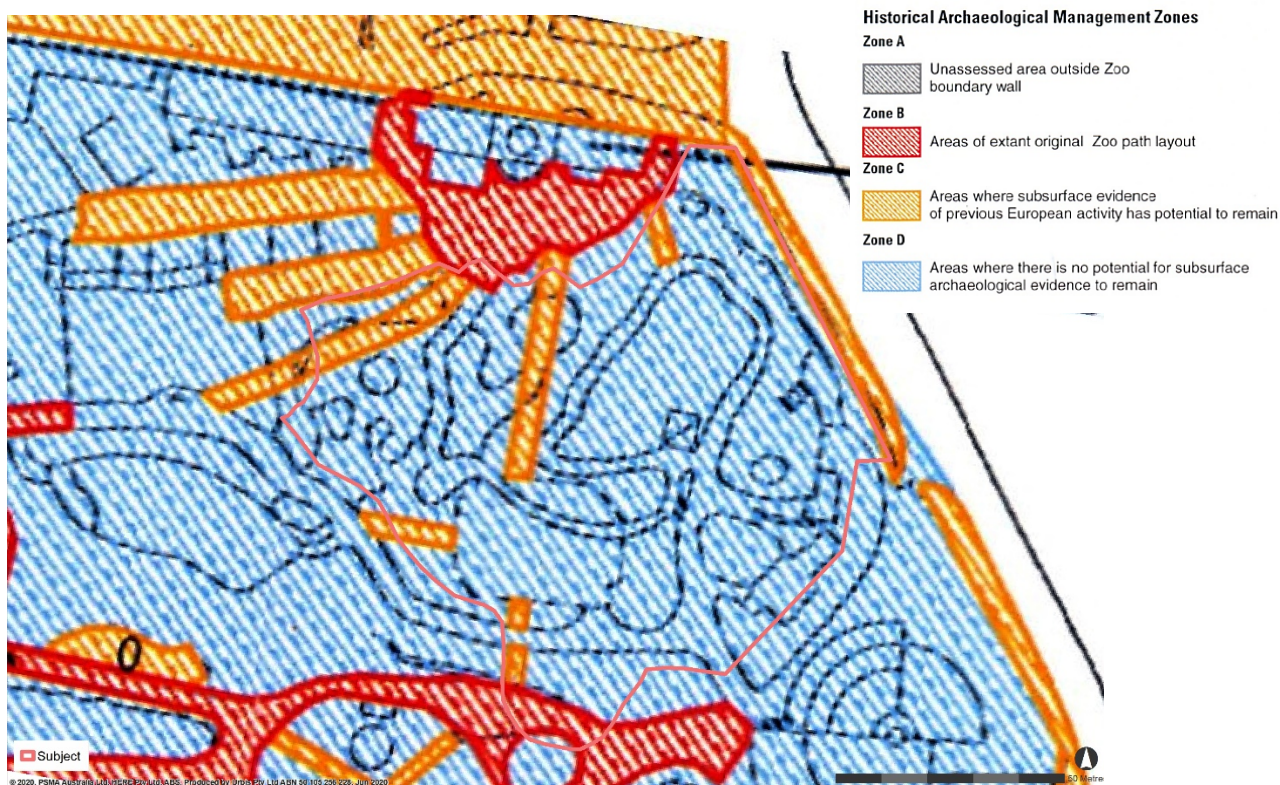
Figure 23 – Historical archaeological management zones. Approximate location of the subject area indicated in red outline.

This Historical Archaeological Management Zone encompasses the rest of the site, where excavations for the foundations of previous Zoo structures have reached down to bedrock or culturally sterile soil profiles, or where there has been little or insignificant historical development. Zone D is not expected to contain any historical material culture and is therefore assessed as having no archaeological sensitivity.

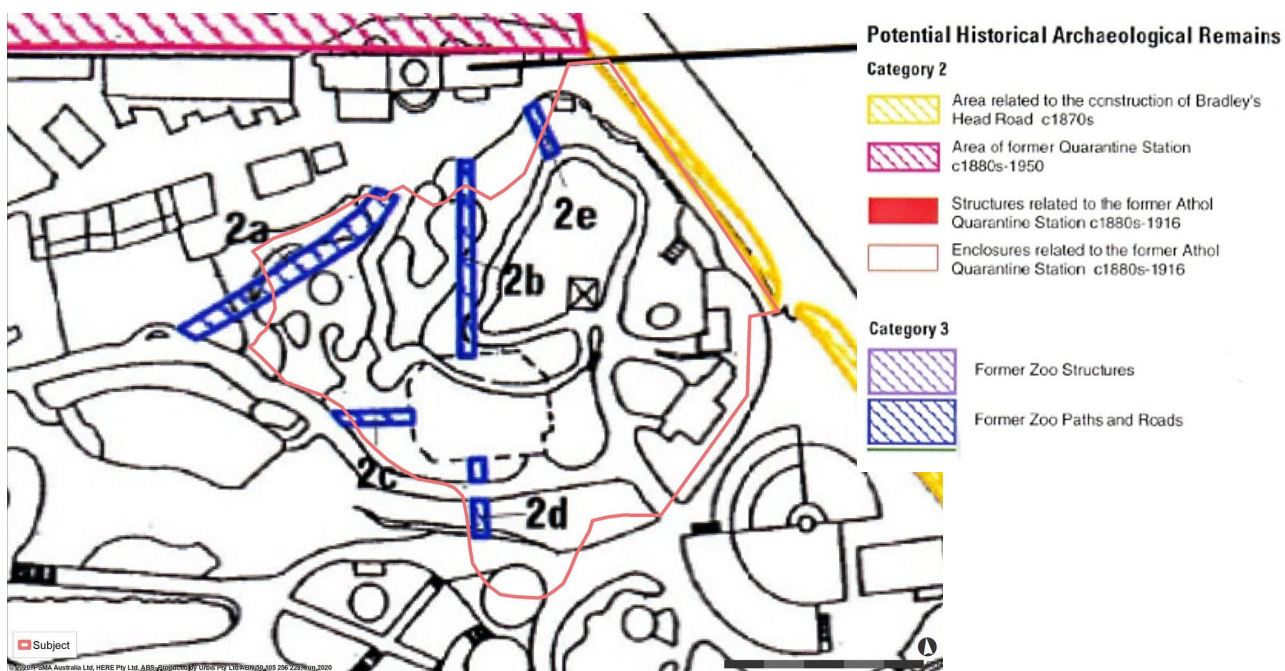
- **Category 2:**
 - Area related to the construction of Bradley's Head Road c.1870s
- **Category 3:**
 - Former Zoo Paths and Roads

Figure 24 - Potential historical archaeological remains

The Taronga Zoo AMP identifies the potential for the following historical archaeological remains within the subject area (Figure 24):

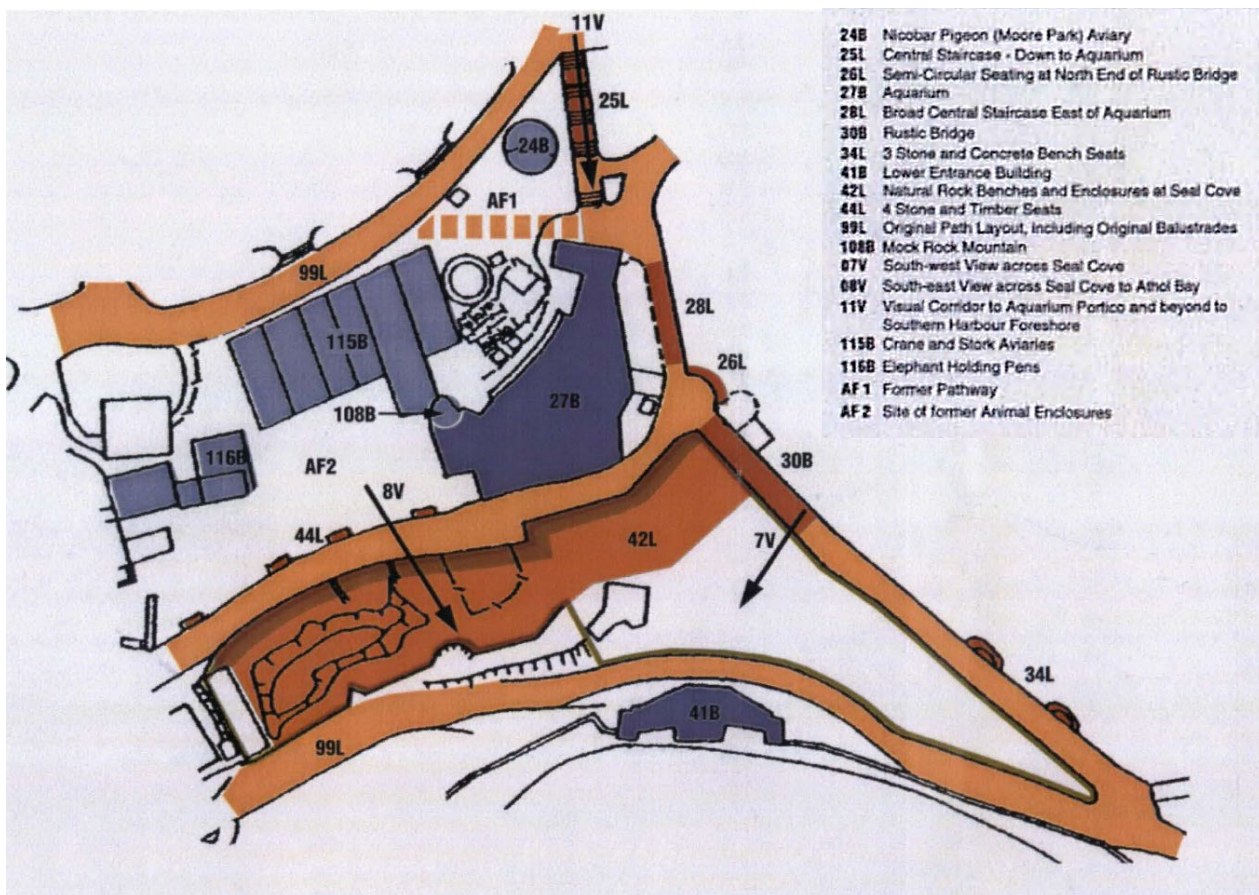
Figure 25 – Location of areas of archaeological potential in relation to the Australian Coastline Precinct

The monitoring works exposed an early concrete path with associated kerbing and guttering to the south of AF2. It was determined that this path reflects the original path layout of the Zoo (1912-1916), although it had been resurfaced with concrete at a later date. With the exception of this feature, the monitoring yielded results which were consistent with the available historical information for the site although and revealed that only fragmentary evidence of these features survives.

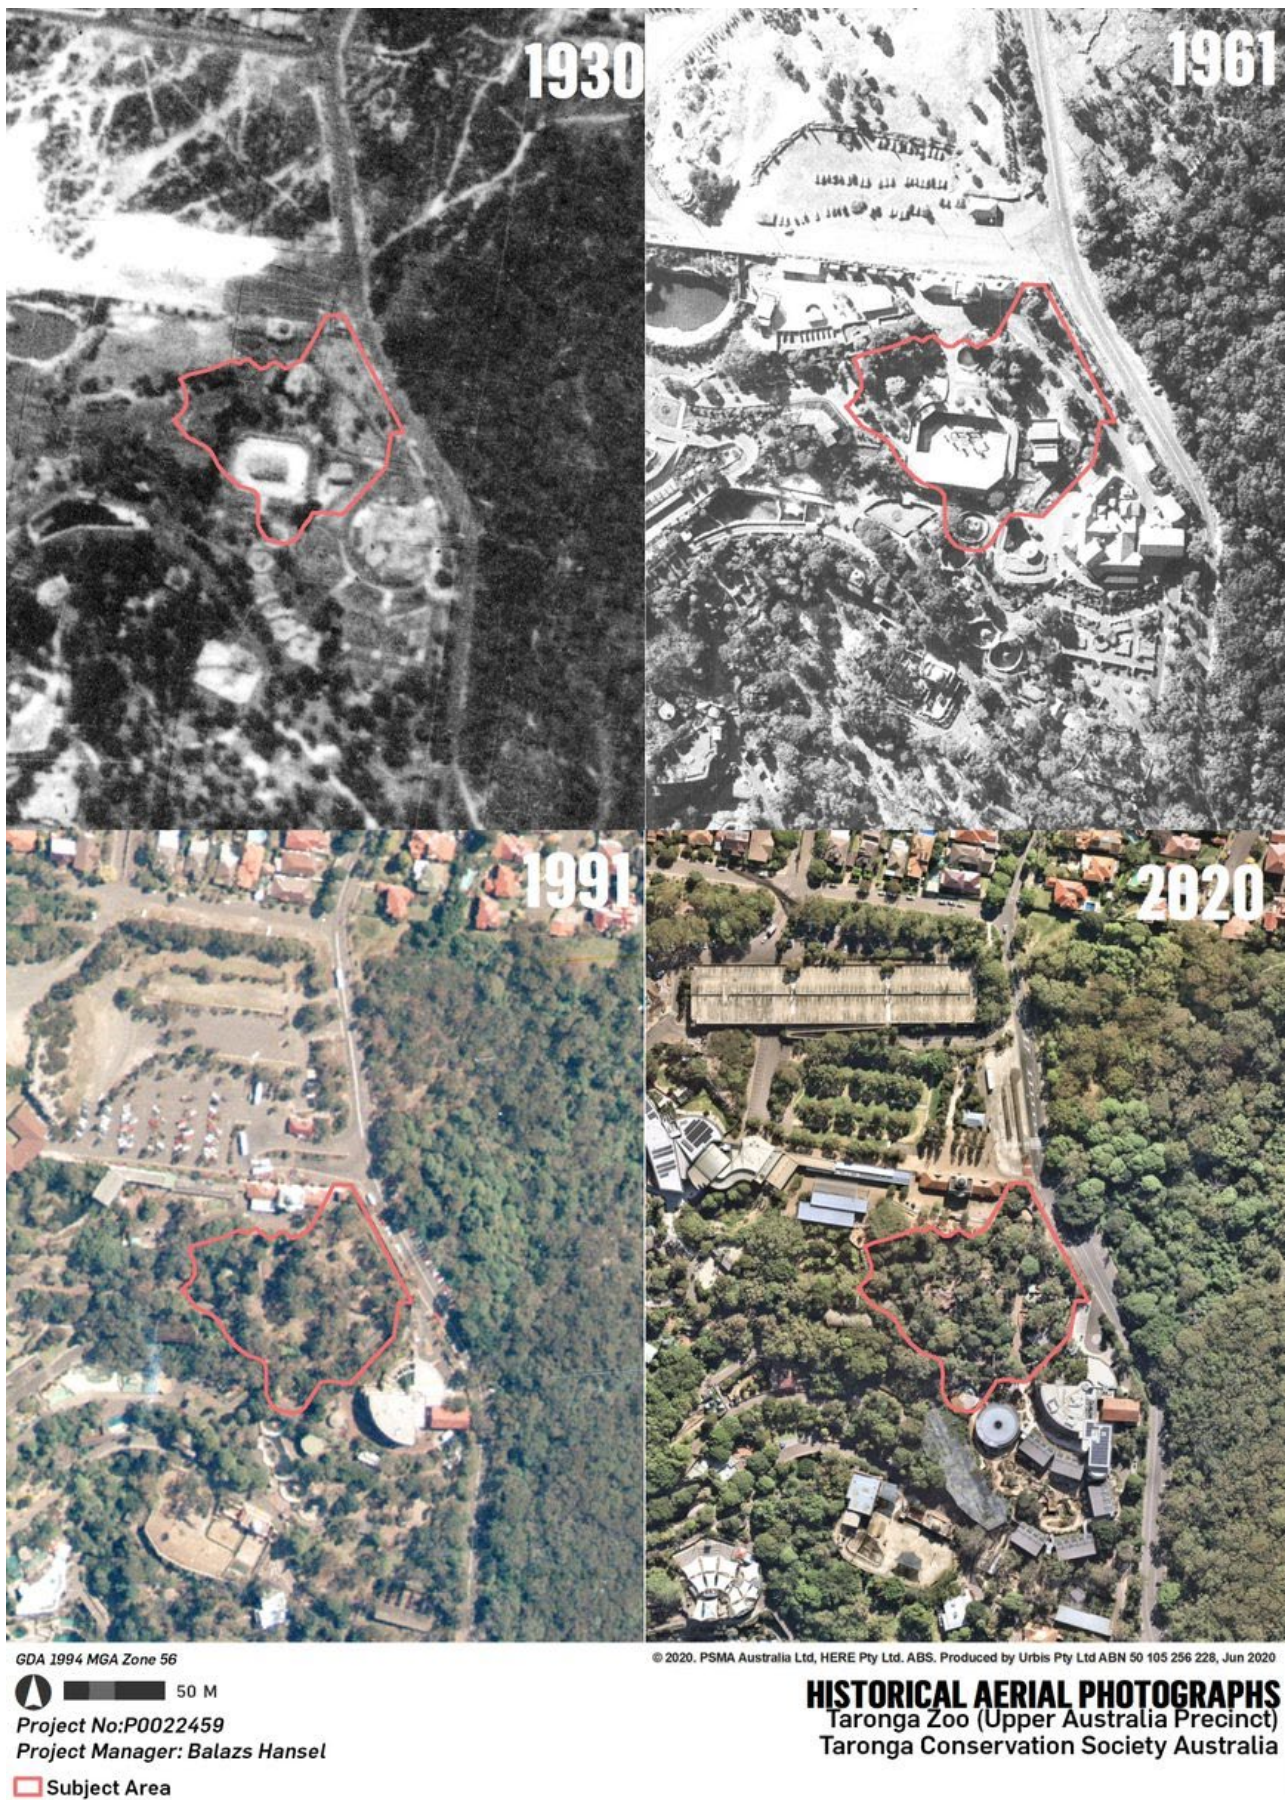
Figure 26 – Historic Aerials

Year	Observation
1930	Taronga zoo was established between 1912-1916. Prior to the establishment of the zoo, the subject area consisted of native bushland, such as that which can be observed to the east of Bradleys Head Road. By 1930 the subject area appears to have already undergone significant disturbance and clearance of vegetation. The network of paths reflect those observed in a 1916 map of the zoo (Figure 11). The Baboon Pit, which is described as a 'concrete and stark enclosure which had been deeply excavated with mounding in the centre for baboons to climb' is clearly visible at the centre of the subject area. The Anteater building is located to the east of the Baboon Pit. The path encircling the Monkey Pit to the south of the Baboon Pit is visible, however, the structure is not visible.
1961	The subject area does not appear to have undergone many significant changes between 1930-1961. The Bandstand and Anteater buildings had been constructed to the east of the Baboon Pit. The Monkey Pit is visible to the south of the Baboon Pit.

1990	The subject area appears more densely vegetated. The stark open concrete Baboon Pit had been partially removed and replaced with the Nocturnal House by this time. The Bandstand and Anteater buildings to the east of the Baboon Pit had been demolished and the Platypus House can be seen to the south-east of these. The extensive Waterfowl Ponds within the western component of the subject area are obstructed by vegetation. The reduced visibility of structures reflects Strahan's period of management (1967-1974) during which new exhibits were landscaped and moated, rather than fenced, and the erection of imposing structures avoided.
2020	There are no clear changes to the subject area in the years between 1990-2020.

The development of facilities within the subject area has caused substantial levels of ground disturbance. This is demonstrated through the analysis of historic aerials. Historic aerial images from 1930, 1961, 1990 and 2020 were analysed to develop an understanding of disturbance (see Figure 26). A summary of this analysis is included in Table 3.

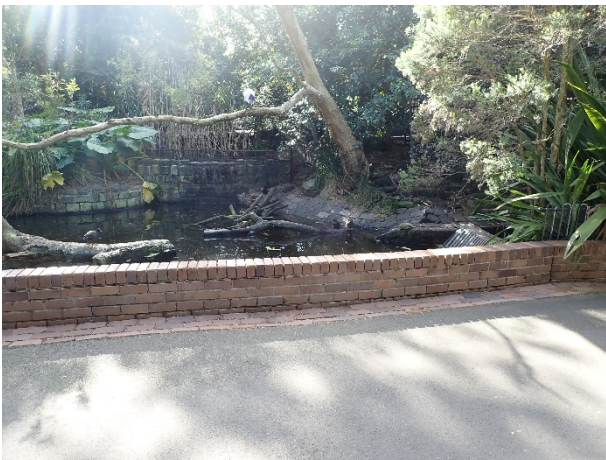
Figure 27 – Location of wetland ponds that will be excavated within the existing stone walls and only impacting the base of the ponds. Photo facing north

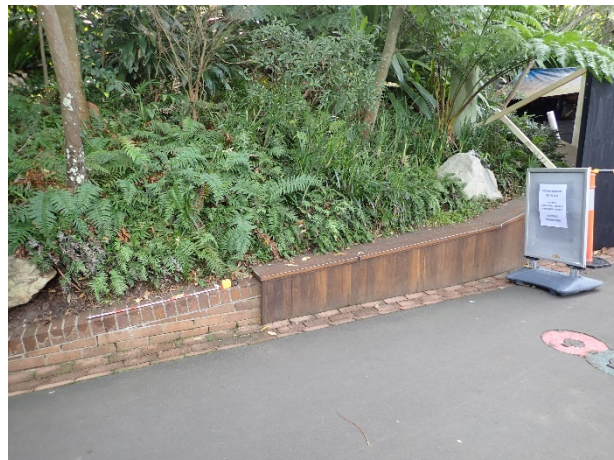
Figure 28 – Location of proposed excavation of fill behind retaining wall. Photo facing north-east.

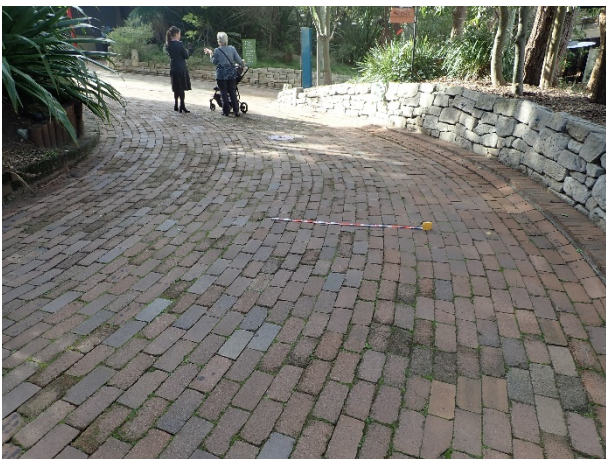
Figure 29 – Location of proposed removal existing brick footpath and consequent small scale of excavation. Photo facing east.

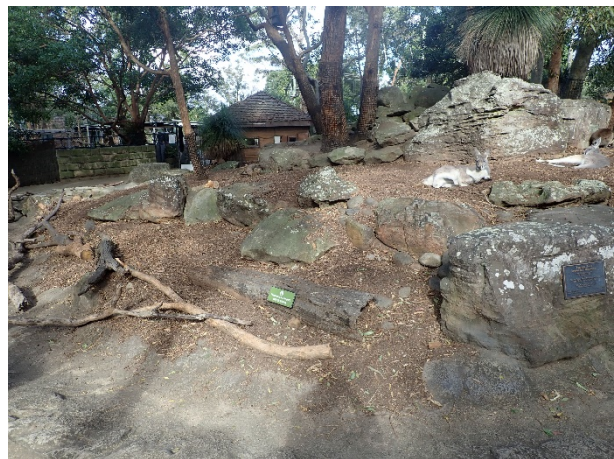
Figure 30 – Location of proposed spot-excavations within the Macropod Exhibit. Photo facing south.
