Bushfire Assessment

Upper Australia Exhibit Redevelopment

Taronga Zoo

Project: 20115

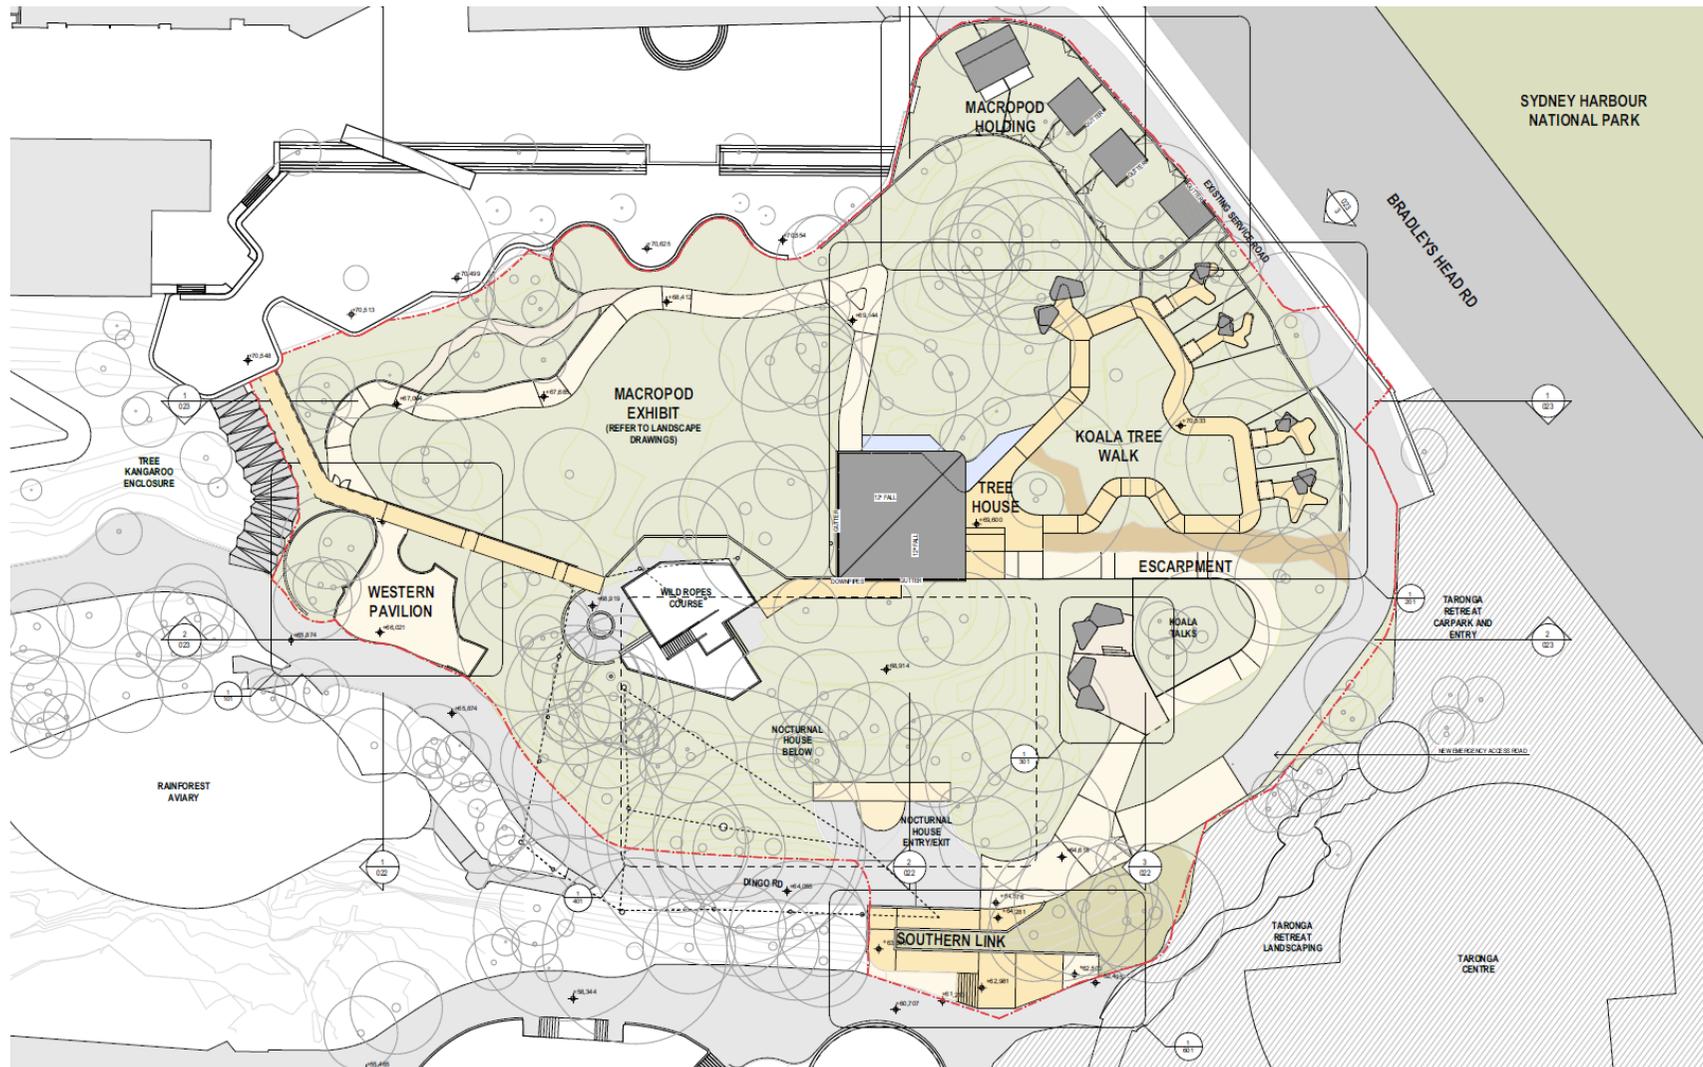
The *Proposed Site Plan* (Drawing A-DA-021) is reproduced in Figure 2.1 on the previous page.

Figure 2.1: Site Plan Extract (Source: Client). North (approx.) to top of page.

Internally, the Zoo also has its own firefighting capability and access to the southern and eastern parts of the exhibit area by staff undertaking fire suppression activities is via internal roadways shown on the proposed site plan at Figure 2.1. This is the same arrangement as for emergency access for the existing Upper Australia exhibit, along with other exhibits in this part of the Zoo. The condition and width of the internal roadways in the area south of the exhibit areas are shown in Photos 2.7 to 2.9.

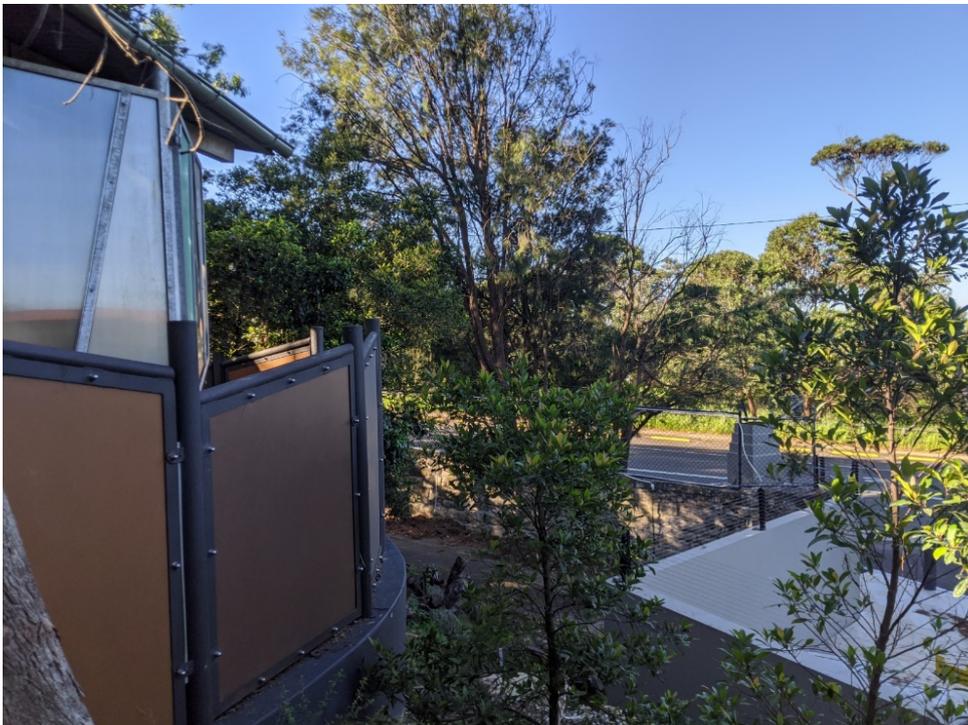
Photo 2.3: View of the south-eastern part of the Upper Australia exhibit with Bradleys Head Road and vegetation in the background.

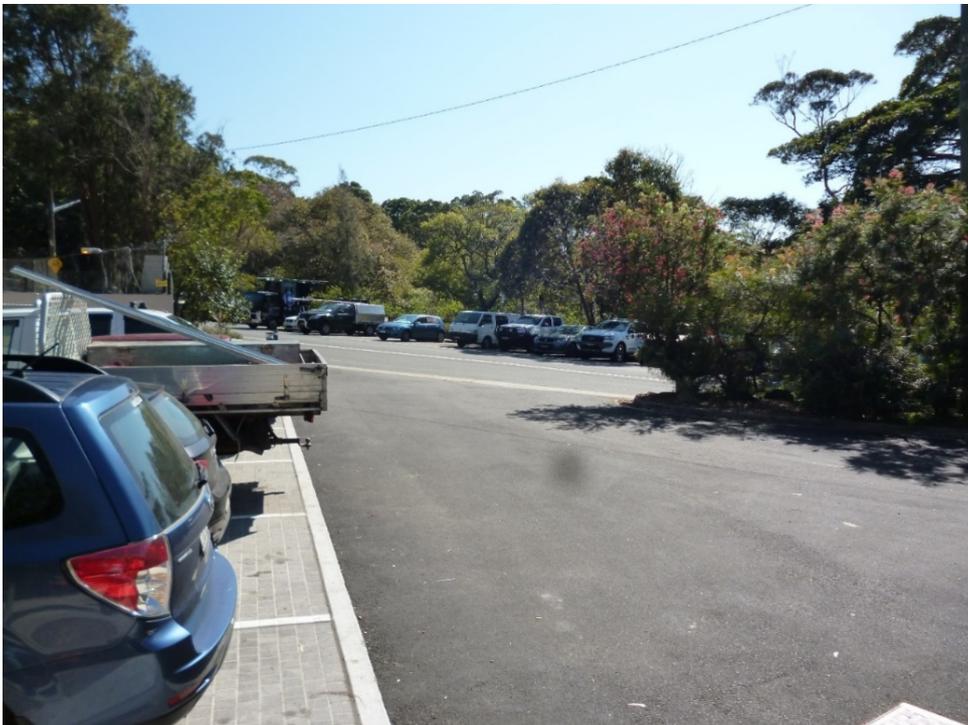
**Photo 2.5: View looking generally north-east from the WR entry structure (shown in Photo 2.4).
The cars in the central and right hand parts of the photo are parked along the eastern/opposite
side of Bradleys Head Road, with vegetation beyond the road and parking areas.**

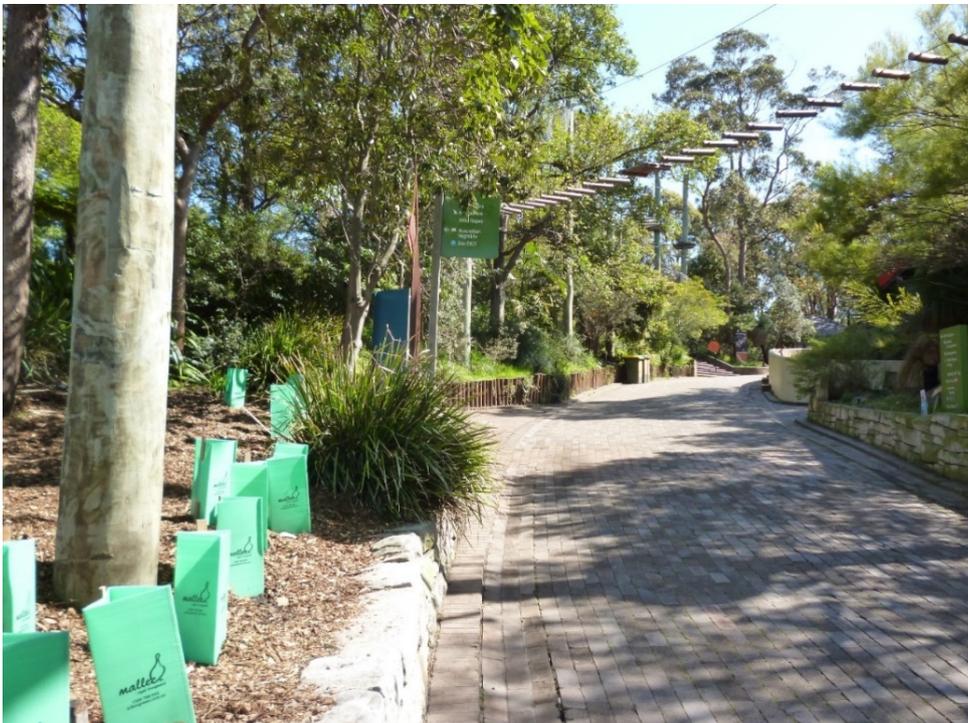
Photo 2.7: Pathways, vegetation and existing elevated rope walk within the Zoo grounds adjacent to the existing Upper Australia exhibit. These areas will remain largely unchanged and the rope walk is to remain as part of the redevelopment of the Upper Australia exhibit.

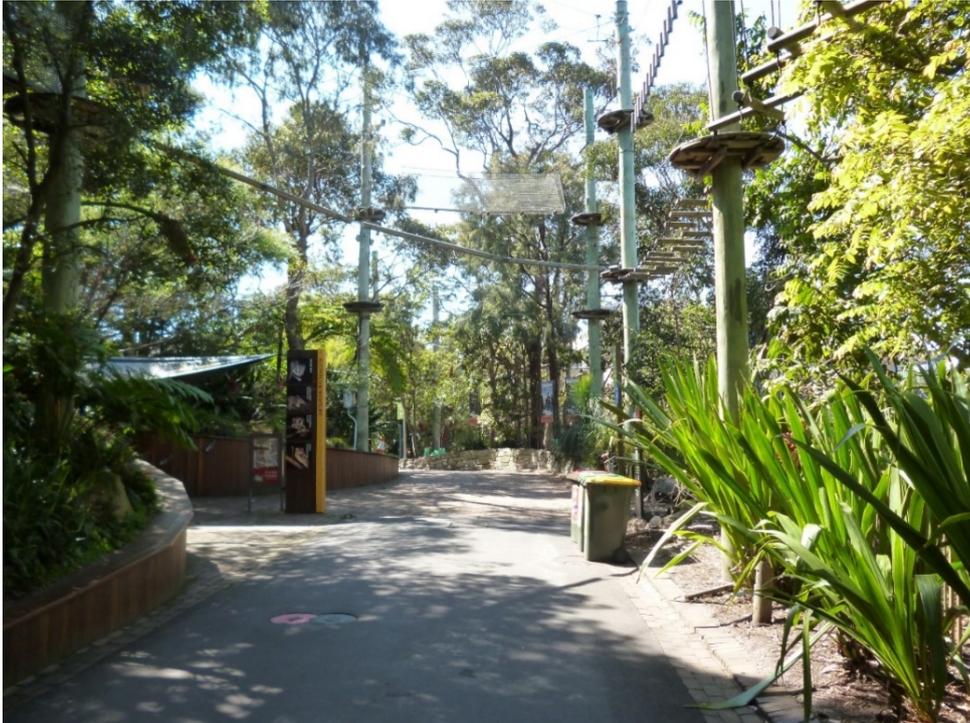
Photo 2.8: As for Photo 2.7. These areas will remain largely unchanged and the rope walk is to remain as part of the redevelopment of the Upper Australia exhibit.

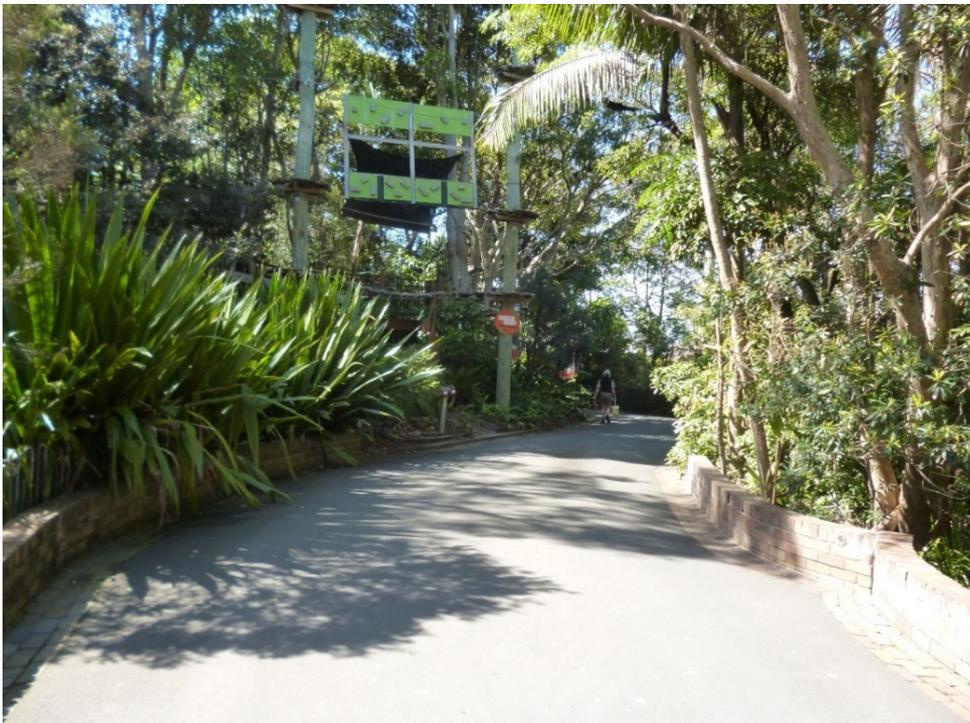
Photo 2.9: As for Photos 2.7 and 2.8. The rope walk is to remain as part of the redevelopment of the Upper Australia exhibit.
