HISTORICAL ARCHAEOLOGICAL ASSESSMENT

Upper Australia Precinct,
Taronga Zoo

TARONGA CONSERVATION SOCIETY AUSTRALIA

20 October 2020

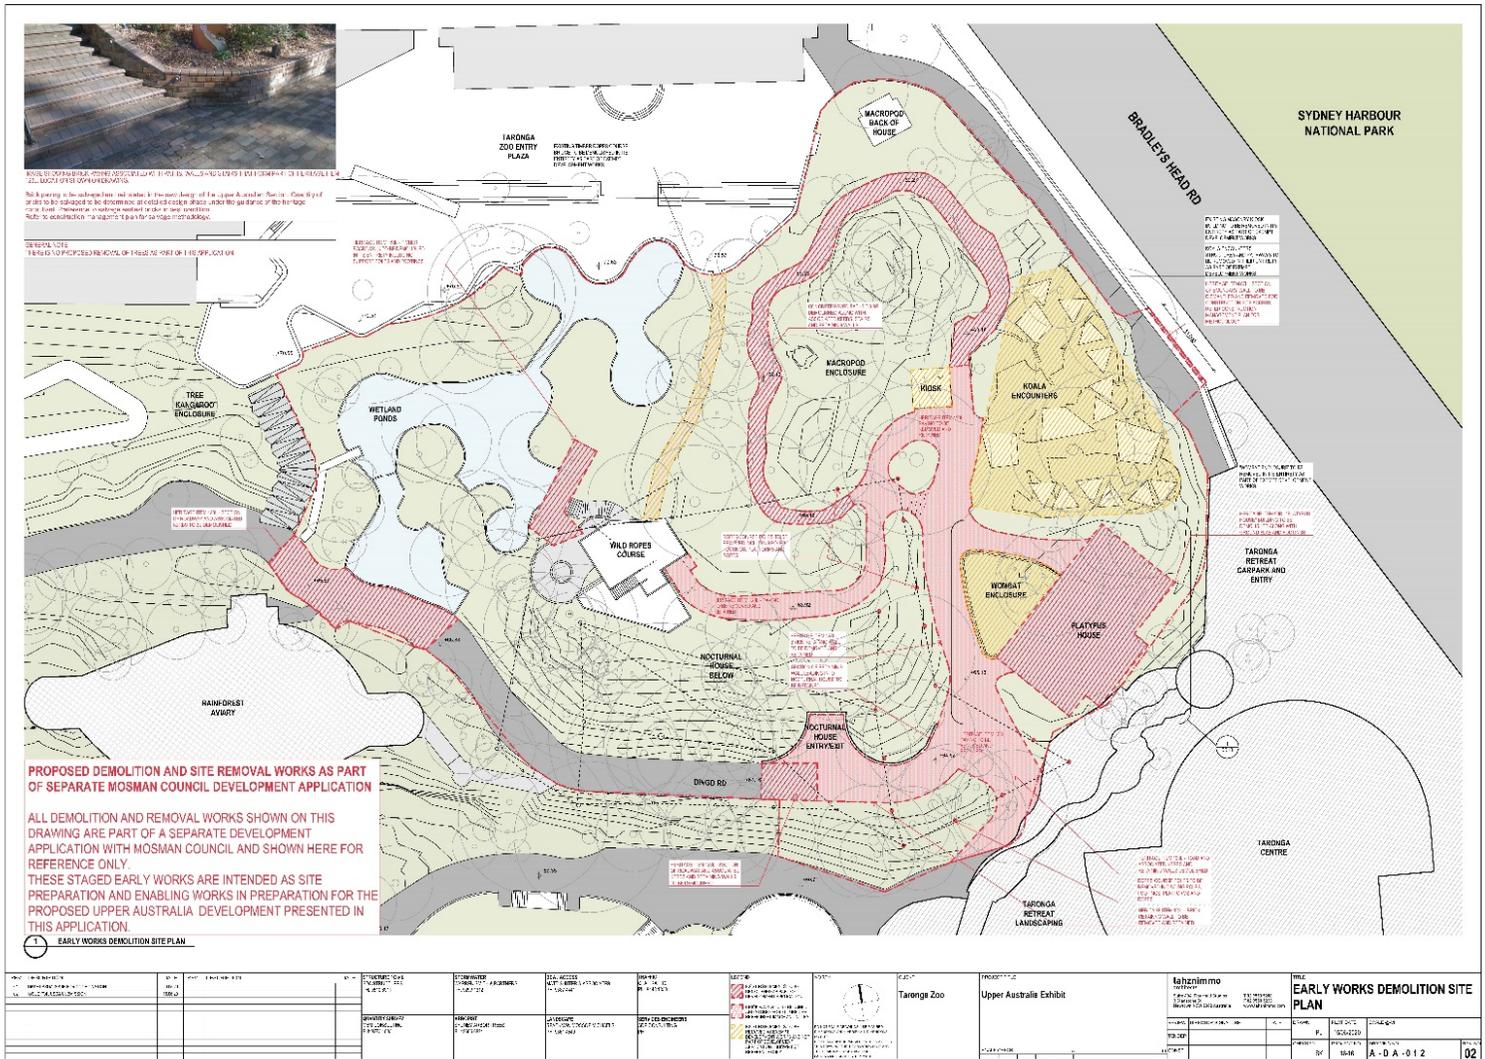
Figure 4 - Proposed demolition plan

The proposed demolition works are detailed in Figure 3 and Figure 4 below.

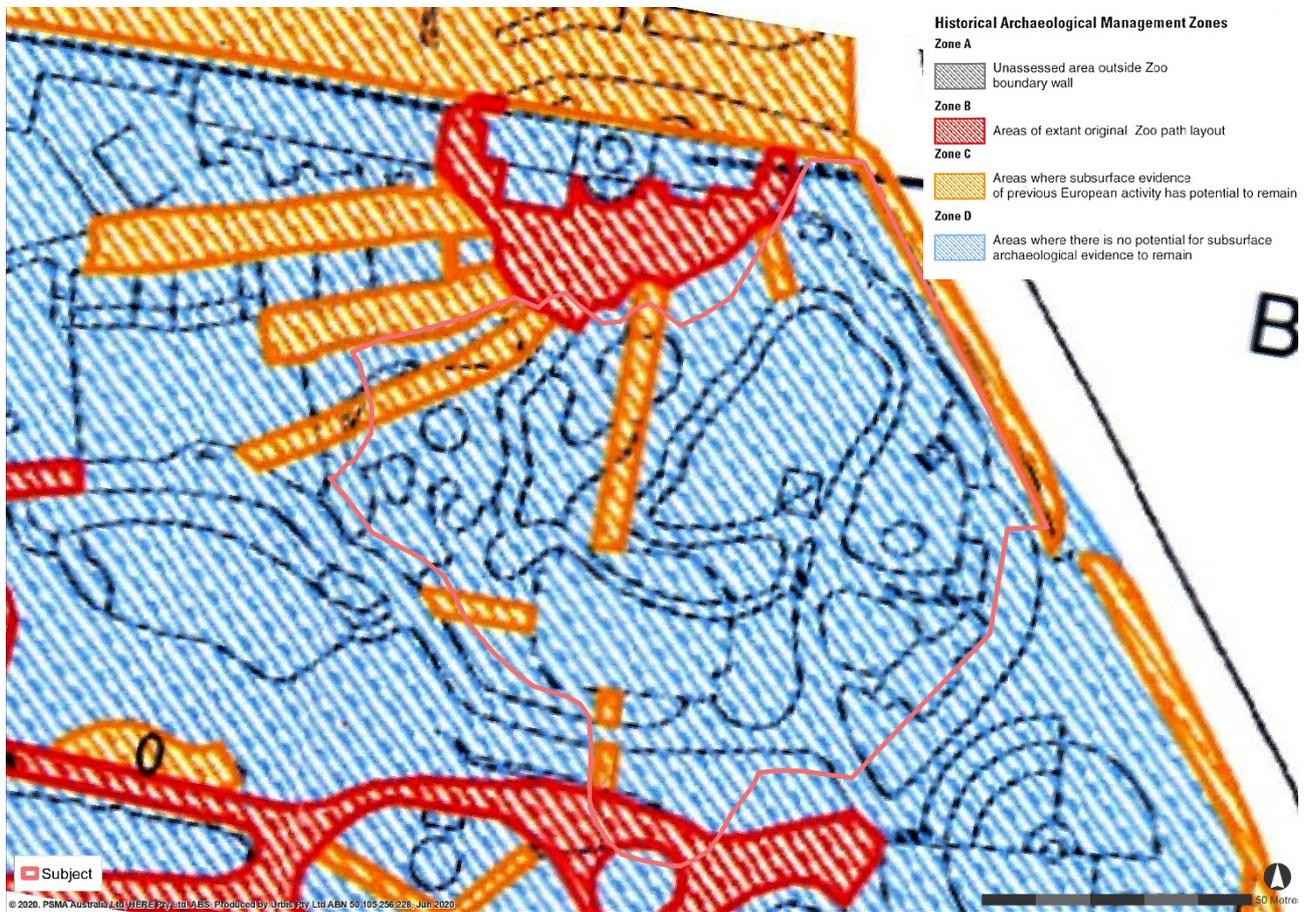
Figure 7 – Historical archaeological management zones

- **Zone B:** Areas of extant original Zoo path layout
- **Zone C:** Areas where subsurface evidence of previous European activity has potential to remain
- **Zone D:** Areas where there is no potential for subsurface archaeological evidence to remain

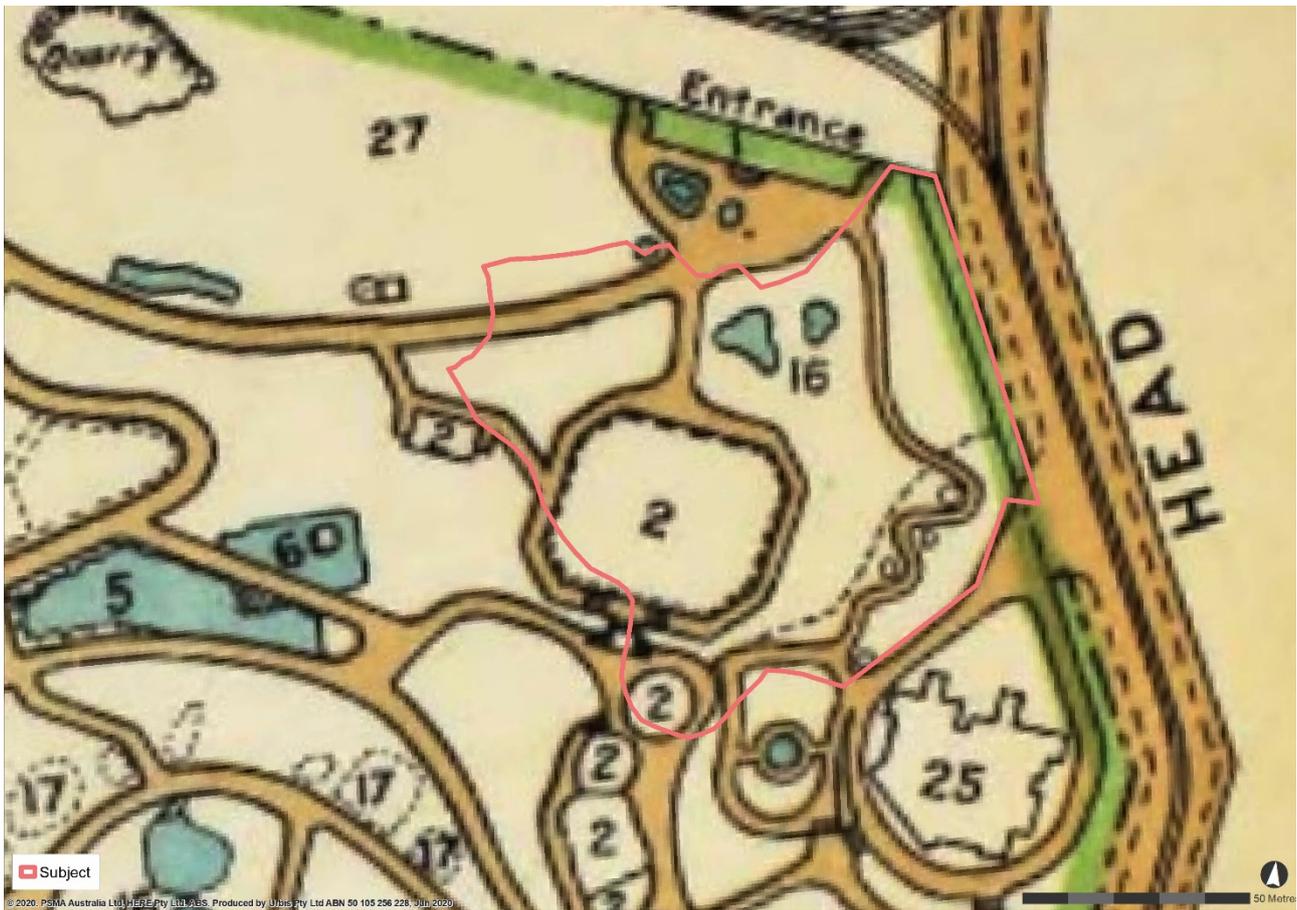
Figure 11 -1916 plan of Taronga Zoological Park, approximate location of the subject area is indicated in red outline. Structures within the subject area as follows: 2 (north) – Baboon Pit; 2 (south) – Monkey Pit; 2 (west) – Orangutan and Monkey Pit; 15 – Waterfowl Ponds;

Figure 11 demonstrates the Zoo in its original plan in 1916, with approximately 23 animal exhibits. The subject area contained a concreted and stark enclosure named the Baboon Pit, which had been deeply excavated with mounding in the centre for the Baboons to climb. A Monkey Pit was located to the south and Orangutan and Monkey Pit to the west. Excavation had also been undertaken within the northern section of the subject area for the purpose of establishing the Waterfowl Ponds. A path network had also been established which allowed access to these facilities.

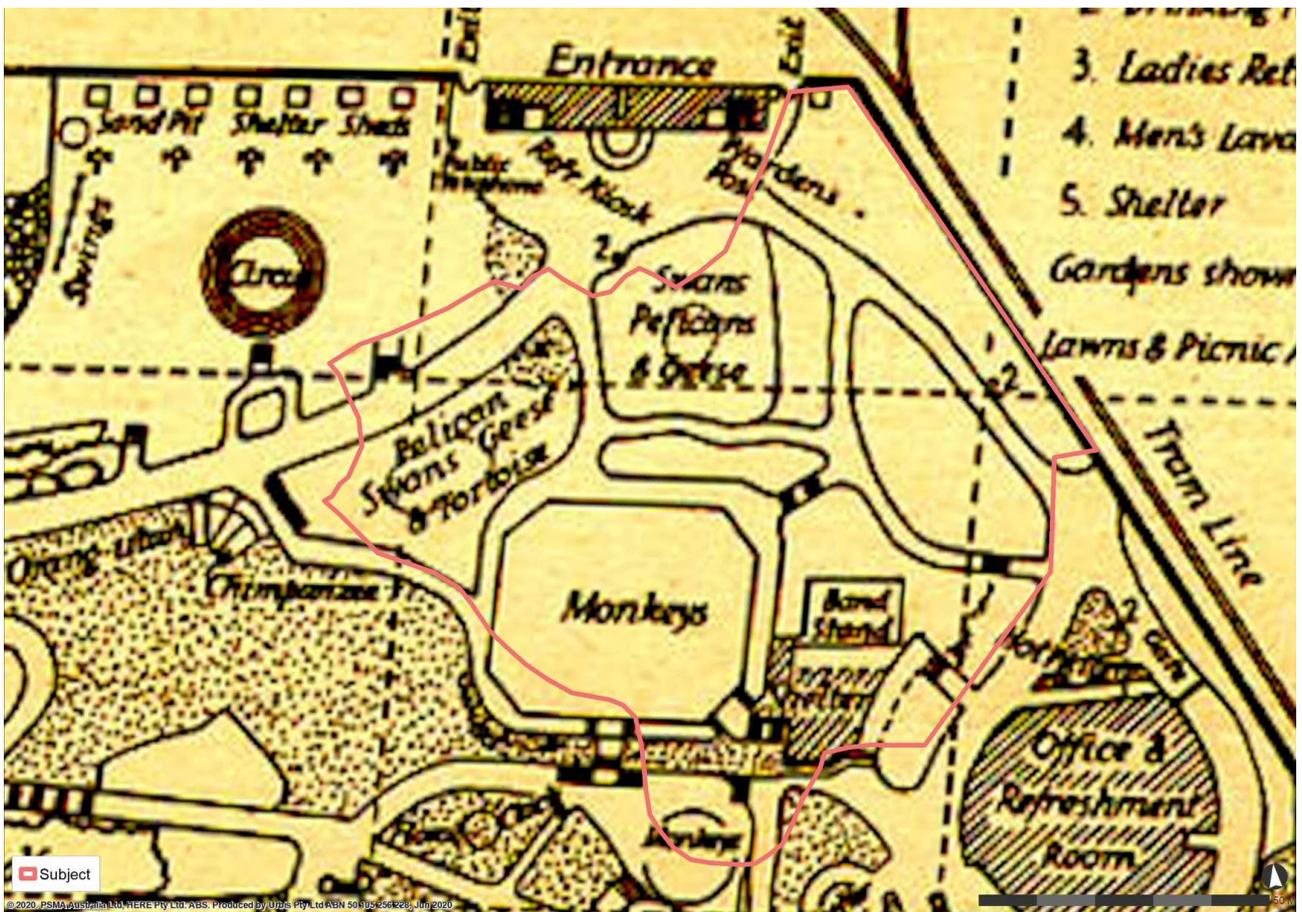
Figure 12 – 1940 Guidebook indicating changes to paths and configuration of enclosures as well as the erection of the Bandstand building to the east of the Baboon Pit. Approximate location of the subject area indicated in red outline.

Following the departure of Le Souef in 1939, Taronga Zoo underwent a number of changes under the new director Sir Edward Hallstrom. Rather than the focus on barless exhibits with moats, the moats began to be filled in and chain and wire fences installed to allow visitors to get closer to the animals. Animal enclosures had concrete floors and walls installed (GML, 2006). Enclosures for swans, pelicans and tortoises had been established to the north and west of the Baboon Pit by this time and a Bandstand had been erected to the east. Some additional paths had also been established within the northern component of the subject area (Figure 12).

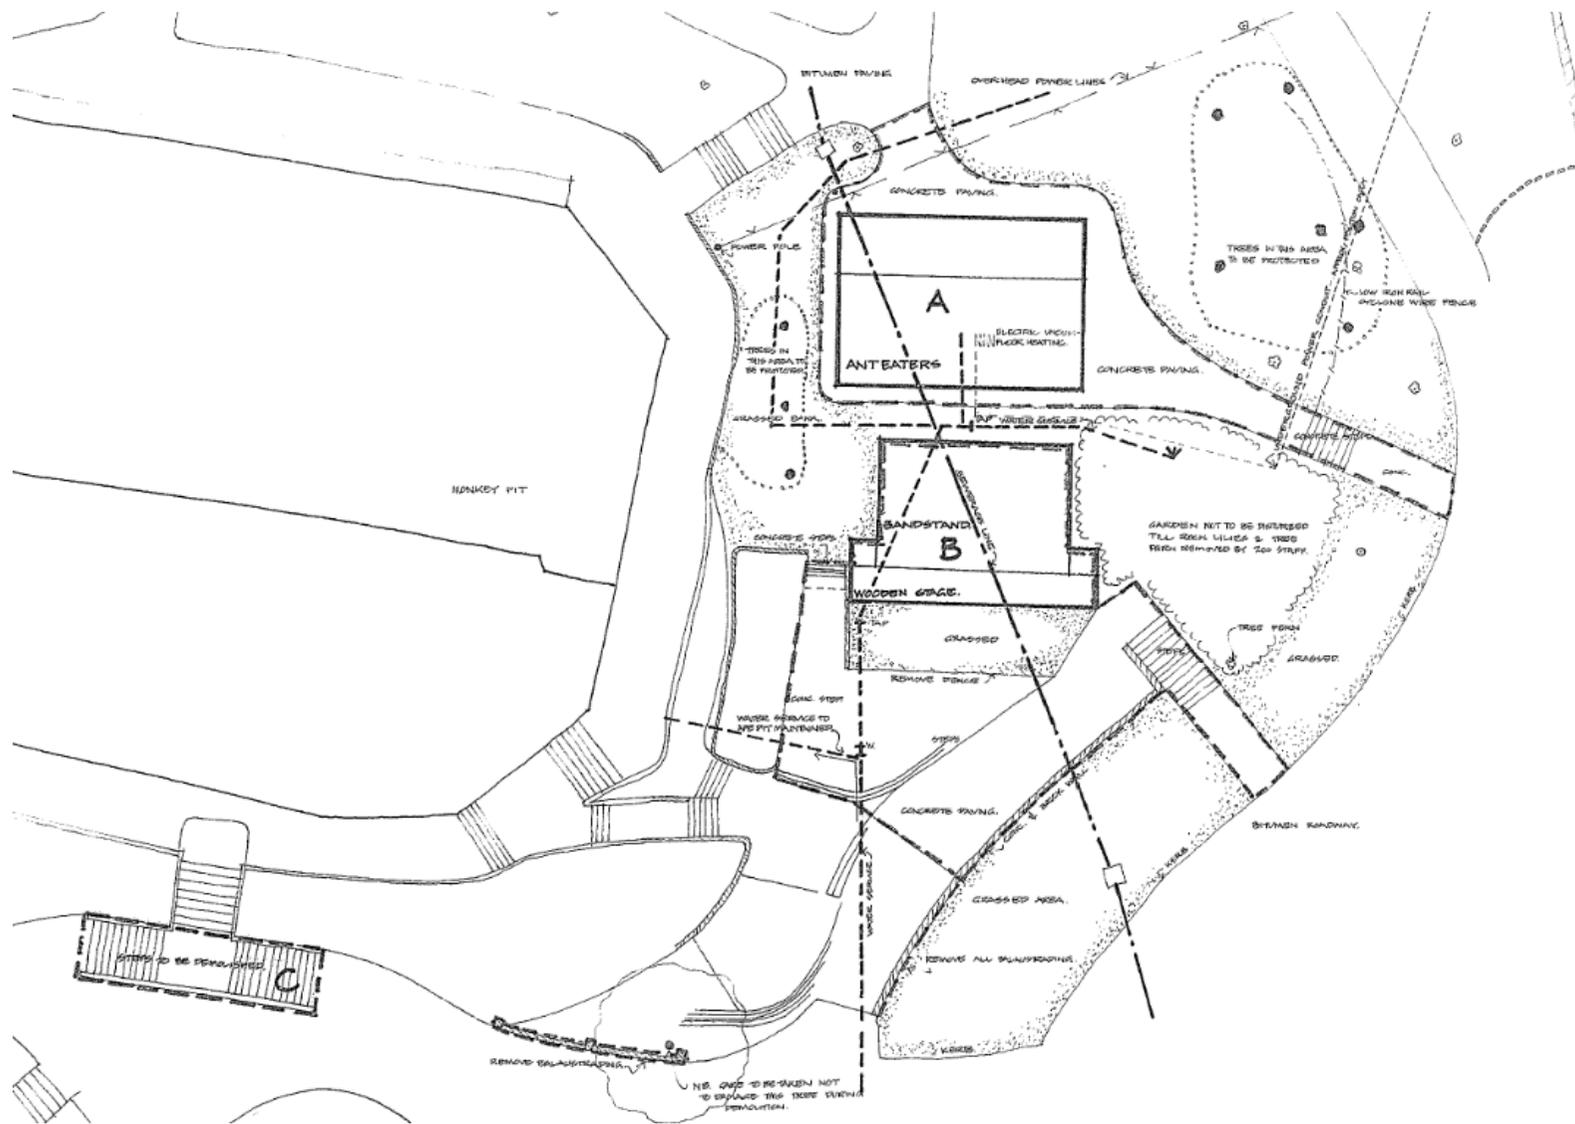
Figure 13 - Demolition plan for the provision of the Australian Sections at Taronga Zoo, c. 1967 indicating demolition of stairs to south of Baboon Pit, Anteaters and Bandstand buildings

One of the first facilities to be upgraded under Strahan's masterplan was the Platypus facilities, resulting in the construction of the Platypus house. A 1967 demolition plan (Figure 12) indicates the demolition of the Anteaters and Bandstand buildings to the east of the Baboon Pit to make way for the construction of Platypus House. The lower section of a staircase to the south of the Baboon Pit was also removed at this time.

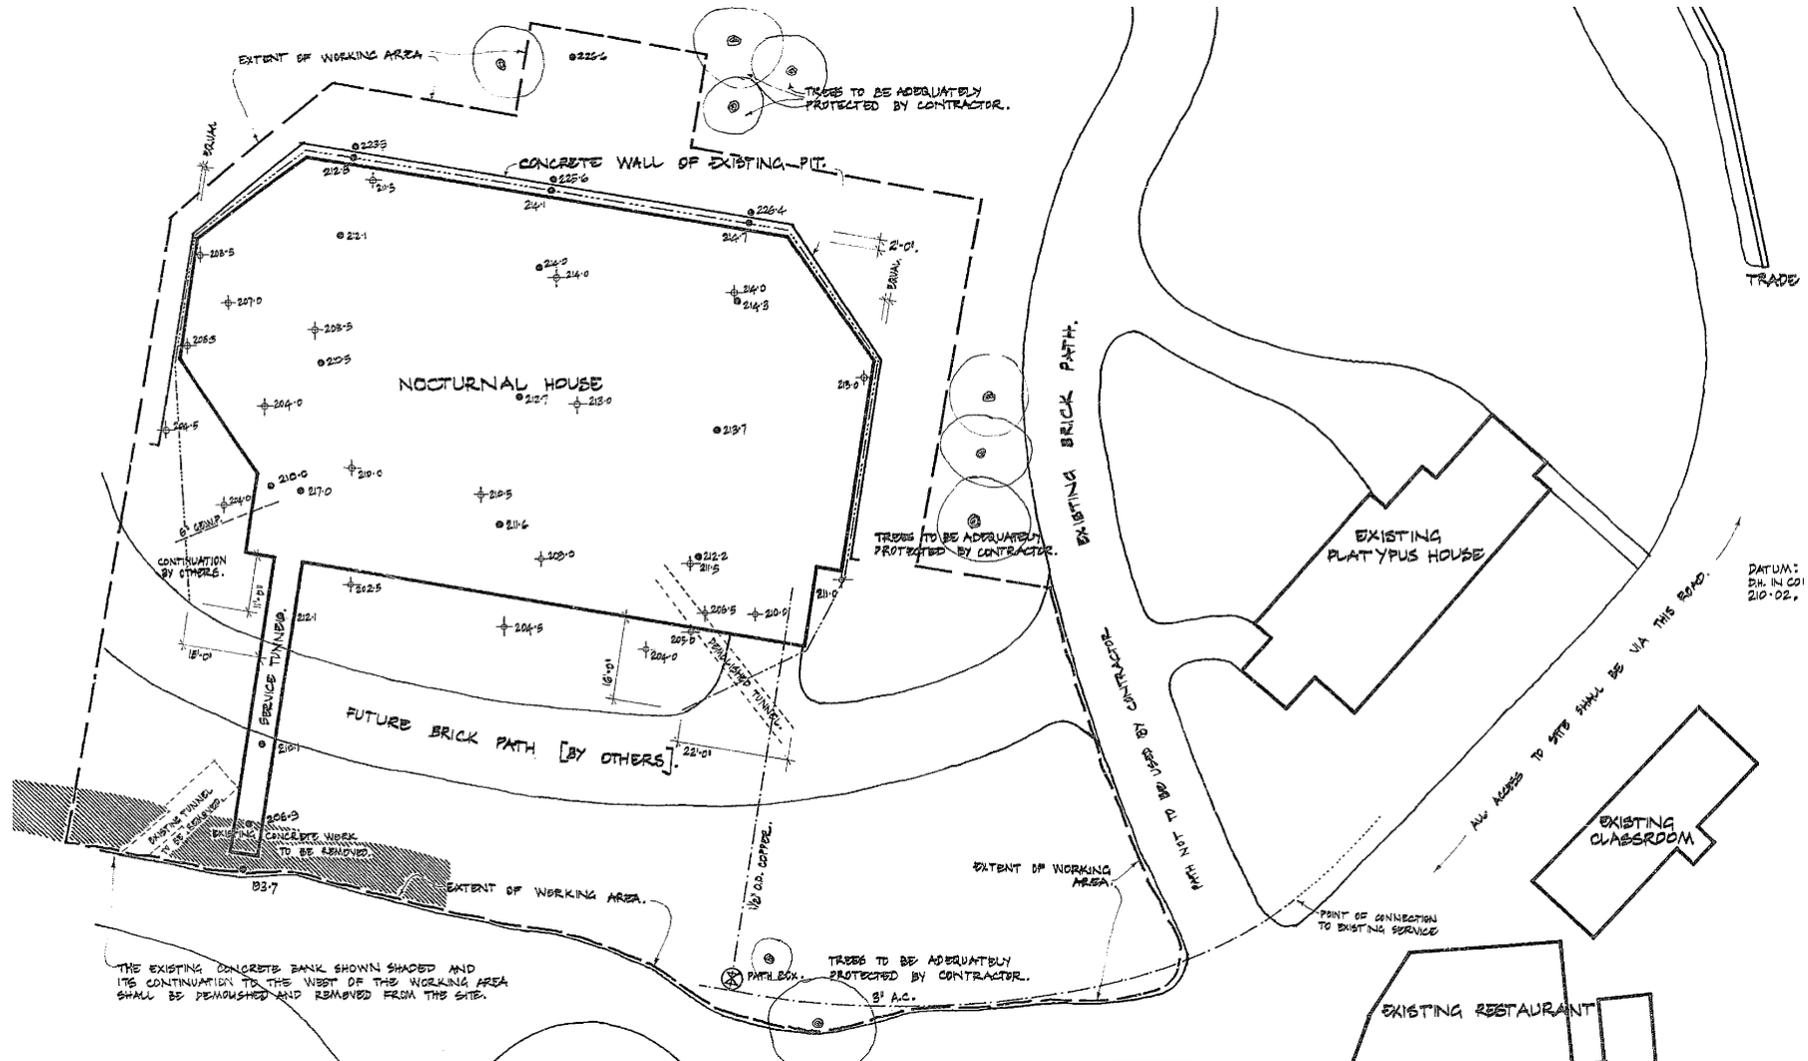
Figure 15 – 1970 site plan indicating Nocturnal House in the location of the former Baboon Pit and Platypus House in the location former location of the former Bandstand and Anteaters buildings

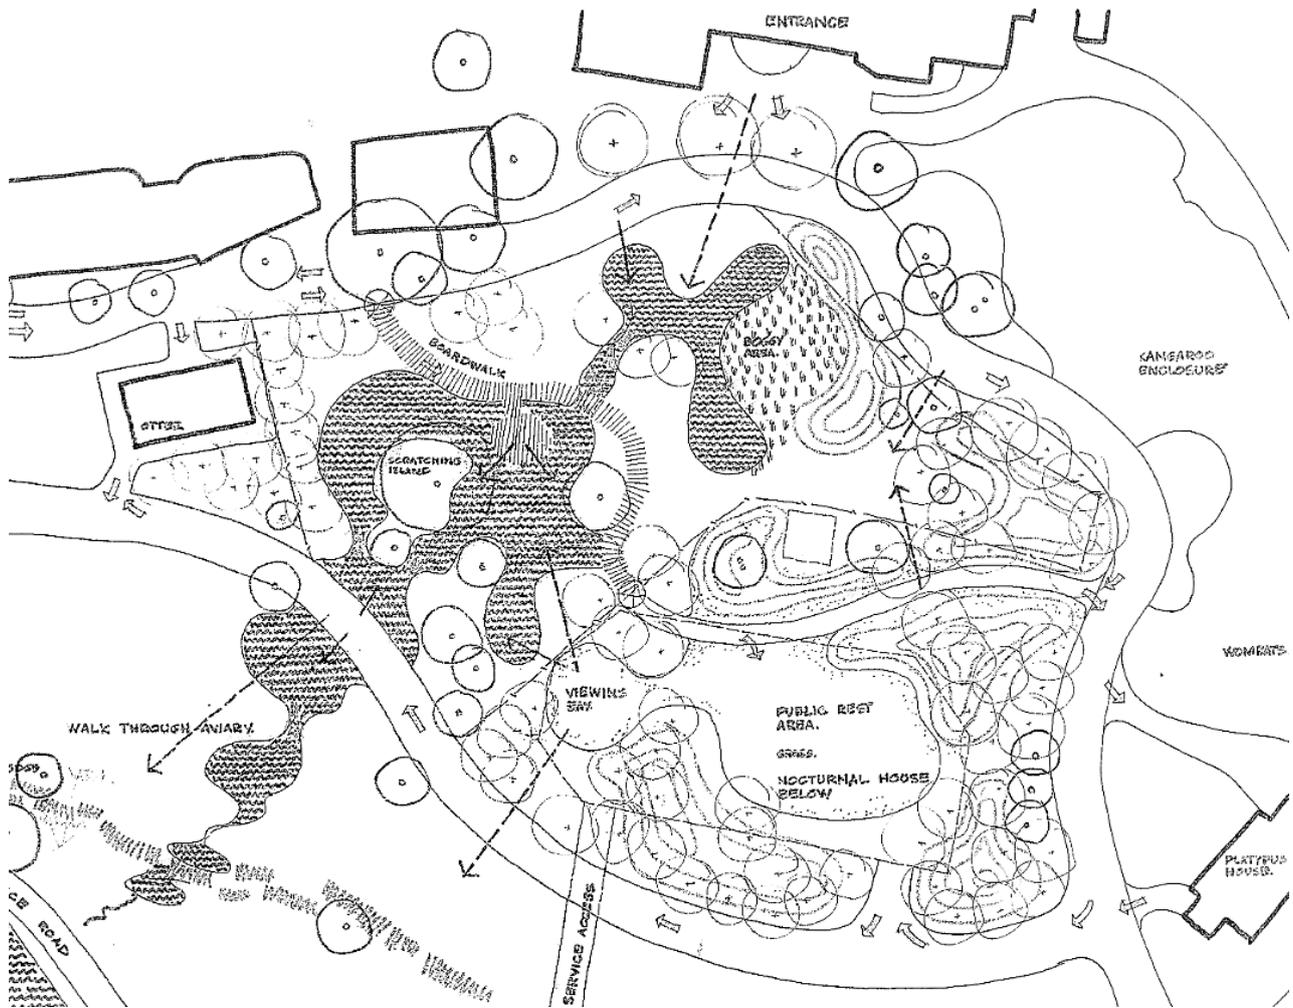
Figure 17 -1969 Waterfowl Enclosure concept plan indicating replacement of the northern and western Duck Ponds within expansive wetland exhibits

Figure 14 indicates the partial demolition of the northern Duck Pond, which was later incorporated within a 'boggy area' (Figure 17). The Duck Pond within the western section of the precinct (Figure 14) was removed completely and a larger pond excavated in this location. The outline of the western pond can still be made out in the 1969 concept plan (Figure 17). The footprint of the Waterfowl Ponds had thus significantly increased by this time, necessitating significant earthworks and disturbance within the north-western component of the subject area.

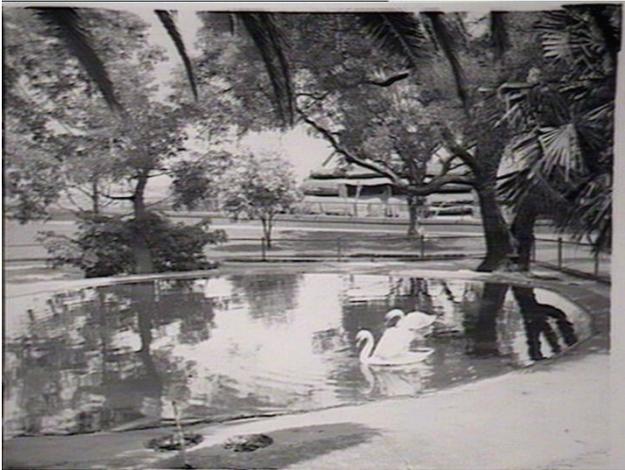
Figure 18 – waterfowl exhibit prior to redevelopment, a series of circular ponds.

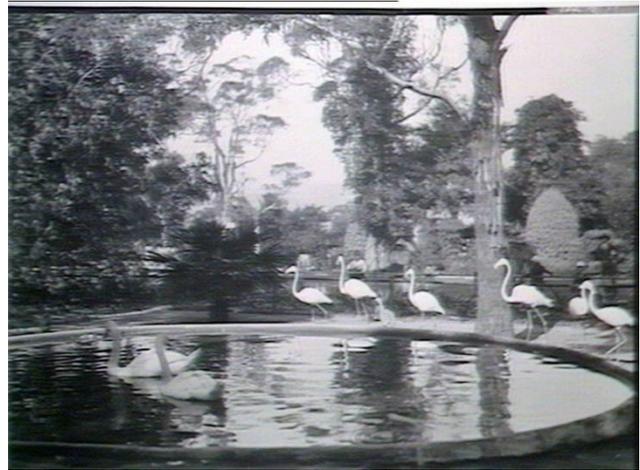
Figure 19 – waterfowl exhibit prior to redevelopment, a series of circular ponds.

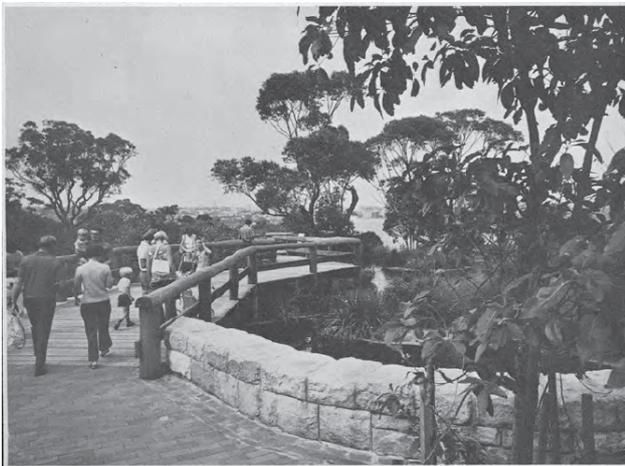
Figure 20 – bridge over the wetlands ponds section.

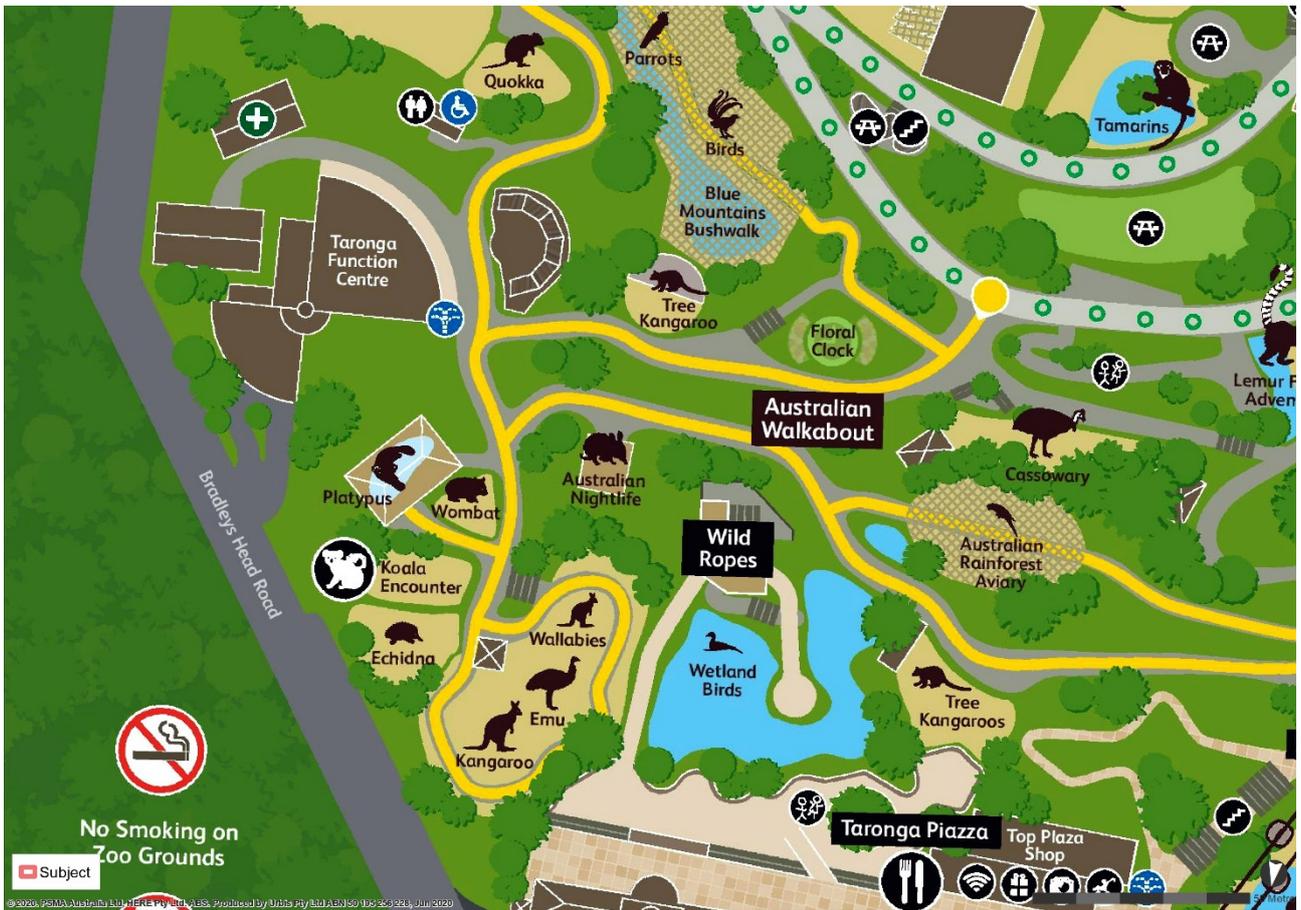
Figure 22 - 2016 Guidebook indicating extent of Wetland Ponds and addition of koala, wombat and echidna enclosures within the eastern component of the site. Approximate location of the subject area indicated in red outline.

Works which were undertaken within the subject area during this period include the upgrade and extension of the Platypus House and removal of the majority of original paths.

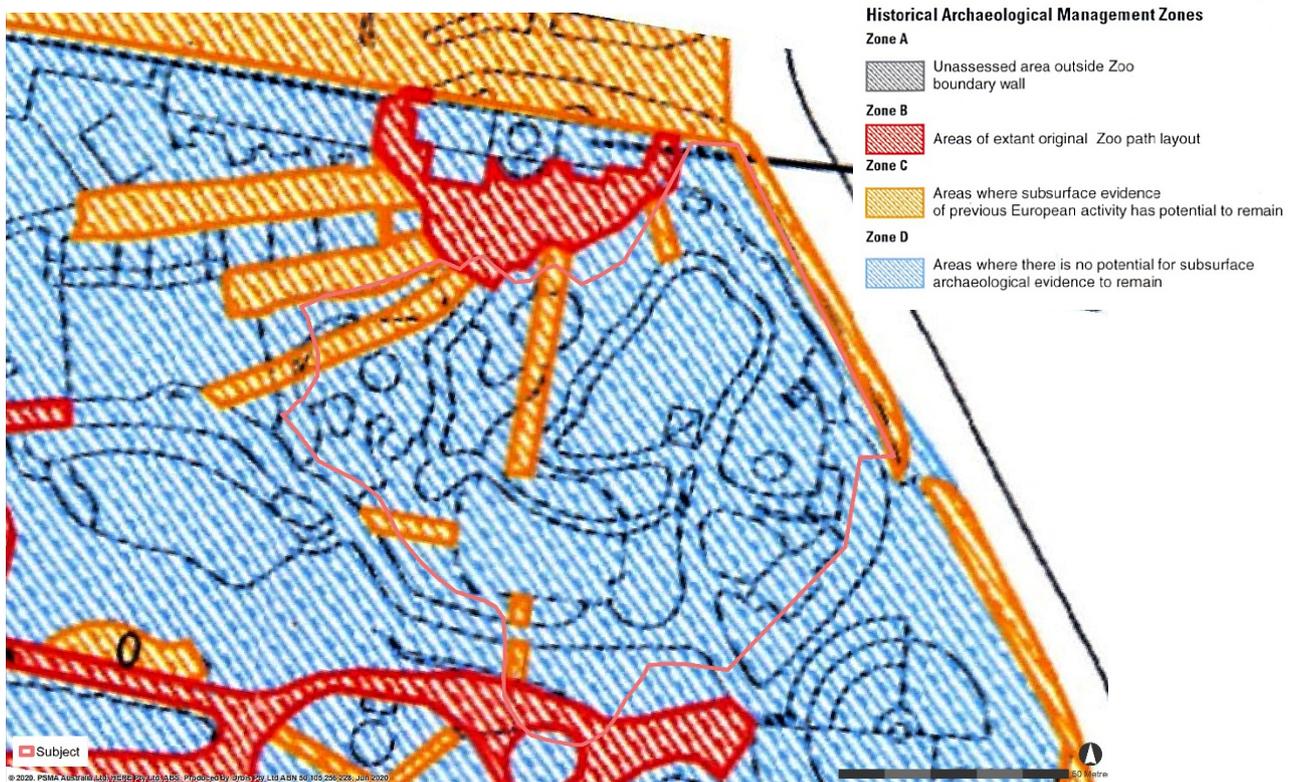
Figure 23 – Historical archaeological management zones. Approximate location of the subject area indicated in red outline.

This Historical Archaeological Management Zone encompasses the rest of the site, where excavations for the foundations of previous Zoo structures have reached down to bedrock or culturally sterile soil profiles, or where there has been little or insignificant historical development. Zone D is not expected to contain any historical material culture and is therefore assessed as having no archaeological sensitivity.

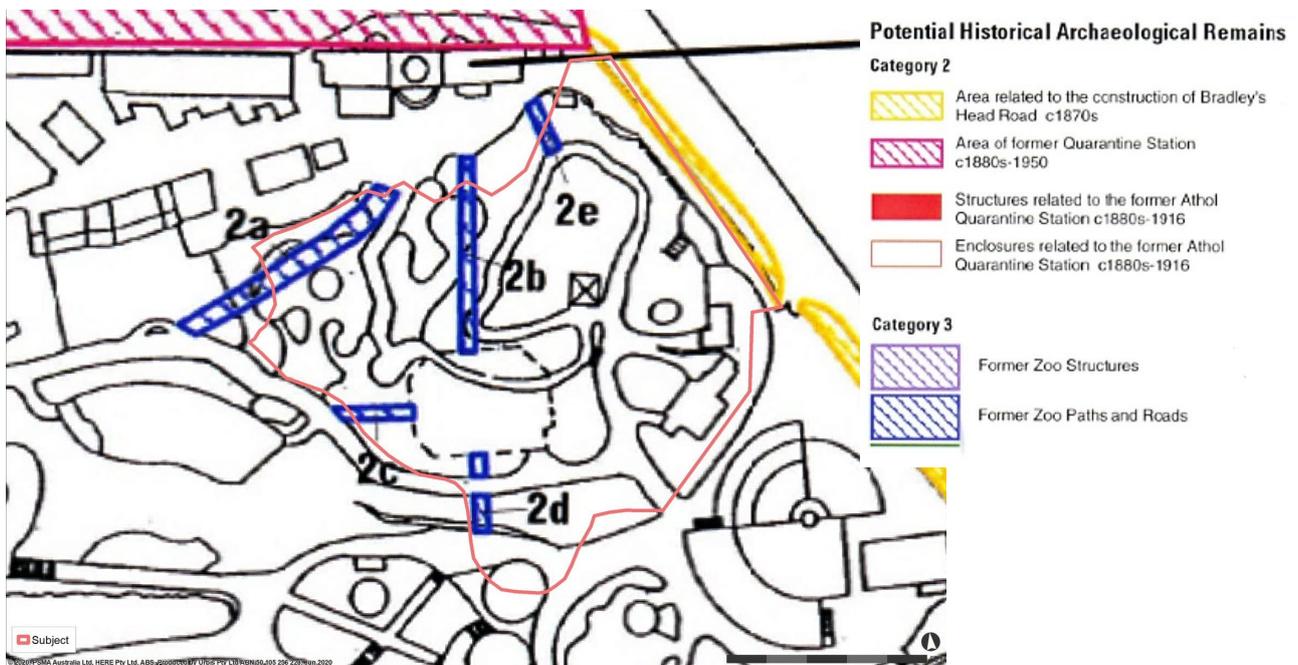
Figure 24 - Potential historical archaeological remains

The Taronga Zoo AMP identifies the potential for the following historical archaeological remains within the subject area (Figure 24):

- **Category 2:**
 - Area related to the construction of Bradley’s Head Road c.1870s
- **Category 3:**
 - Former Zoo Paths and Roads

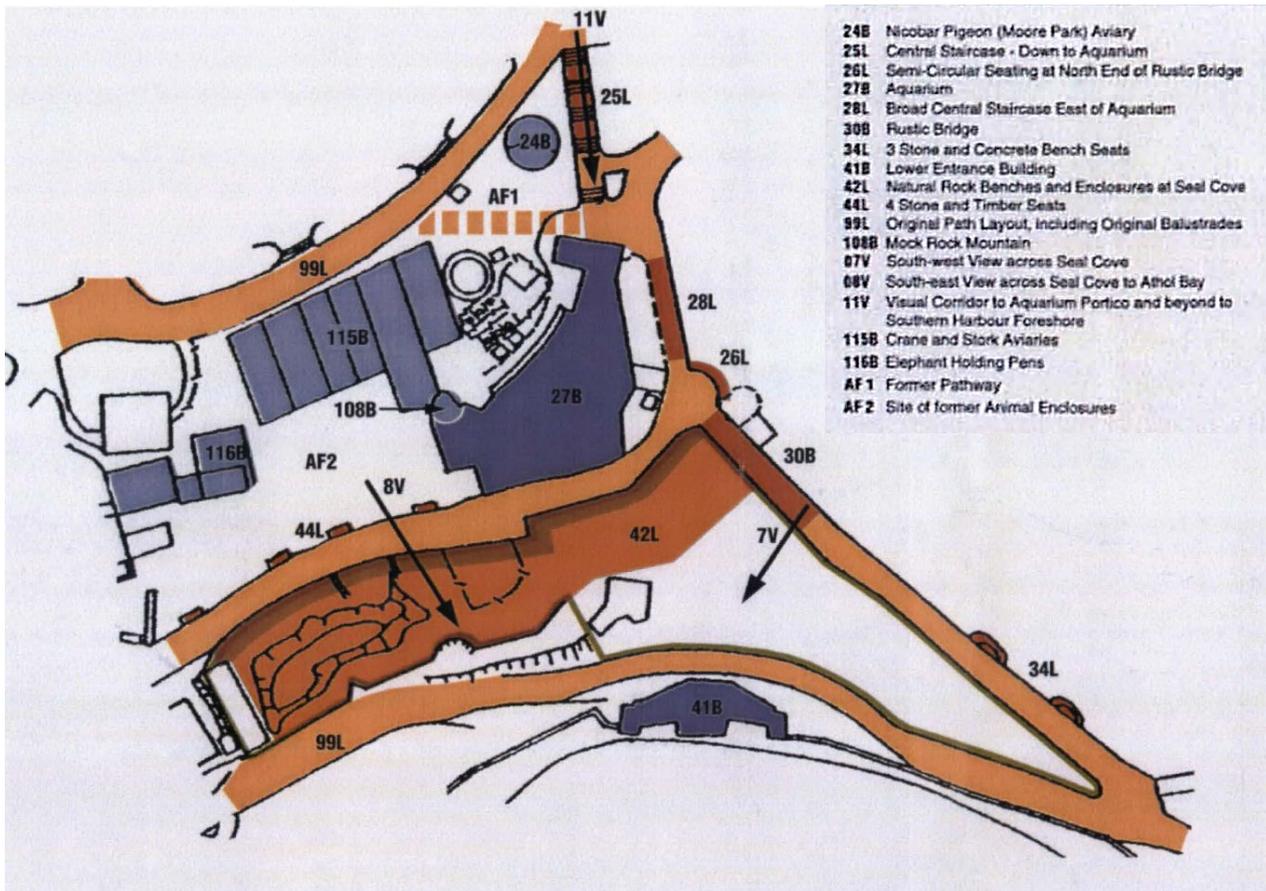
Figure 25 – Location of areas of archaeological potential in relation to the Australian Coastline Precinct

The monitoring works exposed an early concrete path with associated kerbing and guttering to the south of AF2. It was determined that this path reflects the original path layout of the Zoo (1912-1916), although it had been resurfaced with concrete at a later date. With the exception of this feature, the monitoring yielded results which were consistent with the available historical information for the site although and revealed that only fragmentary evidence of these features survives.

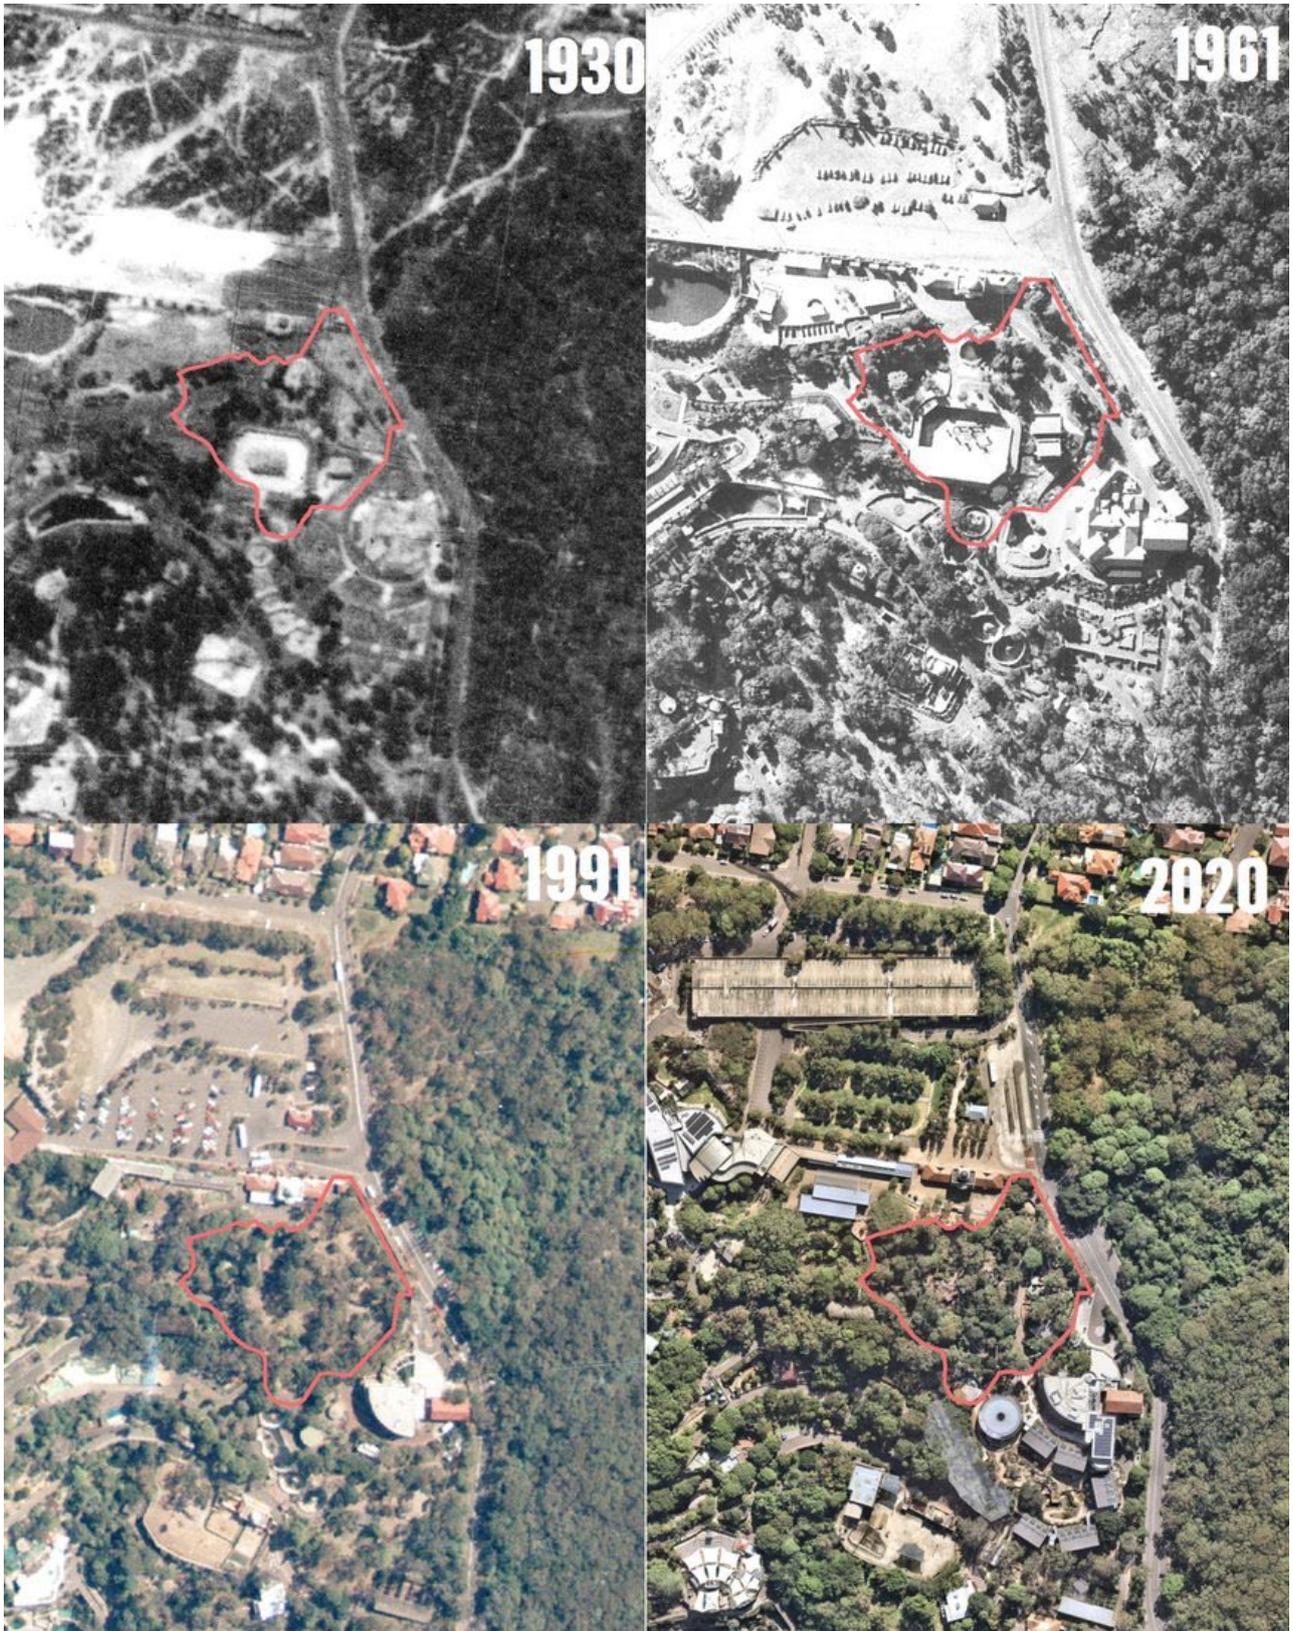
The development of facilities within the subject area has caused substantial levels of ground disturbance. This is demonstrated through the analysis of historic aerials. Historic aerial images from 1930, 1961, 1990 and 2020 were analysed to develop an understanding of disturbance (see Figure 26). A summary of this analysis is included in Table 3.

Year	Observation
1930	Taronga zoo was established between 1912-1916. Prior to the establishment of the zoo, the subject area consisted of native bushland, such as that which can be observed to the east of Bradleys Head Road. By 1930 the subject area appears to have already undergone significant disturbance and clearance of vegetation. The network of paths reflect those observed in a 1916 map of the zoo (Figure 11). The Baboon Pit, which is described as a 'concrete and stark enclosure which had been deeply excavated with mounding in the centre for baboons to climb' is clearly visible at the centre of the subject area. The Anteater building is located to the east of the Baboon Pit. The path encircling the Monkey Pit to the south of the Baboon Pit is visible, however, the structure is not visible.
1961	The subject area does not appear to have undergone many significant changes between 1930-1961. The Bandstand and Anteater buildings had been constructed to the east of the Baboon Pit. The Monkey Pit is visible to the south of the Baboon Pit.

1990	The subject area appears more densely vegetated. The stark open concrete Baboon Pit had been partially removed and replaced with the Nocturnal House by this time. The Bandstand and Anteater buildings to the east of the Baboon Pit had been demolished and the Platypus House can be seen to the south-east of these. The extensive Waterfowl Ponds within the western component of the subject area are obstructed by vegetation. The reduced visibility of structures reflects Strahan's period of management (1967-1974) during which new exhibits were landscaped and moated, rather than fenced, and the erection of imposing structures avoided.
2020	There are no clear changes to the subject area in the years between 1990-2020.

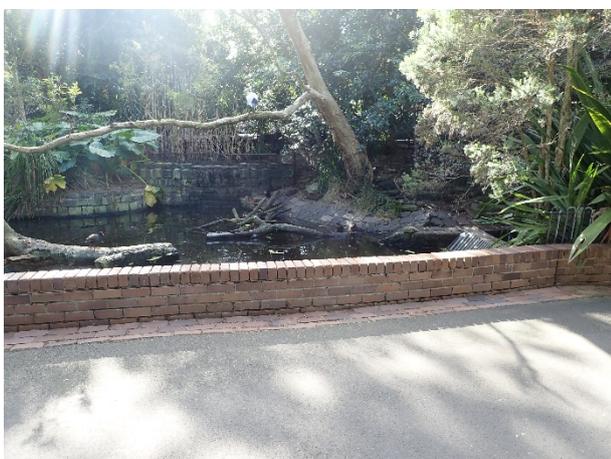
Figure 27 – Location of wetland ponds that will be excavated within the existing stone walls and only impacting the base of the ponds. Photo facing north

The proposed excavation works would be confined to the northern Wetland Ponds and north-eastern Australian Wildlife enclosure. There is some potential for remnant foundations of the northern Wetland Pond to be impacted by excavations. With the exception of remnant paths, no significant historical archaeological relics have been identified within north-eastern component of the subject area. There is some potential for these to be impacted by the proposed spot excavations and insertion of pylons in association with the new boardwalk. Other identified potential archaeological relics, including remnants of the former Baboon Pit, Anteater and Bandstand buildings, are located outside the footprint of the proposal and consequently will not be impacted by the activities under the proposal.

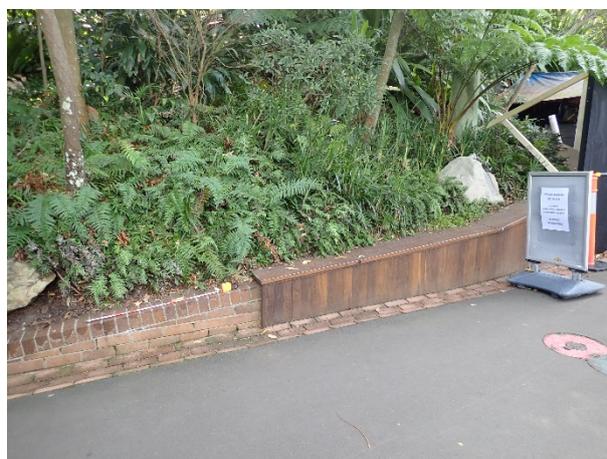
Figure 28 – Location of proposed excavation of fill behind retaining wall. Photo facing north-east.

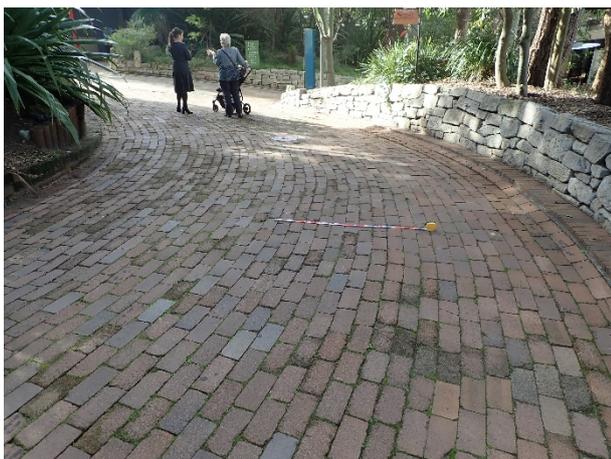
Figure 29 – Location of proposed removal existing brick footpath and consequent small scale of excavation. Photo facing east.

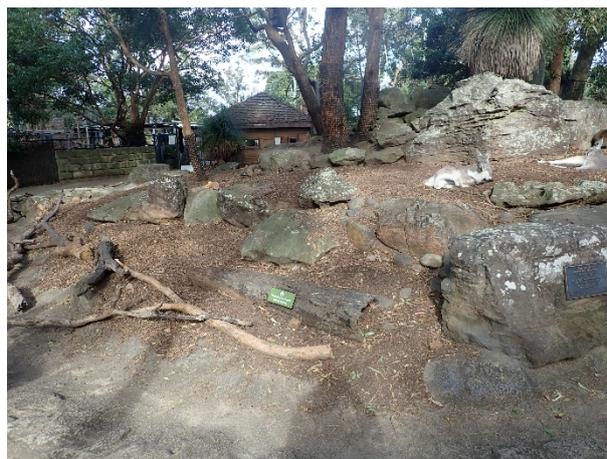
Figure 30 – Location of proposed spot-excavations within the Macropod Exhibit. Photo facing south.
