ARBORICULTURAL IMPACT ASSESSMENT

Upper Australia Exhibit-

Taronga Zoo

Prepared for: Taronga
Conservation Society

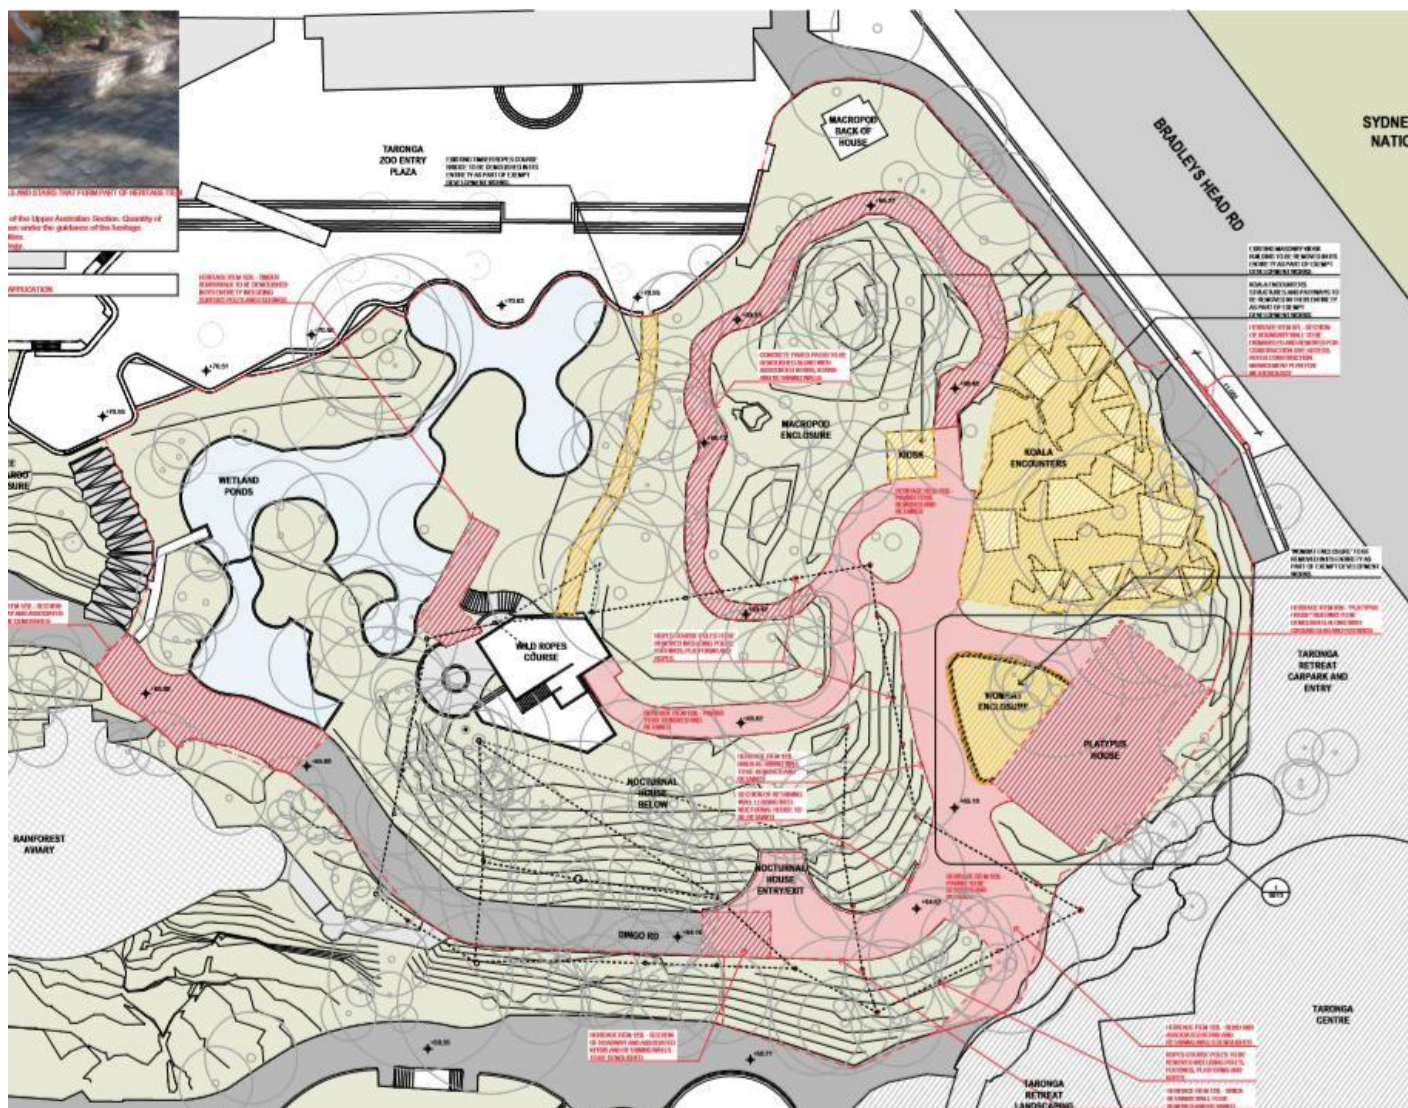
Figure 1- Demolition plan showing the structures to be demolished for stage 1 works.

The proposed development is to demolish the existing site features shown in red and orange in figure 1 below as part of the early works schedule.

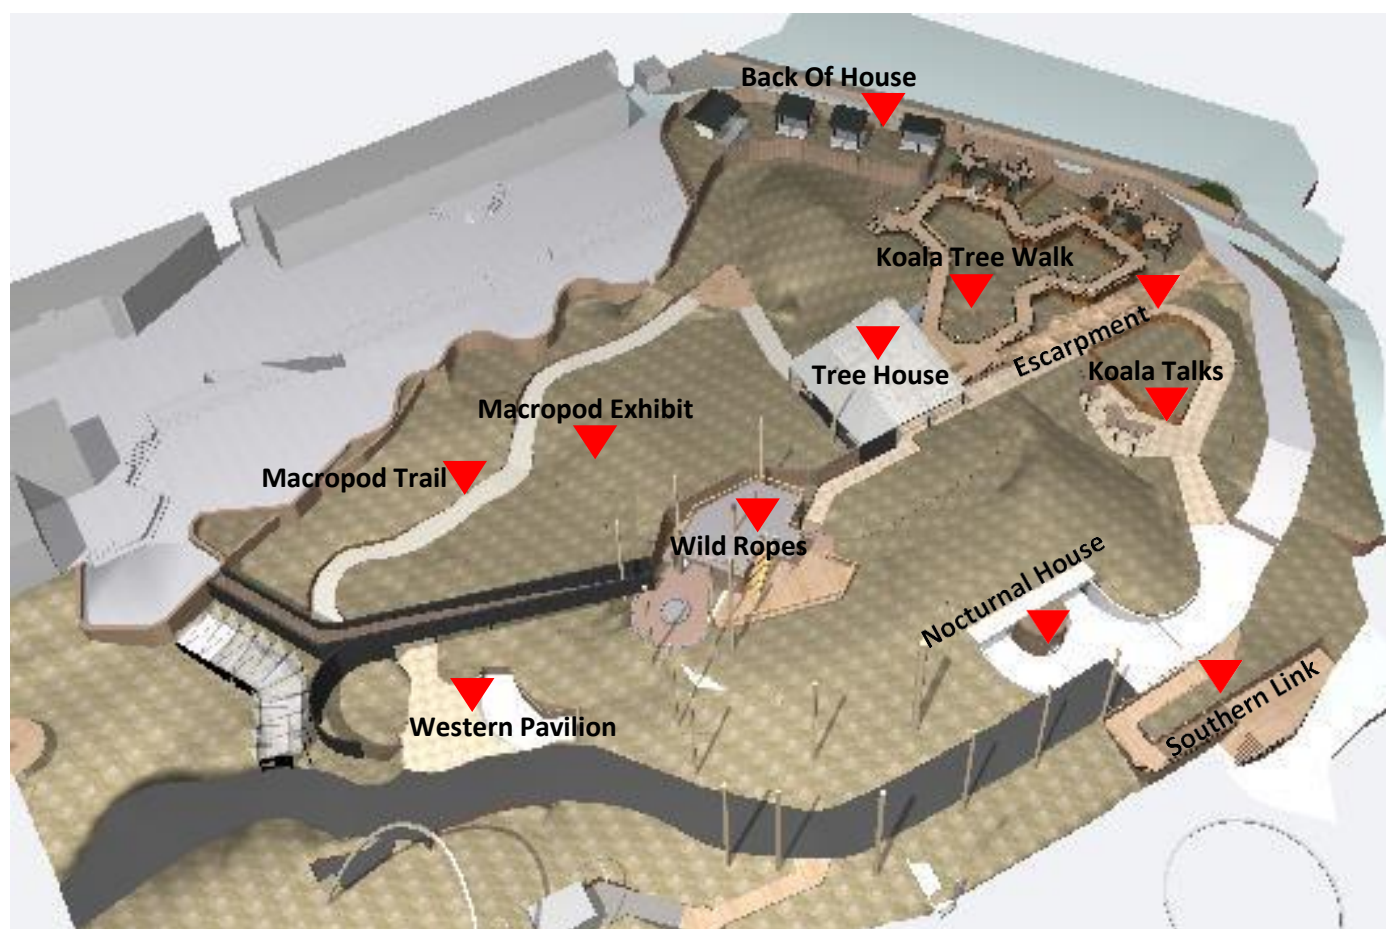
Figure 2- Bimx image showing the proposed development areas. Image provided by the client.

The image shown in figure 2 (below) has been created with 3D modelling technology (Bimx) and has been provided to me by the client to assist in the visualisation of the overall project. The areas labelled below are the main features of this proposed development and each one will be discussed in relation to its potential impact upon trees.

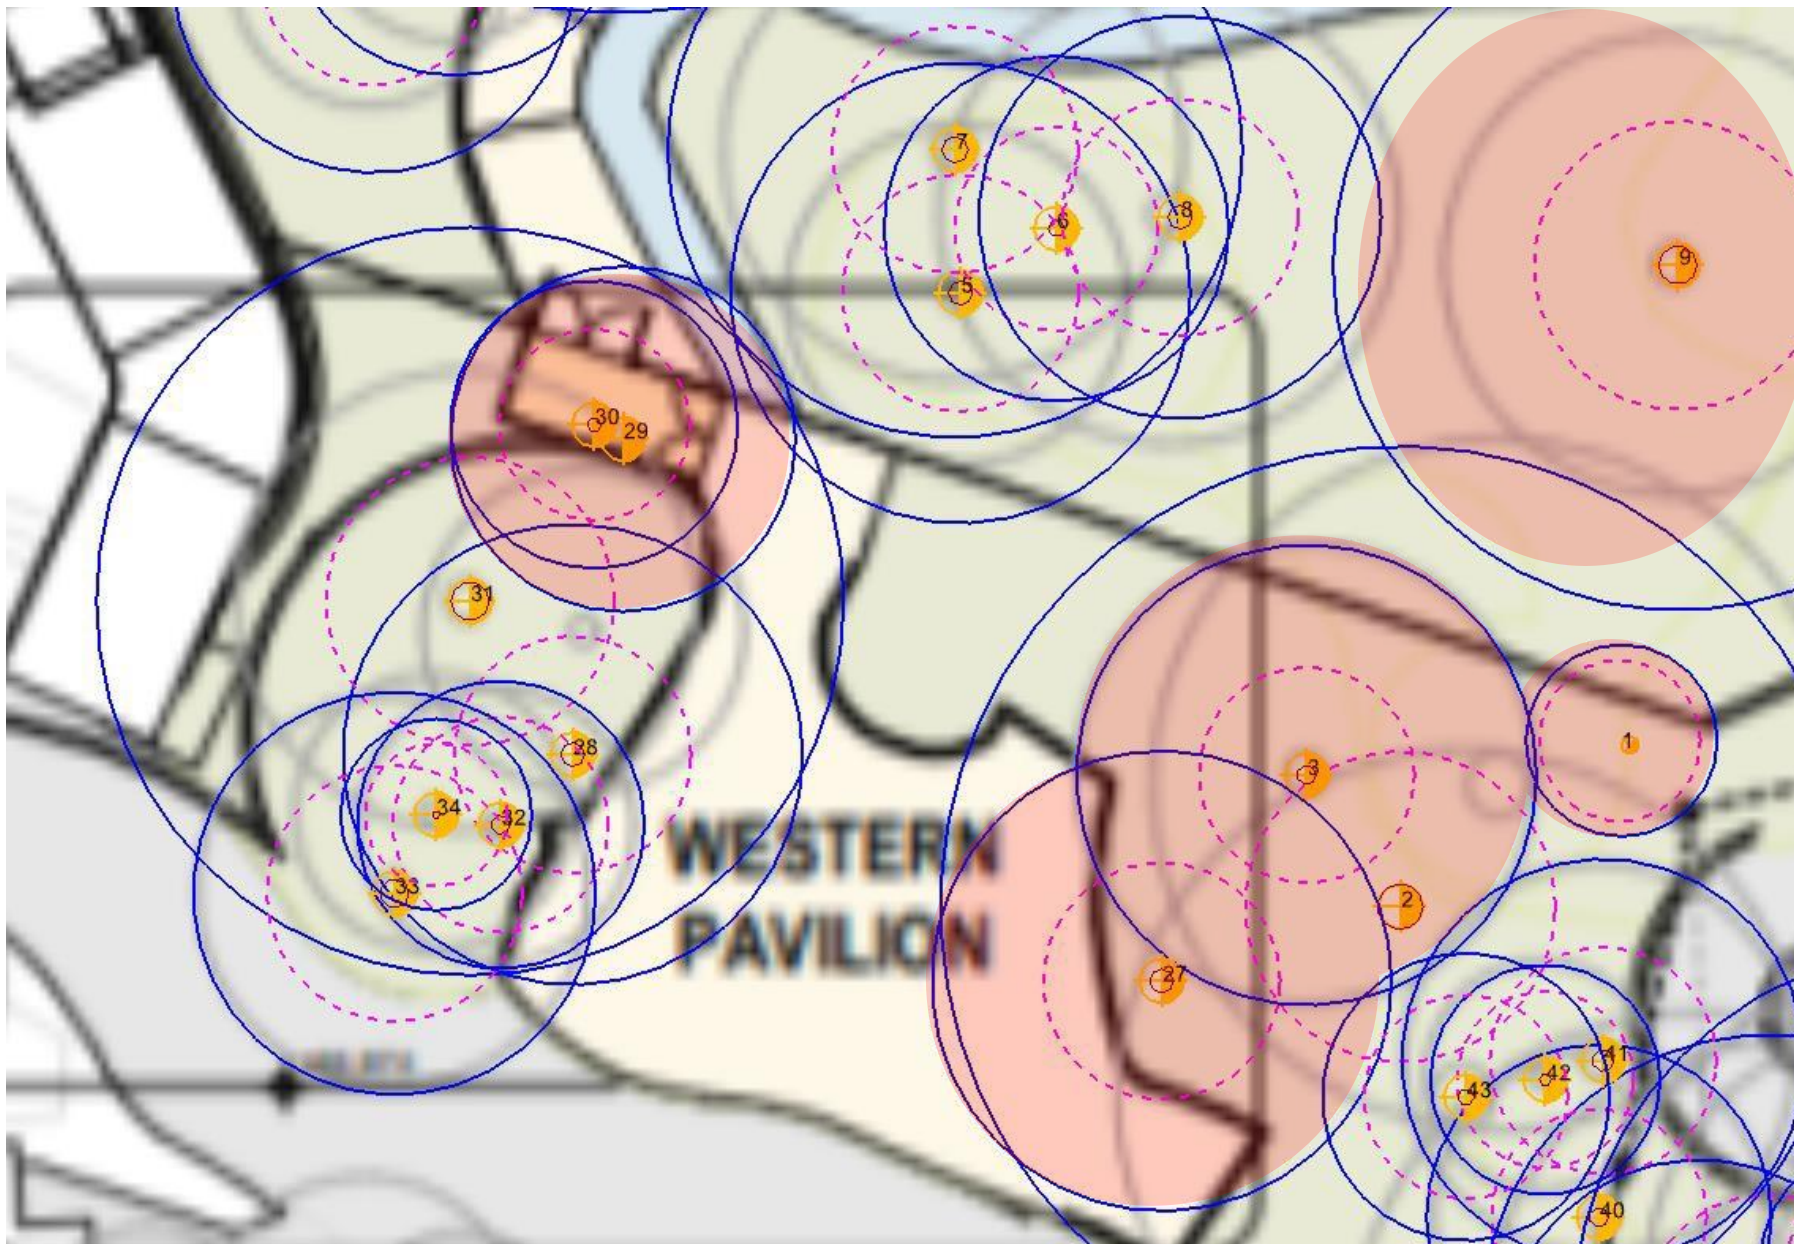
Figure 5- Trees affected by the proposed 'Western Pavilion'.

Tree number	Impacts	Mitigation	Remove/retain
1	Conflicts with footprint of new bridge to wild ropes course	N/A	Proposed for removal
2	Drainage of existing ponds/ altered micro-climate	Install irrigation and misters to maintain moisture levels	Retain & protect
3	Conflicts with footprint of new bridge to wild ropes course	N/A	Proposed for removal
5	Drainage of existing ponds/ altered micro-climate	Install irrigation and misters to maintain moisture levels	Retain & protect
6	Drainage of existing ponds/ altered micro-climate	Install irrigation and misters to maintain moisture levels	Retain & protect
7	Drainage of existing ponds/ altered micro-climate	Install irrigation and misters to maintain moisture levels	Retain & protect
8	Drainage of existing ponds/ altered micro-climate	Install irrigation and misters to maintain moisture levels	Retain & protect
9	Drainage of existing ponds/ altered micro-climate	N/A	Proposed for removal

27	Drainage of existing ponds/ altered micro-climate	N/A	Proposed for removal
28	Drainage of existing ponds/ altered micro-climate	Install irrigation and misters to maintain moisture levels	Retain & protect
29	Conflicts with footprint of new bridge to wild ropes course	N/A	Proposed for removal
30	Conflicts with footprint of new bridge to wild ropes course	N/A	Proposed for removal
31	Drainage of existing ponds/ altered micro-climate	Install irrigation and misters to maintain moisture levels	Retain & protect
32	Drainage of existing ponds/ altered micro-climate	Install irrigation and misters to maintain moisture levels	Retain & protect
33	Drainage of existing ponds/ altered micro-climate	Install irrigation and misters to maintain moisture levels	Retain & protect
34	Drainage of existing ponds/ altered micro-climate	Install irrigation and misters to maintain moisture levels	Retain & protect

Notes: Tree nine (9) is a large Casuarina adjacent to the existing ponds and boardwalk. The tree could be retained throughout this development; however, it has significant decay and structural defects. These defects were of less concern whilst the tree was within an exhibit, however the new development will bring far greater occupancy under the tree and will elevate the risk to an unacceptable level. This tree is proposed for removal on these grounds.

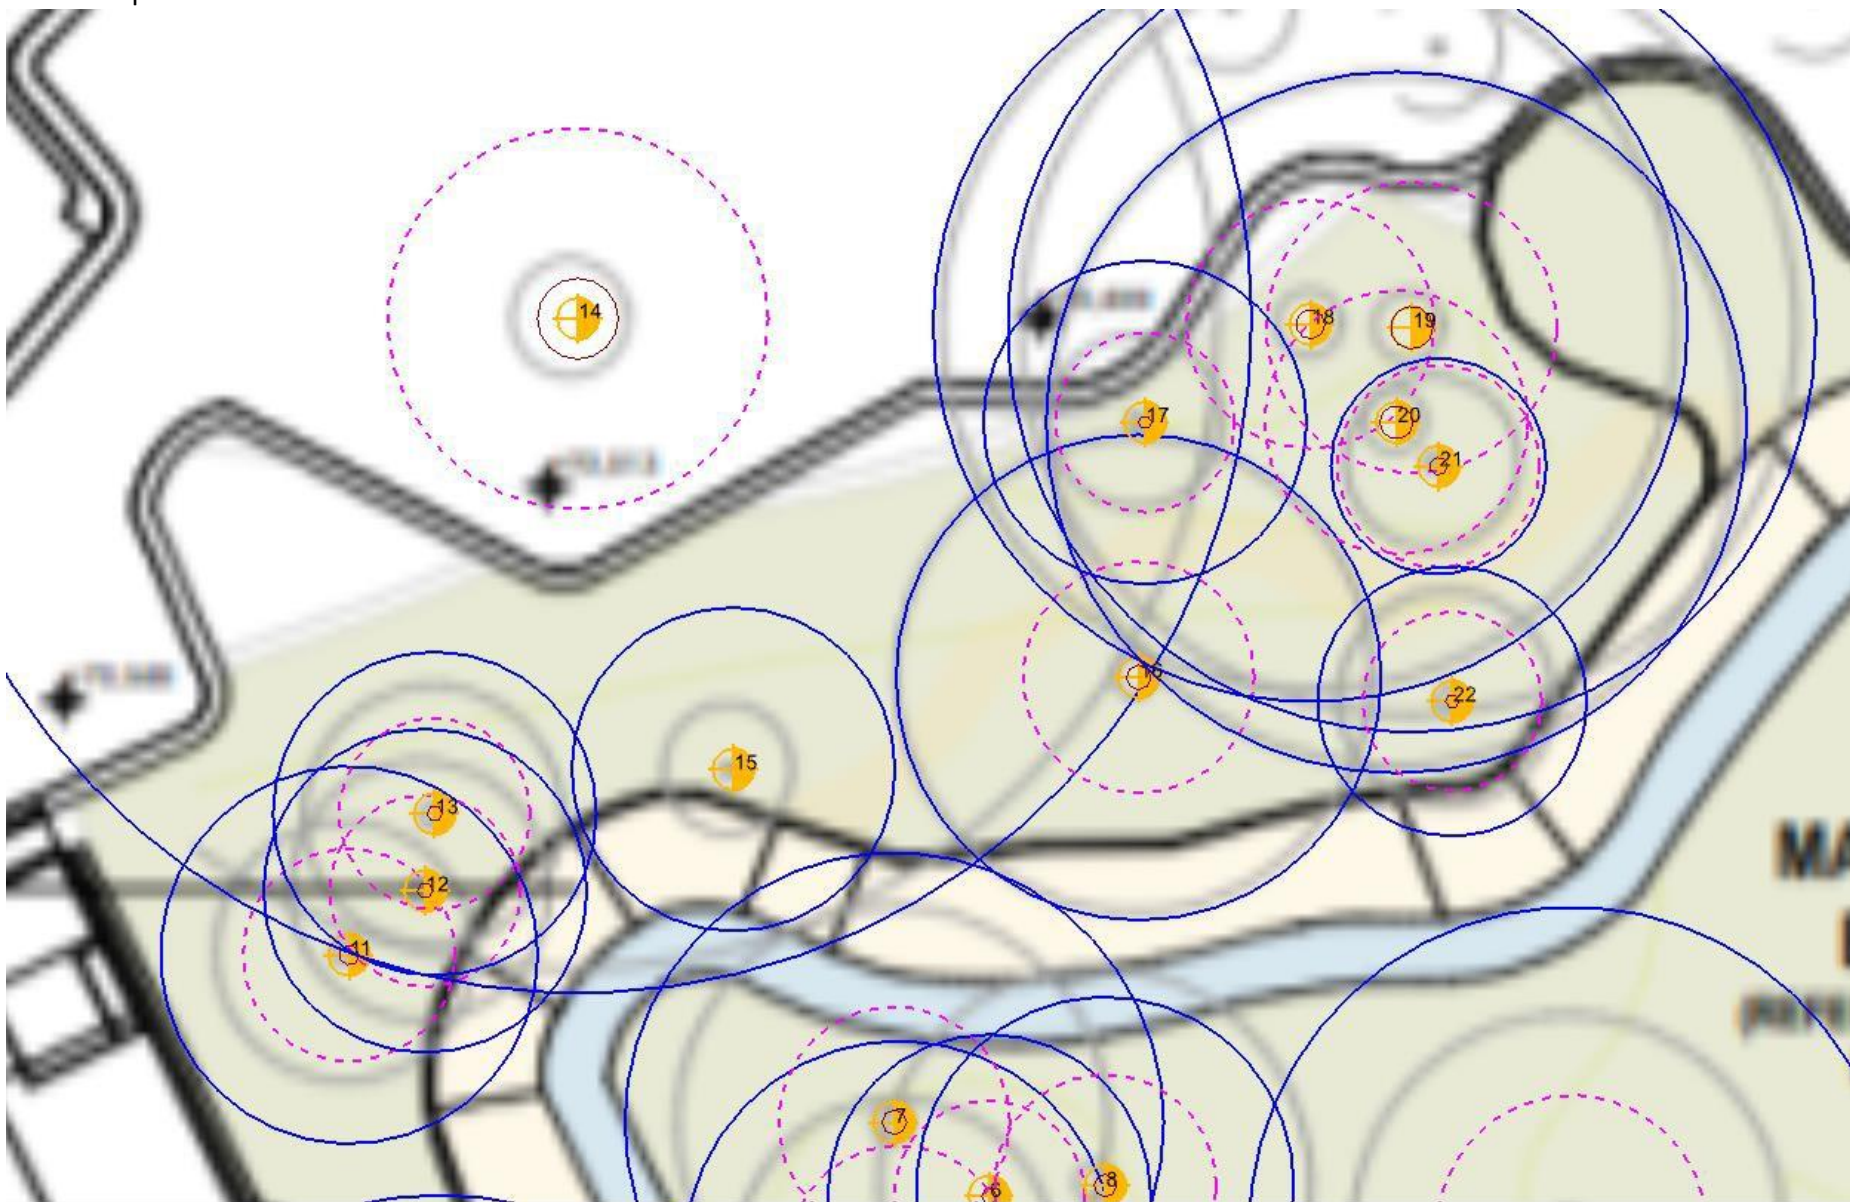
Figure 6- Trees impacted by the Macropod trail

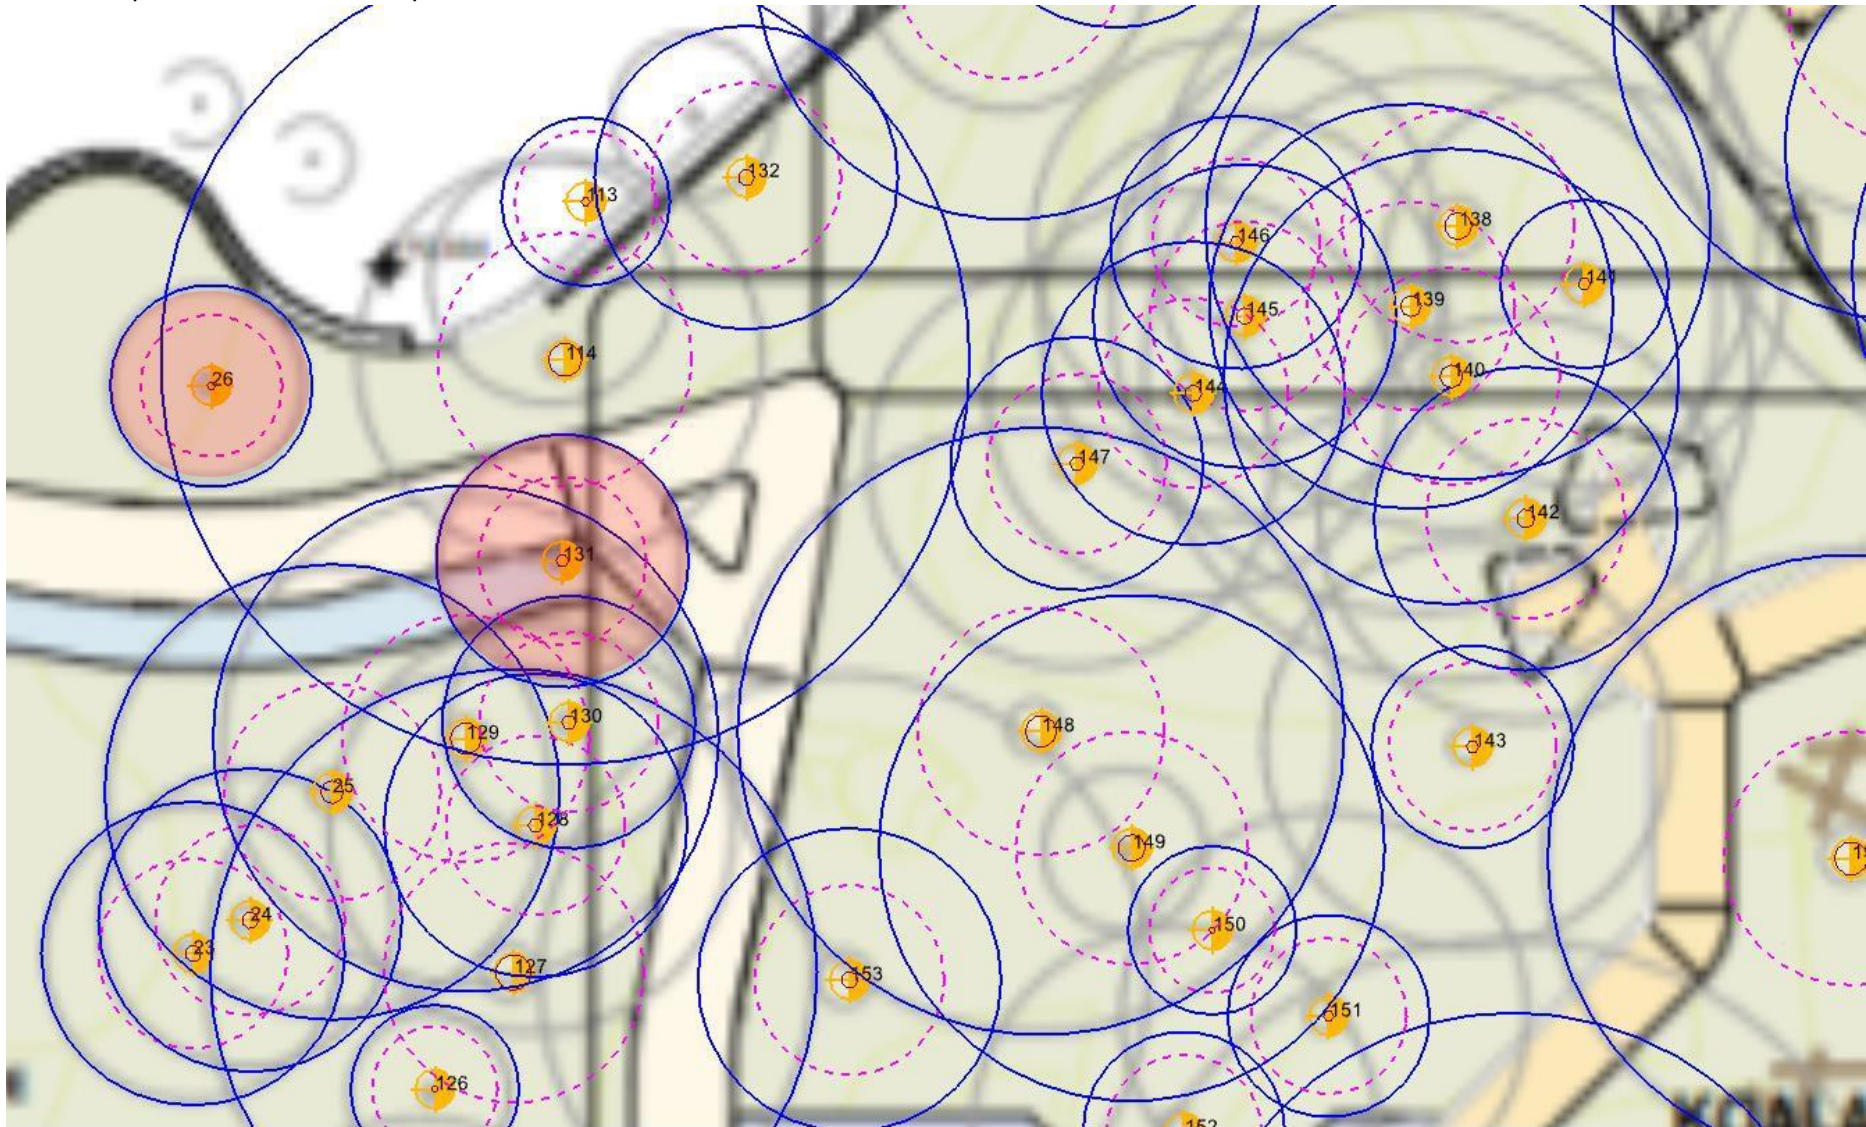
Figure 7- Macropod trail continued.

Tree number	Impacts	Mitigation	Remove/retain
11	Drainage of existing ponds/ altered micro-climate	Install irrigation and misters to maintain moisture levels	Retain & protect
12	Drainage of existing ponds/ altered micro-climate	Install irrigation and misters to maintain moisture levels	Retain & protect
13	Drainage of existing ponds/ altered micro-climate	Install irrigation and misters to maintain moisture levels	Retain & protect
14	Drainage of existing ponds/ altered micro-climate	Install irrigation and misters to maintain moisture levels	Retain & protect
15	Drainage of existing ponds/ altered micro-climate	Install irrigation and misters to maintain moisture levels	Retain & protect
16	Drainage of existing ponds/ altered micro-climate	Install irrigation and misters to maintain moisture levels	Retain & protect
17	Drainage of existing ponds/ altered micro-climate	Install irrigation and misters to maintain moisture levels	Retain & protect

18	Drainage of existing ponds/ altered micro-climate	Install irrigation and misters to maintain moisture levels	Retain & protect
19	Drainage of existing ponds/ altered micro-climate	Install irrigation and misters to maintain moisture levels	Retain & protect
20	Drainage of existing ponds/ altered micro-climate	Install irrigation and misters to maintain moisture levels	Retain & protect
21	Drainage of existing ponds/ altered micro-climate	Install irrigation and misters to maintain moisture levels	Retain & protect
22	Drainage of existing ponds/ altered micro-climate	Install irrigation and misters to maintain moisture levels	Retain & protect
23	Drainage of existing ponds/ altered micro-climate	Install irrigation and misters to maintain moisture levels	Retain & protect
24	Drainage of existing ponds/ altered micro-climate	Install irrigation and misters to maintain moisture levels	Retain & protect
25	Drainage of existing ponds/ altered micro-climate	Install irrigation and misters to maintain moisture levels	Retain & protect

26	Dead tree	N/A	Proposed for removal
113	Unaffected by proposal	Tree protection fencing	Retain & protect
114	Heavily encroached upon by Macropod trail	Section of the trail within the TPZ must be built on or above grade using tree sensitive construction methods.	Retain & protect
126	Unaffected by proposal	Tree protection fencing	Retain & protect
127	Heavily encroached upon by Macropod trail	Section of the trail within the TPZ must be built on or above grade using tree sensitive construction methods.	Retain & protect
128	Minor encroachment from the Macropod trail	Tree protection fencing	Retain & protect
129	Minor encroachment from the Macropod trail	Tree protection fencing	Retain & protect
130	Minor encroachment from the Macropod trail	Tree protection fencing	Retain & protect
131	Heavily encroached upon by Macropod trail and water feature	N/A	Proposed for removal

132	Heavily encroached upon by new containment fence	Fencing must be installed using tree sensitive construction measures with piers located outside of SRZ.	Retain & protect
138	Unaffected by proposal	Tree protection fencing	Retain & protect
139	Unaffected by proposal	Tree protection fencing	Retain & protect
140	Unaffected by proposal	Tree protection fencing	Retain & protect
141	Unaffected by proposal	Tree protection fencing	Retain & protect
142	Encroached upon by viewing platform	Raised platform footings must be installed using tree sensitive construction measures with piers located outside of SRZ.	Retain & protect
143	Unaffected by proposal	Tree protection fencing	Retain & protect
144	Unaffected by proposal	Tree protection fencing	Retain & protect
145	Unaffected by proposal	Tree protection fencing	Retain & protect
146	Unaffected by proposal	Tree protection fencing	Retain & protect
147	Unaffected by proposal	Tree protection fencing	Retain & protect

148	Minor encroachment from the Macropod trail	Tree protection fencing	Retain & protect
149	Unaffected by proposal	Tree protection fencing	Retain & protect
150	Unaffected by proposal	Tree protection fencing	Retain & protect
151	Unaffected by proposal	Tree protection fencing	Retain & protect
152	Unaffected by proposal	Tree protection fencing	Retain & protect
153	Minor encroachment from the Macropod trail	Tree protection fencing	Retain & protect

Notes: Many of the trees are near the edge of the existing ponds. The removal of the ponds must consider sensitive construction methods such as hand demolition or retaining sections of the ponds in situ. The trail must be located within the footprint of the existing ponds. There is a small Melaleuca which does not meet the definition of a prescribed tree which will require removal to enable the pathway to be installed. Tree sixteen (16) is a large Tuckeroo which may require minor crown lifting for pedestrian access.

Trees #144, #127, #132, #142 are heavily encroached upon the proposed structures and tree sensitive construction methods must be employed.

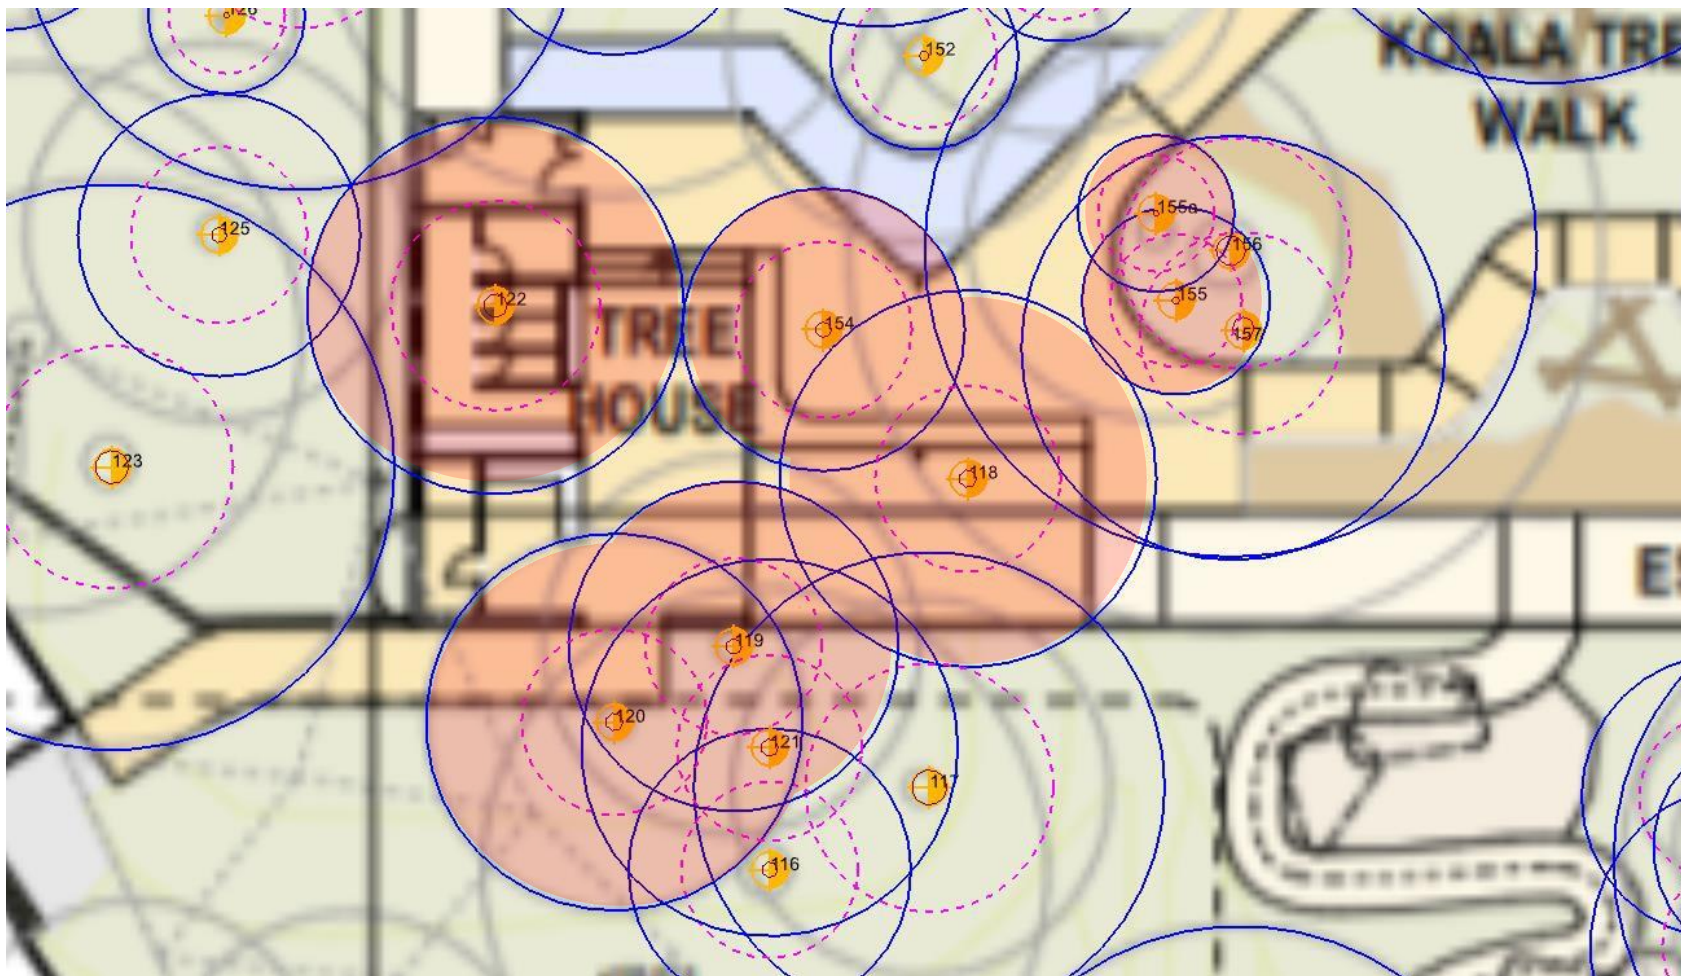
Figure 9- Trees impacted by the tree house

Tree #	Impacts	Mitigation	Remove/retain
116	Unaffected by development	N/A	Retain & protect
117	Minor encroachment from tree house structure	Tree protection fencing	Retain & protect
118	Within Tree House footprint	N/A	Proposed for removal
119	Major encroachment from tree house structure	N/A	Proposed for removal
120	Major encroachment from tree house structure	N/A	Proposed for removal
121	Minor encroachment from tree house structure	Tree protection fencing	Retain & protect
122	Within Tree House footprint	N/A	Proposed for removal
123	Minor encroachment from tree house structure	Tree protection fencing	Retain & protect
125	Unaffected by development	N/A	Retain & protect
152	Unaffected by development	N/A	Retain & protect
154	Within Tree House footprint	N/A	Proposed for removal
155	Major encroachment from tree house structure	N/A	Proposed for removal
155a	Major encroachment from tree house structure	N/A	Proposed for removal

156	Major encroachment from tree house structure	Structures must be installed using tree sensitive construction measures with piers located outside of SRZ.	Retain & protect
157	Major encroachment from tree house structure	Structures must be installed using tree sensitive construction measures with piers located outside of SRZ.	Retain & protect

Notes: The tree house structure is primarily a raised structure and few impacts are anticipated other than what arises from direct conflicts with the building line itself. Trees #118, #122, #154 are all within the building footprint and will require removal. Trees #119 and #120 are too close to the proposed structure to be sustainable in the long-term and are proposed for removal. Trees #155 and #155a are small suppressed trees that are leaning towards the proposed structures, there will be ongoing canopy conflicts between the trees and the proposed structures so they have been recommended for removal.

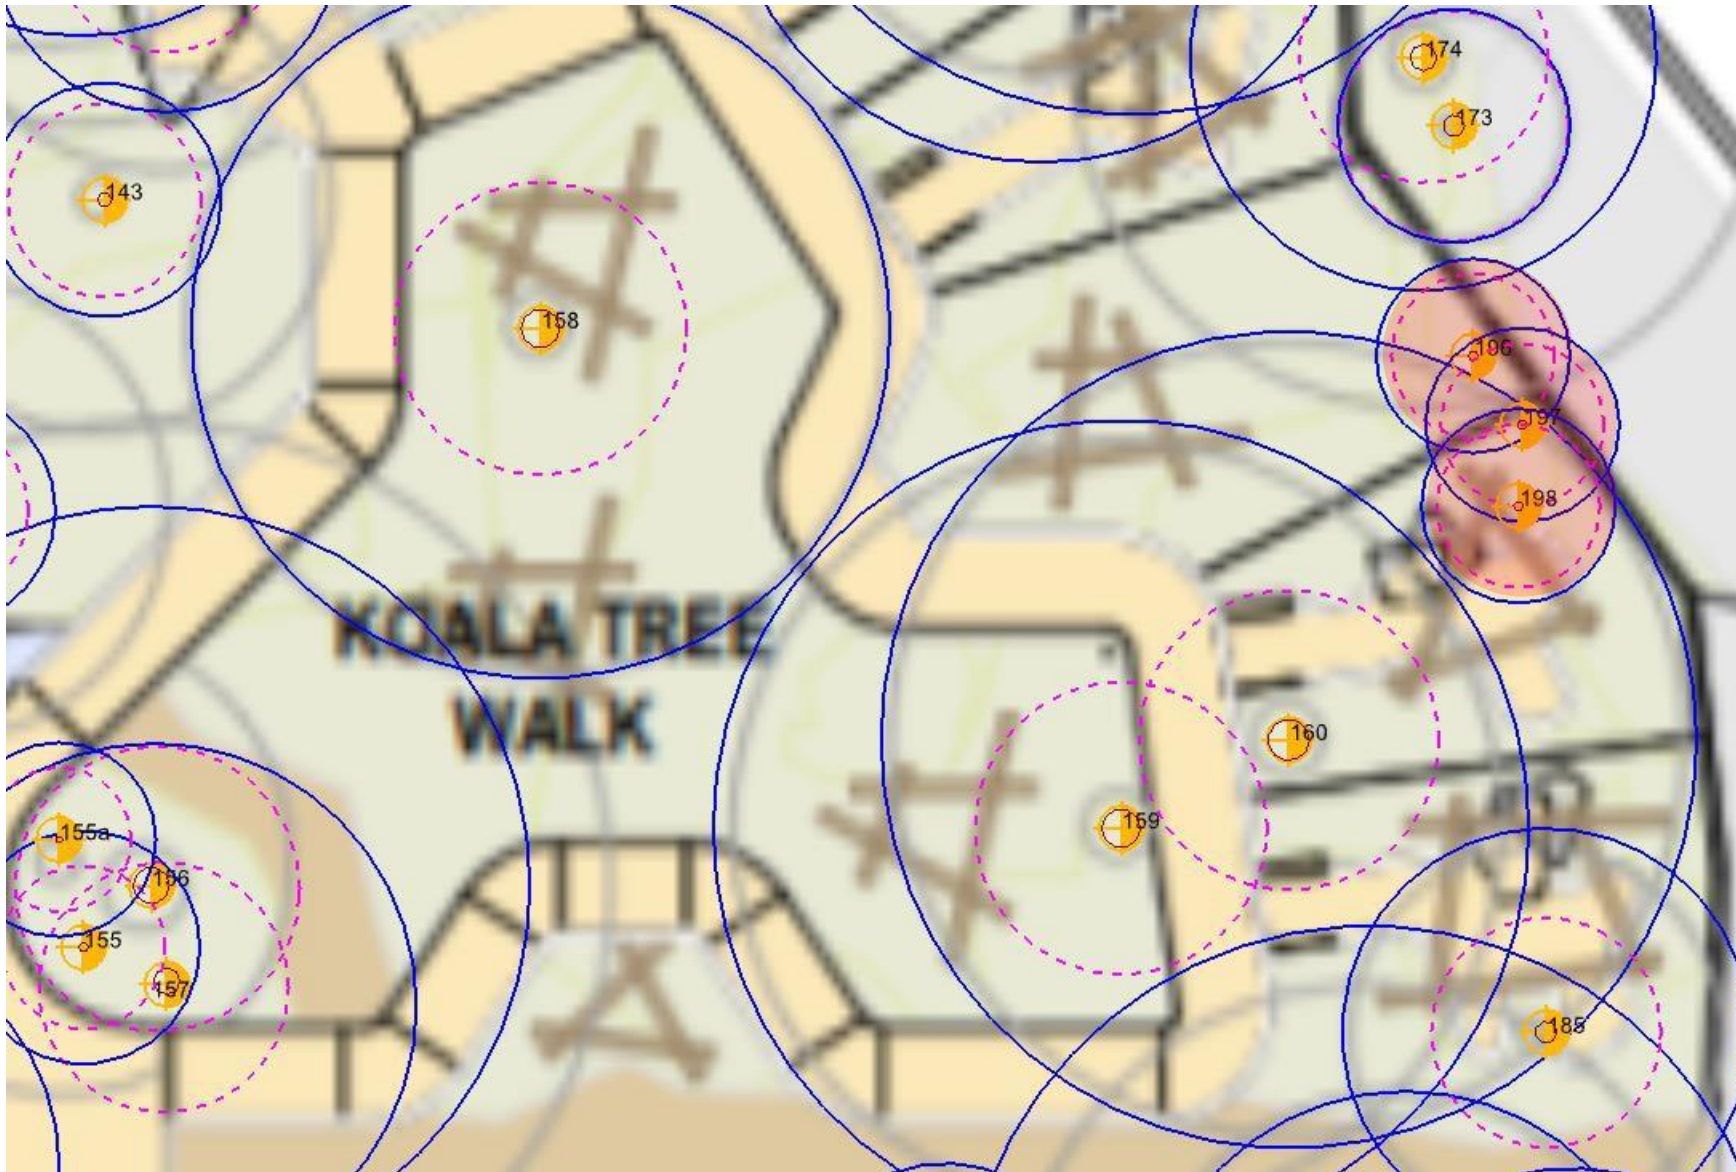
Figure 10- Trees impacted by the Koala tree walk

Tree #	Impacts	Mitigation	Remove/retain
158	Proposed raised boardwalks around the tree	Structures must be installed using tree sensitive construction measures with piers located outside of SRZ. This tree will require pruning (see notes).	Retain & protect
159	Proposed raised boardwalks around the tree	Structures must be installed using tree sensitive construction measures with piers located outside of SRZ.	Retain & protect
160	Proposed raised boardwalks around the tree	Structures must be installed using tree sensitive construction measures with piers located outside of SRZ.	Retain & protect
173	Heavily encroached upon by new containment fence	Fencing must be installed using tree sensitive construction measures with piers located outside of SRZ.	Retain & protect
174	Heavily encroached upon by new containment fence	Fencing must be installed using tree sensitive construction measures with piers located outside of SRZ.	Retain & protect

185	Proposed raised boardwalks around the tree, minor encroachment from containment fence	Structures must be installed using tree sensitive construction measures with piers located outside of SRZ.	Retain & protect
196	Heavily encroached upon by new containment fence	N/A	Proposed for removal
197	Heavily encroached upon by new containment fence	N/A	Proposed for removal
198	Heavily encroached upon by new containment fence	N/A	Proposed for removal
<p>Notes: The boardwalk structures will impose minimal impacts from root disturbance if sensitive construction methods are used. Tree #158 will require a significant amount of pruning to remove the lower branches and provide enough headroom. This would be the lowest branches on the Eastern and Northern sides of the tree. The pruning would require the removal of approximately 10% of the trees canopy and would result in no significant impacts upon tree health. Trees #159 and #160 have substantial amounts of large diameter deadwood within the canopy which will require removal before opening to the public.</p>

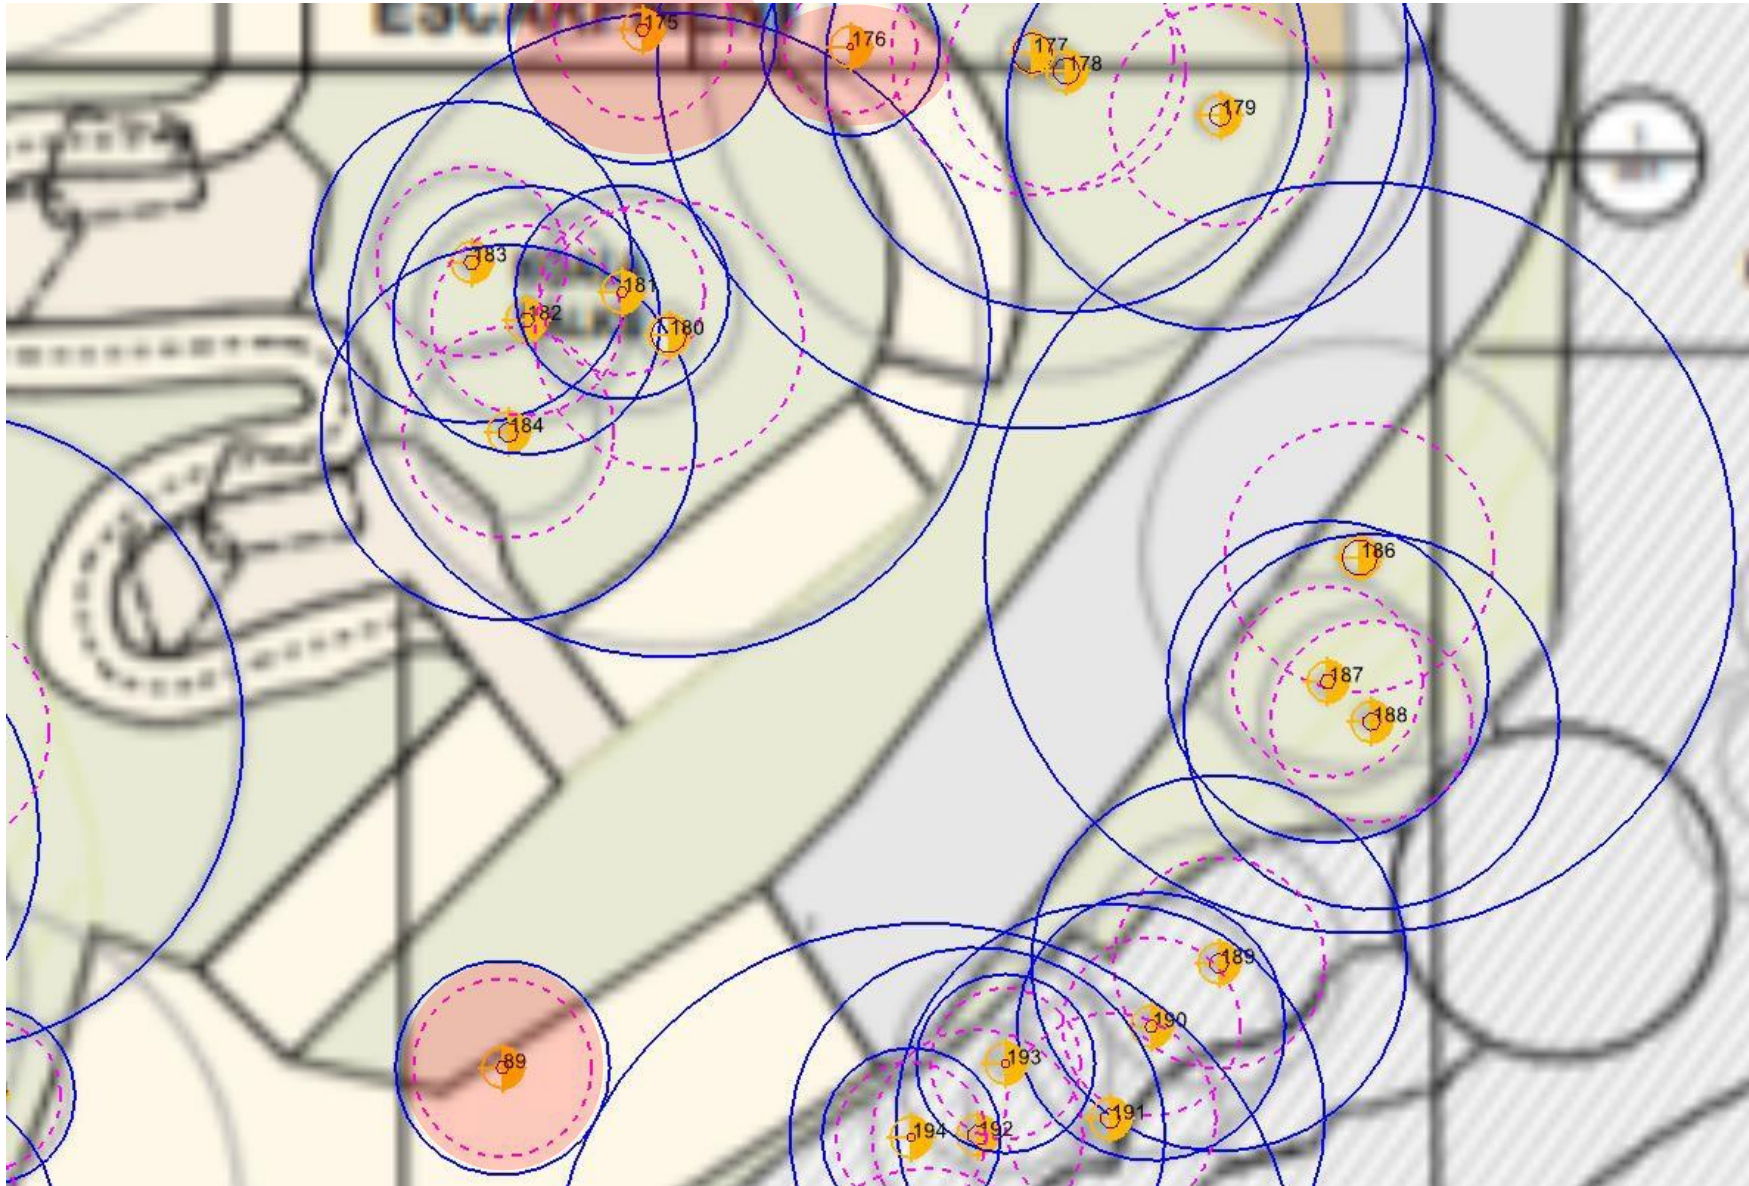
Figure 11-Trees impacted by the escarpment/Koala talks

Tree #	Impacts	Mitigation	Remove/retain
175	Within the escarpment footprint	N/A	Proposed for removal
176	Within the escarpment footprint	N/A	Proposed for removal
177	Major encroachment from escarpment	Tree protection fencing	Retain & protect
178	Major encroachment from escarpment	Tree protection fencing	Retain & protect
179	Minor encroachment from escarpment	Tree protection fencing	Retain & protect
180	Within raised garden bed-Unaffected by proposal	Tree protection fencing	Retain & protect
181	Within raised garden bed-Unaffected by proposal	Tree protection fencing	Retain & protect
182	Within raised garden bed-Unaffected by proposal	Tree protection fencing	Retain & protect
183	Within raised garden bed-Unaffected by proposal	Tree protection fencing	Retain & protect
184	Within raised garden bed-Unaffected by proposal	Tree protection fencing	Retain & protect
186	Behind demolished structure- Unaffected by proposal	Tree protection fencing	Retain & protect

187	Behind demolished structure- Unaffected by proposal	Tree protection fencing	Retain & protect
188	Behind demolished structure- Unaffected by proposal	Tree protection fencing	Retain & protect
189	Behind demolished structure- Unaffected by proposal	Tree protection fencing	Retain & protect
190	Behind demolished structure- Unaffected by proposal	Tree protection fencing	Retain & protect
191	Behind demolished structure- Unaffected by proposal	Tree protection fencing	Retain & protect
192	Behind demolished structure- Unaffected by proposal	Tree protection fencing	Retain & protect
193	Behind demolished structure- Unaffected by proposal	Tree protection fencing	Retain & protect
194	Behind demolished structure- Unaffected by proposal	Tree protection fencing	Retain & protect
89	Within roadway footprint	N/A	Proposed for removal

Notes: Trees #175, #176, #89 are within the footprints of proposed roadways and are recommended for removal. The remaining trees in this area are located surrounding the old Platypus house which is to be demolished. There are specific controls relating to the demolition of the Platypus house and the Wombat exhibit which were contained within the local DA report. The retaining walls holding these trees may be carefully reduced in height (without the use of machinery and under supervision of the project Arborist) to the level of the soil which is holding the trees, all below ground structures must remain in situ. It is unlikely that there will be any significant impact upon these trees from the proposed design.

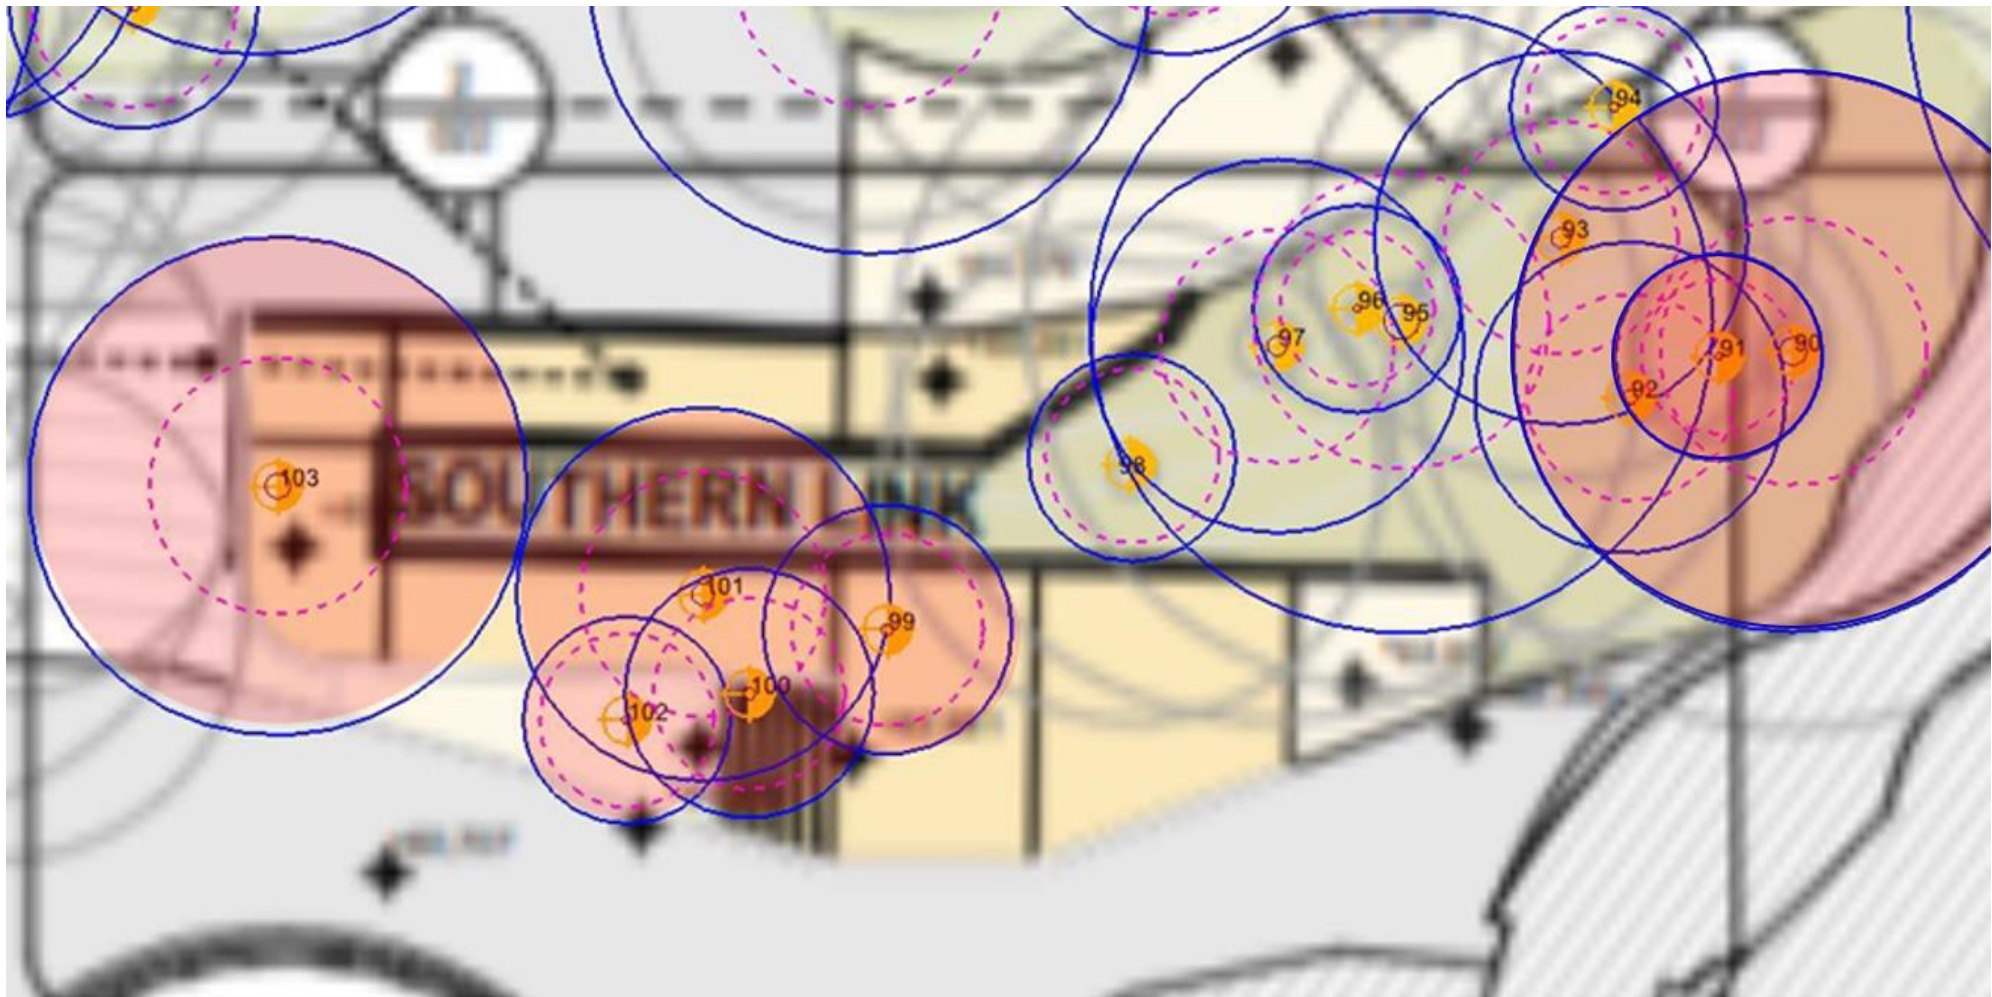
Figure 12- Trees impacted by the Southern link.

Tree #	Impacts	Mitigation	Remove/retain
90	Within footprint of Southern Link	N/A	Proposed for removal
91	Within footprint of Southern Link	N/A	Proposed for removal
92	Unaffected by proposal	N/A	Retain & protect
93	Heavily encroached by roadway	Tree protection fencing	Retain & protect
94	Heavily encroached by roadway	Tree protection fencing	Retain & protect
95	Heavily encroached by roadway	Tree protection fencing	Retain & protect
96	Unaffected by proposal	N/A	Retain & protect
97	Heavily encroached by roadway	Tree protection fencing	Retain & protect
98	Unaffected by proposal	N/A	Retain & protect
99	Within footprint of Southern Link	N/A	Proposed for removal
100	Within footprint of Southern Link	N/A	Proposed for removal
101	Within footprint of Southern Link	N/A	Proposed for removal
102	Within footprint of Southern Link	N/A	Proposed for removal
103	Within footprint of Southern Link	N/A	Proposed for removal

Notes: Trees #90, #91, #99, #100, #101, #102, #103 are within the footprint of the proposed Southern link and are recommended for removal. The remaining trees in this area are located within a raised garden bed. Trees #93, #94, #95, #97 are encroached upon by the roadway but are unlikely to be affected. The retaining walls holding these trees may be carefully reduced in height (without the use of machinery and under supervision of the project Arborist) to the level of the soil which is holding the trees, all below ground structures must remain in situ. It is unlikely that there will be any significant impact upon these trees from the proposed design.

The trees highlighted in Red text are trees which have been impacted by a recent amendment to the Southern Link connection ramp. Please see Appendix 5 of this report for updated drawings.
