ARBORICULTURAL IMPACT ASSESSMENT

Upper Australia Exhibit-

Taronga Zoo

Prepared for: Taronga
Conservation Society

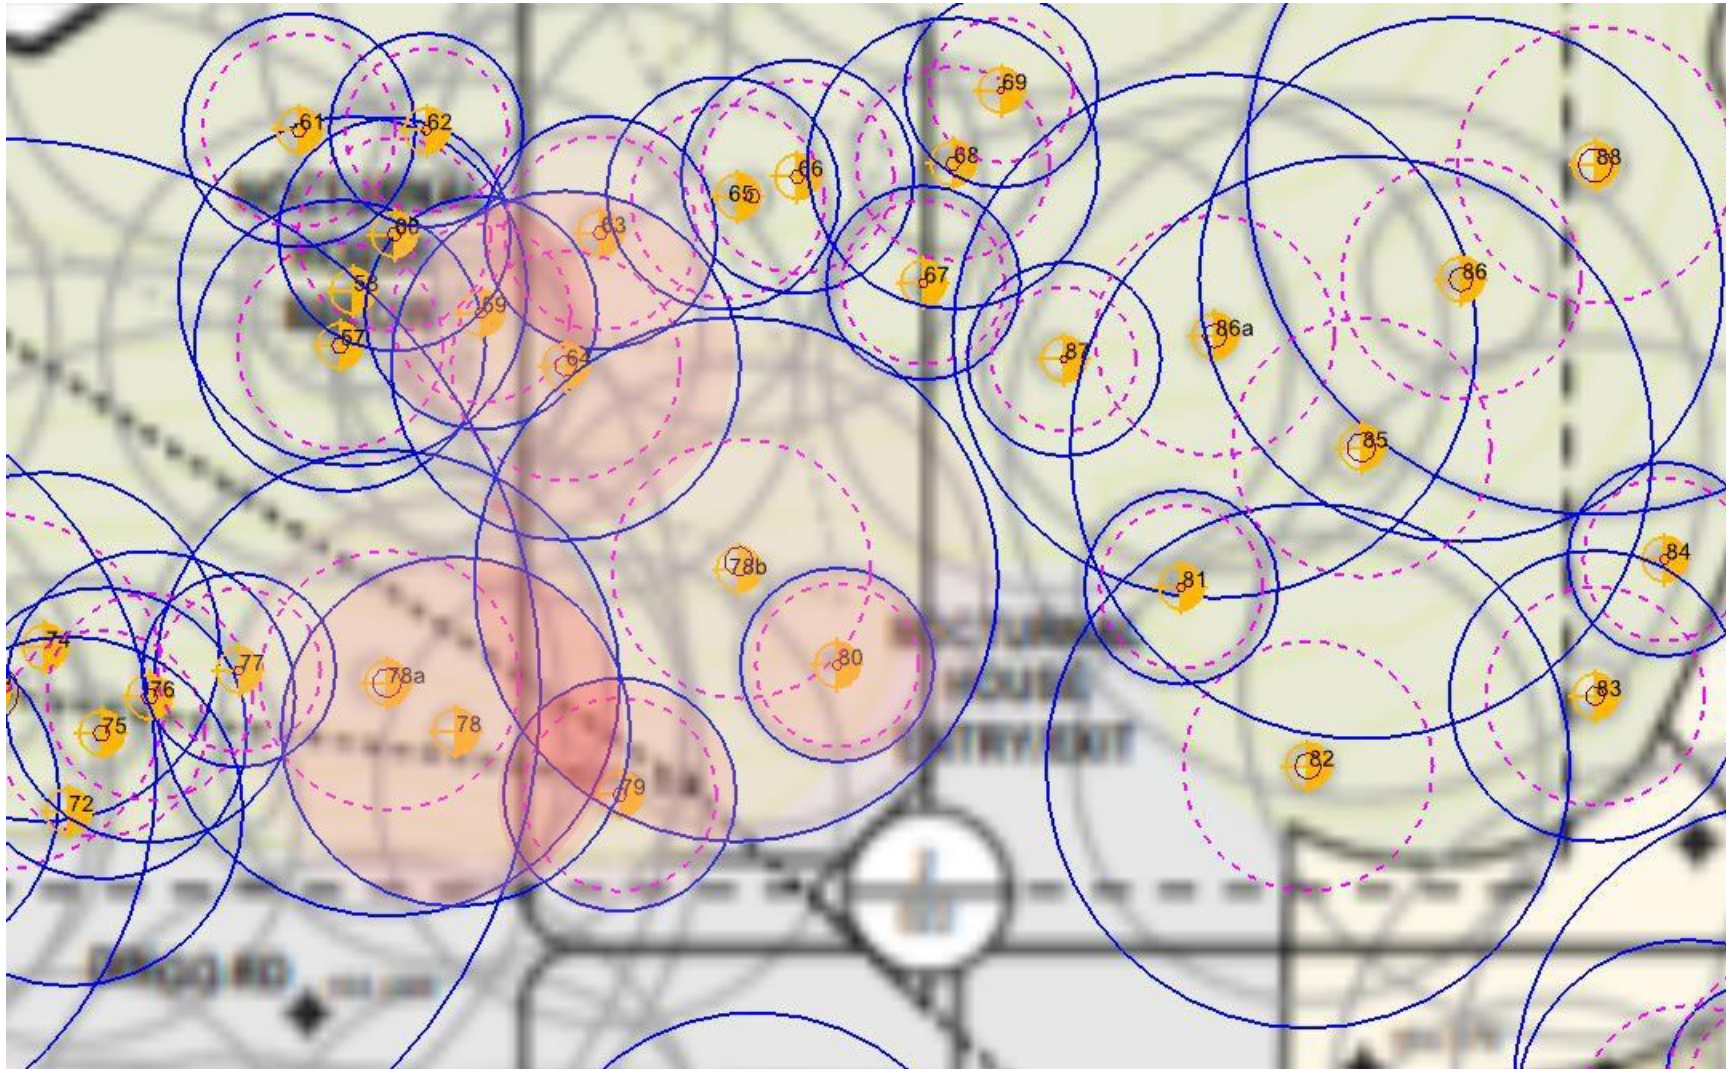
Figure 13- Trees impacted by the nocturnal house.

Tree #	Impacts	Mitigation	Remove/retain
57	Unaffected by proposal	Tree protection fencing	Retain & protect
58	Unaffected by proposal	Tree protection fencing	Retain & protect
59	Nocturnal house demolition	N/A	Proposed for removal
60	Unaffected by proposal	Tree protection fencing	Retain & protect
61	Unaffected by proposal	Tree protection fencing	Retain & protect
62	Unaffected by proposal	Tree protection fencing	Retain & protect
63	Nocturnal house demolition	N/A	Proposed for removal
64	Nocturnal house demolition	N/A	Proposed for removal
65	Unaffected by proposal	Tree protection fencing	Retain & protect
66	Unaffected by proposal	Tree protection fencing	Retain & protect
67	Unaffected by proposal	Tree protection fencing	Retain & protect
68	Unaffected by proposal	Tree protection fencing	Retain & protect
69	Unaffected by proposal	Tree protection fencing	Retain & protect
72	Unaffected by proposal	Tree protection fencing	Retain & protect

86a	Unaffected by proposal	Tree protection fencing	Retain & protect
87	Unaffected by proposal	Tree protection fencing	Retain & protect
88	Unaffected by proposal	Tree protection fencing	Retain & protect

Notes: Trees #59, #63, #64, #75, #78, #78a, #78b, #79, #80 are affected by the nocturnal house demolition and are recommended for removal. The remaining trees in this area are located within a raised garden bed. Trees #82, #83, #84 are encroached upon by the roadway but are unlikely to be affected. The retaining walls holding these trees may be carefully reduced in height (without the use of machinery and under supervision of the project Arborist) to the level of the soil which is holding the trees, all below ground structures must remain in situ. It is unlikely that there will be any significant impact upon these trees from the proposed design.

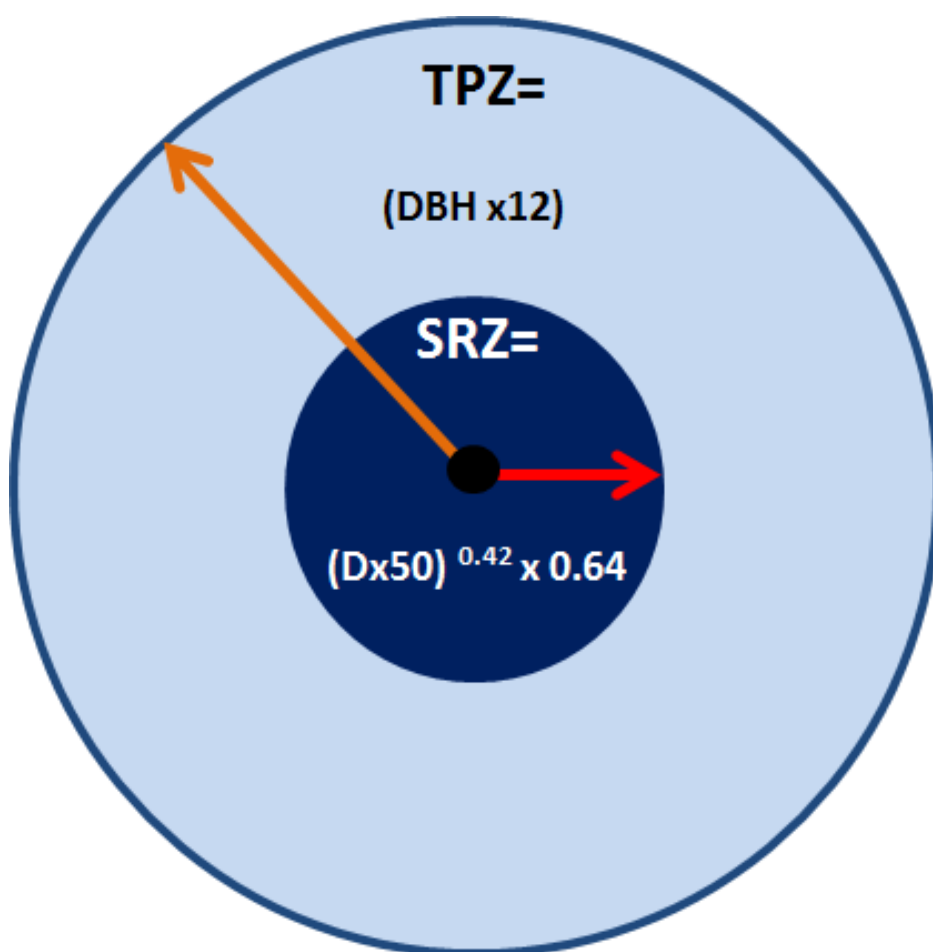
Figure 2 – A representation of TPZ & SRZ calculations.

The Structural Root Zone (SRZ) radius is calculated by measuring the diameter of the stem close to ground level, just above the basal flare. This measurement is taken as D and then used in the following formula: $R_{SRZ} = (D \times 50)^{0.42} \times 0.64$ and becomes the Structural Root Zone, measured radially from the centre of the stem.

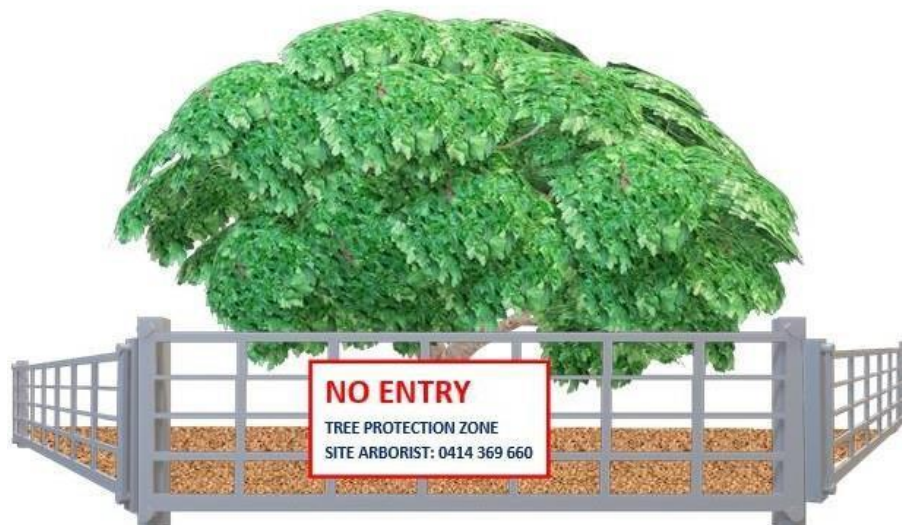
Tree root protection: TPZ Fencing- Figure 1

Tree root protection is generally achieved with the allocation and delineation of a tree protection zone (TPZ) in accordance with AS4970-2009- The Protection of Trees on Development Sites. Temporary fencing is used to isolate the area from construction activity and restrict unauthorized access. Where access into the TPZ is required and unavoidable, ground protection measures may be recommended to ensure that the tree roots which are to be protected remain undamaged during works within the TPZ. Any works within the allocated tree protection zones must be directly supervised by a project Arborist with a minimum AQF level 5 qualification. In situations where there are low lying tree branches to be protected, the TPZ may be extended beyond the calculated TPZ in order to incorporate canopy protection as shown below.

All fencing must be chainmesh fencing 1.8m in height, secured with concrete 'feet' and in accordance with AS4678-Temporary Fencing and Hoardings. Depending on the type of development, shade cloth or similar may be recommended to reduce the spread of dust, particulate matter and liquids into the protected area. Silt fencing may also be required and may be incorporated into the TPZ fencing if required. Once the TPZ fencing has been installed the site Arborist must provide a letter of certification of tree protection measures to the client which may be forwarded on to the private certifier or council. Tree protection fencing is not to be moved, realigned, dismantled or tampered with in any way and shall only be relocated under instruction of the project Arborist. (See Figure 1) If the protective fencing requires temporary removal, trunk, branch and ground protection must be installed and must comply with AS 4970-2009 - Protection of trees on development sites. Existing fencing and site hoarding may be used as tree protection fencing, providing the TPZ remains isolated from construction activities. The purpose of ground protection is to prevent root damage and soil compaction within the TPZ. Ground protection may include a permeable membrane such as geotextile fabric beneath a layer of mulch, crushed rock or rumble boards.

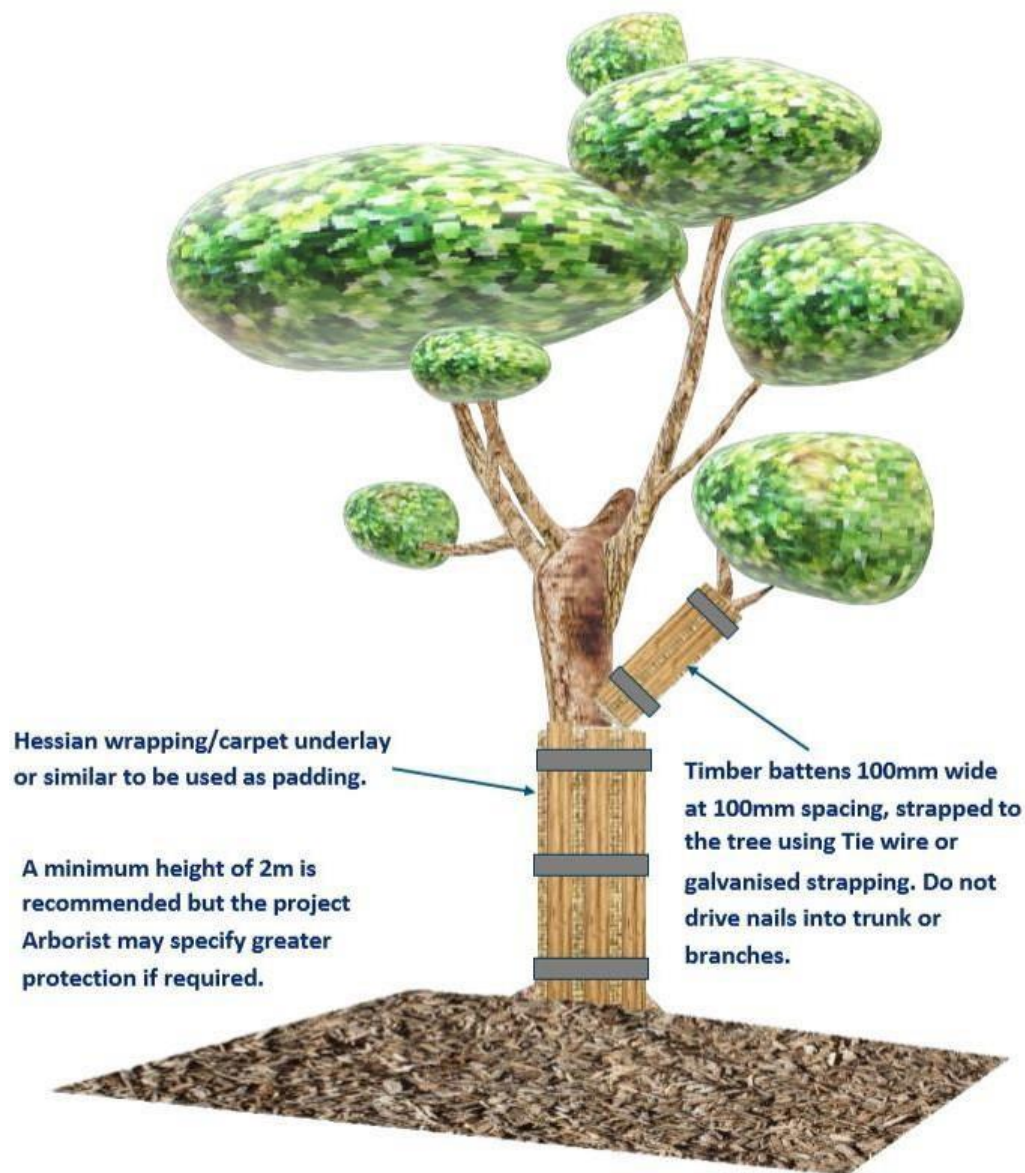
Trunk and branch protection- Figure 3.

Where there is the risk of accidental mechanical damage due to narrow access paths or large machinery movements, trunk and branch protection may also be recommended (see figure 3). The removal of bark or branches allows the potential ingress of micro-organisms which may cause decay. Furthermore, the removal of bark restricts the trees' ability to distribute water, mineral ions (solutes), and glucose.

The timbers must be secured using galvanized hoop strapping or tie wire. The timbers shall be wrapped around the trunk but not fixed to the tree with nails, screws or other means, as this will cause injury/damage to the tree.
