Appendix E
Detailed Dwelling Assessments

Detailed Dwelling Assessments

Dwellings within 3350m

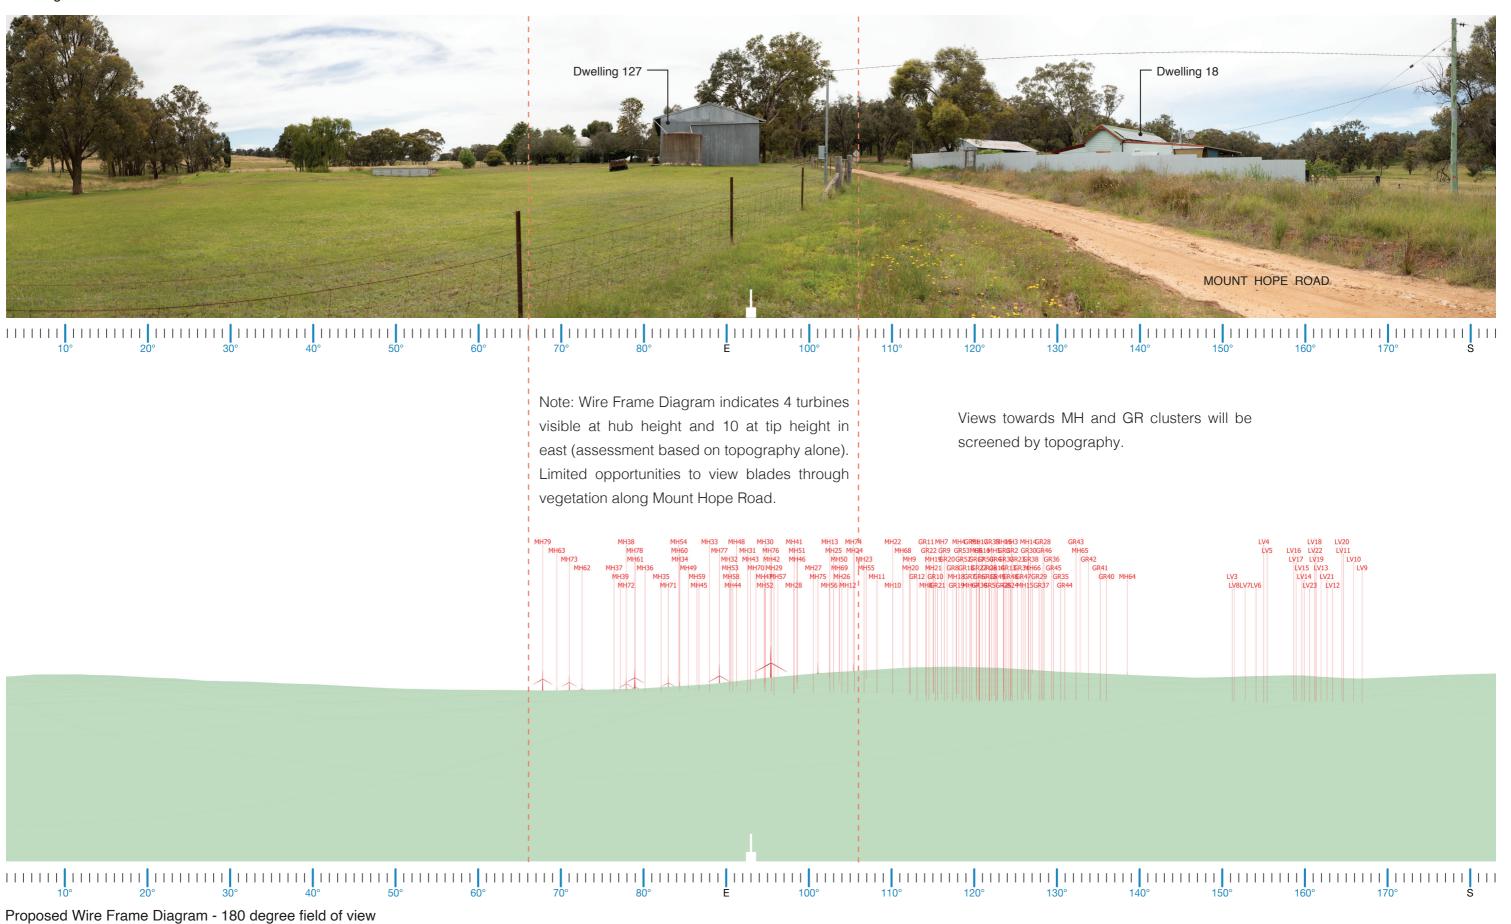
### 180 Degree Baseline Panorama

### E.1. Dwelling Assessment Dwelling 18

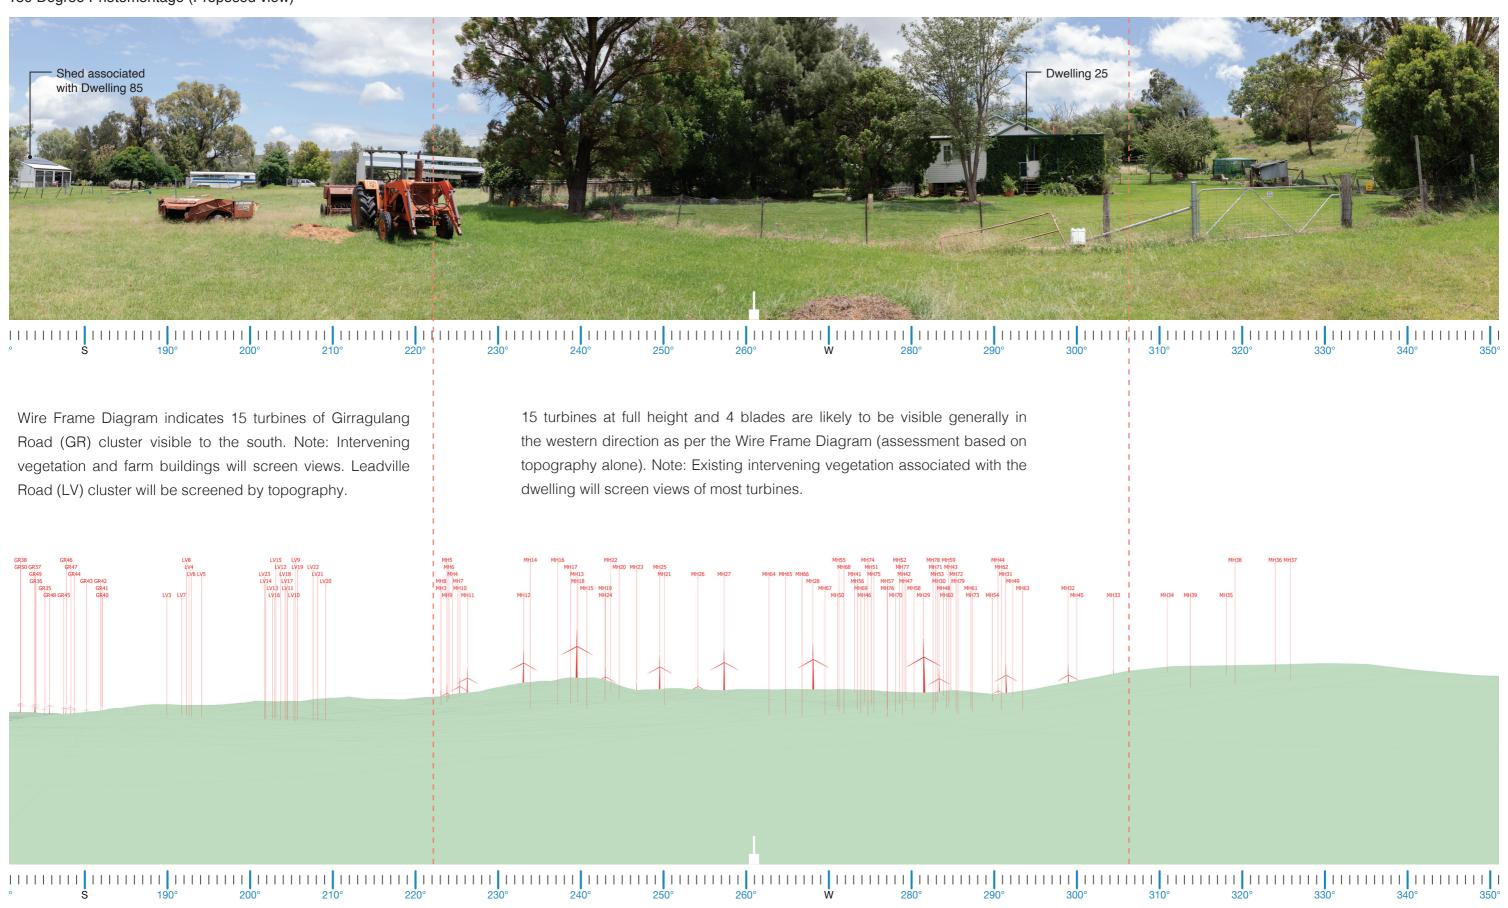
180 Degree Photomontage (Proposed view)

### E.2. Dwelling Assessment Dwelling 25

An assessment based on topography alone identified a total of 73 turbines (18 at tip height and 55 at hub height) would be visible, of which 47 turbines are located within 8km of this dwelling. A viewpoint was taken on the eastern side of the house to represent views from the property and to assess the potential impact of the Project. Aerial imagery indicates that the dwelling is surrounded by scattered vegetation in all directions and is orientated east-west. Prominent views of the Project will be in the western direction and the dwelling is surrounded by dense windbreak vegetation on the western side. A gentle rise in the topography to the northwest will help screen views towards some turbines in this direction. Existing vegetation along the dwelling's western boundary will help fragment most views but given the close proximity of the Project, it is likely that the tips of turbines would be partially visible at the dwelling. There are eight (8) turbines within the black line of visual magnitude and 12 within the blue line of this dwelling. The visual impact resulting from the Project has been rated as **Low** from this dwelling.

Key Feature Disruption: The Project will be a partially visible element on the ridgeline in the western direction. Views from the dwelling will be limited and fragmented by existing vegetation.

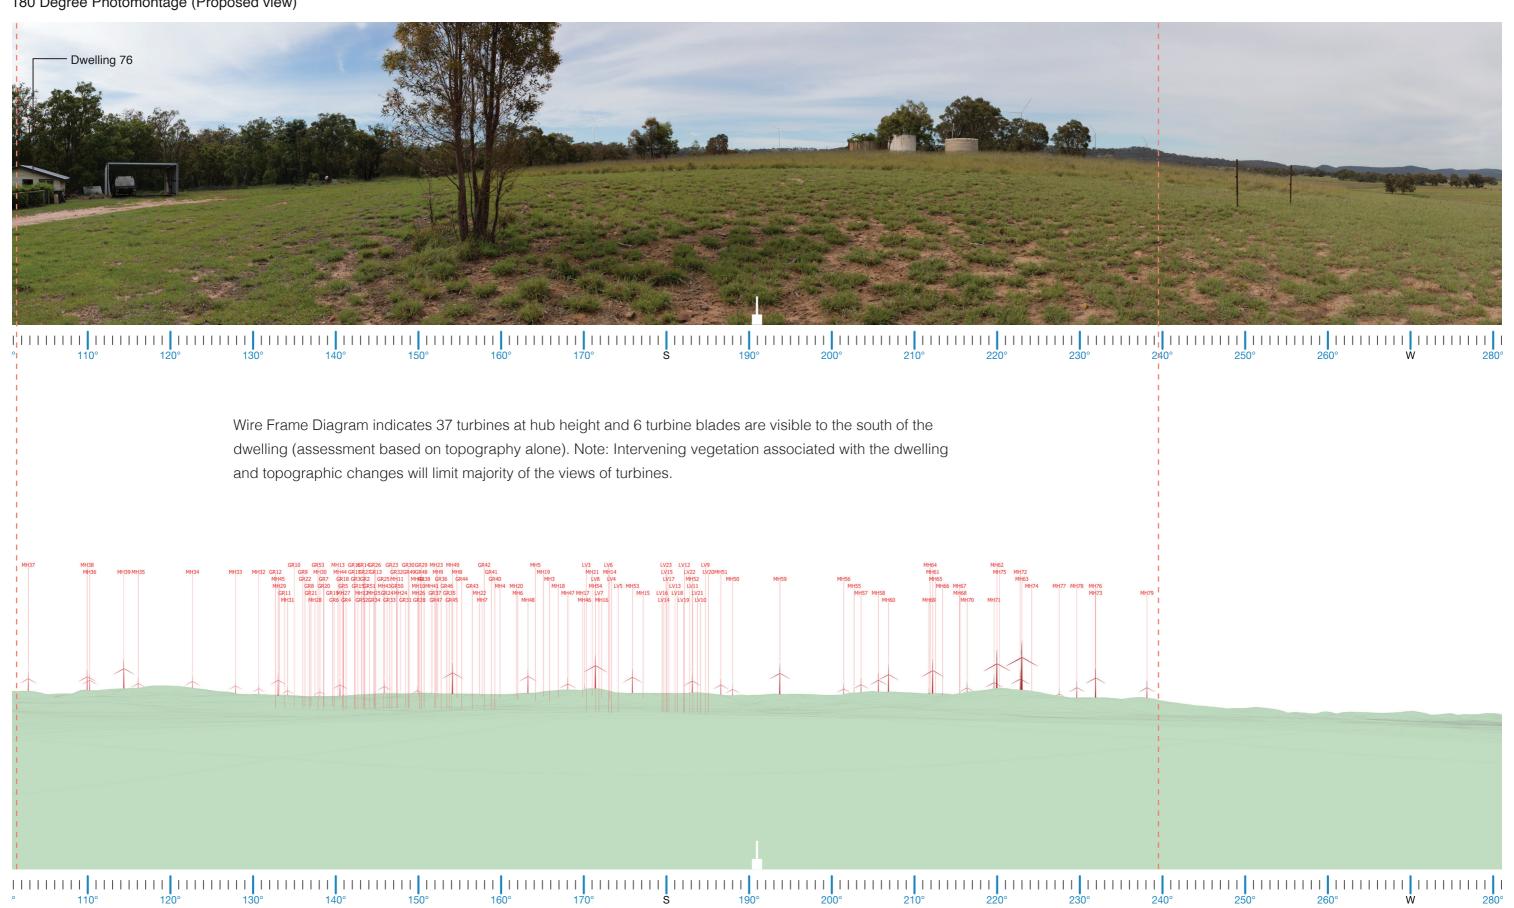
180 Degree Photomontage (Proposed view)

### E.3. Dwelling Assessment Dwelling 76

An assessment based on topography alone identified a total of 54 turbines (12 at tip height and 42 at hub height) would be visible from Dwelling 76. The dwelling is located on a gently undulating terrain to the immediate north of ridges associated with Mount Hope. A viewpoint was taken from the parking area located west of the dwelling. This assessment also represents the potential visual impact on Dwelling 77. Aerial imagery indicates that both dwellings are surrounded by dense vegetation in the foreground to the east and south and this is likely to assist in fragmenting views to majority of the turbines located south of the dwelling. The rise in topography to the south of Dwelling 76 will also play an important role in screening views. Existing windbreak plantation along the west/southwest boundaries will also assist in fragmenting views towards some of the turbines from both these dwellings. There are four (4) turbines within the black line of visual magnitude and 18 within the blue line of this dwelling. The visual impact resulting from the Project has been rated as *Low*.

Key Feature Disruption: The Project will be a visible on the ridgeline, but the views will be disrupted by existing landscape features.

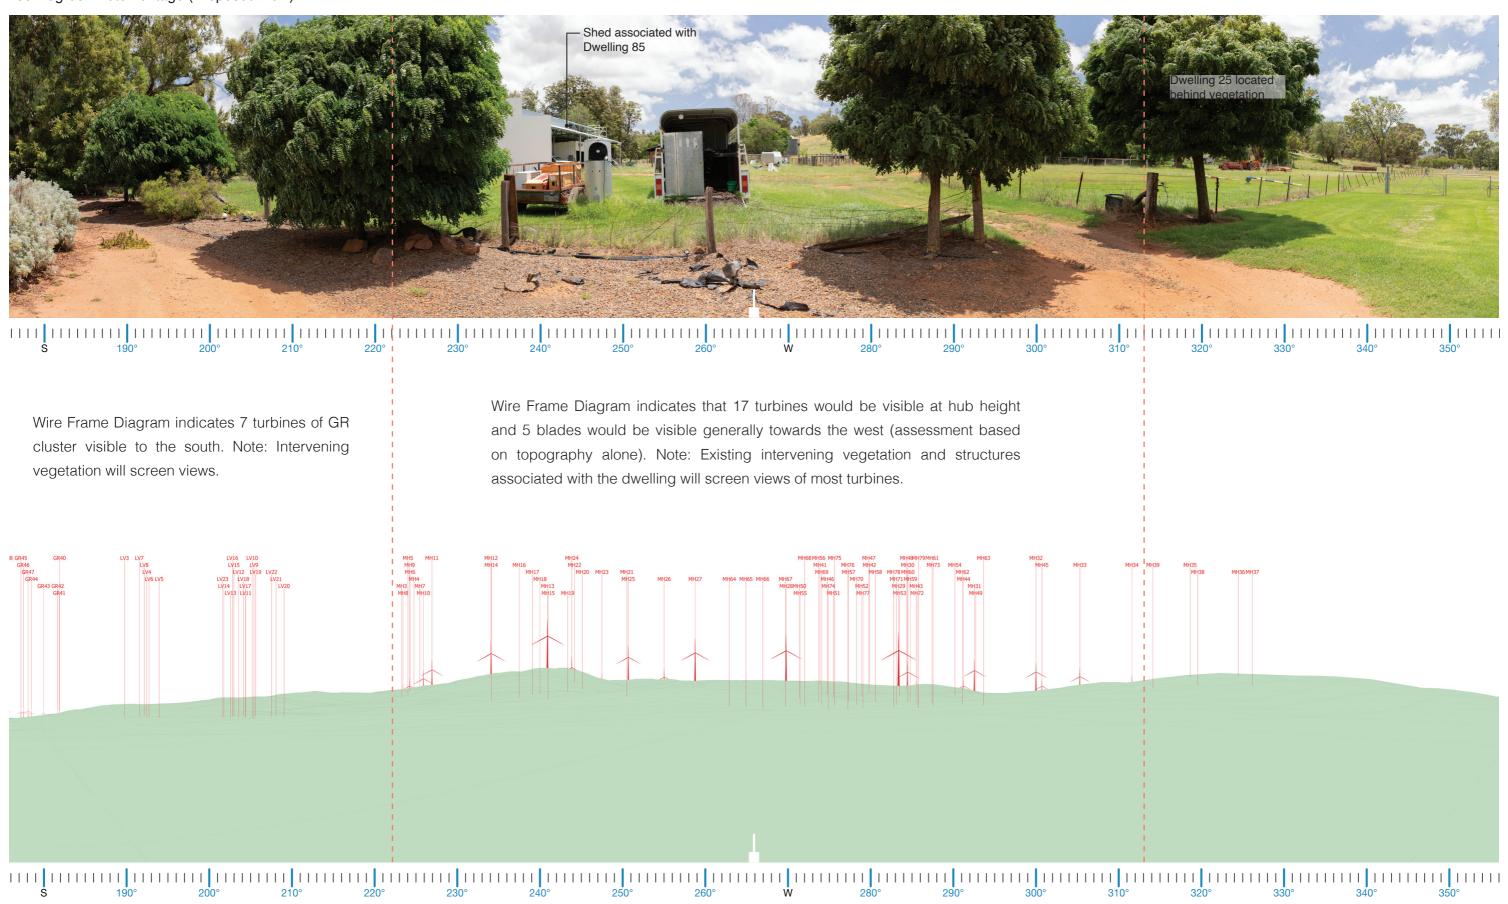
180 Degree Photomontage (Proposed view)

### E.9. Dwelling Assessment Dwelling 85

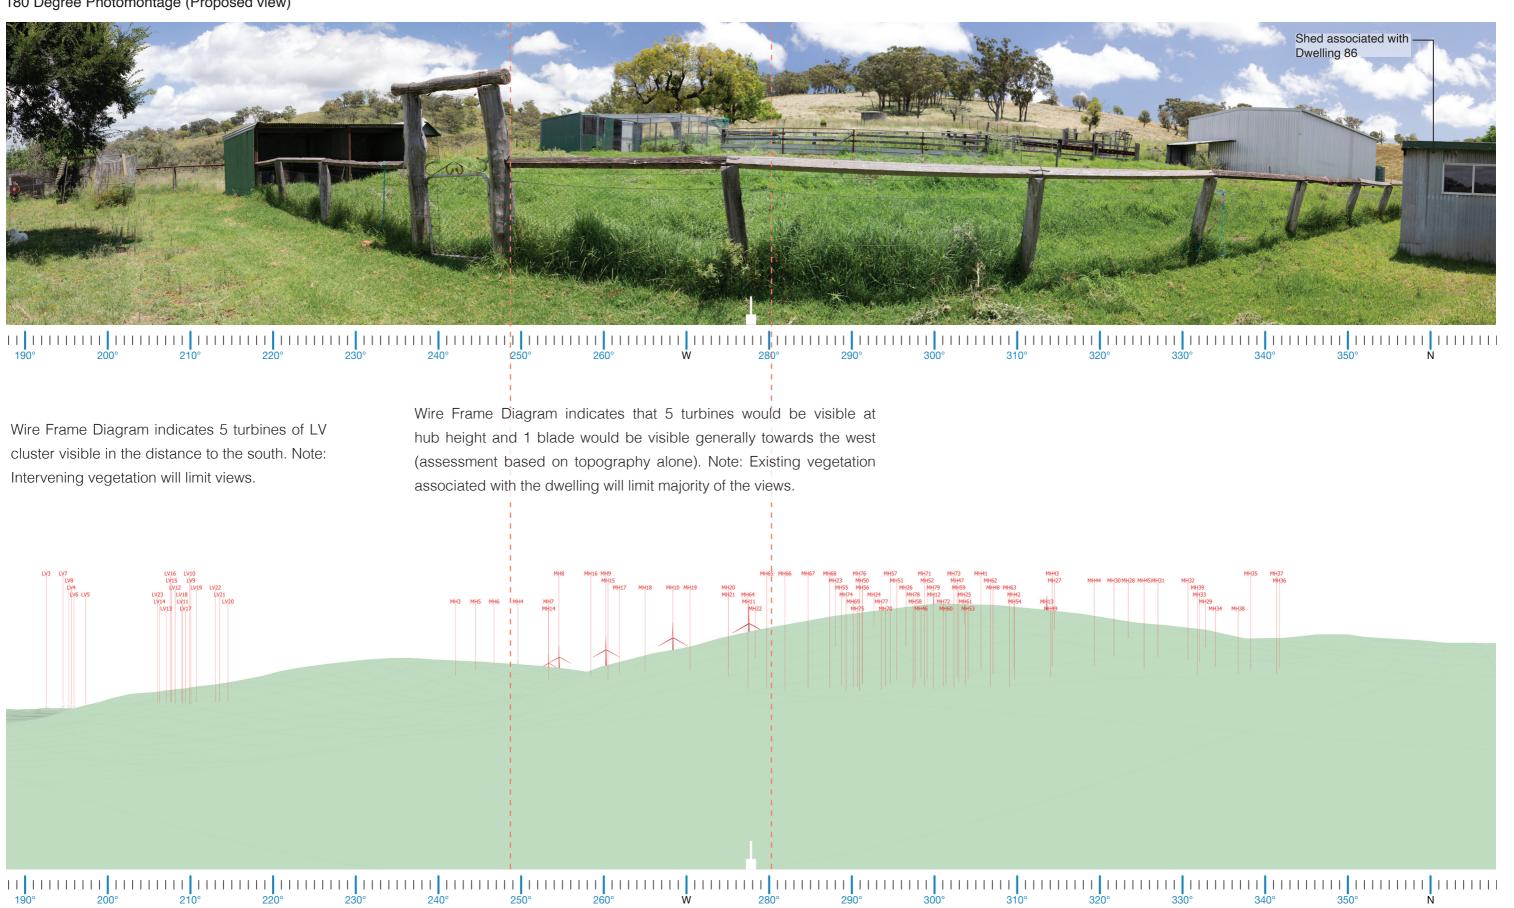
180 Degree Photomontage (Proposed view)

### E.10. Dwelling Assessment Dwelling 86

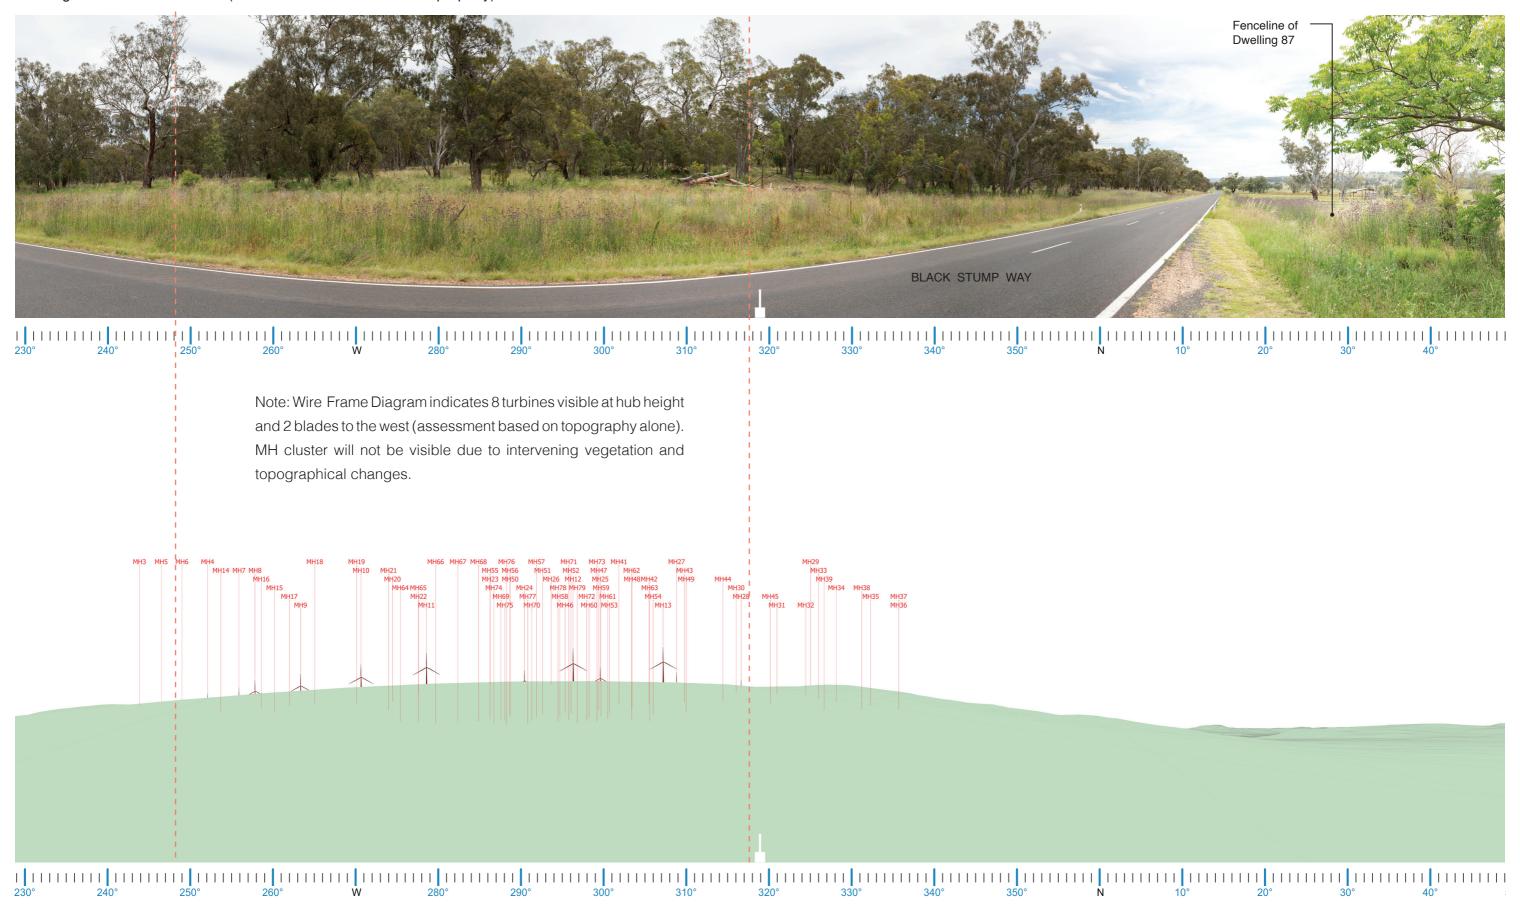
180 Degree Baseline Panorama (Indicative view from mailbox of property)

### E.11. Dwelling Assessment Dwelling 87

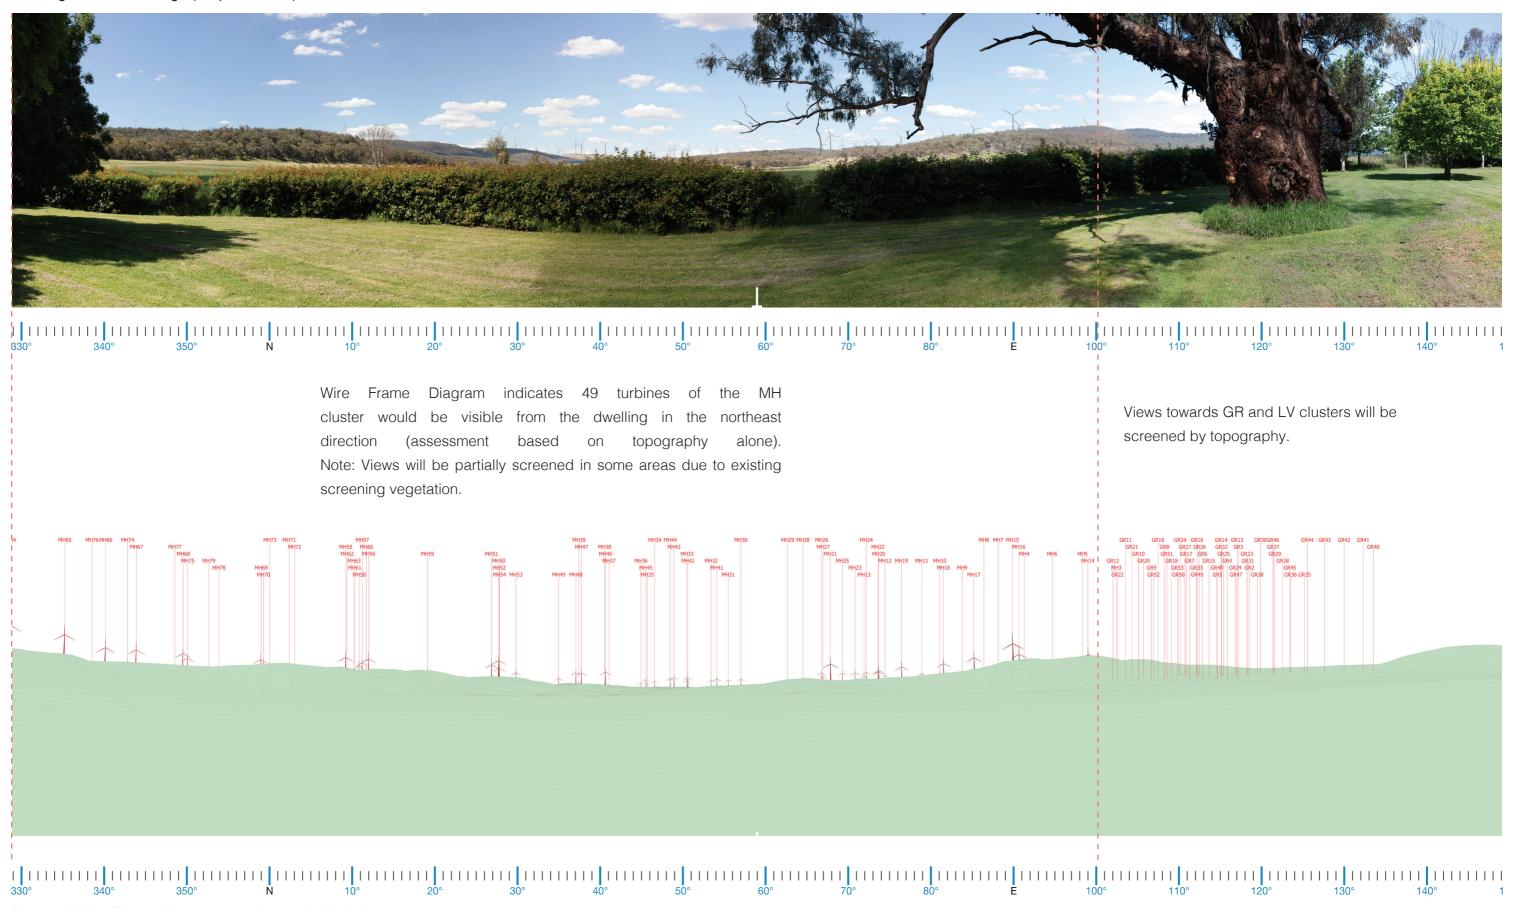
180 Degree Photomontage (Proposed view)

# E.16. Dwelling Assessment Dwelling 298

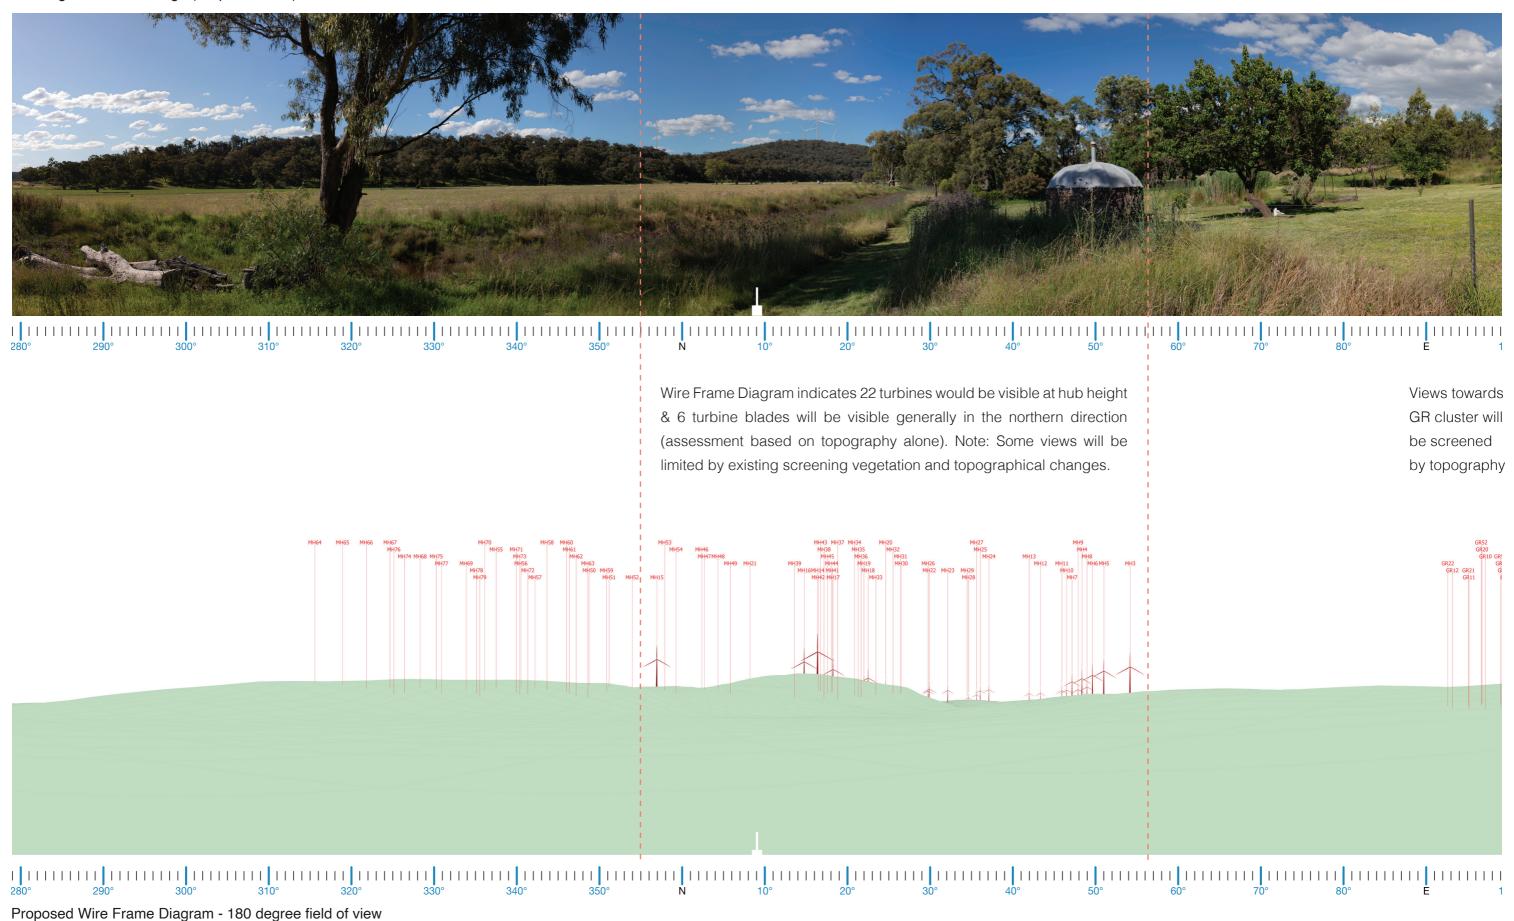
180 Degree Photomontage (Proposed view)

# E.17. Dwelling Assessment Dwelling 314

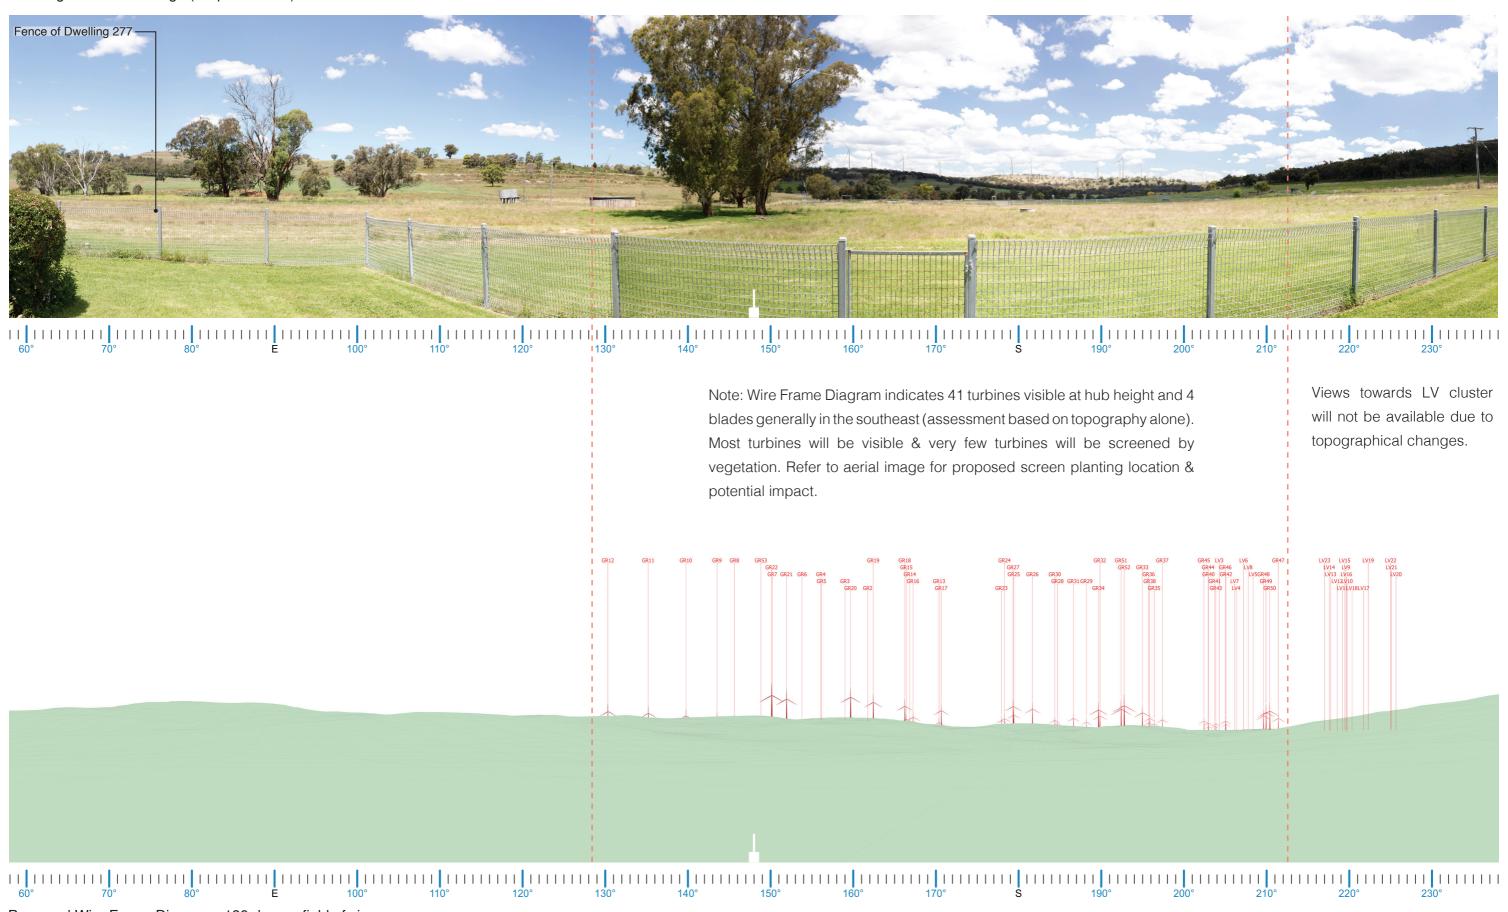
180 Degree Photomontage (Proposed view)

# E.22. Dwelling Assessment Dwelling 277

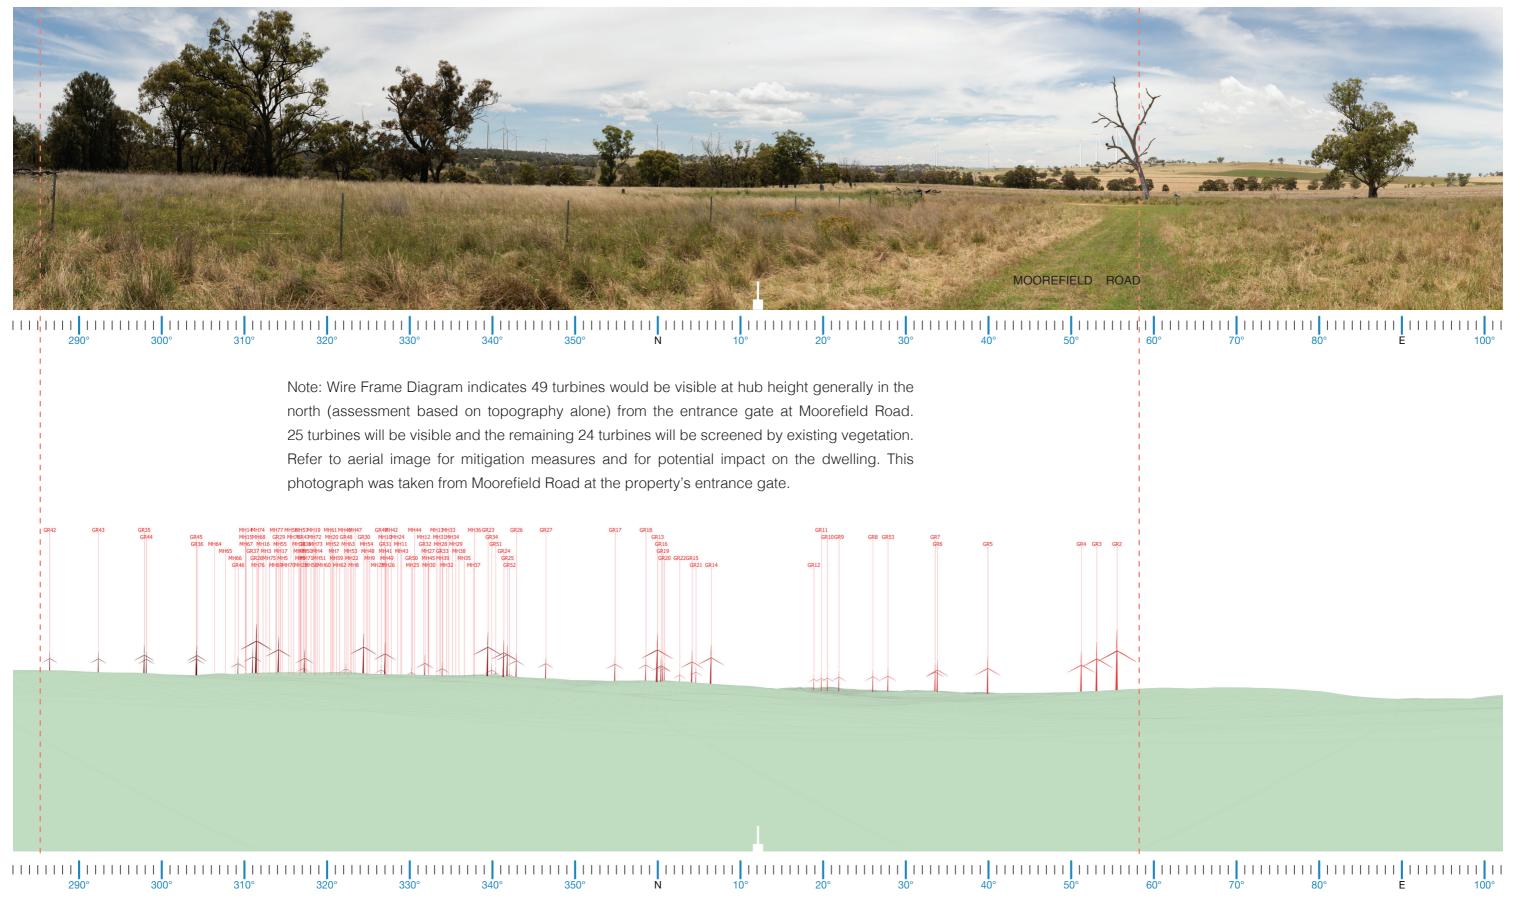
180 Degree Photomontage (Proposed view - as viewed from Moorefield Road)

# E.25. Dwelling Assessment Dwelling 497

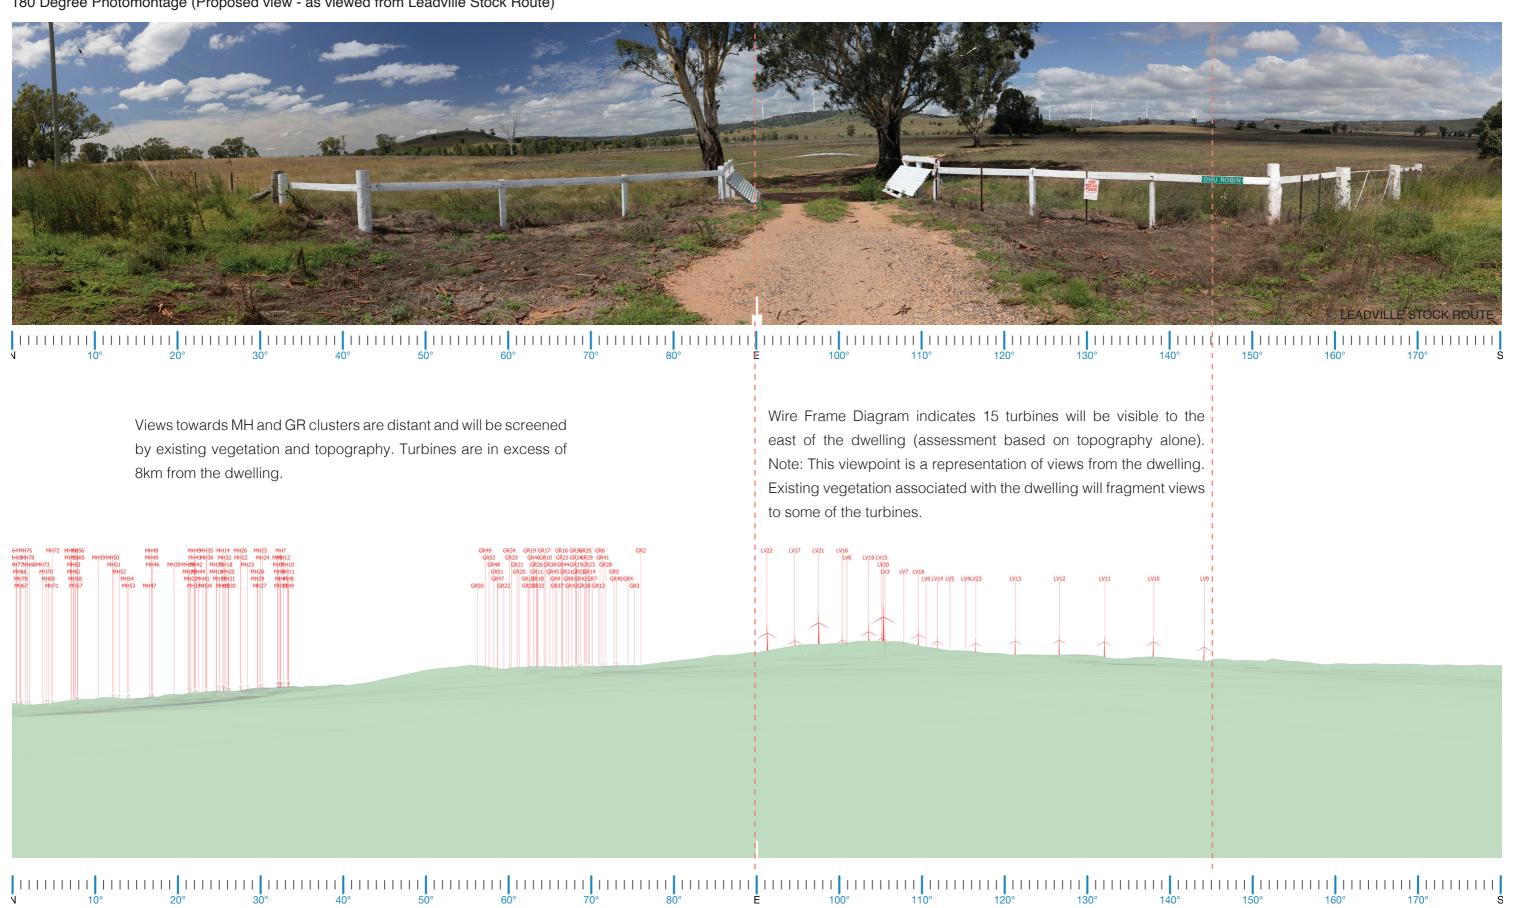
180 Degree Photomontage (Proposed view - as viewed from Leadville Stock Route)

# E.26. Dwelling Assessment Dwelling 20

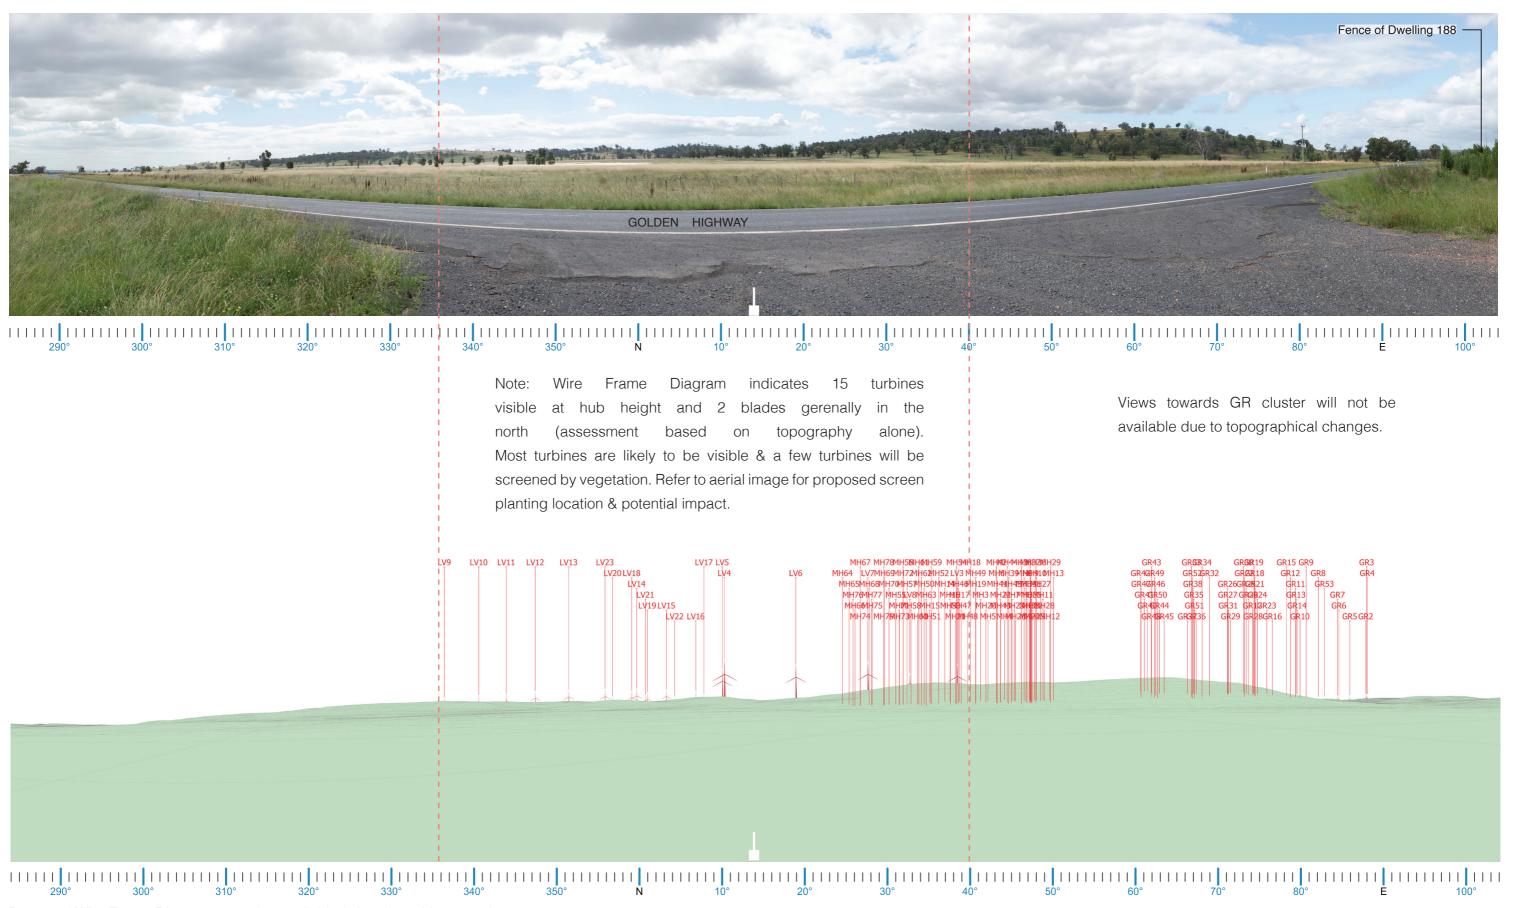
180 Degree Baseline Panorama (Indicative view from driveway of property)

# E.30. Dwelling Assessment Dwelling 188

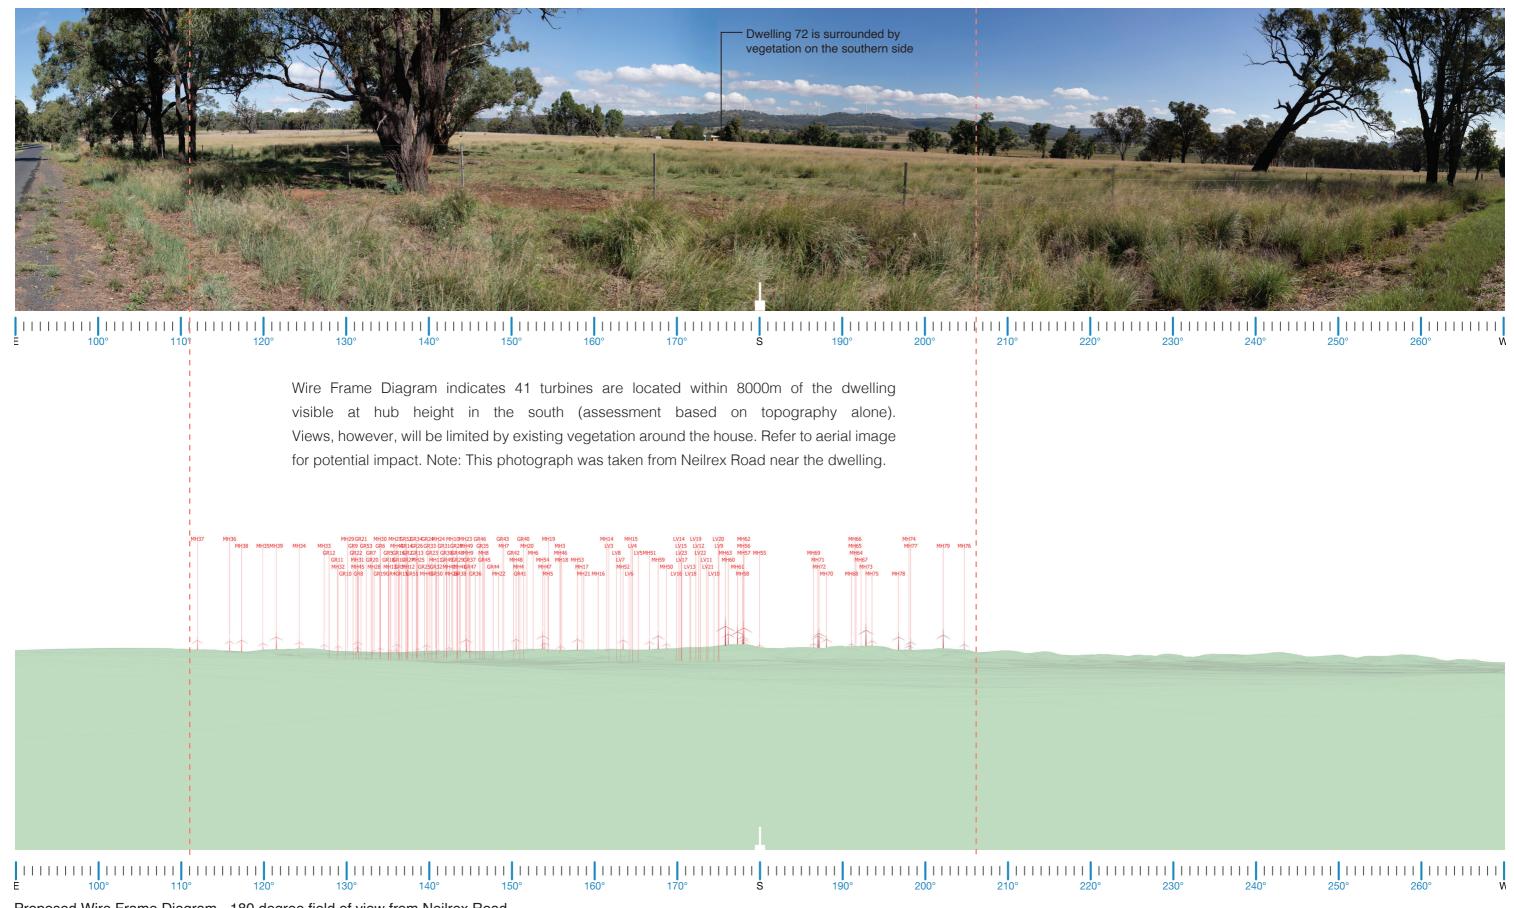
180 Degree Photomontage (Proposed view - as viewed from Neilrex Road)

# E.35. Dwelling Assessment Dwelling 72

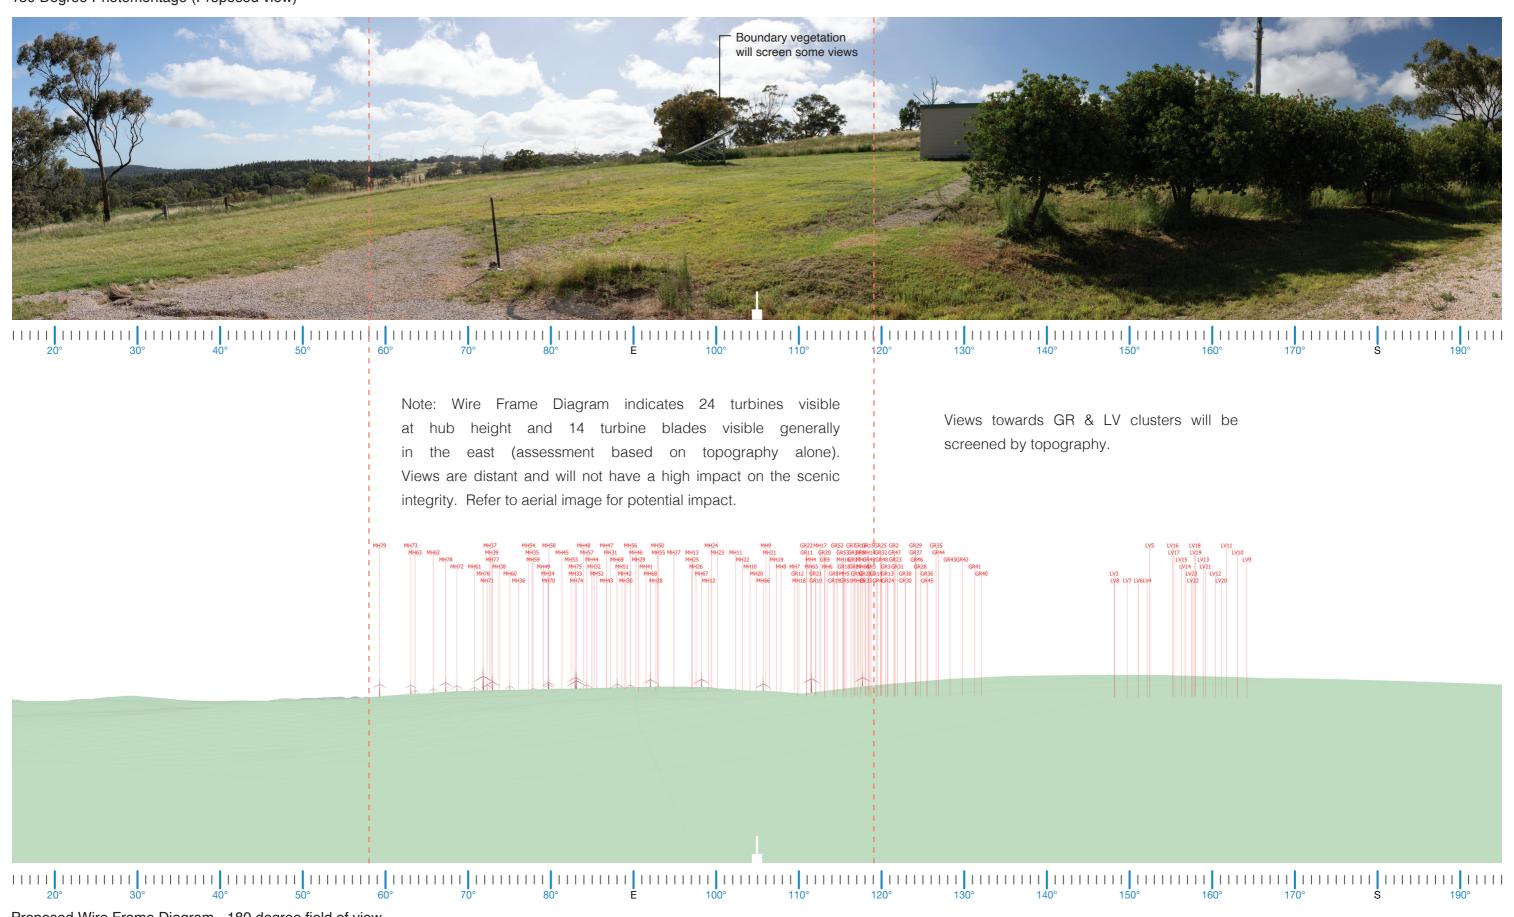
180 Degree Photomontage (Proposed view)

# E.38. Dwelling Assessment Dwelling 128

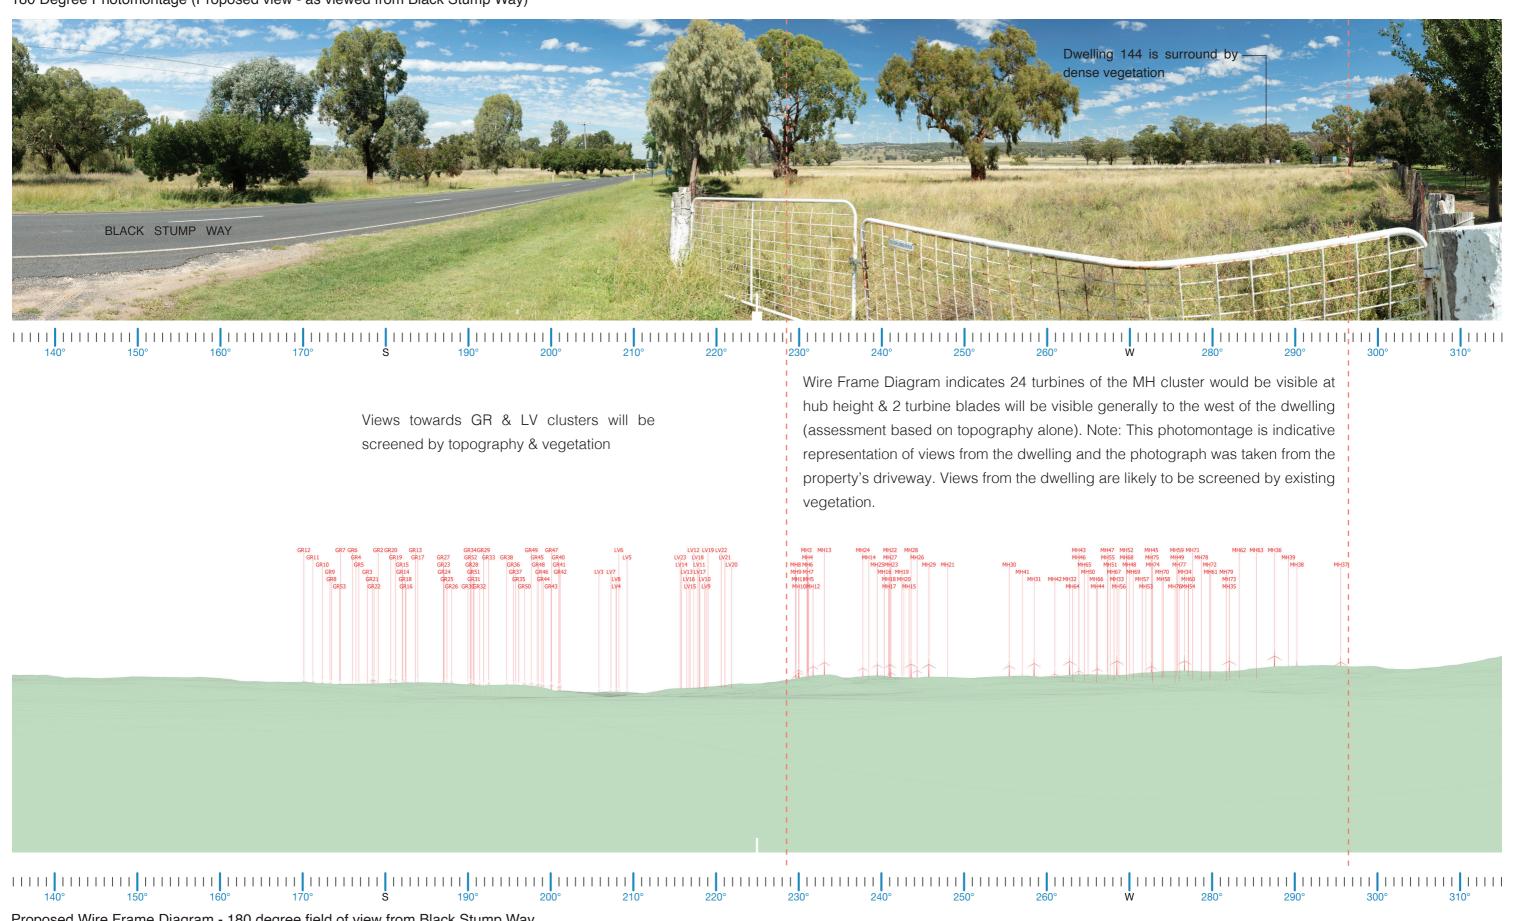
180 Degree Photomontage (Proposed view - as viewed from Black Stump Way)

# E.41. Dwelling Assessment Dwelling 144

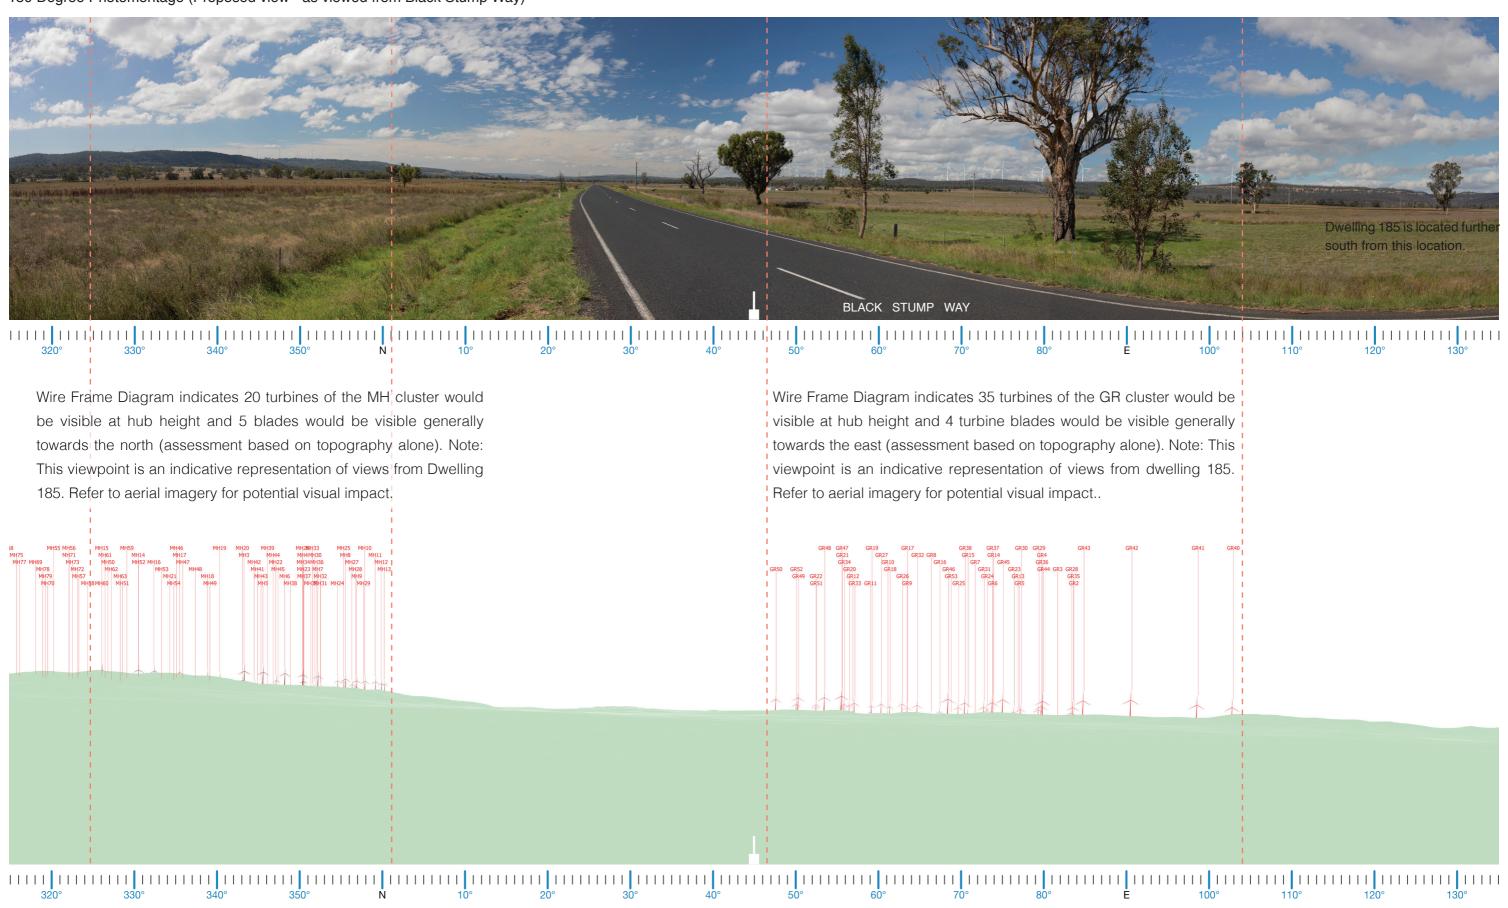
180 Degree Photomontage (Proposed view - as viewed from Black Stump Way)

# E.46. Dwelling Assessment Dwelling 185
