Appendix E
Detailed Dwelling Assessments

Detailed Dwelling Assessments

Dwellings within 3350m

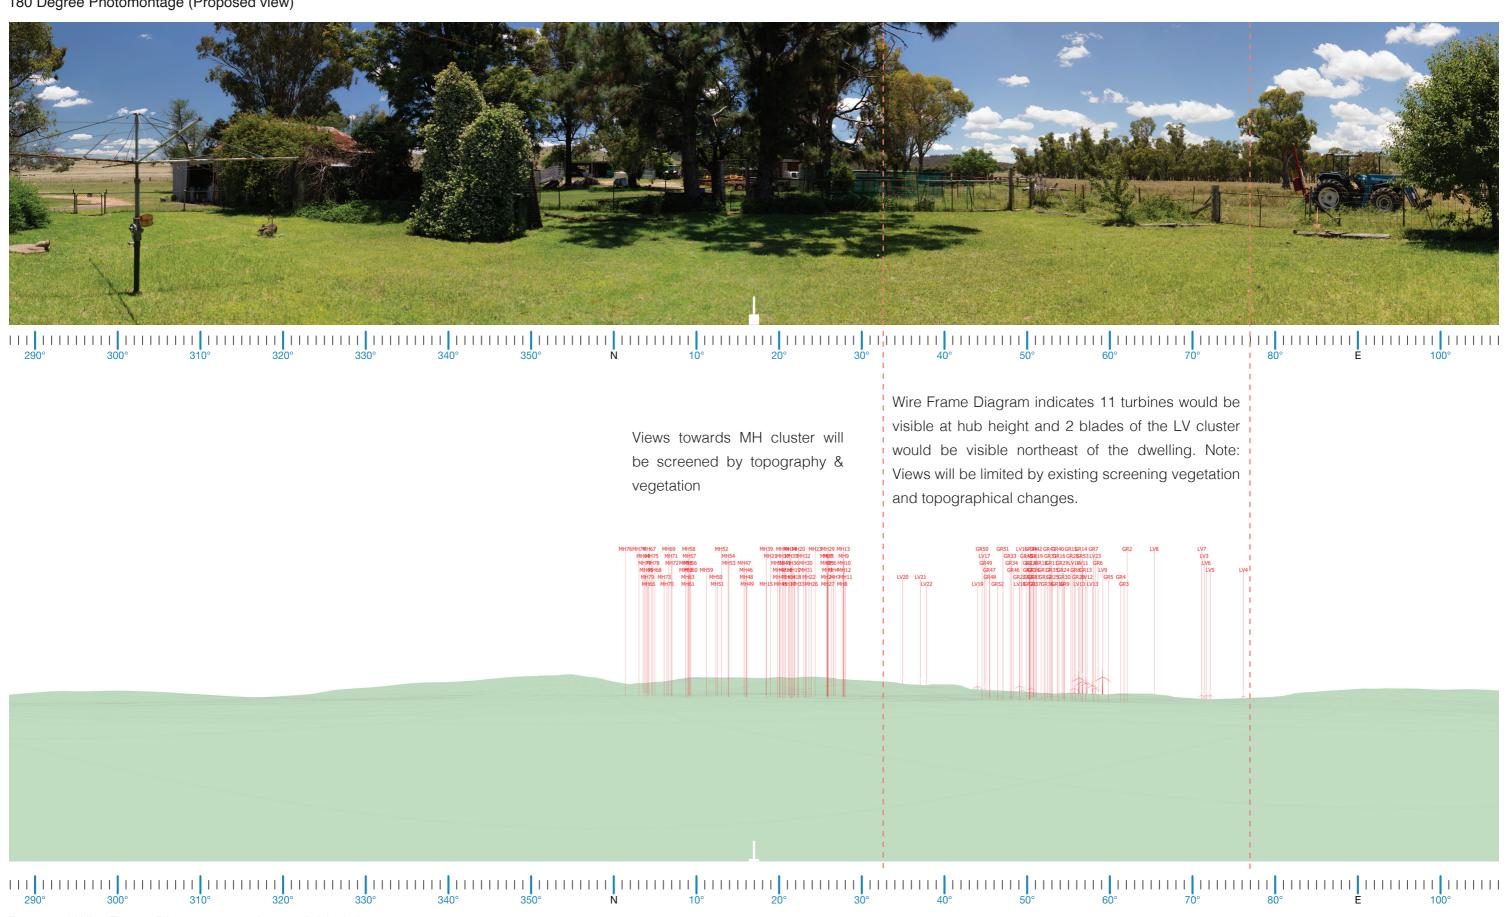
180 Degree Photomontage (Proposed view)

# E.58. Dwelling Assessment Dwelling 193

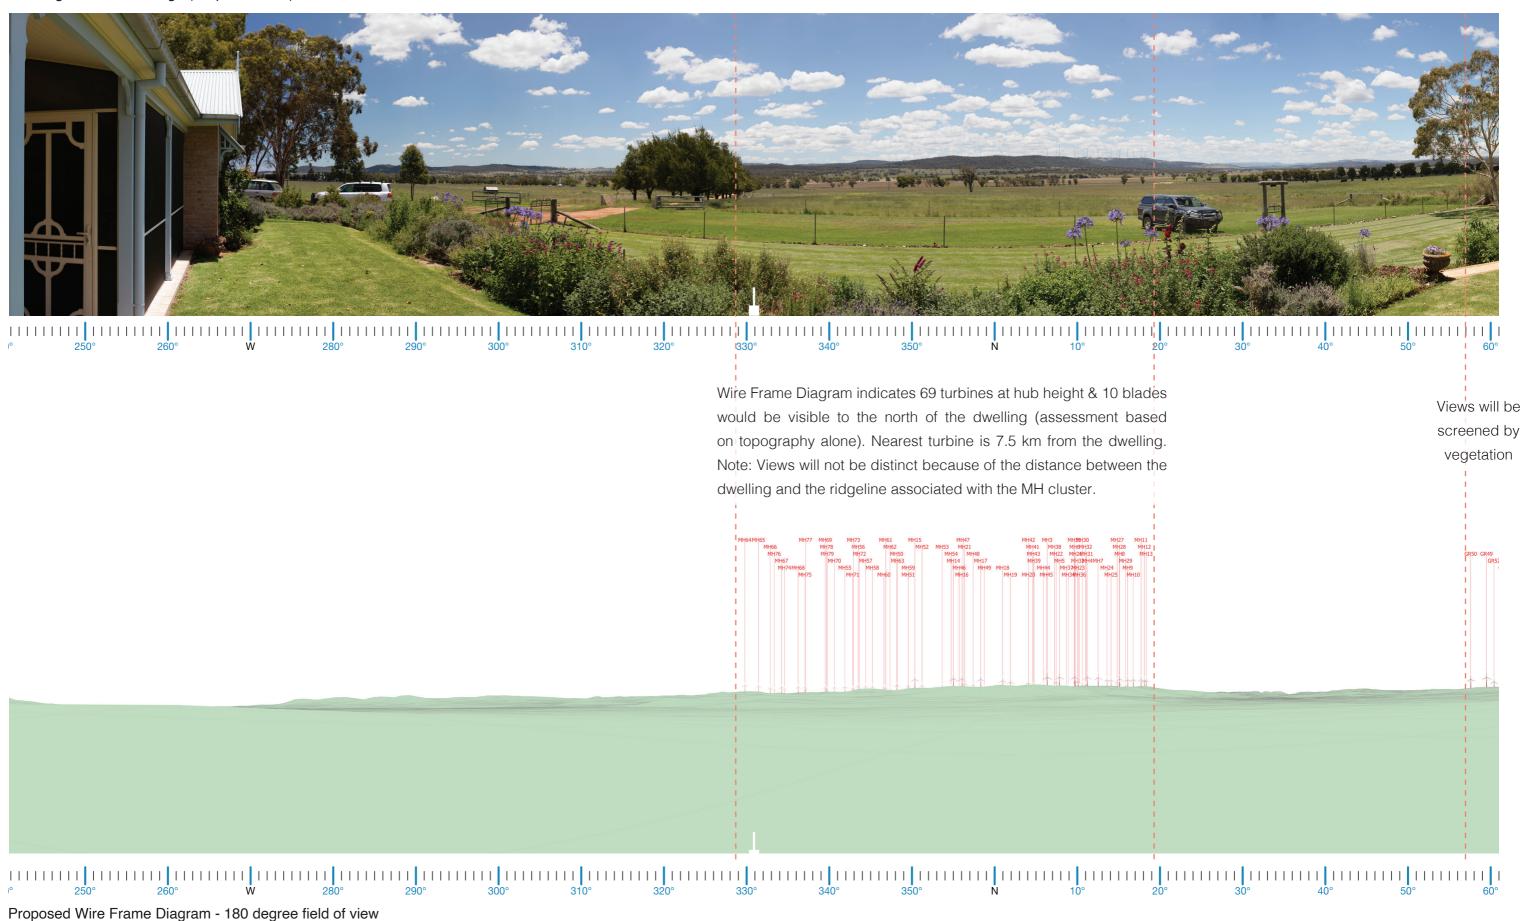
180 Degree Photomontage (Proposed view)

# E.63. Dwelling Assessment Dwelling 184

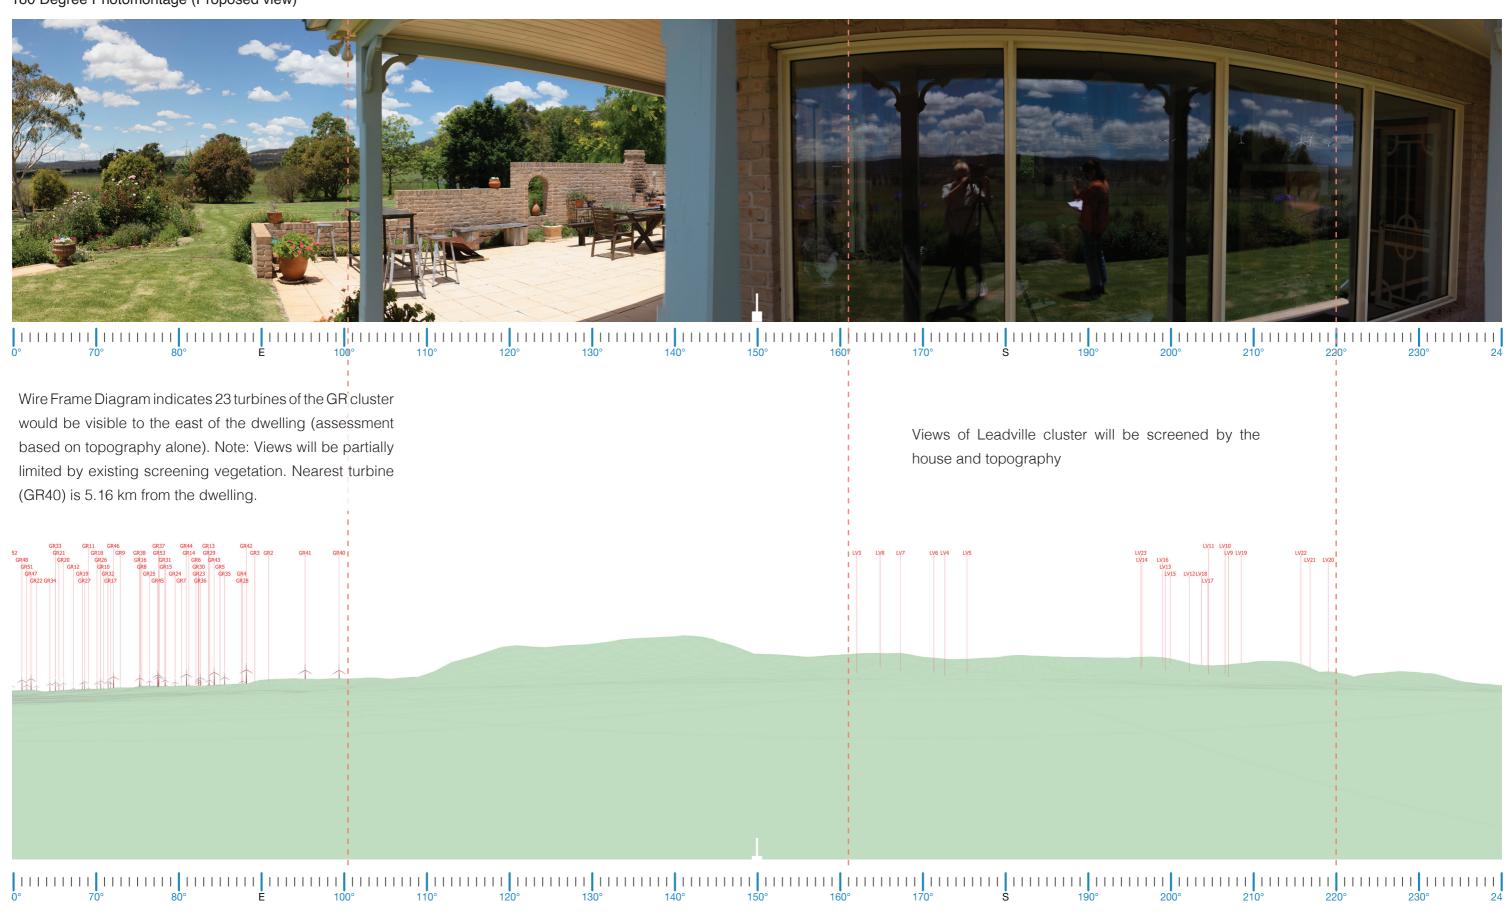
180 Degree Photomontage (Proposed view)

# **E.63.** Dwelling Assessment Dwelling 184 (Representative of Dwelling 183, located outside 4950m)
