Additional Detailed Dwelling Assessments
(Public Exhibition)

B1. Dwelling Assessment Dwelling 284

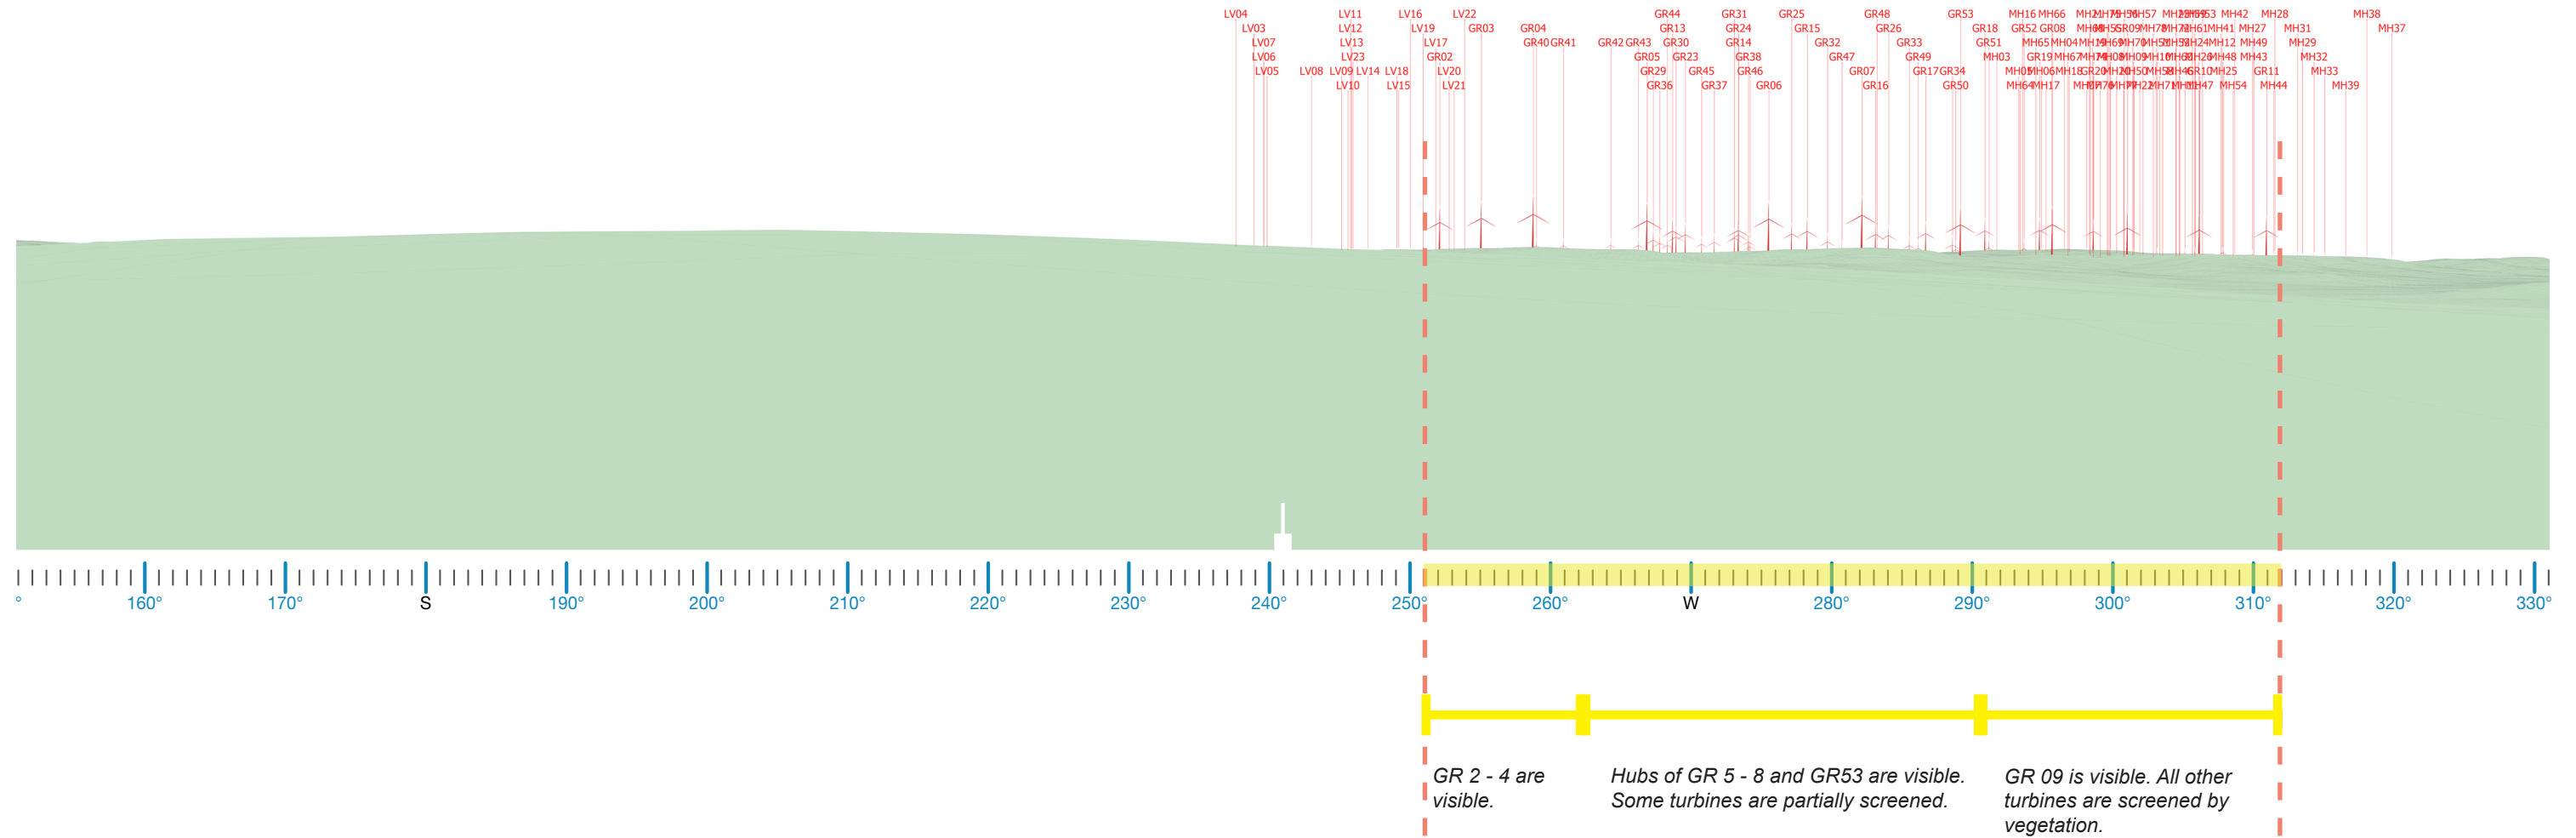
Wire Frame Diagram - 180 degree field of view

The turbines will be visible in one (1) 60 degree sector however turbines to the north west will be predominantly screened by existing vegetation and built form. Views to the west towards turbines located approx 3.9 km away are open and, subsequently, the turbines will be a noticeable element in the view for this dwelling. The scenic quality rating of the landscape is LOW. It has been determined that the Visual Impact Rating for this dwelling is LOW.

Screening of the project is achievable. Tree planting along the fenceline to the west of the dwelling would potentially reduce the Visual Impact Rating to NEGLIGIBLE. Consultation with the landowner would be required to discuss appropriate mitigation options.

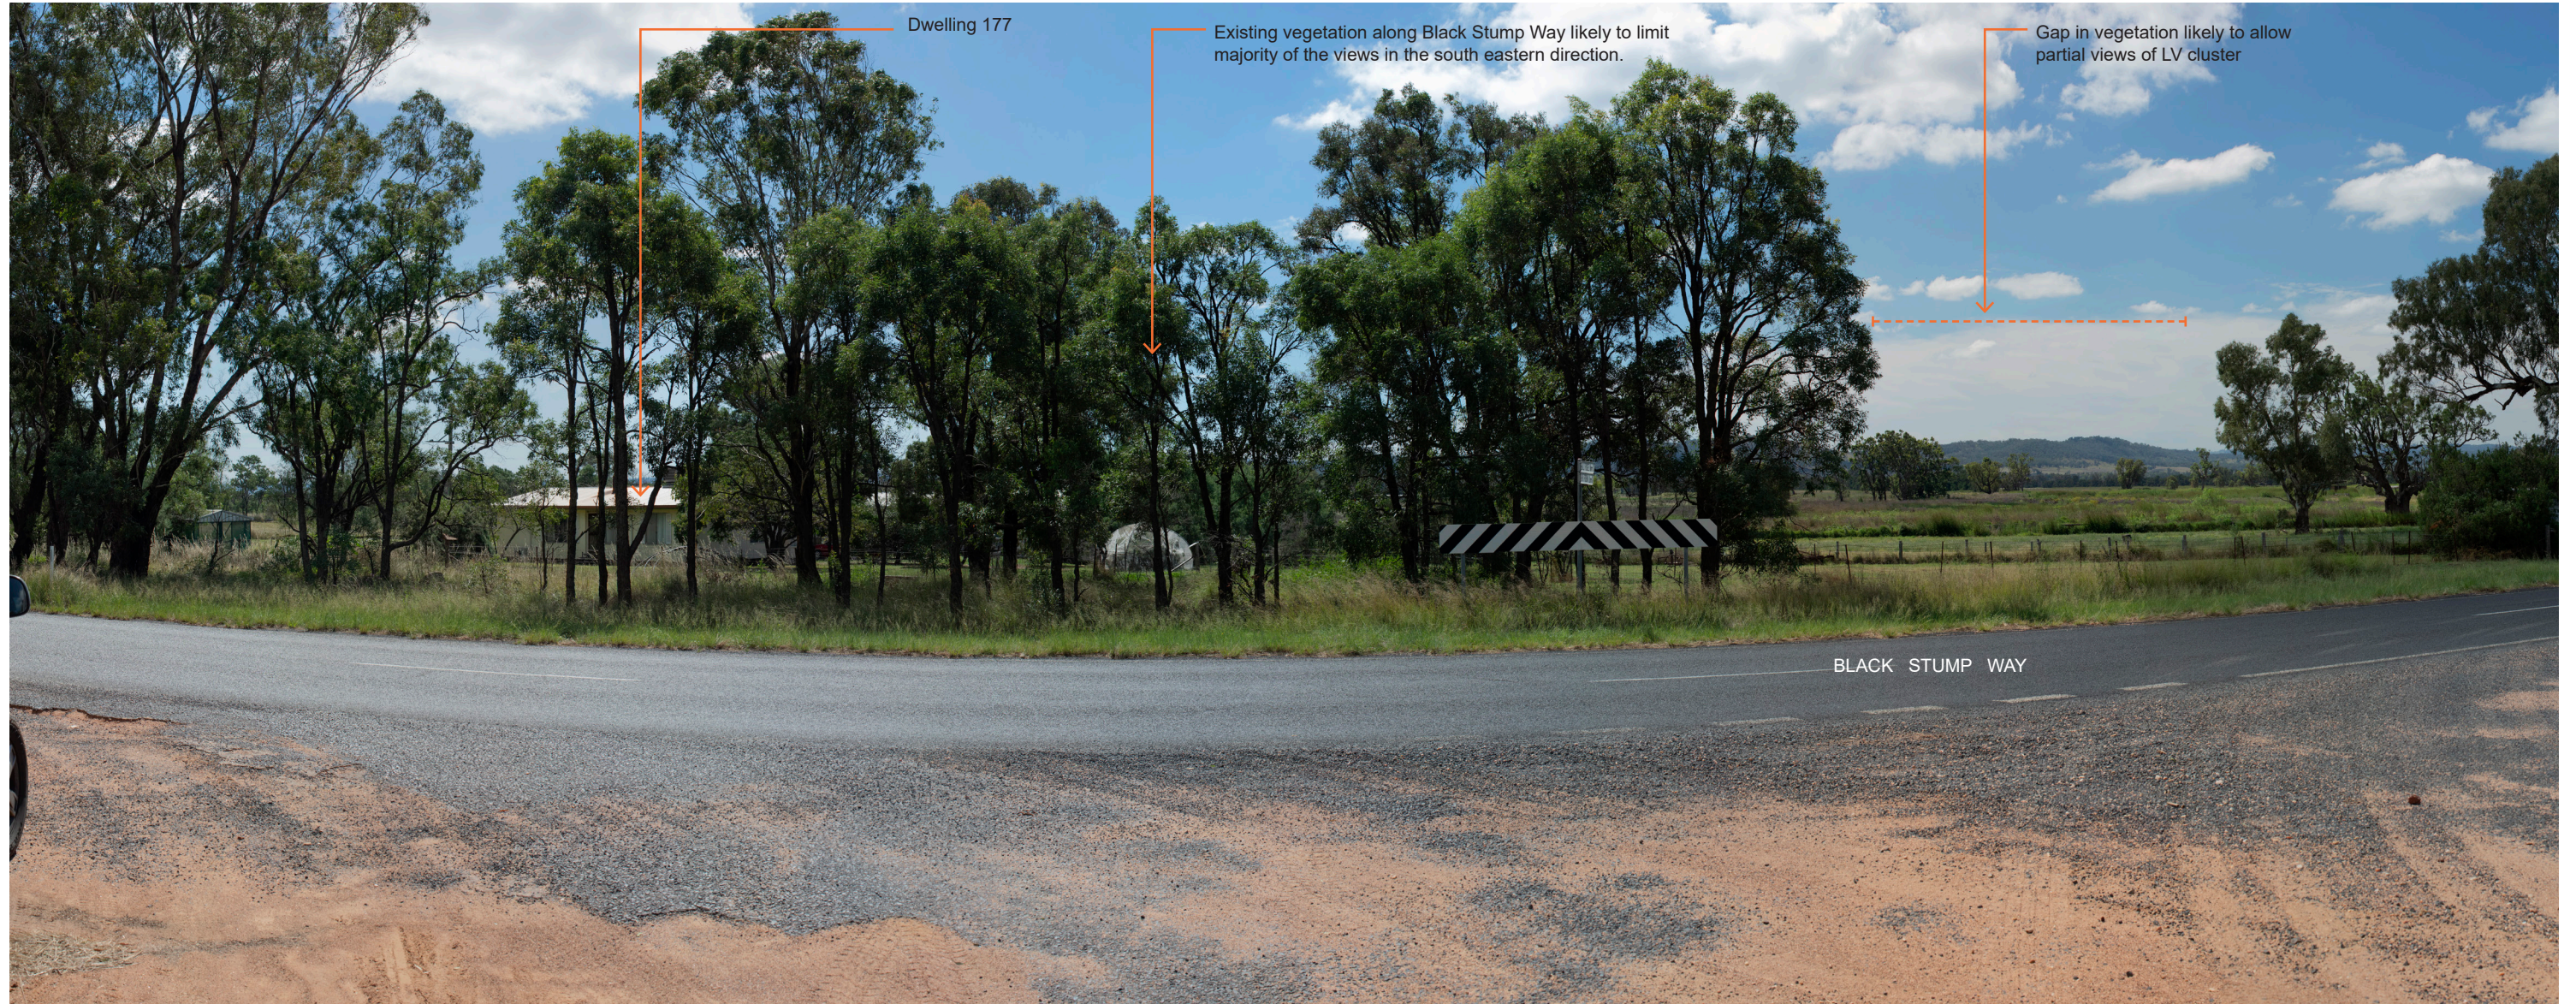
Existing view (photographed from intersection of Black Stump Way and Leadville Stock Route to the south of dwelling 177)

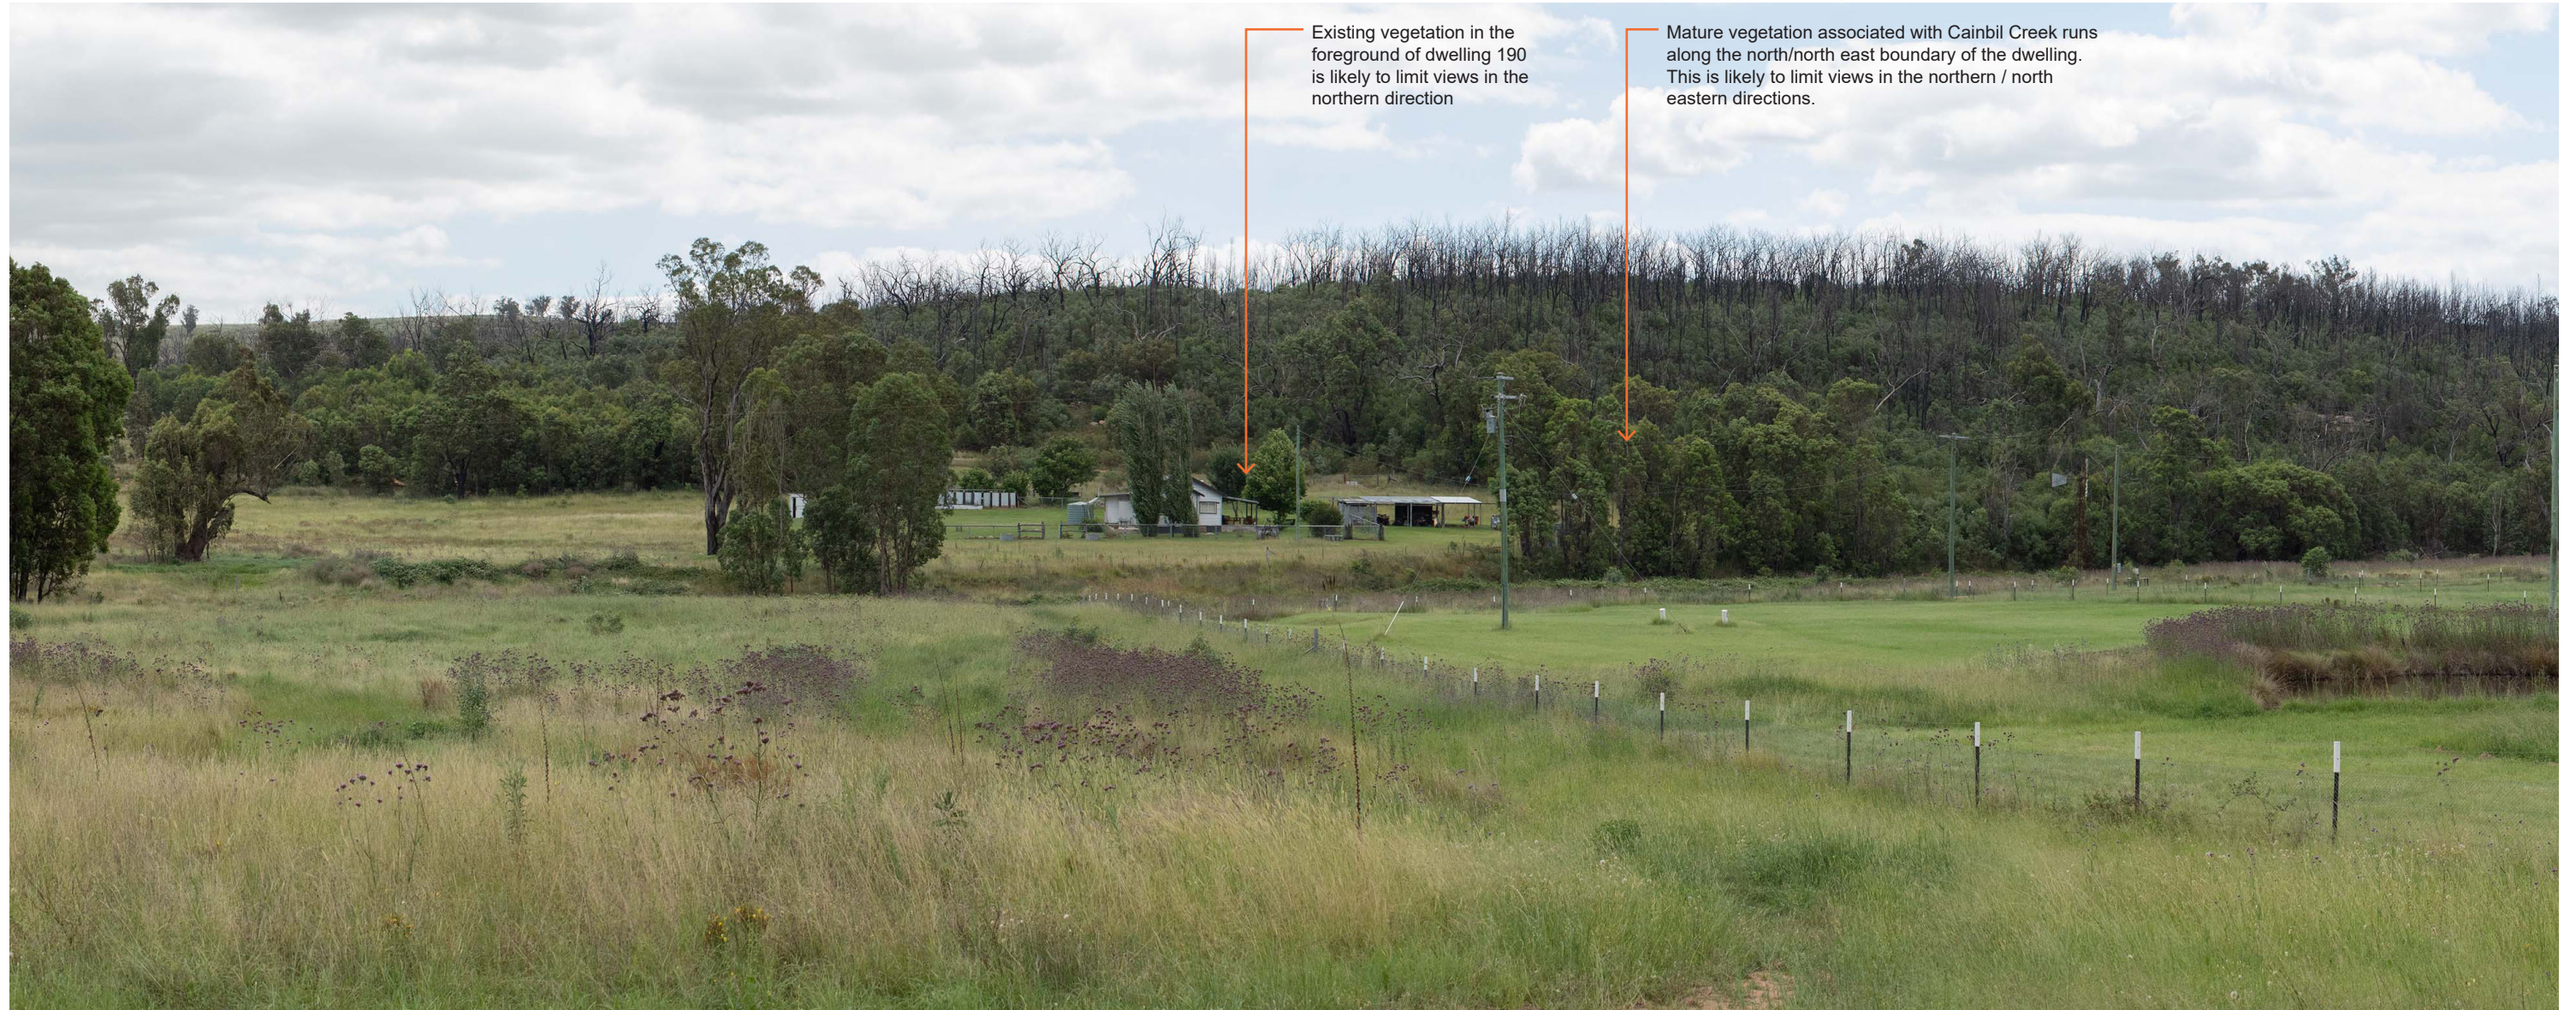
Existing view (photographed from route off Golden Highway which is used to access dwellings 190 and 189. Photograph location is to the west of dwelling 190.

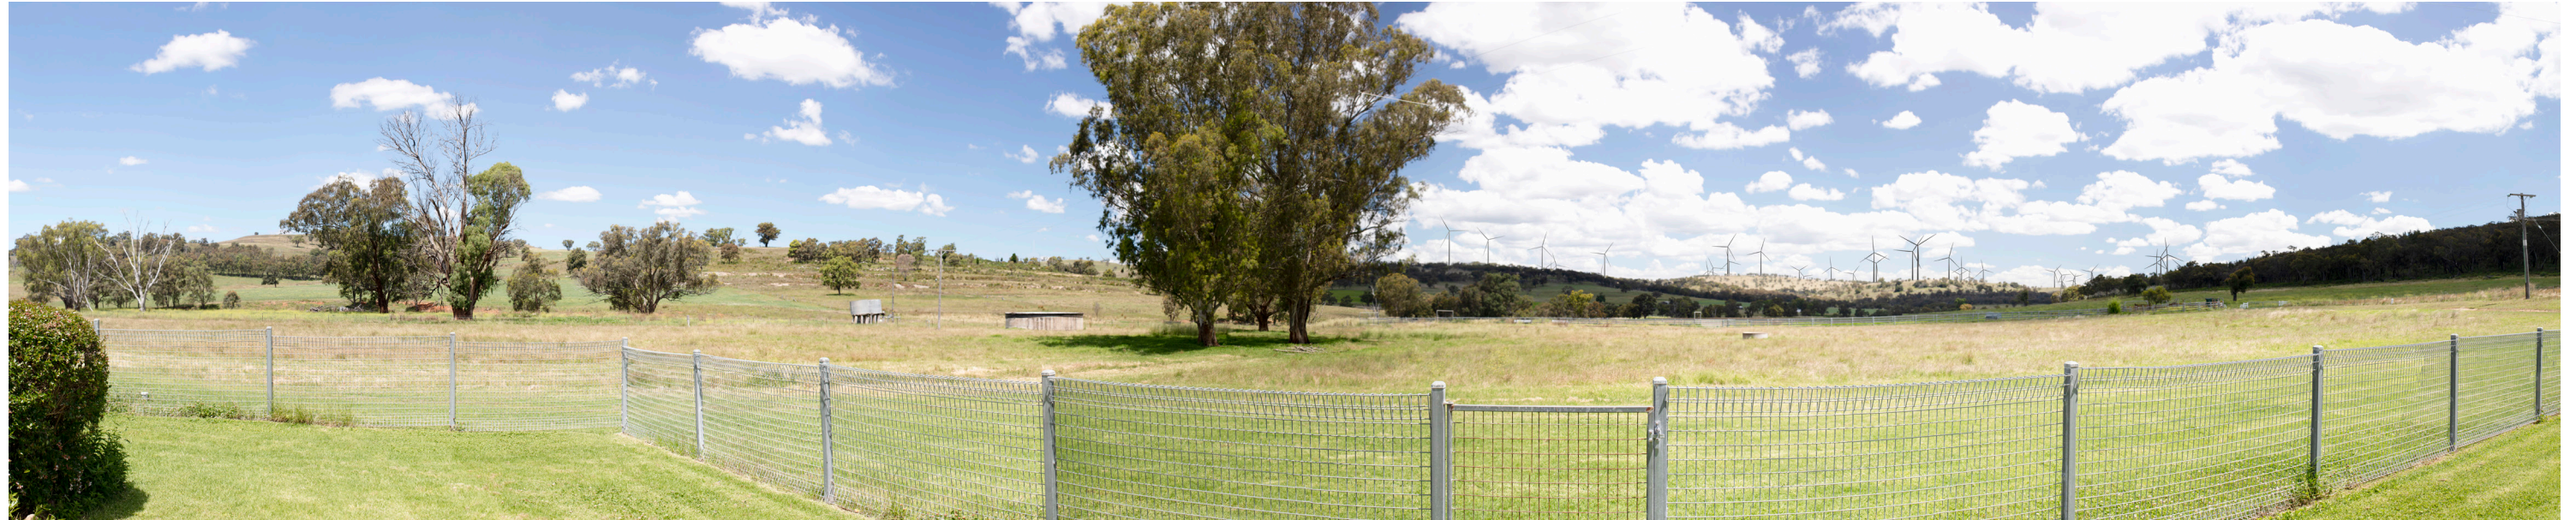
180 Degree Photomontage (Proposed view)

The turbines will be visible in three (3) 60 degree sectors however turbines to the north west will be screened by existing terrain. Views to the west towards turbines located approx 3.31 km away are open and, subsequently, the turbines will be a noticeable element in the view for this dwelling. The scenic quality rating of the landscape is MODERATE and the Project. It has been determined that the Visual Impact Rating for this dwelling is HIGH.

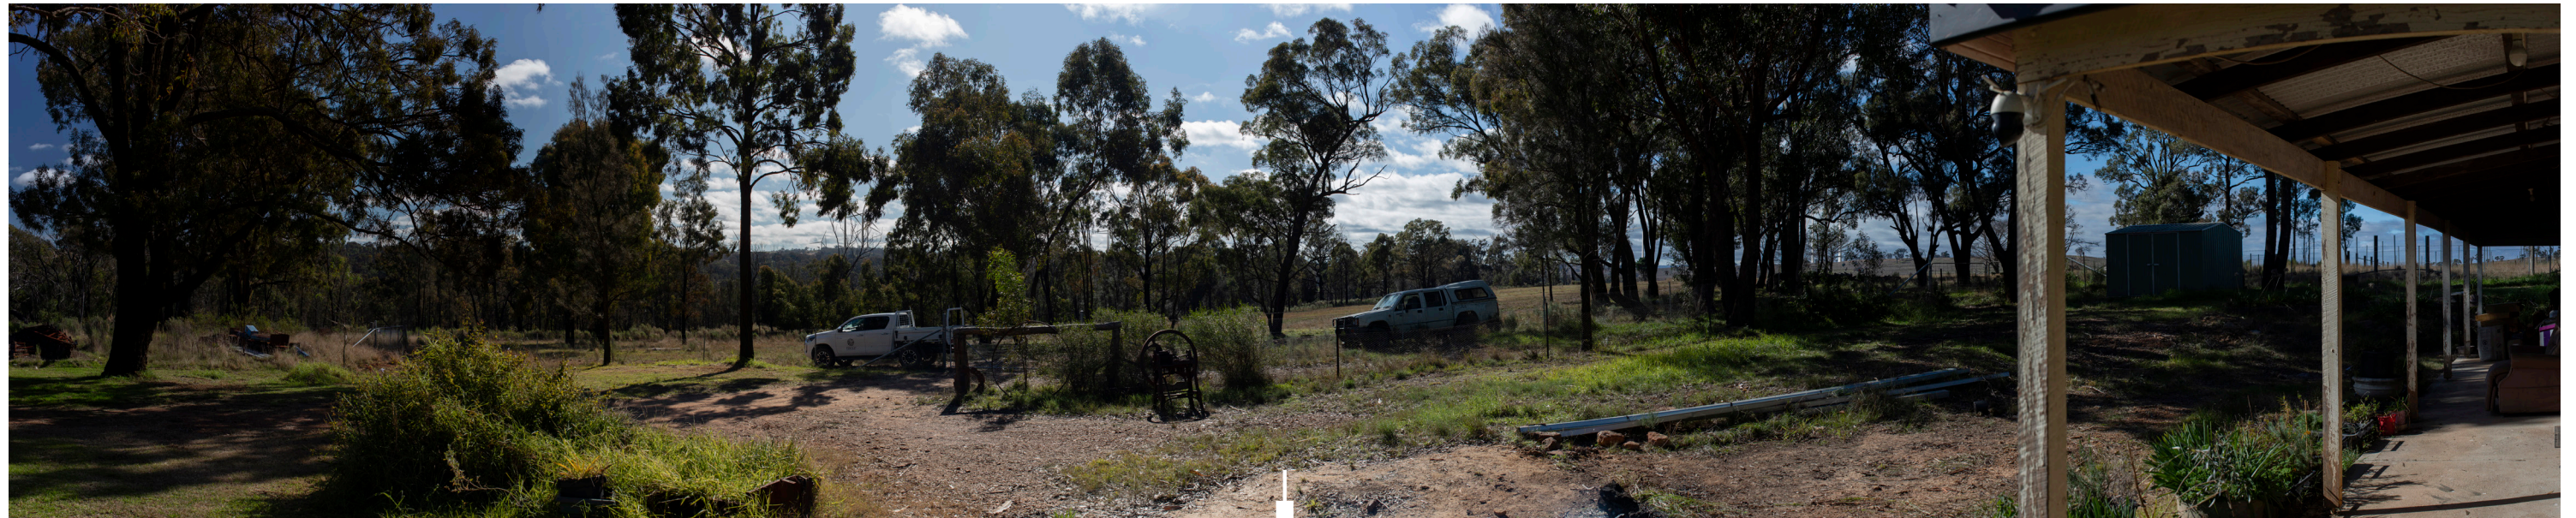
180 Degree Photomontage (Proposed view 1 - looking north)

The dwelling is accessed via Moorefield Road. Moir LA visited the dwelling in June 2022 to identify existing conditions and prepare a photomontage to identify potential visual impacts. Existing vegetation and the farm buildings in the north, west and south west will help to limit views toward majority of the Project. It is likely that up to 15 turbines will be partially visible. There are 10 turbines within the black line of visual magnitude.

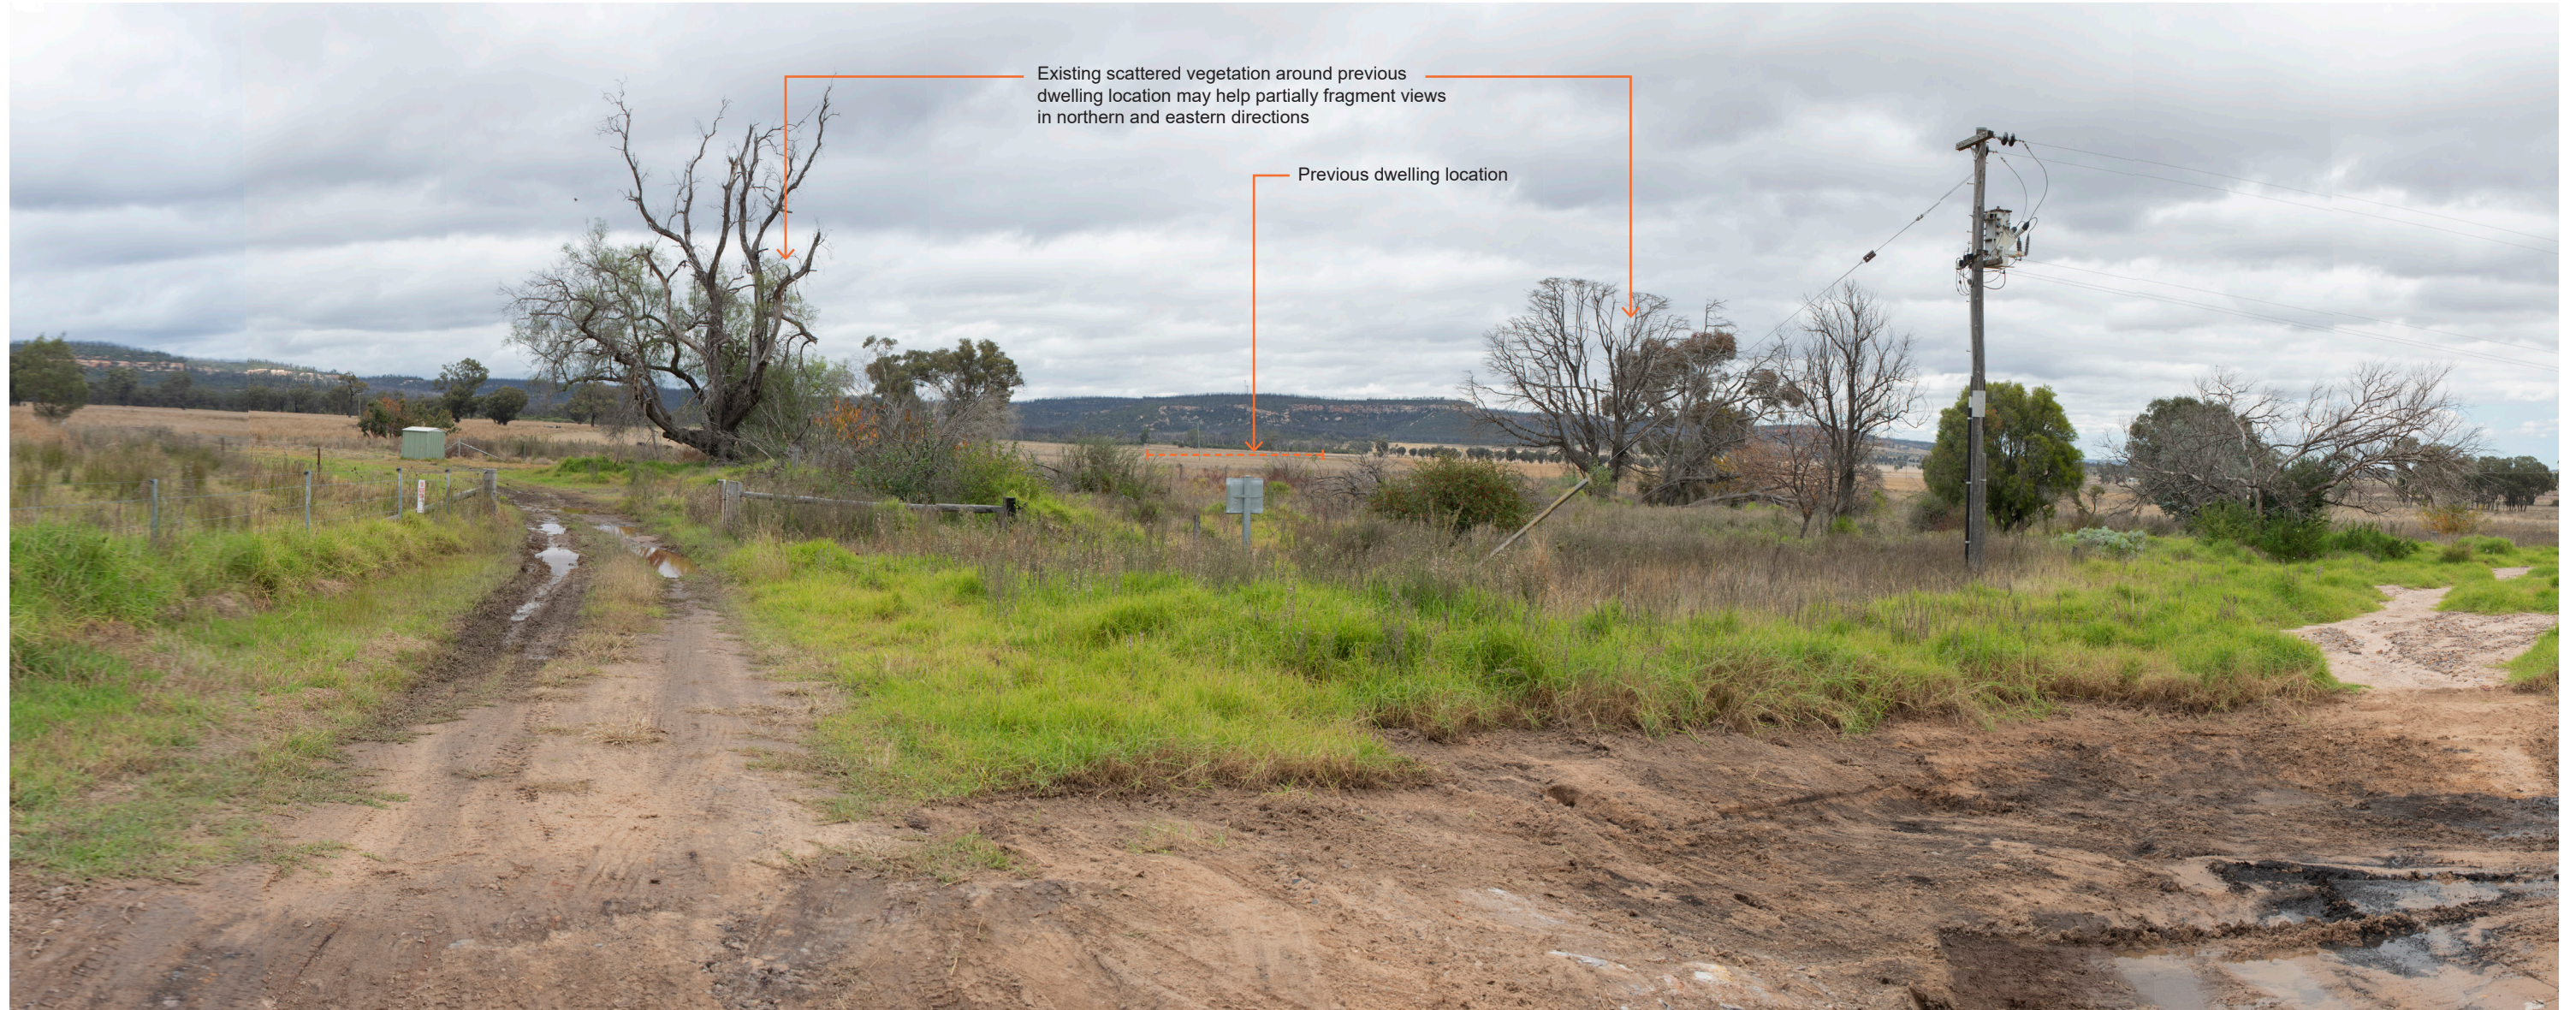
Existing view (photographed from Moorefield Road to the north of Dwelling Location 502)
