**Department of Education (School Infrastructure) NSW
Mosman High School Geotechnical Investigation Report
754-SYDGE233510**

Mosman High School Geotechnical Investigation Report

Prepared for
Department of Education (School Infrastructure) NSW

754-SYDGE233510

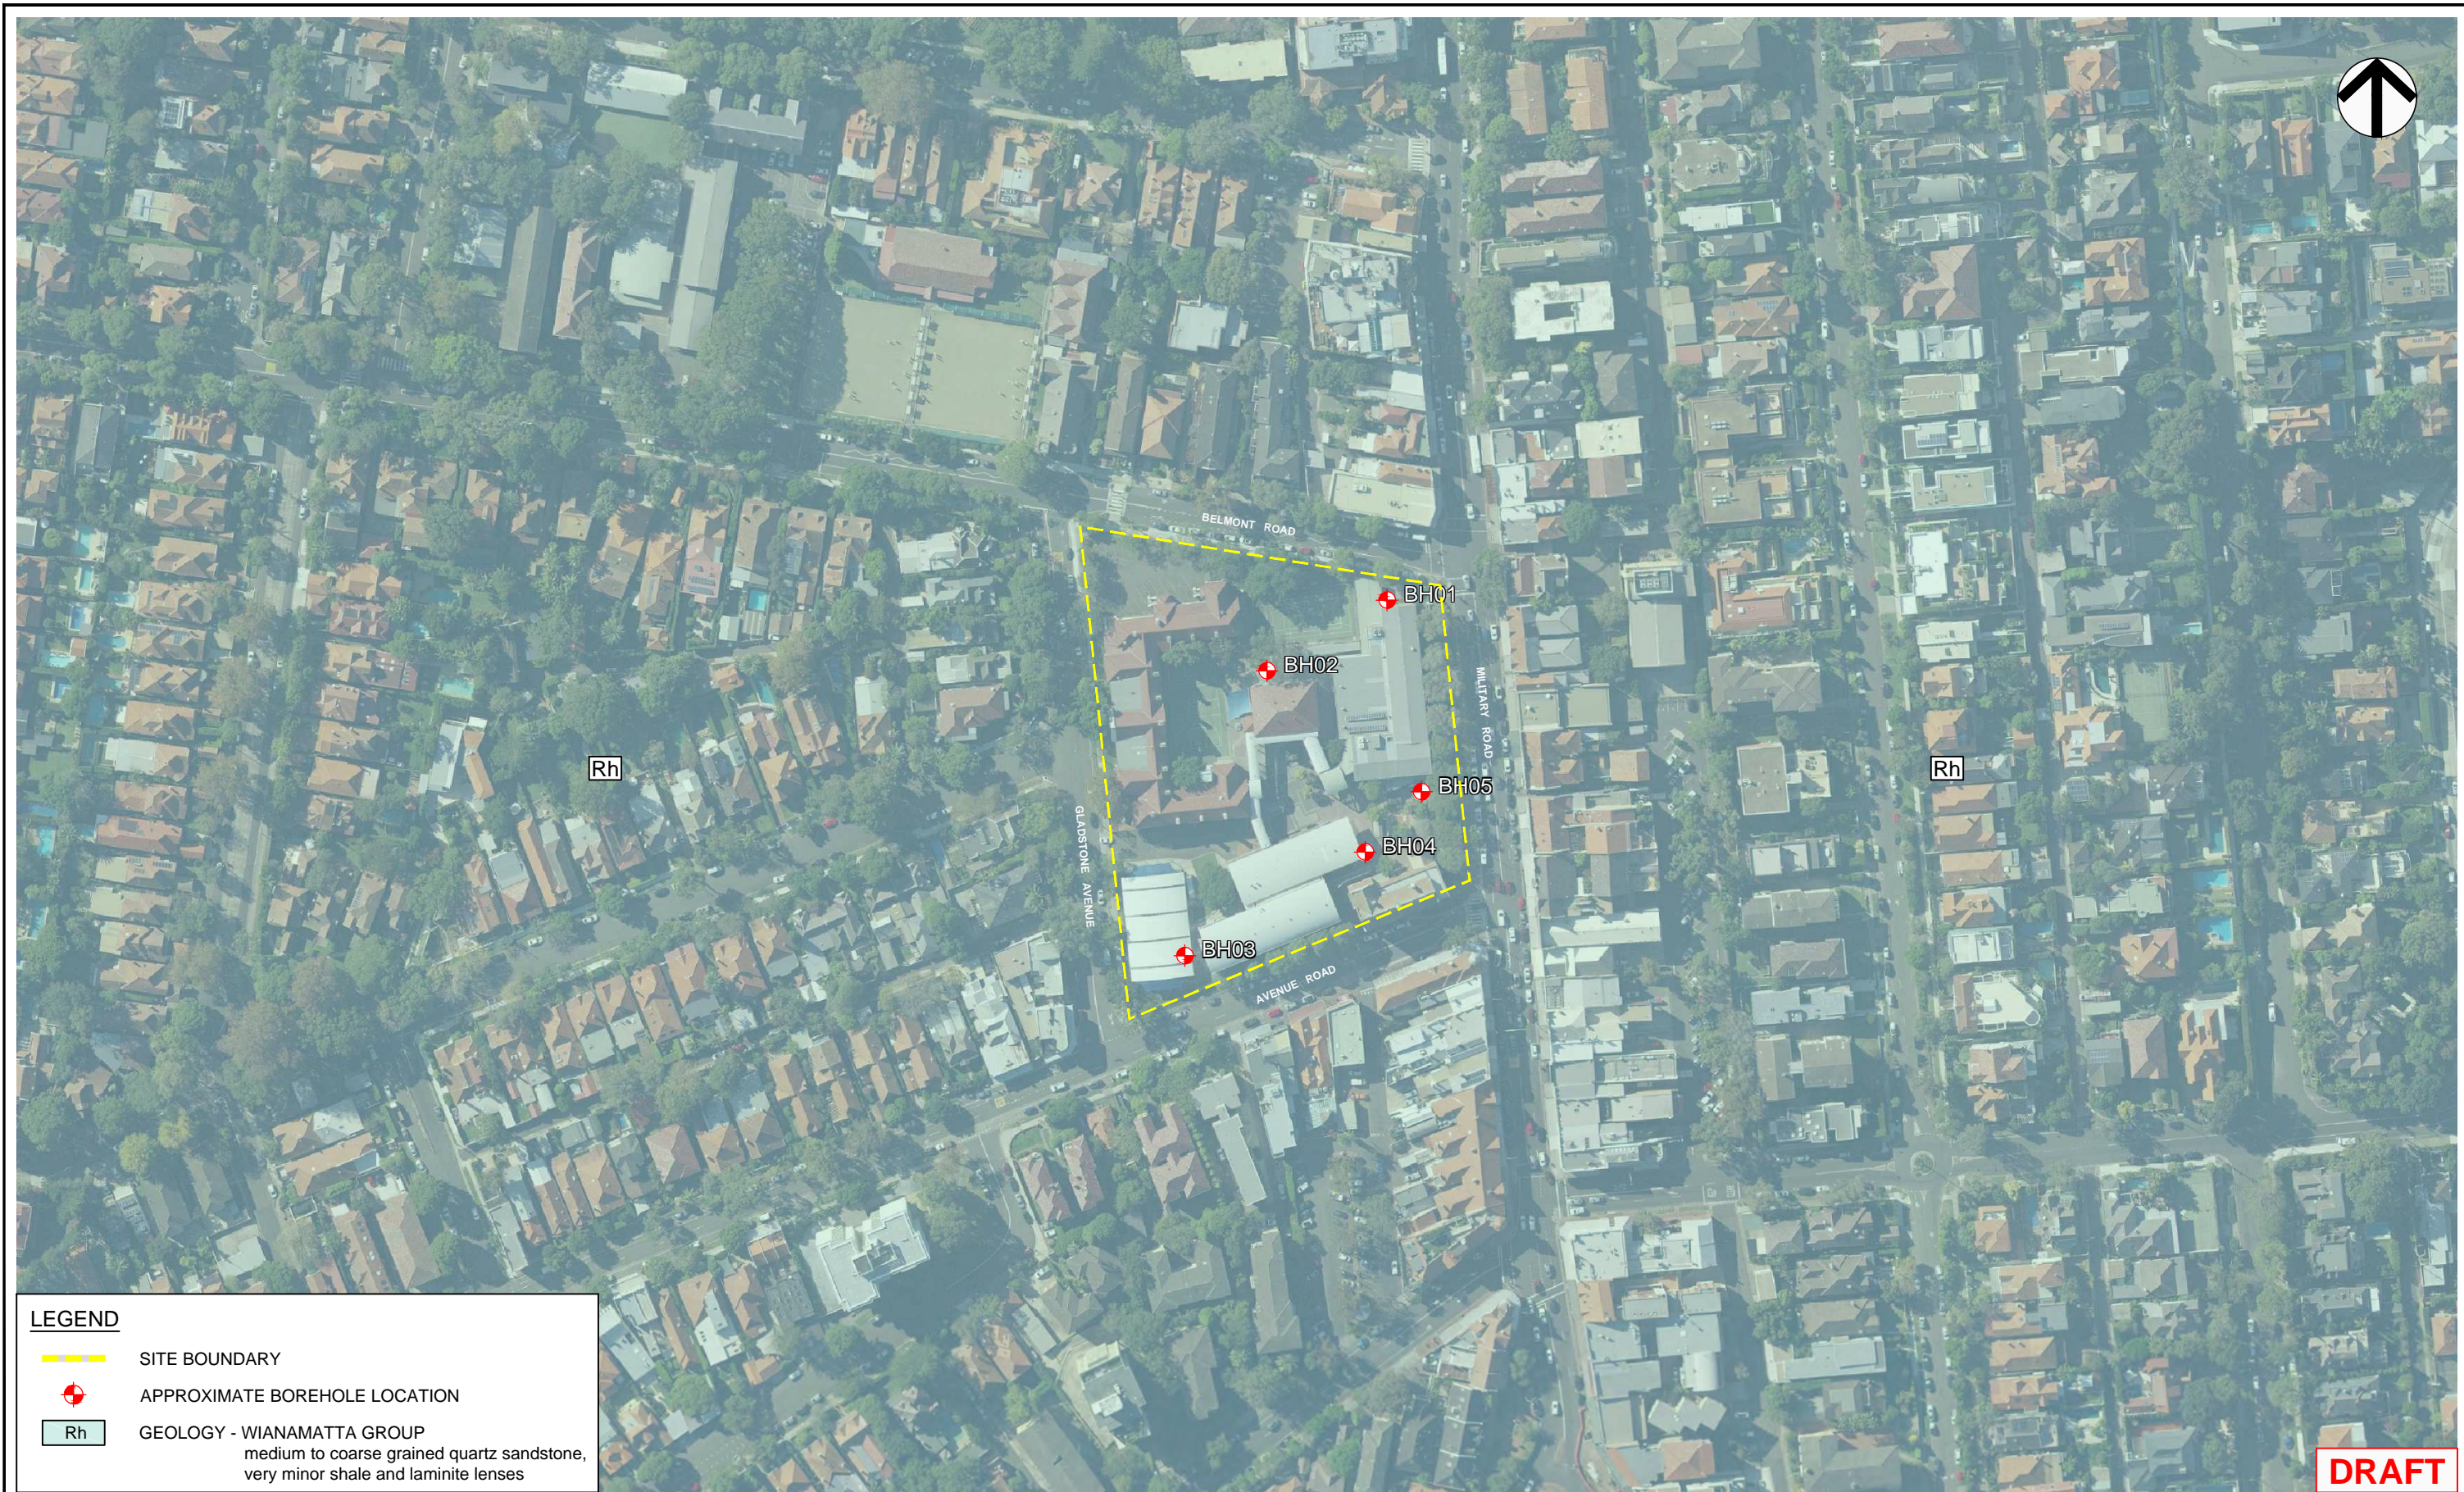
client:	SCHOOL INFRASTRUCTURE NSW		
project:	MOSMAN HIGH SCHOOL GEOTECHNICAL AND CONTAMINATION ASSESSMENT 745 MILITARY ROAD, MOSMAN, NSW		
title:	SITE PLAN SHOWING GEOLOGY		
project no:	754-SYDGE233510-AF	figure no:	FIGURE 2
		rev:	A

- SITE BOUNDARY
- APPROXIMATE BOREHOLE LOCATION
- Rh GEOLOGY - WIANAMATTA GROUP
medium to coarse grained quartz sandstone,
very minor shale and laminite lenses

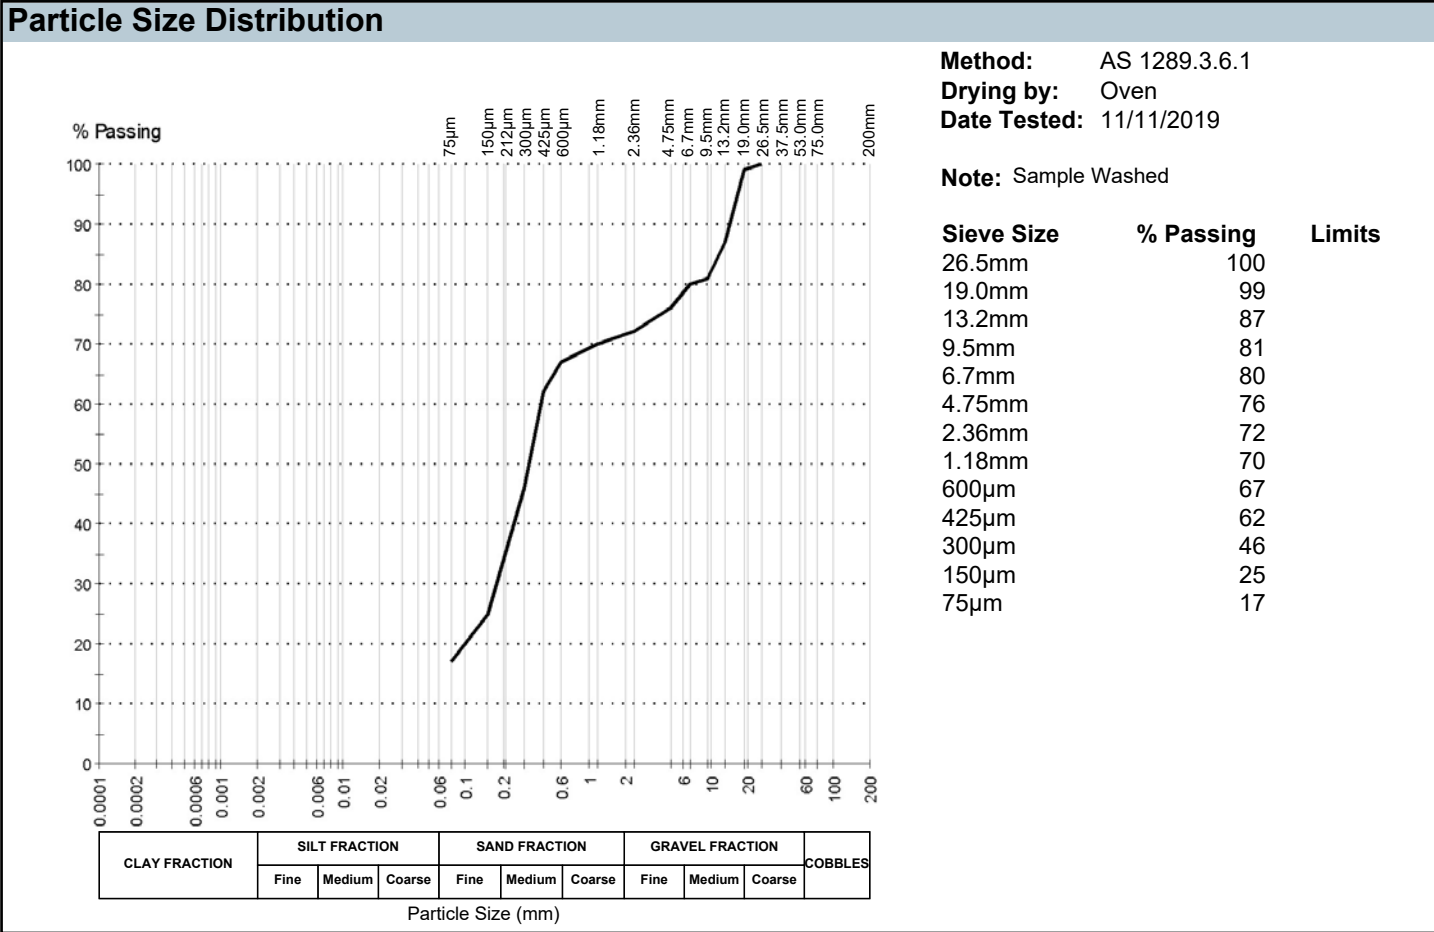
Sample Details		Other Test Results			
Sample ID:	SYDN19S-03138	Description	Method	Result	Limits
Client Sample:		Moisture Content (%)	AS 1289.2.1.1	7.6	
Date Sampled:	02/11/2019	Date Tested		6/11/2019	
Source:	Supplied By Client				
Material:	brown - gravelly Sand				
Specification:	No Specification				
Sampling Method:	Submitted by client				
Project Location:	DOE Mosman High (SYDGE233510)				
Sample Location:	BH04 (0.2-0.4m)

The results of the Particle Size Distribution and Moisture Content tests are summarised in Table 5 below with the laboratory report sheets attached in Appendix D. Results of Point Load Index testing are presented on the borehole logs attached in Appendix C.
