Report on  
Geotechnical Investigation

Buildings B, C and D  
11-17 Khartoum Road and 33-39 Talavera Road  
Macquarie Park

Prepared for  
Stockland Pty Ltd

Project 99609.02  
July 2020

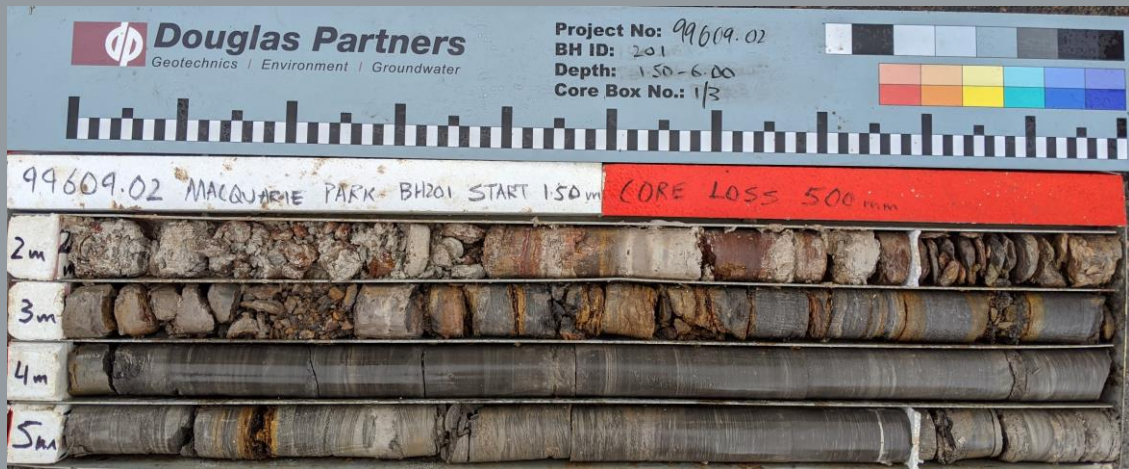
BORE: 201

1.50-6.0m

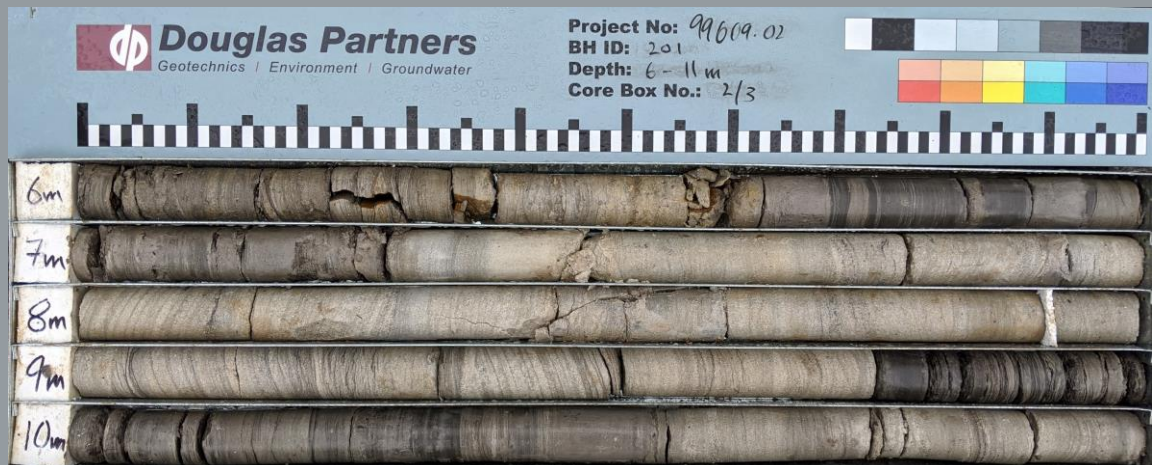
BORE: 201

6.0-11.0m

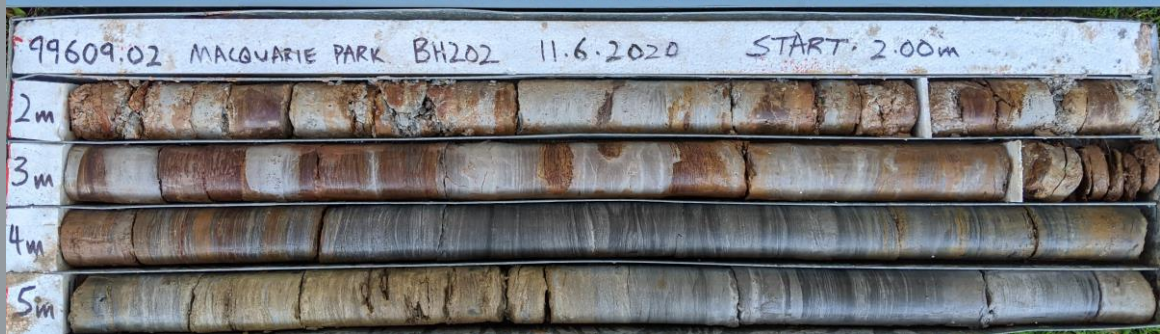
Project No: 99609.02  
BH ID: 202  
Depth: 2.00 - 6.00 m  
Core Box No.: 1/4

2.0-6.0m

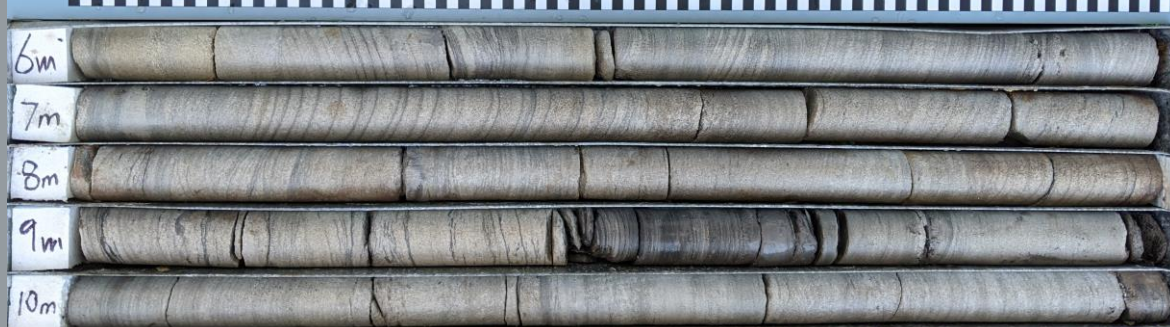
Project No: 99609.02  
BH ID: 202  
Depth: 6.00 - 11.00 m  
Core Box No.: 2/4

6.0-11.0m

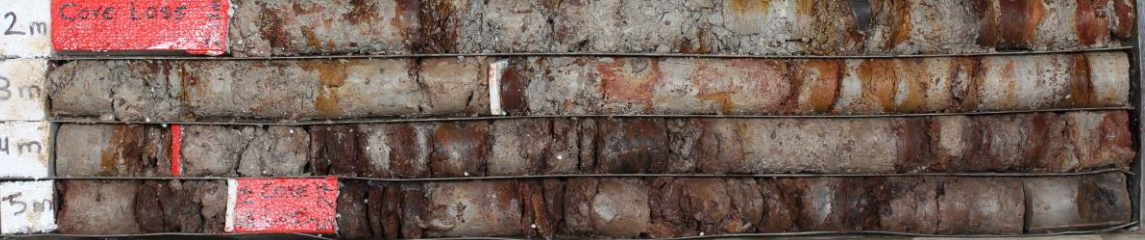
99609.00 Mac Park BH 101 27/02/20 Start at 1.95 m

1.95 - 6.00m

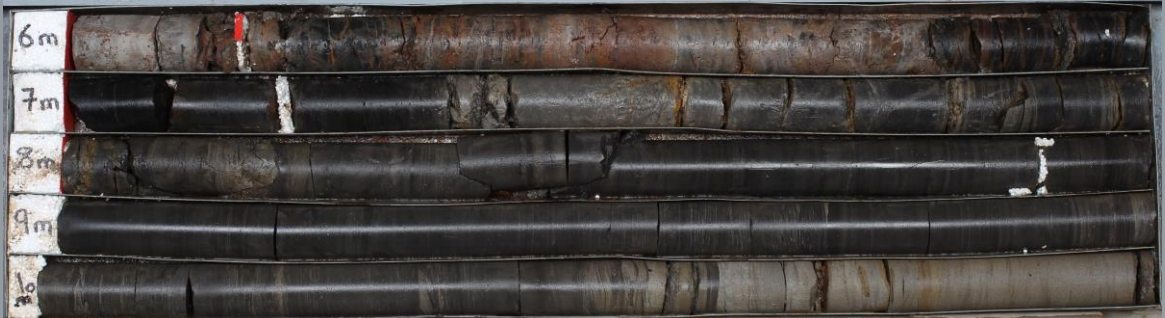
Project No: 99609.00  
BH ID: BH 101  
Depth: 6.00 - 11.00 m  
Core Box No.: 2/4

6.00 - 11.00m
