19 October 2020

LW-009

SITE AUDIT REPORT

PROPOSED WAREHOUSE AND CUSTOMER FULFILLMENT CENTRE, 74 EDINBURGH ROAD, MARRICKVILLE, NSW

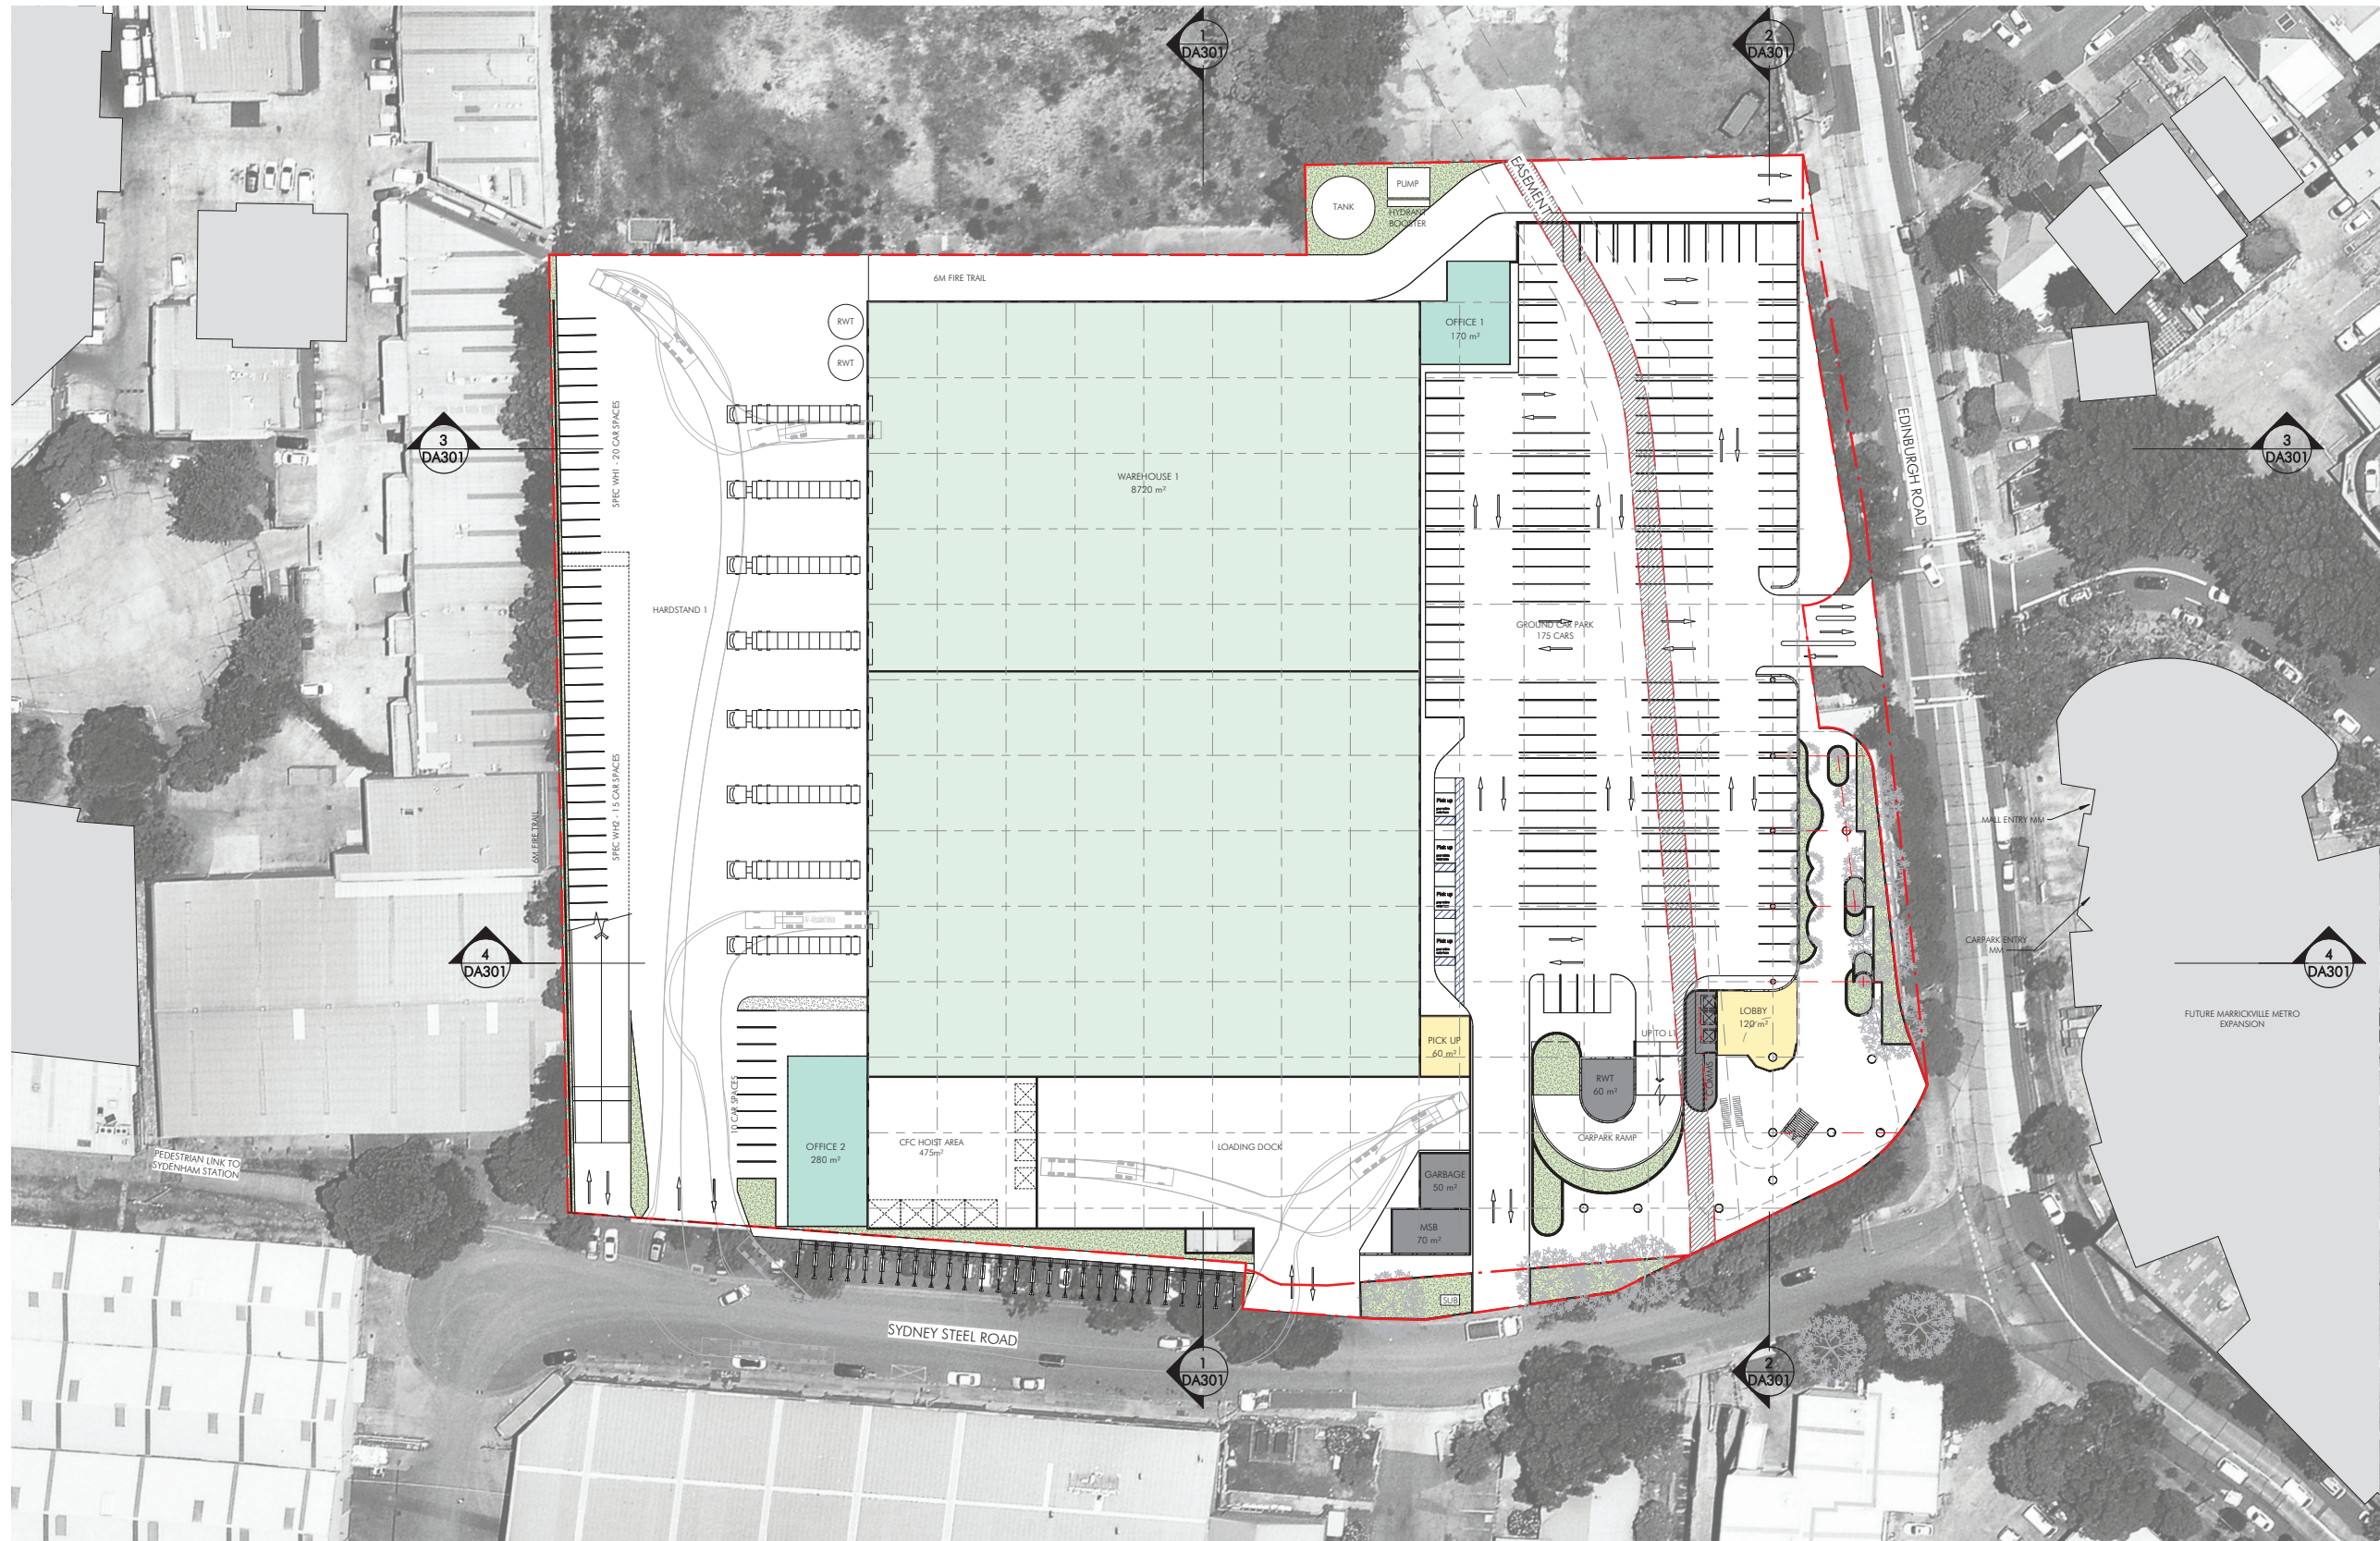
Drawing Title: Ground Floor Plan			
Author: Min	Checker: DC	Sheet Size:	Scale: 1:500
Drawing Number: 10437_DA0101		Issue:	P2

The site is to be redeveloped by Fabcot as a warehouse and CFC comprising a slab on ground warehouse across the majority of the site with a multi-storey car park in the northern portion of the site, access road and loading docks to the east and south and five levels of office space above the warehouse and car park. Access to the site will be from two driveways along the boundary with Edinburgh Road and four along Sydney Steel Road. The proposed site layout is shown in Attachments 4 and 5, Appendix A.
