# SOIL VAPOUR INVESTIGATION REPORT

11-13 Percy Street, Auburn NSW

Fabcot Pty Ltd – September 2020

# Report reference: 2001029Rpt02FinalV02\_21Sep20

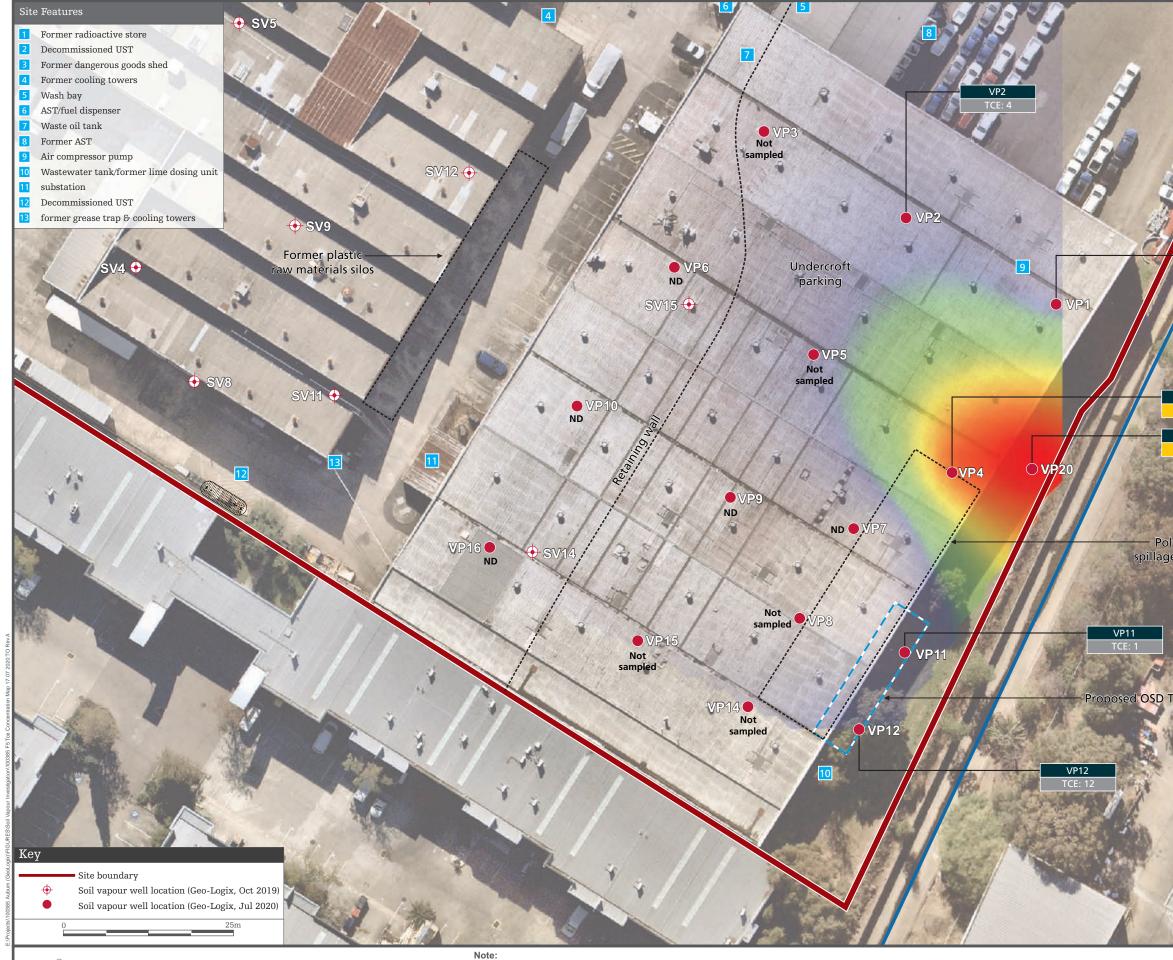
PCE: Tetrachloroethylene VP3, VP5, VP8, VP14 and VP15 were not sampled because of saturated ground conditions

Soil vapour well locations VP3, VP5, VP8, VP14 and VP15 could not be sampled due to saturated ground conditions.

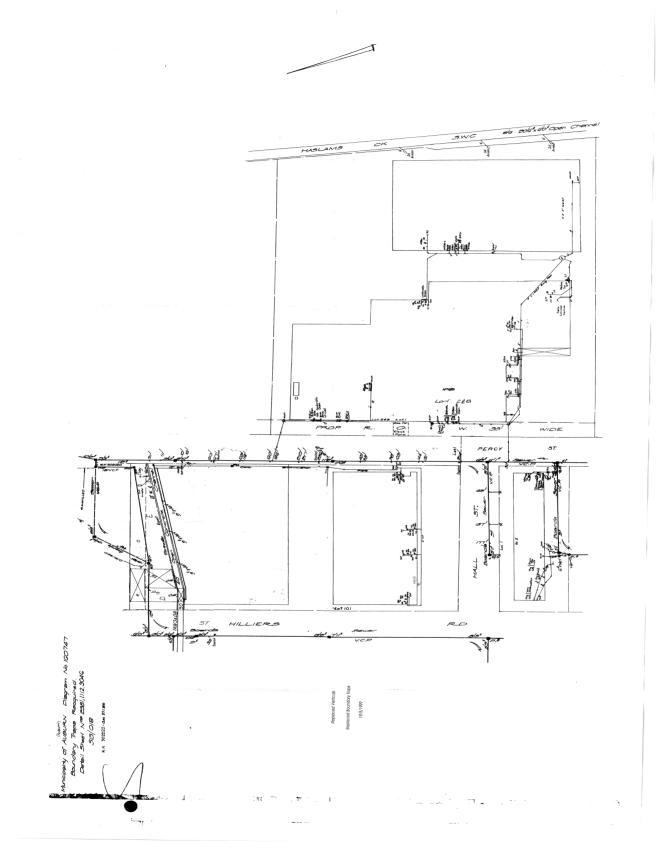
# Sewer Service Diagram

The information in this diagram shows the private wastewater pipes on this property. It may not be accurate or to scale and may not show our pipes, structures or all property boundaries. If you'd like to see these, please buy a **Service location print**.

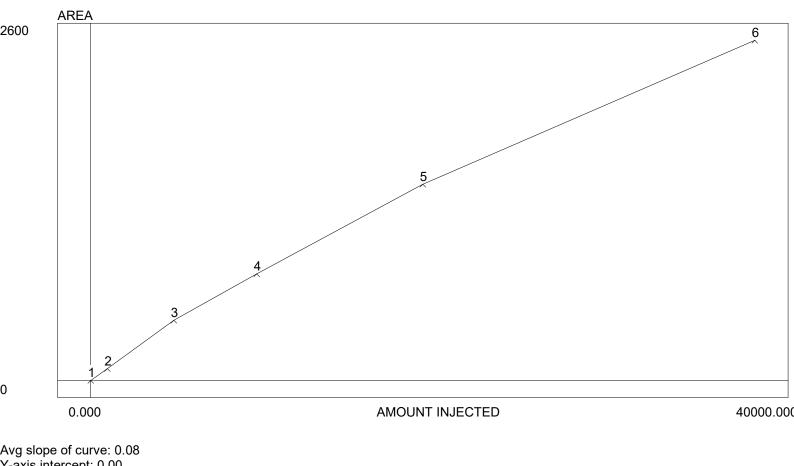
Avg slope of curve: 0.08 Y-axis intercept: 0.00 Linearity: 0.82 Number of levels: 6 SD/rel SD of CF's: 0.0/51.2 Y=<multi-line> r2: 1.0000 Last calibrated: Fri Apr 05 07:43:20 2019

Lvl	. Area/ht.	Amount	CF	Current	Previous #1	Previous #2
1	0.000	0.000	0.000	0.000	N/A	N/A
2	91.000	1000.000	0.091	91.000	N/A	N/A
3	460.000	5000.000	0.092	460.000	N/A	N/A
4	815.000	10000.000	0.082	815.000	N/A	N/A
5	1500.000	20000.000	0.075	1500.000	N/A	N/A
6	2600.000	40000.000	0.065	2600.000	N/A	N/A

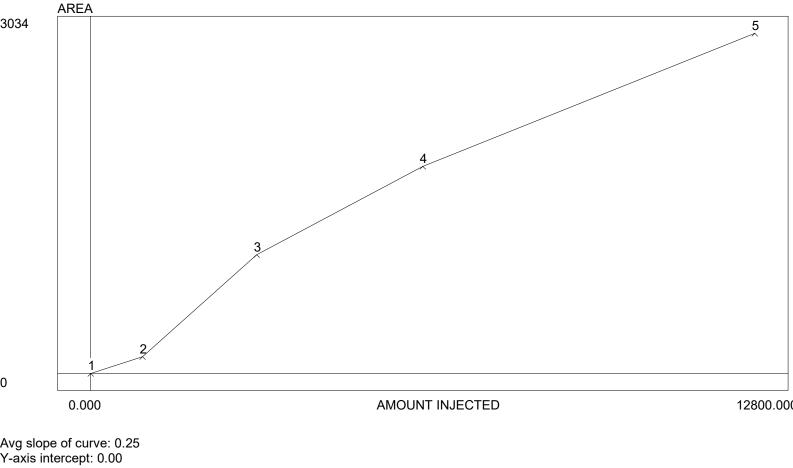
## Calibration file: C:\peak454-64bitWin10\cis DCE Hi Range Hi gain.cal

Y-axis intercept: 0.00 Linearity: 0.60 Number of levels: 5 SD/rel SD of CF's: 0.1/65.2 Y=<multi-line> r2: 1.0000 Last calibrated: Thu Nov 15 11:58:10 2018

Lvl	. Area/ht.	Amount	CF	Current	Previous #1	Previous #2
1	0.000	0.000	0.000	0.000	N/A	N/A
2	150.000	1000.000	0.150	150.000	N/A	N/A
3	1060.000	3200.000	0.331	1060.000	N/A	N/A
4	1847.000	6400.000	0.289	1847.000	N/A	N/A
5	3034.000	12800.000	0.237	3034.000	N/A	N/A

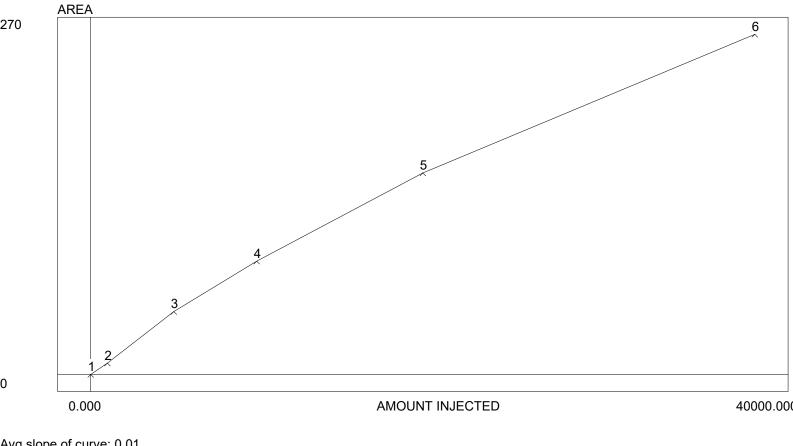
## Calibration file: C:\peak454-64bitWin10\PID Ethyl B.cal

Avg slope of curve: 0.01 Y-axis intercept: 0.00 Linearity: 0.78 Number of levels: 6 SD/rel SD of CF's: 0.0/51.4 Y=<multi-line> r2: 1.0000 Last calibrated: Fri Apr 05 07:45:30 2019

Area/ht.	Amount	CF	Current	Previous #1	Previous #2
0.000	0.000	0.000	0.000	N/A	N/A
9.000	1000.000	0.009	9.000	N/A	N/A
50.000	5000.000	0.010	50.000	N/A	N/A

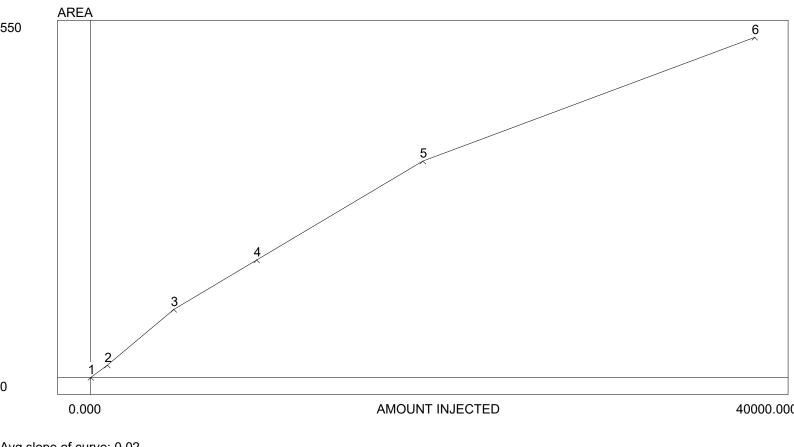
Avg slope of curve: 0.02 Y-axis intercept: 0.00 Linearity: 0.75 Number of levels: 6 SD/rel SD of CF's: 0.0/52.2 Y=<multi-line> r2: 1.0000 Last calibrated: Fri Apr 05 07:48:47 2019

Area/ht.	Amount	CF	Current	Previous #1	Previous #2
0.000	0.000	0.000	0.000	N/A	N/A
20.000	1000.000	0.020	20.000	N/A	N/A
110.000	5000.000	0.022	110.000	N/A	N/A
190.000	10000.000	0.019	190.000	N/A	N/A
350.000	20000.000	0.018	350.000	N/A	N/A
550.000	40000.000	0.014	550.000	N/A	N/A
	0.000 20.000 110.000 190.000 350.000	0.0000.00020.0001000.000110.0005000.000190.00010000.000350.00020000.000	0.0000.0000.00020.0001000.0000.020110.0005000.0000.022190.00010000.0000.019350.00020000.0000.018	0.0000.0000.0000.00020.0001000.0000.02020.000110.0005000.0000.022110.000190.00010000.0000.019190.000350.00020000.0000.018350.000	0.0000.0000.0000.000N/A20.0001000.0000.02020.000N/A110.0005000.0000.022110.000N/A190.00010000.0000.019190.000N/A350.00020000.0000.018350.000N/A

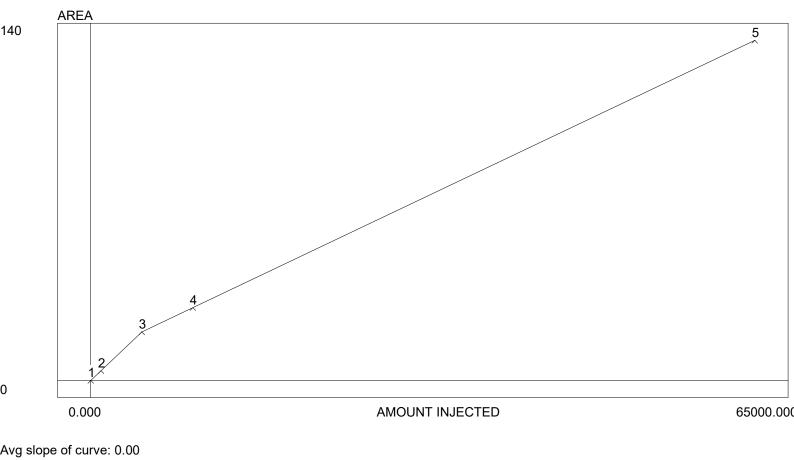
Avg slope of curve: 0.00 Y-axis intercept: 0.00 Linearity: 0.75 Number of levels: 5 SD/rel SD of CF's: 0.0/63.1 Y=<multi-line> r2: 1.0000 Last calibrated: Thu Dec 19 08:53:10 2019

Lvl	. Area/ht.	Amount	CF	Current	Previous #1	Previous #2
1	0.000	0.000	0.000	0.000	N/A	N/A
2	4.000	1000.000	0.004	4.000	N/A	N/A
3	20.000	5000.000	0.004	20.000	N/A	N/A
4	30.000	10000.000	0.003	30.000	N/A	N/A
5	140.000	65000.000	0.002	140.000	N/A	N/A

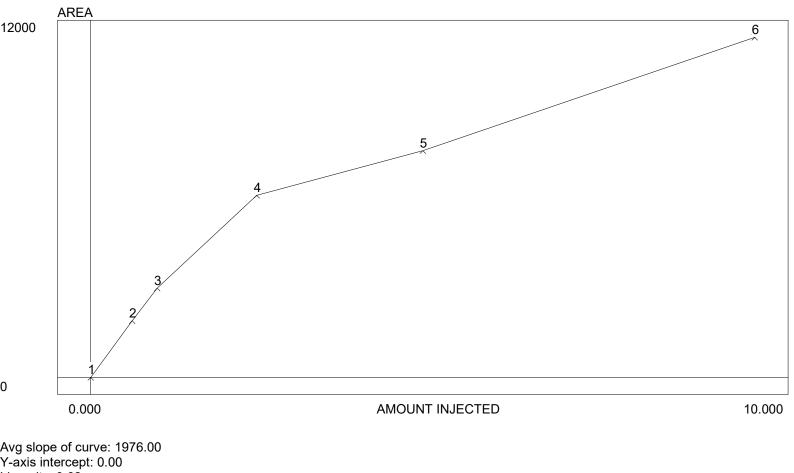
Avg slope of curve: 1976.00 Y-axis intercept: 0.00 Linearity: 0.62 Number of levels: 6 SD/rel SD of CF's: 1254.9/64.2 Y=<multi-line> r2: 1.0000 Last calibrated: Fri Feb 14 10:52:35 2020

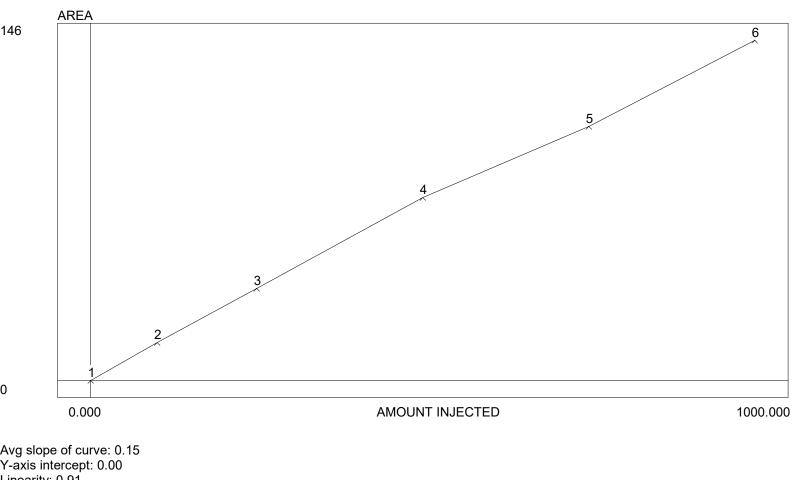
Avg slope of curve: 0.15 Y-axis intercept: 0.00 Linearity: 0.91 Number of levels: 6 SD/rel SD of CF's: 0.1/49.3 Y=<multi-line> r2: 1.0000 Last calibrated: Tue Oct 16 14:13:44 2018

Lvl	. Area/ht.	Amount	CF	Current	Previous #	1Previous #2
1	0.000	0.000	0.000	0.000	N/A	N/A
2	16.300	100.000	0.163	16.300	N/A	N/A
3	39.500	250.000	0.158	39.500	N/A	N/A
4	78.550	500.000	0.157	78.550	N/A	N/A
5	109.000	750.000	0.145	109.000	N/A	N/A
6	146.000	1000.000	0.146	146.000	N/A	N/A

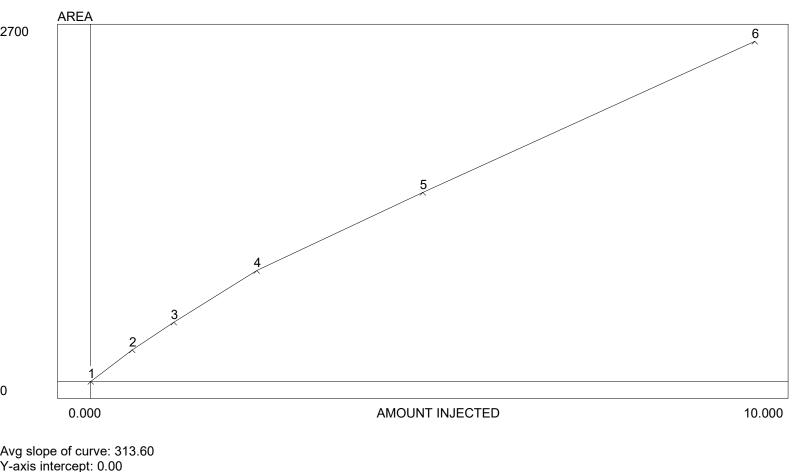
Avg slope of curve: 313.60 Y-axis intercept: 0.00 Linearity: 0.78 Number of levels: 6 SD/rel SD of CF's: 146.7/51.8 Y=<multi-line> r2: 1.0000 Last calibrated: Fri Jun 21 15:57:37 2019

Lvl	. Area/ht.	Amount	CF	Current	Previous #	1Previous #2
1	0.000	0.000	0.000	0.000	N/A	N/A
2	250.000	0.625	400.000	250.000	N/A	N/A
3	470.000	1.250	376.000	470.000	N/A	N/A
4	880.000	2.500	352.000	880.000	N/A	N/A
5	1500.000	5.000	300.000	1500.000	N/A	N/A
6	2700.000	10.000	270.000	2700.000	N/A	N/A

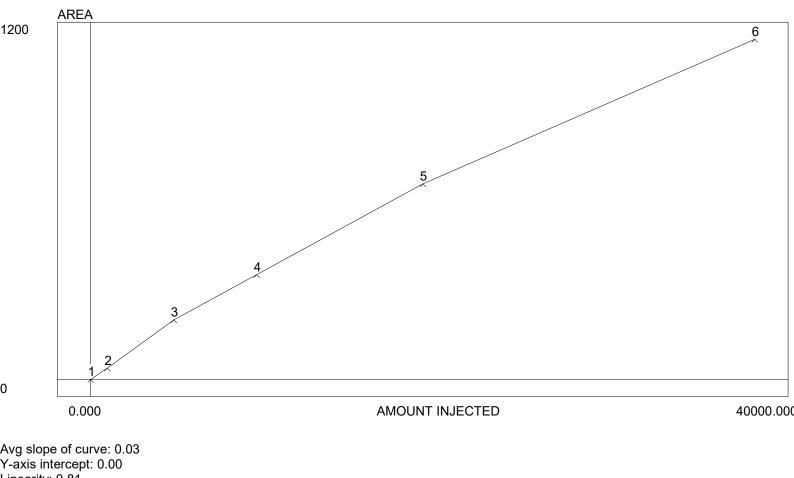
Avg slope of curve: 0.03 Y-axis intercept: 0.00 Linearity: 0.81 Number of levels: 6 SD/rel SD of CF's: 0.0/50.9 Y=<multi-line> r2: 1.0000 Last calibrated: Fri Apr 05 07:44:25 2019

Area/ht.	Amount	CF	Current	Previous #1	Previous #2
0.000	0.000	0.000	0.000	N/A	N/A
40.000	1000.000	0.040	40.000	N/A	N/A
210.000	5000.000	0.042	210.000	N/A	N/A
370.000	10000.000	0.037	370.000	N/A	N/A
690.000	20000.000	0.035	690.000	N/A	N/A
1200.000	40000.000	0.030	1200.000	N/A	N/A
	0.000 40.000 210.000 370.000 690.000	0.0000.00040.0001000.000210.0005000.000370.00010000.000690.00020000.000	0.0000.0000.00040.0001000.0000.040210.0005000.0000.042370.00010000.0000.037690.00020000.0000.035	0.0000.0000.0000.00040.0001000.0000.04040.000210.0005000.0000.042210.000370.00010000.0000.037370.000690.00020000.0000.035690.000	0.0000.0000.0000.000N/A40.0001000.0000.04040.000N/A210.0005000.0000.042210.000N/A370.00010000.0000.037370.000N/A690.00020000.0000.035690.000N/A
